Our Ref: B3031

#### Re: Minto Resource Recovery Facility (SSD-5339) 23 February 2022 - Request for additional Information

### SUPPLEMENTARY TRAFFIC AND PARKING ADVICE FOR RESOURCE RECOVERY FACILITY AT 7 MONTORE ROAD, MINTO

## Re: 7 Montore Road, Minto – Updated Noise Model RWDI# 2101743

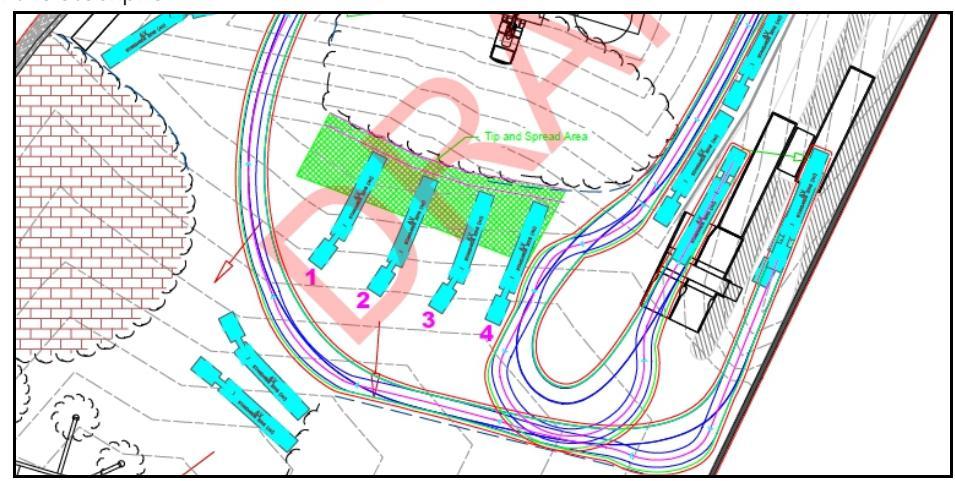
Below is an extract from Drawing No.2021-276-04E of the McLaren Report which depicts the Site at capacity. The area shown as hatched green is the tip and spread area. As indicated above, the trucks reverse into the tip and spread area and the hydraulic tray of the truck is elevated such that material is discharged as the truck moves forward. The material is deposited in the tip and spread area and then pushed into the stockpile. The location of the tip and spread area will vary according to the volume of material in the stockpile

The tipping trucks are required to reverse into the tip and spread area to tip their loads. As the tray of the truck tips the truck moves forward to enable the load to be deposited onto the ground. The truck then moves forward and onto the standing areas to enable the material to be spread on the ground. Once the material is inspected it pushed into the stockpile, ready for the next load to be tipped.

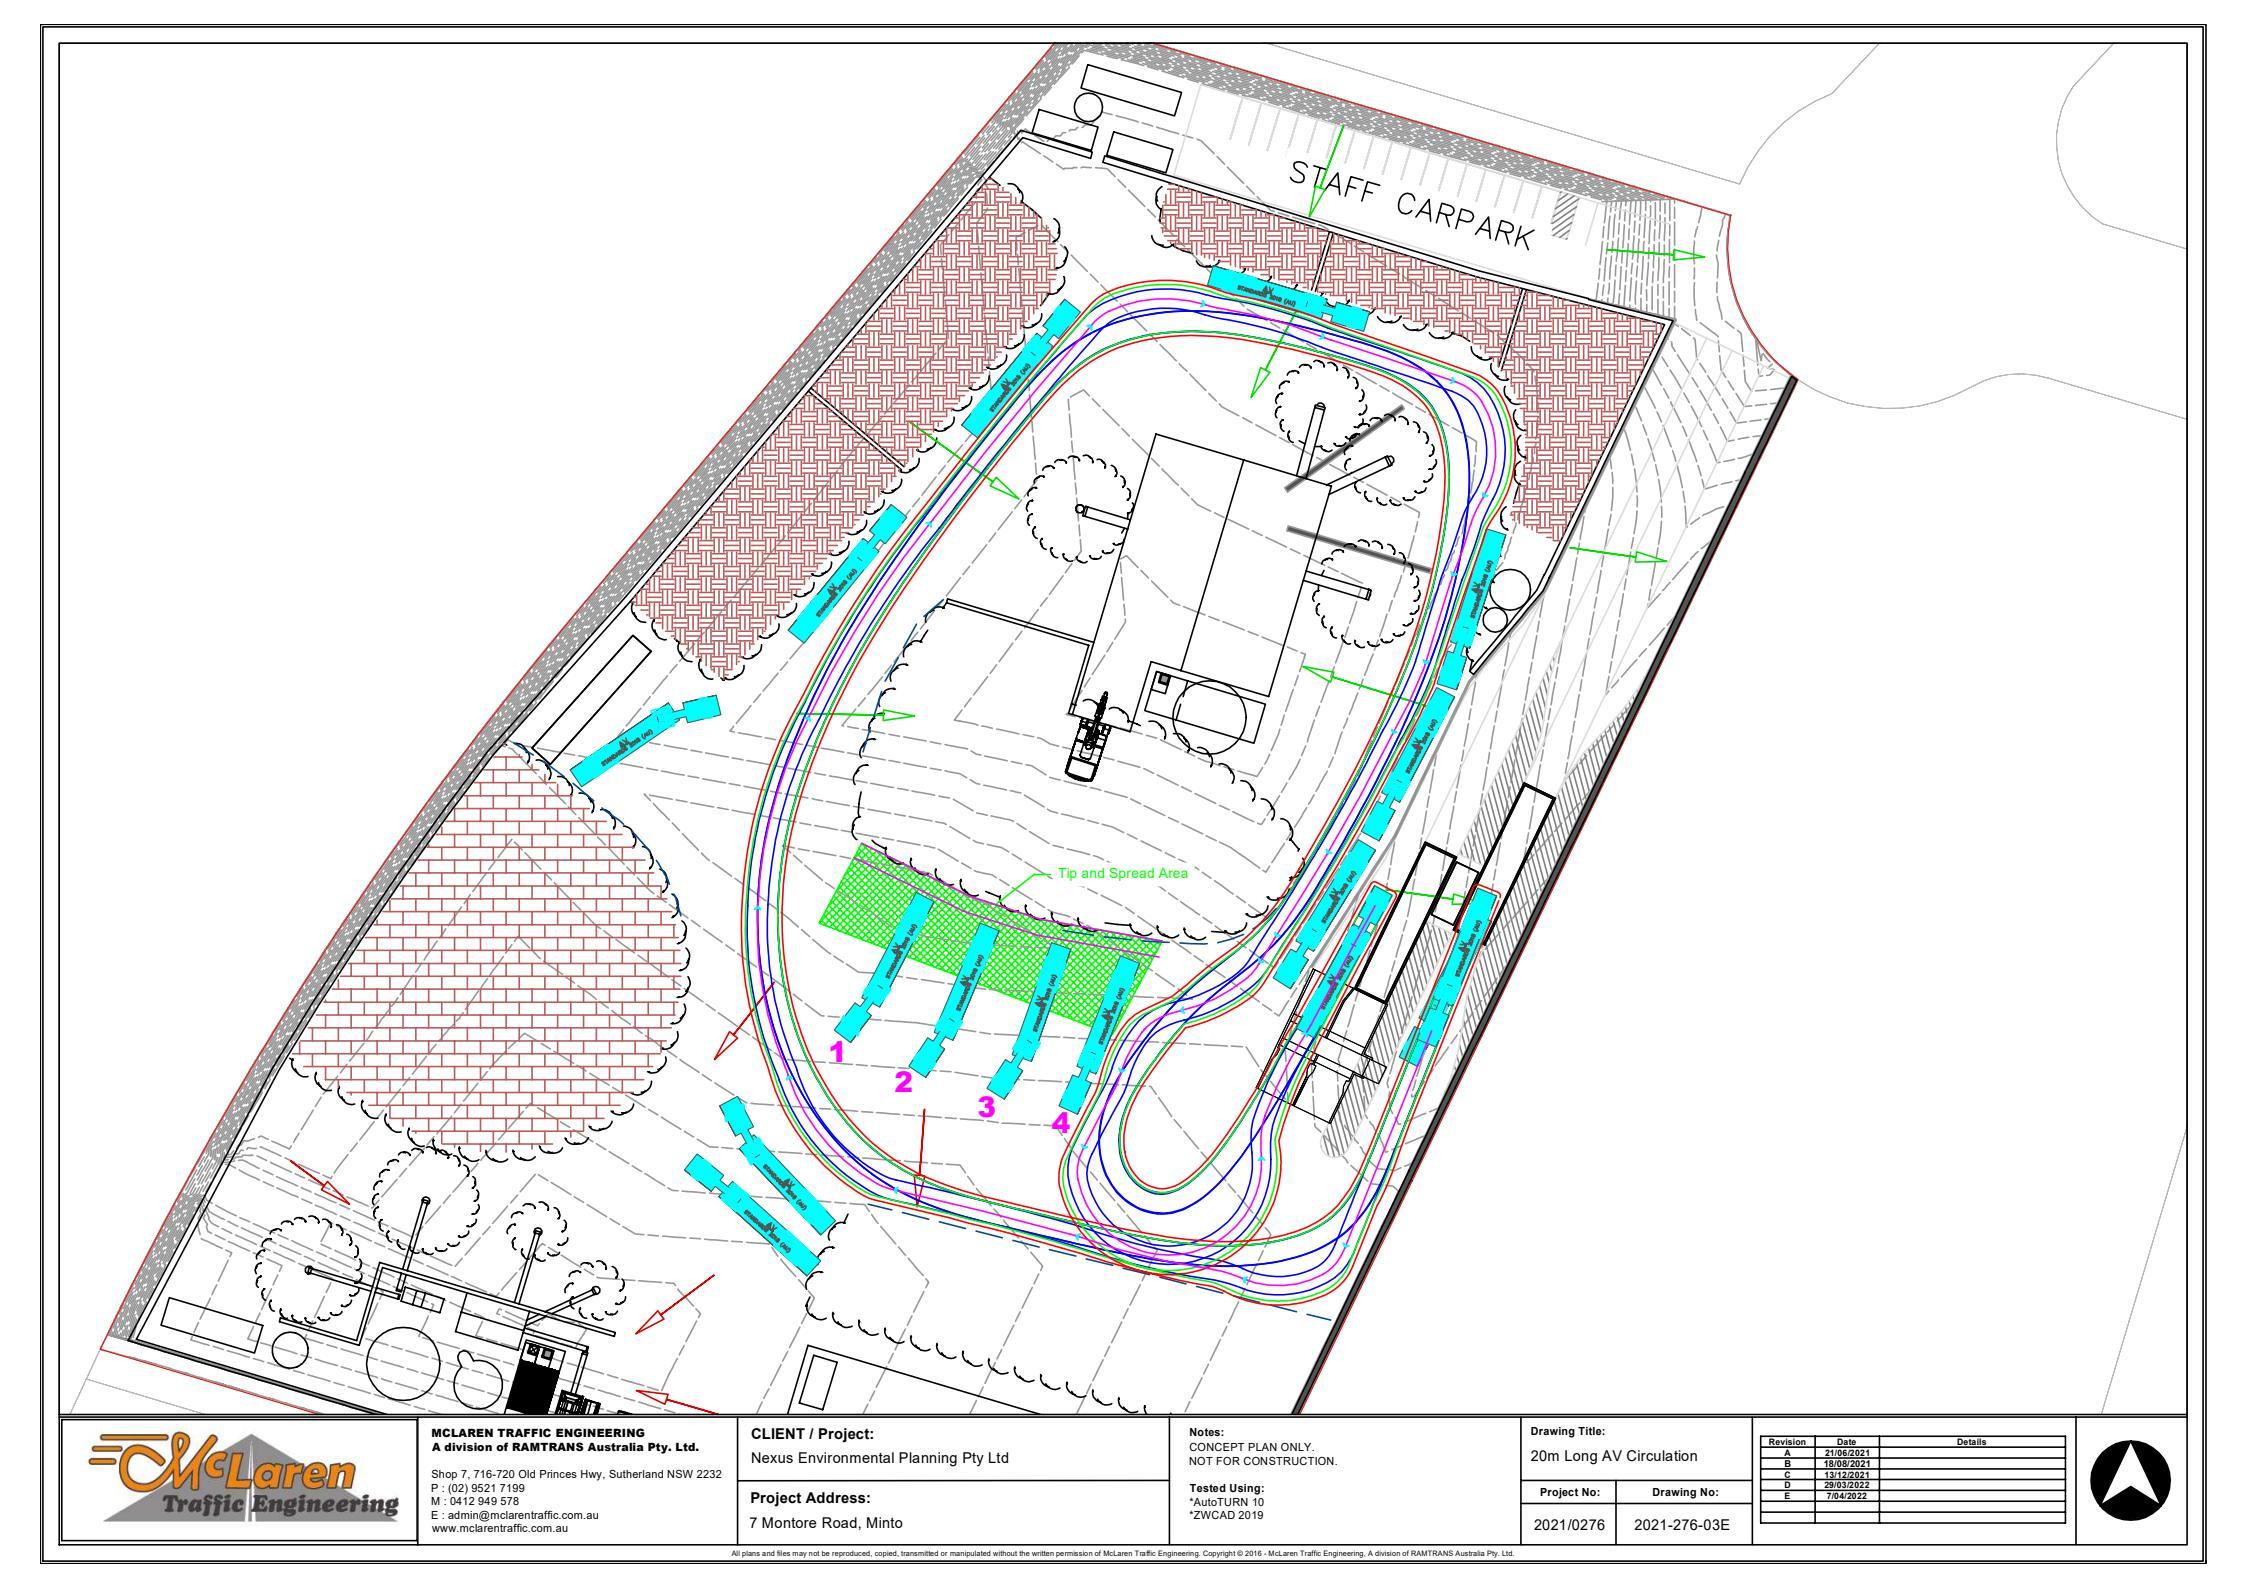
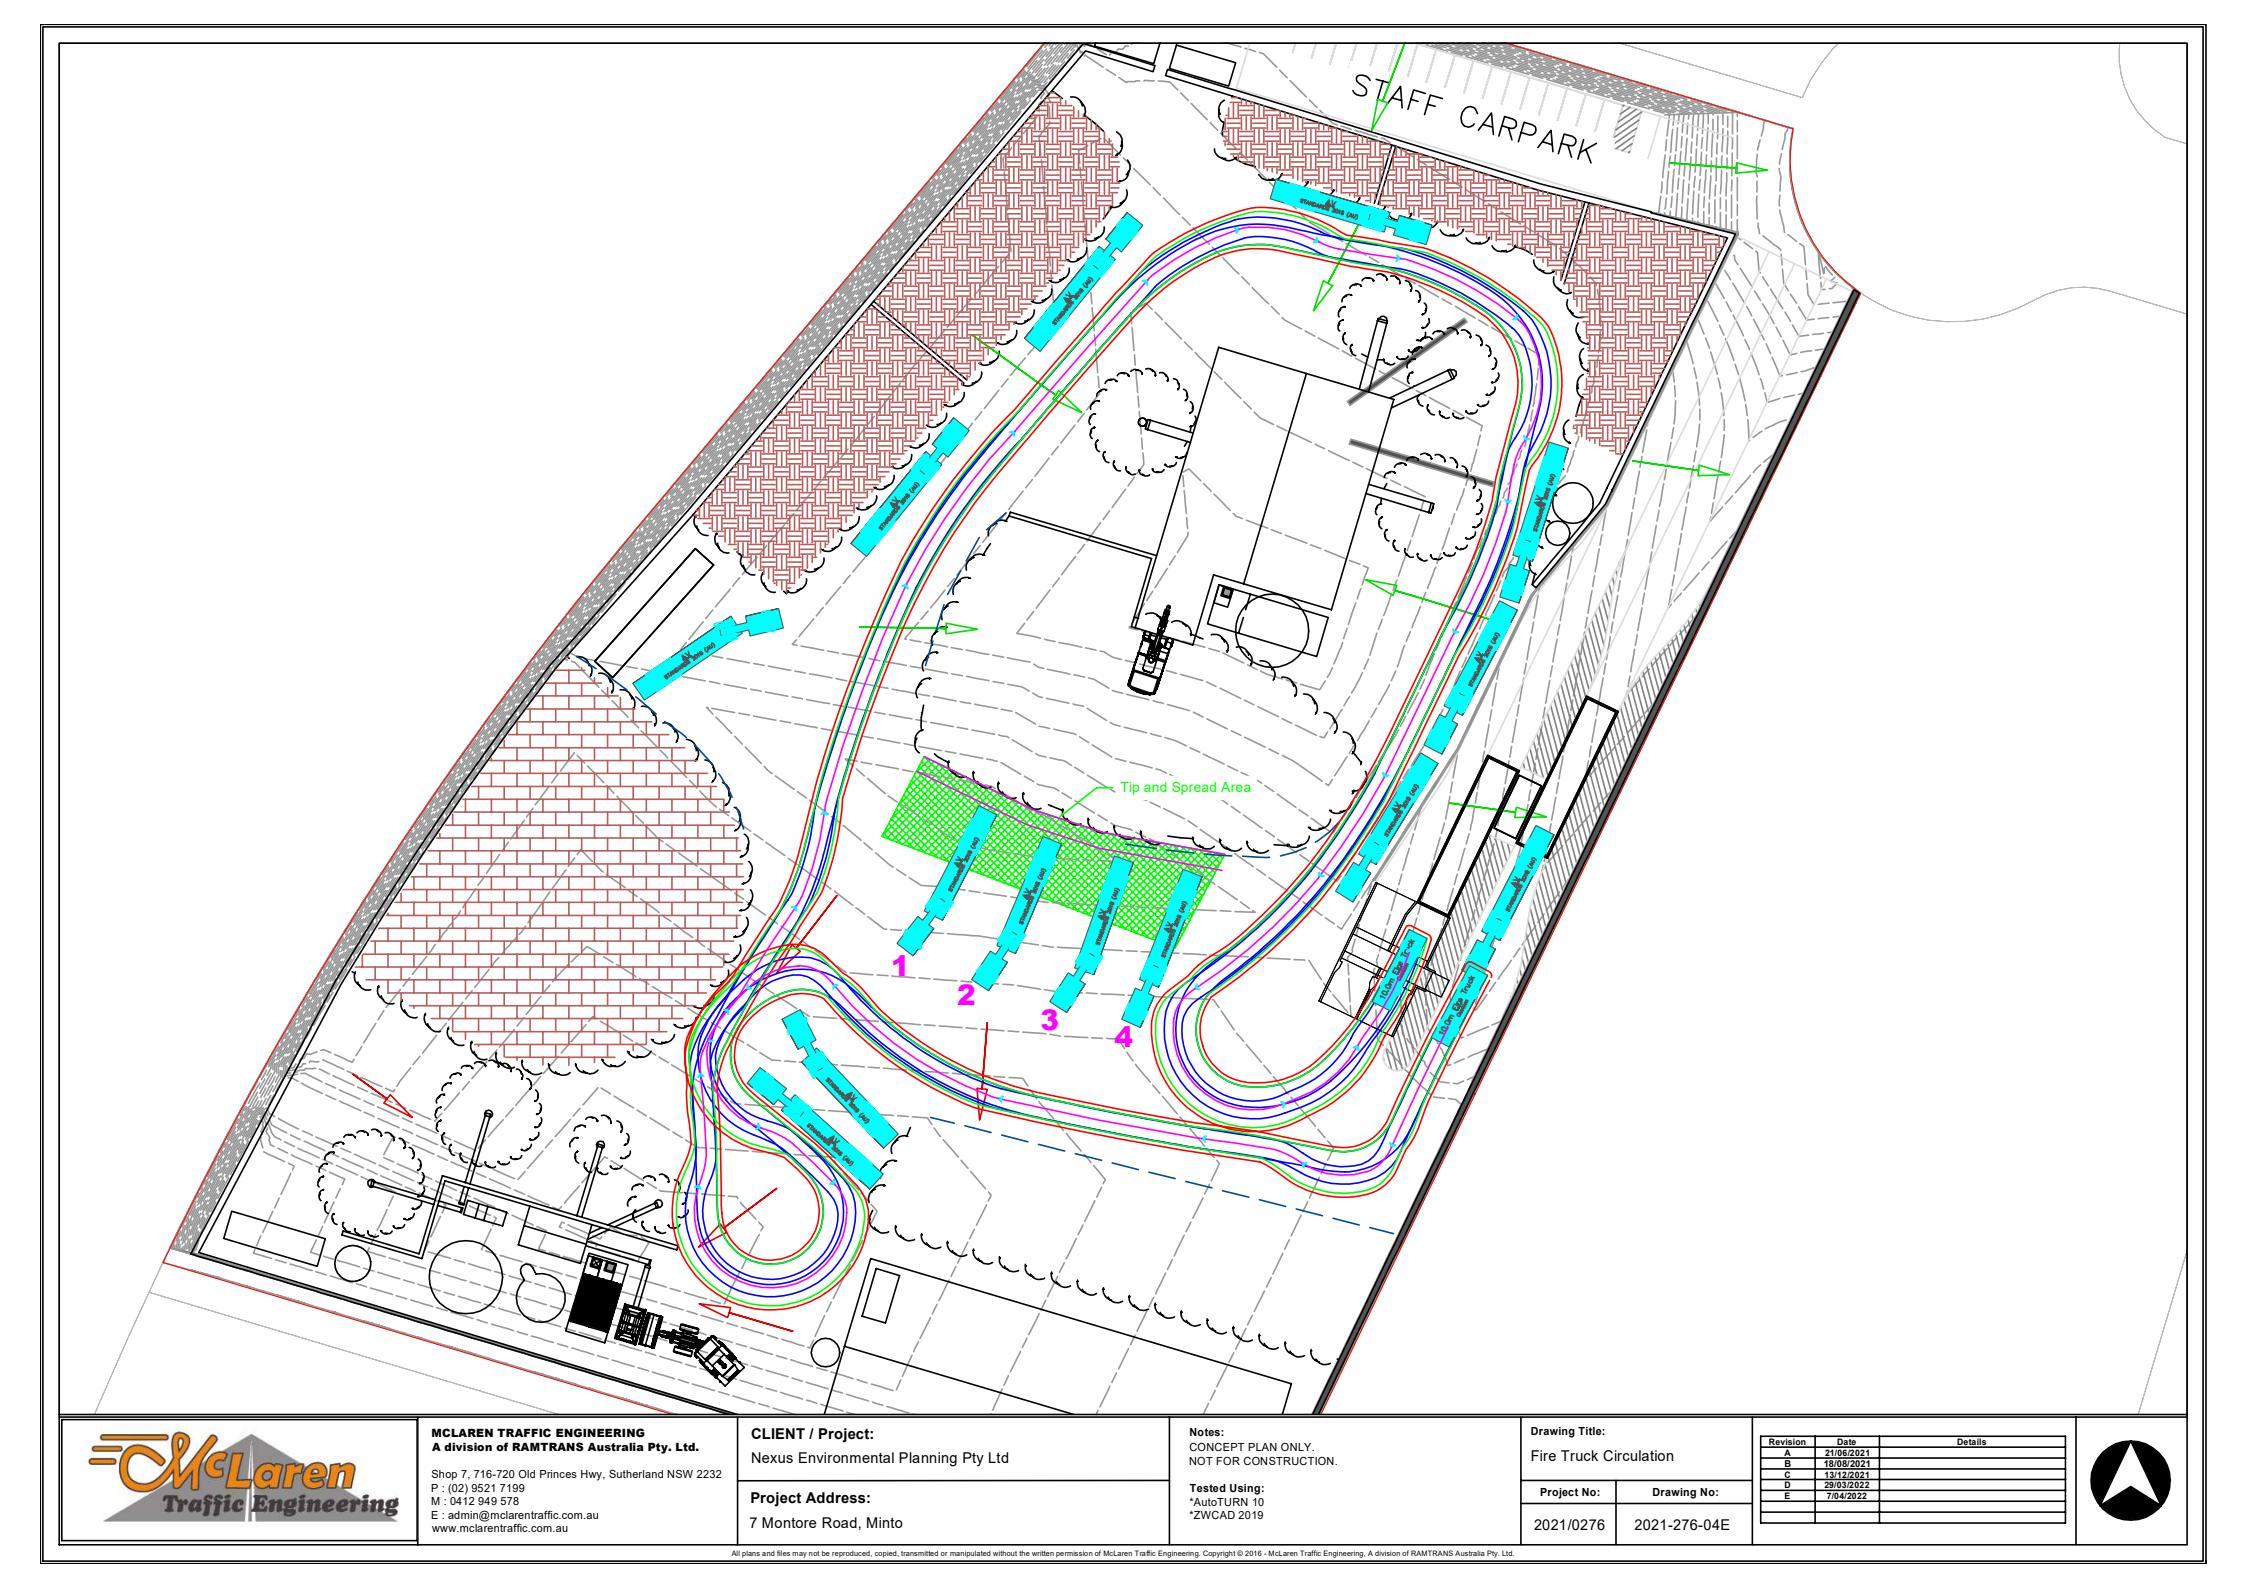
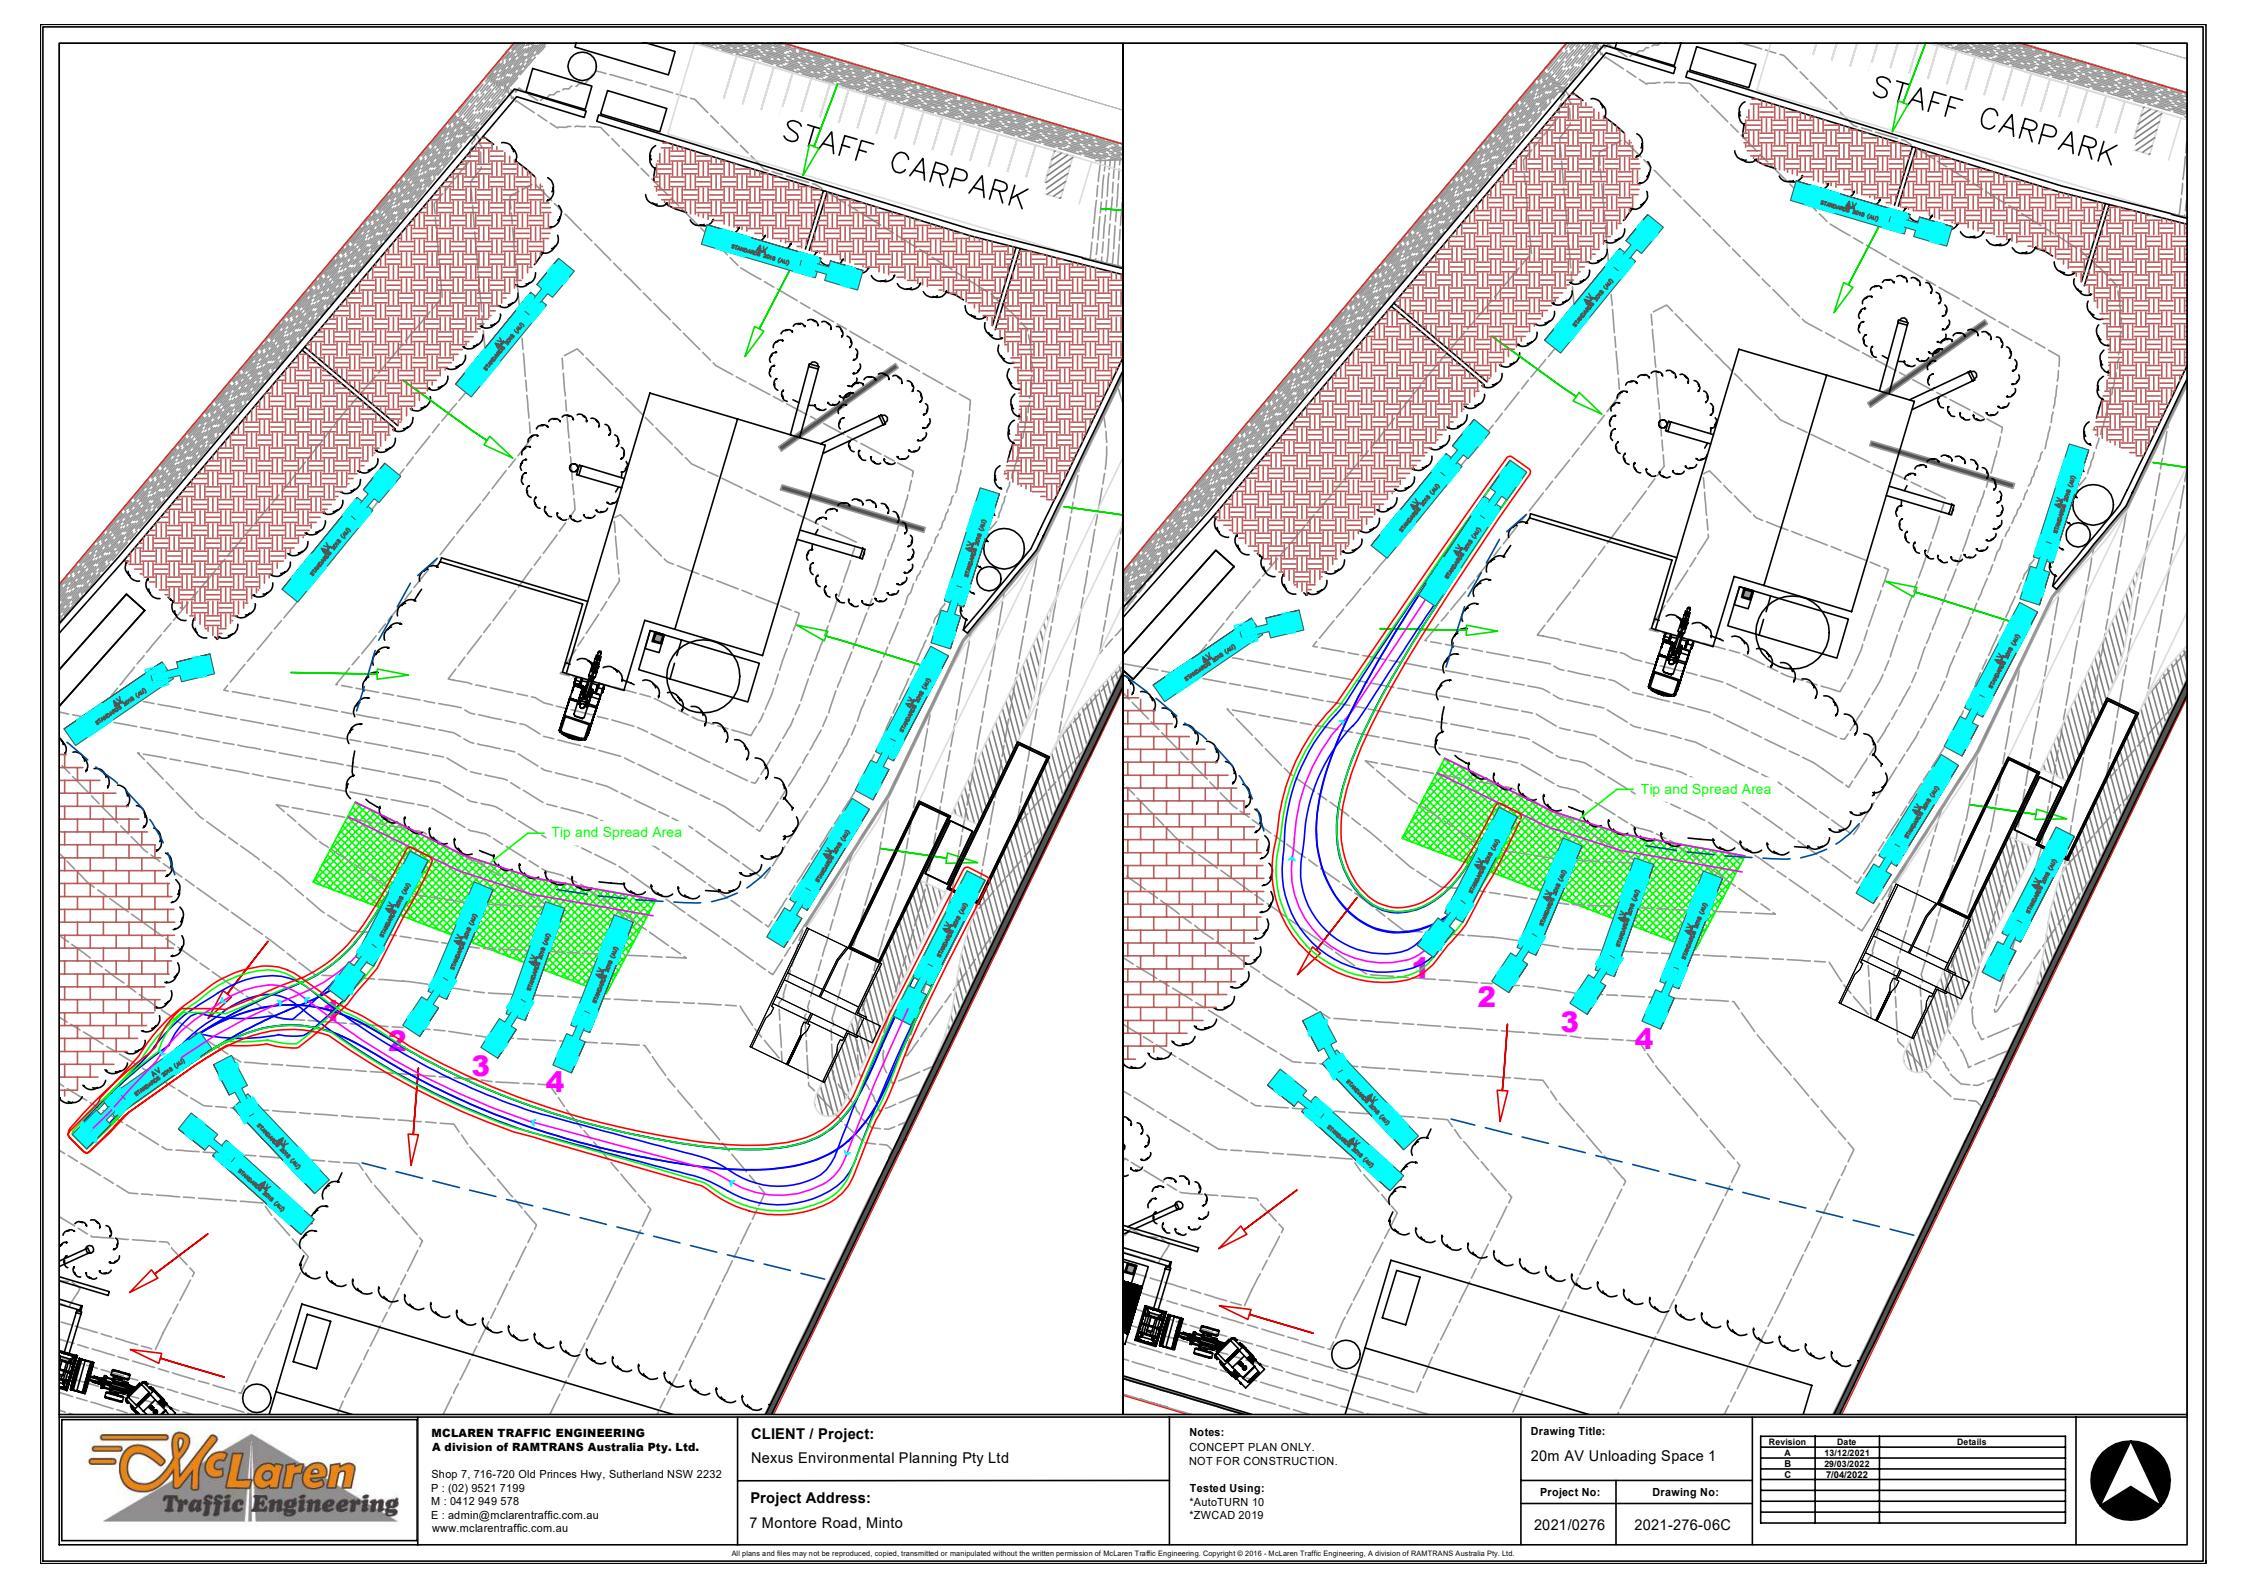
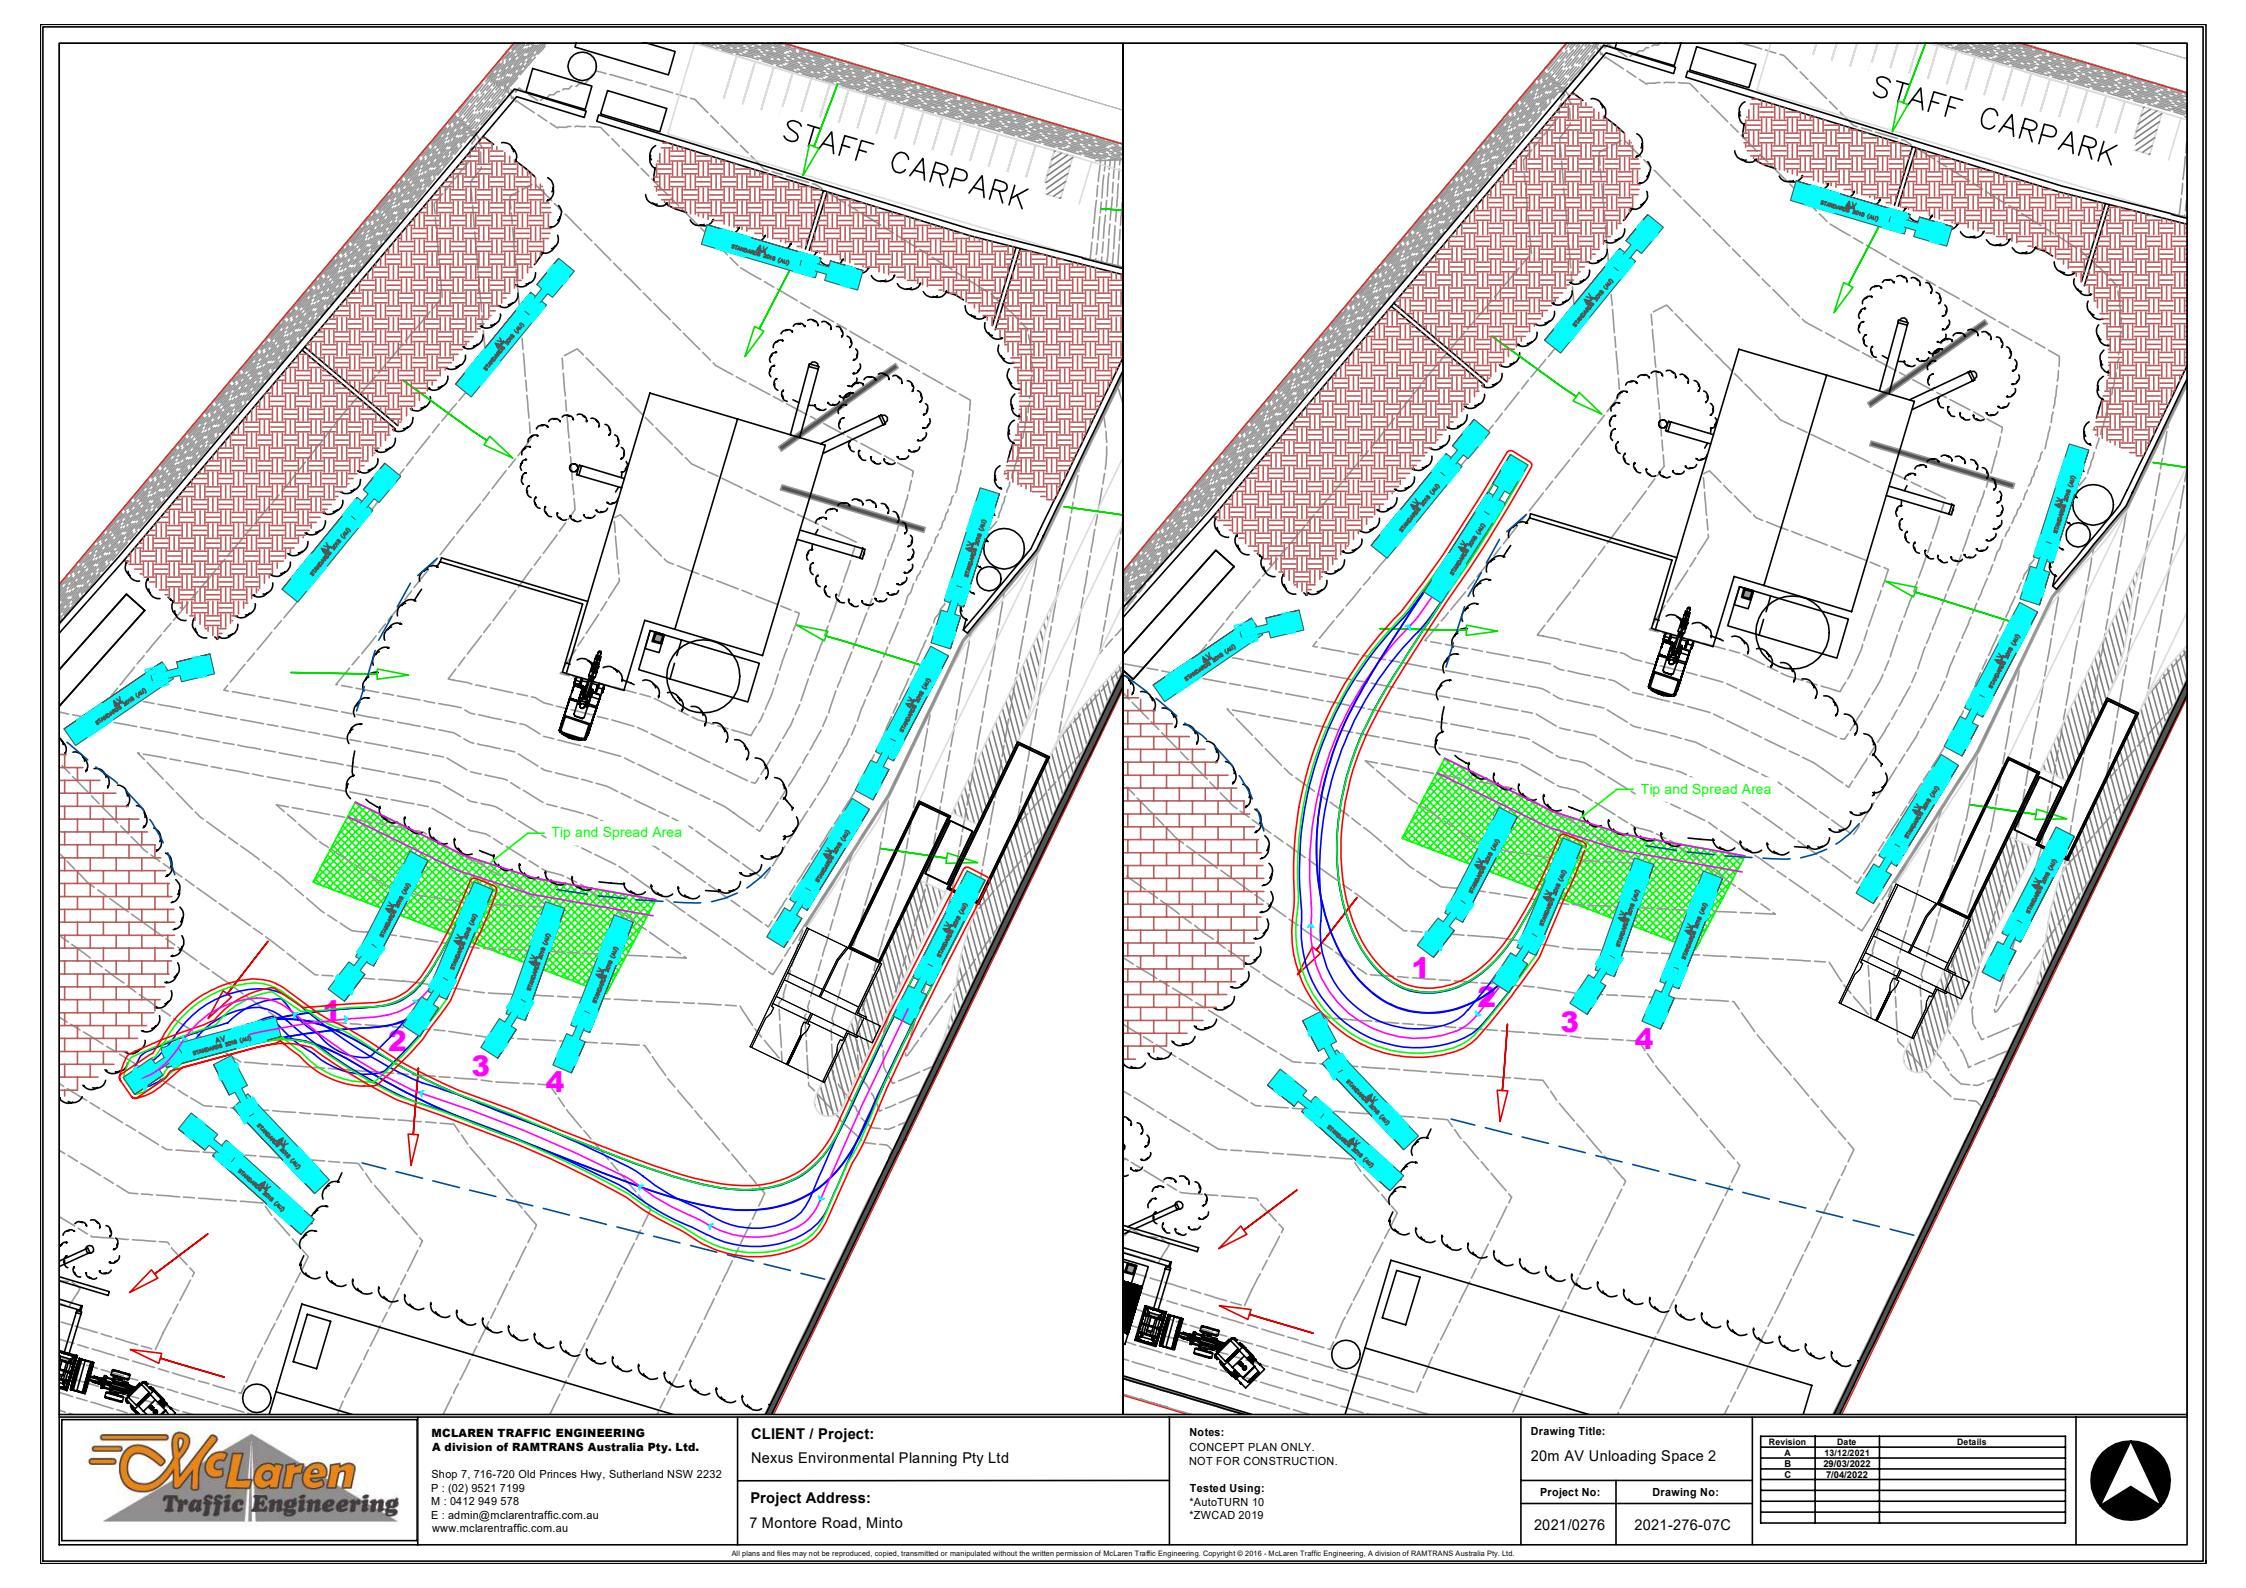
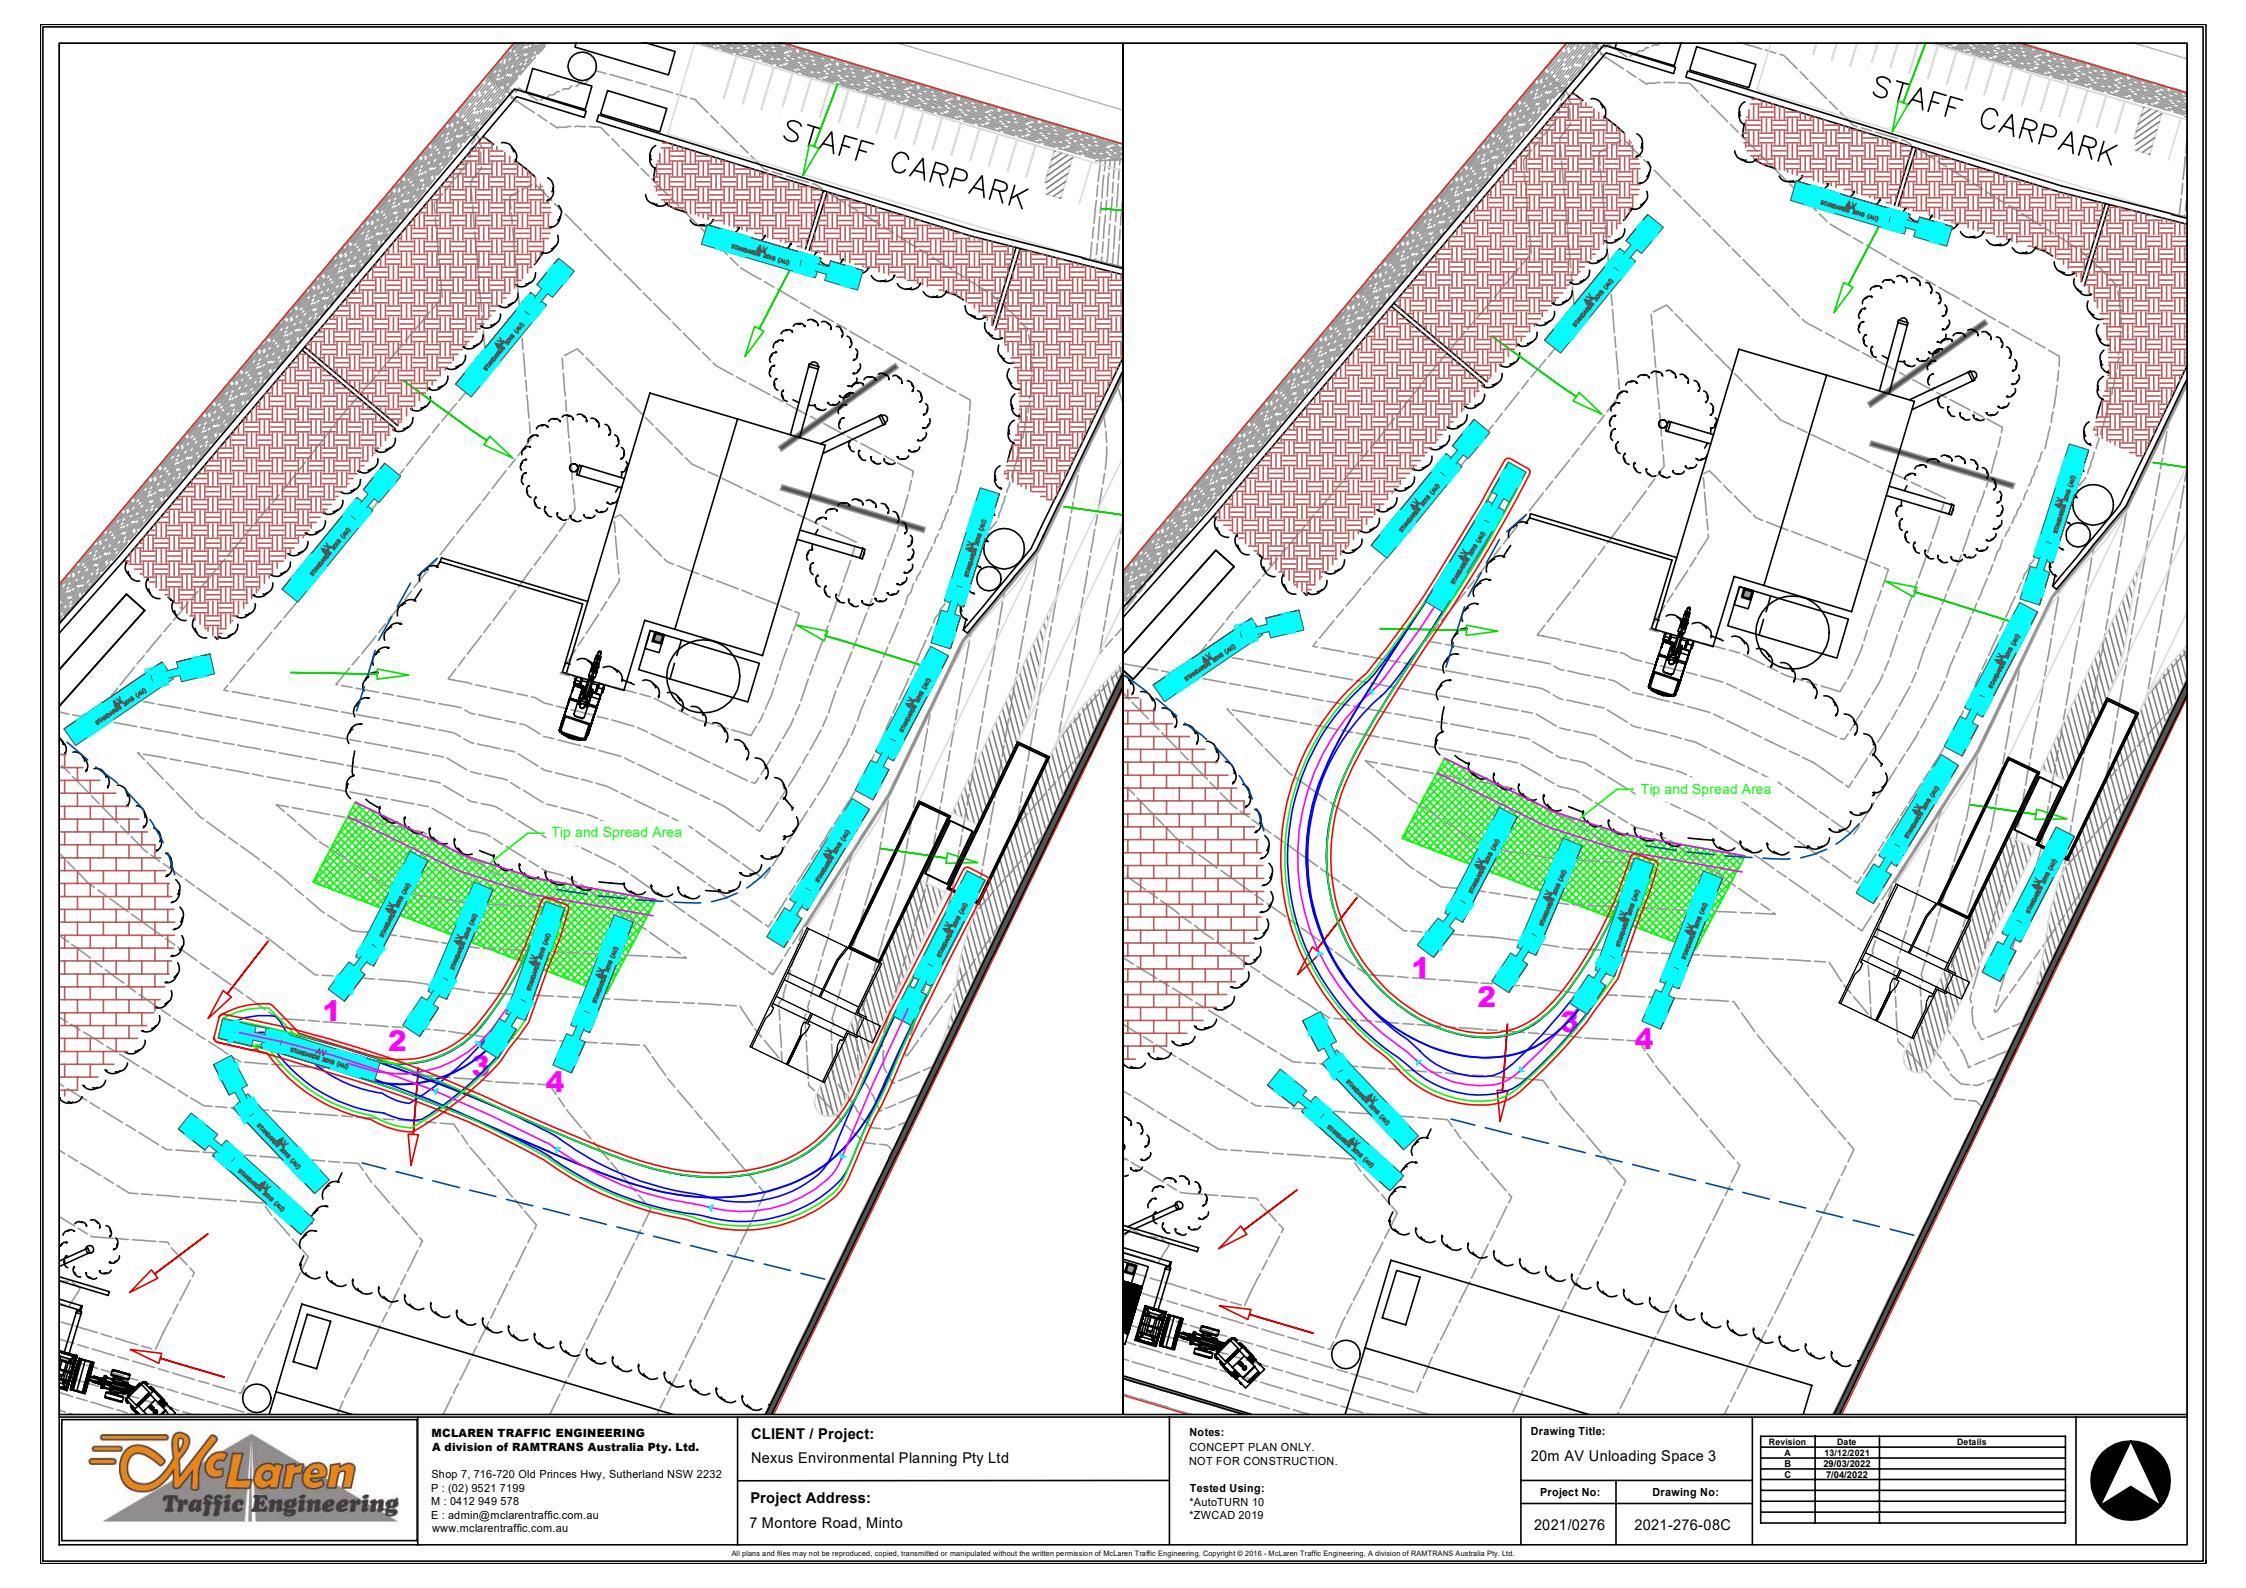
ANNEXURE A: SWEPT PATH TESTS (12 SHEETS)

**MTE Response**: The locations of the tip and spread areas when stockpiles are at their maximum are detailed within **Annexure A**. As a result, the swept paths shown in **Annexure A** demonstrate that site circulation is easily possible in the worst-case scenario. It should be noted that there will be more manoeuvring space available on a regular basis than what is shown in **Annexure A**.

**MTE Response**: Updated swept path test results have been undertaken with the results presented in **Annexure A**. In summary, the tipping trucks are to reverse into the tip and spread areas to conduct tipping operations. Once loading operations are completed the trucks can forward out of the tipping areas. Throughout the site, tipping trucks can successfully circulate and conduct their unloading operations without conflicting with other vehicles.

The locations of the tip and spread areas when stockpiles are at their maximum are detailed within Annexure A [of the McLaren Report]. As a result, the swept paths shown in Annexure A [of the McLaren Report] demonstrate that site circulation is easily possible in the worst-case scenario. It should be noted that there will be more manoeuvring space available on a regular basis than what is shown in Annexure A [of the McLaren Report].

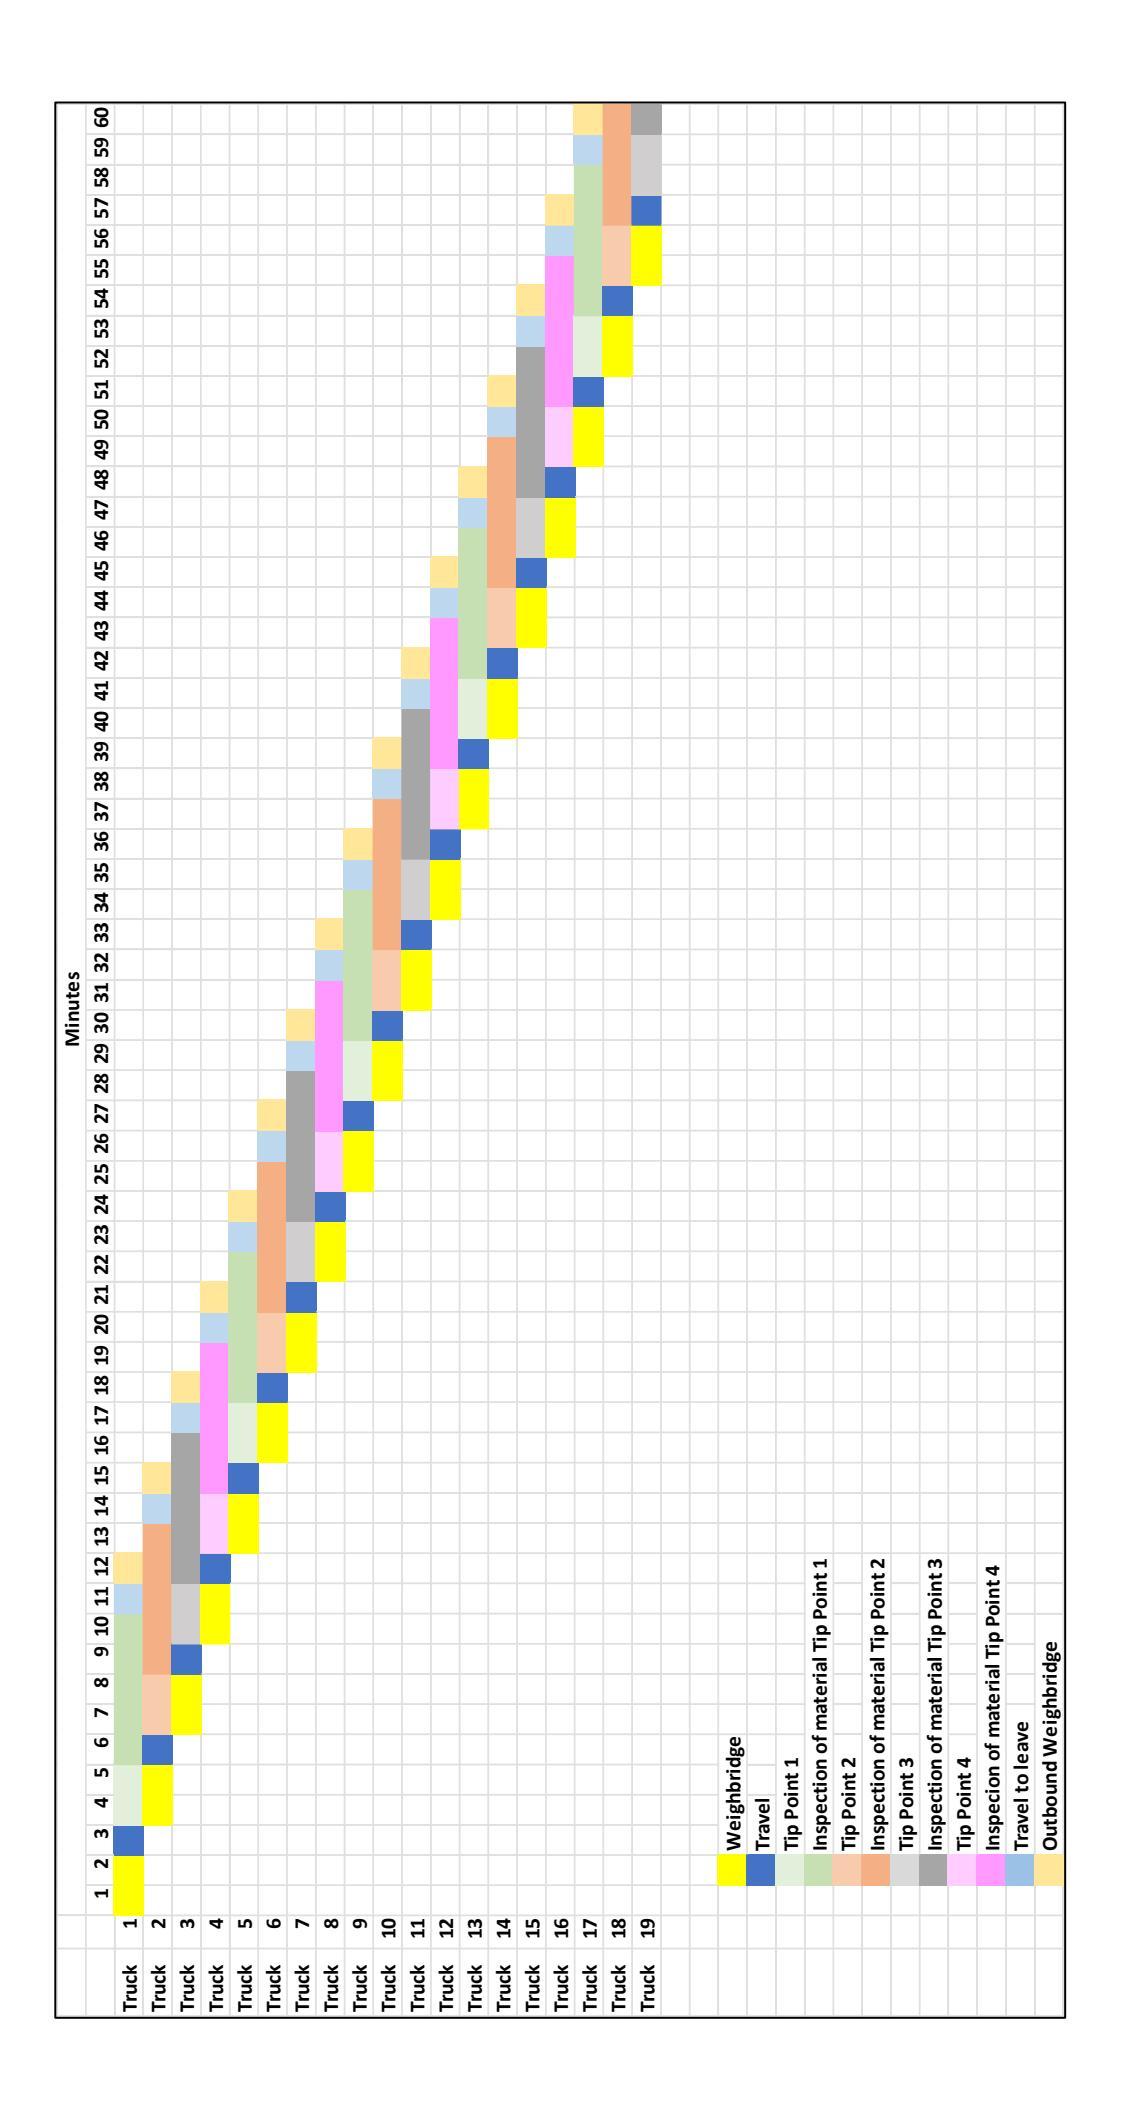
ANNEXURE B: UNLOADING TRUCK TIMES (1 SHEET)

**Annexure B** shows approximate timings of truck tipping movements throughout the site. As shown, there is only ever one truck tipping at a time in the tip and spread area, however there may be two loads being inspected. For example, at minute 10 of the table shown in **Annexure B** the is the following truck movements occurring:

- Two (2) trucks waiting for their load to be inspected that would be at standing point 1 and 2 (truck parking area along the eastern side of the site);
- One (1) truck tipping at truck point 3; and
- One (1) truck on the entrance weighbridge.

**MTE Response**: Swept path results of the design vehicle accessing and loading from stockpile C is reproduced in **Annexure B**.
