Integrated Acute Services Building Addition -Arboricultural Impact Assessment

Advisian on behalf of Health Infrastructure

Project Name	Integrated Acute Services Building Addition - Arboricultural Impact Assessment
Project Number	19SYD-13097
Project Manager	Belinda Failes
Prepared by	Elizabeth Hannon
Reviewed by	Beth Medway
Approved by	Beth Medway
Status	DraftDraft
Version Number	v3
Last saved on	16 August 2019

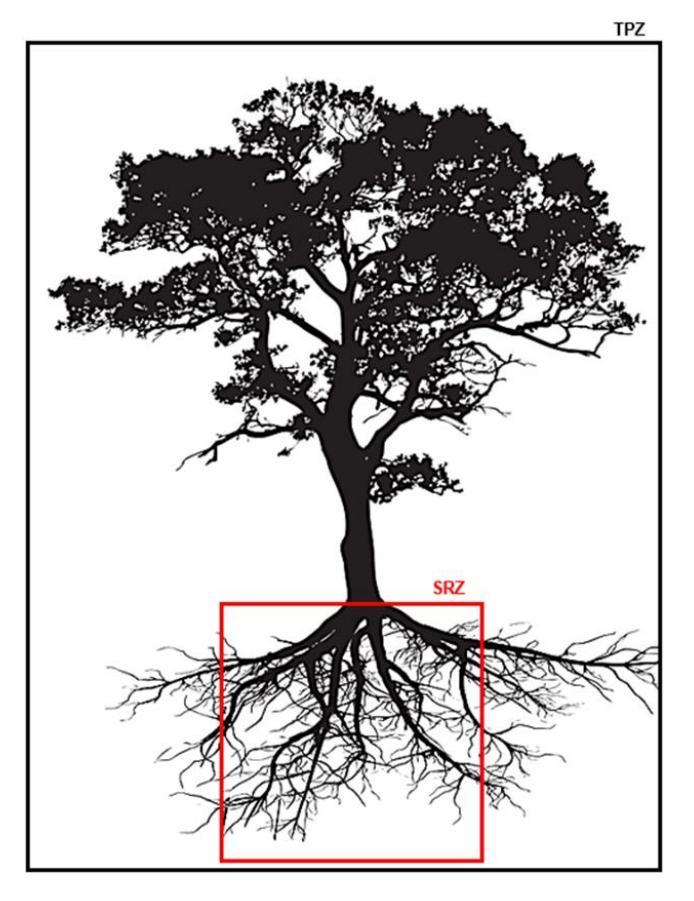
Figure 1: Indicative TPZ and SRZ

The TPZ is the combination of crown and root area (as defined by AS 4970-2009) that requires restriction of access during the construction process. Tree sensitive construction measures must be implemented if works are to proceed within the Tree Protection Zone.

The SRZ is the area of the root system (as defined by AS 4970-2009) used for stability, mechanical support and anchorage of the tree. It is critical for the support and stability of trees. Severance of roots within the SRZ is not recommended as it may lead to the destabilisation and/or decline of the tree.

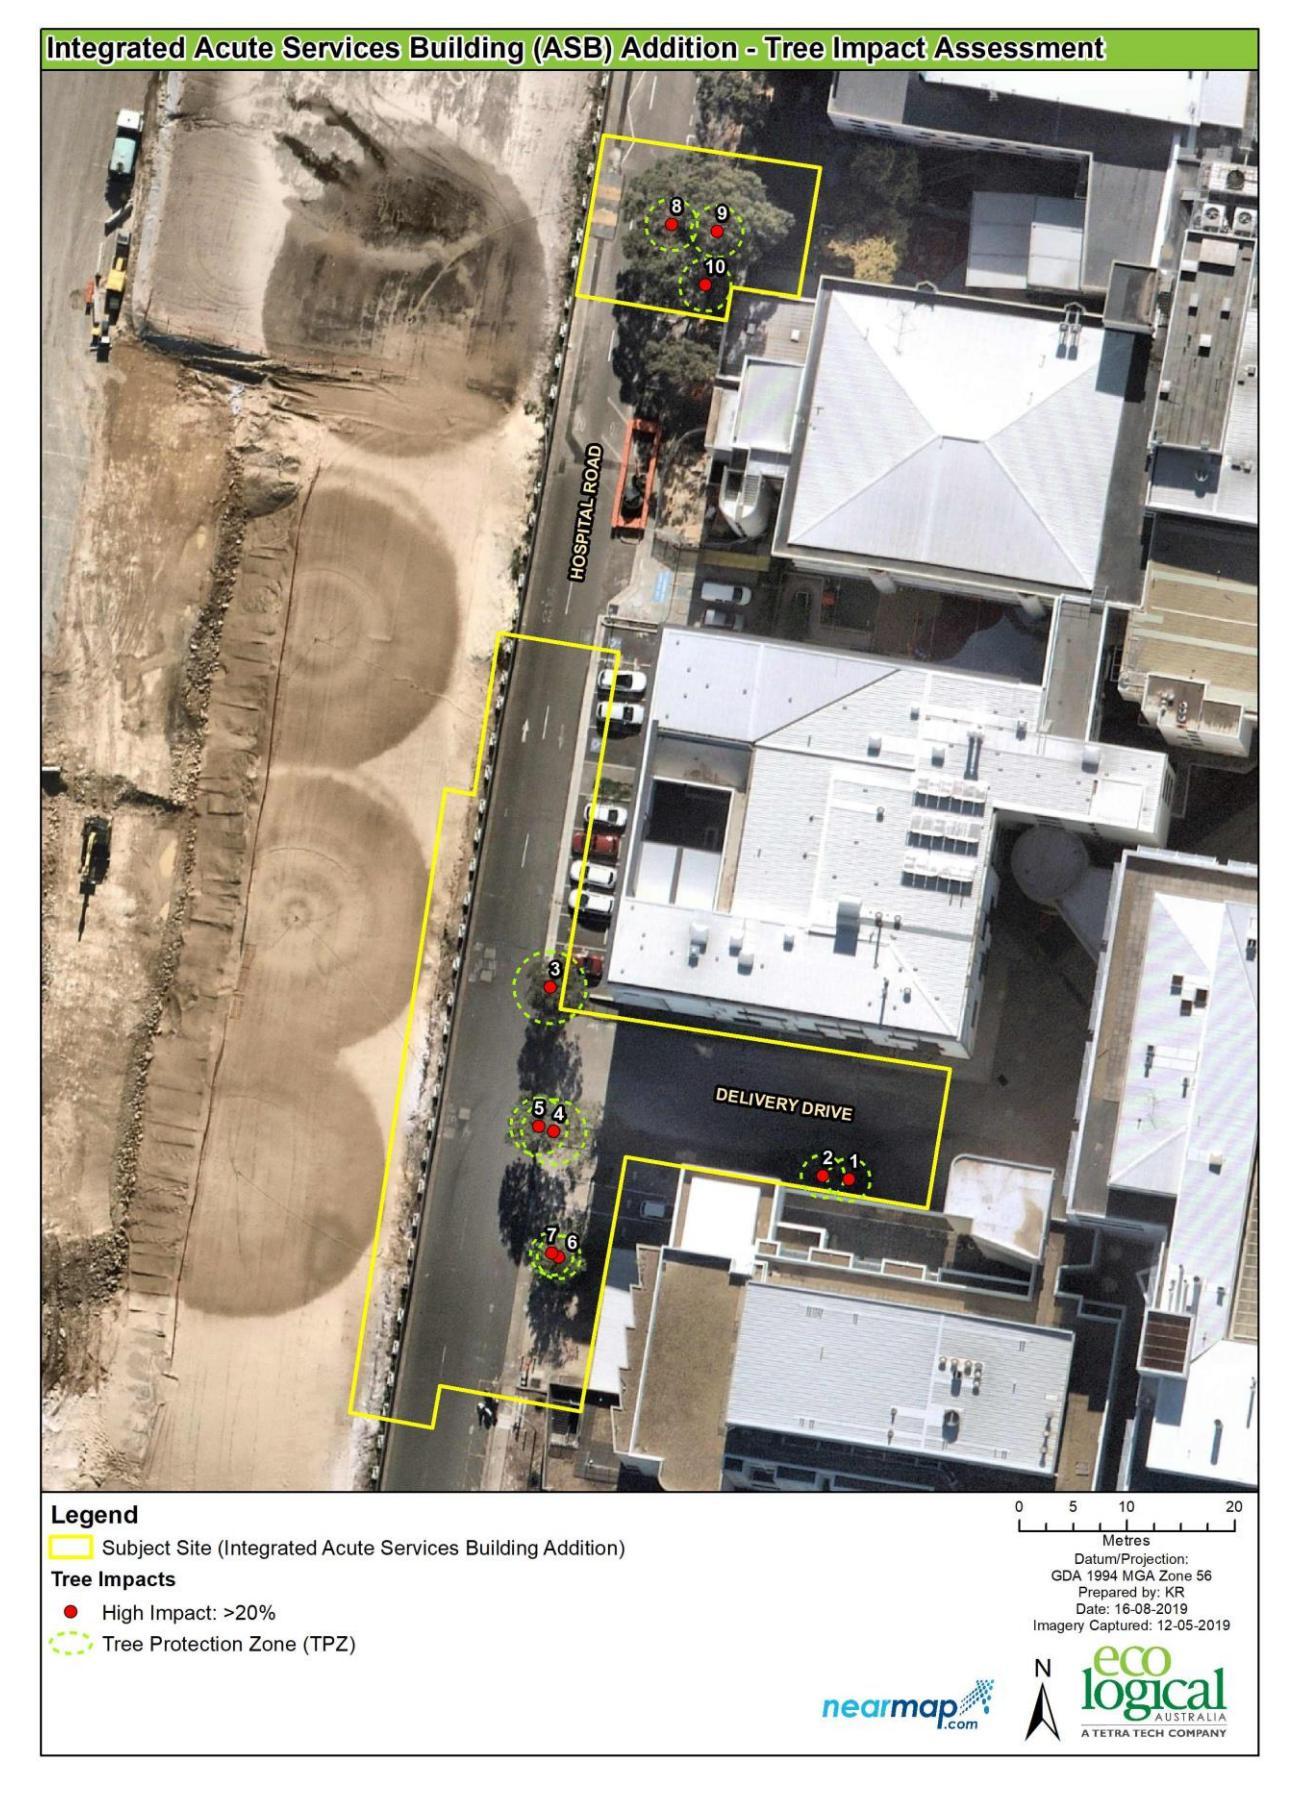
Figure 3: Tree impacts

All **ten** trees would be subject to a major encroachment (>20%) within the TPZ from the proposed development. These trees are unable to be sustainably retained without substantial modification of the proposed footprint. The trees have the following retention values:

- **four** trees with a low retention value
- **six** trees with a medium retention value.

Tree	Scientific Name	Height (m)	Spread (m)	Health	Structure	ULE	Tree Significance	Retention Value	DBH (mm)	TPZ (mm)	SRZ (mm)	Tree Impact
1	Tecoma stans	6	6	Fair	Poor	Short	Low	Low	100	2000	1500	High Impact: >20%
2	Tecoma stans	3	4	Fair	Poor	Short	Low	Low	100	2000	1500	High Impact: >20%
3	Angophora costata	4	3	Fair	Fair	Medium	Medium	Medium	280	3400	1900	High Impact: >20%
4	Corymbia maculata	5	7	Fair	Fair	Medium	Medium	Medium	250	3000	1900	High Impact: >20%
5	Angophora costata	5	4	Fair	Fair	Medium	Medium	Medium	220	2600	1800	High Impact: >20%
6	Angophora costata	4	3	Poor	Poor	Short	Low	Low	150	2000	1500	High Impact: >20%
7	Tecoma stans	3	3	Fair	Poor	Short	Low	Low	100	2000	1500	High Impact: >20%
8	Angophora costata	8	6	Good	Faire	Medium	Medium	Medium	200	2400	1700	High Impact: >20%
9	Angophora costata	8	6	Good	Faire	Medium	Medium	Medium	200	2400	1700	High Impact: >20%
10	Angophora costata	8	6	Good	Faire	Medium	Medium	Medium	200	2400	1700	High Impact: >20%
