Arboricultural Development Assessment Report

Nepean Hospital Redevelopment STAGE 2 WORKS September 2021 *FINAL Updated 25.11.2021*

Health Infrastructure c/o CBRE P/L, Level 21, 363 George Street, Sydney NSW 2000. The report concerns a proposed development works for Nepean Hospital Redevelopment, Main Works project, Stage 2.

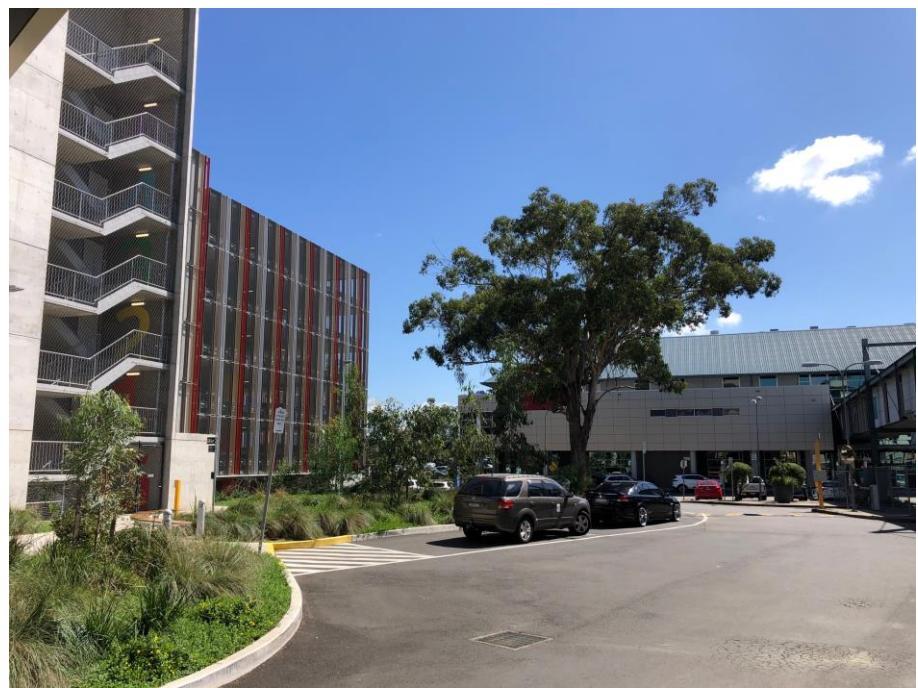
Plate 1: Trees 1-5. P. Vezgoff.

- **3.4** Tree 1 is a large mature Grey box (*Eucalyptus moluccana*). Great lengths have been undertaken to retain this tree through previous construction works, namely the construction of the car park tower (Plate 1). This tree has survived this process and all efforts should be made to ensure its continued survival. Near this tree are Trees 2-6 which are all newly planted *Eucalyptus* saplings.

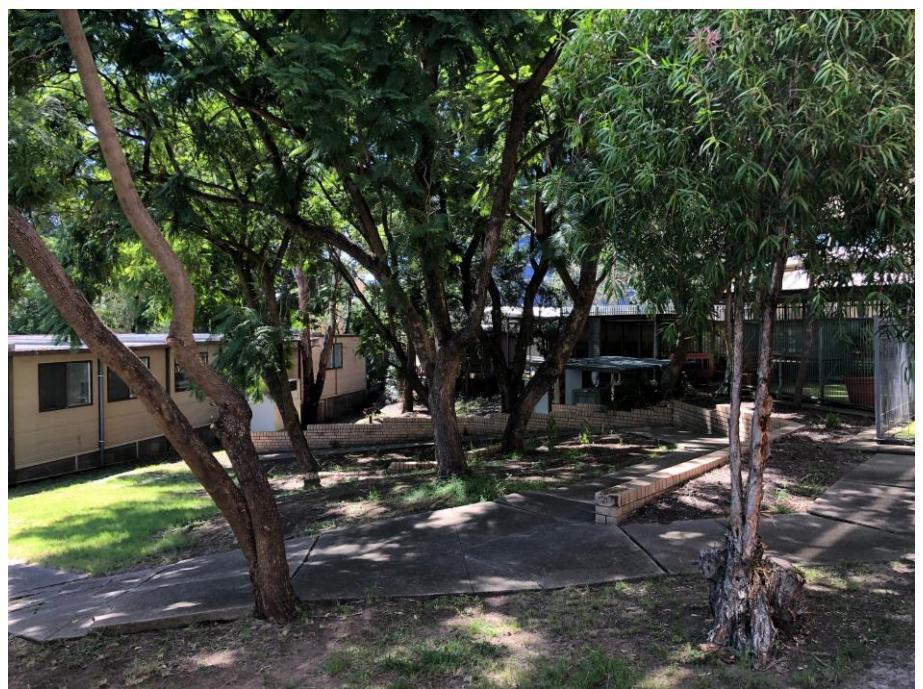
Plate 2: Trees 196-210. P. Vezgoff.

3.5 Trees 196-210 are a dense mix of native and exotic specimens including Brushbox (*Lophostemon confertus*), Willow Bottle brush (*Callistemon salignus*), Jacaranda (*Jacaranda mimosifolia*). These trees are growing in a confined area and have codominant canopies with each other (Plate 2). These trees would not be considered significant. Near this same area are Trees 195, 365-367 being a row of small Willow Bottle brush (*Callistemon salignus*), *Acacia* and a *mature* Spotted gum (*Corymbia maculata*). These trees would not be considered significant (Plate 3).

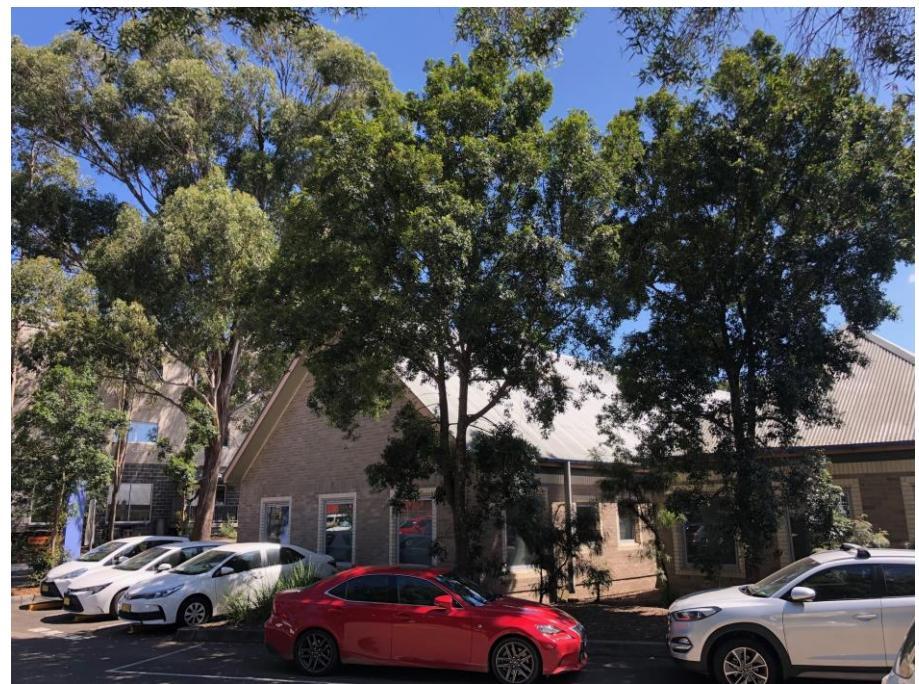
Plate 6: From left, Trees 229, 282, 283. P. Vezgoff.

3.6 Between the new childcare centre and construction offices are various trees that consist of Tallowwood (*Eucalyptus microcorys*), Forest red gum (*Eucalyptus tereticornis*), Spotted gum (*Corymbia maculata*), Jacaranda (*Jacaranda mimosifolia*), Willow Bottle brush (*Callistemon salignus*), Brushbox (*Lophostemon confertus*), Acmena smithii, Grey box (*Eucalyptus moluccana*). In general, all trees were in good health and condition in this area (Plates 6 and 7). Trees 231 and 237 are in an area of mostly completed works so no impacts are expected near this area (Plate 7).

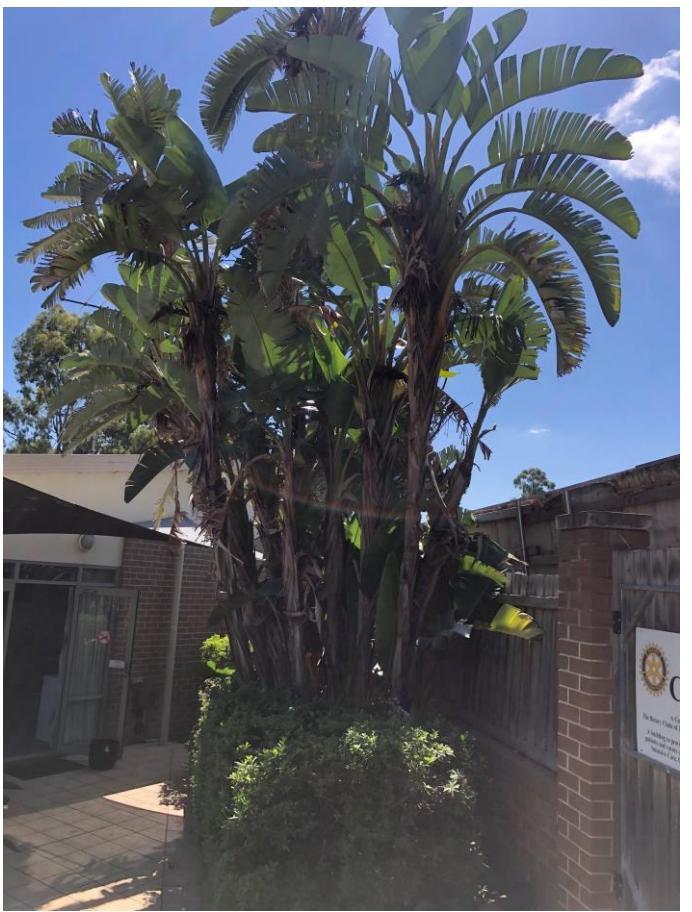
Plate 8: Trees 363, 364. P. Vezgoff.

3.7 Trees 363 and 364 are both Giant Bird of paradise (*Strelitzia nicolai*). These trees would not be considered highly significant to the site.

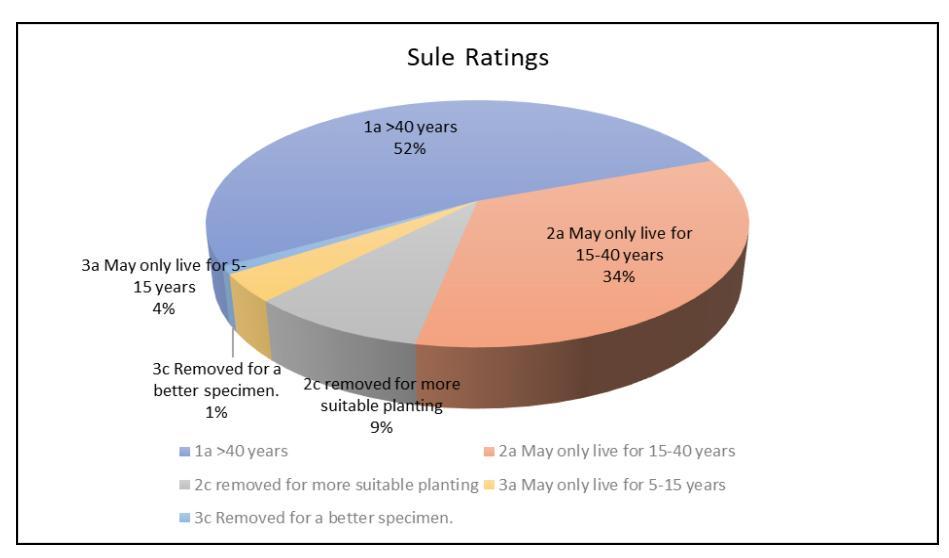
Graph 1: SULE ratings for the site.

recorded to help future users of the information appreciate the reason for each allocation decision. It is normal to have instances where trees will not fit neatly into a single SULE category. The assessment of the site trees can be seen in Graph 1. In general, the trees were mostly assessed as being in good health. SULE results show that 52% of the site's tree population has a life expectancy of greater than forty (40) years and 34% had a medium life expectancy. Trees that have a short life expectancy total 14%.

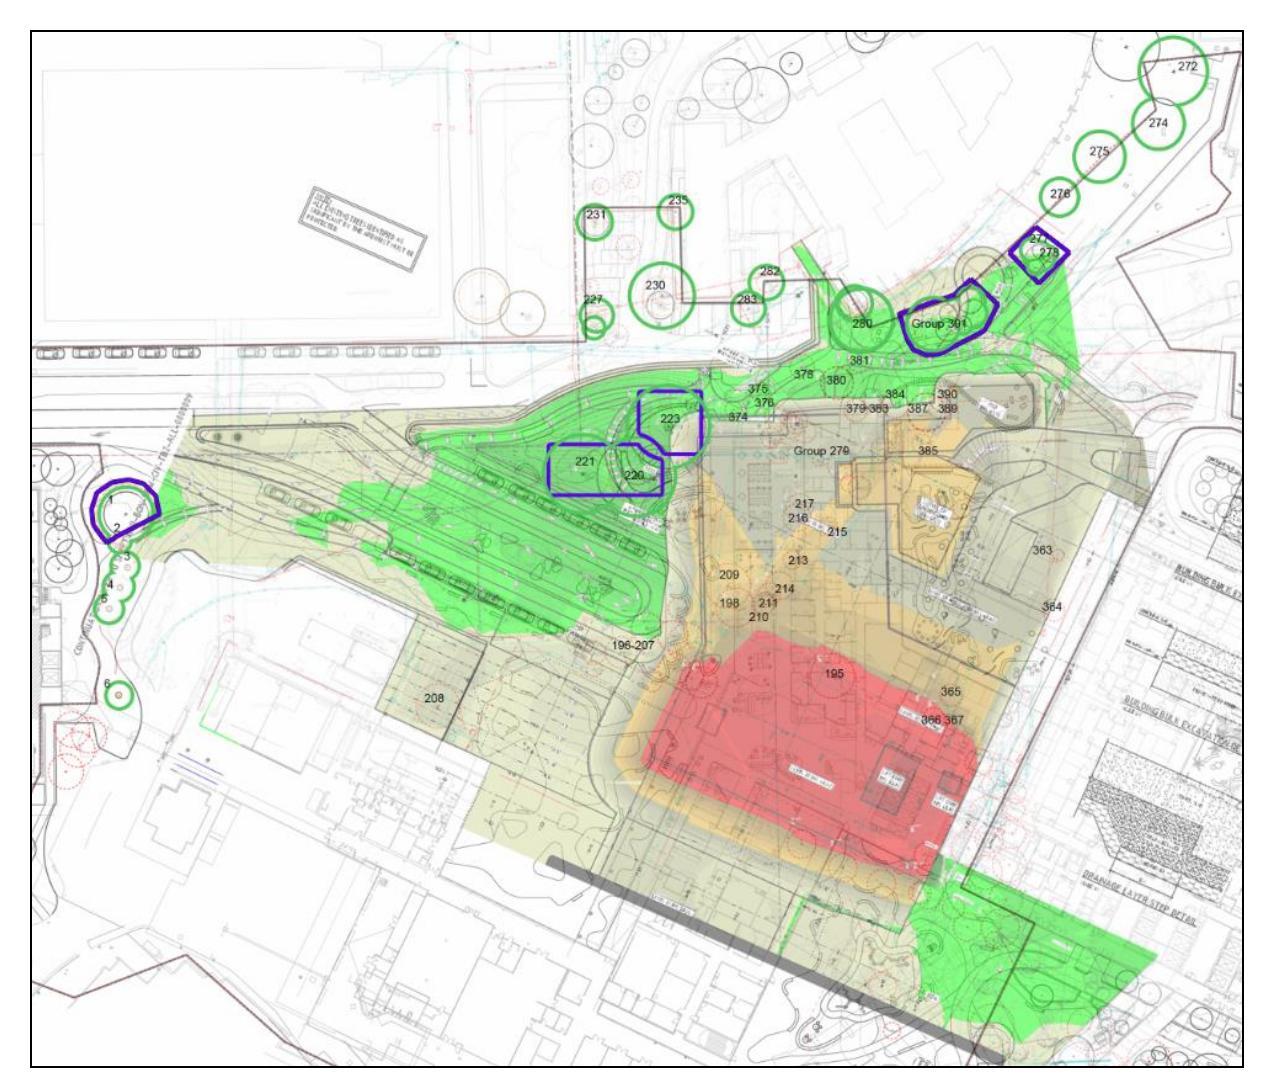
3.10 Impacts: Based on the plans provided, site trees will be required to be removed due to bulk earth works and level changes (Plate 9). Tree to be retained are numbered as 1-6, 220, 221, 223, 227, 230, 231, 235, 272, 274, 275, 276, 277, 278, 280, 282, 283 and Tree group 391. All other trees will be removed.

Plate 9: Part plan showing the extent of bulk earth works which will have the greatest impacts to the site trees. (Part plan of Tree Protection Plan and Project plan overlays).

- **4.1** Based on the plans provided tree to be retained are numbered as 1-6, 220, 221, 223, 227, 230, 231, 235, 272, 274 275, 276, 277, 278, 280, 282, 283 and Tree group 391. All other trees within the Stage 2 area will be removed.

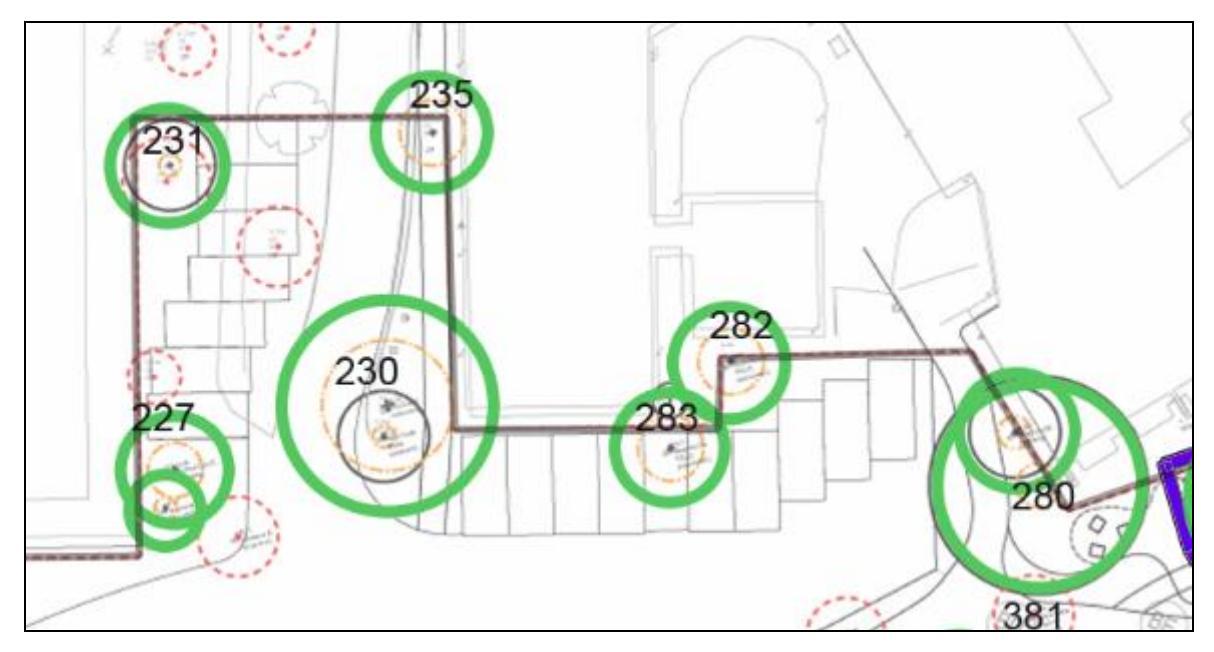
3.11 Trees 227, 230, 231, 235, 280, 282 and 283 are shown within the project boundaries however this area of the site has already had works completed that included landscaping, access ramps and car parking. It is not envisaged that these trees will be impacted by the works (Plate 10). It is assumed the child care centre will remain operational during the works so access to the car parking (between Trees 230 and 227) will be required thus Trees 227, 230, 231, 235, 280, 282 and 283 should be outside of the actual works area.

Plate 10: Trees 227, 230, 231, 235, 280, 282 and 283 are shown within the project boundaries however this area of the site has already had works completed that included landscaping, access ramps and car parking. (Part plan of Tree Protection Plan and Project plan overlays).

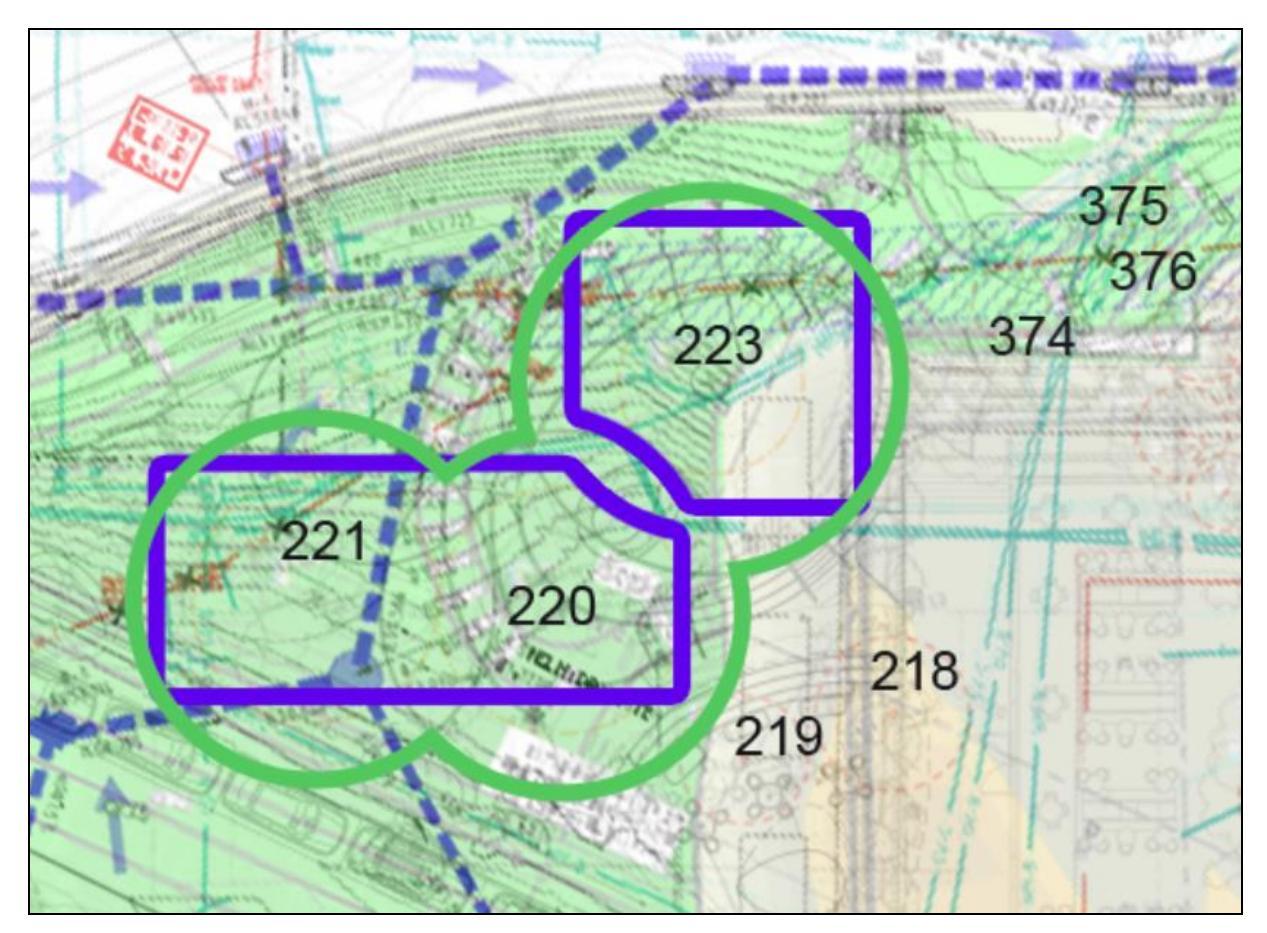
3.12 The levels changes from the bulk earthworks will impact most of the other site trees. Although these works indicate the minimum disturbance being 0-0.5 metre, a five hundred (500) millimetre disturbance across a TPZ area will have long term impacts to any mature tree. Fine feeder roots and structural woody roots will be located within this five hundred (500) millimetres of soil profile (Appendix 8). Tree 223 (Plate 9) which, I have been informed is to be retained, has level changes across the entire TPZ area (Plate 11) of seven (7) radial metres. I have shown this tree to be retained however the levels within the TPZ of this tree will need to remain as is in order for this tree to survive (Plate 11).

Plate 11: Part plan showing the extent of bulk earth works and services below Trees 220, 221 and 223. The green shade indicates a potential change in levels of 0-.5m which would not be acceptable in order to retain Tree 223. Redundant services (Red dashed line) will be left in situ (Part plan of Tree Protection Plan and Project plan overlays).

- **4.3** The proposed new stormwater line (NSW211526-REF-0000-SM-DRAI-PLAN-TB2-MAIN-WORKS-SHEET-2-211115) that will be a 600mm diameter pipe will be very close to Tree 223. Taking into consideration the shoring that may be required for this 2 metre deep trench the excavation should be no closer than 4.5 metres to the trunk. This would equate to a 20% TPZ incursion of the overall 7.2 metre TPZ distance. That said, preferably the excavations would be no closer than 6 metres. If works require a large degree of root loss or the severing of roots greater than 100mm in diameter this tree may have to be removed once works commence. The project Arborist shall have to be present for the excavation works within the TPZ of Tree 223.

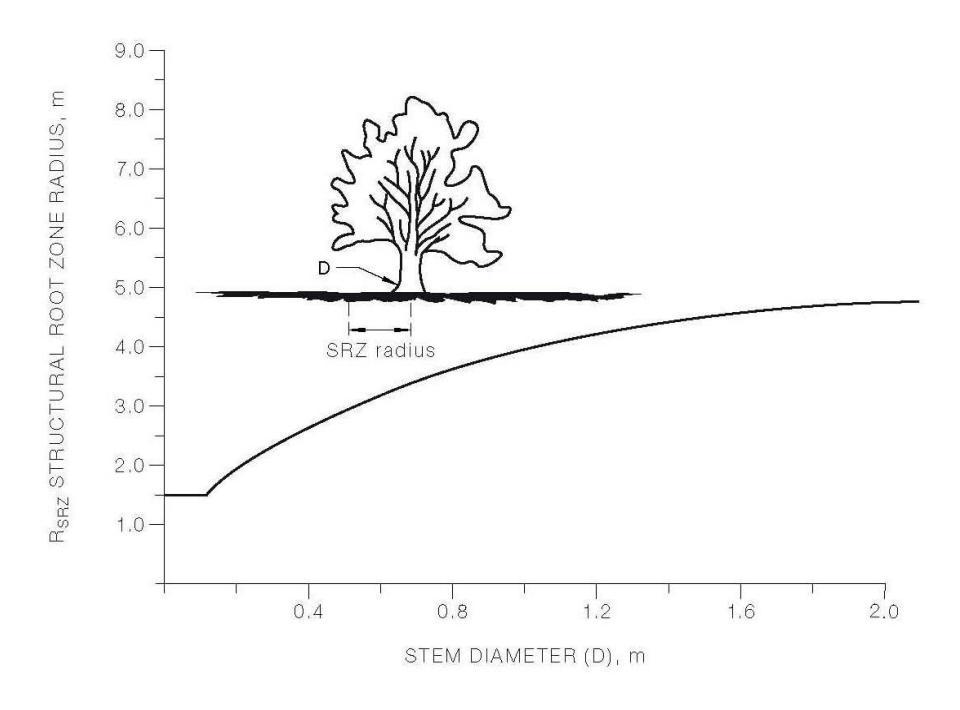
FIGURE 1 - STRUCTURAL ROOT ZONE

NOTE: The SRZ for trees with trunk diameters less than 0.15m will be 1.5m (see Figure 1).

The curve can be expressed by the following formula: R_{SRZ} = (D \times 50) $^{0.42}$ \times 0.64

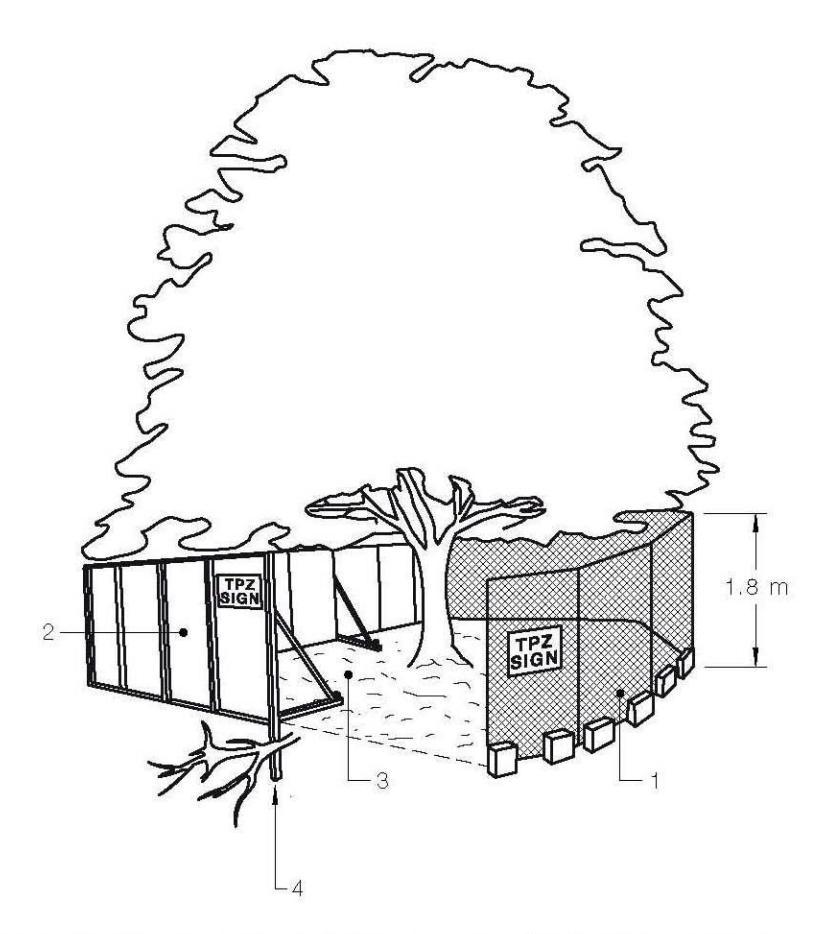
specifications

- 1 Chain wire mesh panels with shade cloth (if required) attached, held in place with concrete feet.
- 2 Alternative plywood or wooden paling fence panels. This fencing material also prevents building materials or soil entering the TPZ.
- 3 Mulch installation across surface of TPZ (at the discretion of the project arborist). No excavation, construction activity, grade changes, surface treatment or storage of materials of any kind is permitted within the TPZ.
- 4 Bracing is permissible within the TPZ. Installation of supports should avoid damaging roots.

- **5.2 Implementation of Tree Protection Zone:** All tree protection works should be carried out before the start of demolition or building work. It is recommended that chain mesh fencing with a minimum height of 1.8 metres be erected as shown in the Tree Protection Plan (Appendix 1) at a seven metre radius from the trunk. Specifications for this fencing are shown in Tree Protection Fencing Specifications (Appendix 5).
