#### Prepared for Charter Hall Site Address: 600 Woodstock Avenue Rooty Hill 24<sup>th</sup> December 2021

This report has been prepared by Tristan Bradshaw of Bradshaw Consulting Arborists for Charter Hall at the property 600 Woodstock Avenue Rooty Hill. The report request was to inspect Forty three trees throughout the property and surrounding properties.

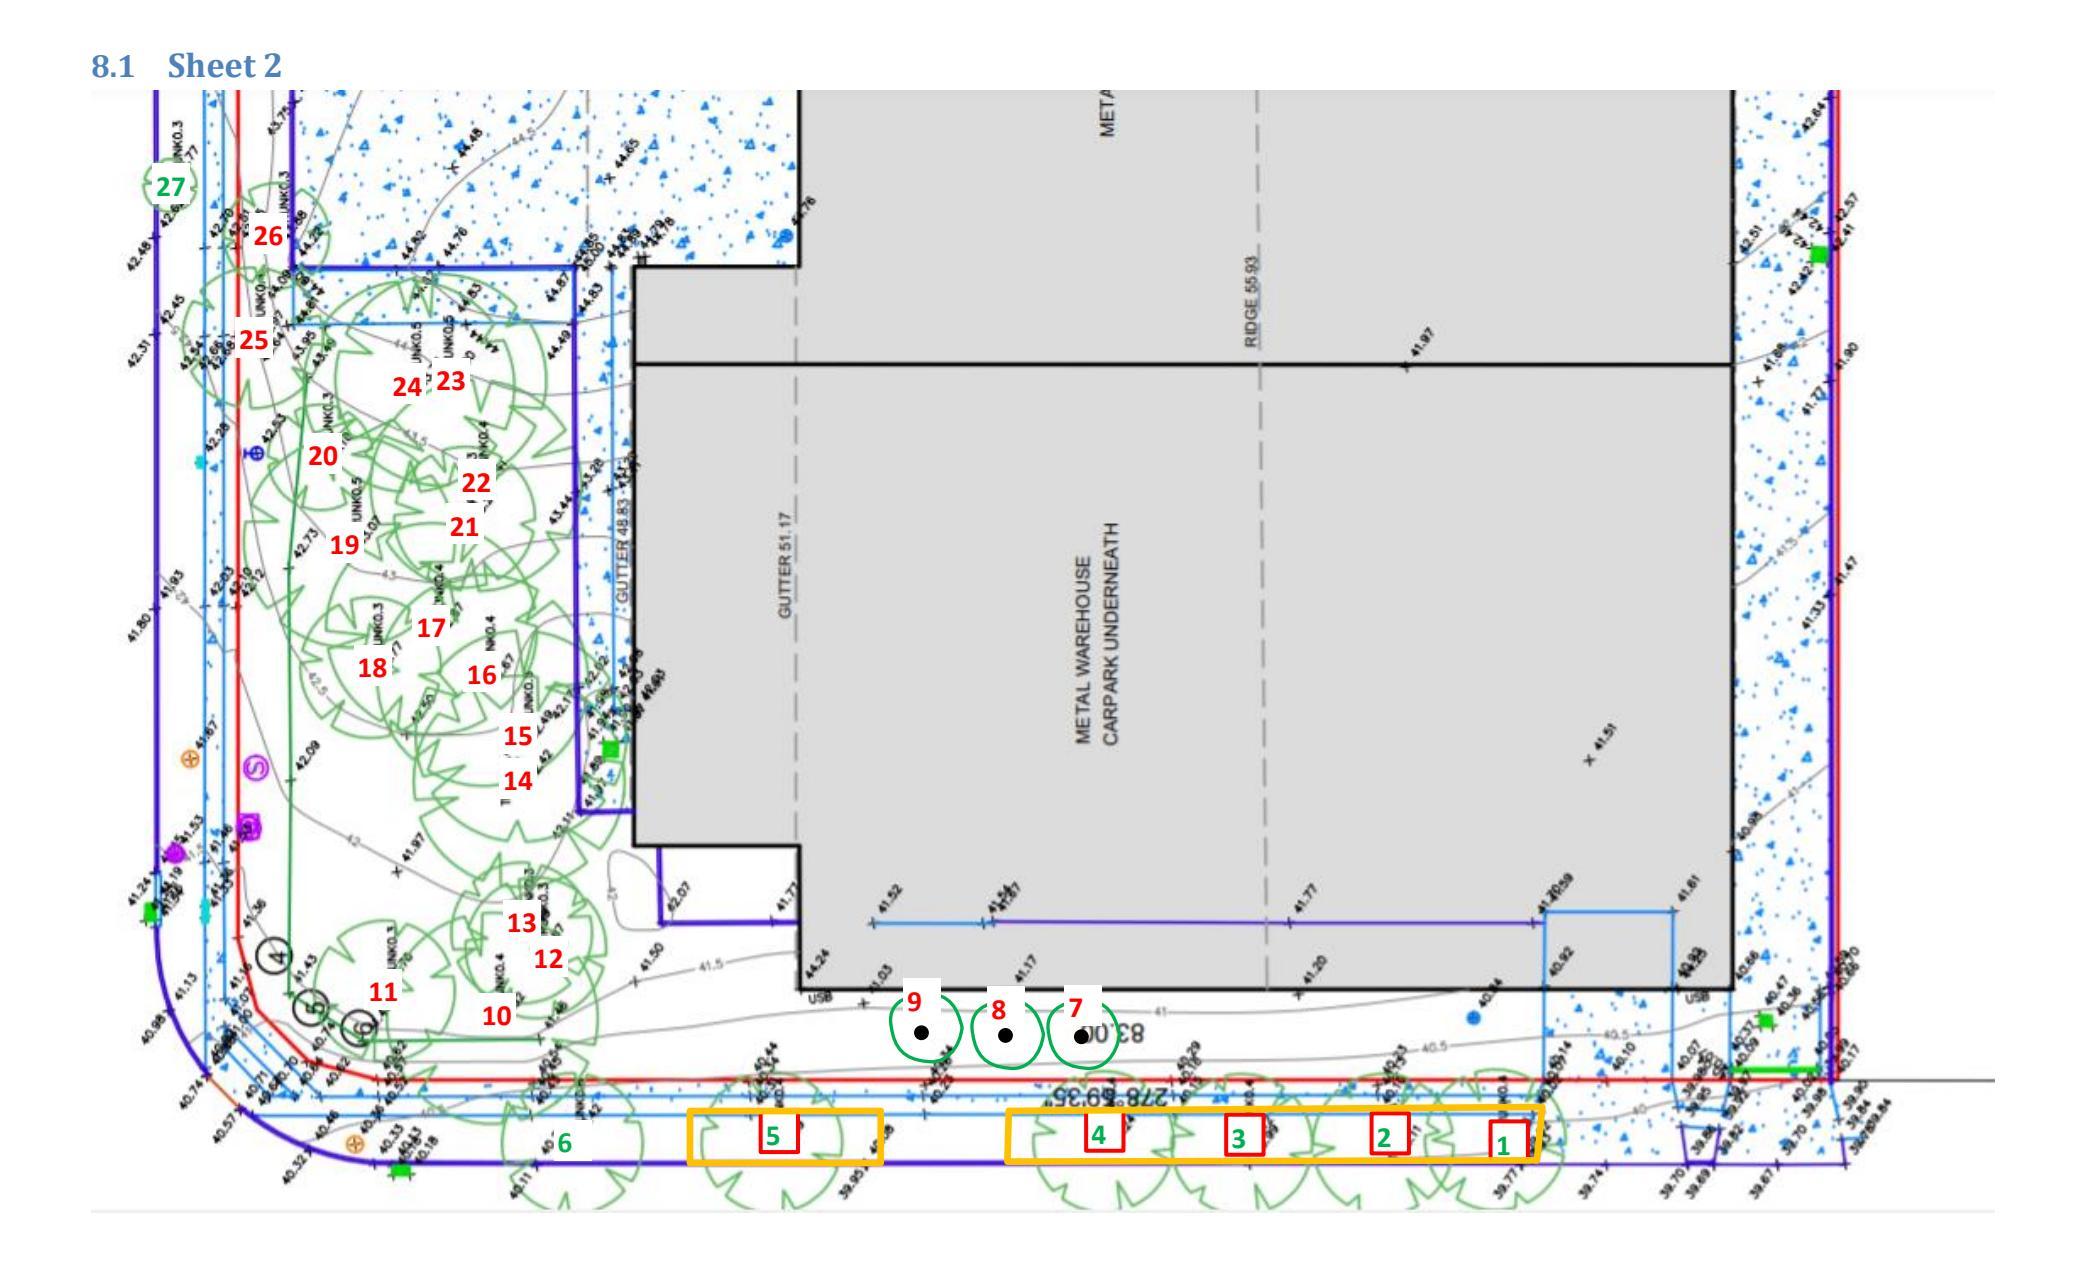
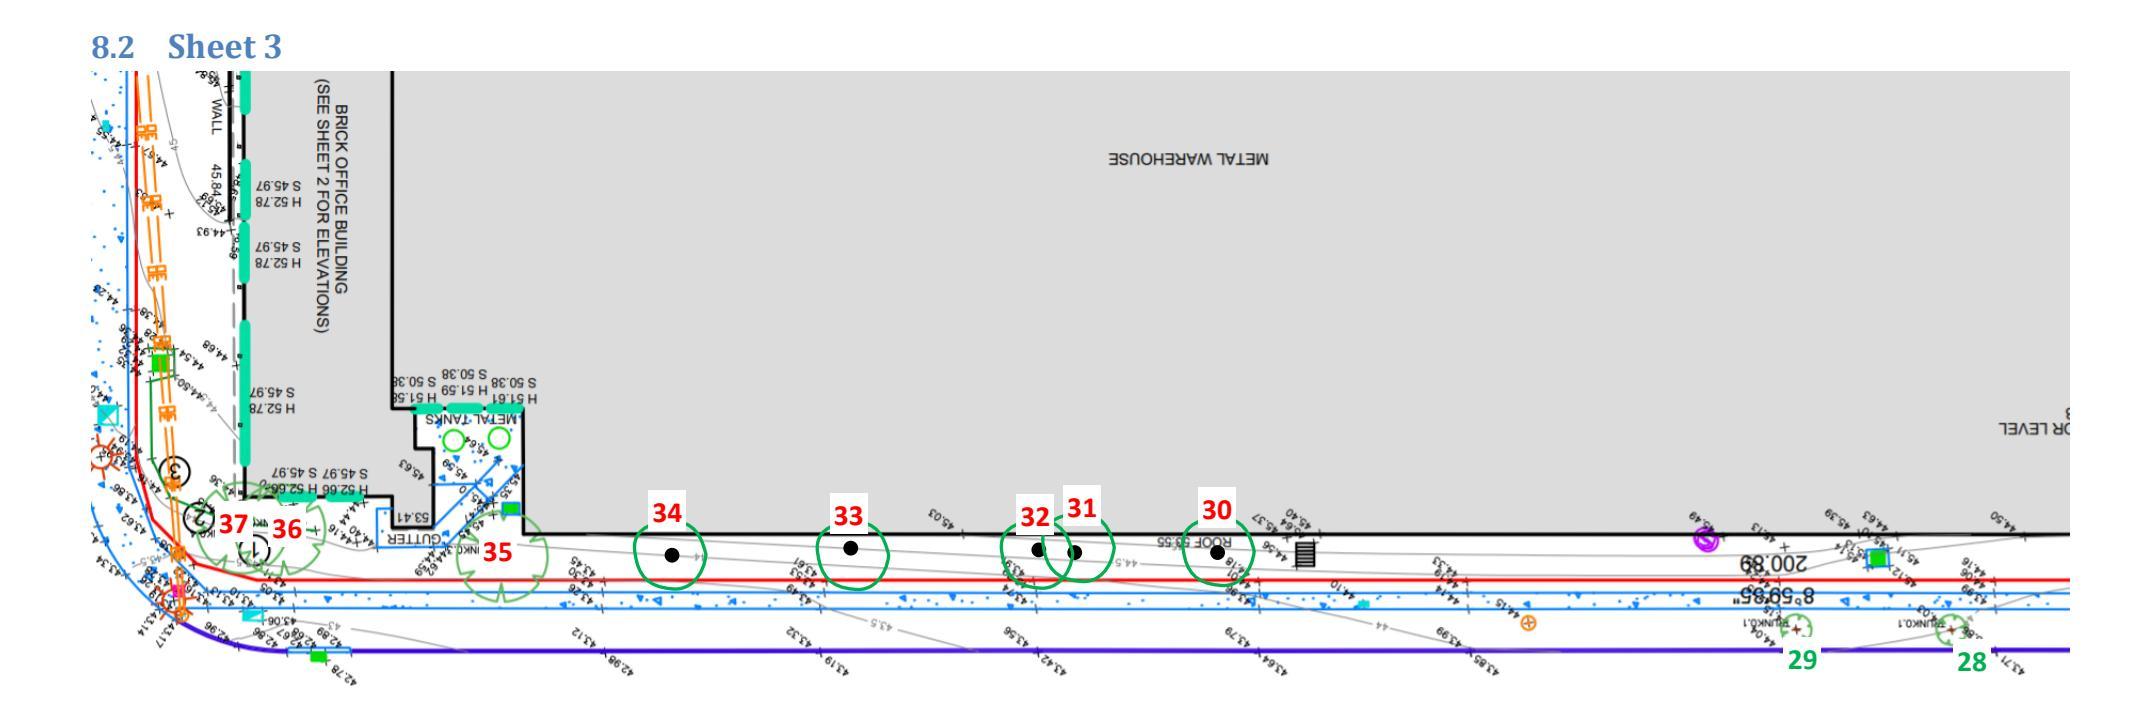
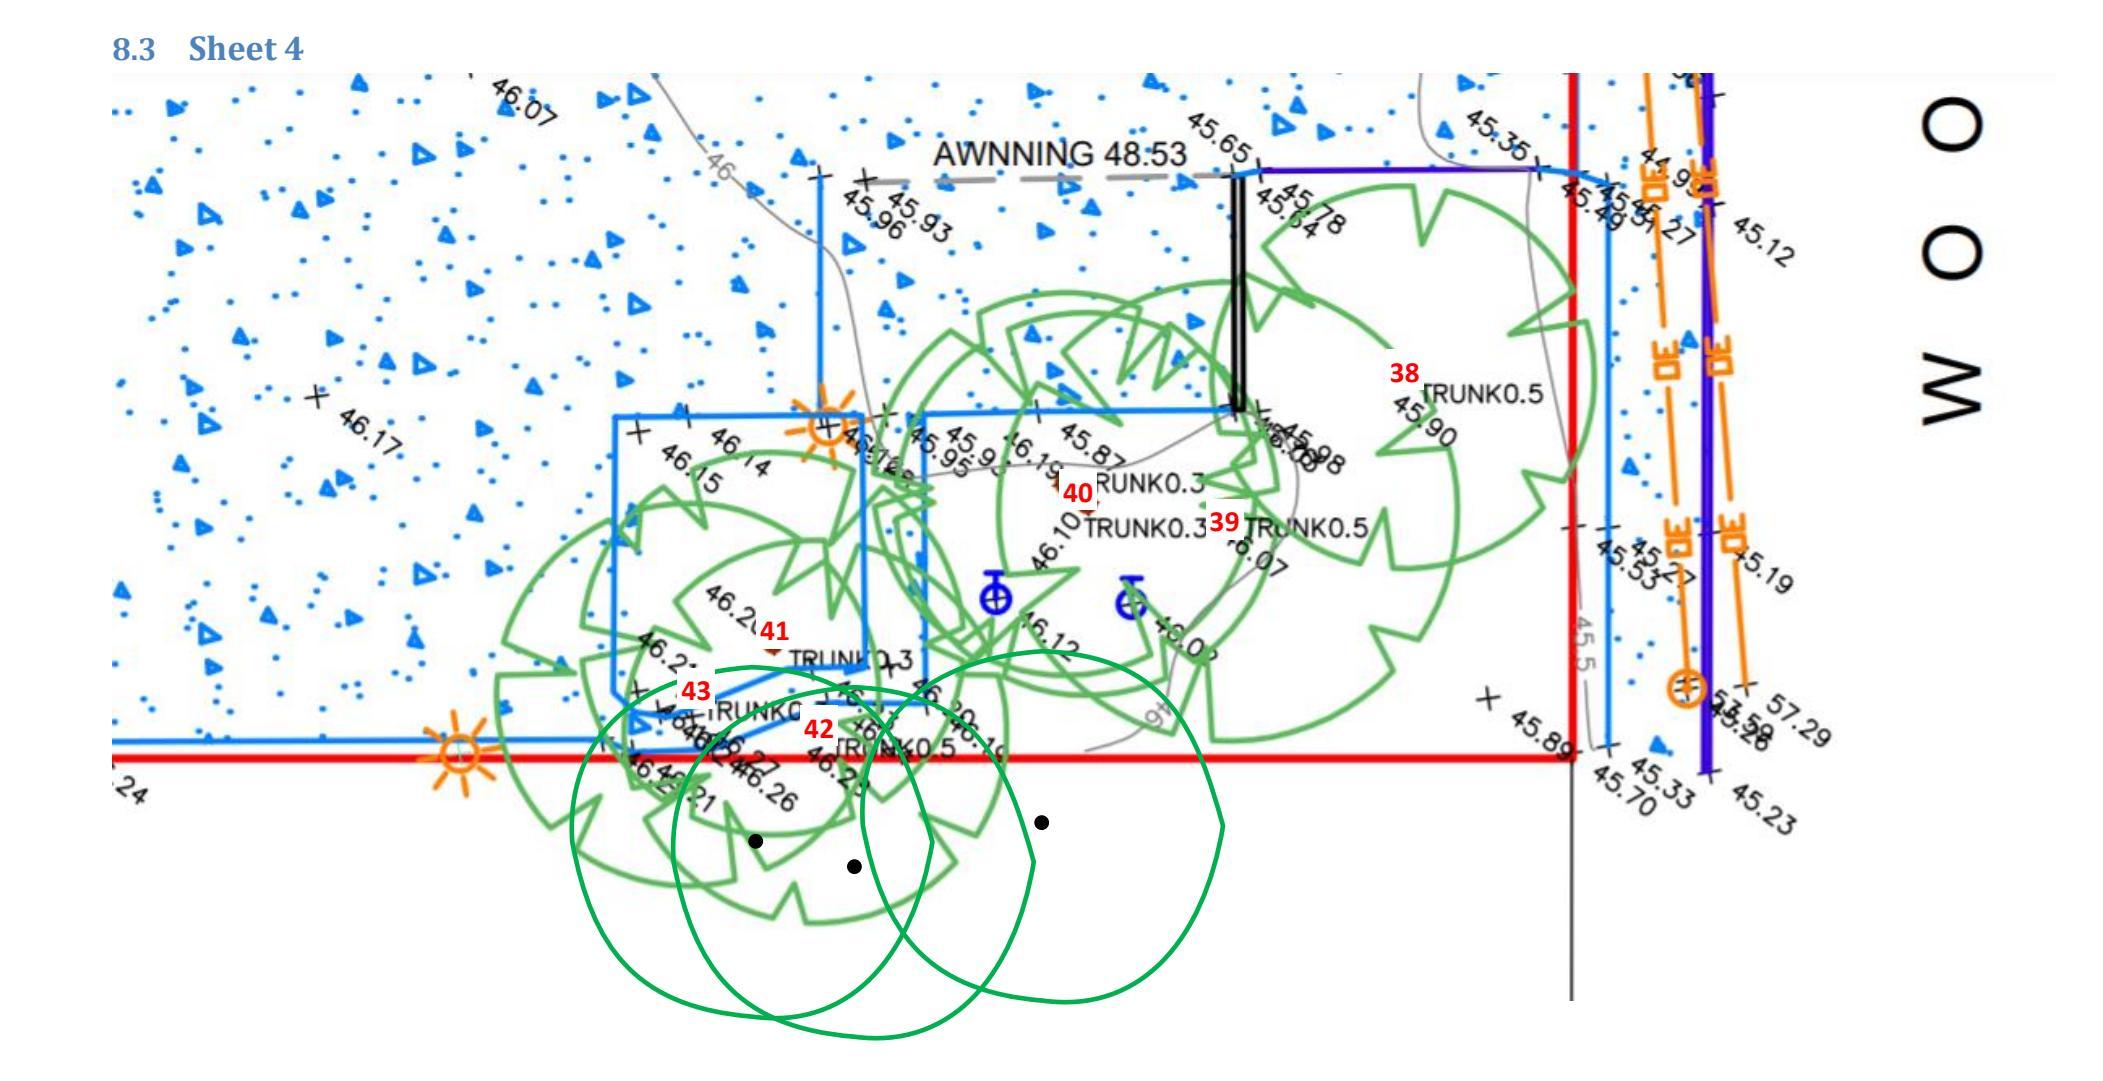
## 8 Appendix B Tree locations, sheet 1 Tree Protection Plan

Requirement	Total	Tree Number	Legend
Trees Removed	38	6-43	Red
Trees Retained	5	1-5	Green
Trunk Protection	5	1-5	
Tree protection fencing	5	1-5

- 1. Removal of trees 6-42.
- 2. Retain trees 1-5.
- 3. Tree removal should be conducted by an Arborist with a minimum (Australian Qualification Framework) AQF level 3.

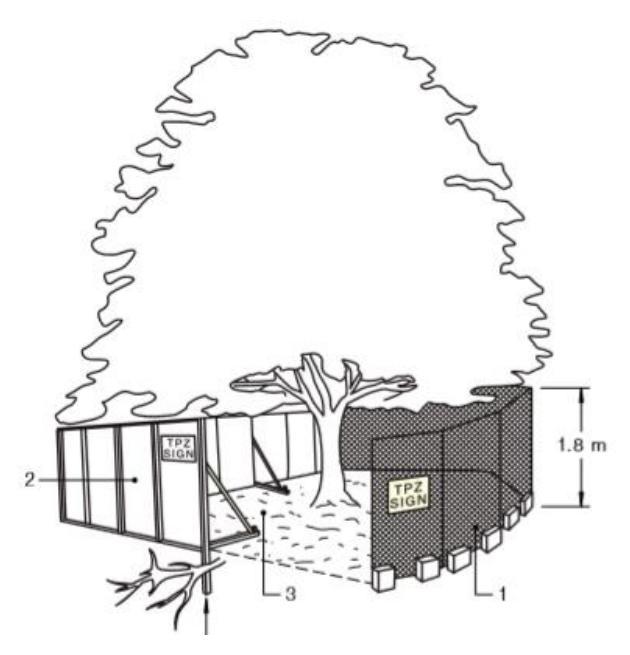
Figure 2 Drawing taken from AS 4970-2009

The TPZ must be enclosed with a fully supporting chainmesh protective fencing. The fencing shall be secure and fastened to prevent movement. The fencing shall have a lockable opening for access. Roots greater than 30mm diameter are not to be damaged/severed during the construction of the fence. See Figure 2 Drawing taken from AS 4970-2009below.

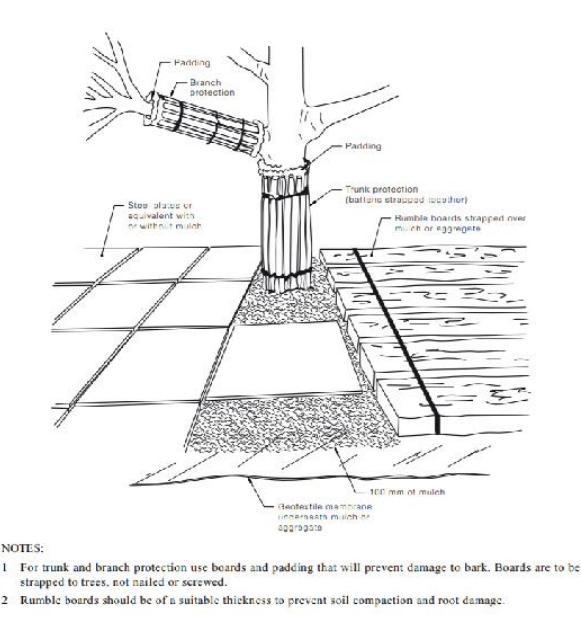
Figure 4 Trunk and branch Protection (AS 4970-2009)

Hessian or similar material is used as a wrap around the trunk/branch to a height of 2.6 metres from the base of the tree. Covering the hessian are timbers 100x50x2500mm These are to be spaced around the trunk with gaps of approximately 100mm. The timbers are to be secured with metal strapping. These materials are not to be directly fastened to the tree. See Figure 3 and 4 above.
