# 7.3 HERITAGE SIGNIFICANCE

# 8 NORTH ANNEX

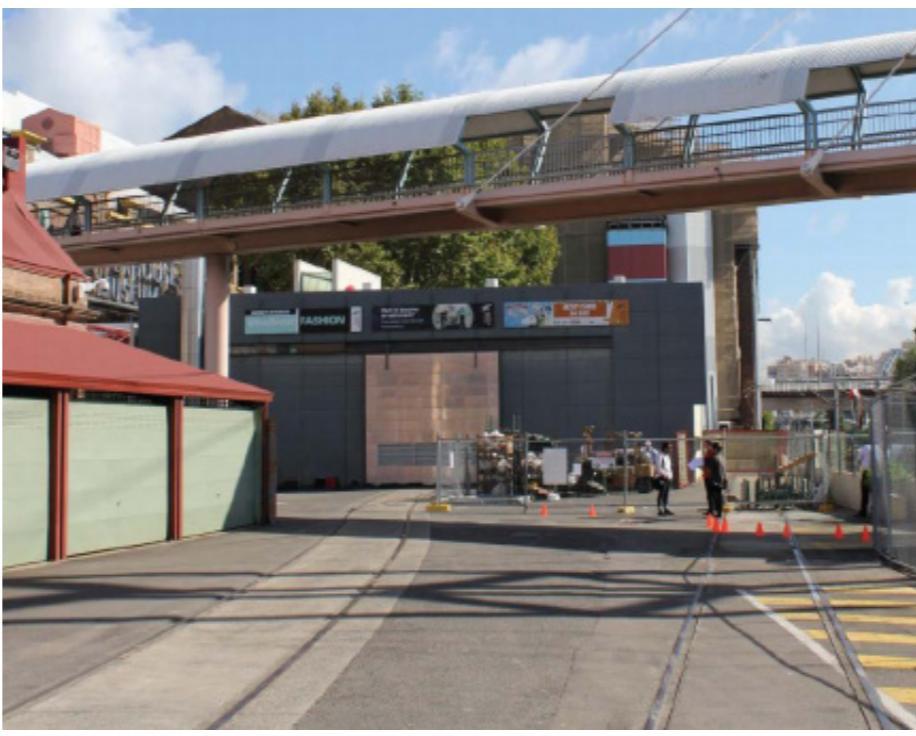
Figure 7.24 Ultimo Tram Depot with additions on the East façade, the Goods Line, Pedestrian walkway (Source: JBA 2014 SEE letter to City of Sydney Council)

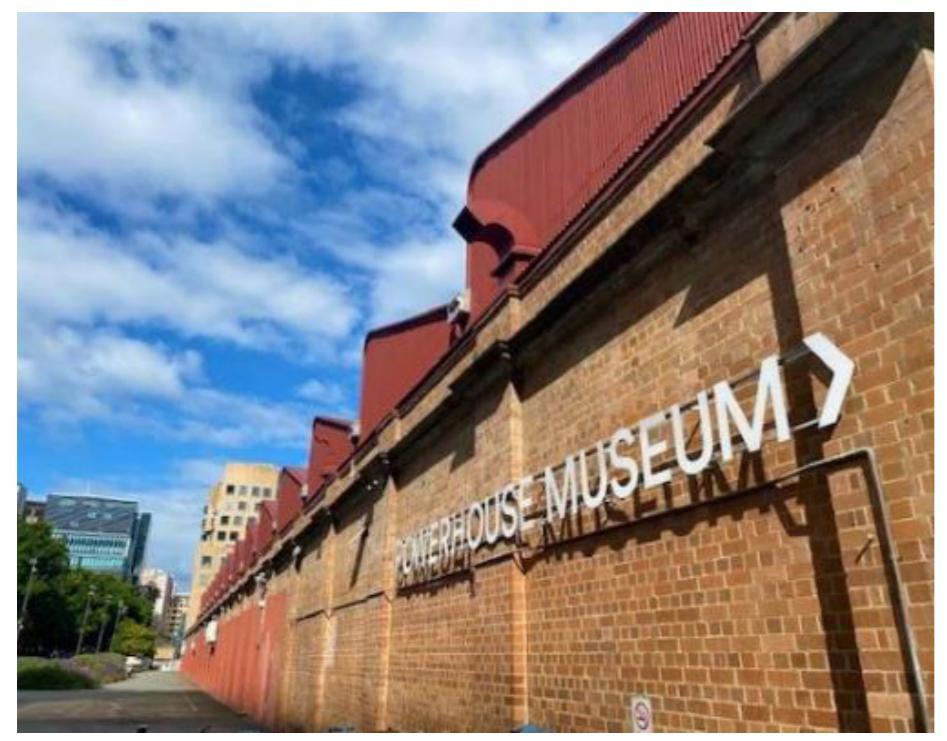
Figure 7.26 The eastern wall of the Harwood building, original brickwork in blue (Source: Curio Projects)

The external walls on the north, east and west faces of the building retain original brickwork from the 1888 construction to the 1908 extension and have exceptional significance. A section of the north face shows the contrast between the original brickwork and later brickwork.

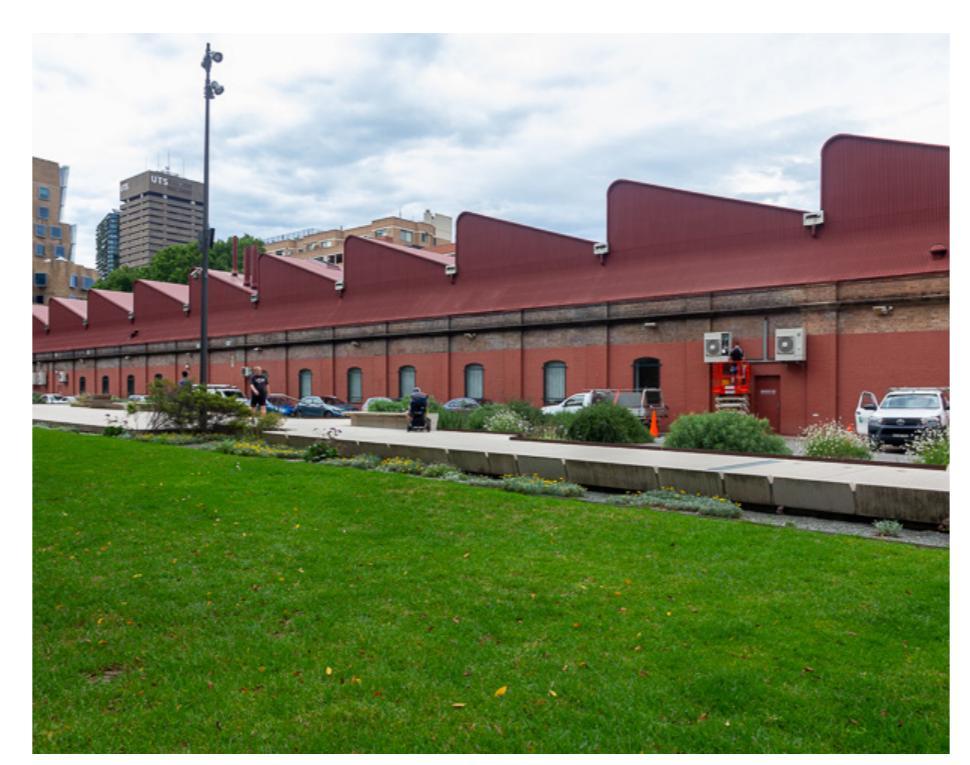
Figure 7.27 The north east corner of the Harwood building (Source: Powerhouse)

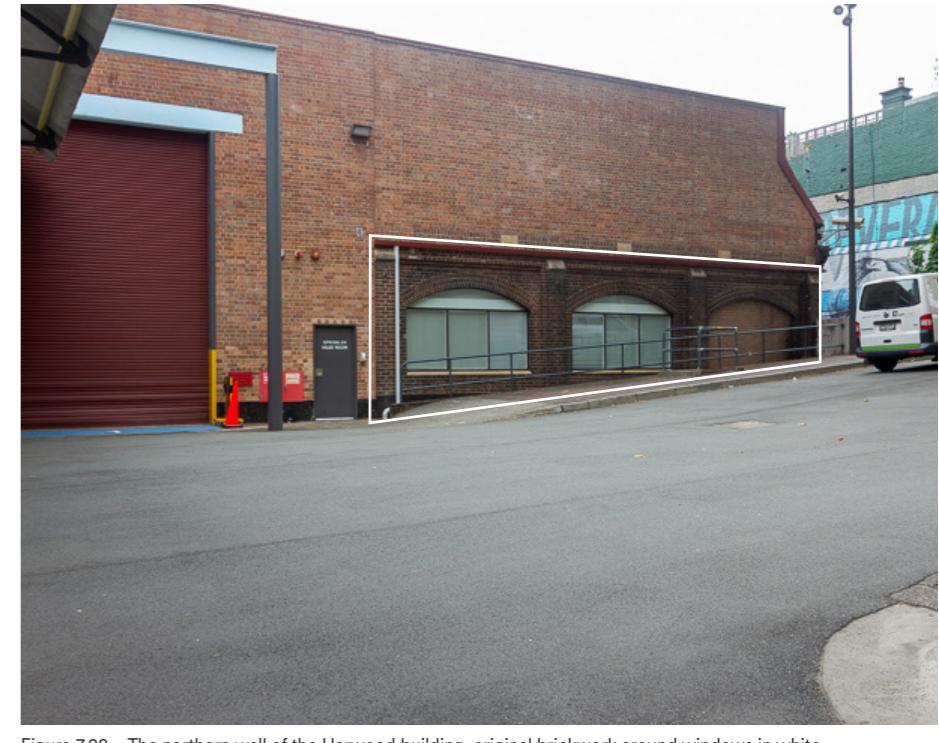
Figure 7.28 The northern wall of the Harwood building, original brickwork around windows in white (Source: Curio Projects)

There are three "original" windows to the north-west of the building, two have been infilled with modern glass, while the third has been bricked over.

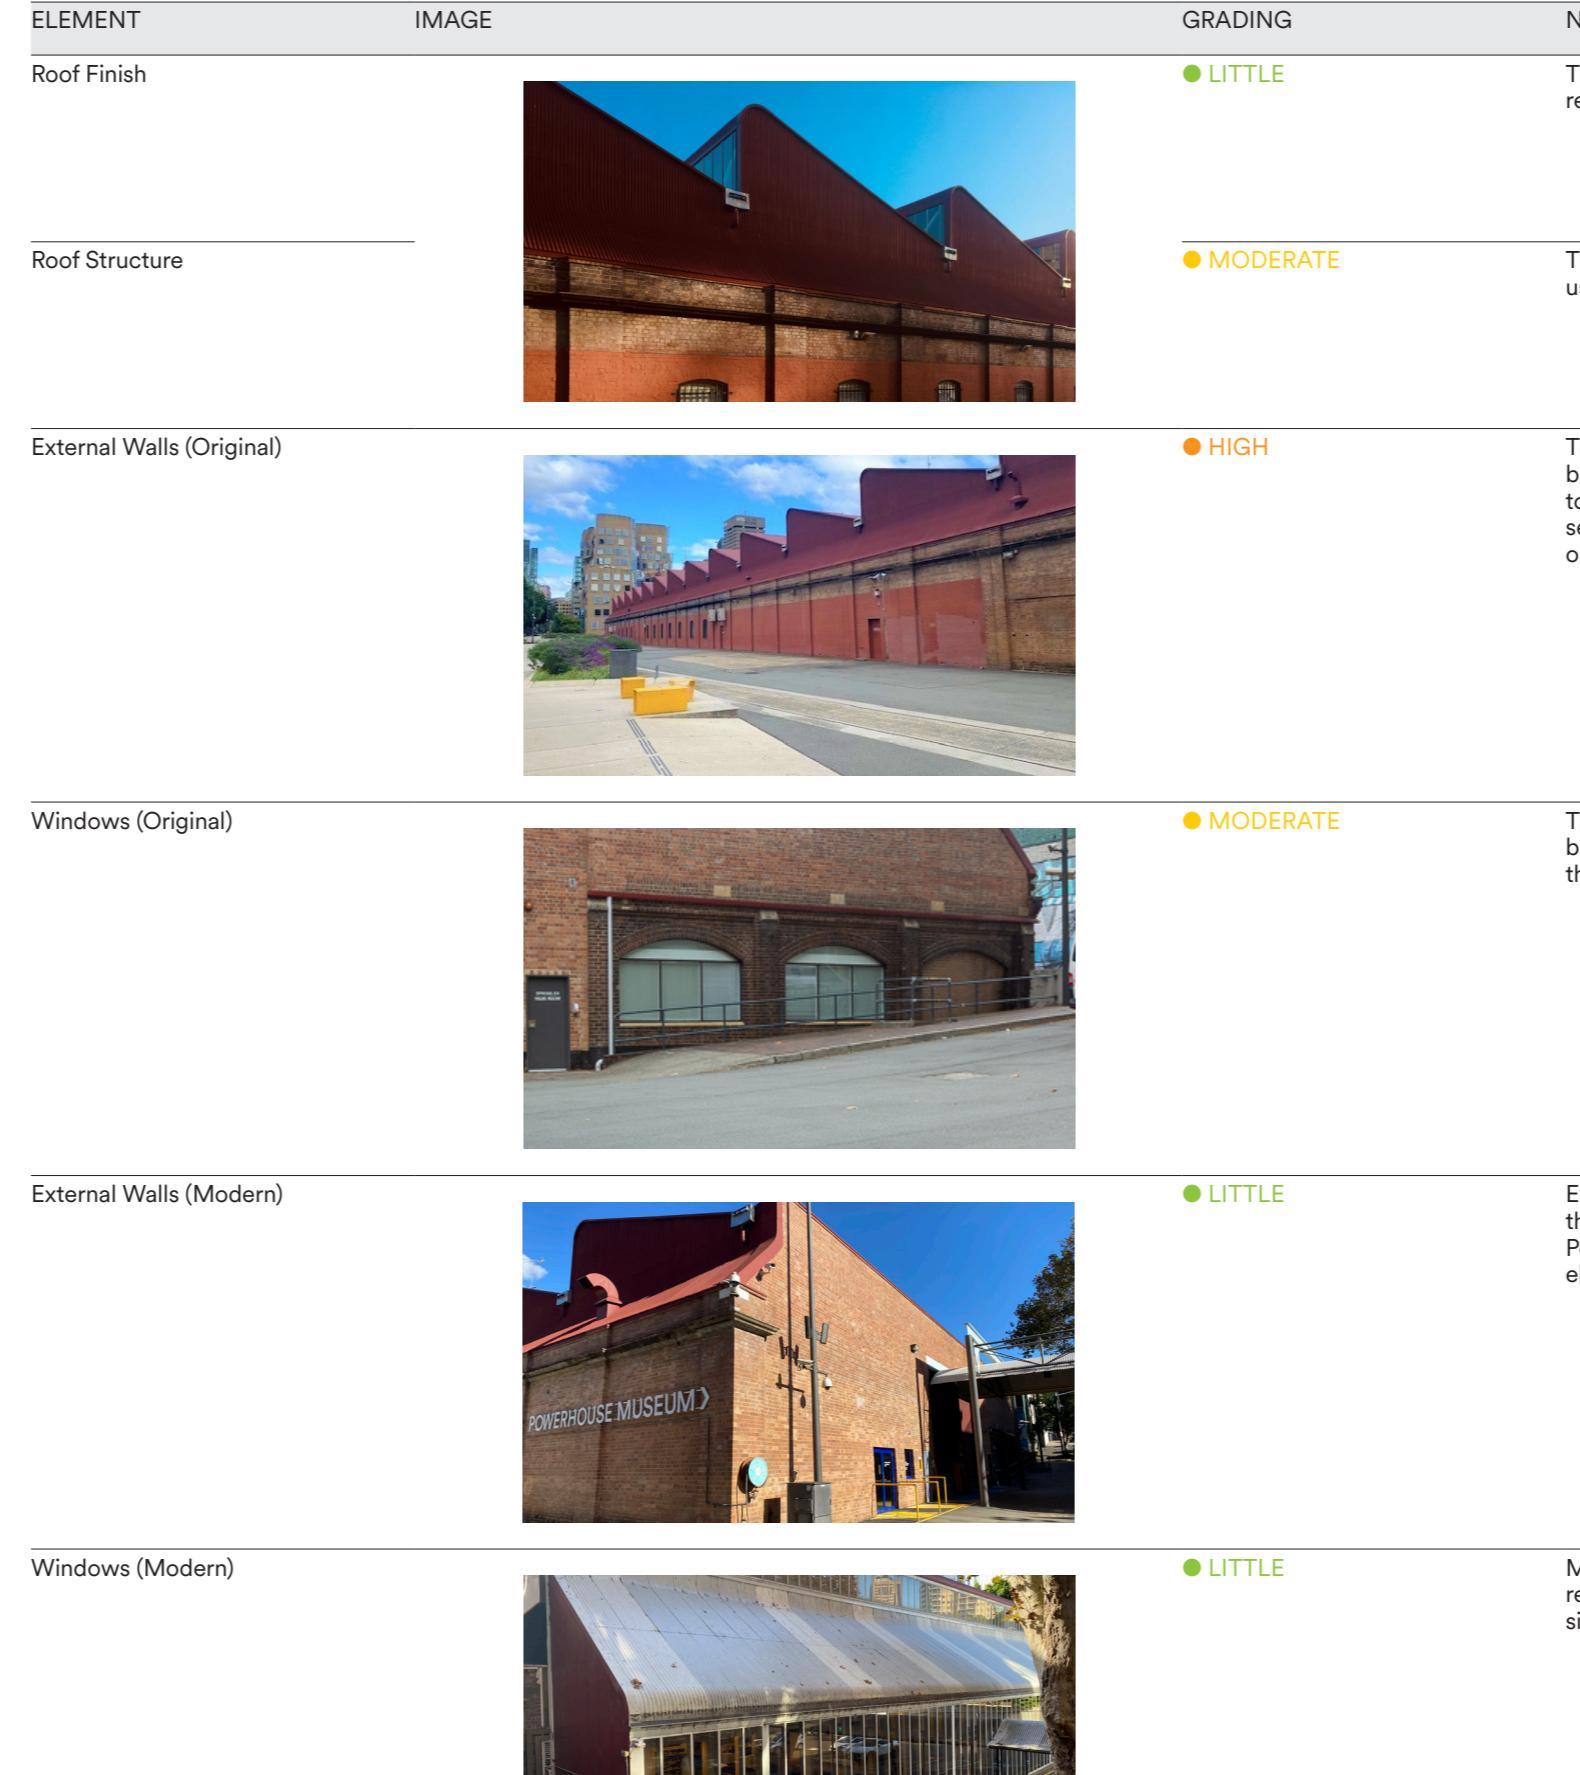
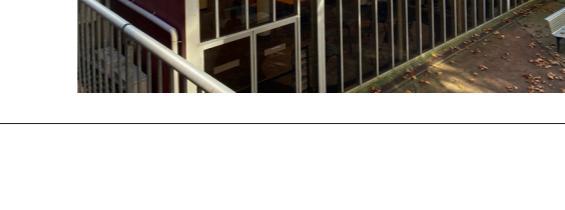
The roof finish is not original, reconstructed during the 1980s refurbishment works.

The structure of the roof has a visual significance for its former use as a tram depot, although the fabric is not original.

External walls to the Harwood Building constructed in the 1980s as part of the adaptive reuse of the site for the Powerhouse Museum (i.e. brick infill along the southern elevation) have little significance.

Modern windows installed in the 1980s as part of the adaptive reuse of the site for the Powerhouse Museum have little significance.

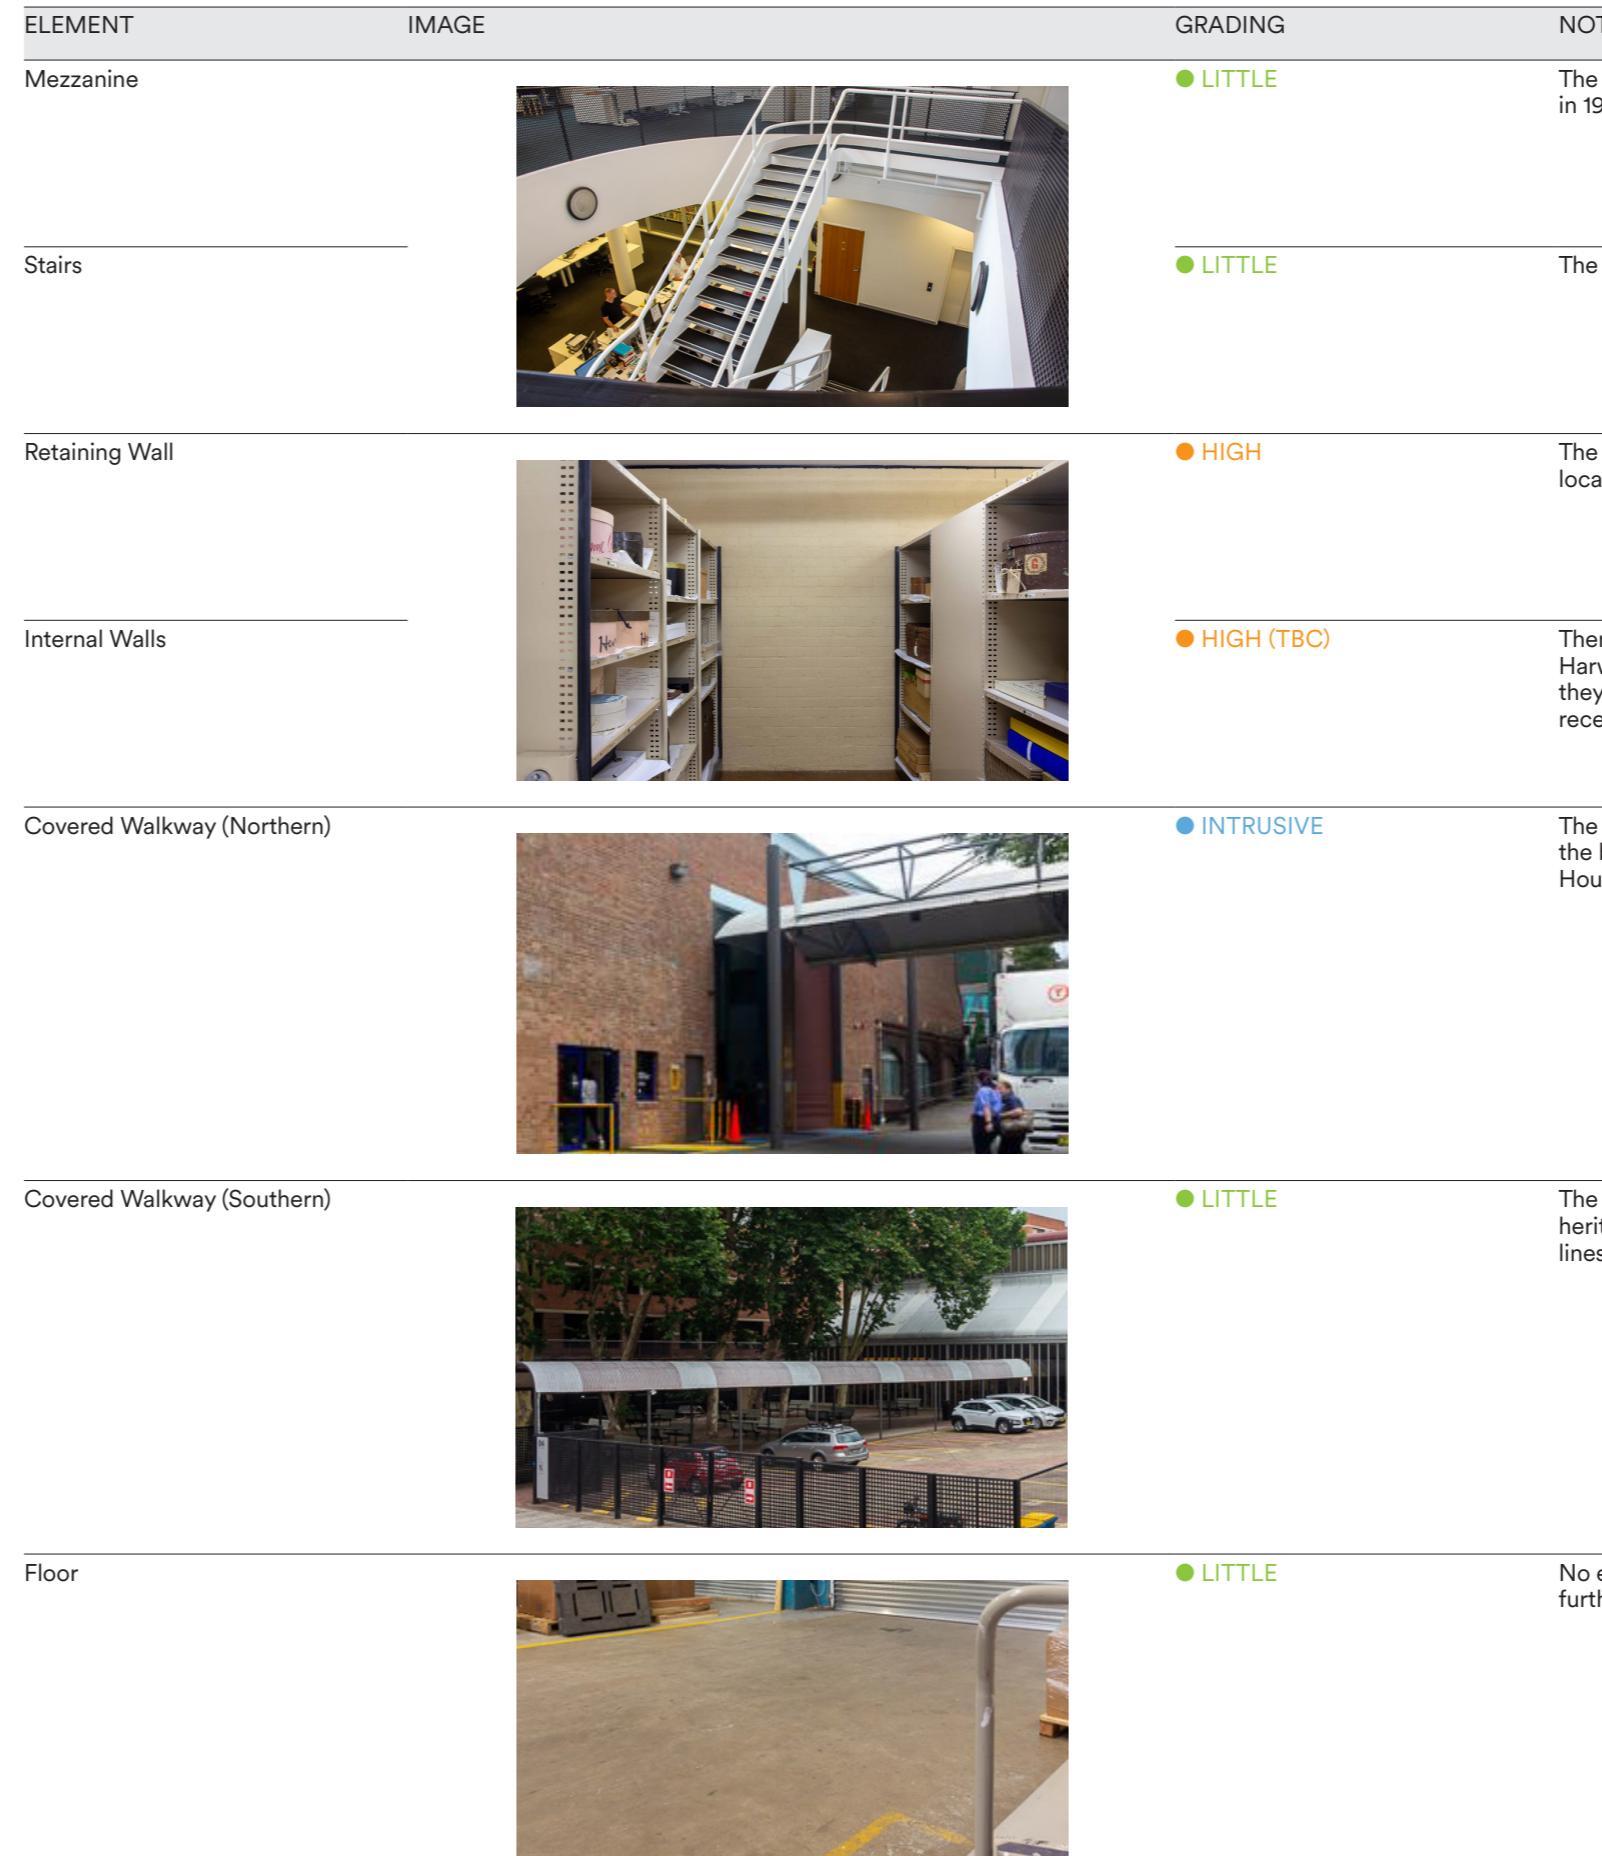
The mezzanine level of the Harwood Building was constructed in 1995 and has little significance.

The stairs are a later addition and have little significance.

The retaining wall from the original 1899 tram shed building is located underground and form a zig-zag pattern.

There are painted brick walls evident in the basement of the Harwood building which will require further analysis to clarify if they have any association with the 1899 building or are a more recent addition.

The modern covered walkway extending from the north of the building impacts the view of the Switch House and Boiler House, and is considered intrusive.

The covered walkway to the south of the building is of no heritage significance, yet its position does not impact the view lines to the significant elements of the building.

No evidence of the original floor was found during site visits, further visits may be necessary to clarify

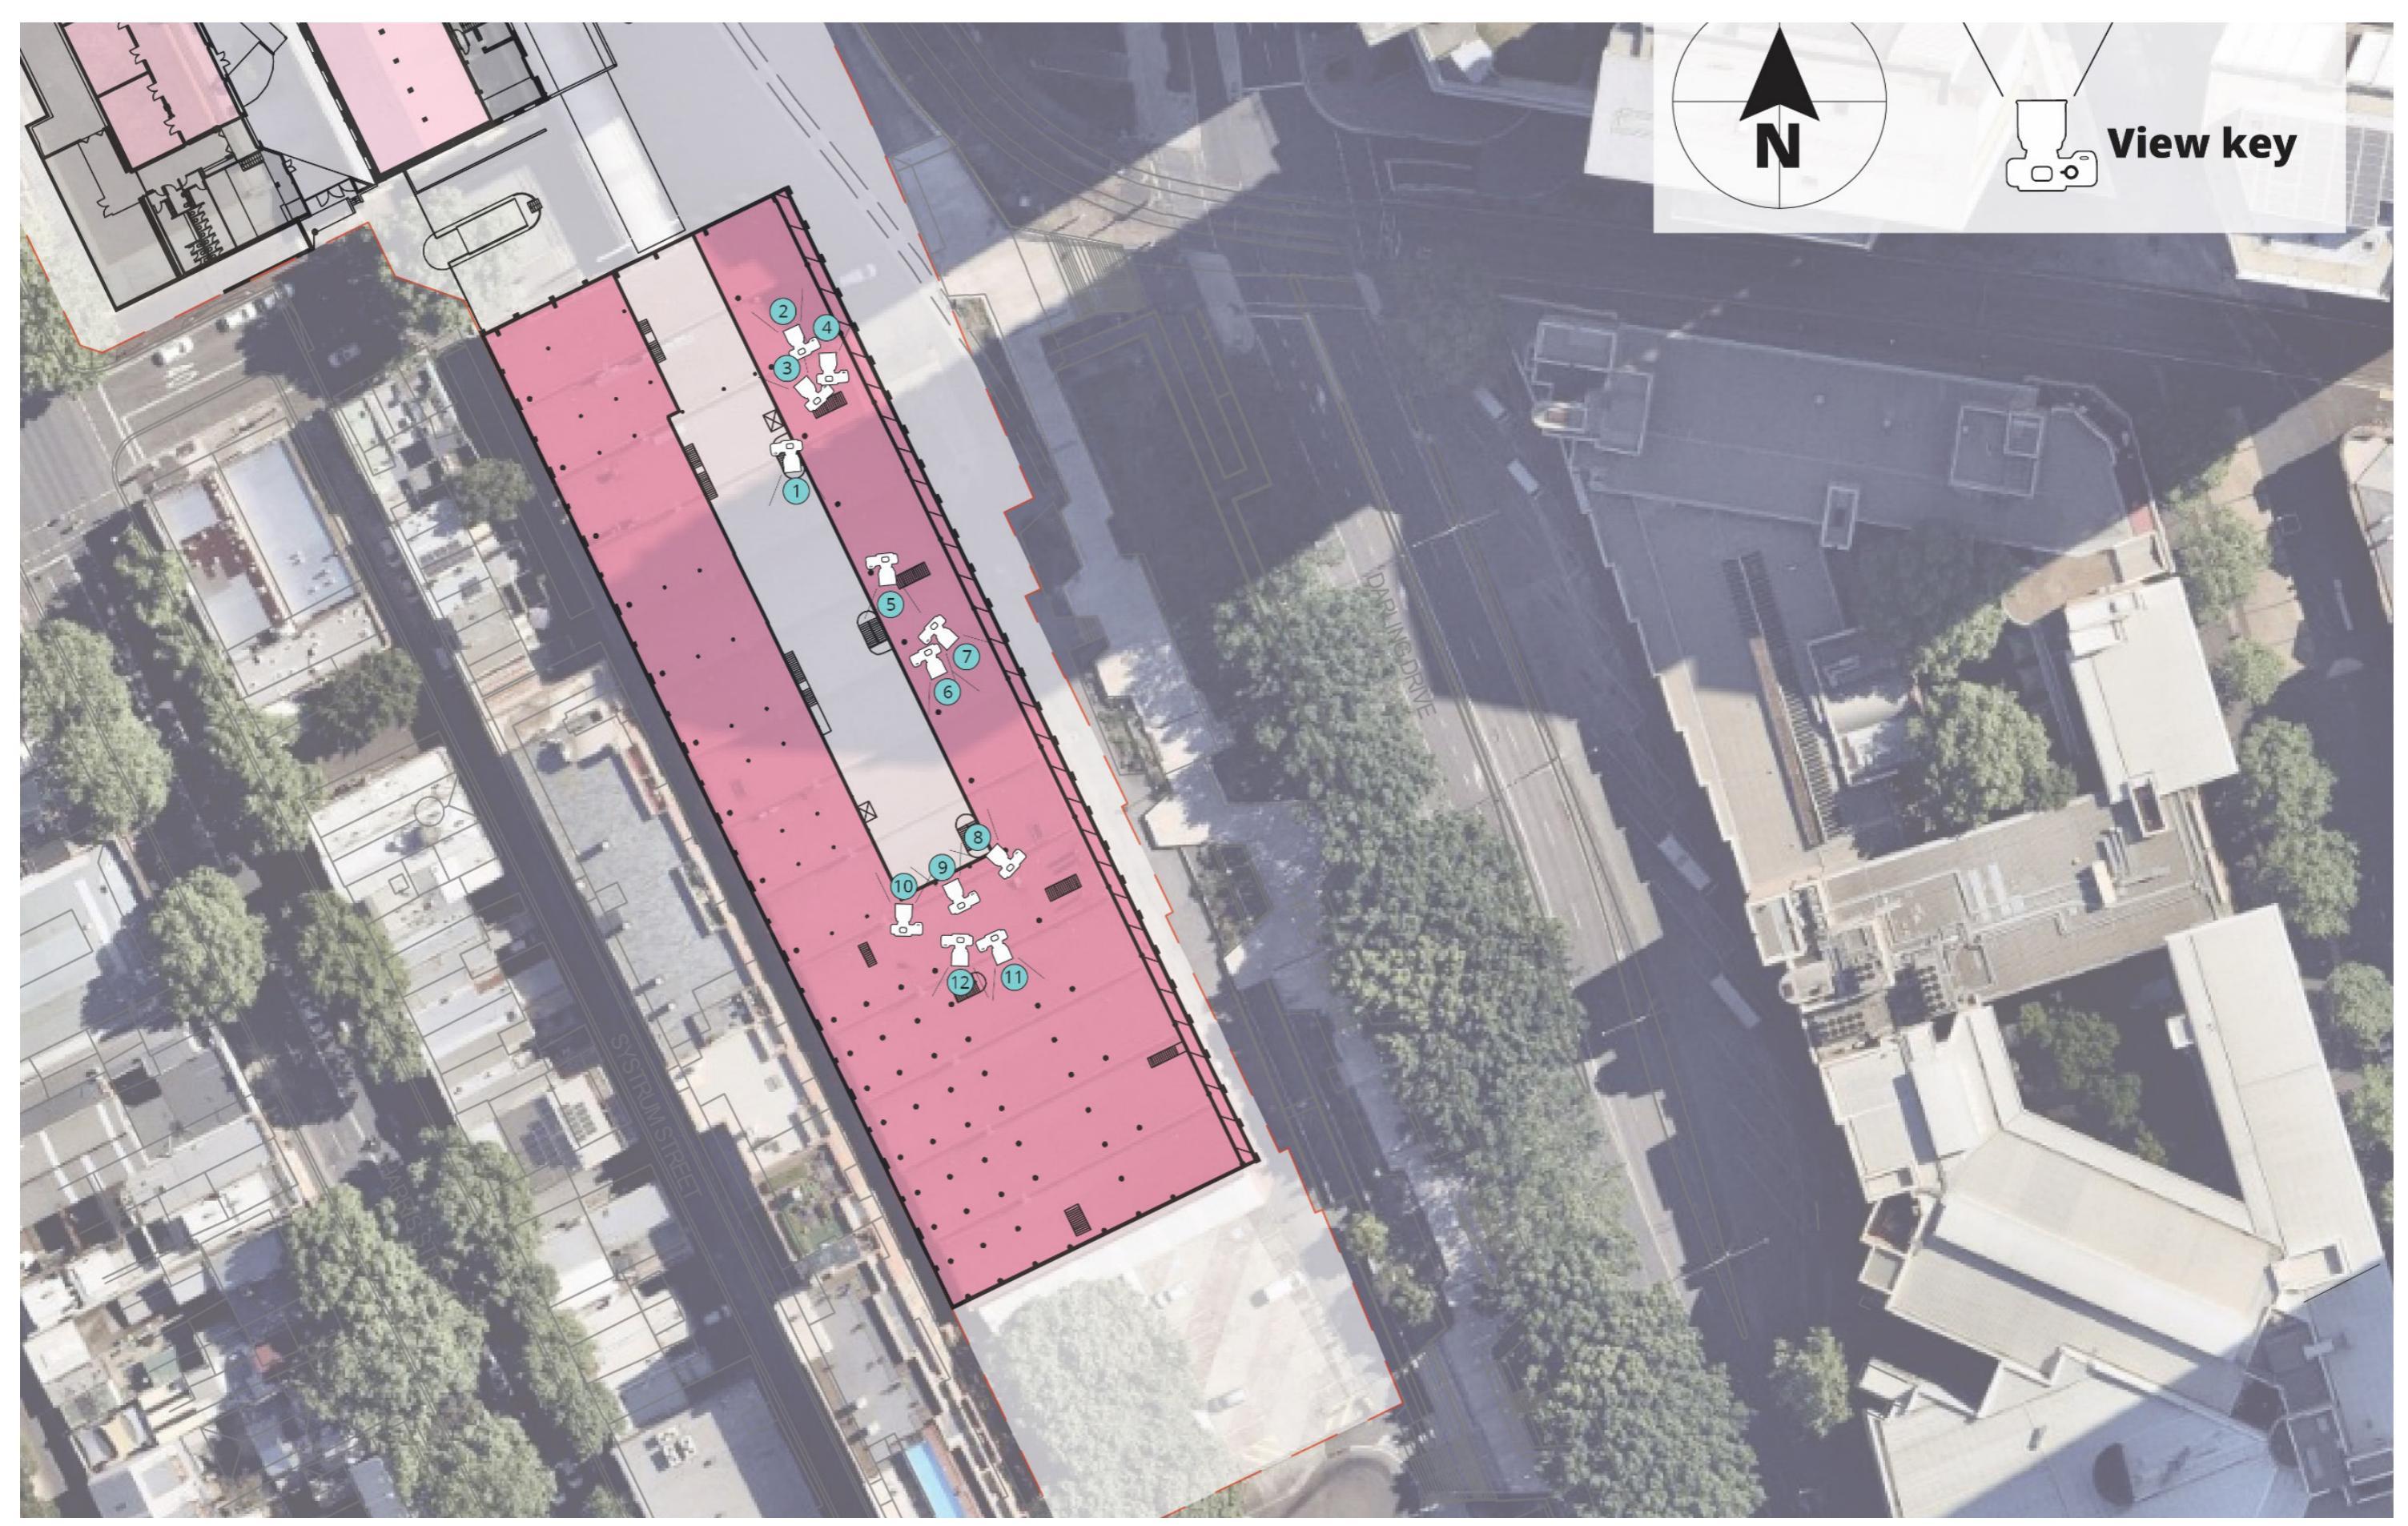
Figure 7.33 Harwood Building Photo Register (Level 2)
