GRINDING GROOVES DF04 AND PS11

Phase 3 Post Mining Inspection – Avoidance and mitigation

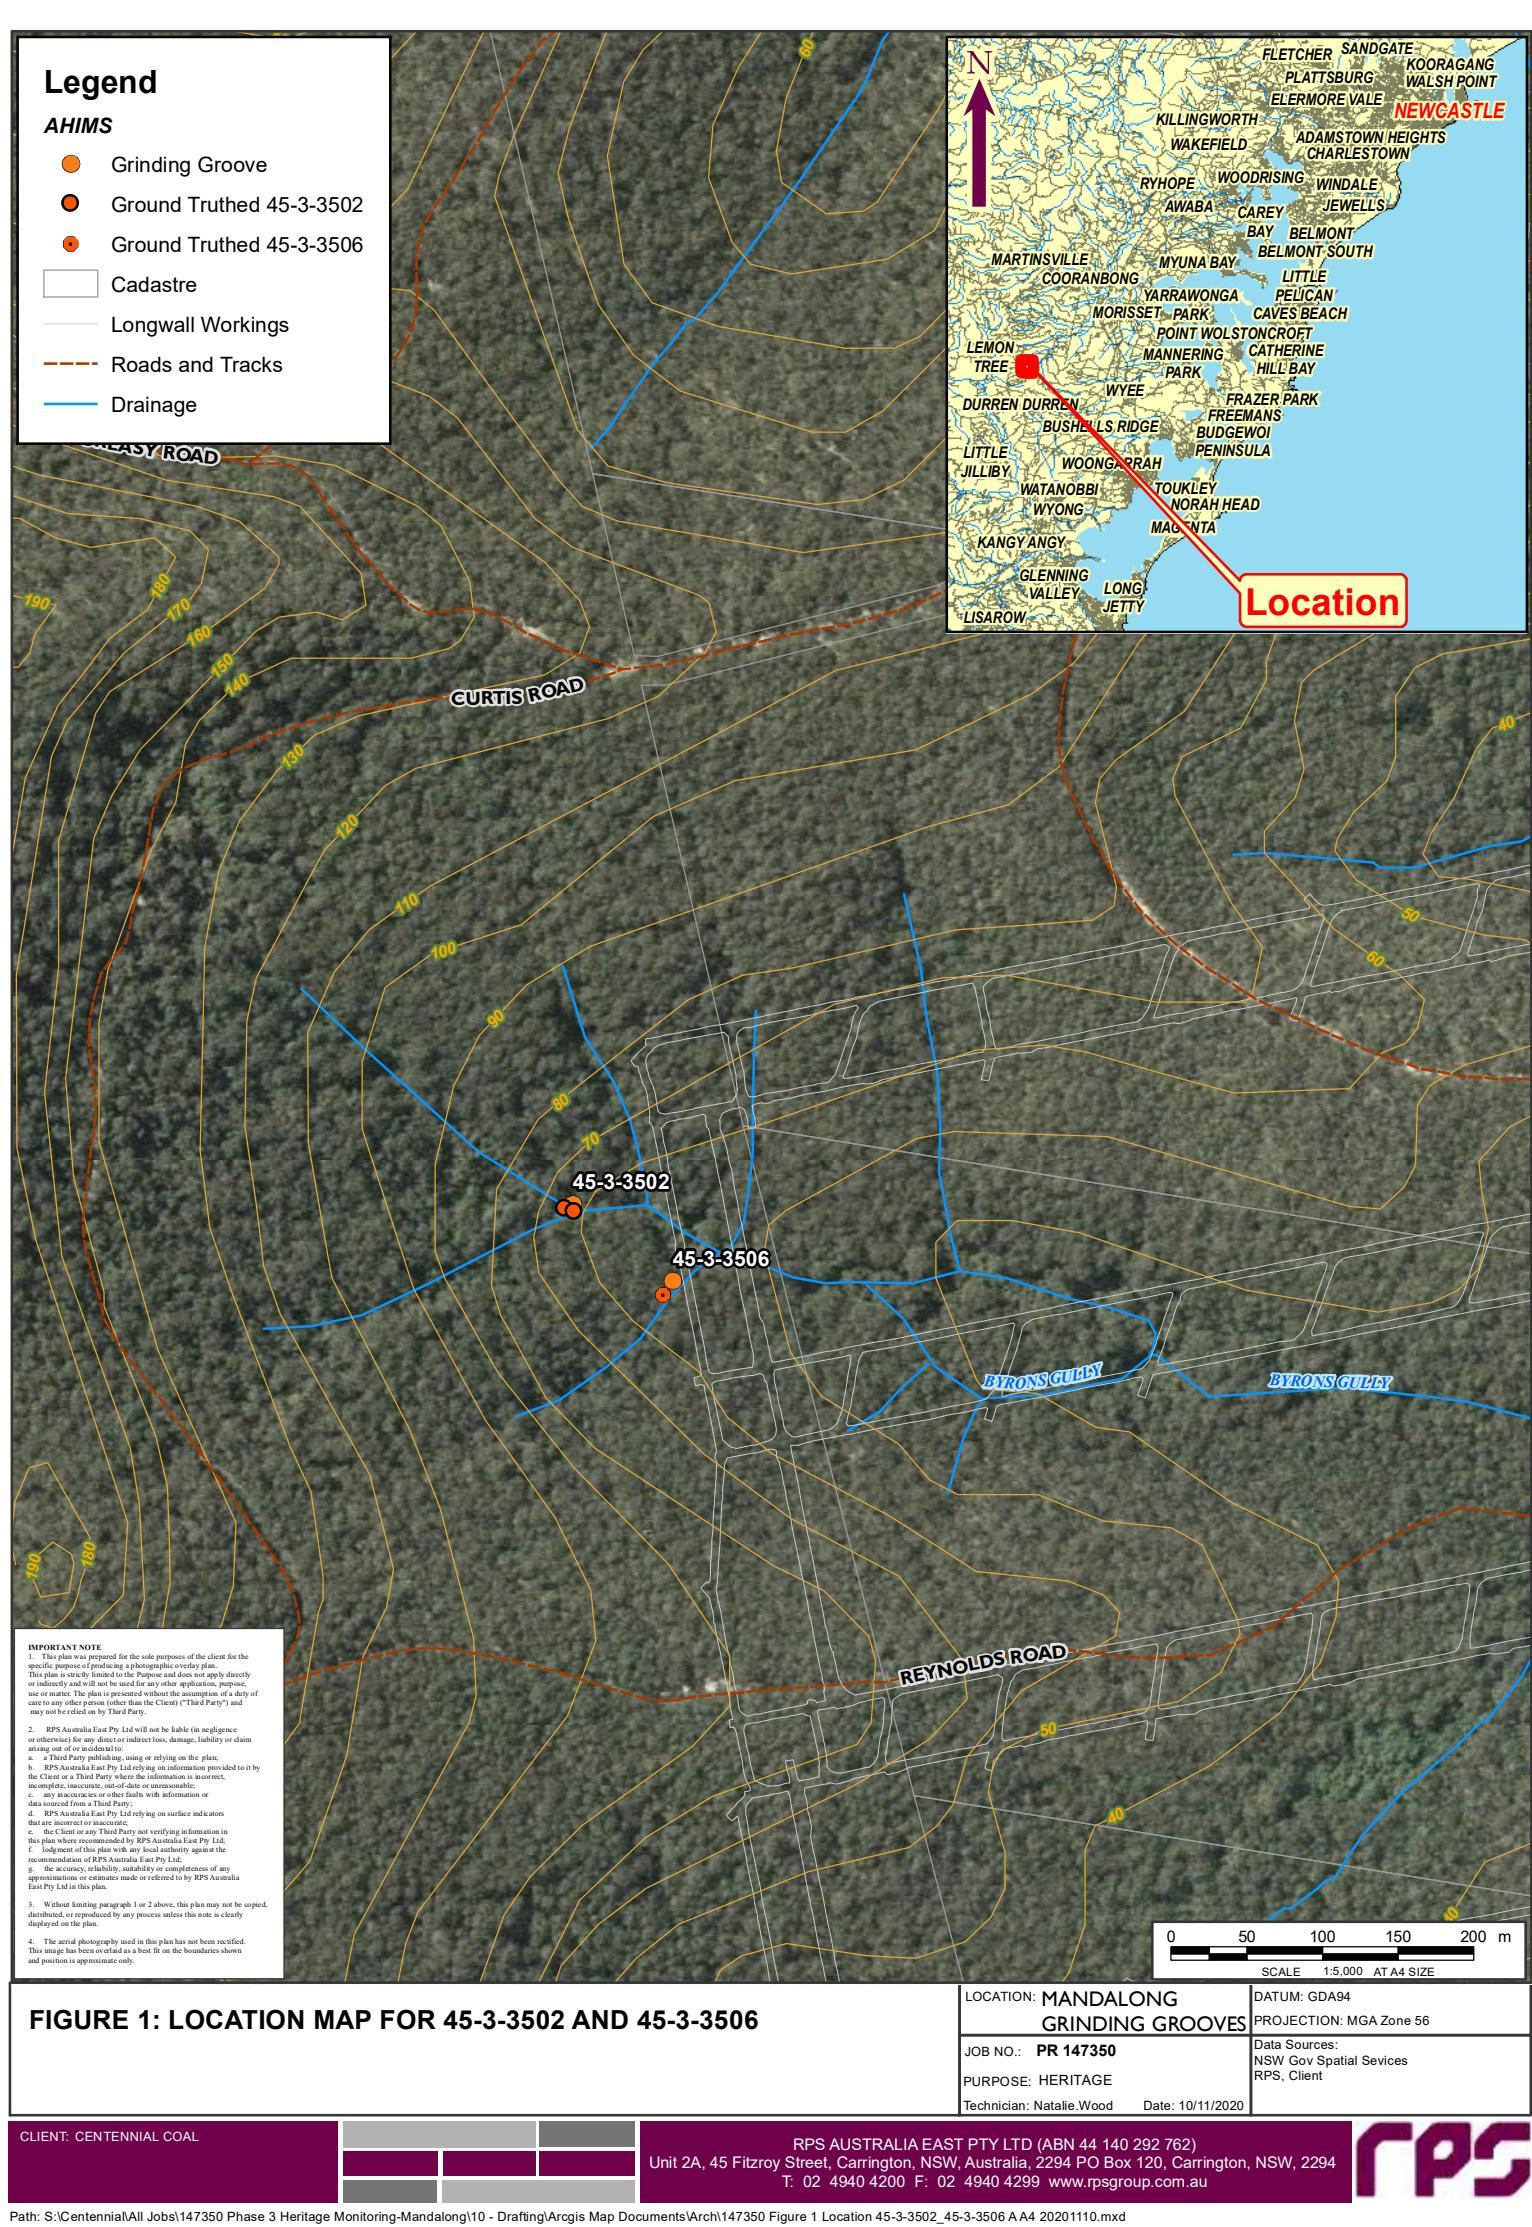
Aboriginal grinding groove site AHIMS 45-3-3506 (RPS site name PS11) was originally recorded by Philippa Sokol on 11/3/2011 during investigations related to Mandalong Southern Extension Project Heritage Impact Assessment (RPS 2013). This site is located on the course of a first order tributary of Byron's Gully above longwall 25, GDA94, Zone 56, E350536, N6330234 (Figure 1). Rock pools occur directly north west of the

two grinding grooves. The grinding grooves are located beyond the western end of Longwall 25, but within the 26.5 degree angle of draw however, impact to this site from cracking is also unlikely.

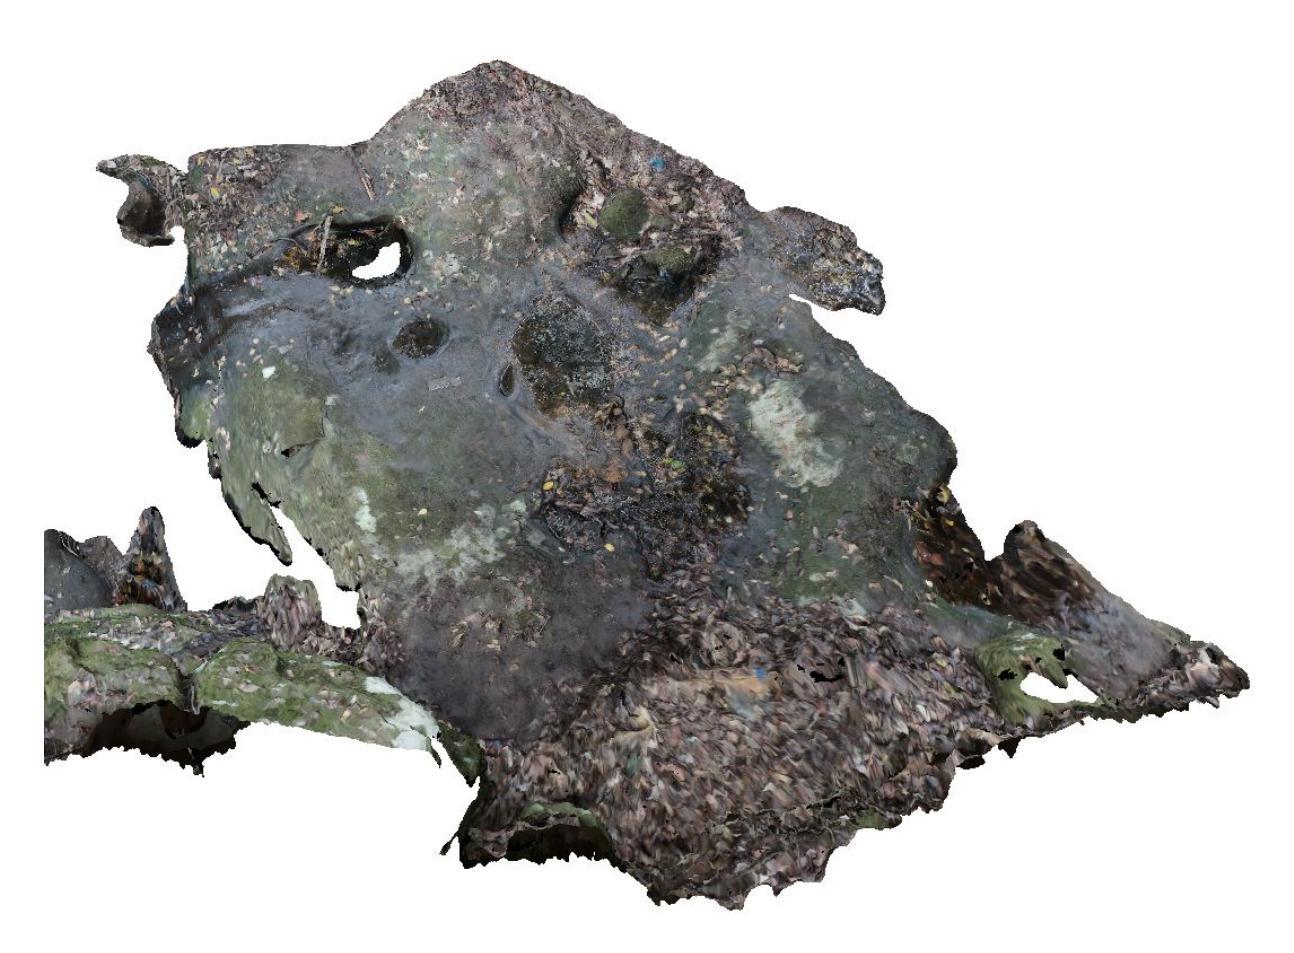
Figure 2 AHIMS (DF04) 45-3-3502 Original Orthomosaic

Four grinding grooves were originally identified as a result of the original recording of the site, with one additional groove identified during the Phase 1 baseline recording. Water flow along the drainage line is from east to west and was flowing during the time of the Phase 3 inspection. Measurements were able to be taken of all grooves and all were consistent with the baseline recording.

Groove ID Number	Length (mm)	Width (mm)	Depth (mm)	Notes
1	250	40	20	Single groove
2	310	70	40	Single groove
3	100	45	10	Single groove
4	110	40	10	Single groove
5	238	78	11	Single groove

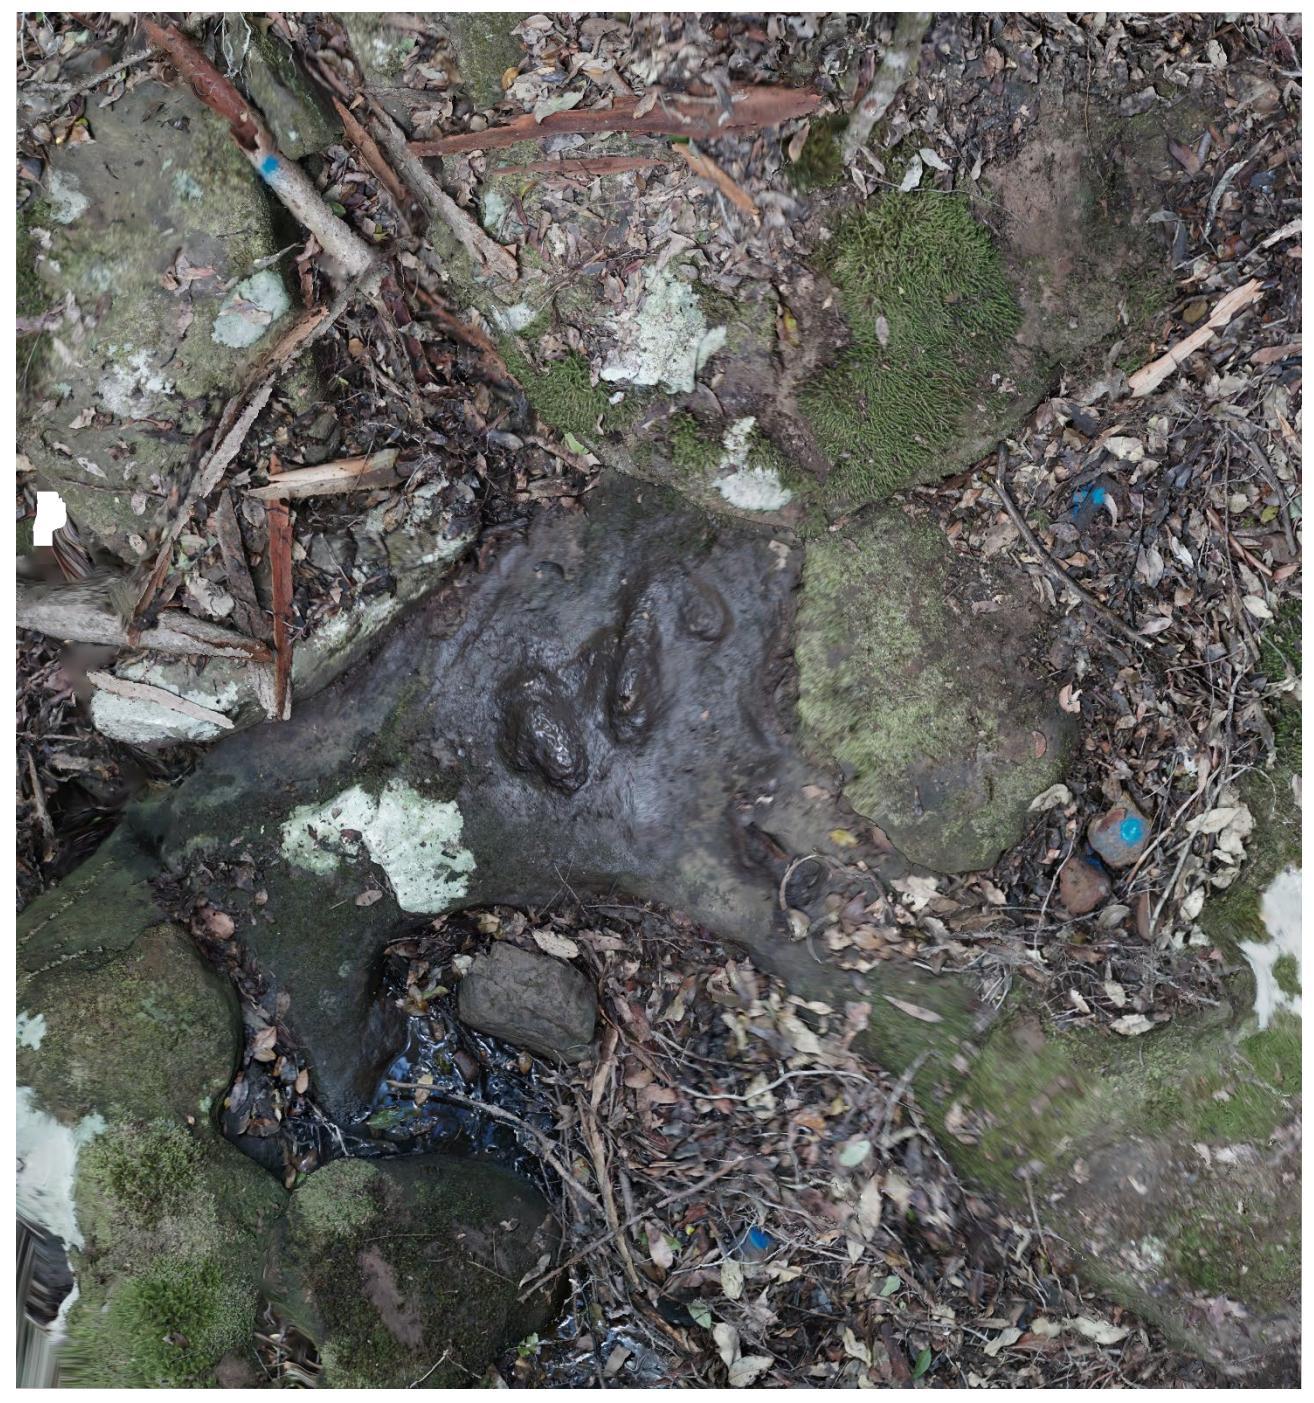
Figure 3 45-3-3506 (PS11) Original Orthomosaic

Two grinding grooves were identified during the Phase 3 inspection as previously identified during the previous inspections. These were consistent with the Phase 1 and Phase 2 inspections. Although no running water was observed over the grooves, pooling of water was prevalent throughout indicating recent heavy rains and inundation of the grinding grooves.

Groove ID Number	Length (mm)	Width (mm)	Depth (mm)	Notes
1	100	40	38	Single groove
2	110	40	34	Single groove

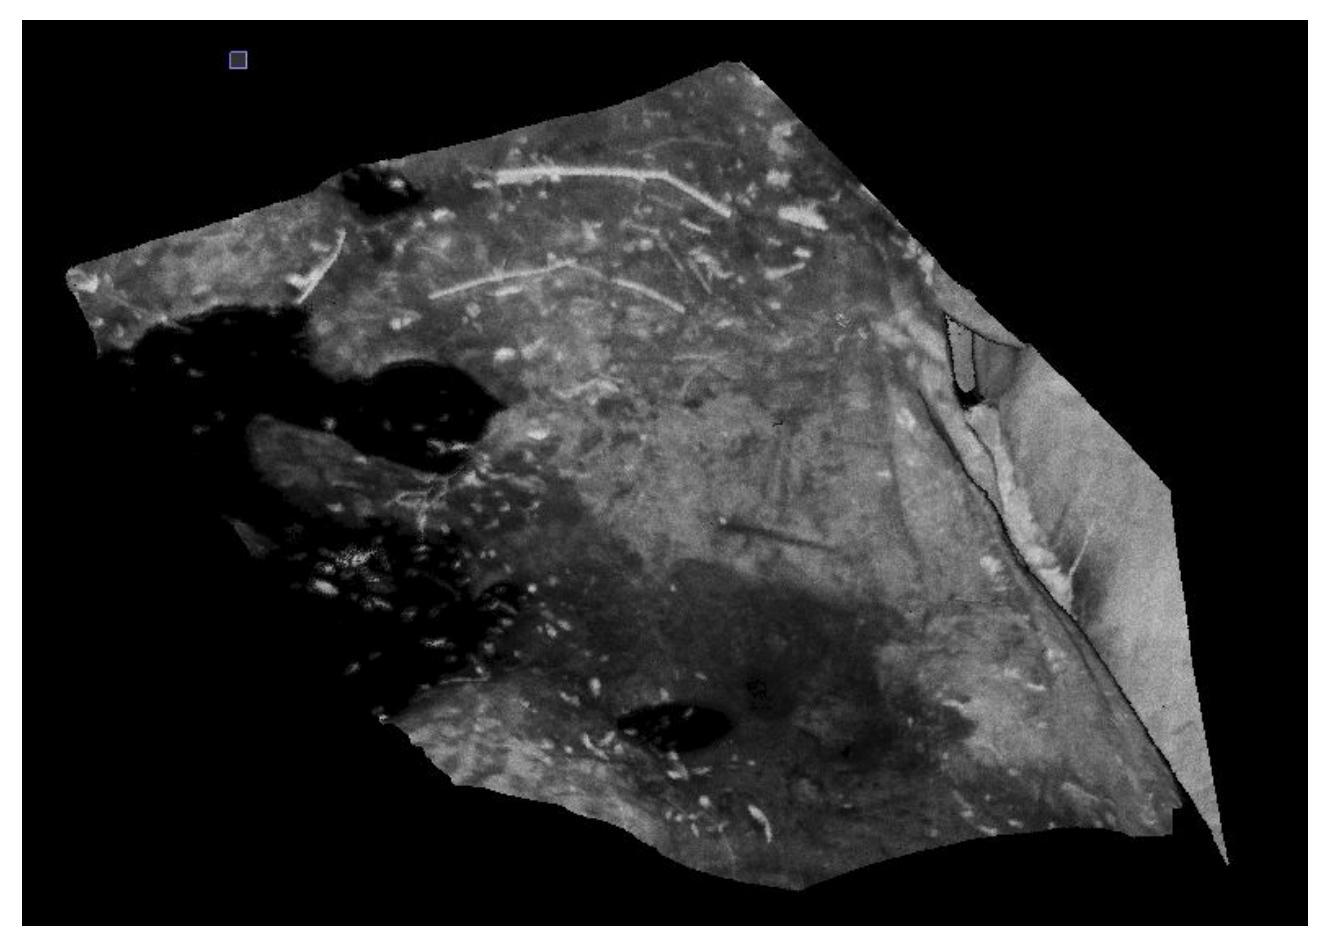
Figure 4 AHIMS 45-3-3502 (DF04) Scan Data

3D scans were taken by Centennial of the grinding grooves using Trimble SX10 instrument to provide comprehensive coverage of the grooves.

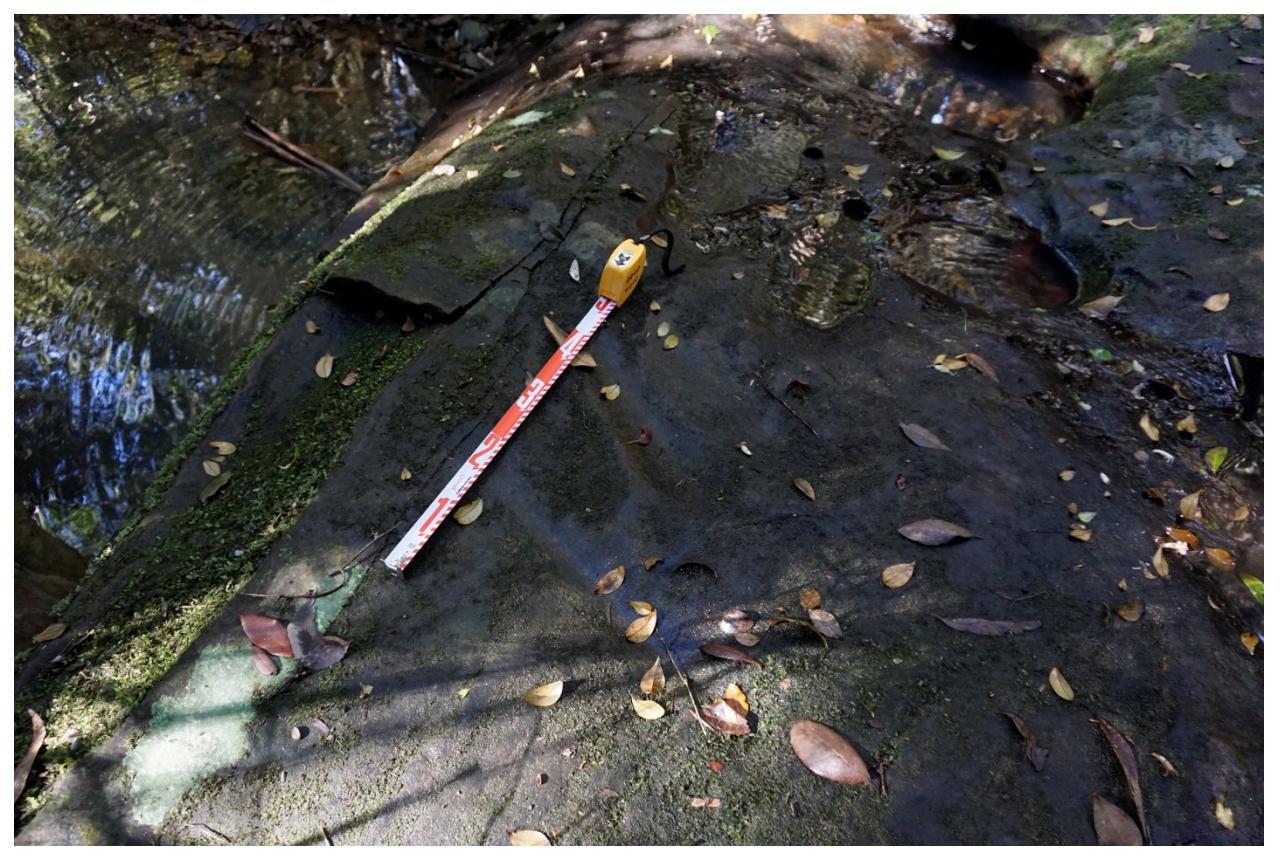
AHIMS site 45-3-3502 (RPS DF4) experienced subsidence of -0.019 m which is consistent with the expected (0.01) subsidence predictions for Longwall 25-31.

Plate 1 AHIMS Site 45-3-3502 grinding grooves (17 August 2020)

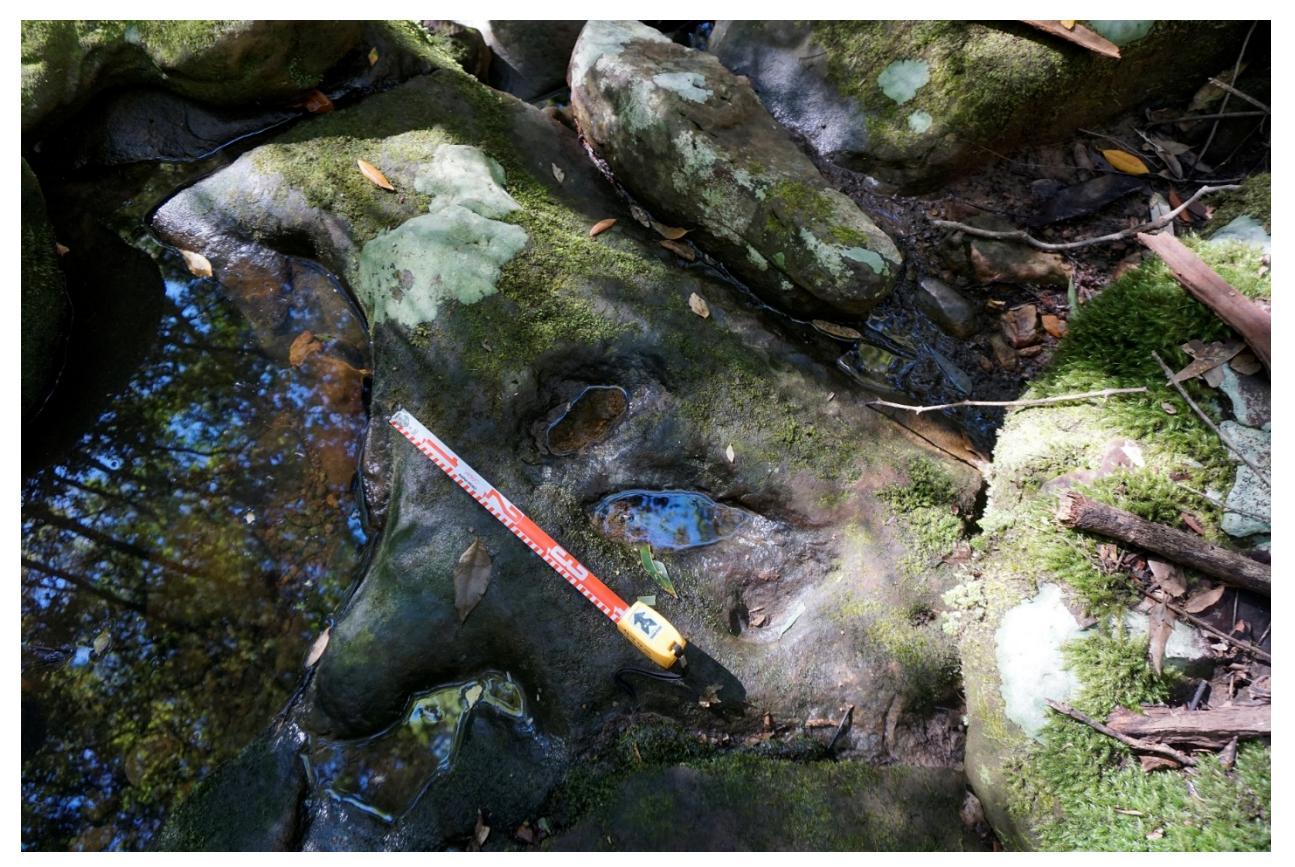
AHIMS site 45-3-3506 (RPS PS11) experienced subsidence of -0.032 m which is below the expected (0.09) subsidence predictions for Longwall 25-31.

Plate 3 AHIMS 45-3-3506 Grinding Grooves (17 August 2020)
