LAND AND SOIL CAPABILITY ASSESSMENT

Proposed Battery Energy Storage System

57 Burgess Lane, Calala, NSW, 2340 Also known as 474 Calala Lane, Calala, NSW, 2340 ENV218049

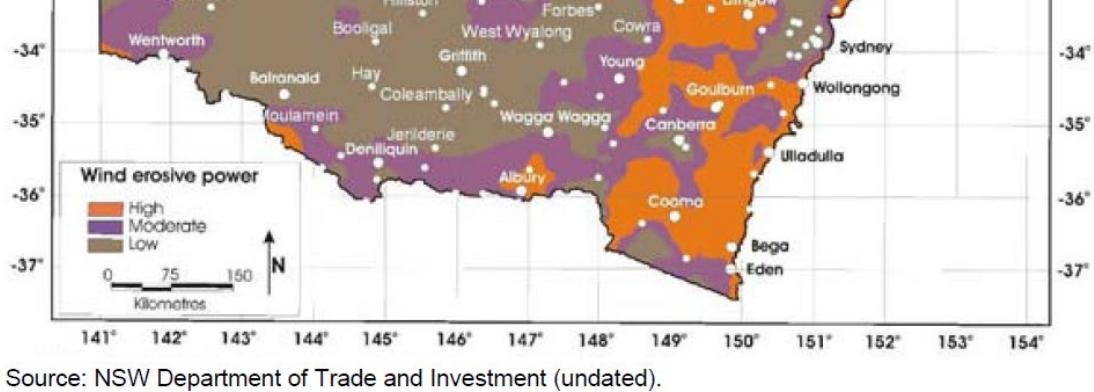
Figure 1 - Wind Erosive Power

wind erosion hazard is the potential for the detachment of soil and movement from the effects of wind blowing across the soil surface. Soil texture, rainfall, wind erosive power and site exposure all influence the wind erosion hazard for the site. Table 4 outlines the wind erodibility class of the soil.

Based upon the low wind erodibility class of surface soils, a high wind erosive power, a moderate exposure to wind and an average annual rainfall >500mm, the site has a wind erosion hazard of 3.

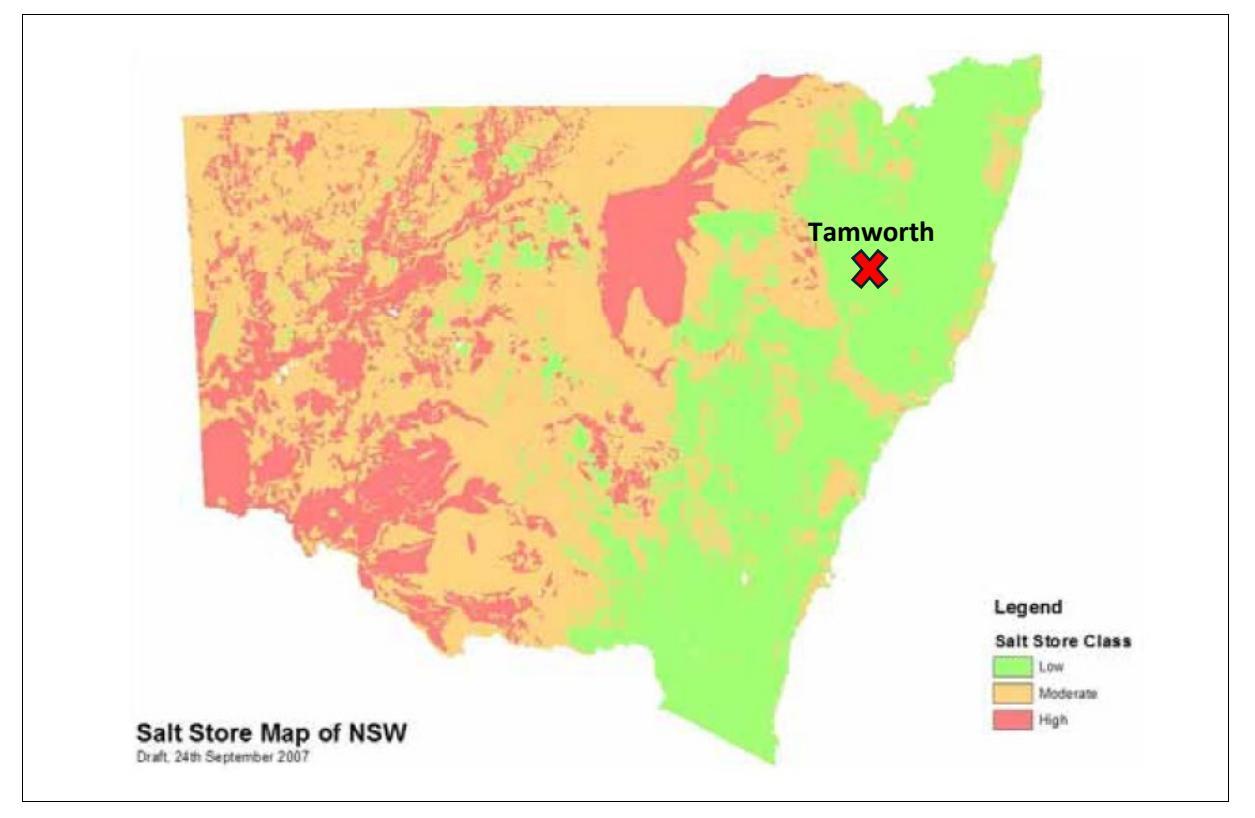
Figure 2 - Salt Store Map of NSW.

Salinity hazard is the potential for mobilised salts to migrate to the substrate surface and waterways due to the changes in land management and land uses. Different farming practises, land clearing and irrigation and can impact salinity. Figure 2 illustrates the salt stores of NSW with the general Tamworth region being within a low salt store zone.

Due to the dissenting creek and watercourse with high clay content soils (less permeable soils), the property is considered to have a moderate recharge potential and moderate discharge potential. Table 9 provides the LSC class for salinity hazard.

Based upon a moderation recharge potential, a moderate discharge potential and a low salt store, the site has a LSC salinity hazard of 2.

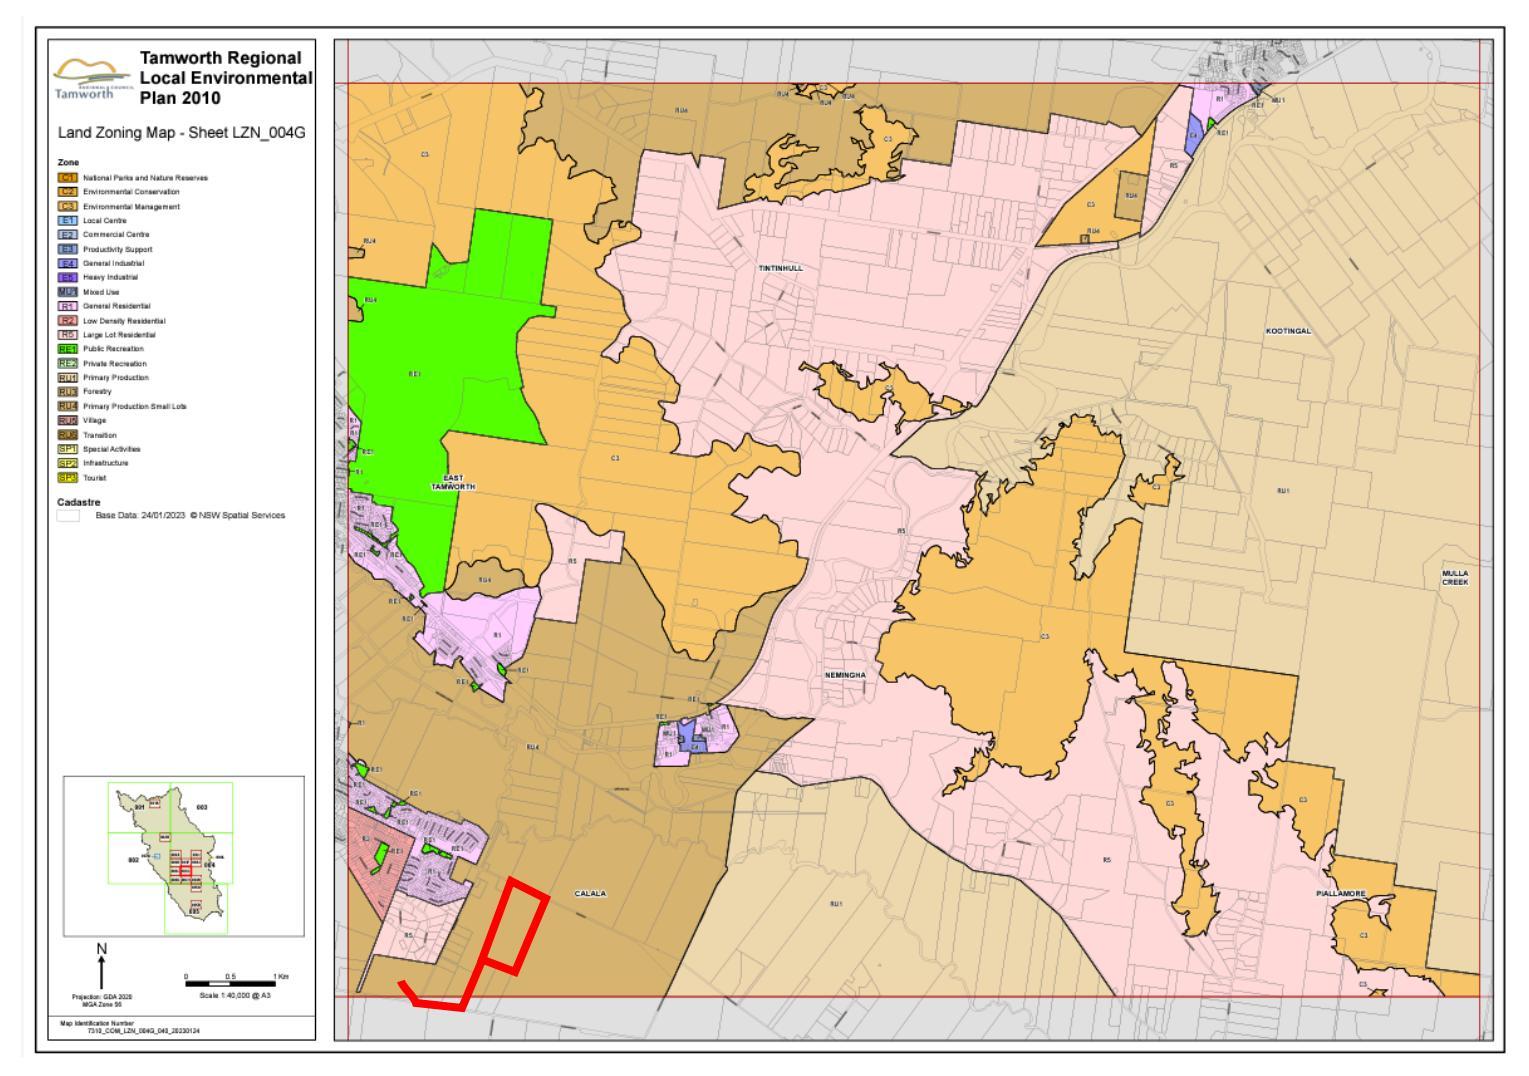
Figure 3 – Zoning Map 474 Calala Lane, Calala, NSW, 2340

The site is zoned RU4 – Primary Production Small Lots, under the Tamworth Regional Council Local Environmental Plan (LEP) (2010). The following land uses are permitted without consent within an RU4 zone: Agricultural produce industries; Aquaculture; Cellar door premises; Dual occupancies (attached); Dwelling houses; Farm buildings; Intensive plant agriculture; Kiosks; Landscaping material supplies; Light industries; Markets; Plant nurseries; Roadside stalls; Rural workers' dwellings. The site is currently used for Rural activities improved grazing/cropping. See the Tamworth LEP Zoning Map in Figure 3, Appendix A.

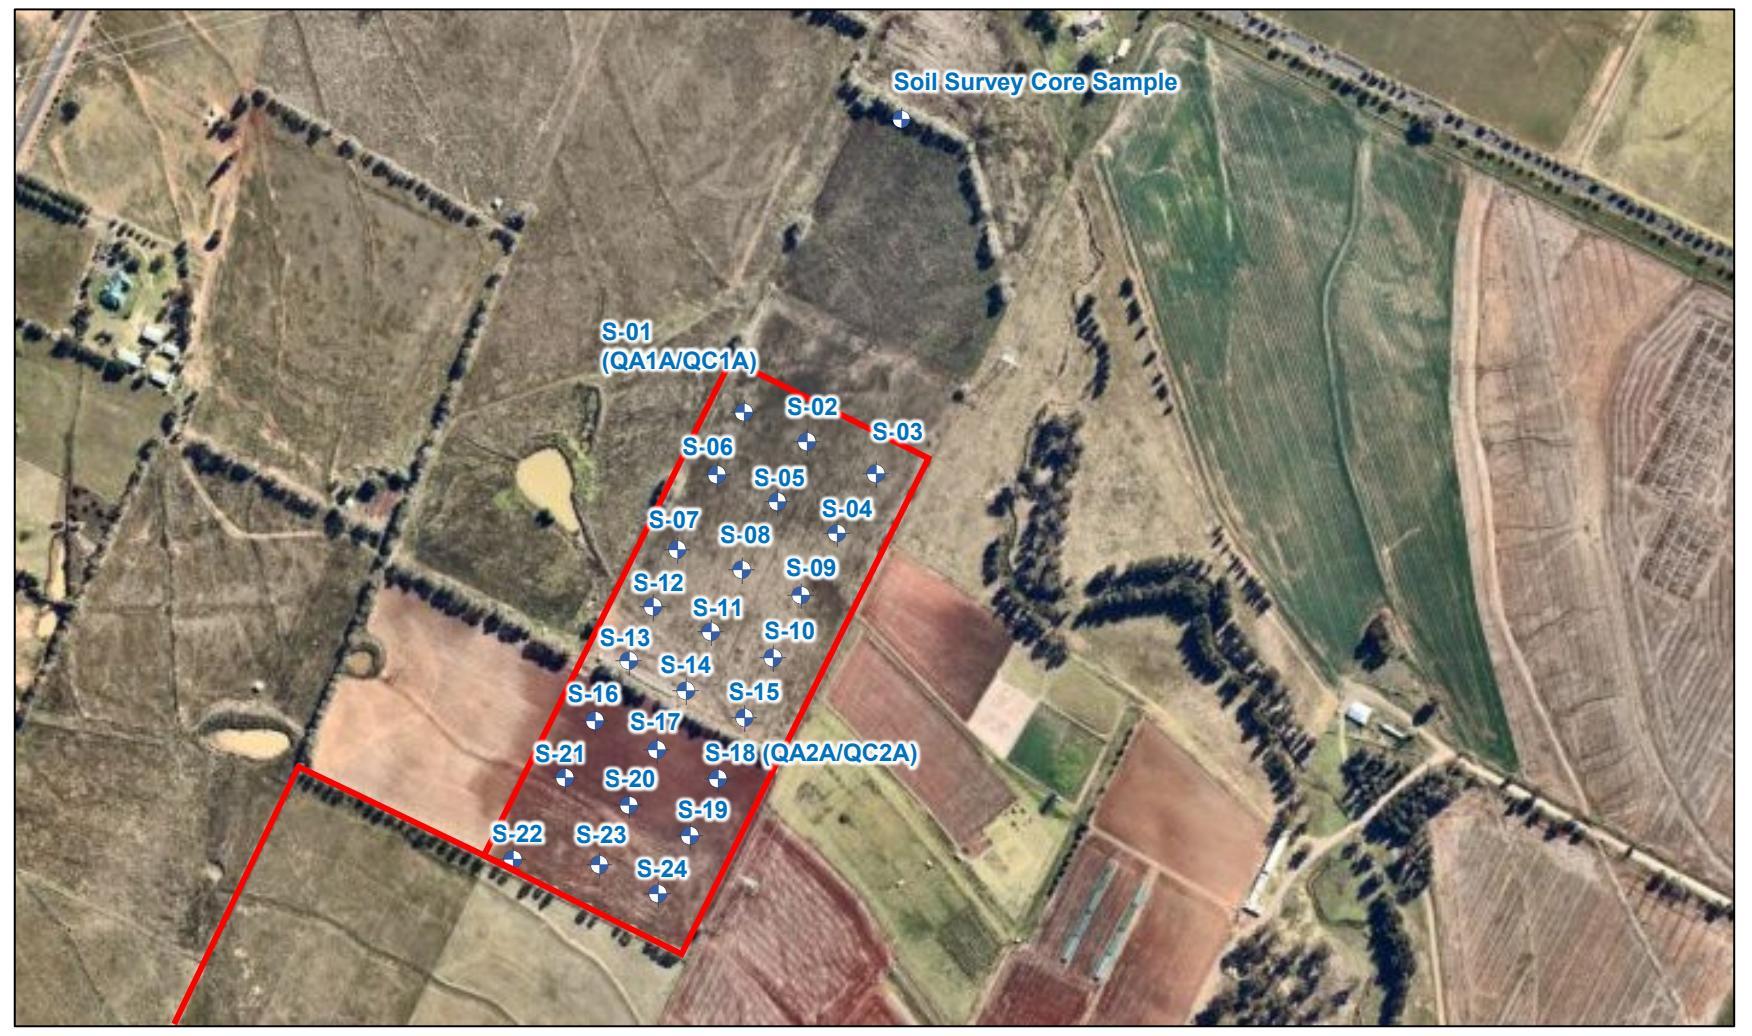
Figure 7 – Sampling Plan 474 Calala Lane, Calala, NSW, 2340

Project Site Area (approximate)
