PYMBLE LADIES COLLEGE PYMBLE, SYDNEY, NSW 2073

AQUATIC & FITNESS CENTRE MASTERPLAN

ARBORICULTURAL ASSESSMENT & DEVELOPMENT IMPACT REPORT

PLC Aquatic Centre 2126 Master Plan Arboricultural Assessment Report, April/2013 PYMBLE LADIES COLLEGE, AVON ROAD, PYMBLE, SYDNEY NSW

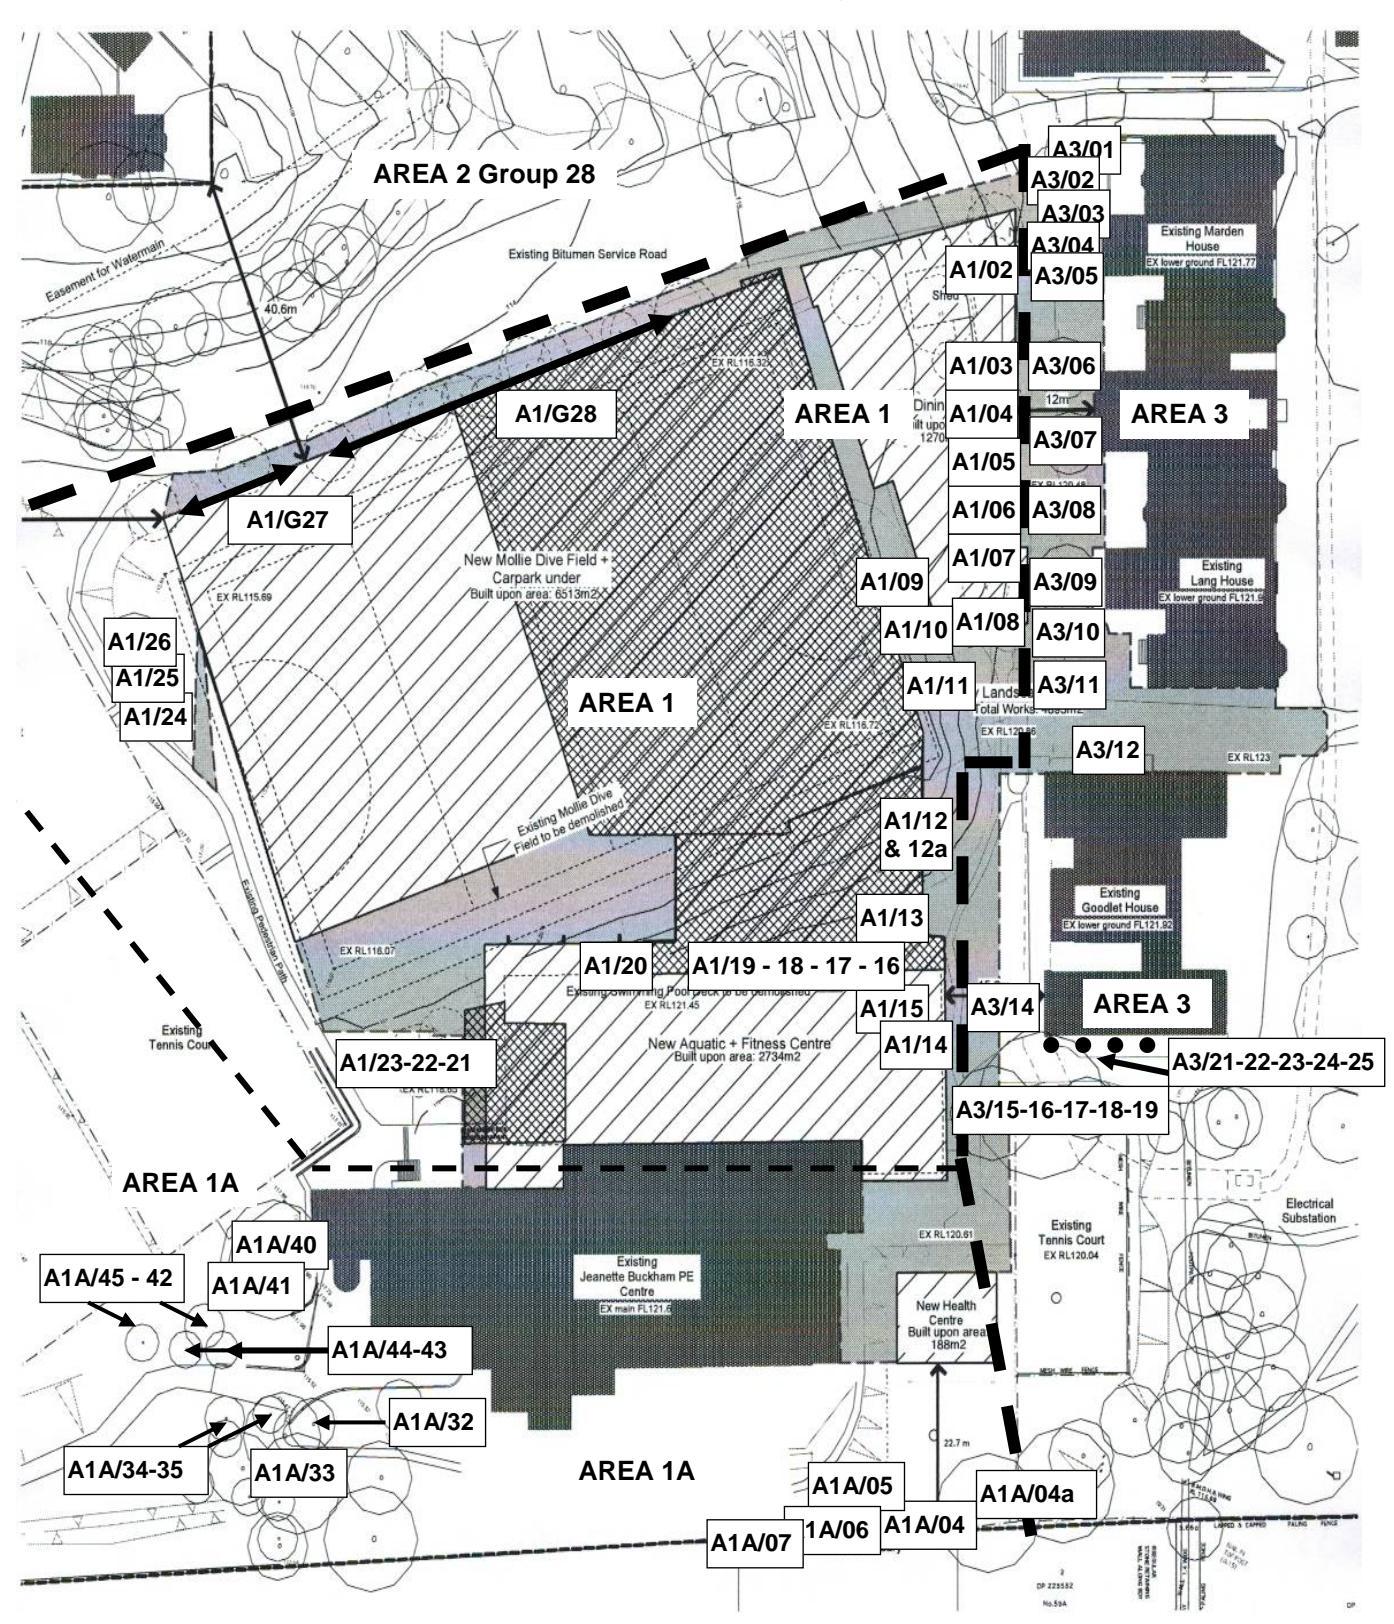
APPENDIX D: Tree Location Plan / modified for page setup

The trees may be referenced within the Tree Assessment Schedule and Tree Location Plan Appendices C and D.
