Appendix I3

Contaminated land assessment

Narrabri Gas Project - Environmental Impact Statement Contaminated Land Assessment

July 2016

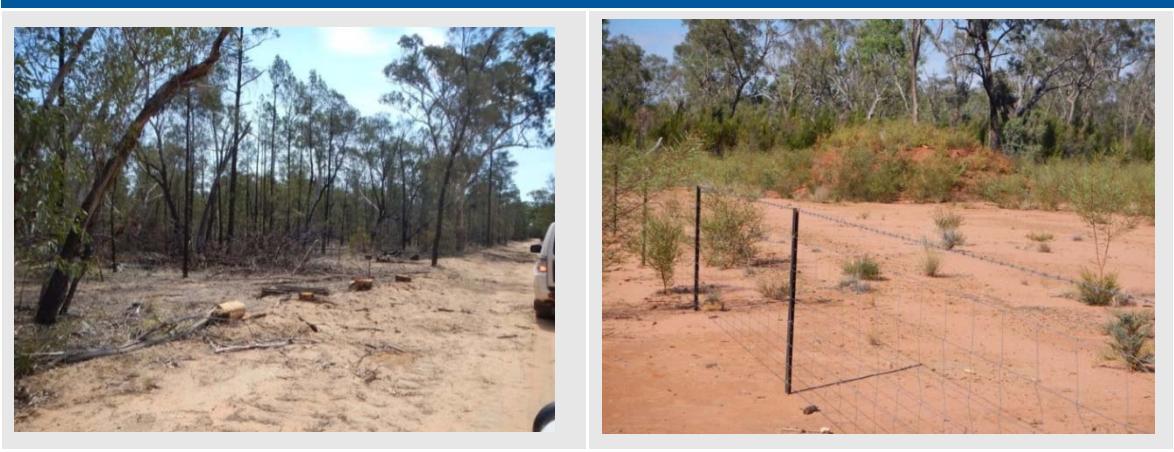
Plate 1: Minor tree clearance

- relatively small areas of tree clearing was evidenced (refer to Plate 1). The clearing area was potentially associated with flowline installation. Possible minor fuel spills associated with former logging activities were also observed in this area
- soil stockpiles adjacent to well pads were observed (refer to Plate 2). Relatively well established vegetation was noted on the stockpiles, indicating that the stockpiles has not been recently generated
- examples of isolated illegal dumping within the forest area were sighted, including corroded car bodies (refer to Plate 3) and empty and corroded 44 gallon drums (refer to Plate 4).

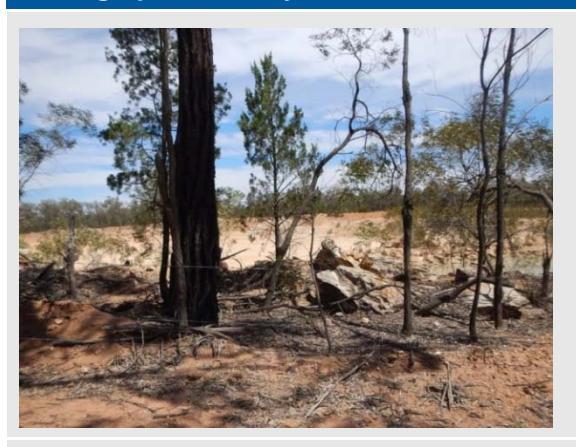
Plate 5: Excavation pit

- during the site inspection, a large formed quarry pit was observed (approximately 100 metres long, 50 metres wide and 10 metres deep) being excavated, with spoil being taken offsite (refer to Plate 5)

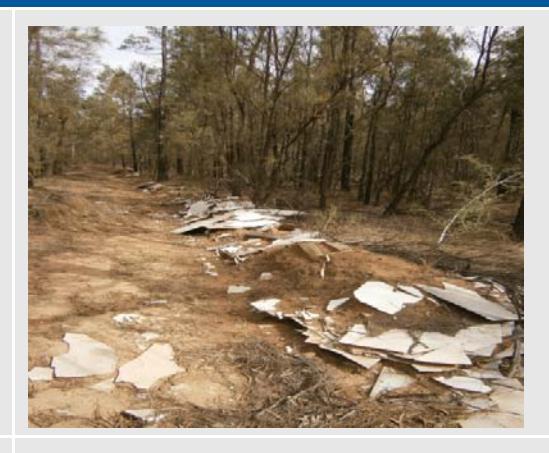
Plate 6: Fibre cement sheeting

- fibre cement sheets, possibly containing asbestos, were observed close the north eastern boundary of the project area (refer to Plate 6)
- stockpiles of soil and gravel were observed in a cleared area adjacent to the Newell Highway. The stockpiles comprised of soils and blue metal / road base gravels. The stockpile area was not fenced and no environmental controls were present. No signage was present to indicate the origin of the material (refer to Plate 7)

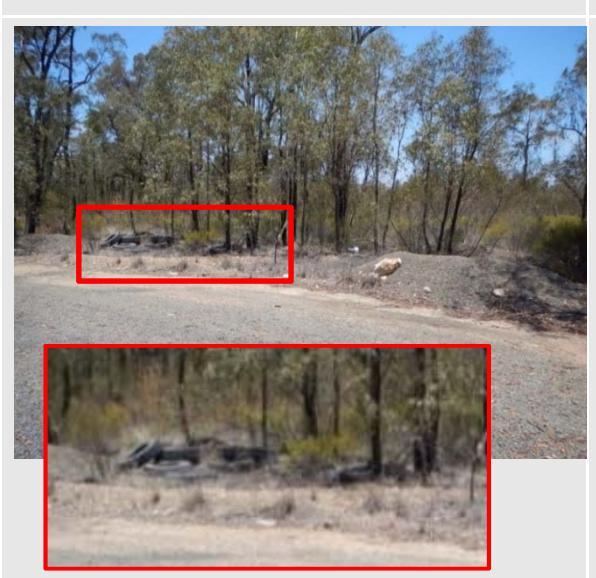
Plate 9: Rubber tyres

- abandoned rubber tyres were noted adjacent to the road (Plate 9).
- empty 20 litre and 205 litre steel drums were noted adjacent to the Newell Highway. At least one 20 litre drum formerly contained what appeared to be engine oil. The former contents of the 205 litre drums are unknown (refer to Plate 10).

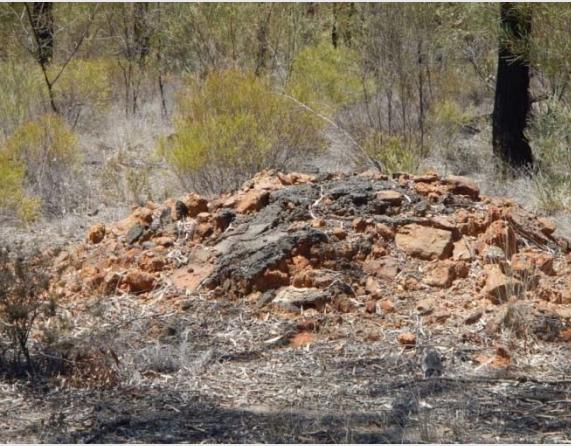
Plate 8: Stockpiled material

- stockpiled materials, including clay soil with traces of asphalt/bitumen, were noted adjacent to the Newell Highway. The origin of the material was not confirmed (refer to Plate 8)
