Re: Lands Department – SSDA 7484 – MOD 18 – Methodology for the templating, removal, reinstatement, and reconstruction of plaster cornices

The Department of Lands Building Heritage Cornice Salvaging Methodology

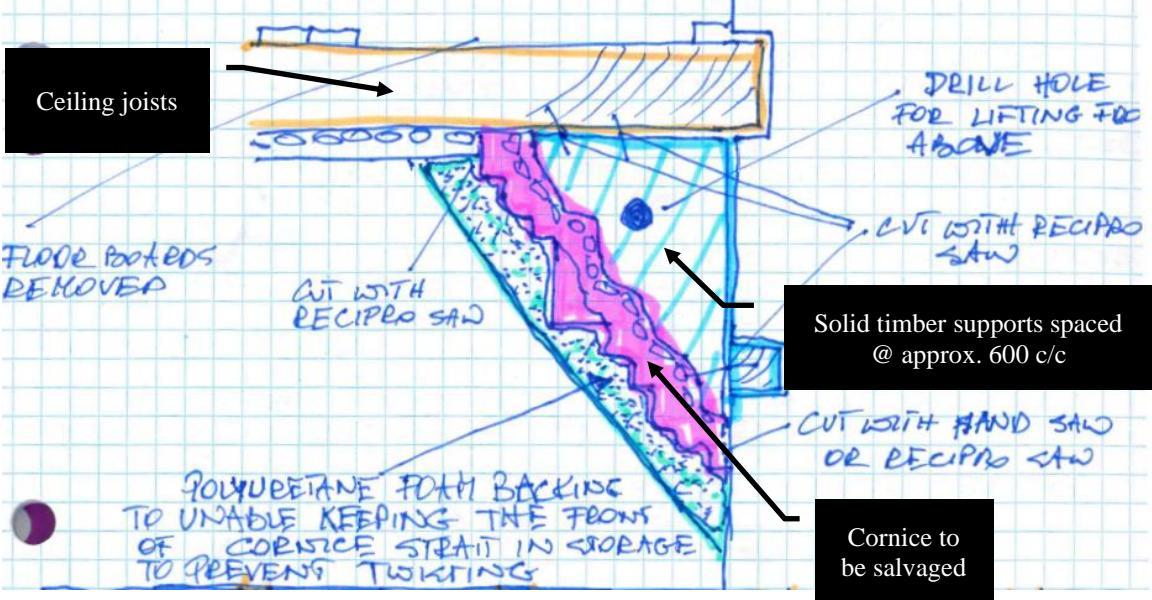
- 2.15Once the cornice is loose, it can be gently lowered to the floor using the block and tackle and the unique ID code can be applied to the rear face.

- 2.16 Place the salvaged cornice into the polyurethan foam mould and gently strap to keep them together.
- 2.17Place the strapped and salvage cornice with mould into the bespoke crate marked with the unique ID code and transport through the building to the loading dock on ground floor for transport to the TRC factory.
