# ARBORICULTURAL IMPACT ASSESSMENT REPORT STAFF CARPARK; CAMPERDOWN

STURT NOBLE ARBORICULTURE CONSULTING ARBORISTS Suite 91, 330 Wattle Street, ULTIMO NSW 2007

6<sup>th</sup> April 2016 PROJECT: 1609

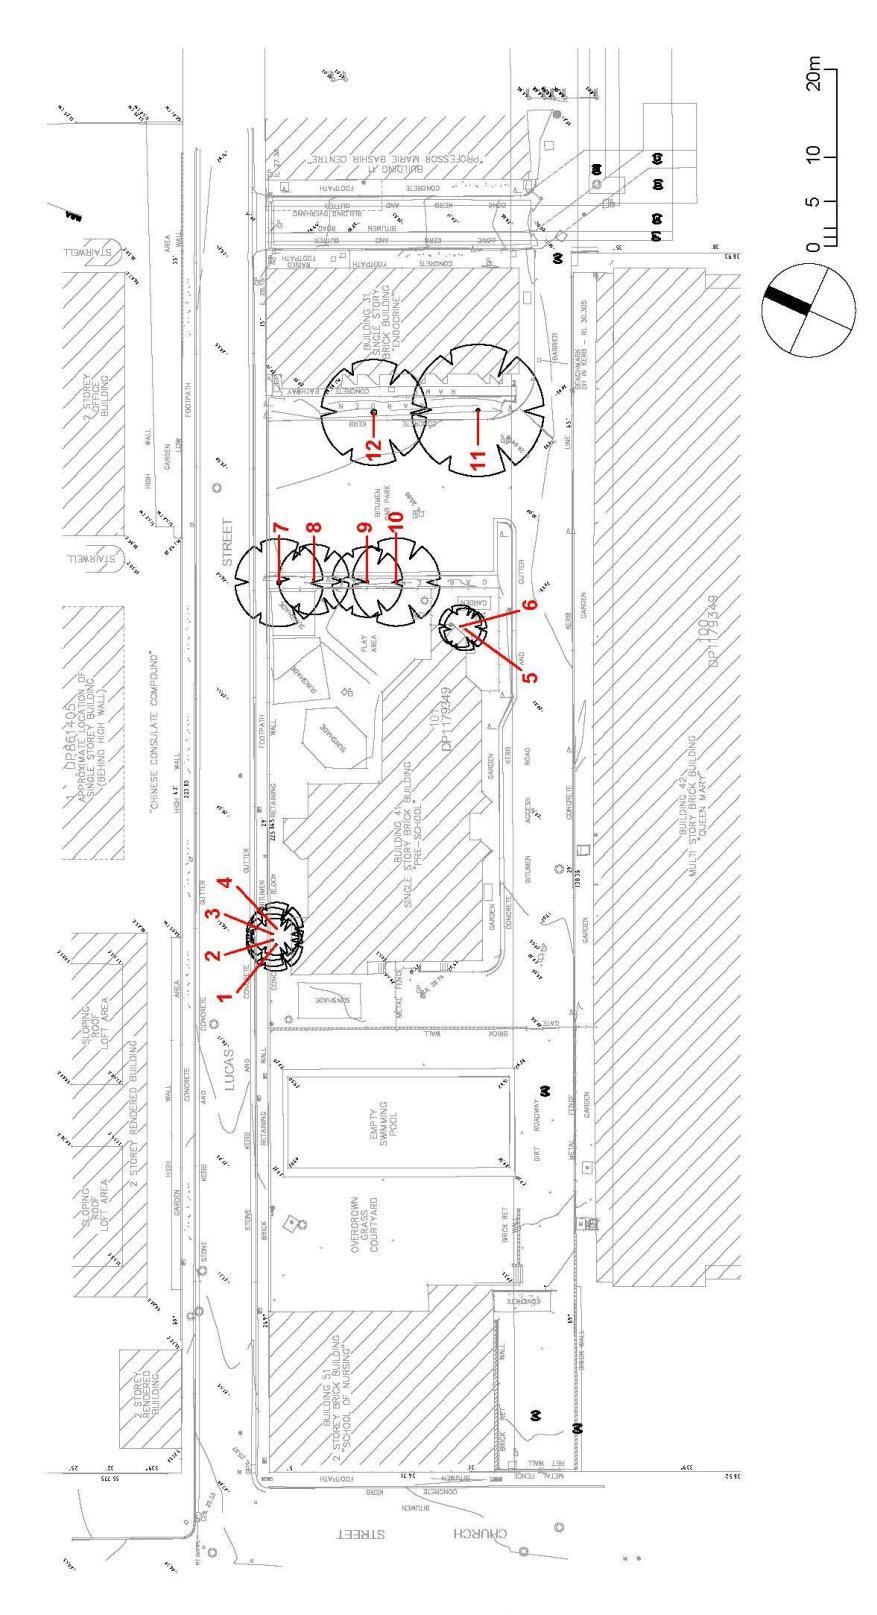
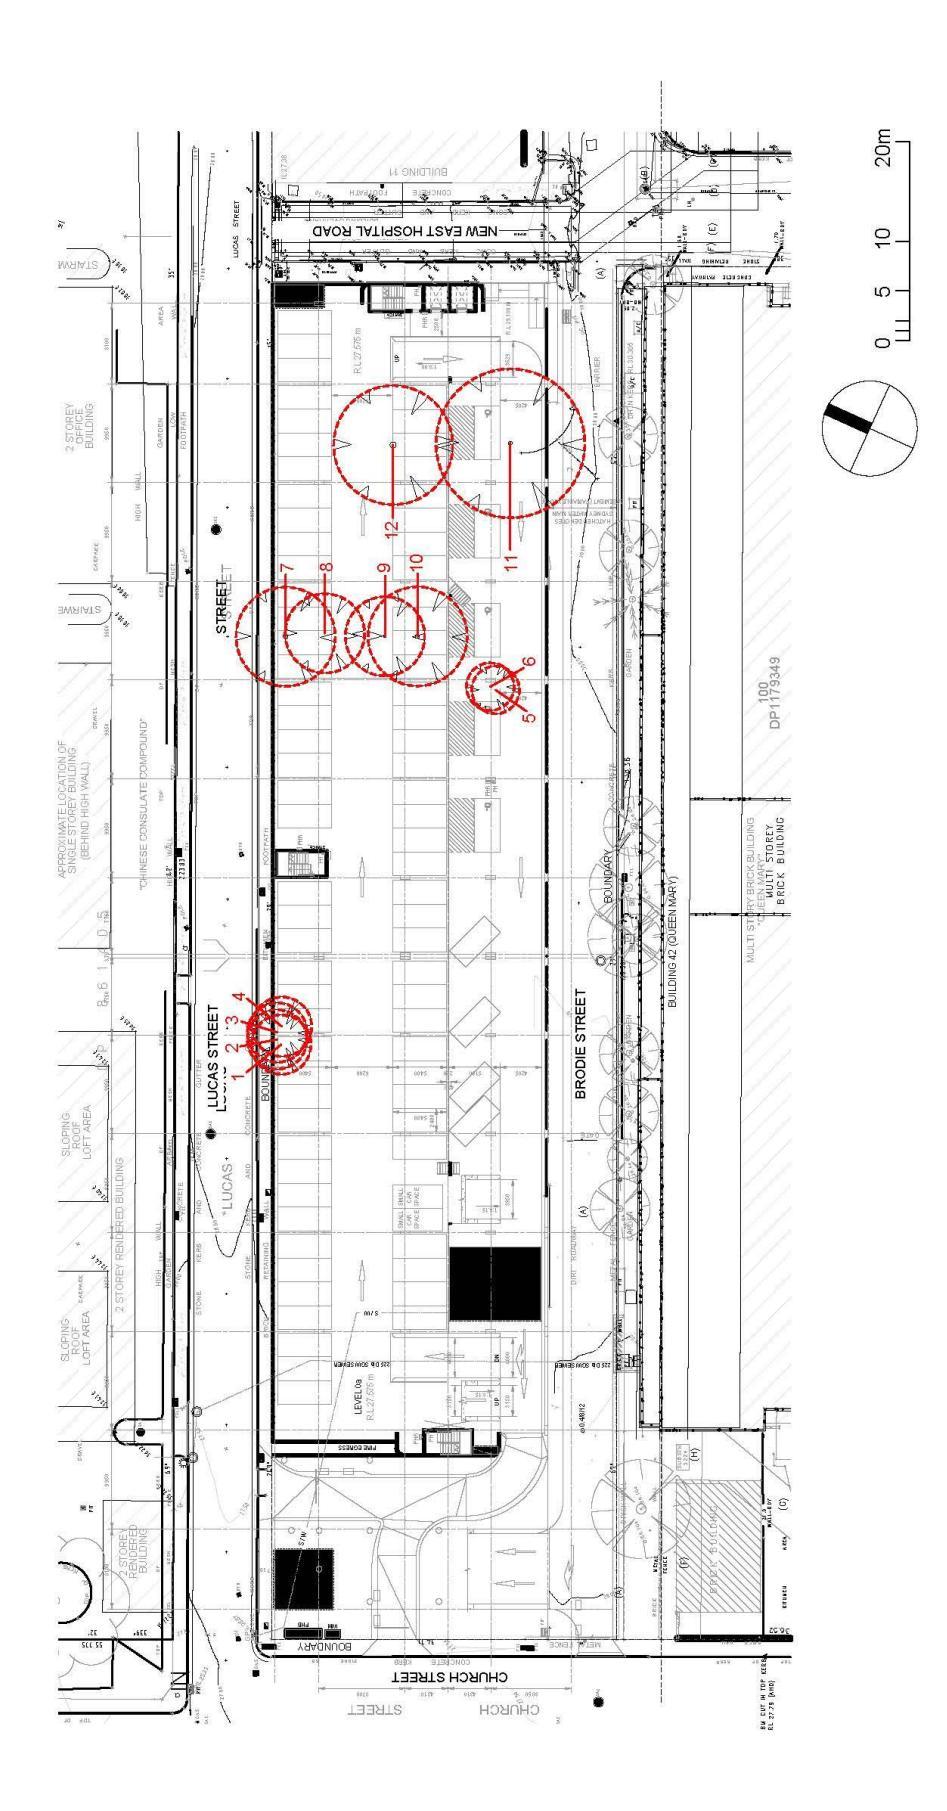
12 trees were identified on the site - 2 exotic species and 10 Australian native species. Figure 2 indicates the tree locations.

All twelve (12) trees have been identified as requiring removal to enable the construction of the development.
