Moorebank Precinct East -Stage 2 Proposal

Contamination Summary Report

Contamination Summary Report MPE Project Stage 2 Development

15 November 2016 51432-105534 (Rev 1) JBS&G

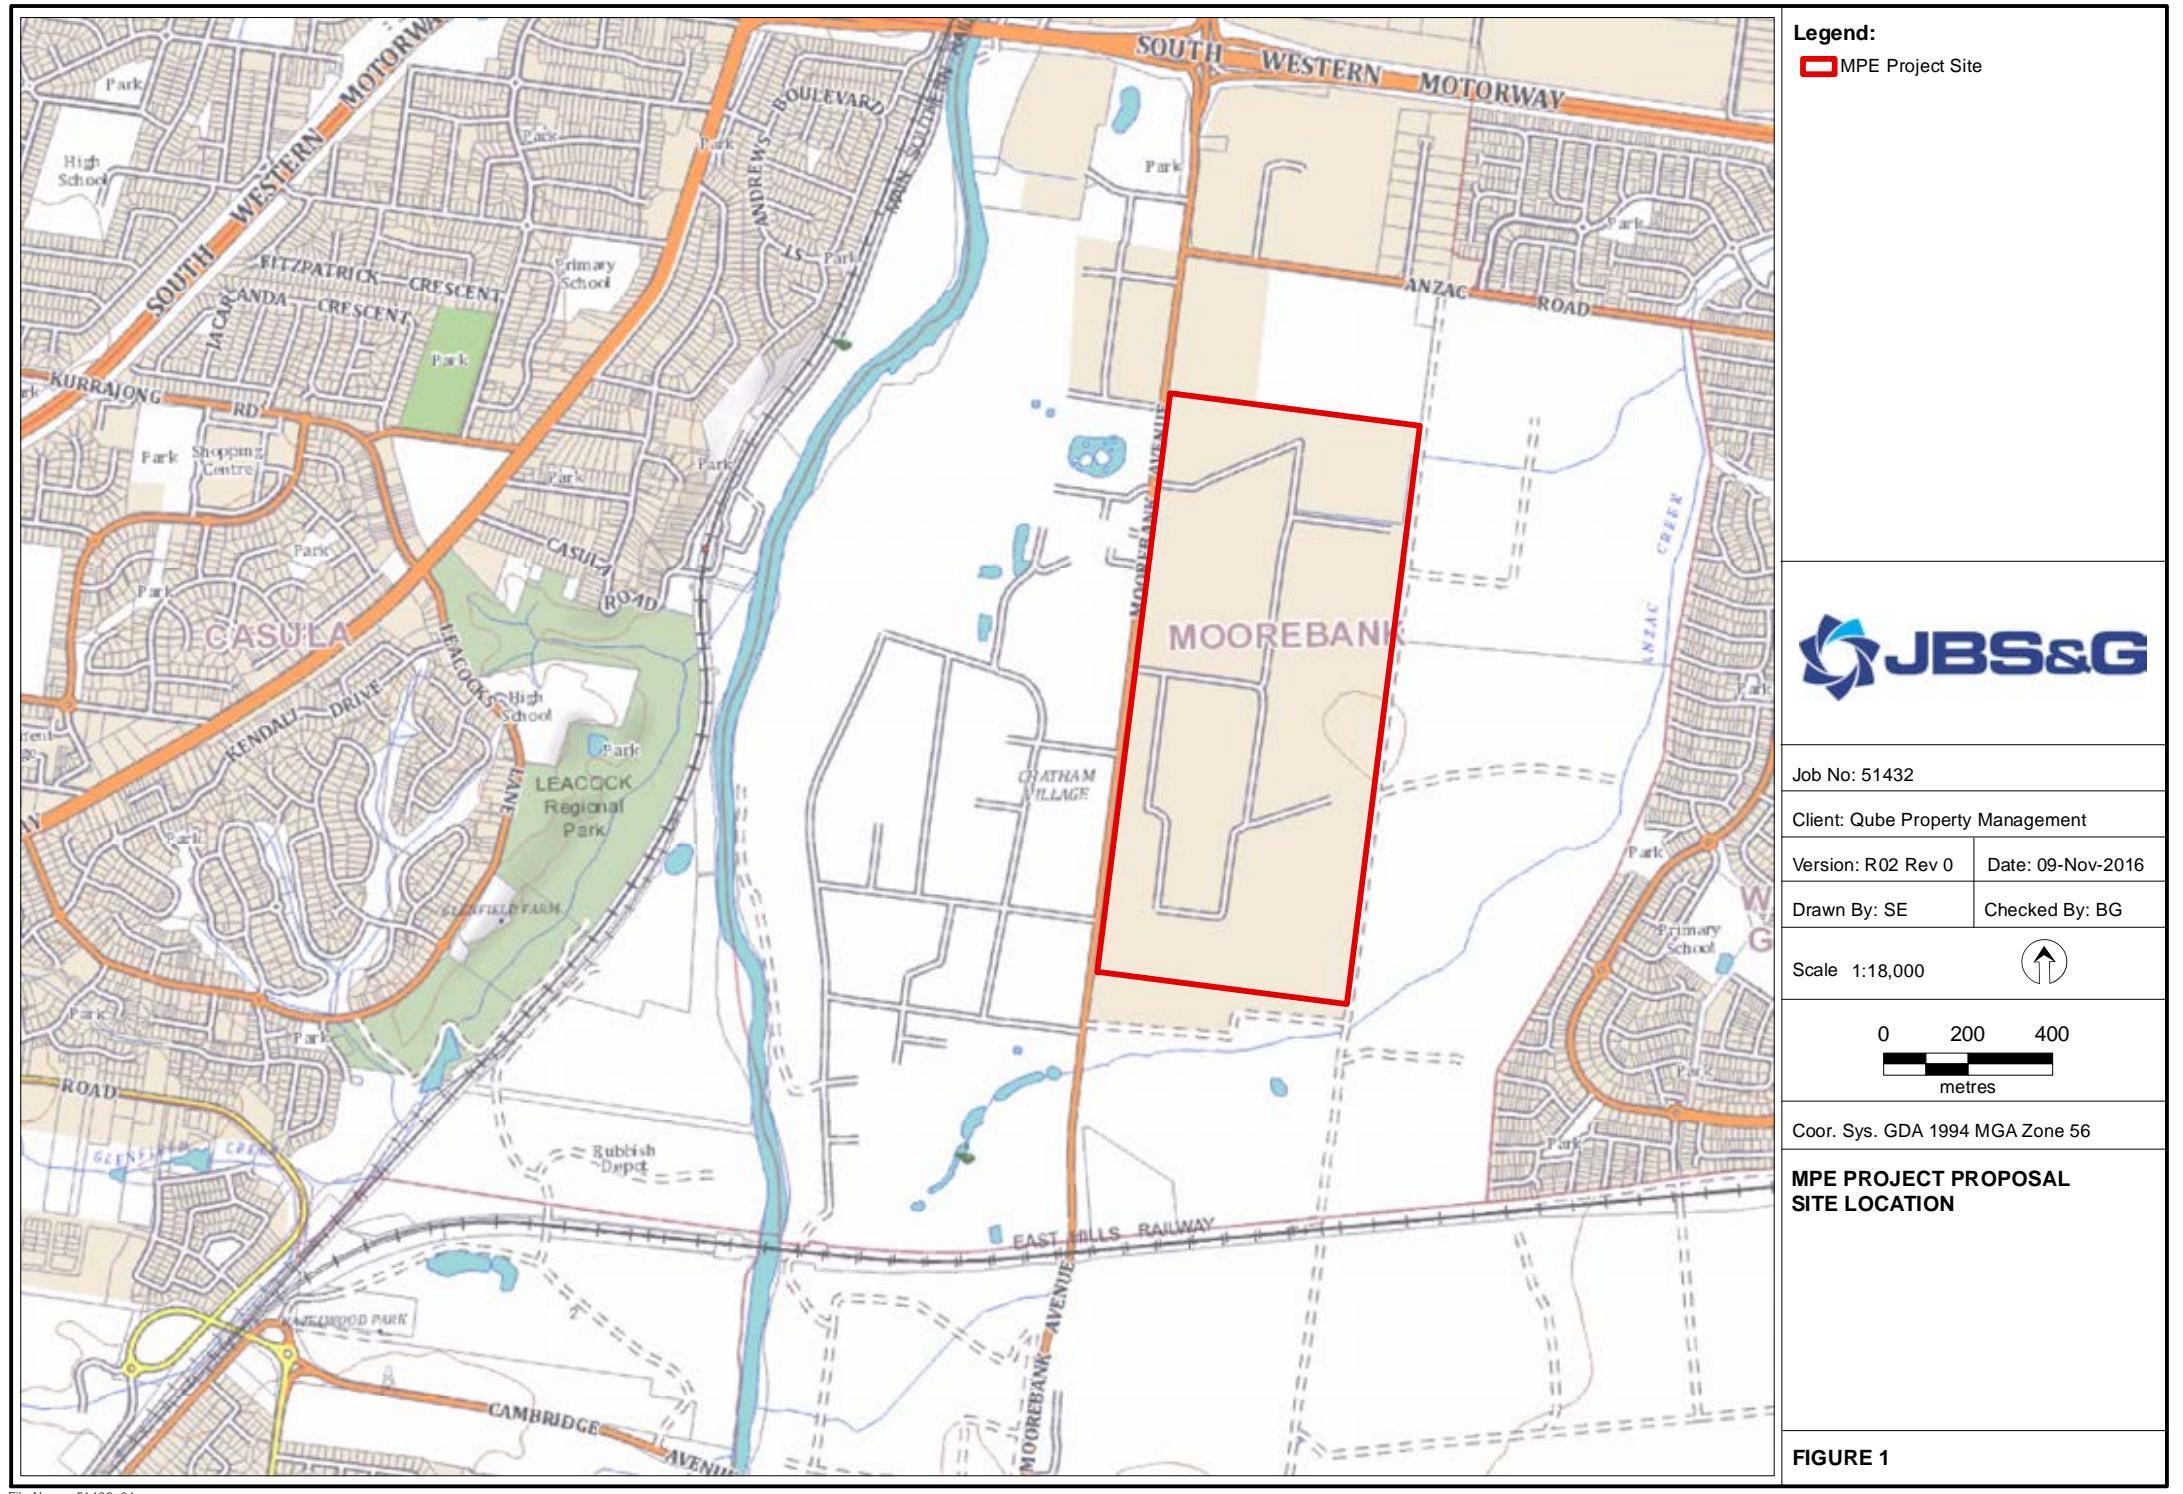
The location of the Project site is shown in **Figure 1** (**Appendix A**). The layout of the area of the Proposal site area and regional context is shown in **Figure 2** (**Appendix A**). Cadastral boundaries are shown in **Figure 3** (**Appendix A**). It is noted that not all lots shown are included in this assessment, but relevant land for this assessment is associated with part of Lot 1 DP 1048263.

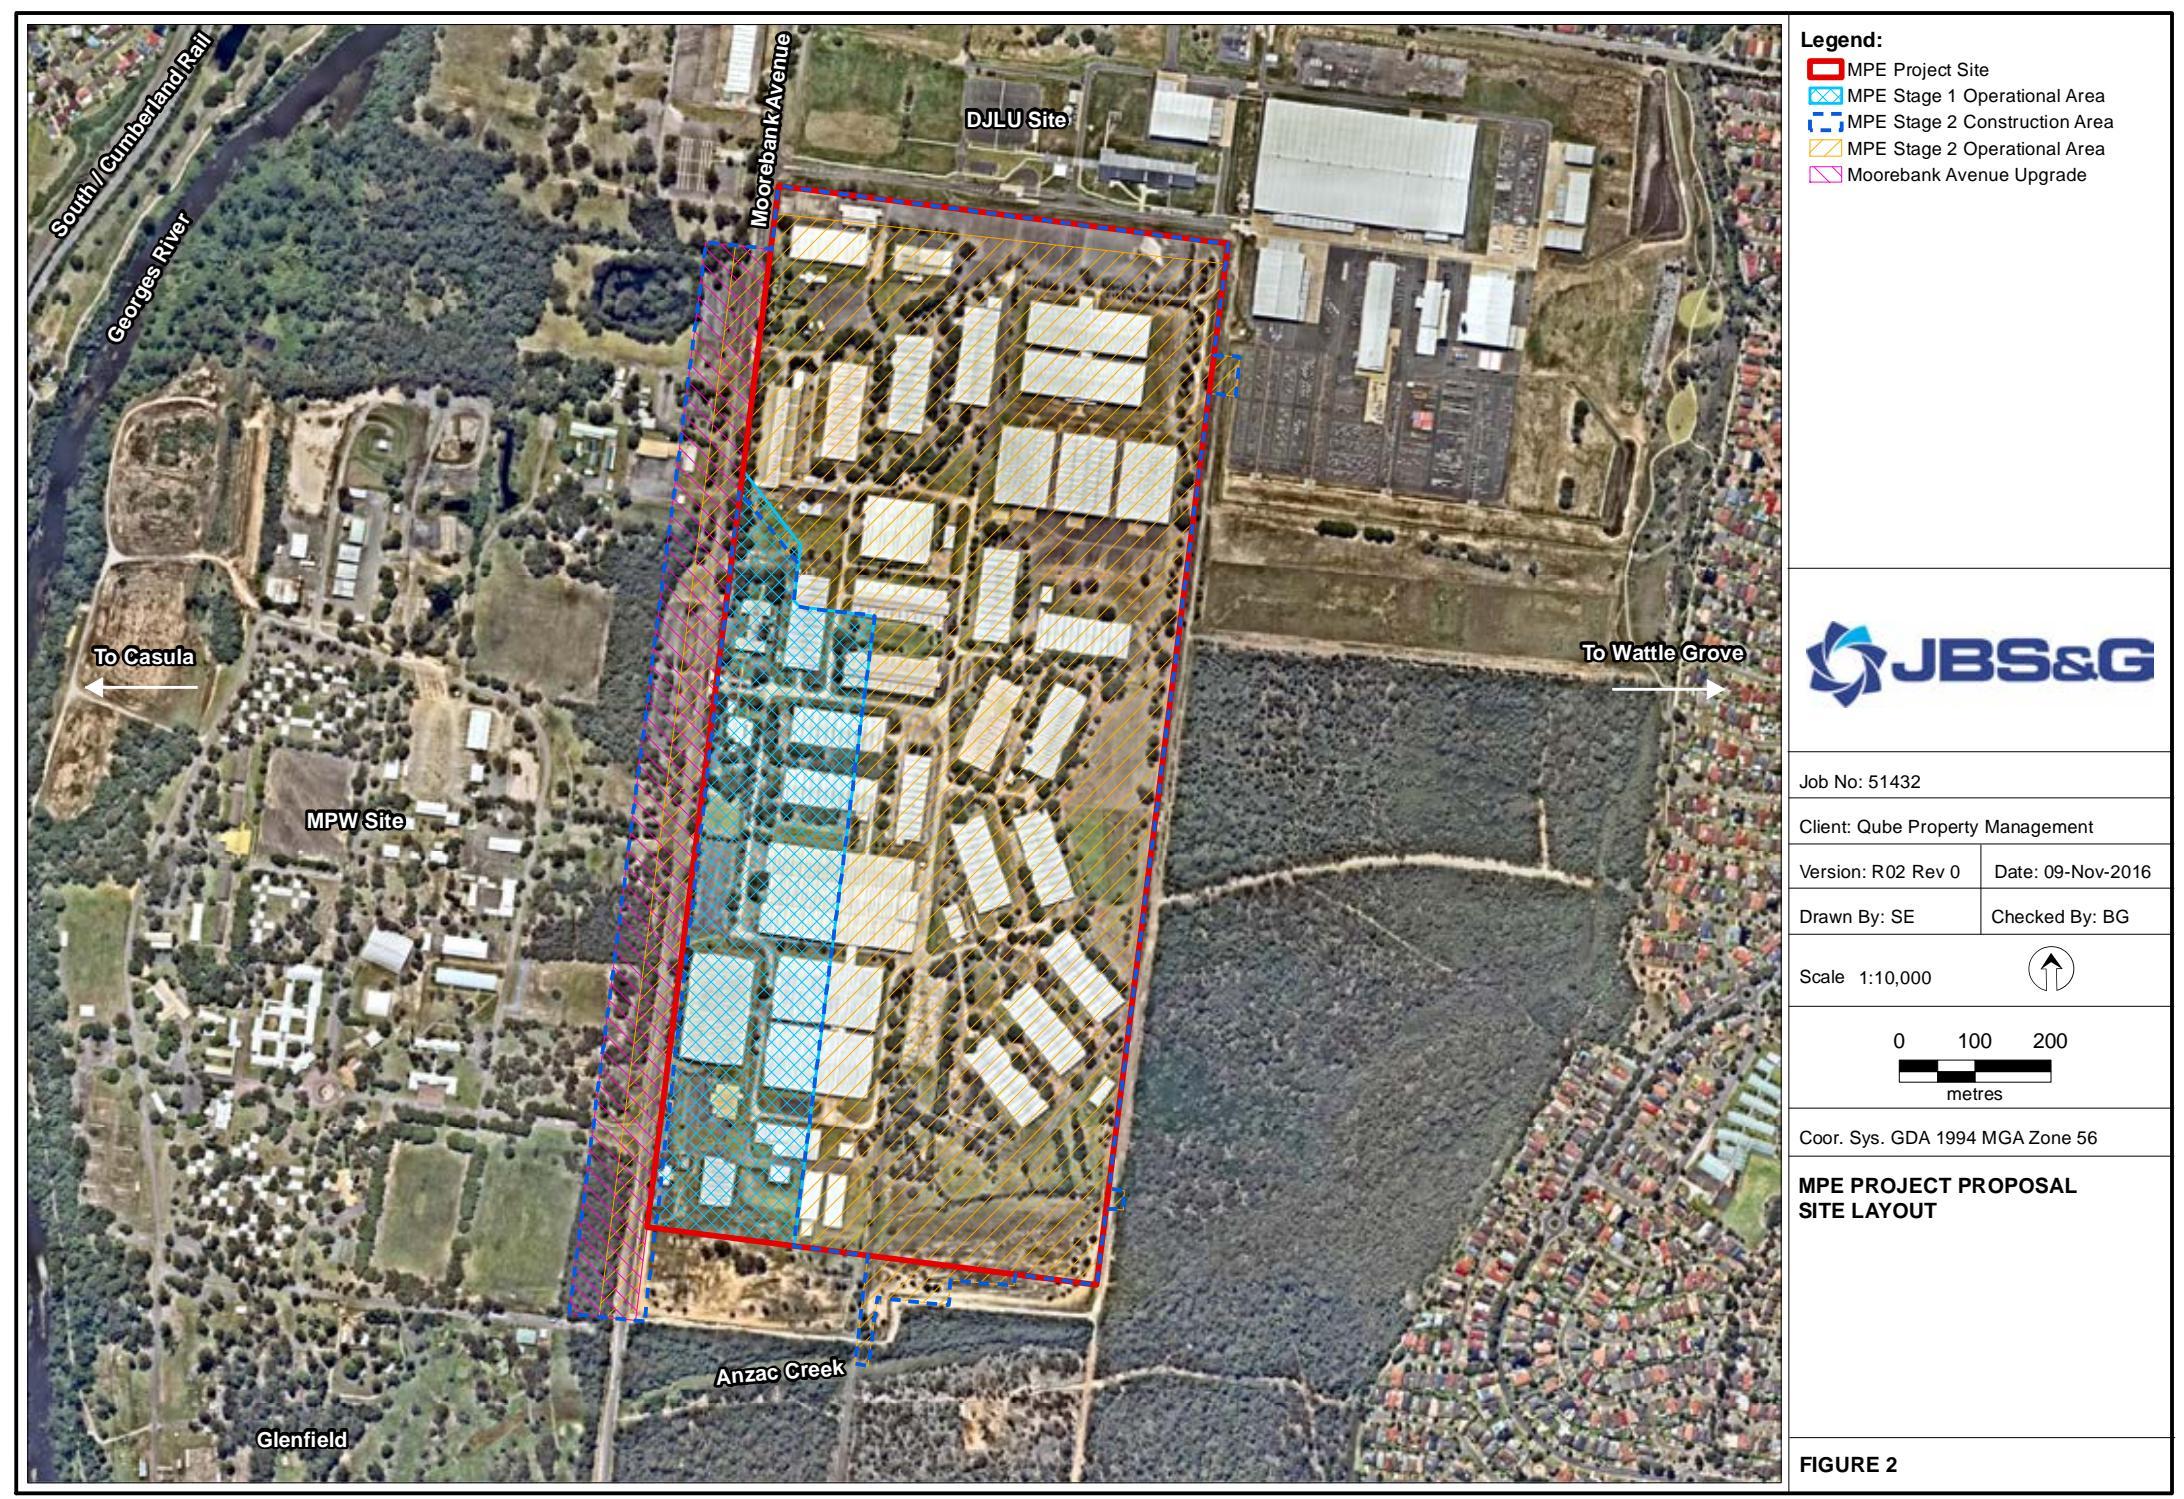
The MPE Stage 2 site lies predominantly to the north and east of the MPE Stage 1 Project and includes the construction area as presented in **Figure 2** (**Appendix A**). The eastern portion of the MPE Stage 2 site includes a variety of buildings which have been previously used to store various items, including batteries, electrical equipment and chemicals. The area along the northern boundary of the MPE Stage 2 site is currently being used for the storage of vehicles. A portion of the northern area is noted to be underlain by areas of historical waste disposal. It is also noted that a spray painting shop (B83) and a waste oil UST (B79) are located near the eastern boundary of the site. What appears to be a recently installed groundwater monitoring well was noted directly downgradient of the aforementioned UST.

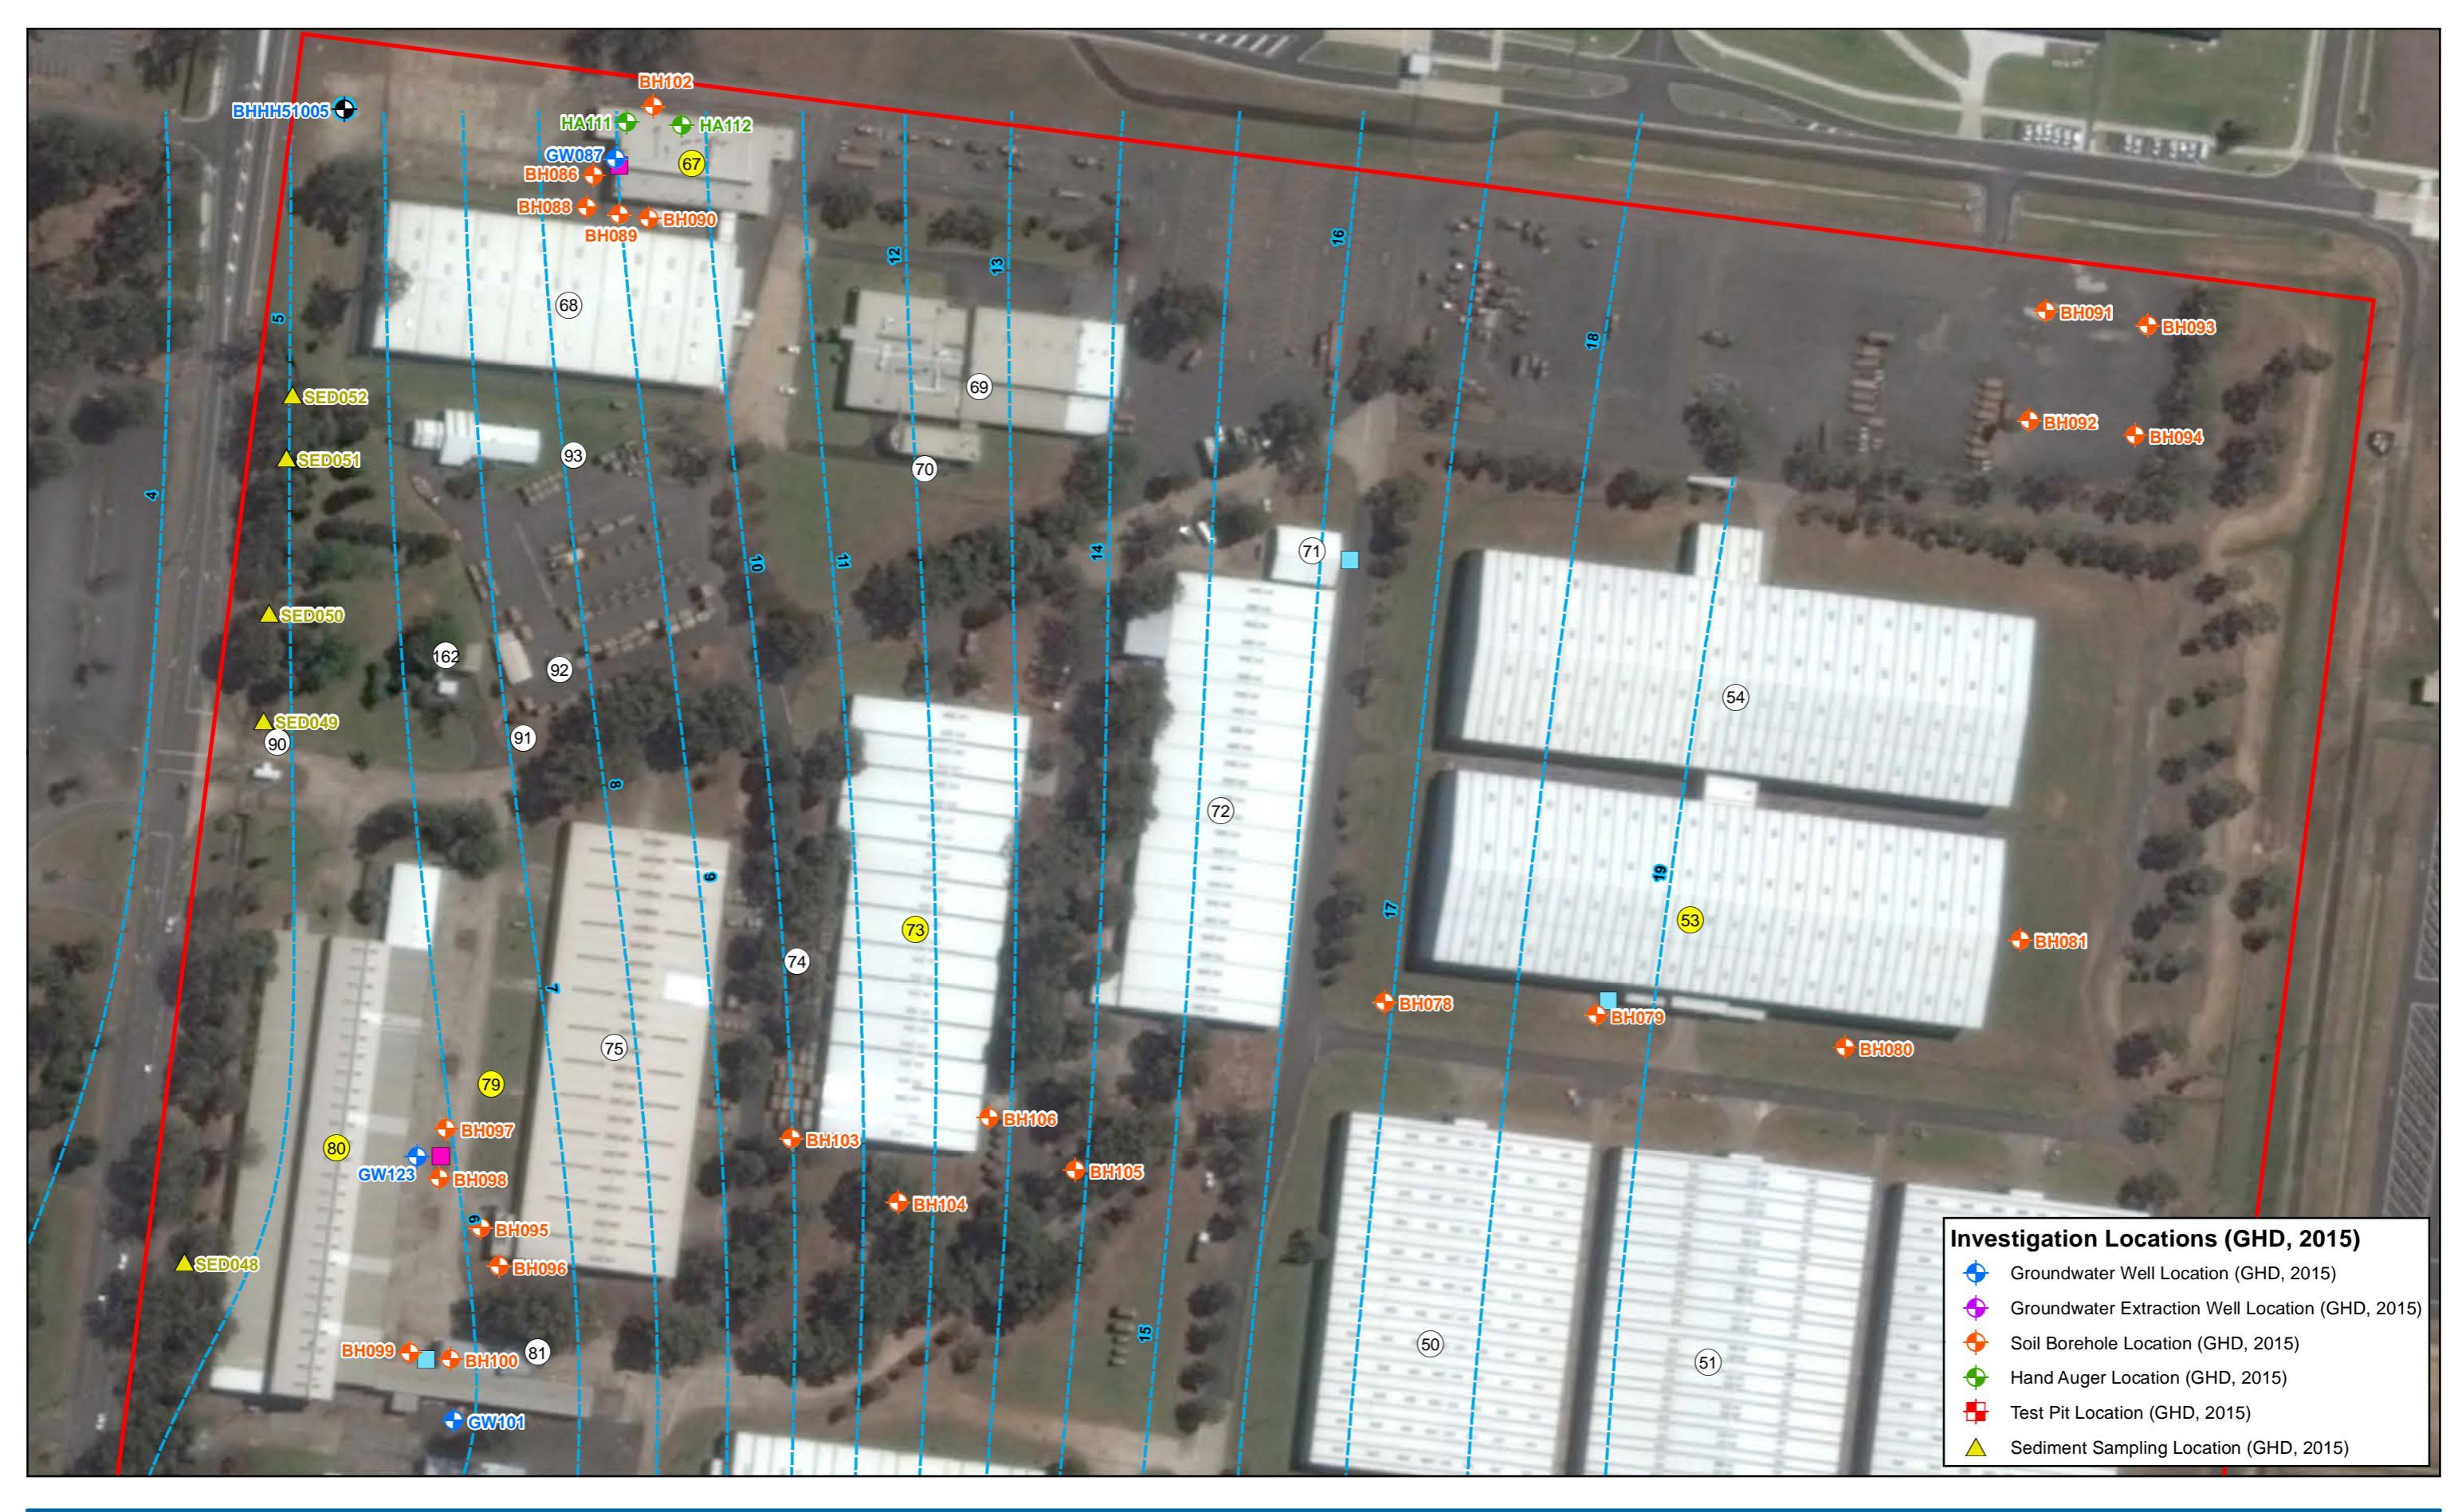
Appendix C GHD (2016) Sample Locations
