# SUNTOP SOLAR FARM

# **Aboriginal Heritage Assessment**

Prepared for Photon Energy

Ref. 1711.05

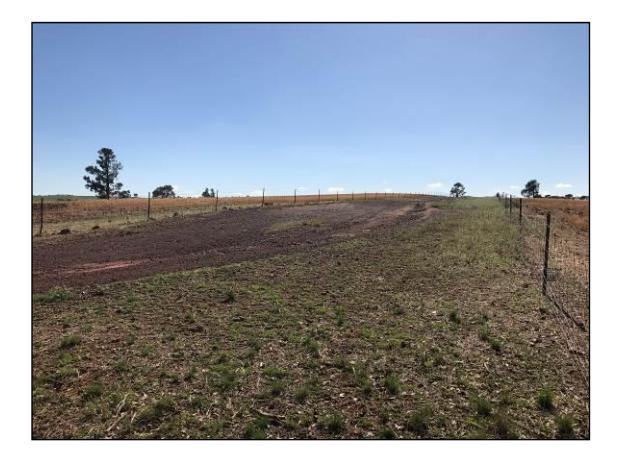
Plate 1. Survey Unit 1 - Hillslope with low spurline, visibility and exposures, facing south east

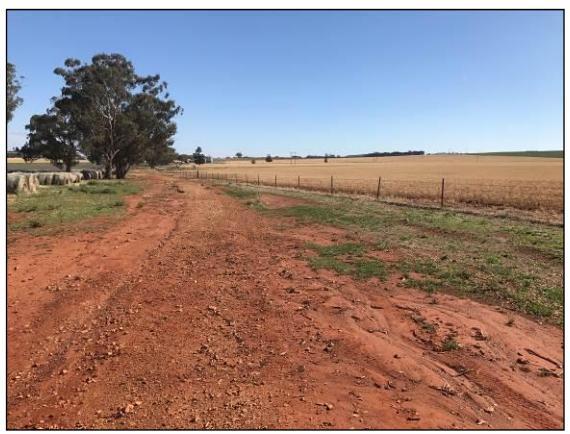
Plate 2. Survey Unit 1 - Vehicle track west of the farm buildings and crops to the east, showing ground surface visibility and erosion conditions, facing north

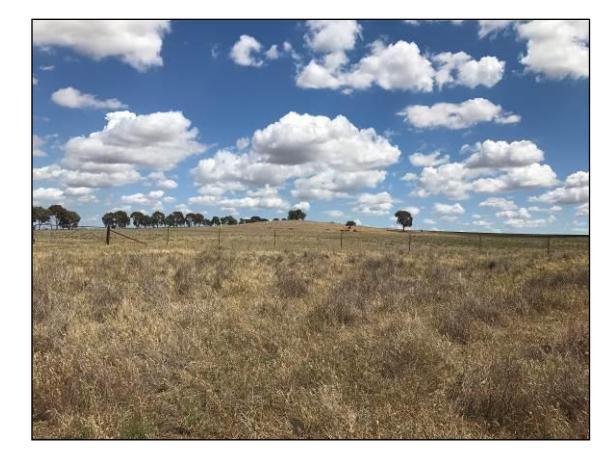
Plate 3. Survey Unit 1, central part - rocky outcrop, facing north

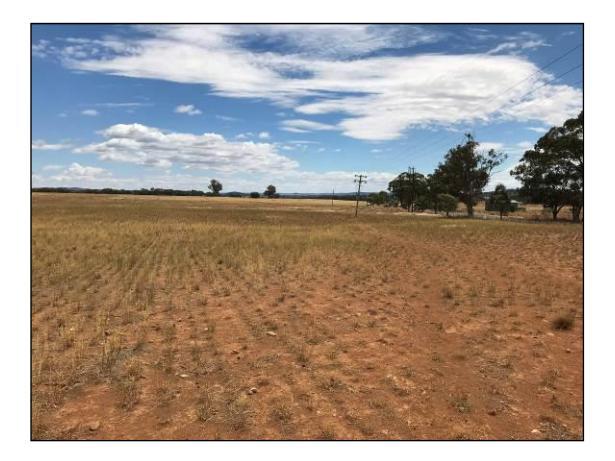
Particular attention was paid to the northern part of Survey Unit 1 where the proposed substation will be situated. The area was covered with patchy very dry crops (Plate 5) and intersected with irrigation channels for agricultural purposes (Plate 6). Two small artificial dams were located immediately south of Suntop Road and associated with irrigation channels throughout the northern part of the study area. These land use practices have caused significant ground disturbance to the natural soil layers that would directly impact on the preservation of archaeological deposits in this area. An electricity transmission line ran across the north western part of the study area. Its installation would have impacted ground conditions within pole locations as well as clearing of vegetation within the easement.

Plate 5. Survey Unit 1, northern section – transmission line, facing south

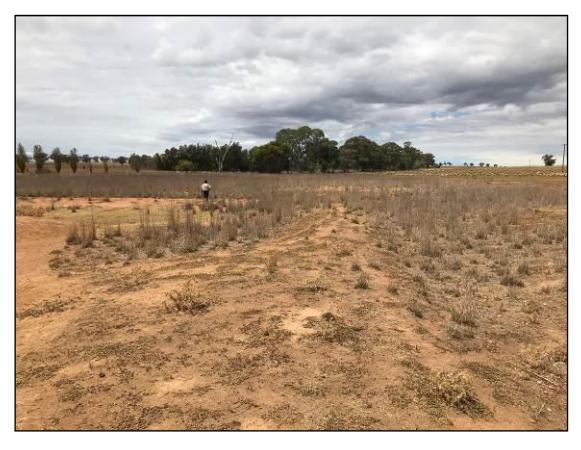
Plate 6. Survey Unit 1, northern section – irrigation channels, facing north

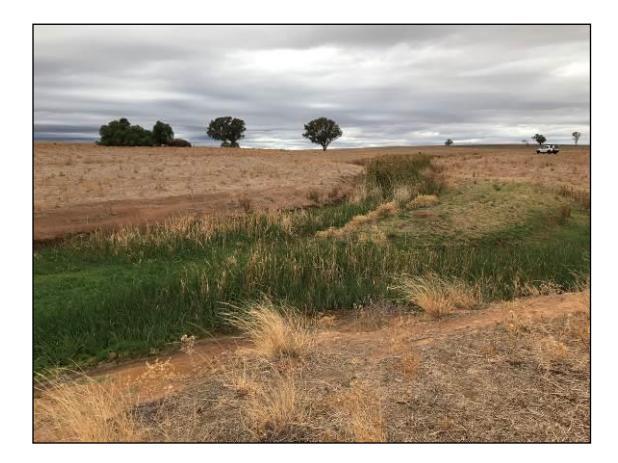
Plate 7. Survey Unit 2, eastern section - second order creek line, visibility within the creek bed, facing south east

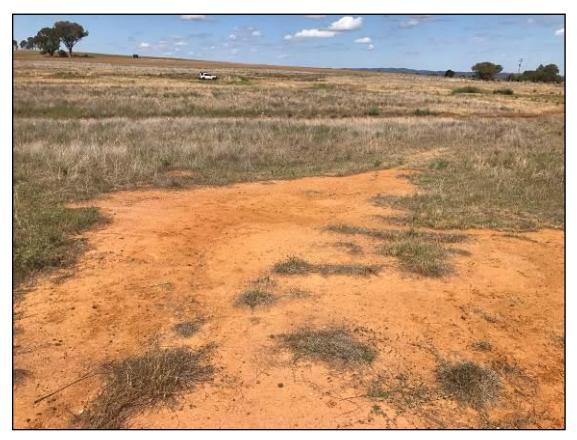
Plate 8. Survey Unit 2, eastern section - erosion visible within creek banks

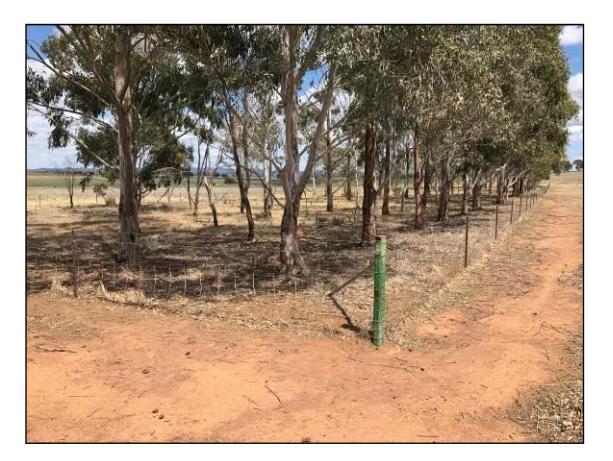
A small stand of trees was situated on the northern side of the creek (Plate 9). The trees were fenced off and consisted of mainly young, replanted Eucalyptus species. They were all inspected, but none contained evidence of modification or scarring and it was noted that there were no trees of suitable age. Significant erosion was also visible around the fence line due to water runoff and pedestrian traffic (Plate 9). Within the western part of the study area, significant land modifications were observed in association with irrigation for agricultural purposes. Two water tanks and a windmill were located in proximity to other farm buildings (Plate 10). Two artificial dams for agricultural purposes were constructed within the western extent of the study area, one within the second order creek line and the other within a very small drainage line (Plate 9). Ground surface visibility was good with some patches covered in dry grass,

Plate 9. Survey Unit 2 - cluster of trees, northern bank of the creek and areas of erosion, facing north west

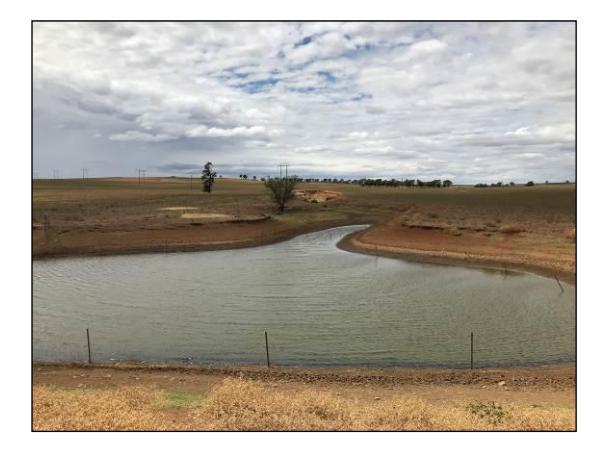
averaging around 70%. Areas of exposure included around the dam walls and along dirt tracks (Plate 11 and 12). The areas of exposure were closely inspected but no Aboriginal cultural material was observed. Construction of the dams and modifications to the creek bed, including construction of the informal track above the waterway had involved significant ground works that would have removed or displaced the majority of the natural soils and therefore any possible Aboriginal cultural material in the area.

Plate 11. Survey Unit 2 – dam at the western extent of the study area, general visibility and conditions, facing east

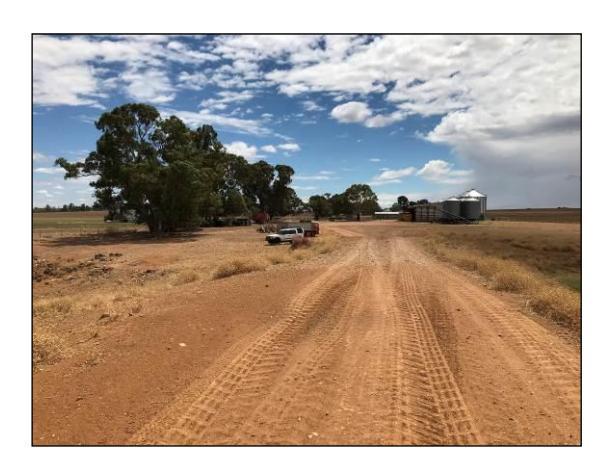
Plate 12. Survey Unit 2 – track west of dam, facing north towards the silos

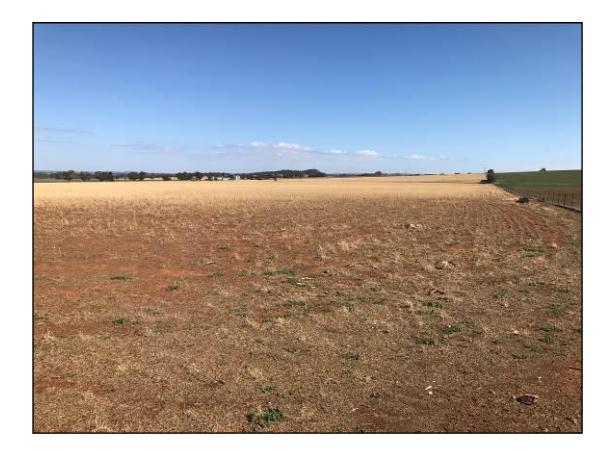
Plate 13. Survey Unit 3 – Facing north west towards the hill and silos, general ground conditions

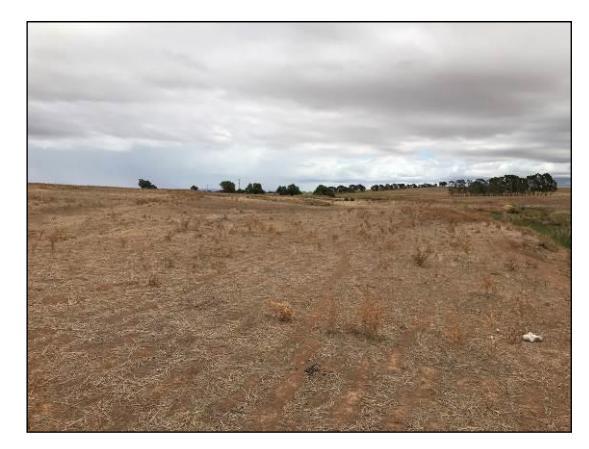
Plate 14. Survey Unit 3 – lower slopes of the hillslope, facing north towards the cluster of trees in Survey Unit 2 across the second order creek line, general ground surface visibility

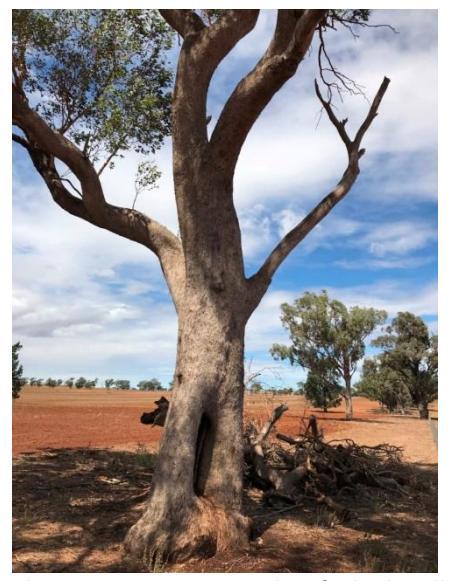
Plate 16. Survey Unit 4 – identified culturally significant tree on western boundary of study area

Field inspection also located one culturally significant tree at the western extent of the study area. The tree had a scar which could not be positively identified as being culturally modified, however it was identified by Wellington LALC as being of high cultural significance to local Aboriginal people. It was recommended the tree be avoided by proposed activities.

A culturally significant tree was also identified at the western extent of the study area. The tree was a *Eucalyptus sp.* and contained one scar that could not be positively identified as being of cultural origin. The tree holds high cultural significance to local Aboriginal people. It was recommended that the tree be conserved *in situ* and all proposed impacts avoid the location of the tree.

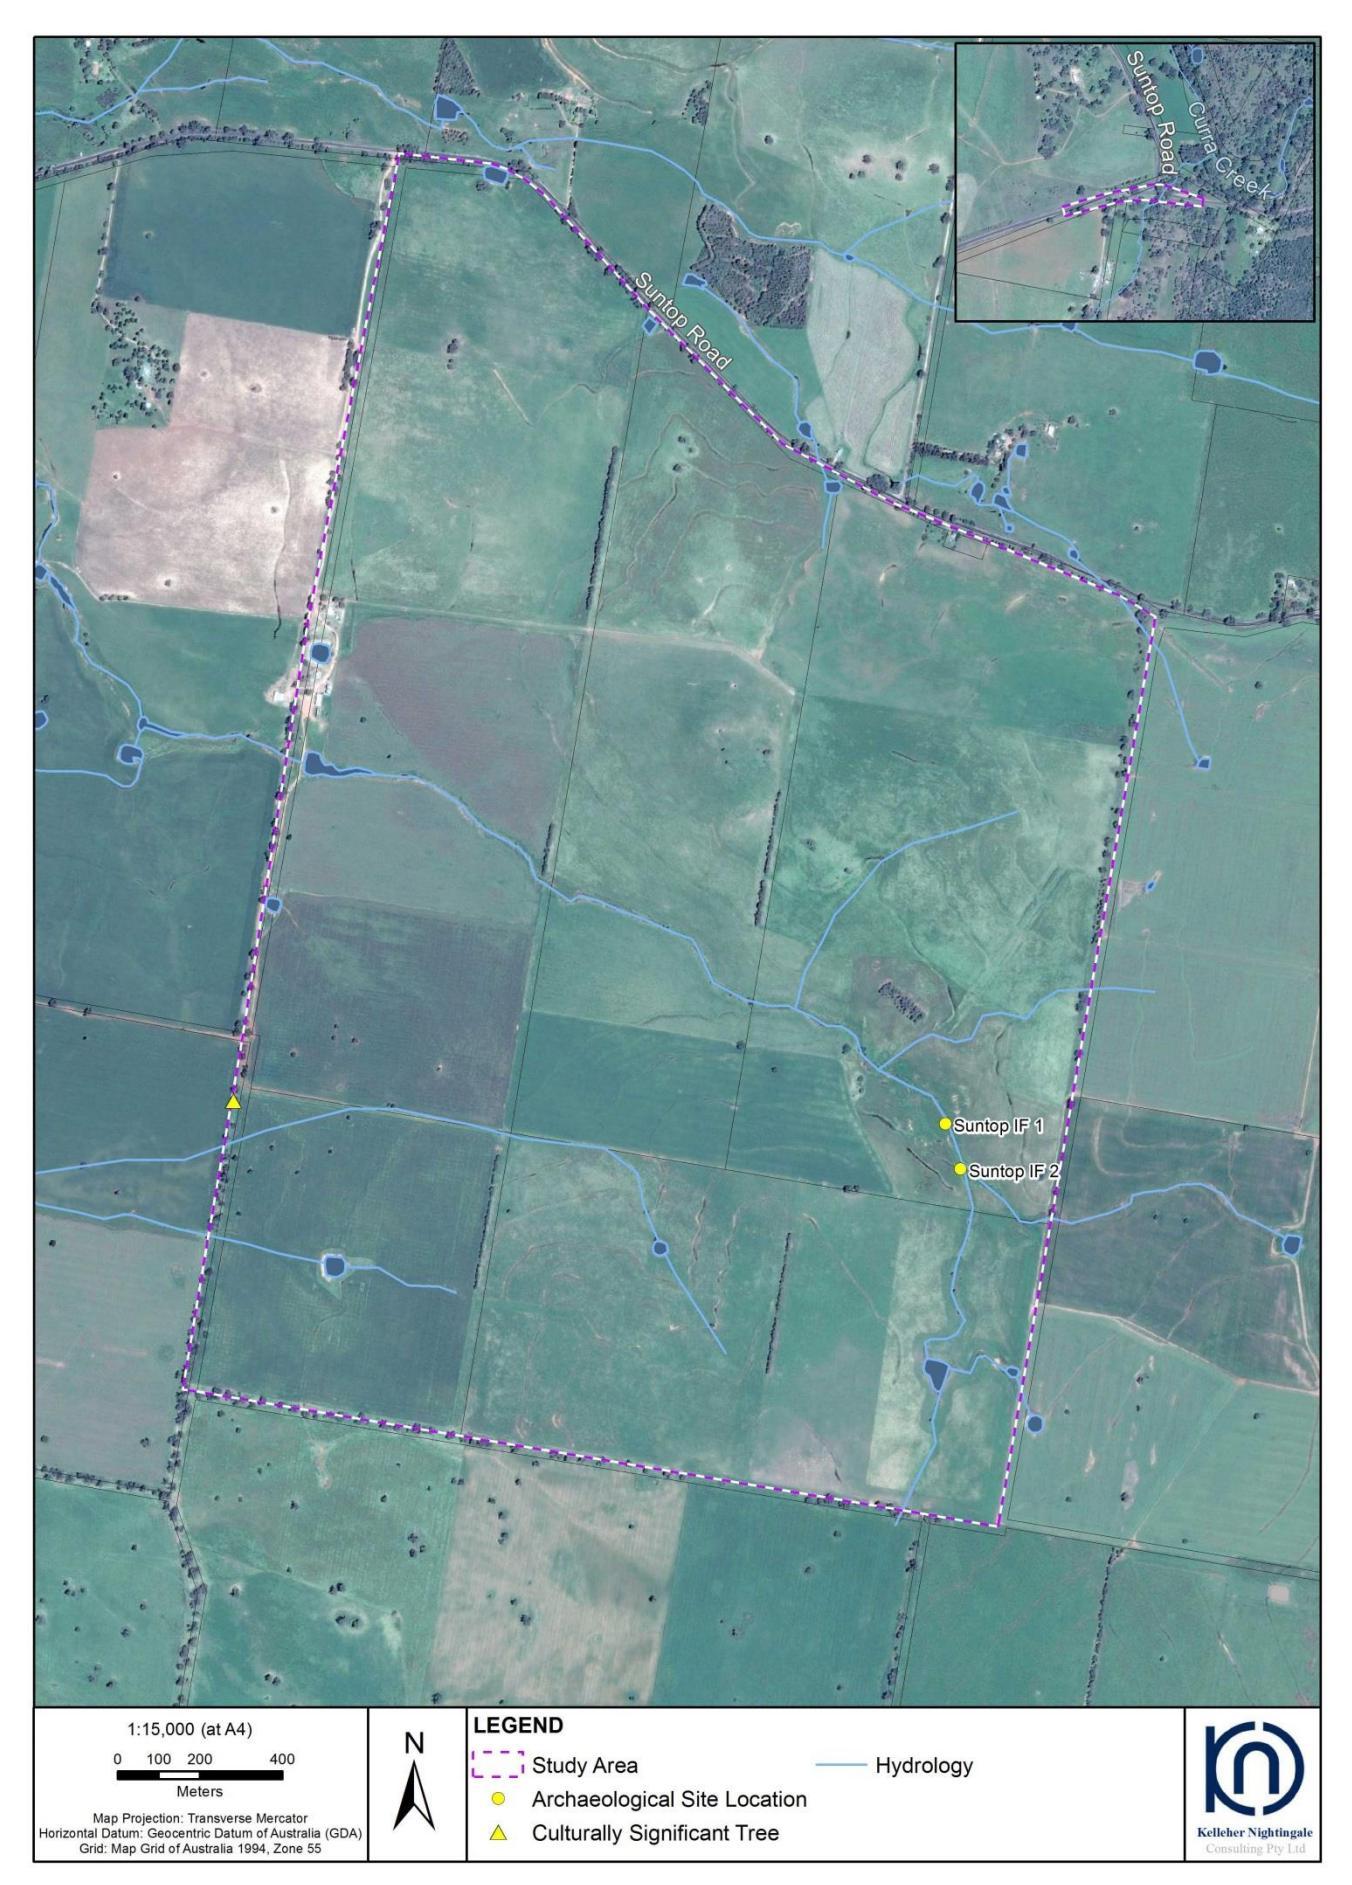
Figure 6. Aboriginal archaeological sites and culturally significant tree within the study area

It is recommended that the identified site locations (Suntop IF 1, Suntop IF 2 and culturally significant tree) should be included within the construction environment management plan for the Suntop Solar Farm.

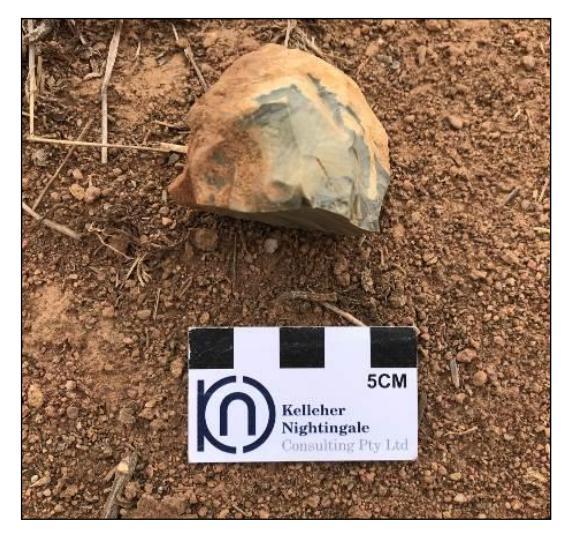
Suntop IF 1 comprised a single chert core. It was located on the southern banks of the second order creek line, a tributary to Barneys Creek, within the southern part of Lot 90 DP657805. The artefact was observed in an exposure approximately 20 metres south of the unnamed creek (Plates 19 and 20). The ground gently inclined to the south to a low spurline extending south east to north west and intersected with irrigation channels. The site was located approximately 1.4 kilometres south of Suntop Road within an open paddock with no tree cover. A stand of young replanted trees was located approximately 350 metres to the north west, on the northern side of the creek.

| Artefact type | Raw<br>material | Length<br>(mm) | Width<br>(mm) | Thickness<br>(mm) | Notes |
|---|---|---|---|---|---|
| Core | Chert | 45 | 40 | 20 | Yellowish grey chert unidirectional core, cortex 26-<br>51% |

Plate 19. Chert core identified at Suntop IF 1

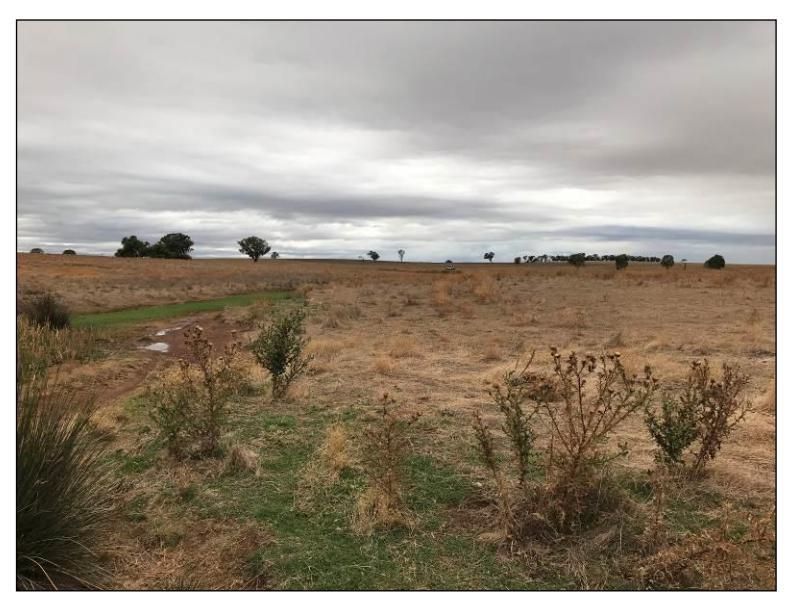
Visibility across the surface of the exposure was moderate, with swamp tussocks within the creek bed and short dry grass cover bordering the exposure. Site condition was generally poor, with the area affected by stock movement and continued sheet erosion from fluvial movement along the drainage line. Sediment observed both in and along the margins of the exposure consisted of yellowish grey sandy loams soil, derived from the natural parent material. The artefact had been exposed by erosion processes and likely displaced by fluvial movement. The area was highly disturbed by natural processes and retained no potential for intact archaeological deposit. Suntop IF 1 is described in Table 6.

Plate 20. Suntop IF 1, exposure in foreground, facing south east

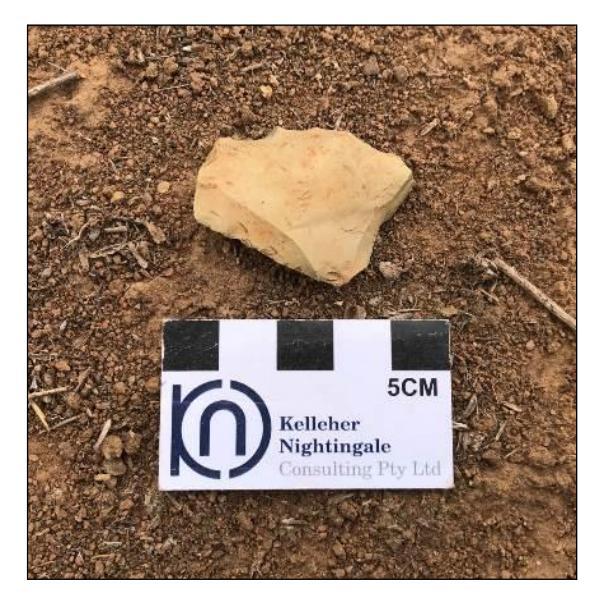
Suntop IF 2 comprised a single chert flake. The site was also located on the southern banks of the second order creek line, a tributary to Barneys Creek, within the southern part of Lot 90 DP657805, approximately 115 metres south of Suntop IF 1. The artefact was observed in an exposure approximately 20 metres south of the unnamed creek. The ground gently inclined to the south to a low spurline extending south east to north west that was also intersected with irrigation channels. The site was located around 1.4 kilometres south of Suntop Road within an open area with no tree cover. A small stand of young replanted trees was located approximately 350 metres to the north west, on the northern side of the creek.

Visibility across the surface of the exposure was moderate, with swamp tussocks within the creek bed and short dry grass cover bordering the exposure area. Site condition was generally poor, with the area affected by stock movement and continued sheet erosion from fluvial movement along the drainage line. Sediment observed both in and along the margins of the exposure consisted of yellowish grey sandy loams soil, derived from the natural parent material. The artefact had been exposed by erosion processes and likely displaced by fluvial movement. The area was highly disturbed by natural processes and retained no potential for intact archaeological deposit. Suntop IF 2 is described in Table 7 and shown in Plate 21.

| Artefact type | Raw<br>material | Length<br>(mm) | Width<br>(mm) | Thickness<br>(mm) | Notes | |
|---|---|---|---|---|---|--|
| Flake | Chert | 43 | 32 | 4 | Pale brown flake | |

Plate 21. Chert flake identified at Suntop IF 2
