GROUNDWATER MANAGEMENT PLAN EXPANSION OF THE CONCRUSH RESOURCE RECOVERY FACILITY, TERALBA

Prepared for CONCRUSH PTY LIMITED Prepared by RCA Australia RCA ref 13589-805/1 SEPTEMBER 2020

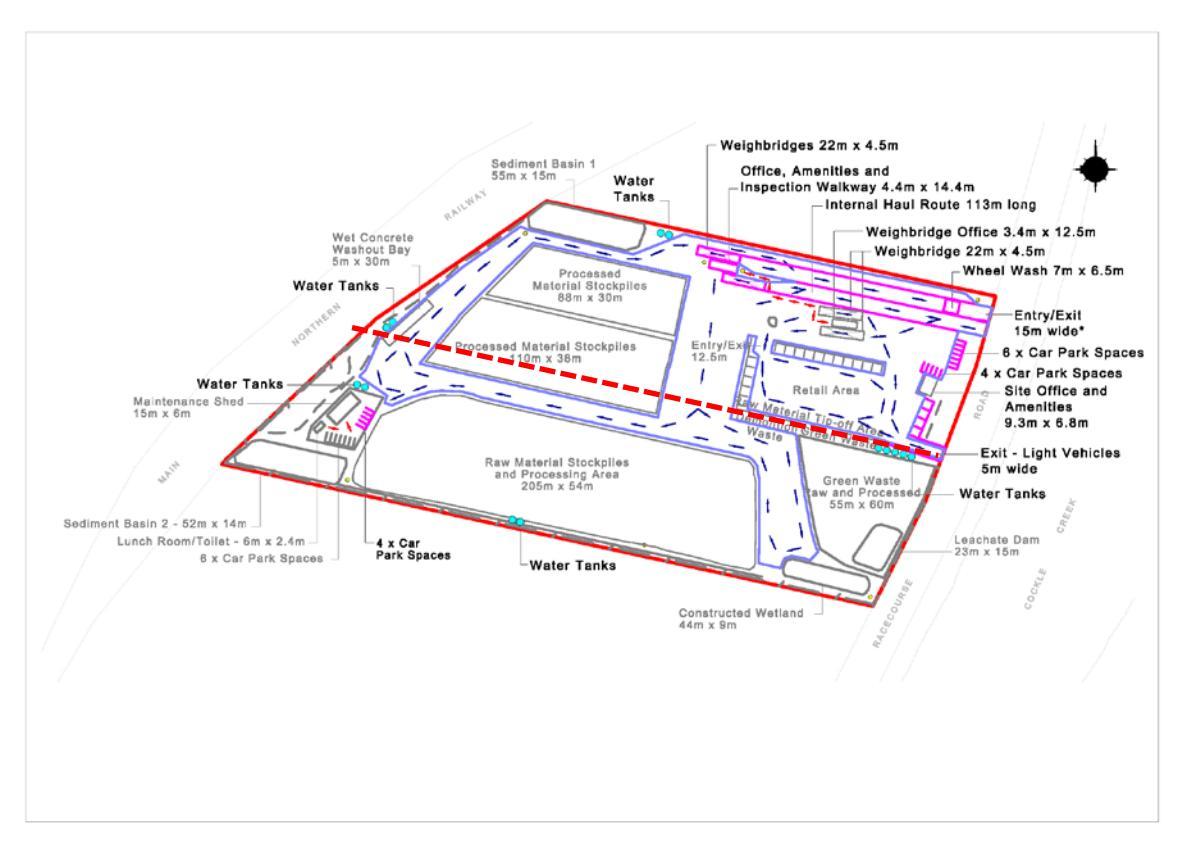
The schematic of Stage 2 is presented in **Figure 3** below.

There are a number of excavations, refer **Figure 3**, which will be undertaken at the site during the construction, some of which will remain as part of the site features. The design depth of the excavations has been considered with the modelled depth of groundwater, refer **Figure 4**, at the location in **Table 5** below.

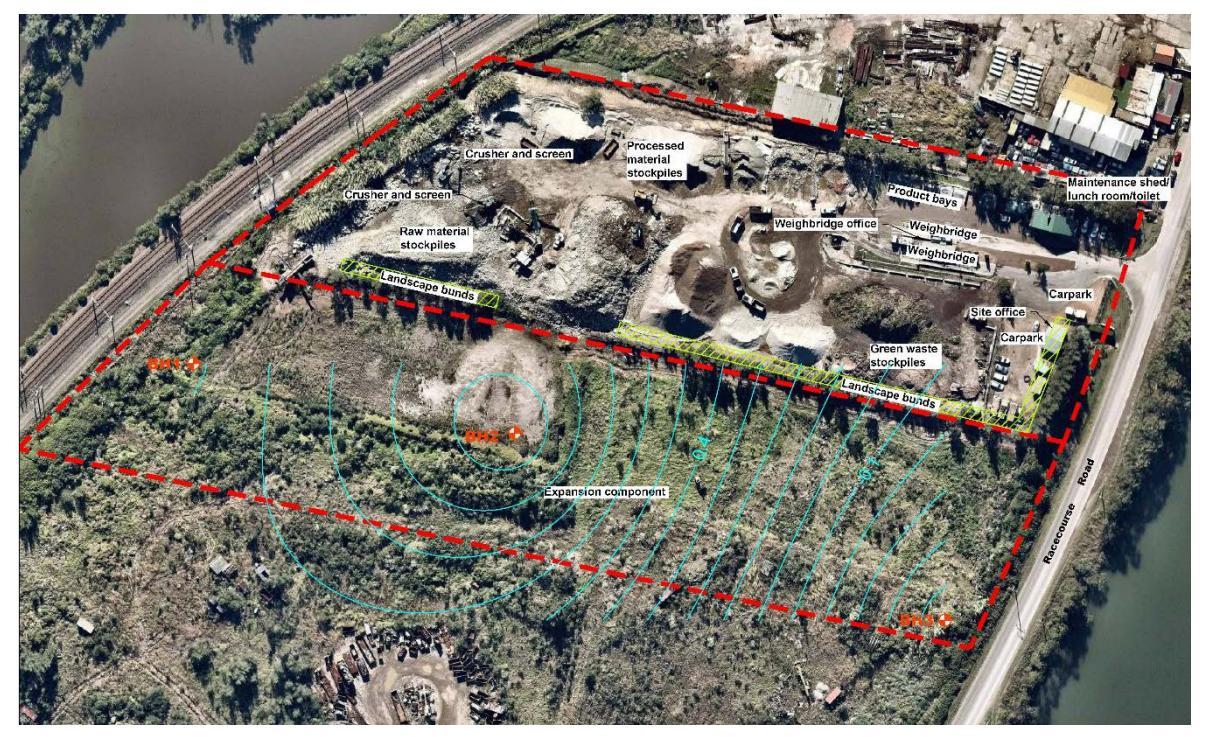
Figure 4Groundwater Flow based on Data from Monitoring Wells 22 May 2020

Based on this, groundwater flow has been estimated as presented in **Figure 4** above, noting that the layout and number of the groundwater monitoring wells may not provide sufficient information to understand the specific groundwater flows at the site.

Based on the contours it is considered that the groundwater flow direction is predominantly towards the east towards Cockle Creek however that some groundwater also flows in a westerly direction to the wetland. It is noted that the contours derived with the data from 29<sup>th</sup> May, 30<sup>th</sup> June and 4<sup>th</sup> September were generally consistent with those derived from 22<sup>nd</sup> May, albeit at different levels.
