### Tree Impact Assessment Report – Southwest Metro Corridor Works

SMCSWSSJ-JHL-WEC-EM-REP-000015

Document Details	
Title	Tree Impact Assessment Report
Client	Sydney Metro City & Southwest
Client reference no.	SMCSWSSJ-JHL-WEC-EM-REP-000015
JHLOR JV contract no.	К44

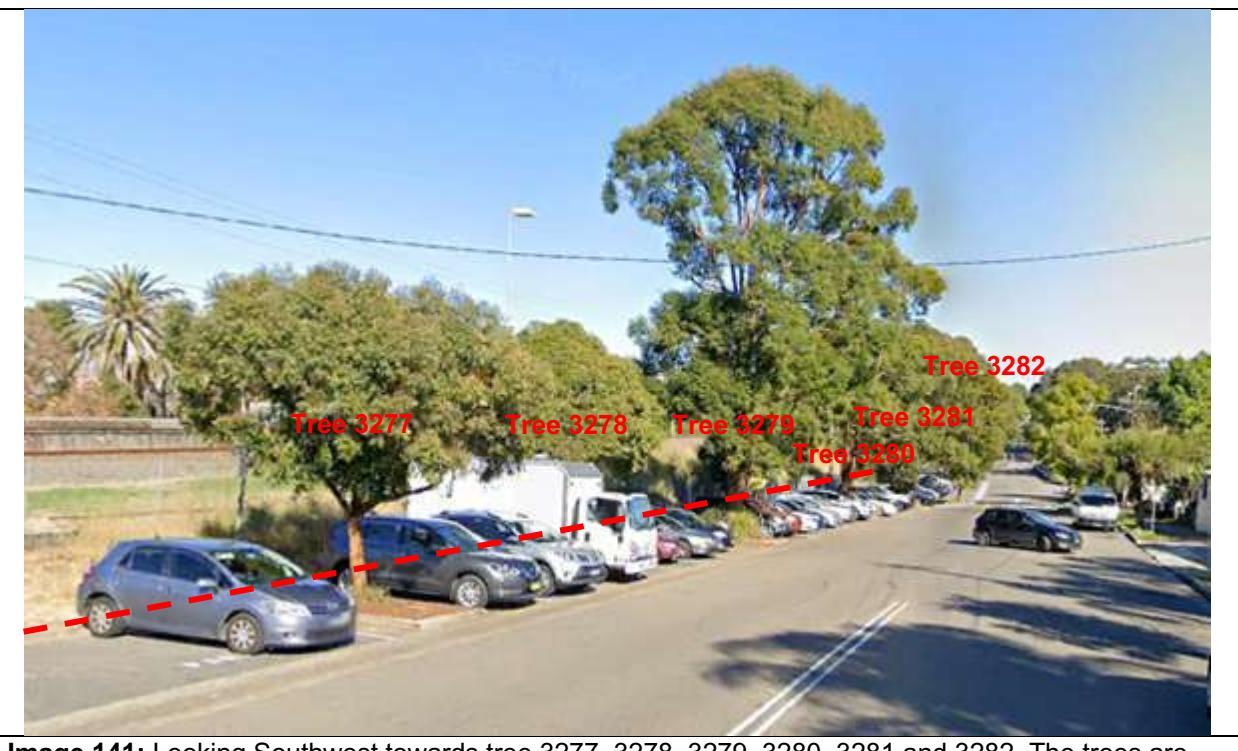
**Image 141:** Looking Southwest towards tree 3277, 3278, 3279, 3280, 3281 and 3282. The trees are recommended for removal due to construction impacts from the proposed services trench (dashed red).

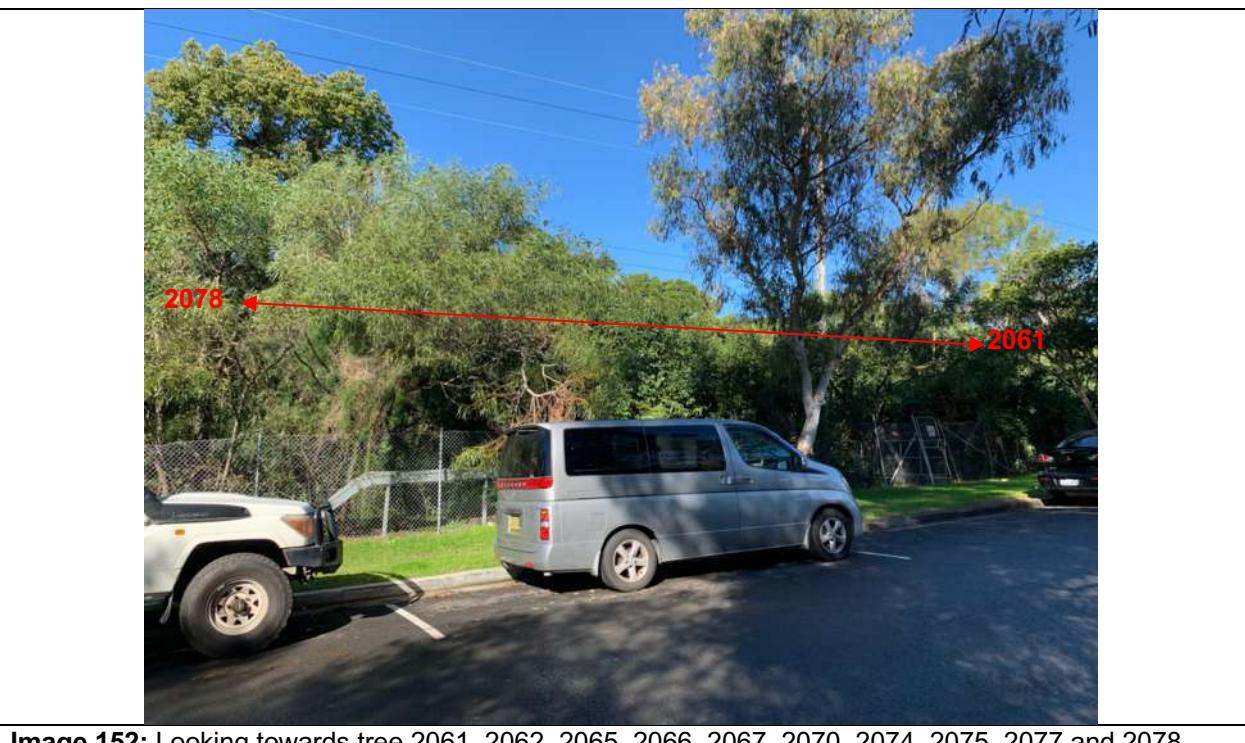
**Image 152:** Looking towards tree 2061, 2062, 2065, 2066, 2067, 2070, 2074, 2075, 2077 and 2078. The trees are located behind the fence on the upper embankment and are recommended or removal due to impacts from the proposed CSR. Weed species adjacent to the trees are also to be removed.

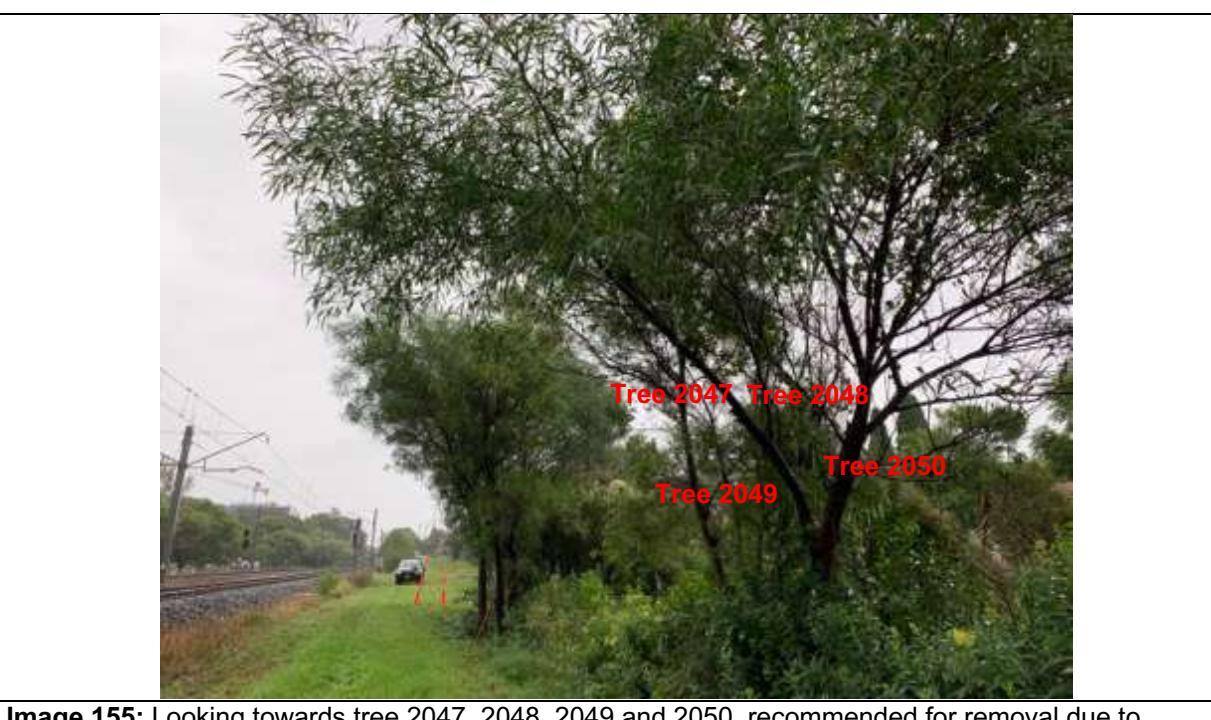
**Image 155:** Looking towards tree 2047, 2048, 2049 and 2050, recommended for removal due to development impacts from the proposed works area.

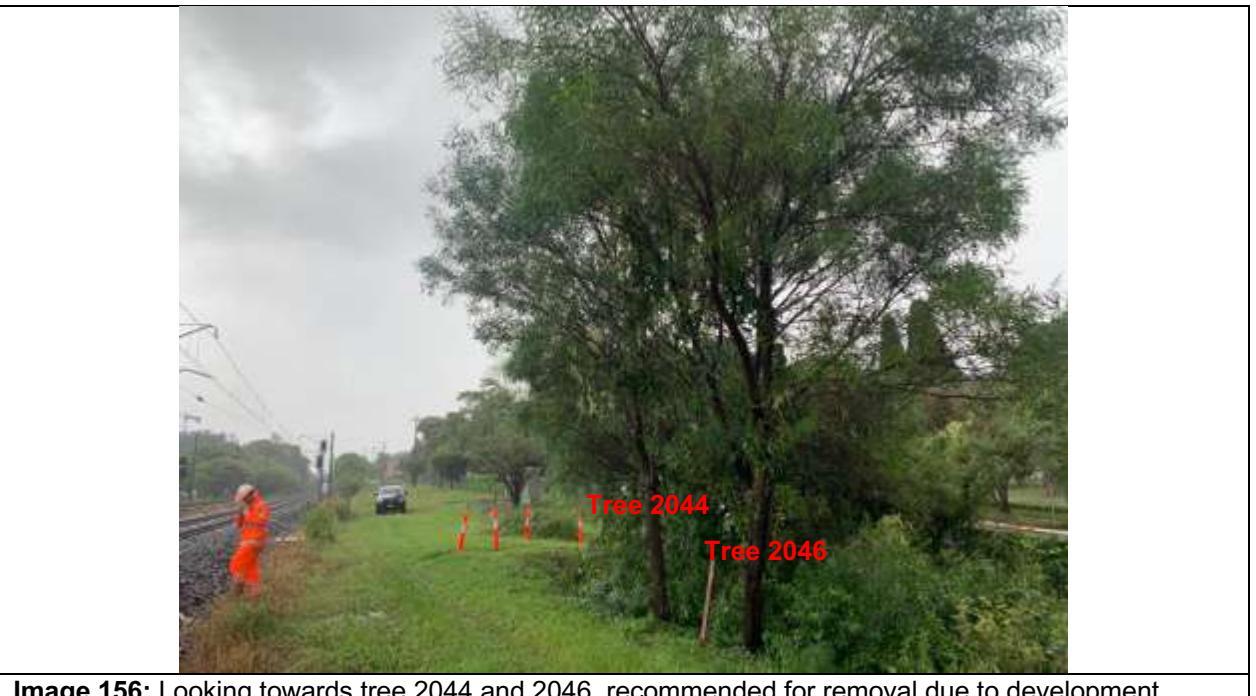
**Image 156:** Looking towards tree 2044 and 2046, recommended for removal due to development impacts from the proposed works area.

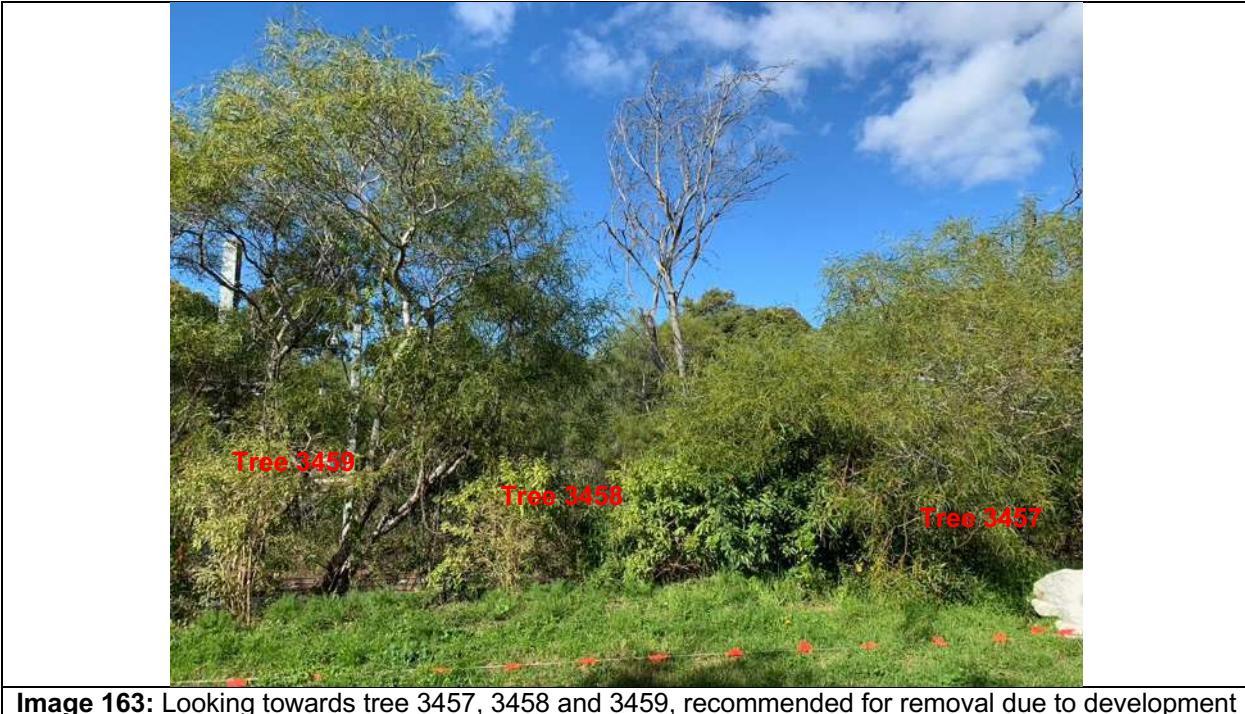
**Image 163:** Looking towards tree 3457, 3458 and 3459, recommended for removal due to devel impacts from the proposed CSR.

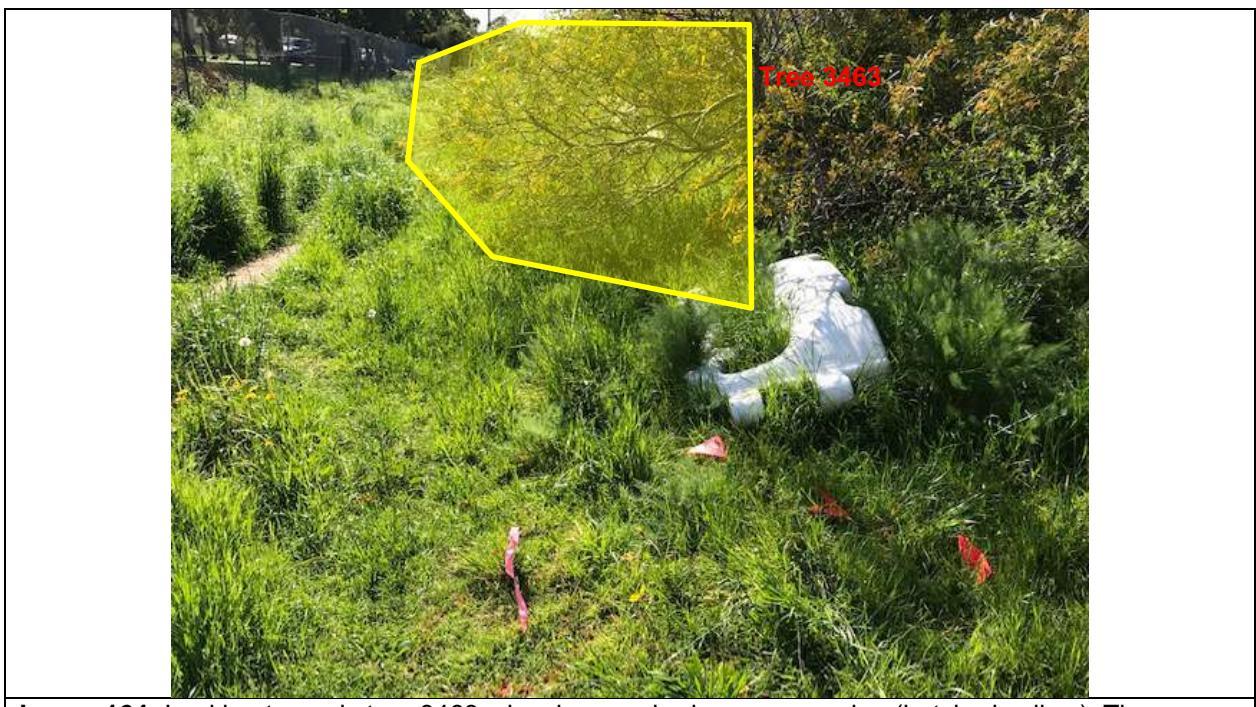
**Image 164:** Looking towards tree 3463, showing required canopy pruning (hatched yellow). The crown is to be reduced to allow for the installation of the GST post/trough. The pruning will result in the removal of 15-20% of the overall live canopy.

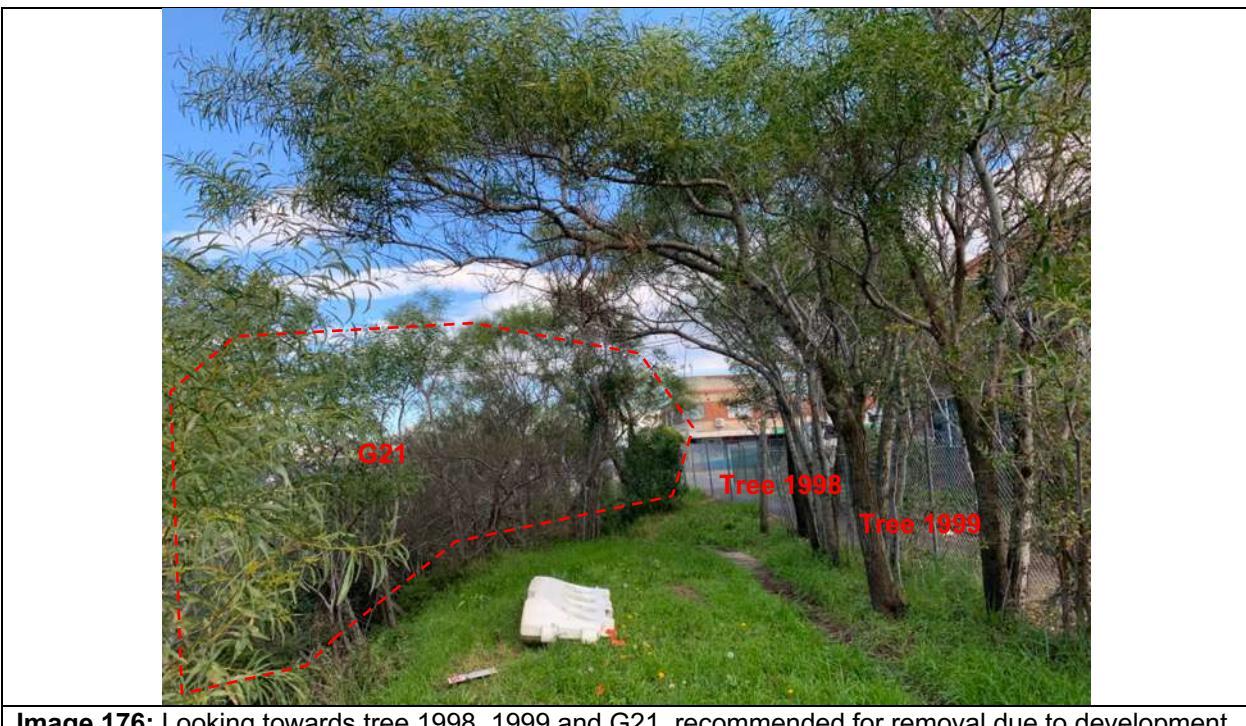
**Image 176:** Looking towards tree 1998, 1999 and G21, recommended for removal due to development impacts from the proposed CSR.

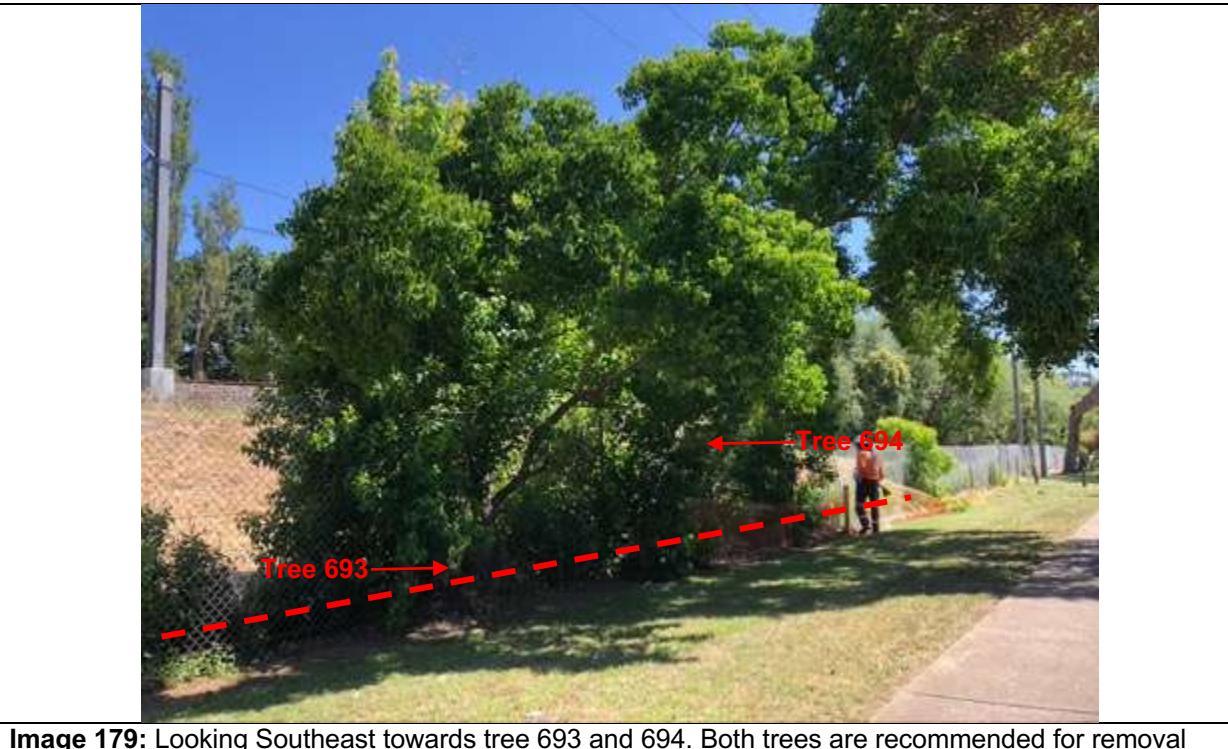
**Image 179:** Looking Southeast towards tree 693 and 694. Both trees are recommended for removal due to the proposed services trench (dashed red).

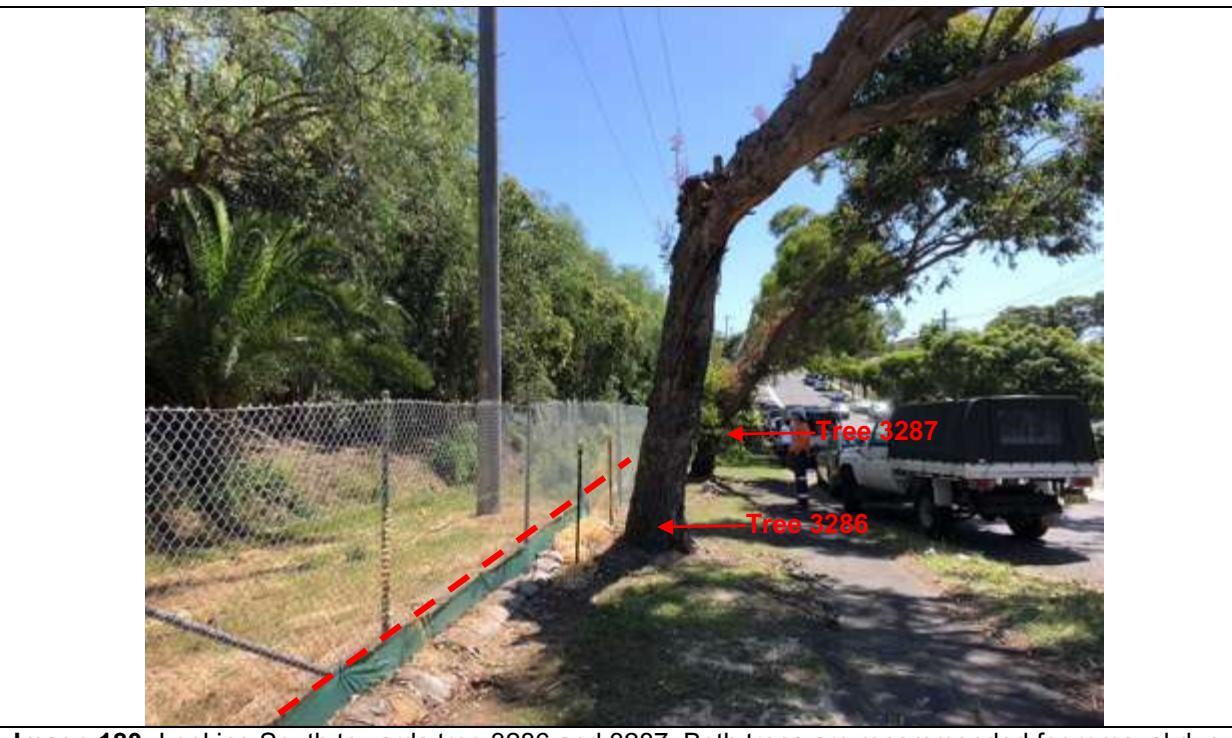
**Image 180:** Looking South towards tree 3286 and 3287. Both trees are recommended for removal due to the proposed services trench (dashed red).

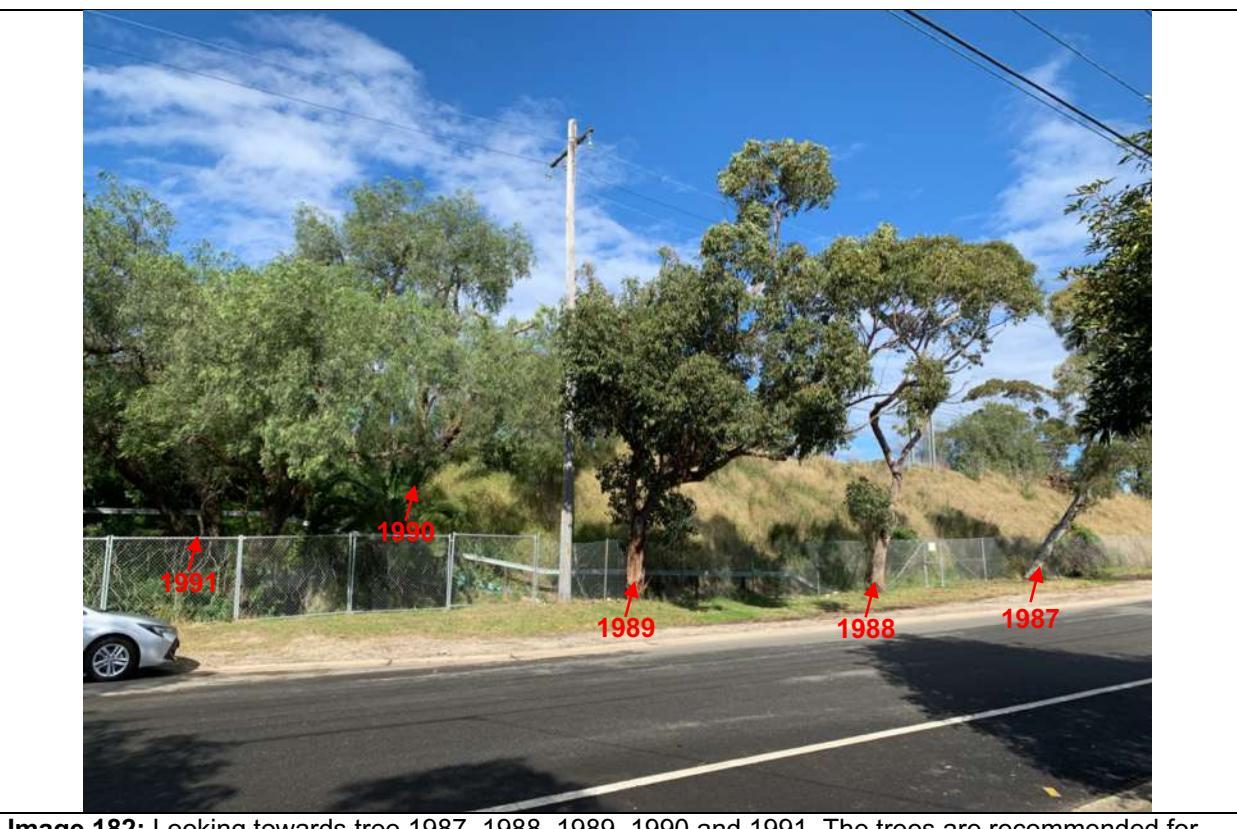
**Image 182:** Looking towards tree 1987, 1988, 1989, 1990 and 1991. The trees are recommended for removal due to the proposed CSR.

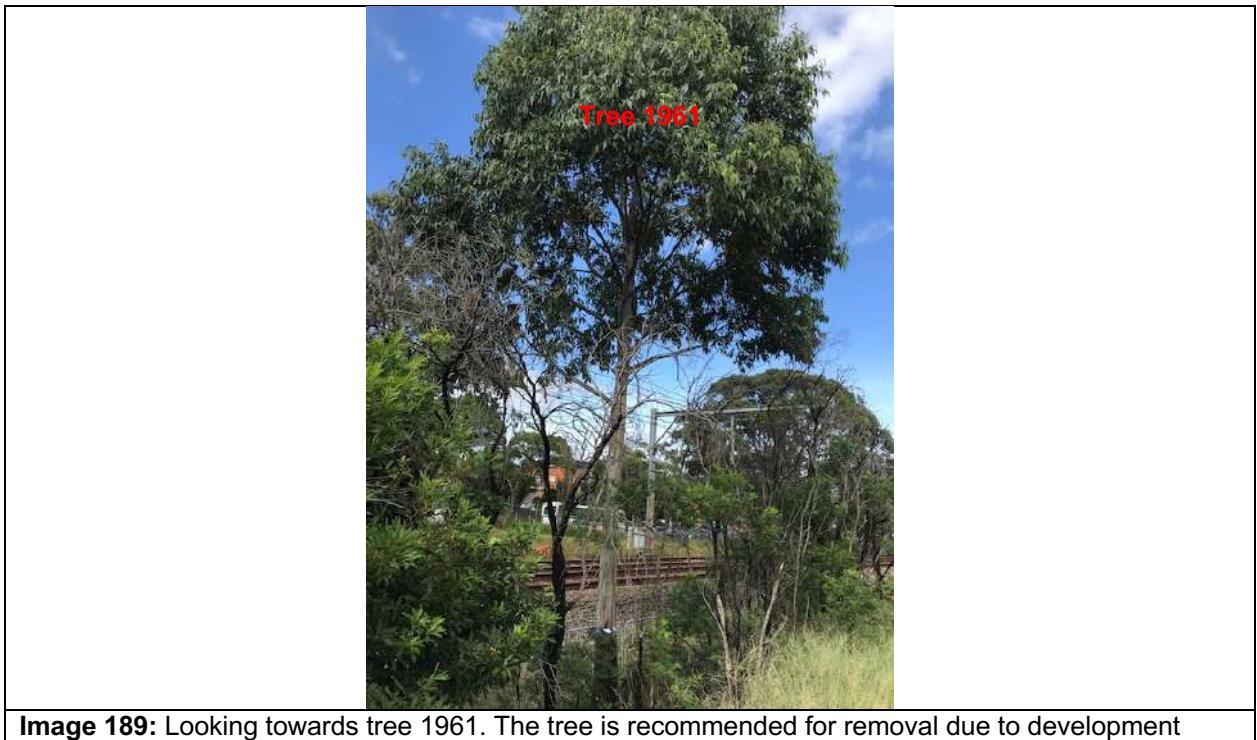
**Image 189:** Looking towards tree 1961. The tree is recommended for removal due to developme impacts.

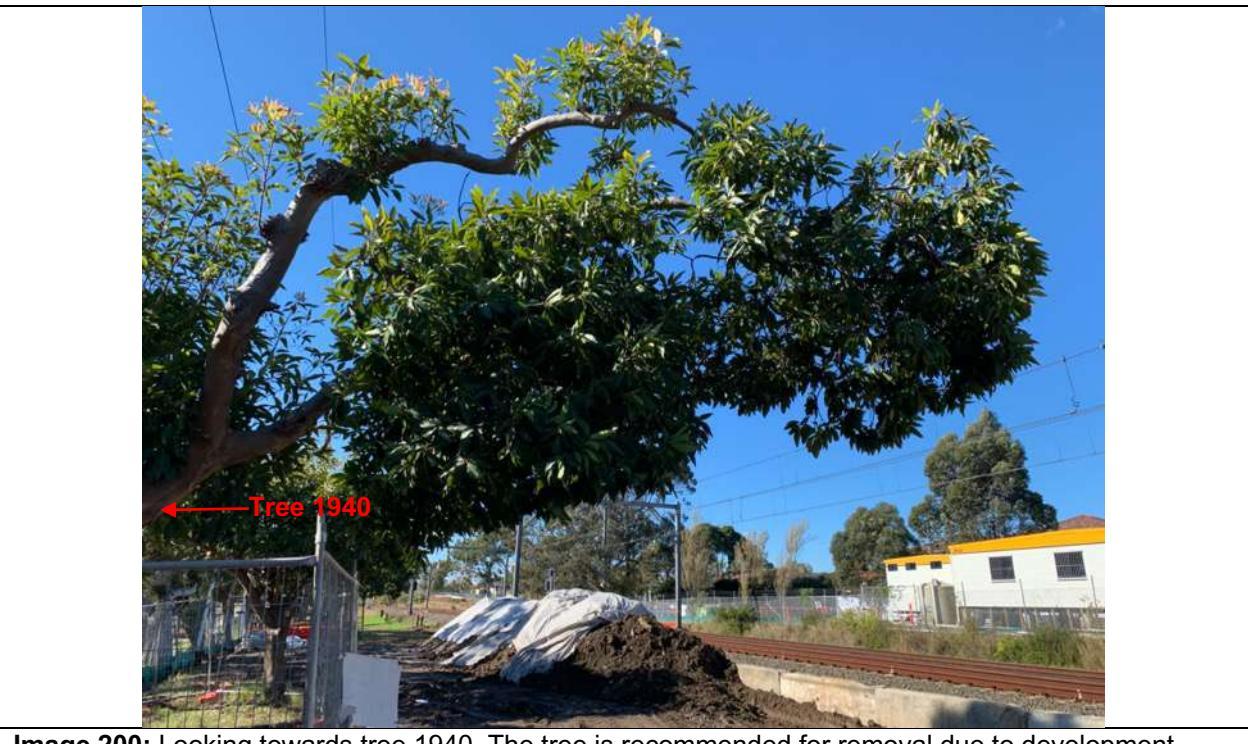
**Image 200:** Looking towards tree 1940. The tree is recommended for removal due to development impacts.

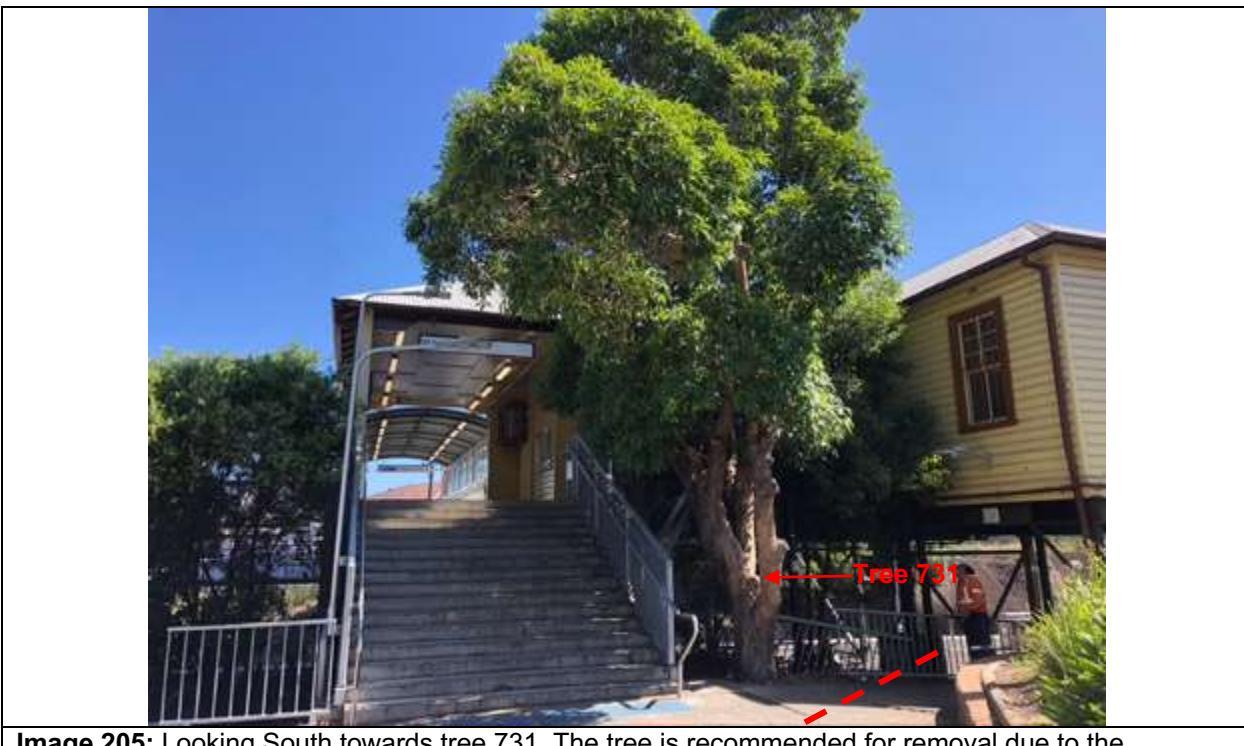
**Image 205:** Looking South towards tree 731. The tree is recommended for removal due to the proposed services trench (dashed red).

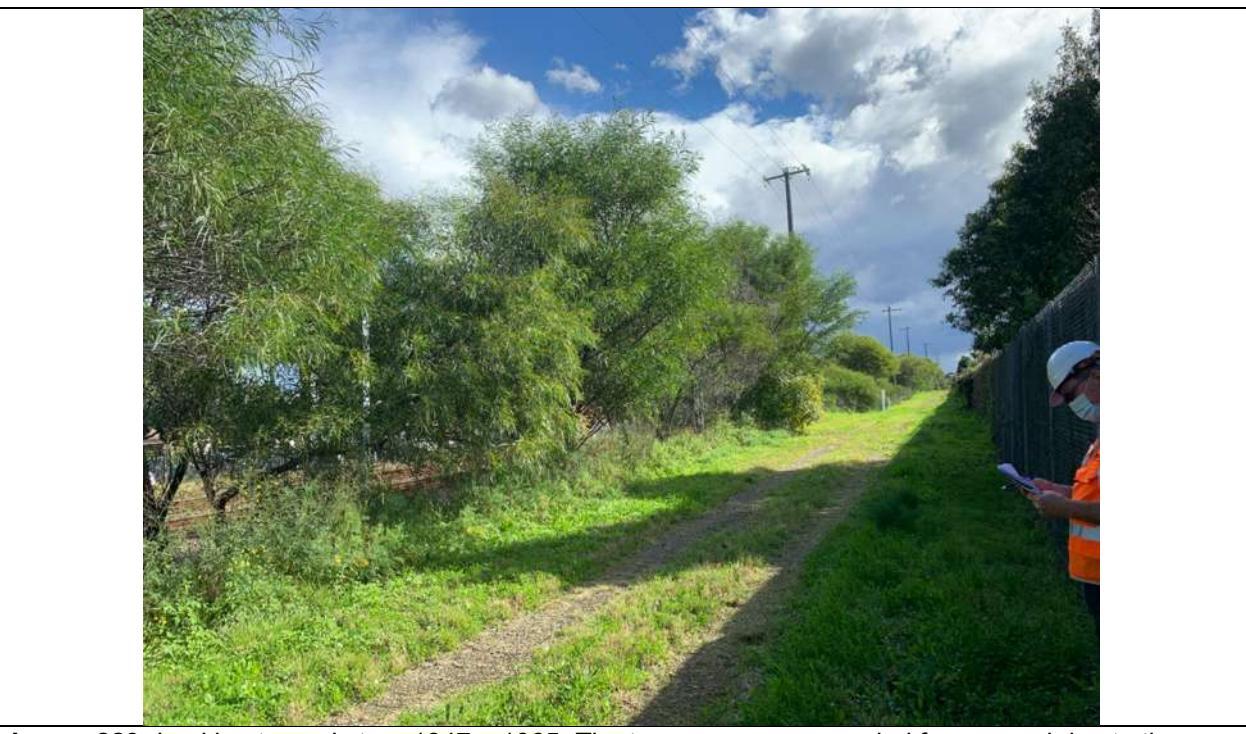
**Image 229:** Looking towards tree 1847 – 1865. The trees are recommended for removal due to the proposed development impacts.

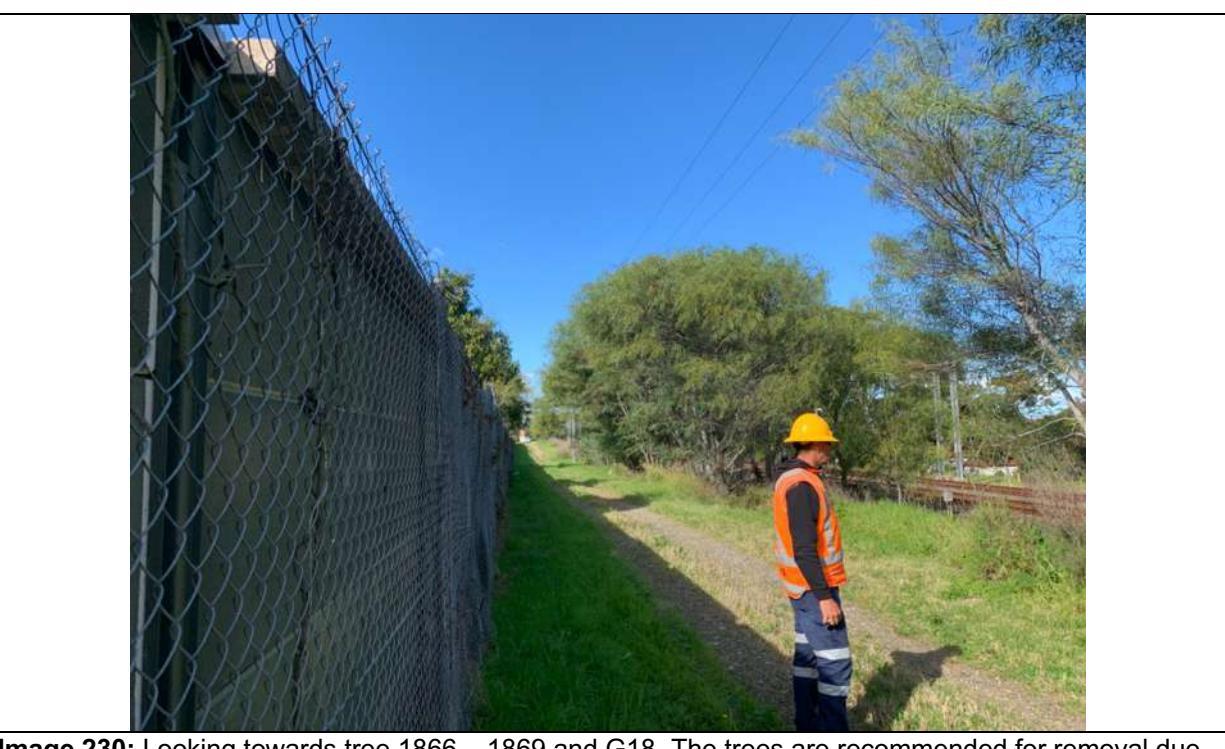
**Image 230:** Looking towards tree 1866 – 1869 and G18. The trees are recommended for removal due to the proposed development impacts.

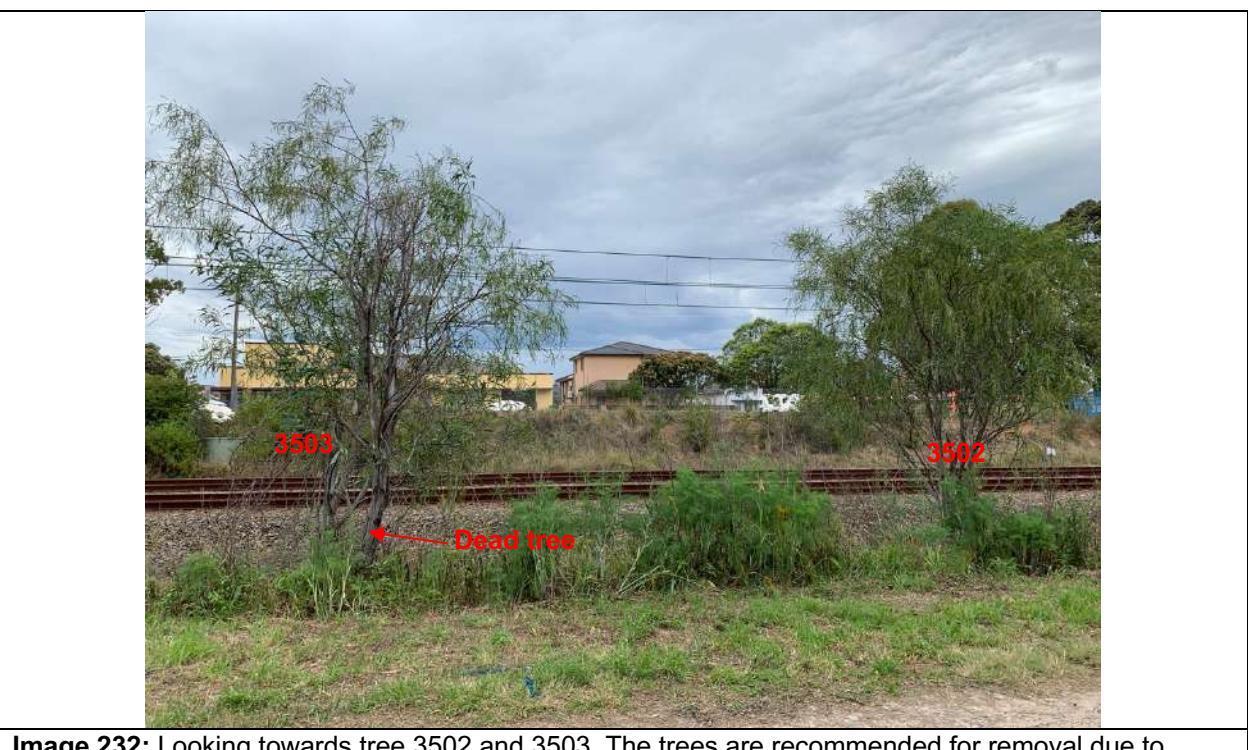
**Image 232:** Looking towards tree 3502 and 3503. The trees are recommended for removal due to conduit excavations between pits. The dead tree to the North of tree 3503 is also to be removed.

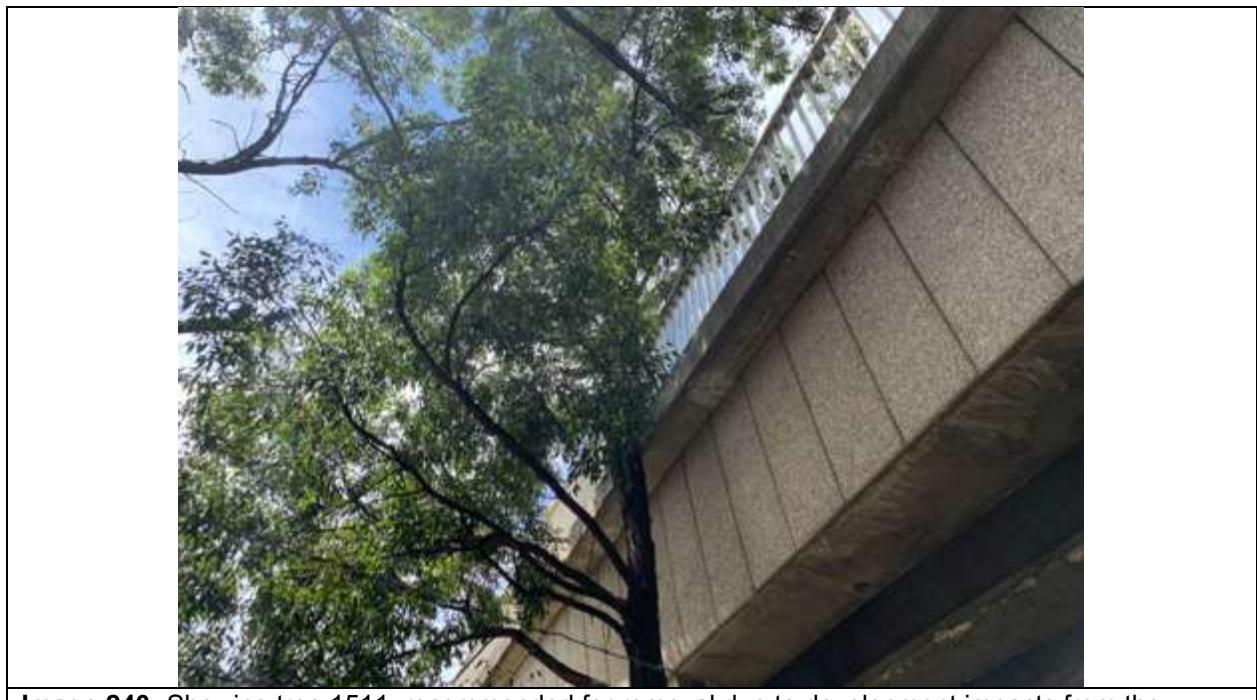
**Image 240:** Showing tree 1511, recommended for removal due to development impacts from the proposed works area.

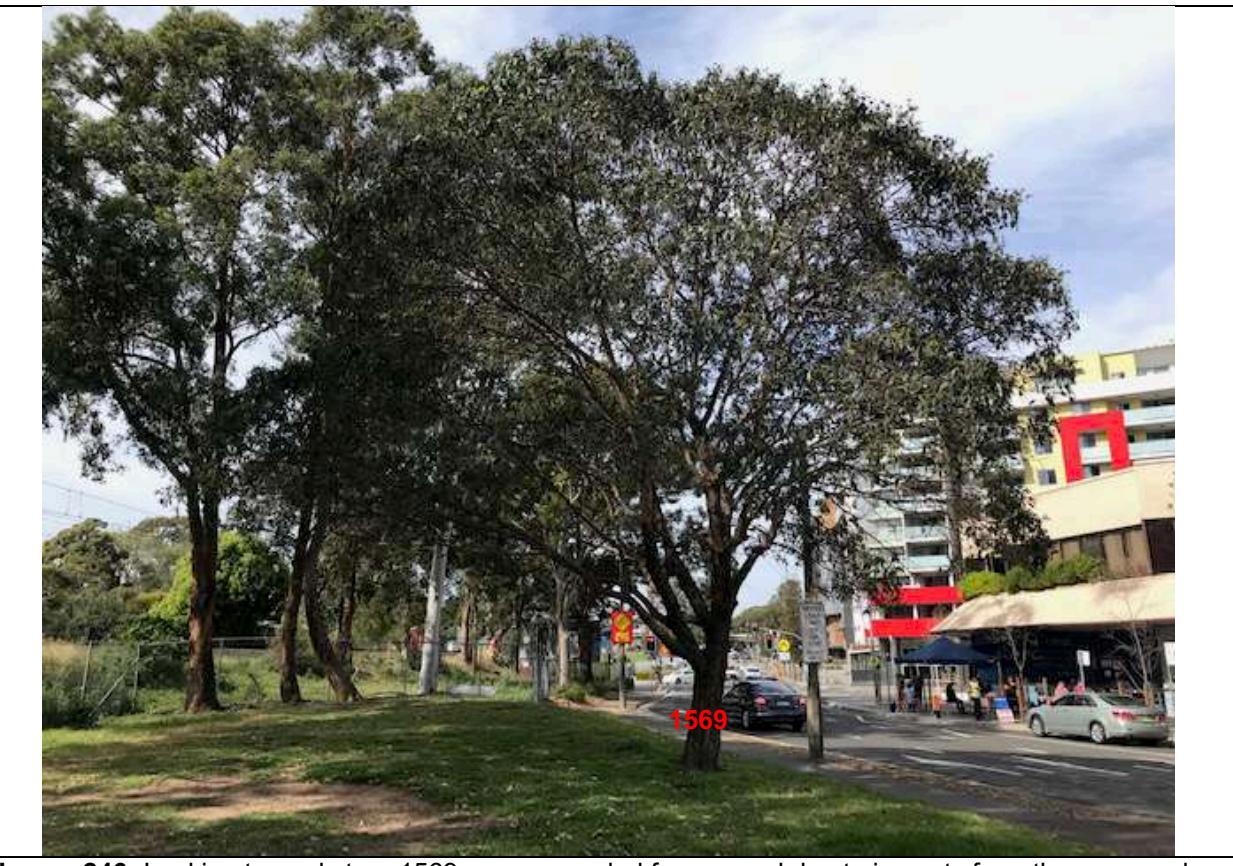
**Image 246:** Looking towards tree 1569, recommended for removal due to impacts from the proposed development.
