# M6 Motorway Stage 1

#### Remedial Action Plan Princes Highway Construction Ancillary Facility (C6)

CPB Contractors Ghella UGL Engineering (CGU) joint venture

#### Reference: M6S1-COF-NWW-ENLD-RPT-670752\_v3

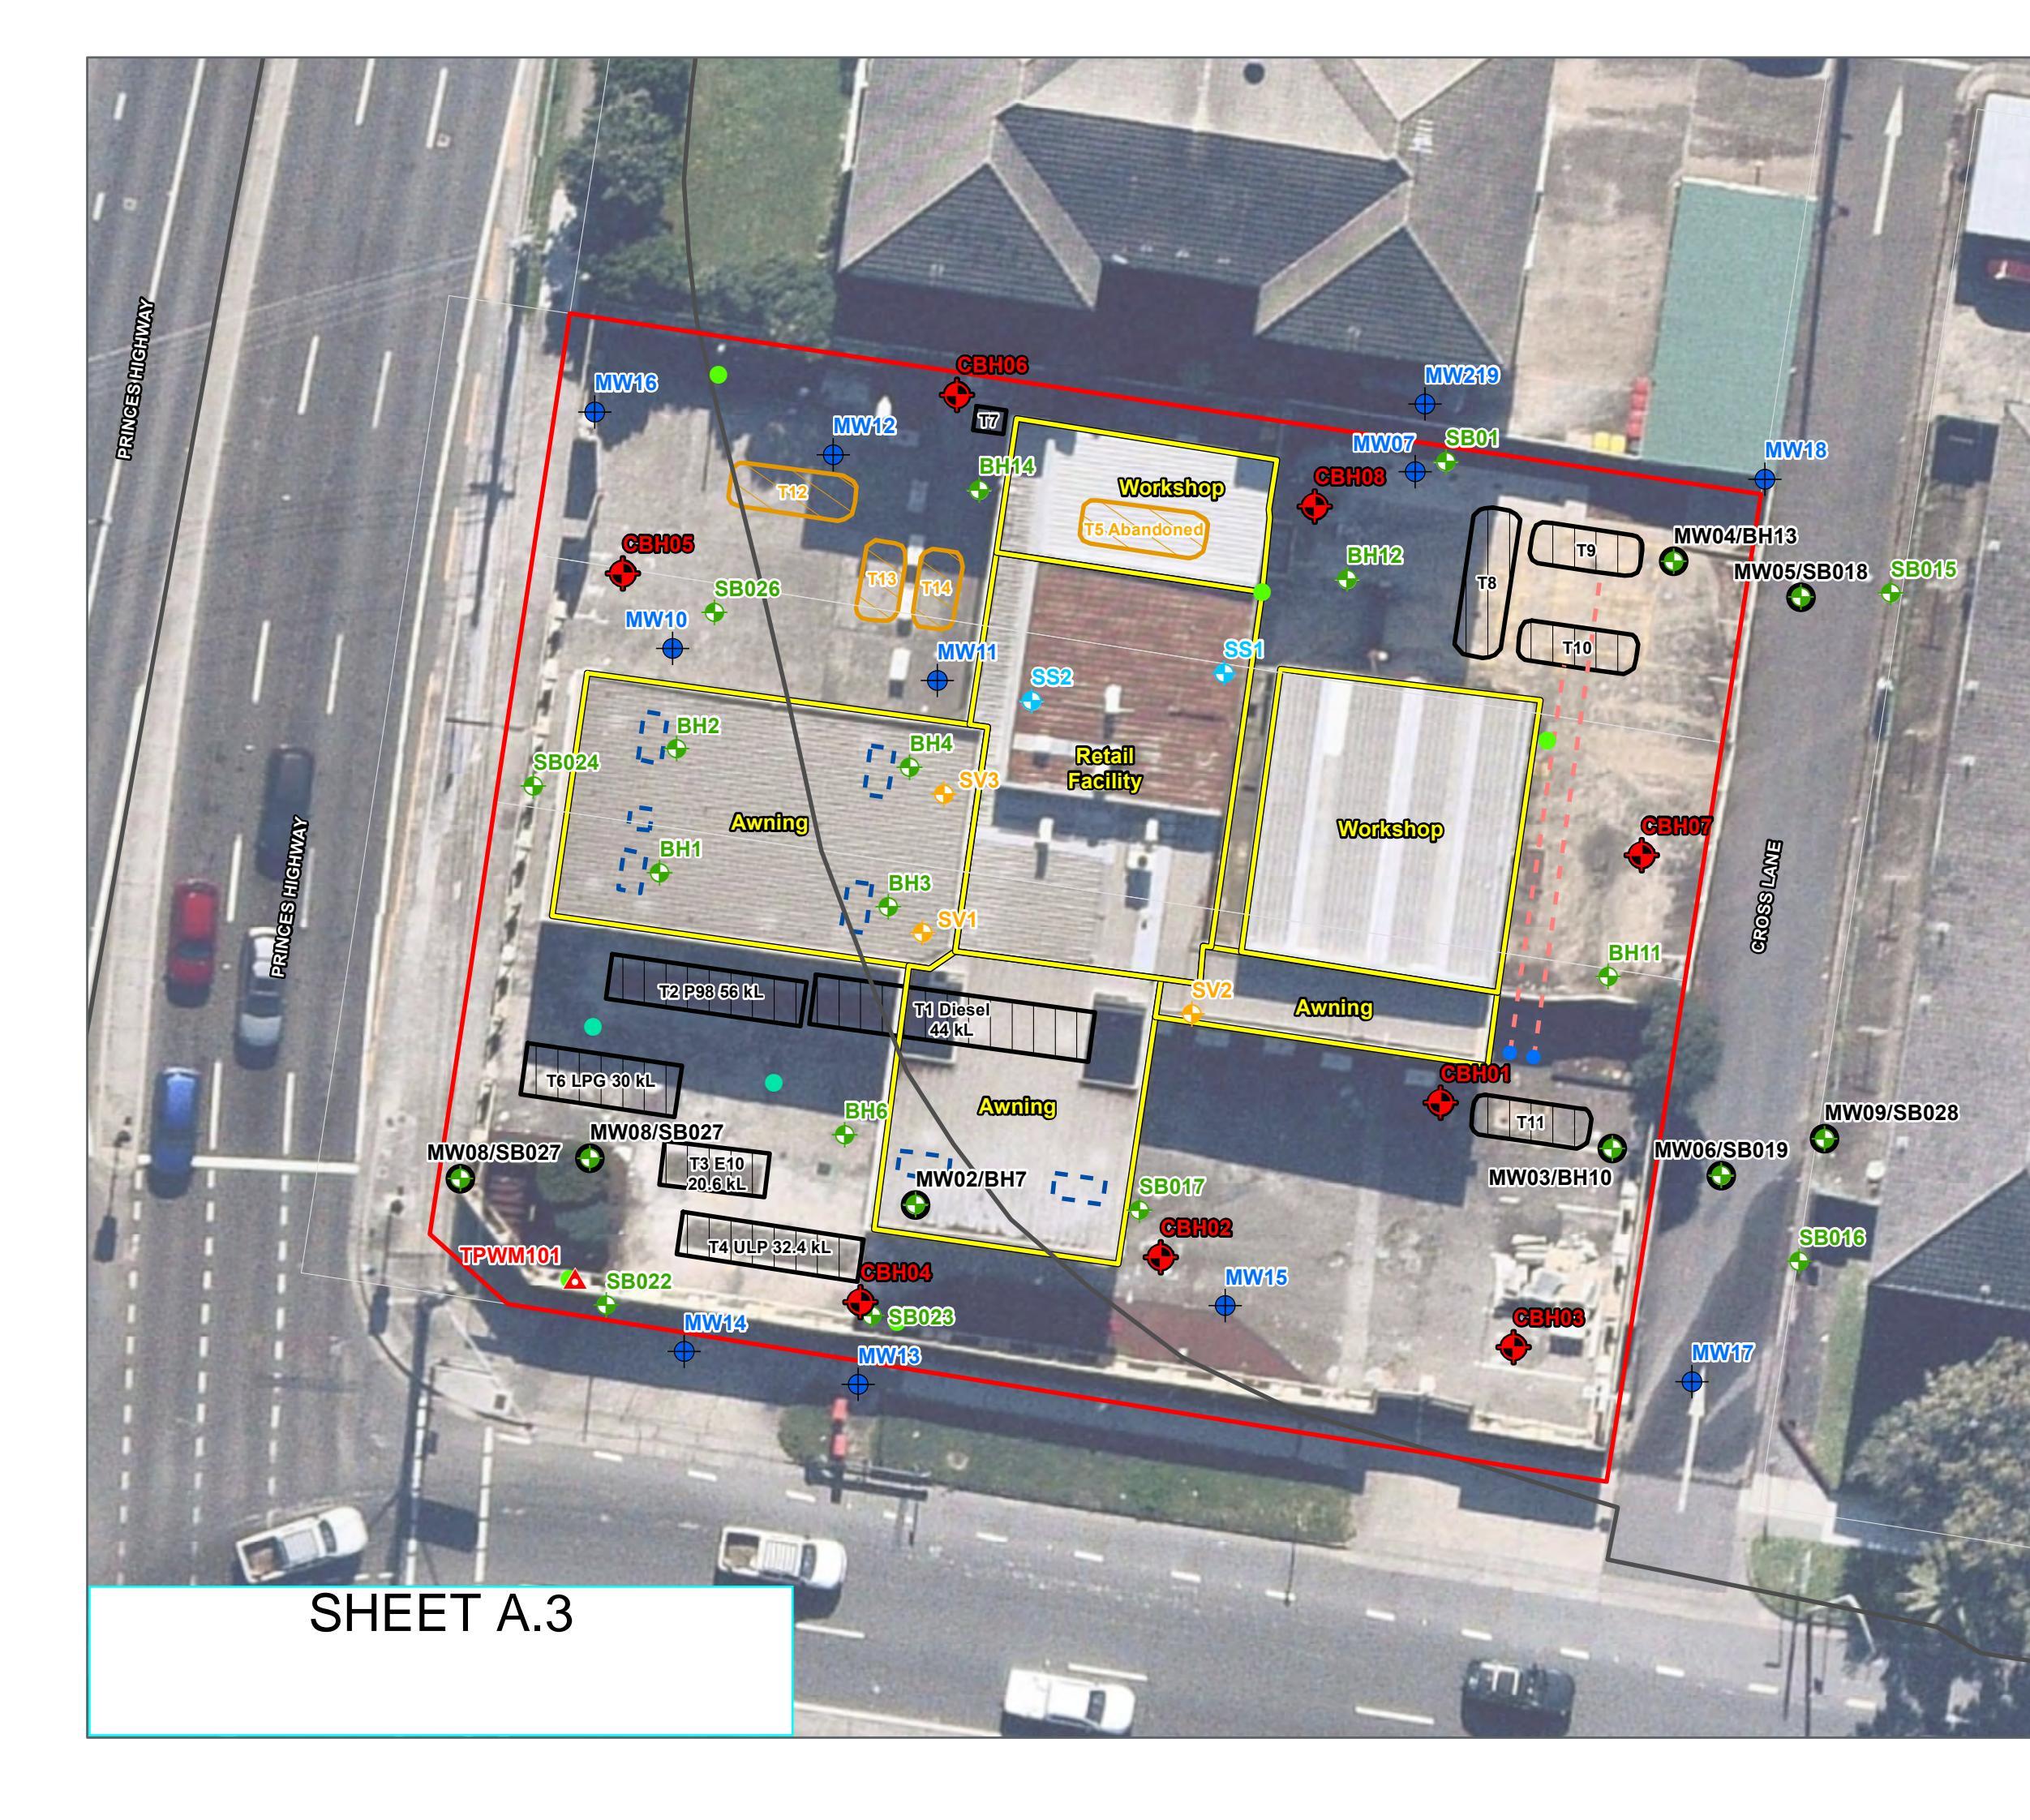
# 7-Eleven Service Station - Borehole Locations

Map Produced by Cardno NSW/ACT Pty Ltd (NW&E) Date: 2020-08-14 | Project: 4NE30036 Coordinate System: GDA 1994 MGA Zone 56 Map: 4NE30036-GS-005-711\_SamplingPlan.mxd 01 Aerial imagery supplied by Nearmap (August, 2020)

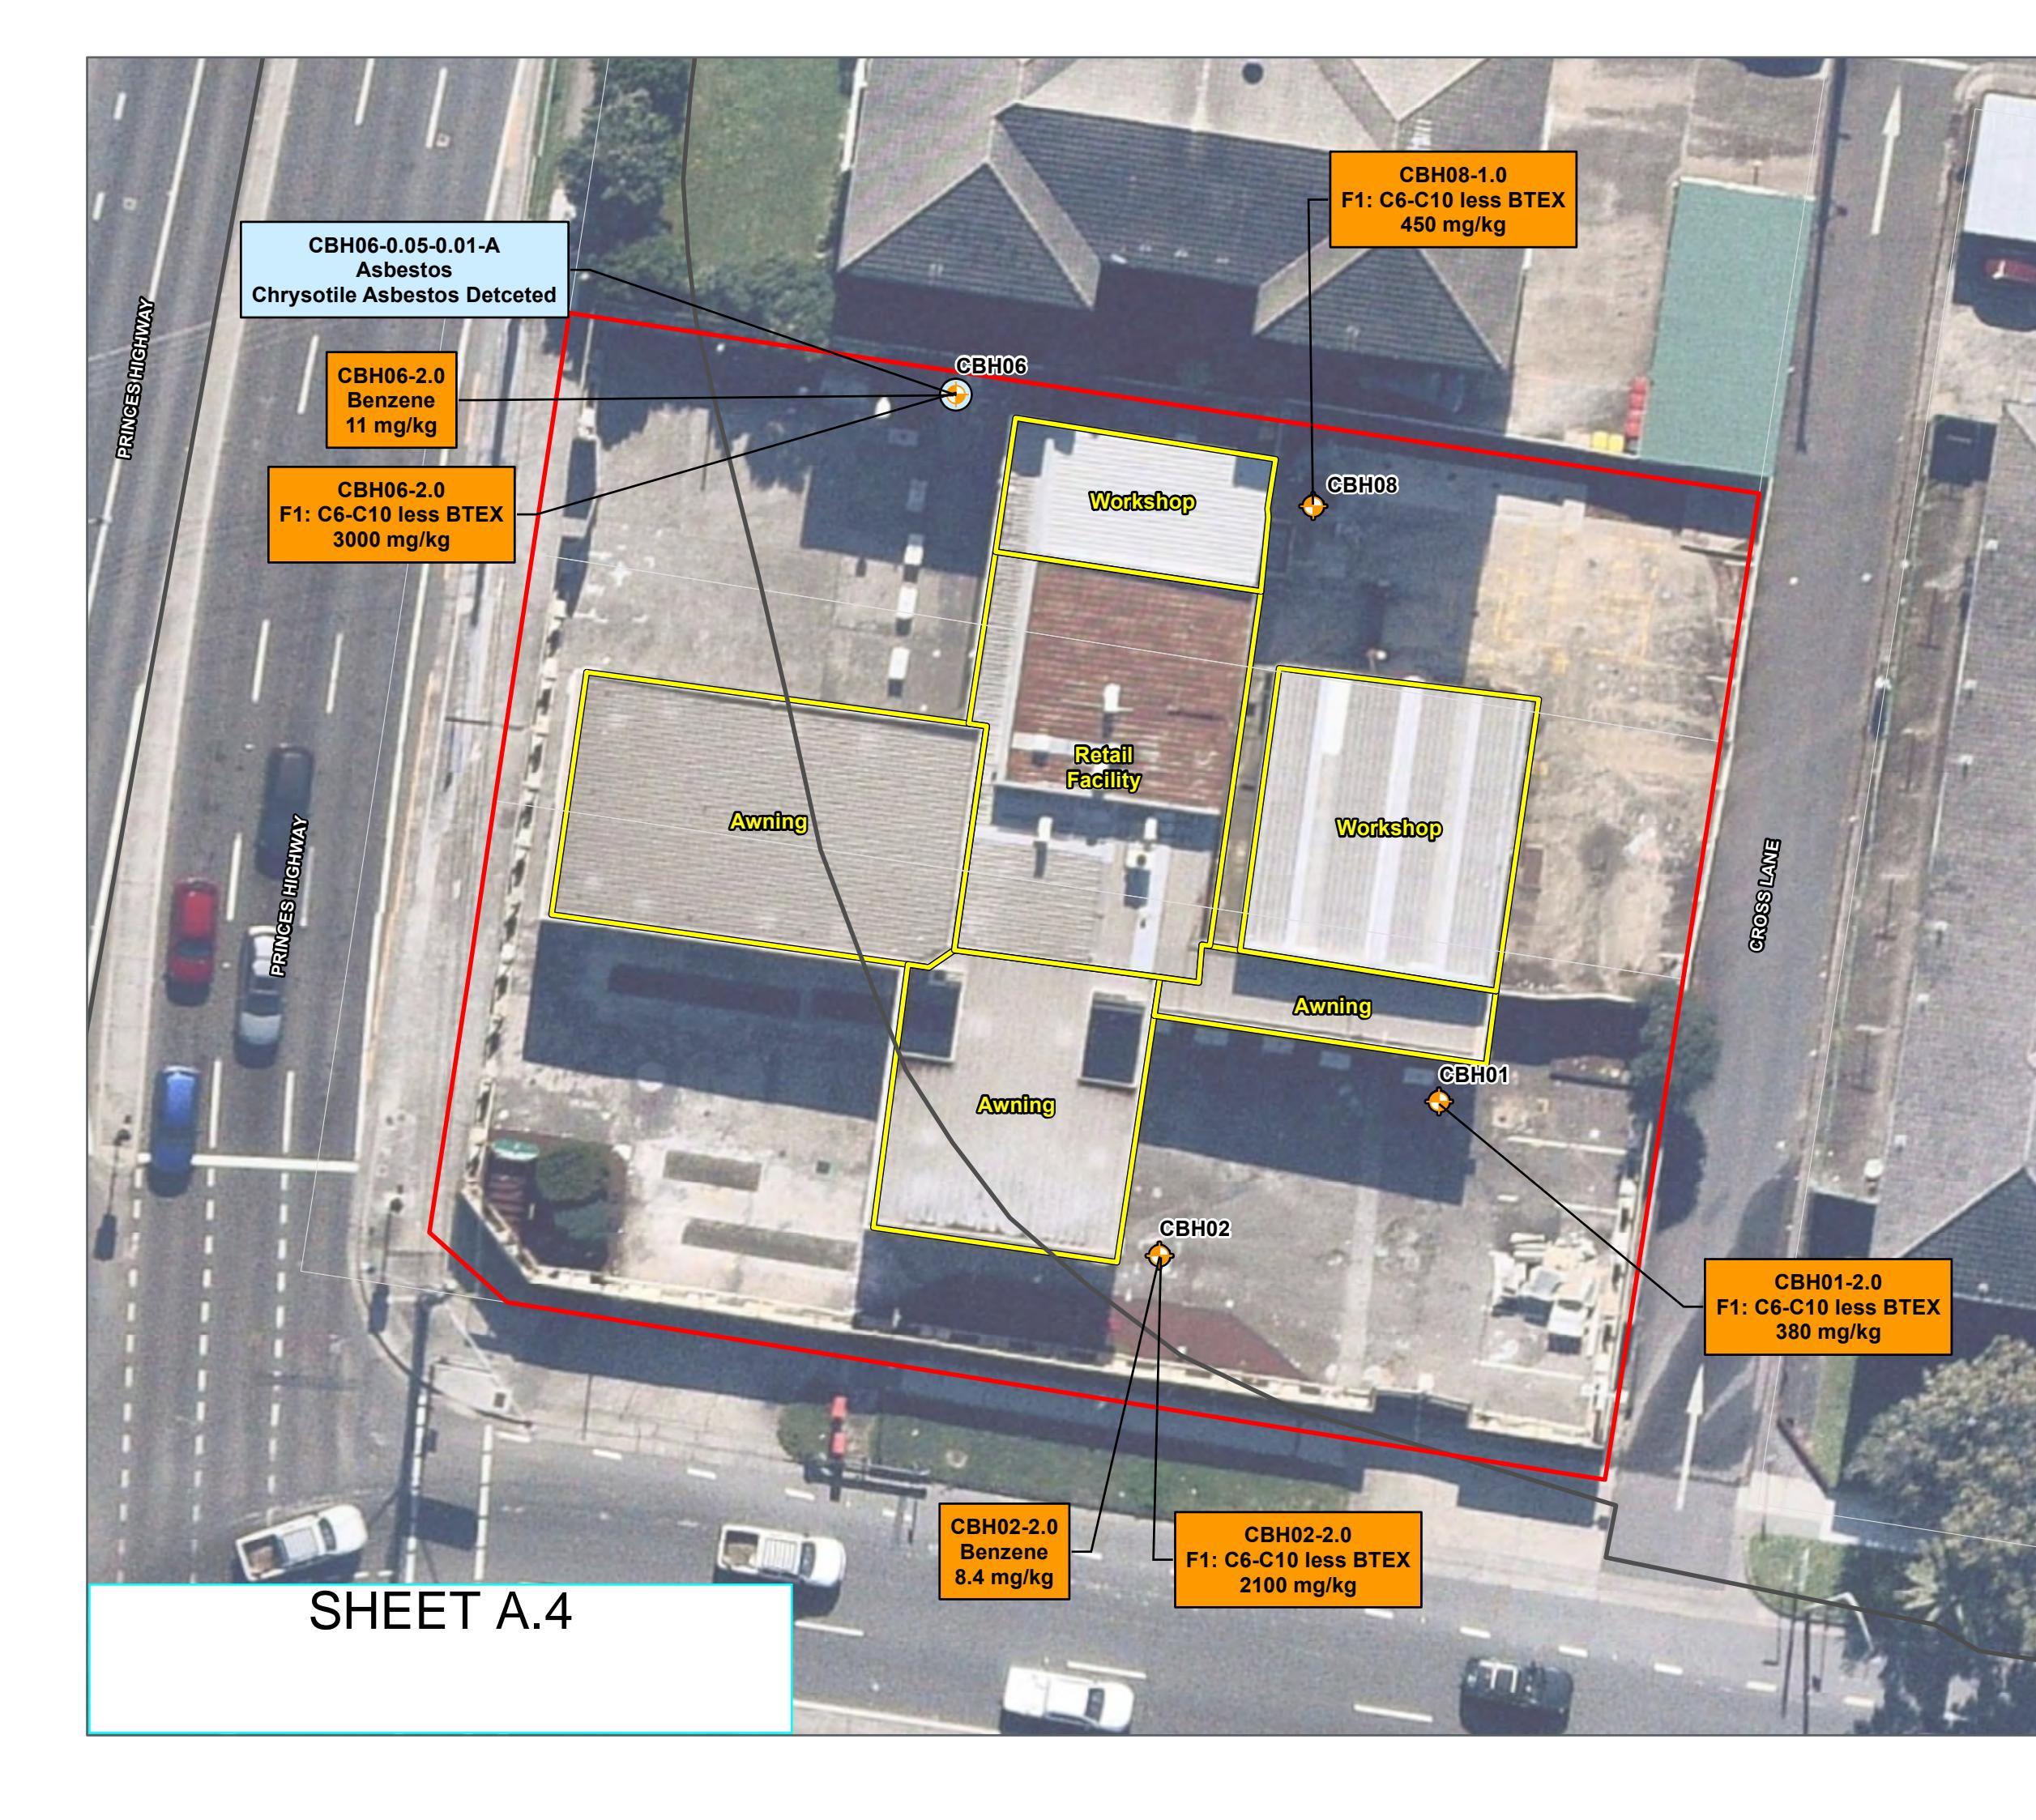
# 7-Eleven Service Station - Human Health Exceedances

Map Produced by Cardno NSW/ACT Pty Ltd (NW&E) Date: 2020-08-17 | Project: 4NE30036 Coordinate System: GDA 1994 MGA Zone 56 Map: 4NE30036-GS-014-711\_HH\_Exceedances.mxd 01 Aerial imagery supplied by Nearmap (August, 2020)

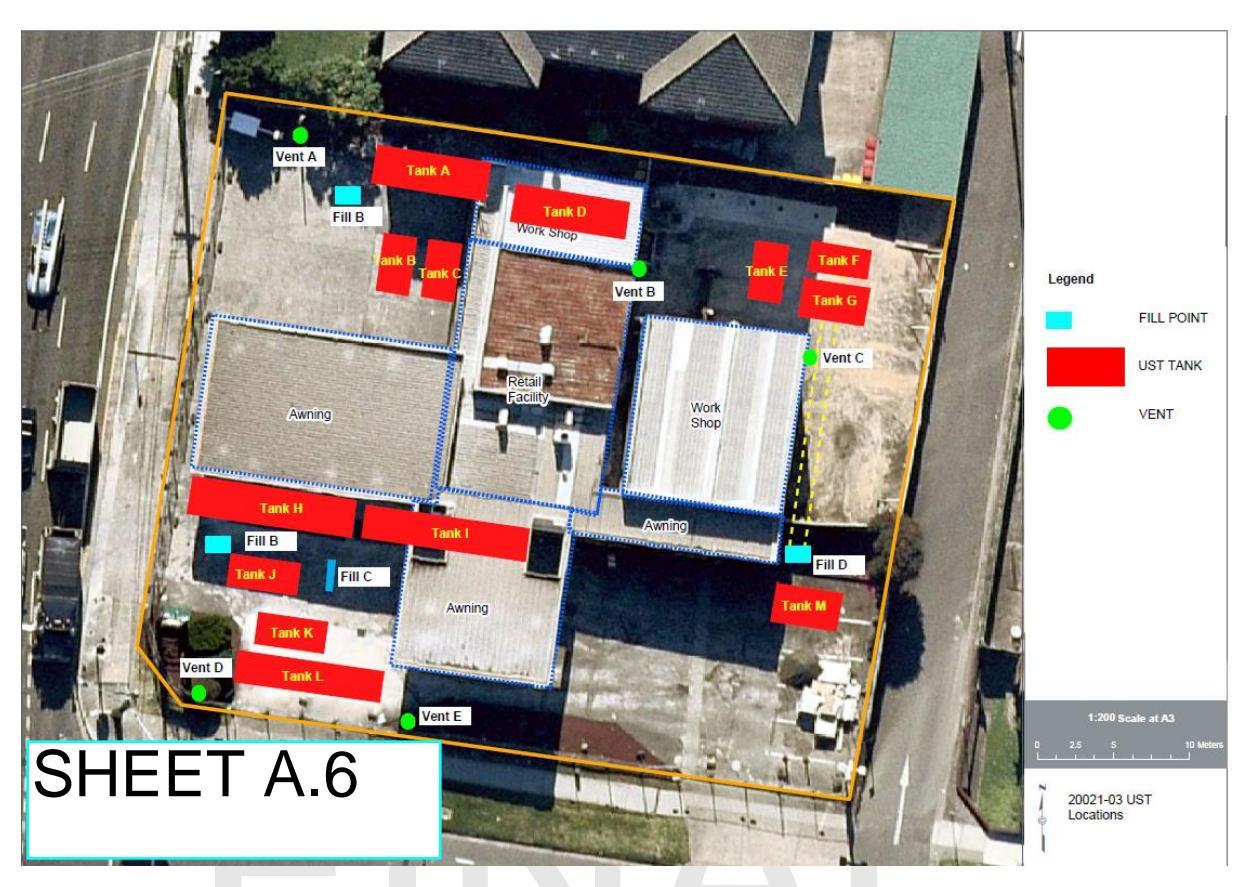
Where individual tanks are described in the following table.

ID	Volume (SFL)	Likely Total Volume (litres)	
Tank A	21,400 Litres (4,700 UK Imp Gallons)	24,000	*
Tank B	13,638 Litres (3,000 UK Imp Gallons)	15,000	-
Tank C	13,638 Litres (3,000 UK Imp Gallons)	15,000	
Tank D	21,400 Litres (4,700 UK Imp Gallons)	24,000	-
Tank E	18,184 Litres (4,000 UK Imp Gallons) <sup>1</sup>	19,345	-
Tank F	13,638 Litres (3,000 UK Imp Gallons)	14508	
Tank G	18,184 Litres (4,000 UK Imp Gallons)	19,345	
Tank H	56,000 Litres	56,000	
Tank I	44,000 Litres	45,000	
Tank J	30,000 Litres	30,000	
Tank K	20,600 Litres	24,000	
Tank L	32,400 Litres	34,000	T
Tank M	13,638 Litres	15,000	T

Groundwater remediation was carried out at the site between 2017 and 2019 following the failure of diesel tank T5 (Tank D on Sheet A.6) and product line during integrity testing in 2013. Groundwater remediation included the installation of a groundwater interception trench, groundwater extraction and treatment system to reduce the mass of dissolved phase hydrocarbons and LNAPL migrating off-site in groundwater. The groundwater extraction system comprised a passive skimmer units within four groundwater extraction wells for the removal of LNAPL which was expected to form within a 3 m deep, 10 m long gravel-filled groundwater interception trench on the eastern end of the northern boundary of the site. 129,728 litres (L) of impacted groundwater was extracted during trench construction and system operation. Treated water was either disposed offsite at licensed facilities or to sewer under a trade waste agreement. The system ran for approximately 13 months from November 2017 to July 2019. At the conclusion of the groundwater extraction program LNAPL was not detected with a measurable thickness in the trench in April 2019, or in any monitoring well during the August 2019 GME. The absence of LNAPL in monitoring wells indicated a reduced direct contact risk to onsite and offsite receptors where excavations intercept groundwater. The groundwater interception trench remains in-situ. The location of the trench is shown on the Sheet A.11 in Appendix A.

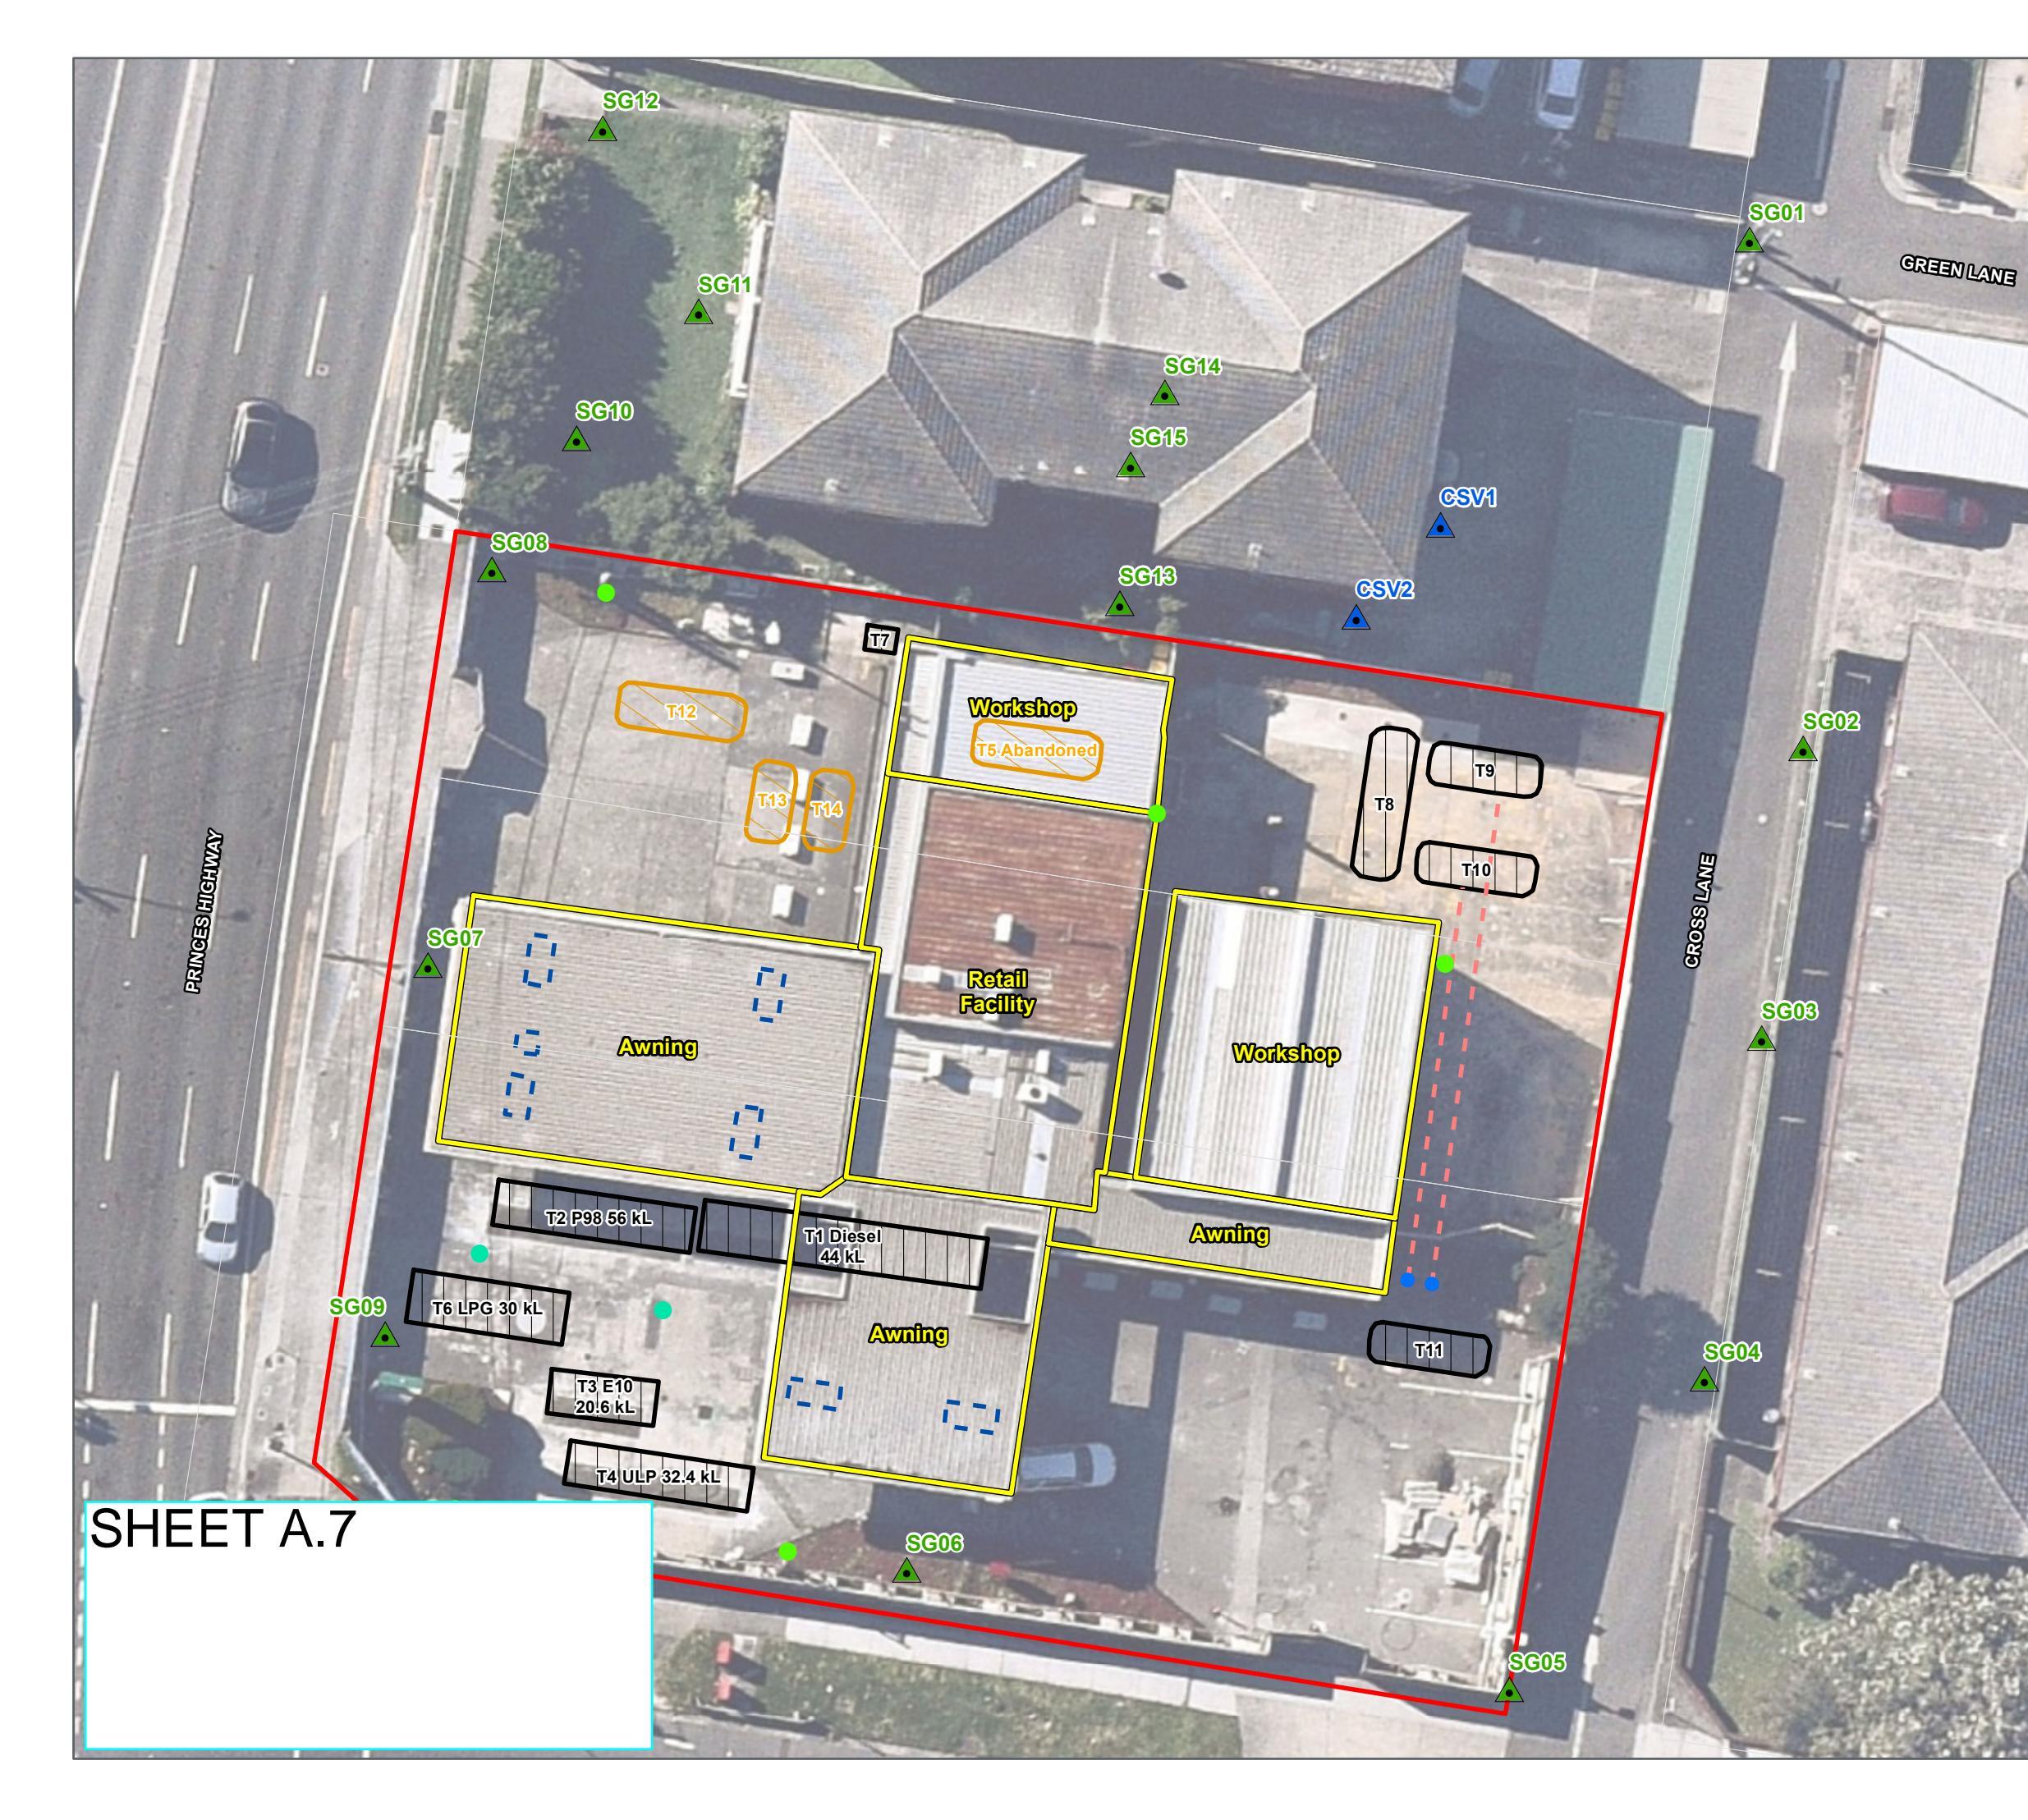
### 7-Eleven Service Station - Gas Monitoring Locations

Site Boundary
Control on	UST Fill Point
THAT	Vent Stack
西尼日料	<ul> <li>Waste Oil Fill Point</li> </ul>
	– – 🕕 UST Transfer Line
	Cadastre (NSW SS, 2019)
	Building Layout
	Fuel Dispensing Unit
	Known UST
	Suspected UST
	Gas Monitoring Locations (Cardno, 2020)
	A Passive Soil Gas Samplers
	🛕 Soil Vapour Pins
E Constant	
	FIGURE 1
	1:250 Scale at A3
	<u> </u>
	0 2.5 5 7.5 10
	Cardno
5	Map Produced by Cardno NSW/ACT Pty Ltd (NW&E)
a le	Date: 2020-10-20   Project: NE30054 Coordinate System: GDA 1994 MGA Zone 56 Map: NE30054-GS-020-711_GasMonitoring.mxd 01

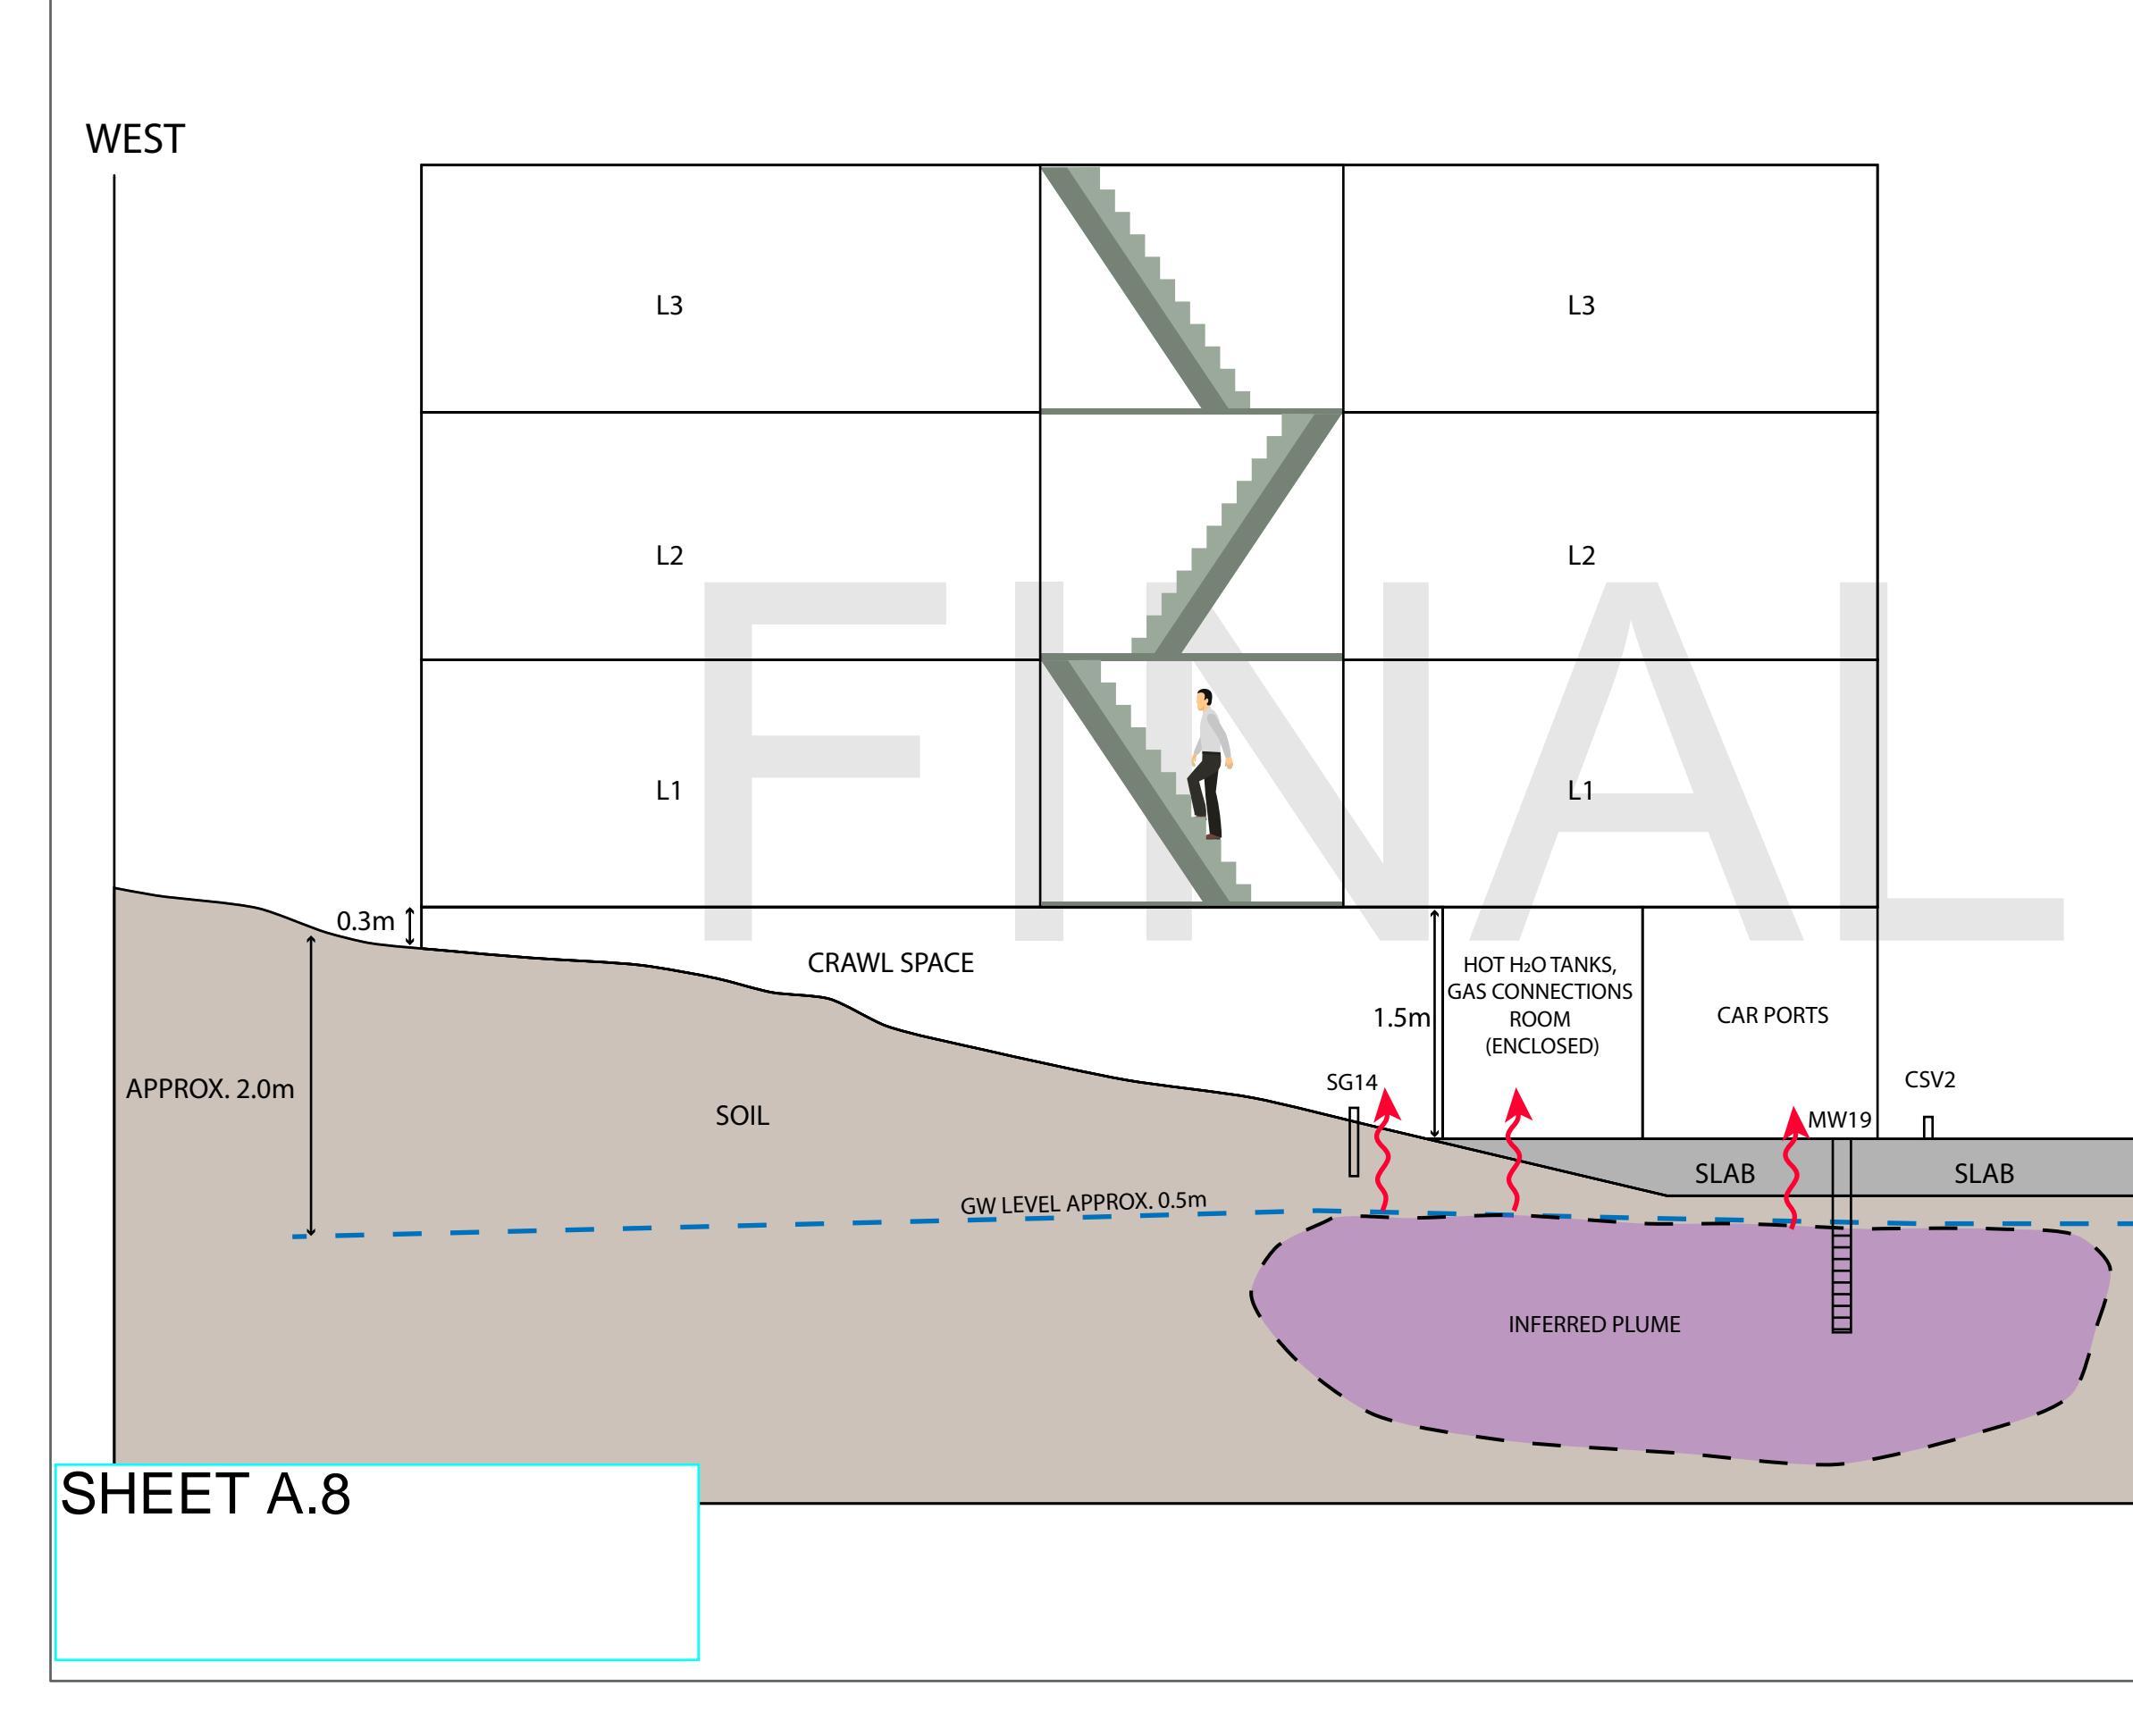
GOVERNMENT Transport for NSW
EAST	7-Eleven Service Station Conceptual Site Model
	LEGEND SOIL INFERRED PLUME
	GROUNDWATER LEVEL
	FIGURE 3
	NOT TO SCALE
	Map Produced by Cardno VIC Date: 2020-10-21   Project: NE30054 Coordinate System: GDA 1994 MGA Zone 56 Map: NE30054-AI-021-711_CSM.ai 01

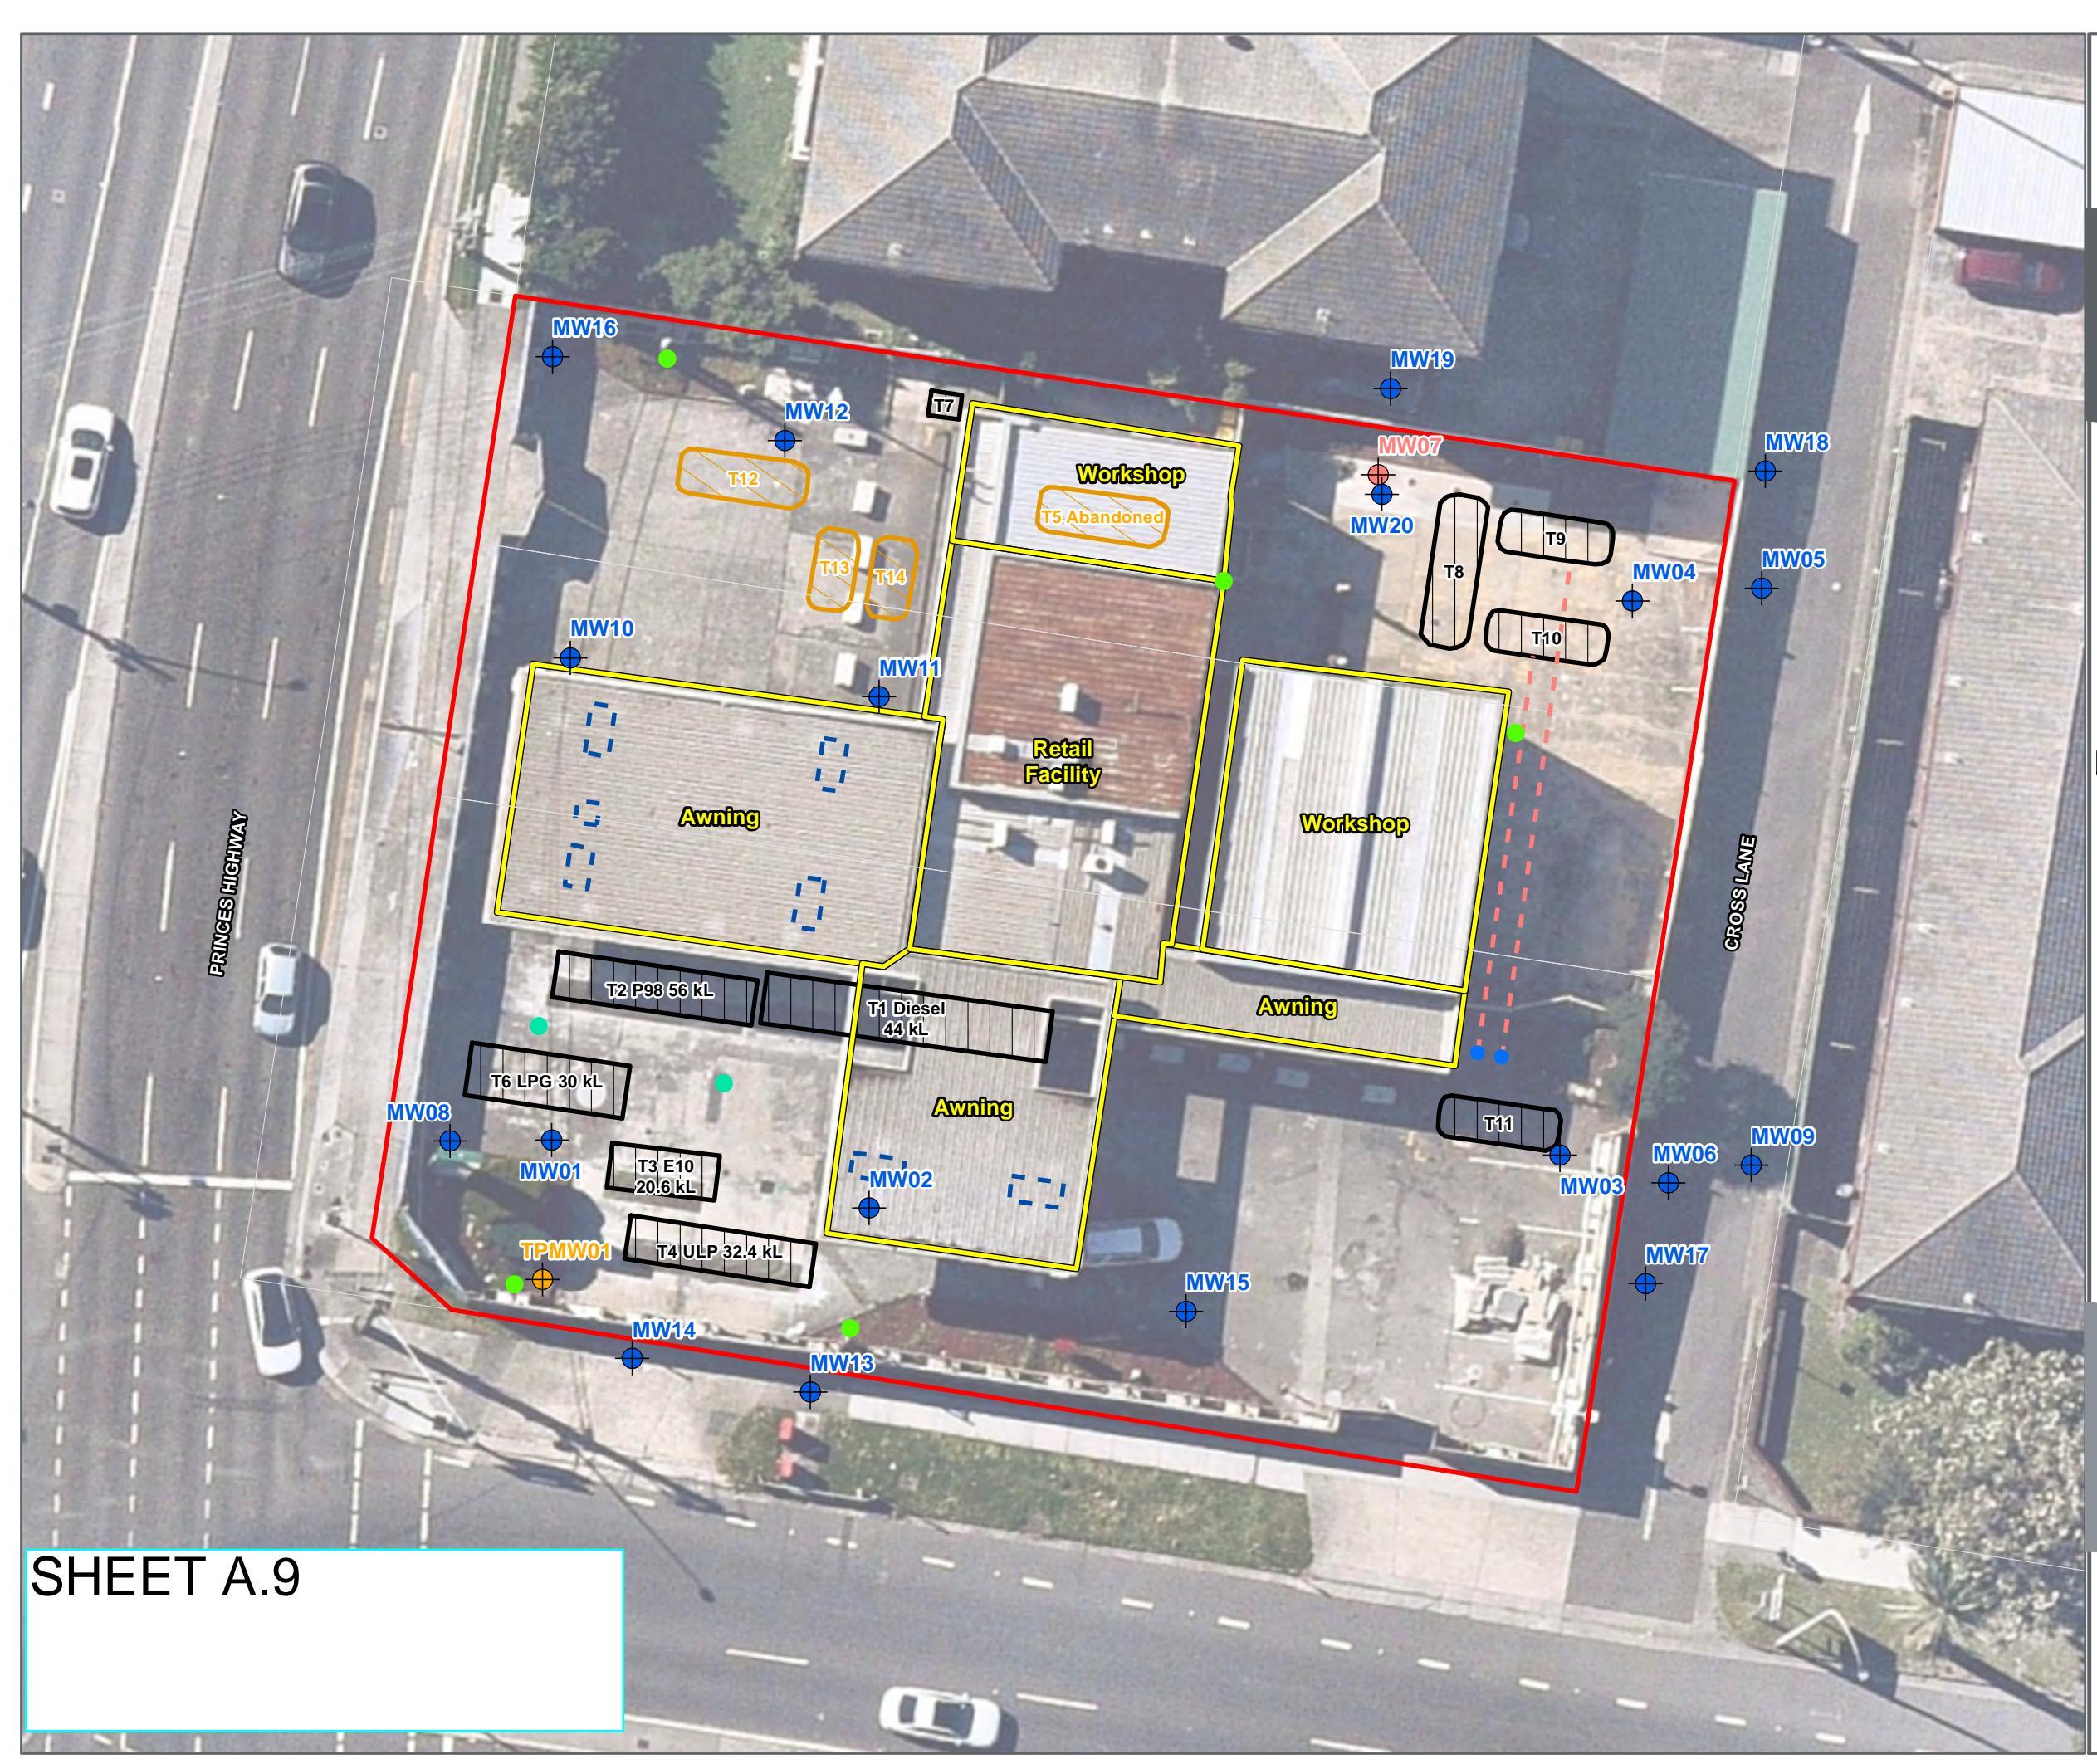
### 7-Eleven - Site Layout and Well Locations

Map Produced by Cardno NSW/ACT Pty Ltd (NW&E) Date: 2020-10-21 | Project: NE30054 Coordinate System: GDA 1994 MGA Zone 56 Map: NE30054-GS-019-711\_GME\_SiteWide.mxd 01 Aerial imagery supplied by Nearmap (September, 2020)

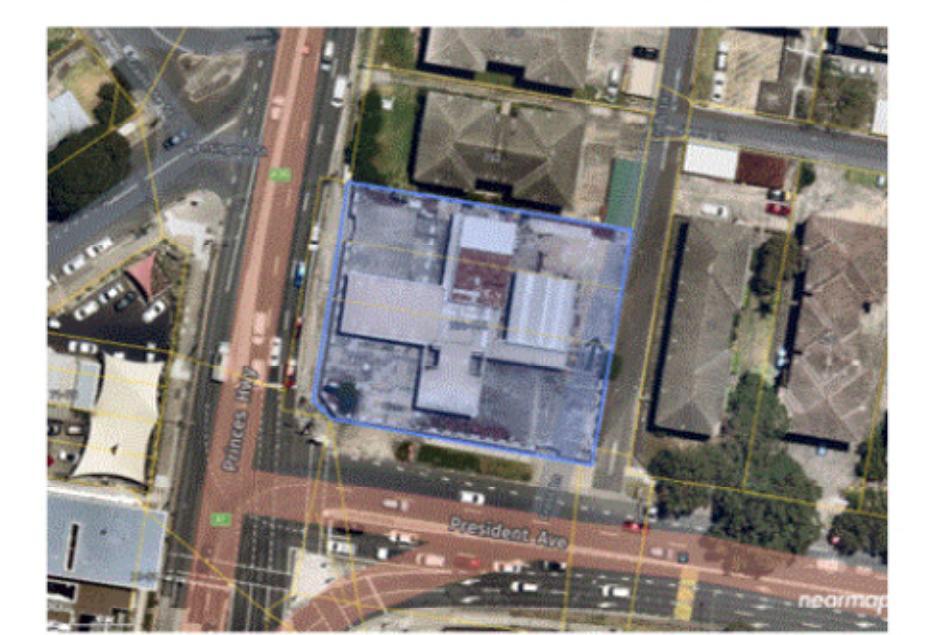
The Land to which this Declaration applies is shown shaded and bounded in blue, and identified as Lot 2 In DP659366, Lot 2 in DP659367 and Lot 1 in DP659365. The original image was sourced from <u>Designan</u>.
