ANALYSIS AND OBJECTION

A Review of Lead Contamination in the Bungendore Rail Corridor and its Impact New BHS Site

This review has been undertaken to examine the extent of lead contamination within the Bungendore Rail Corridor and its impact on the site chosen for the new Bungendore High School (BHS)

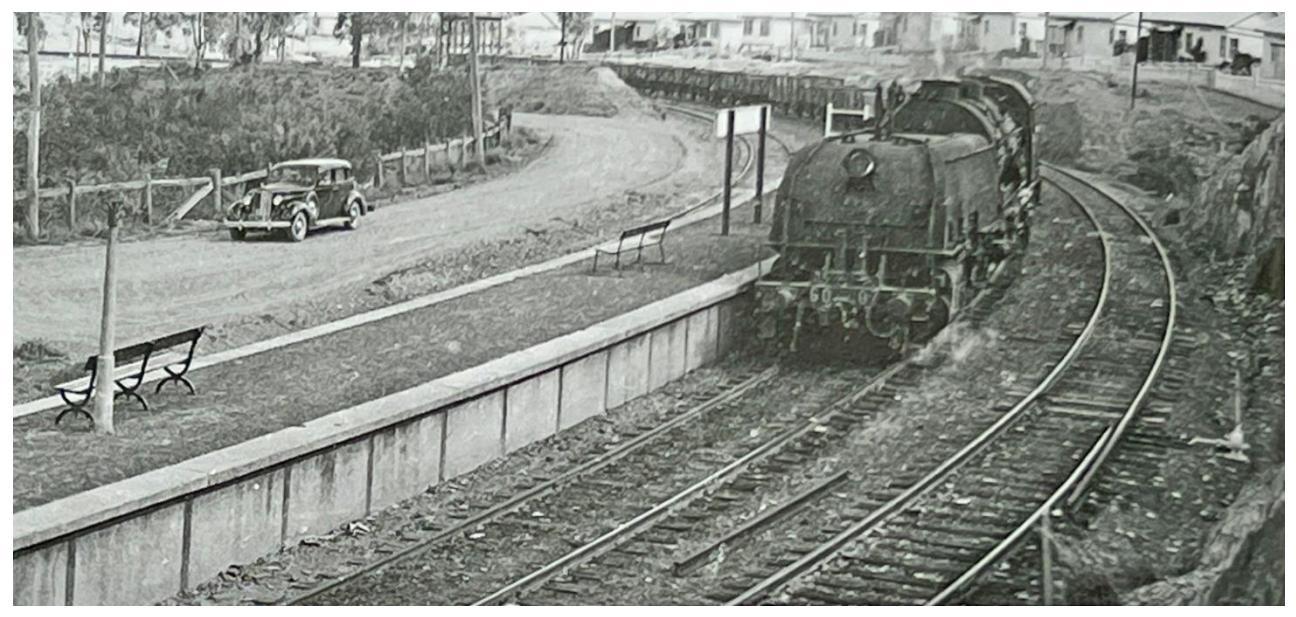
A shipment of lead ore departing Captain's Flat for Bungendore circa mid 1950s

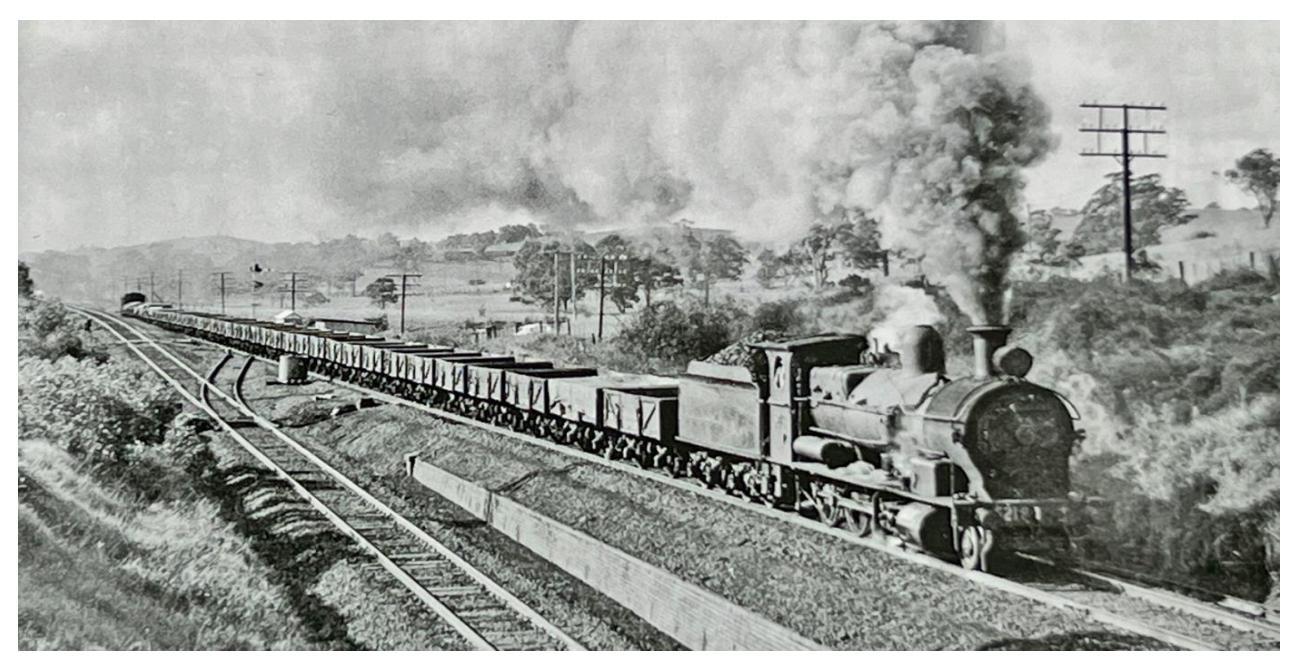
Uncovered wagons of the type that departed Bungendore for Port Kembla carrying lead ore from the Captain's Flat mines.

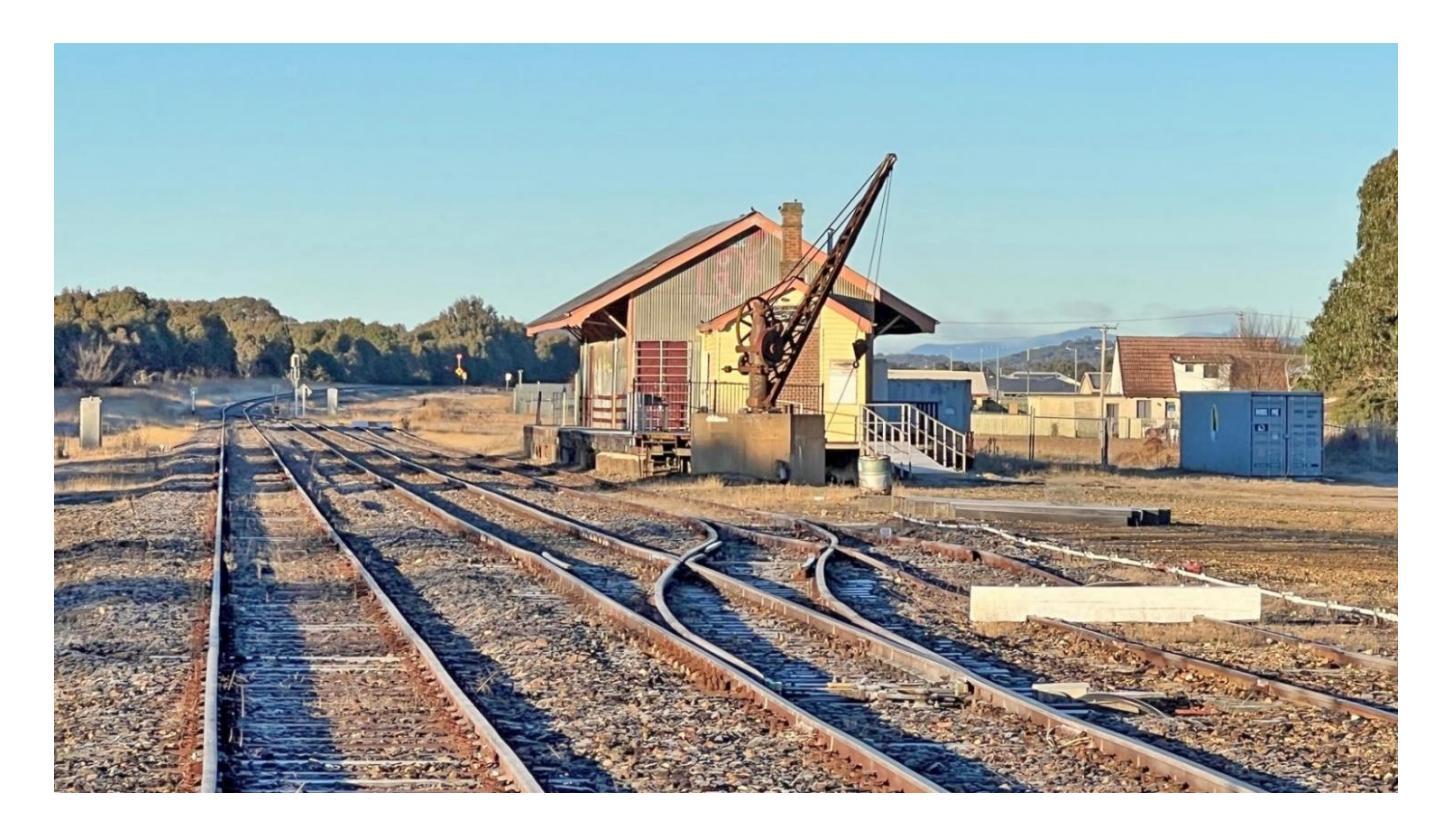
The results of the soil sampling indicated that the reported concentration of lead was generally elevated immediately adjacent to or within rail ballast. The reported lead concentrations generally increased in areas where trains may have been required to slow down or stop (e.g., the Bungendore Station area and sidings where ore is understood to have been transferred between railway wagons).

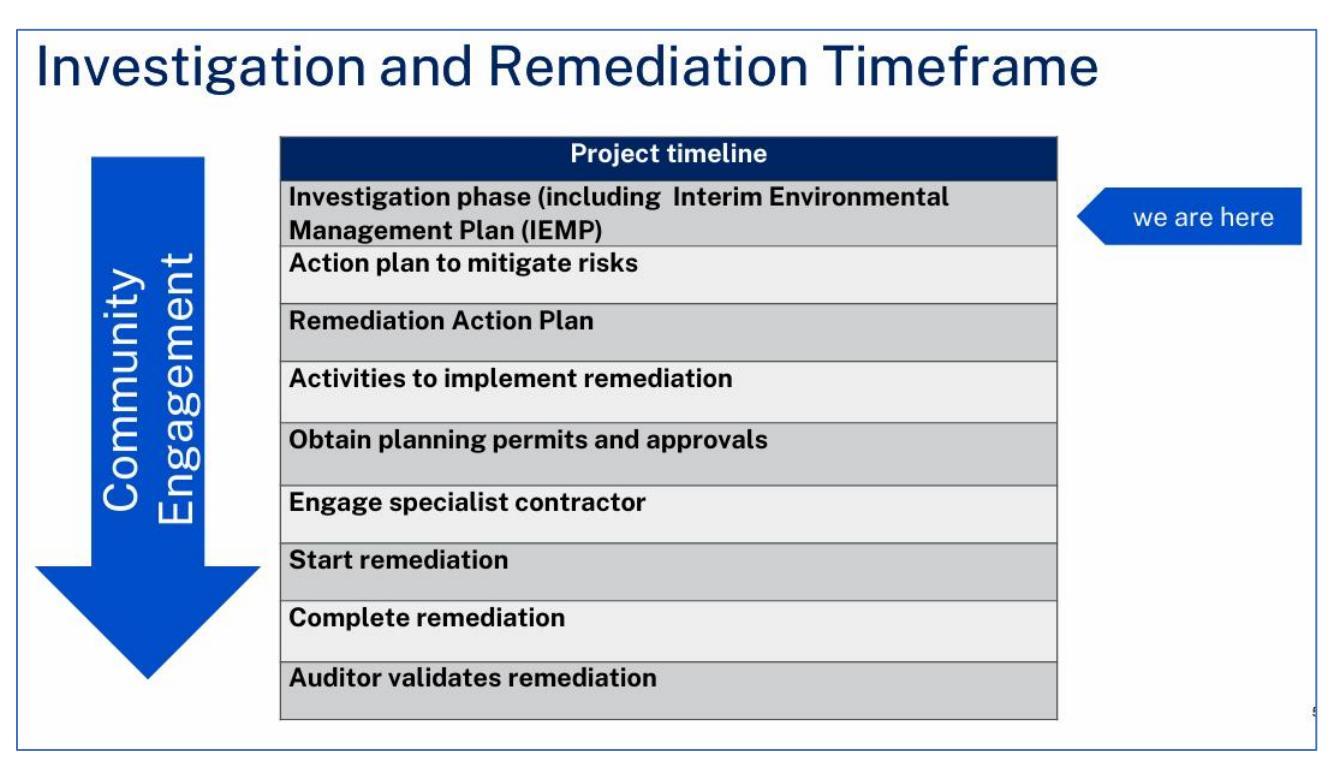
considered to have changed to the point where controls are no longer required. The table above, taken from the Department of Transport website, provides the current proposed timeline for remediating the Bungendore rail corridor.

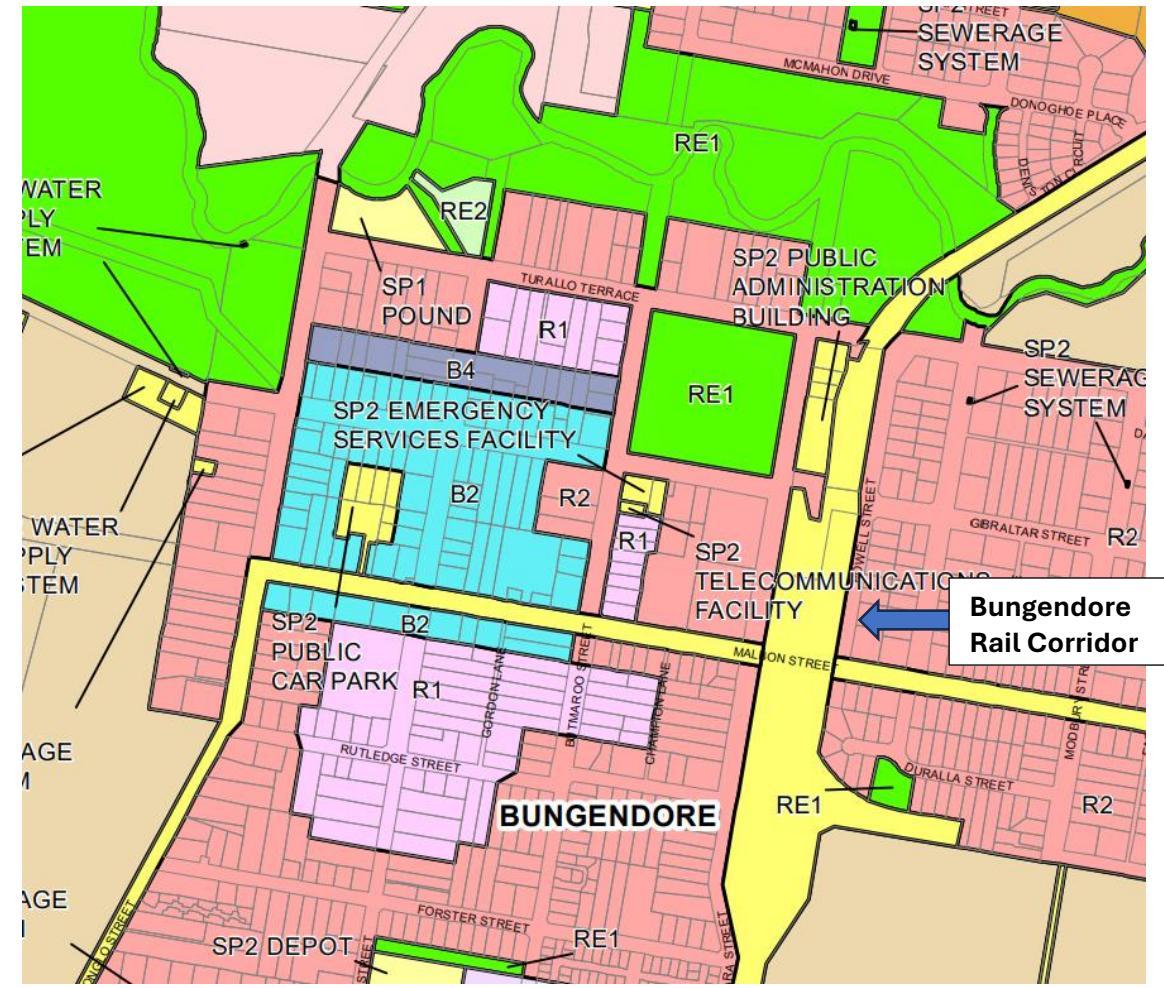
Map 1 – The northern section of the Bungendore rail corridor is shown shaded in yellow. The source of the map below is the Bungendore Structure Plan 2048.

Map 1 at Appendix A to this report shows the Bungendore rail corridor.

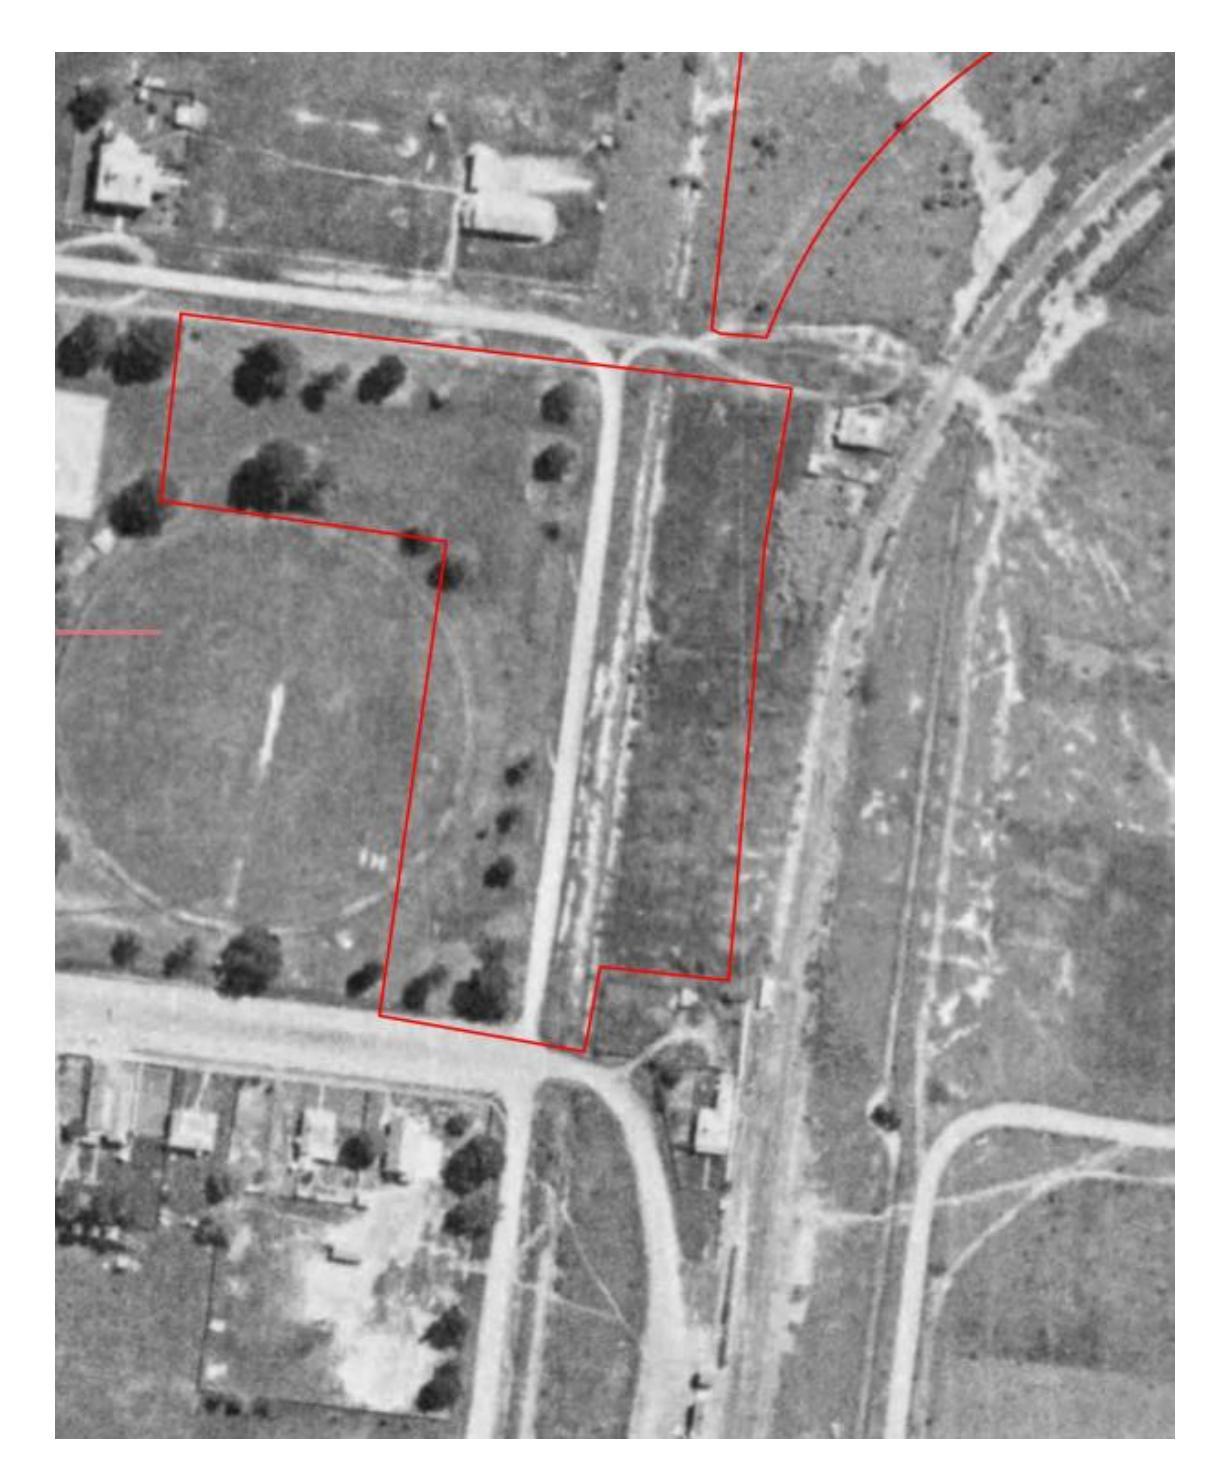
Map 2. The rail corridor between Turallo Terrace and Gibraltar Street circa 1961 – 12 months before the transportation of lead ore through Bungendore ceased. Note that there is no physical or vegetative barrier on the eastern boundary of the site (outlined with a red line) that would inhibit the uniform distribution of lead contamination (e.g. spillage and dust from the open ore wagons) across the entire site. Note that there is no road linking Turallo Terrace and McCusker Drive.

See Maps 2, 3, 4 and 5 at Appendix A to this report

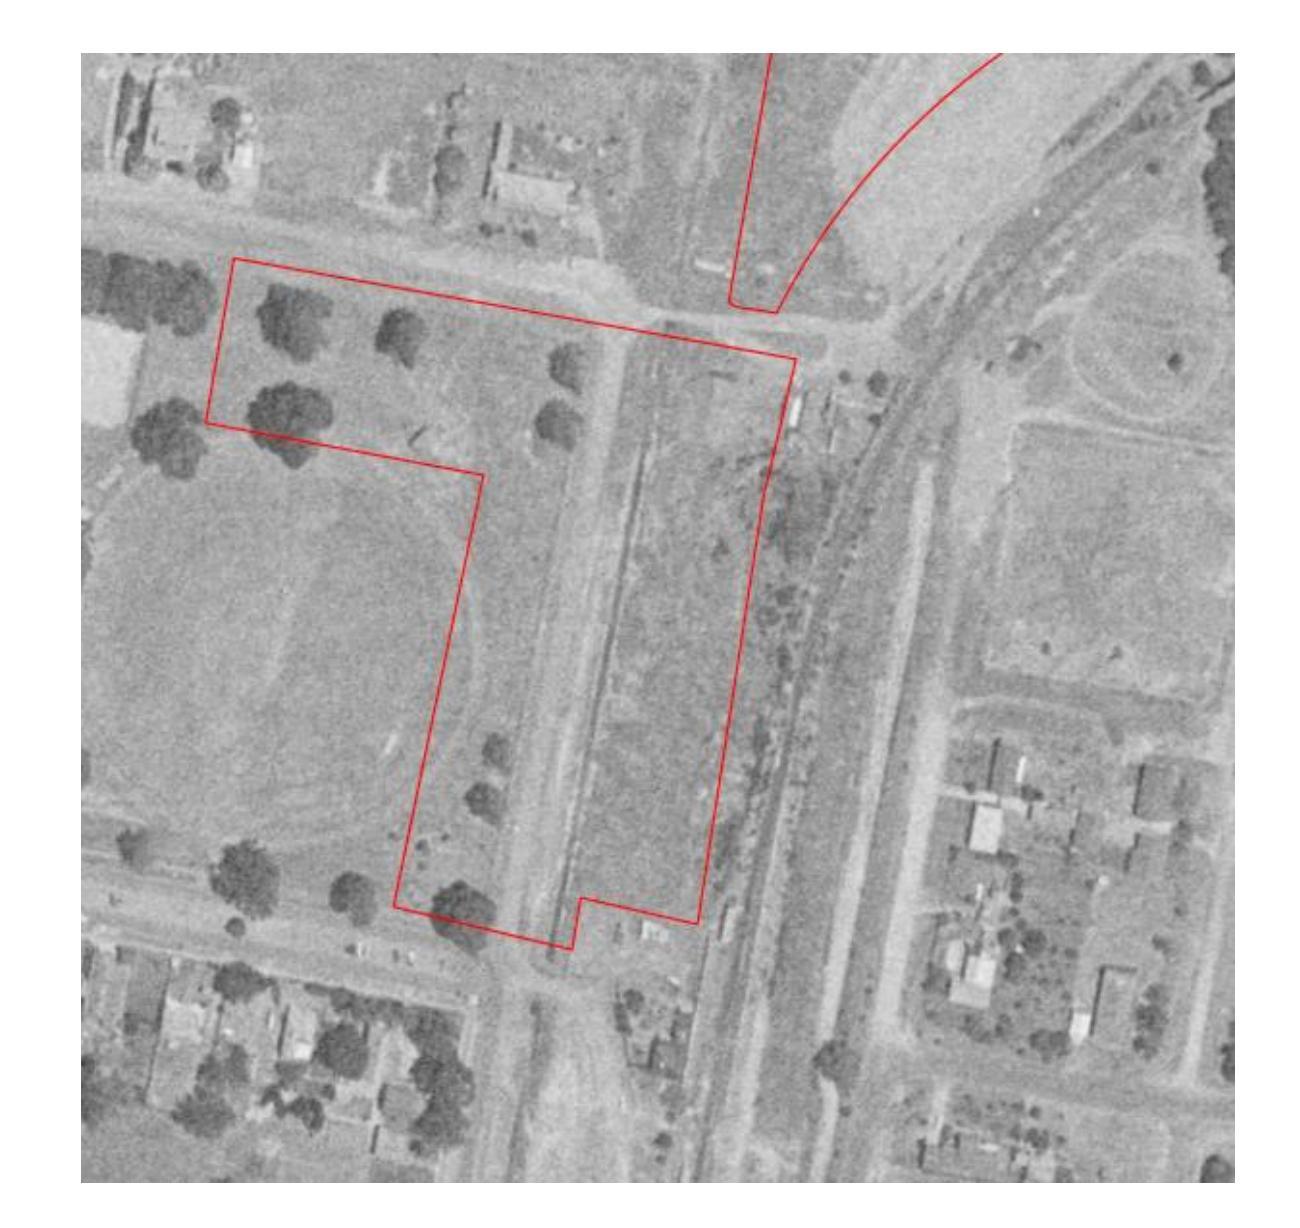
Map 3 shows the site in 1986. It is largely free of vegetation or evidence of topsoil disturbance.

It is unlikely that building waste/fill containing ACM is the source of the asbestos found in the soil. The proposed BHS site was virgin land before any construction began. See Maps/Images 3, 4 and 5 at Appendix A.

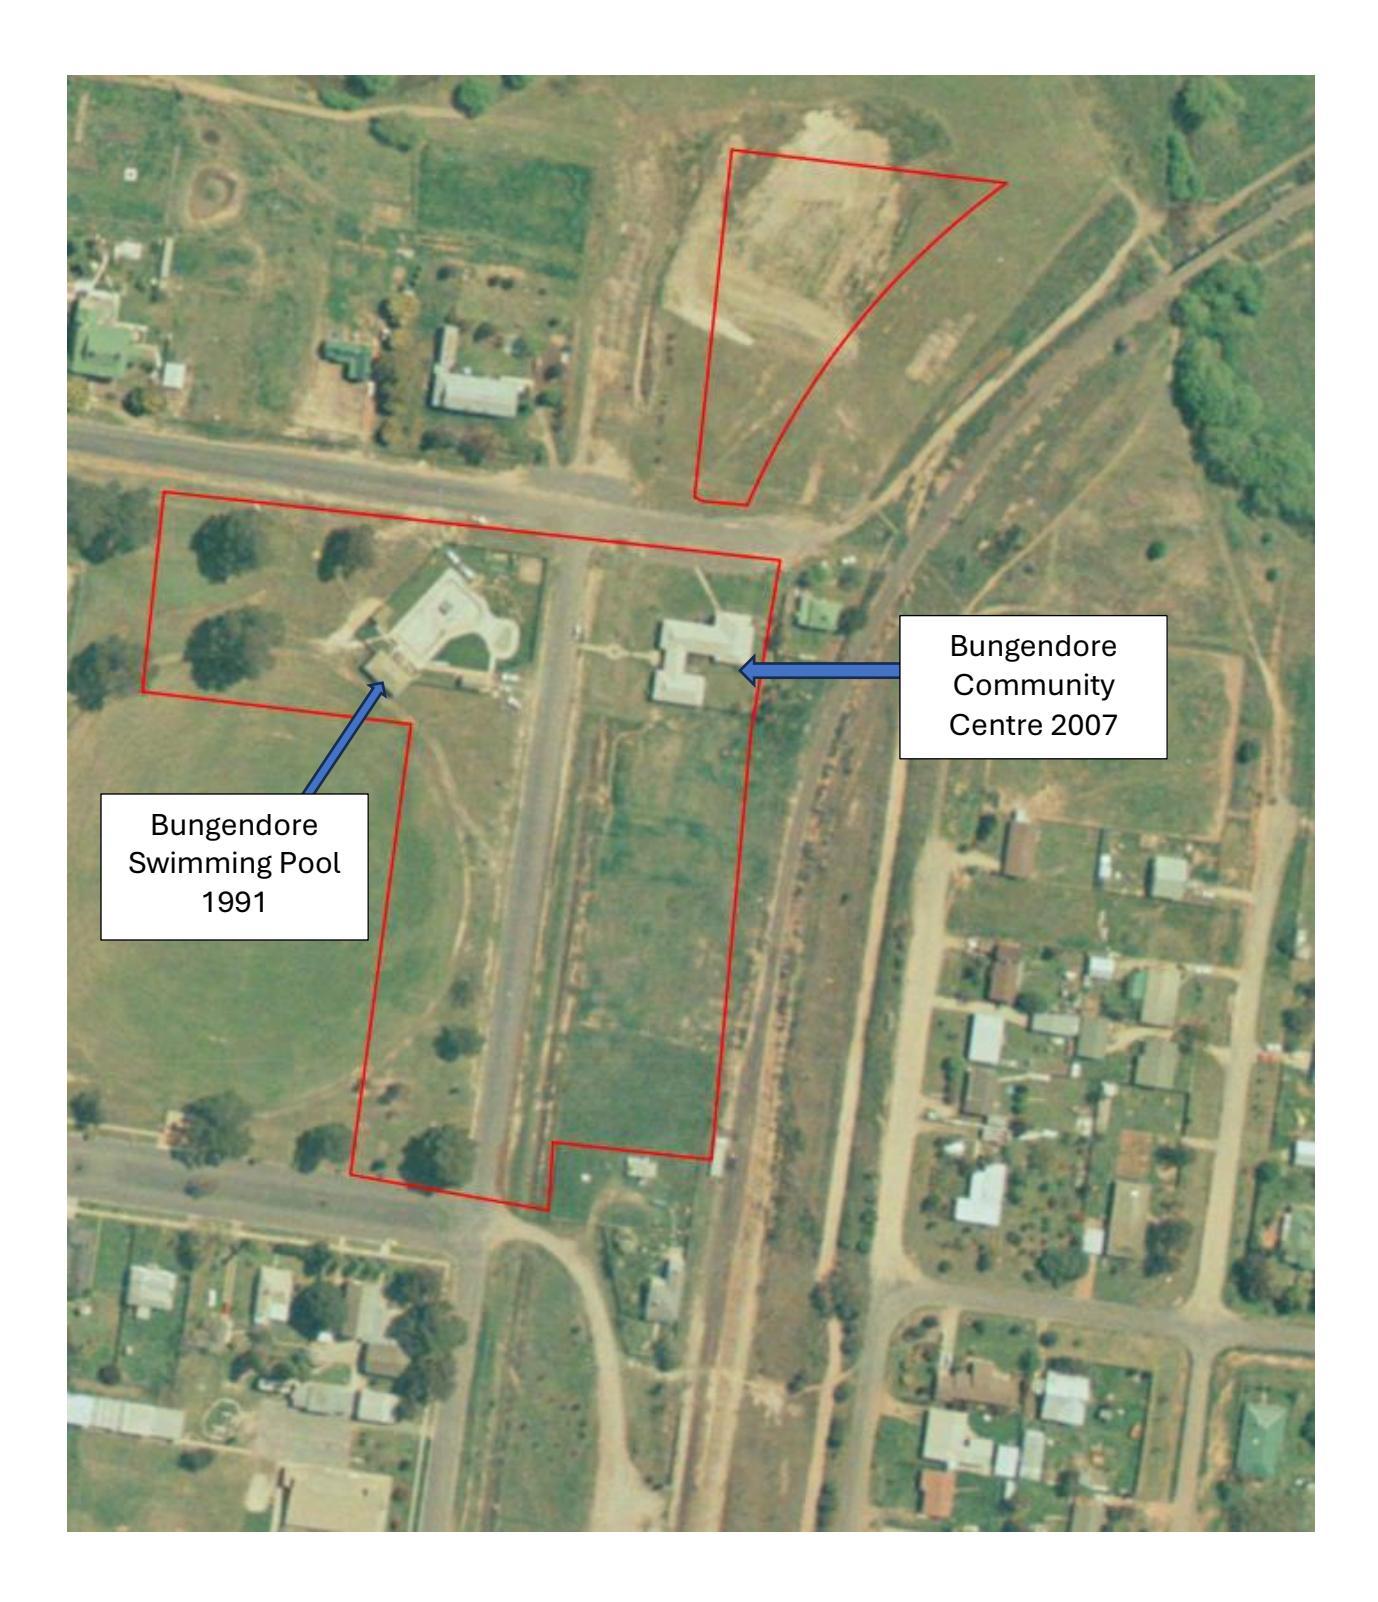
Map 4. The Bungendore Rail Corridor circa 2007. Note the dirt track leading from Turallo Terrace to Turallo Creek. Note also the swimming pool which was officially opened on 30 November 1991 and later (2007) the newly constructed Bungendore Community Centre.

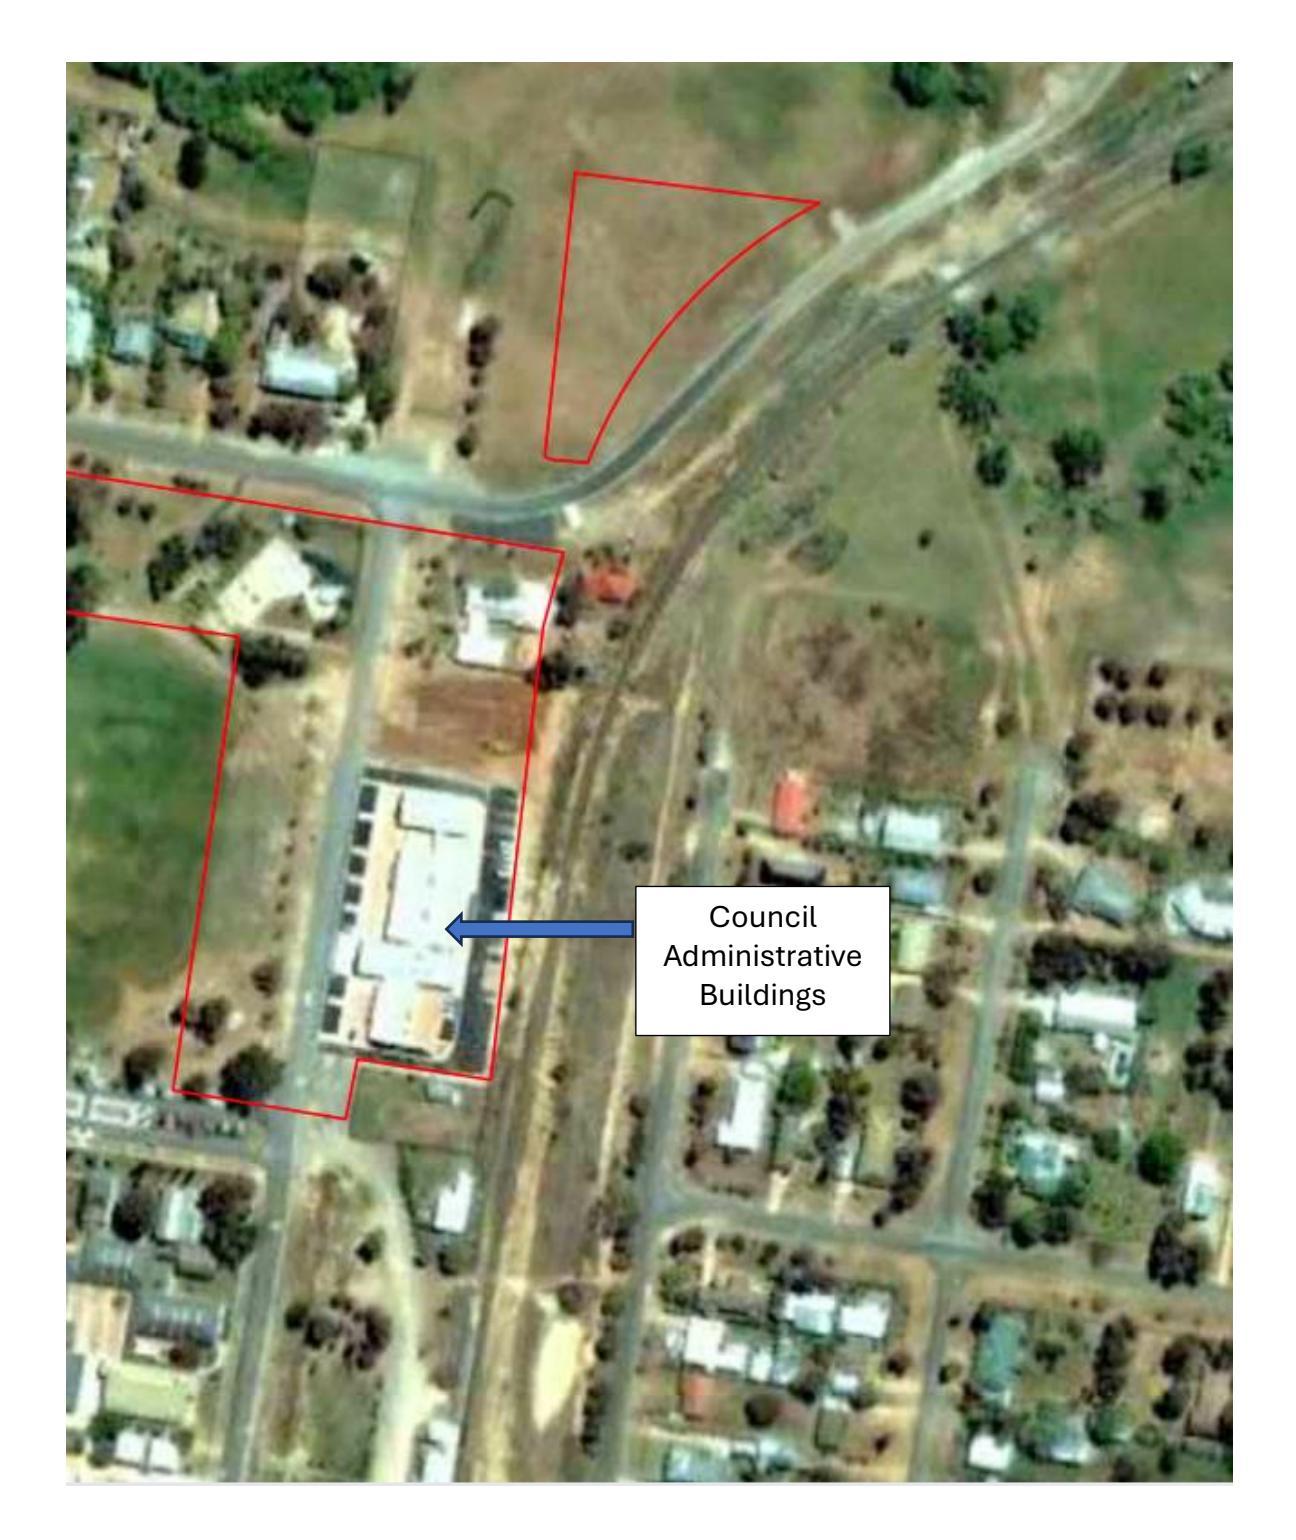
Map 5. Rail Corridor circa 2014. Note construction of Council Buildings and more substantial unnamed road linking Turallo Terrace and McCusker Drive.

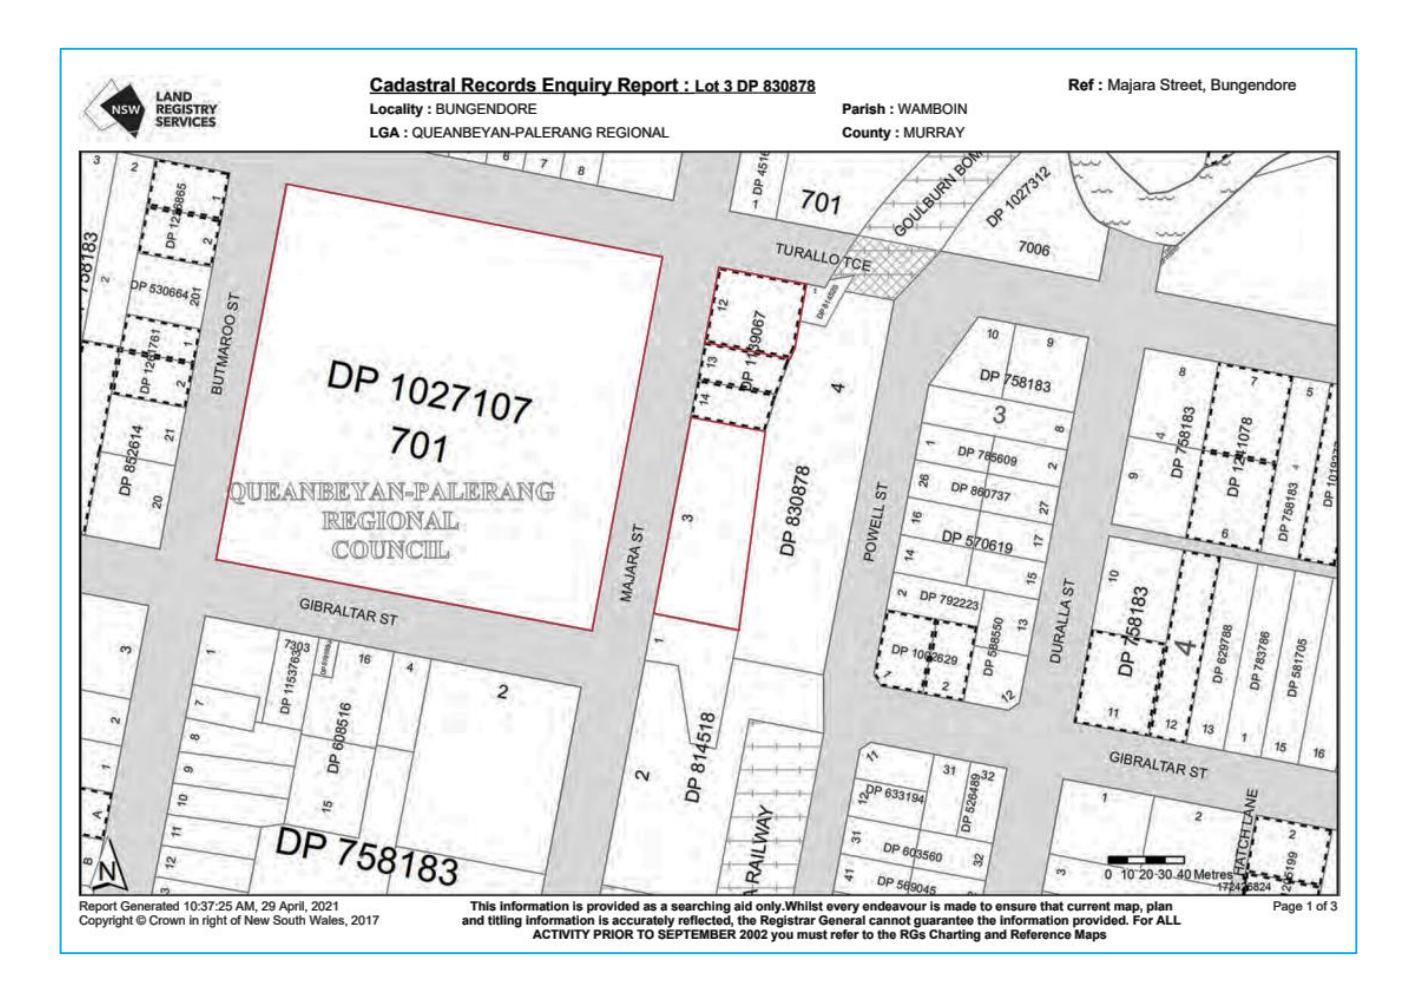
Map 6 shows the extent of lead contamination in the north sector of the Bungendore rail corridor. Note the location of DP 830878 Lot 4 which extends from the eastern boundary of the proposed high school site to Powell St on the east side of the rail line and from Turallo Terrace south to Gibraltar Street.

See Maps 6 and 7 at Appendix A

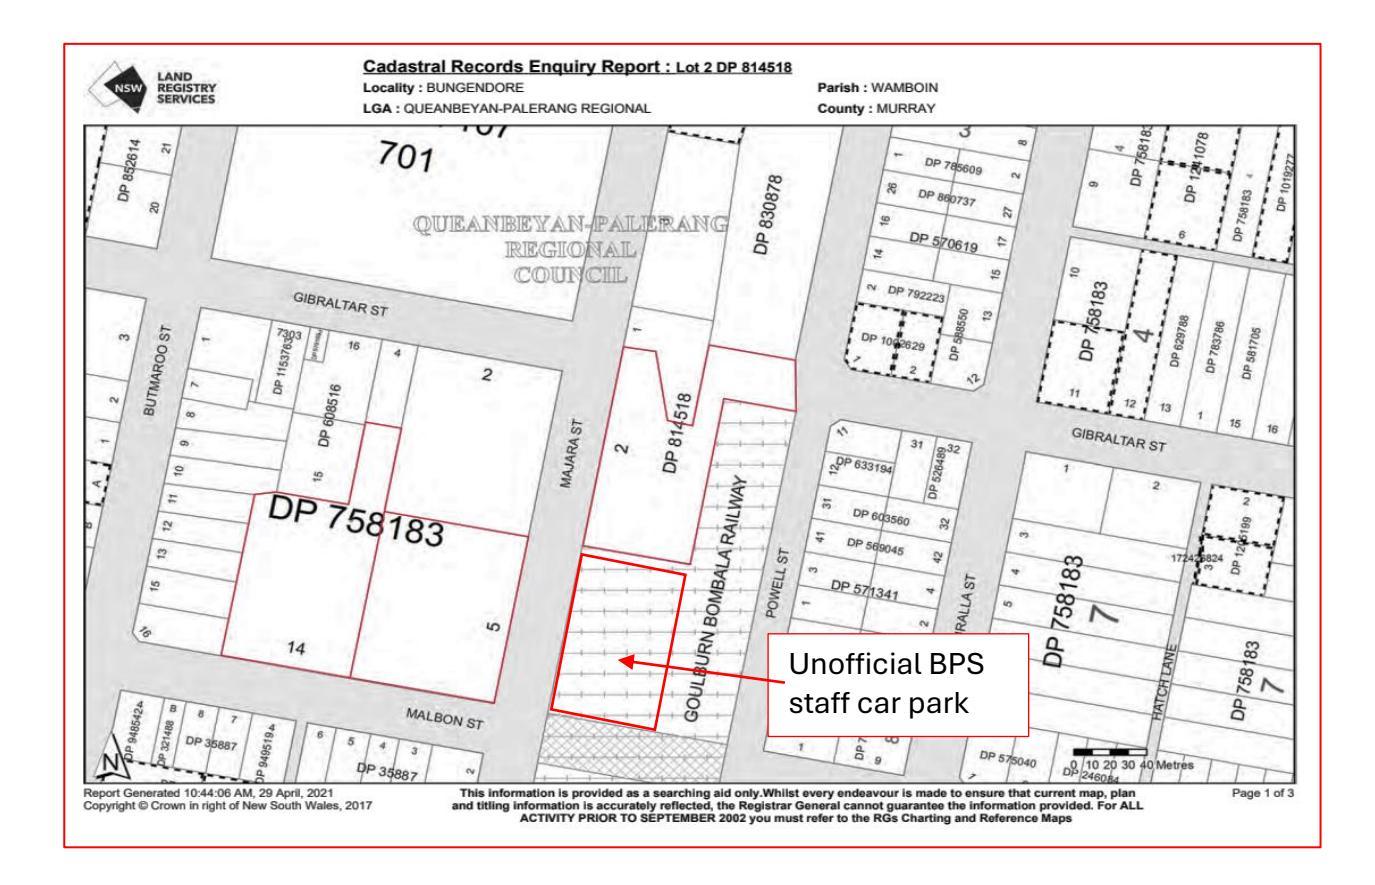
Map 7 shows the location of DP 814518 Lot 2, which extends across the southern boundary of the proposed high school site and the fenced-off unofficial BPS car park.

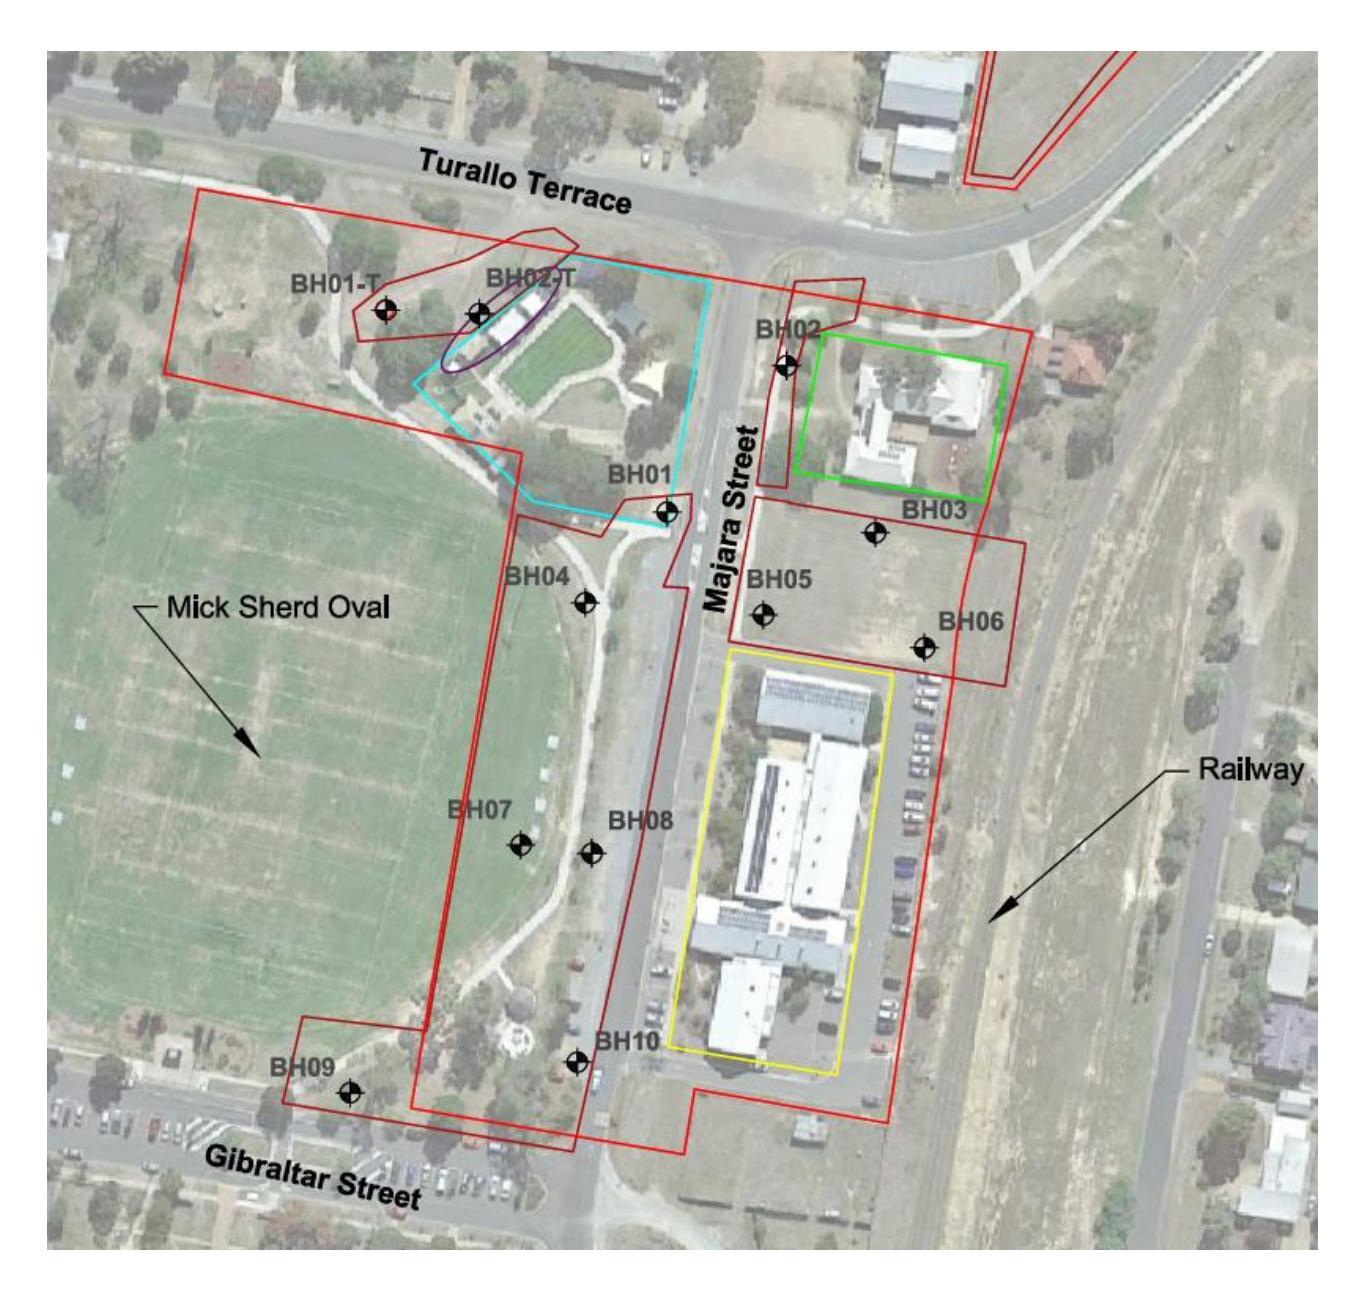
Map 10 shows the location of the ten boreholes drilled during the PSI. Their purpose was to provide geotechnical data for construction purposes, not lead contamination.

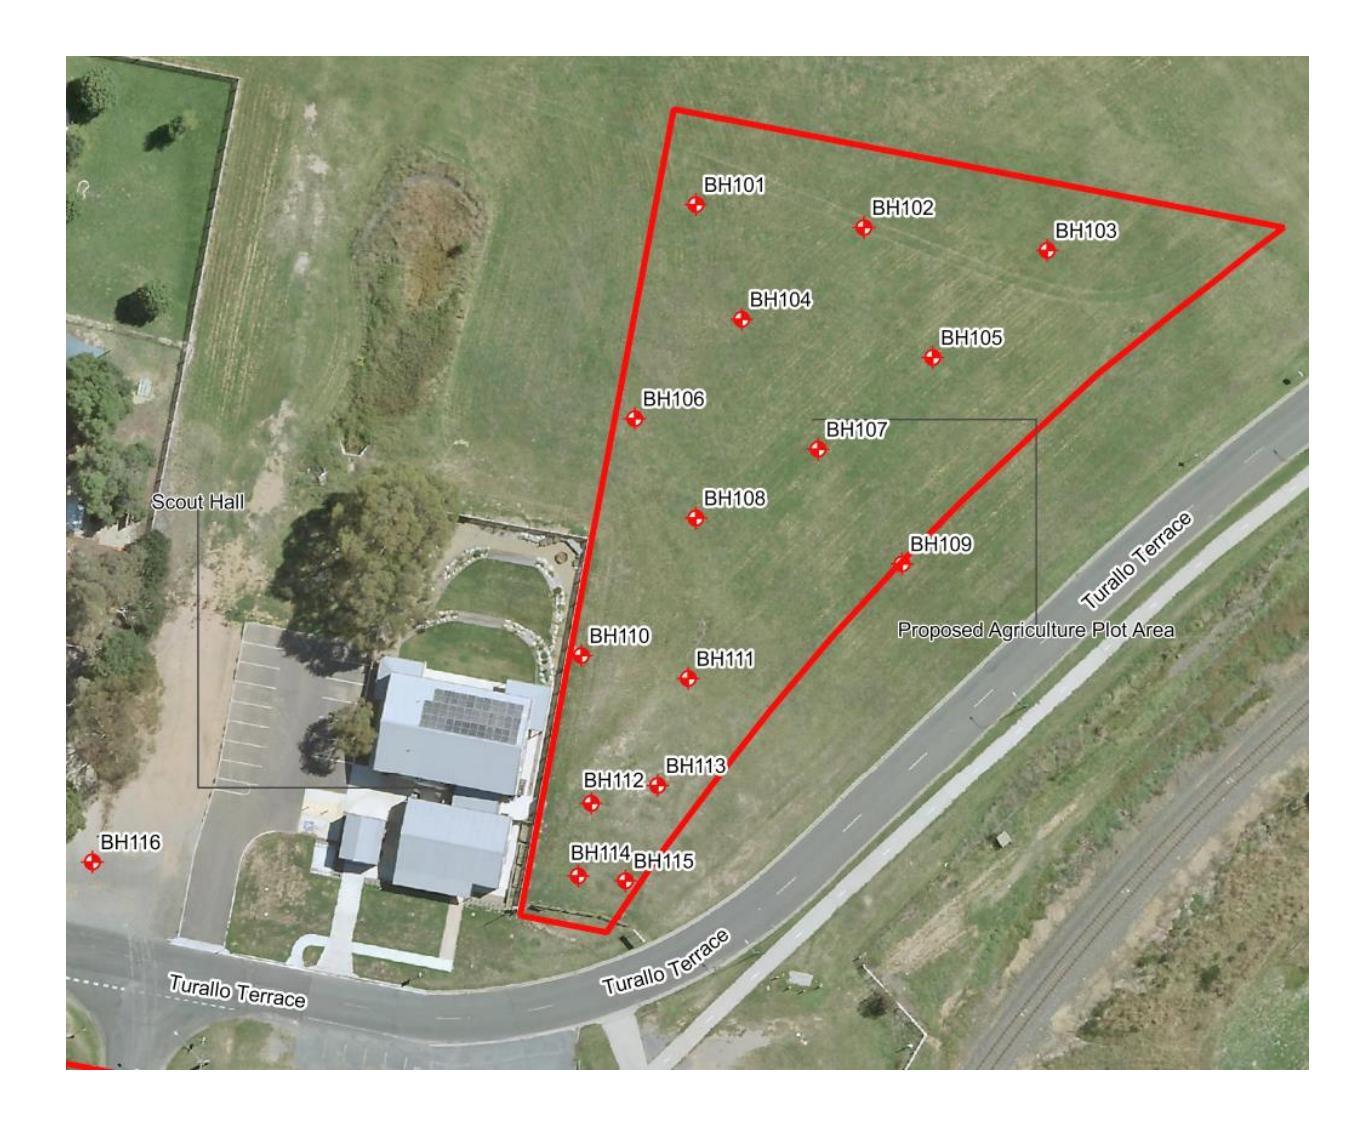
Map 11 shows the location of the planned boreholes that were never drilled because of site access issues in particular BH 101 – 115.

The DSI commissioned by DP, did not carry out drilling at any of the 52 borehole sites shown at Maps 11 and 12. The DSI states quite clearly that: 'It should be noted that Bores 101 – 152 could not be drilled in the building footprints of the Bungendore Community Centre and QPRC building or within the Bungendore Swimming Pool area due to access constraints'. The access constraints are most likely to be the refusal by DoE to allow DP access to drill the boreholes on their compulsorily acquired BHS site.

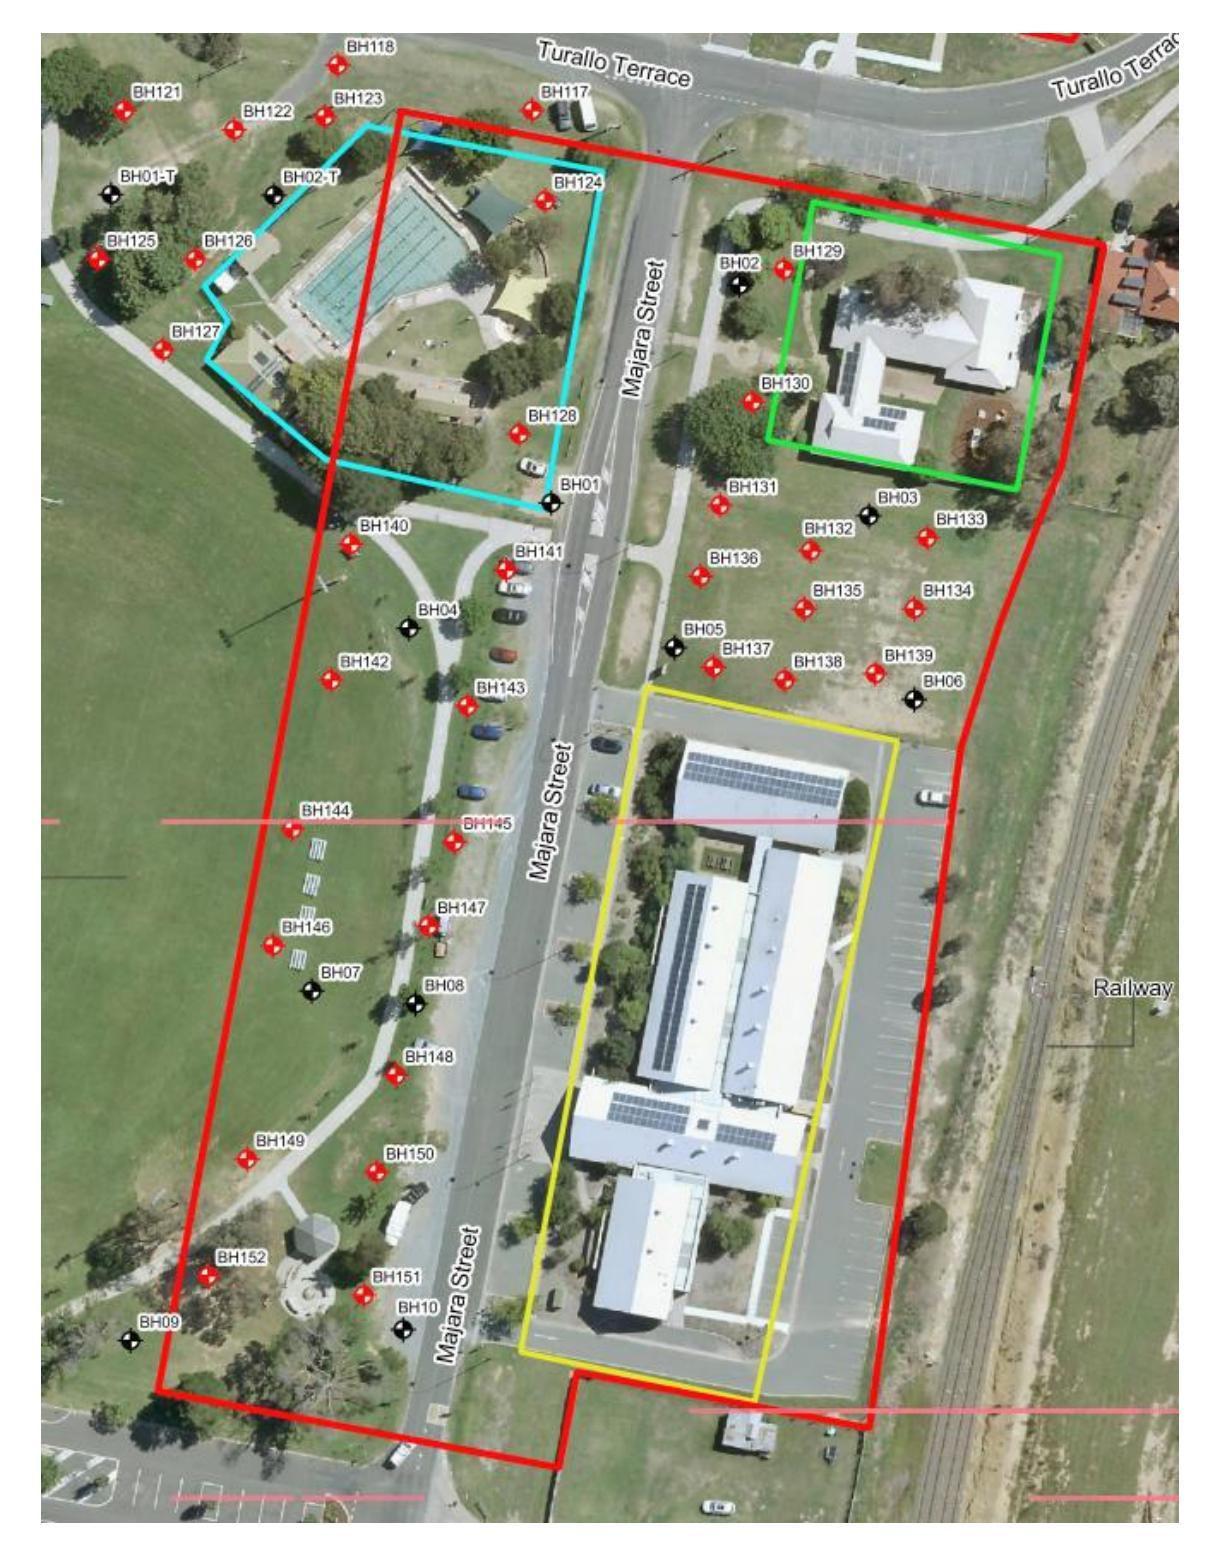
Map 12 shows the location of the planned boreholes that were never drilled because of 'site access issues' in particular BH 129 – 139 within the proposed new BHS site.
