ANALYSIS AND OBJECTION

A Review of Lead Contamination in the Bungendore Rail Corridor and its Impact New BHS Site

This review has been undertaken to examine the extent of lead contamination within the Bungendore Rail Corridor and its impact on the site chosen for the new Bungendore High School (BHS)

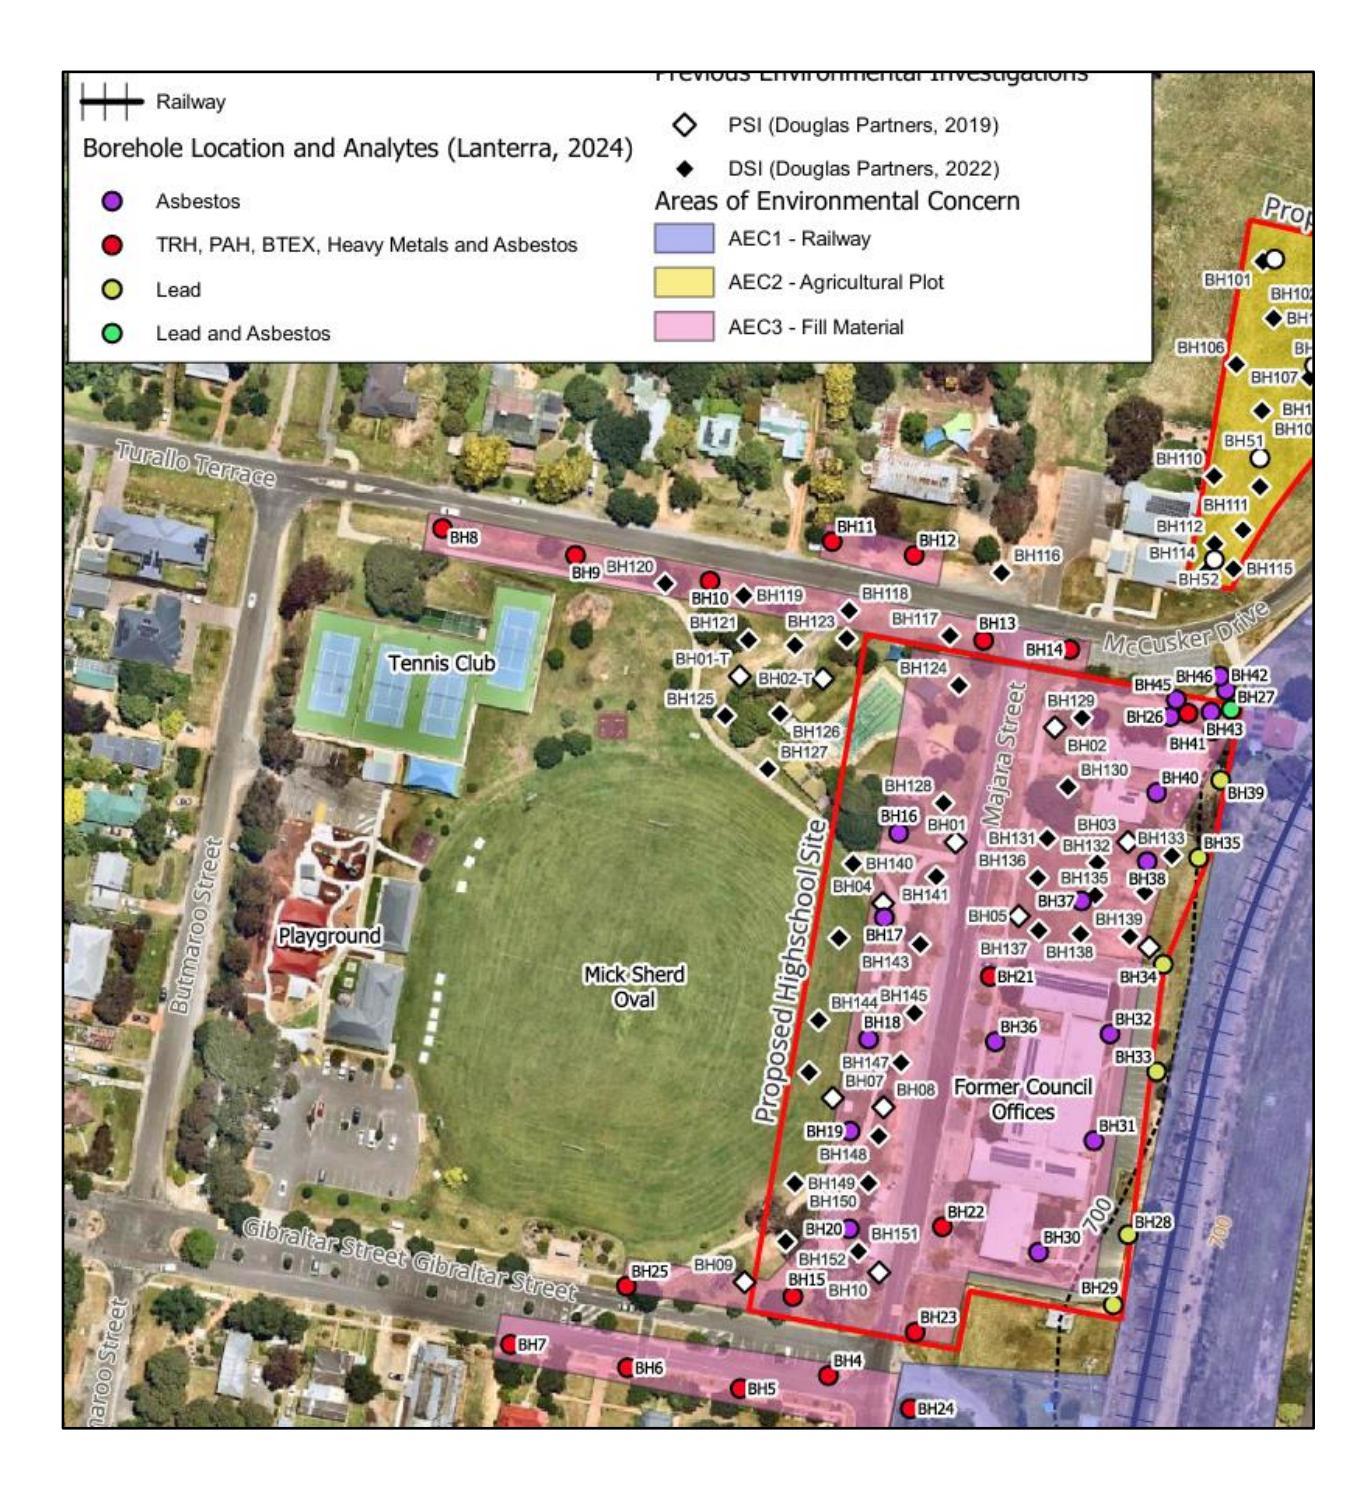
Map/Image 18

Borehole Locations and Analytes – Lanterra 2024
