# MODIFICATION OF SPRING FARM QUARRY CONSENT (DA 75/256)

# LANDSCAPE RESTORATION AND BUSH REGENERATION REPORT

## SPRING FARM QUARRY

27 February 2018

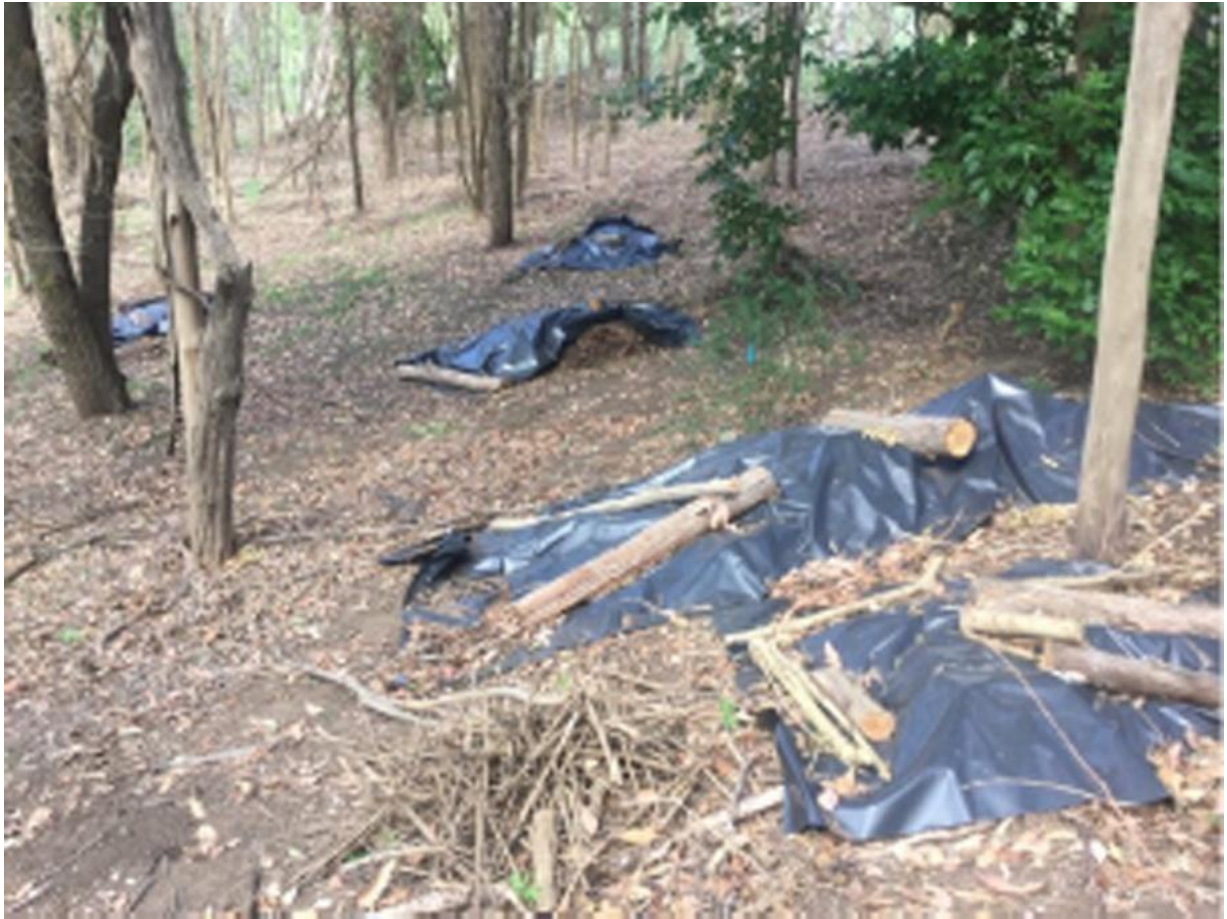
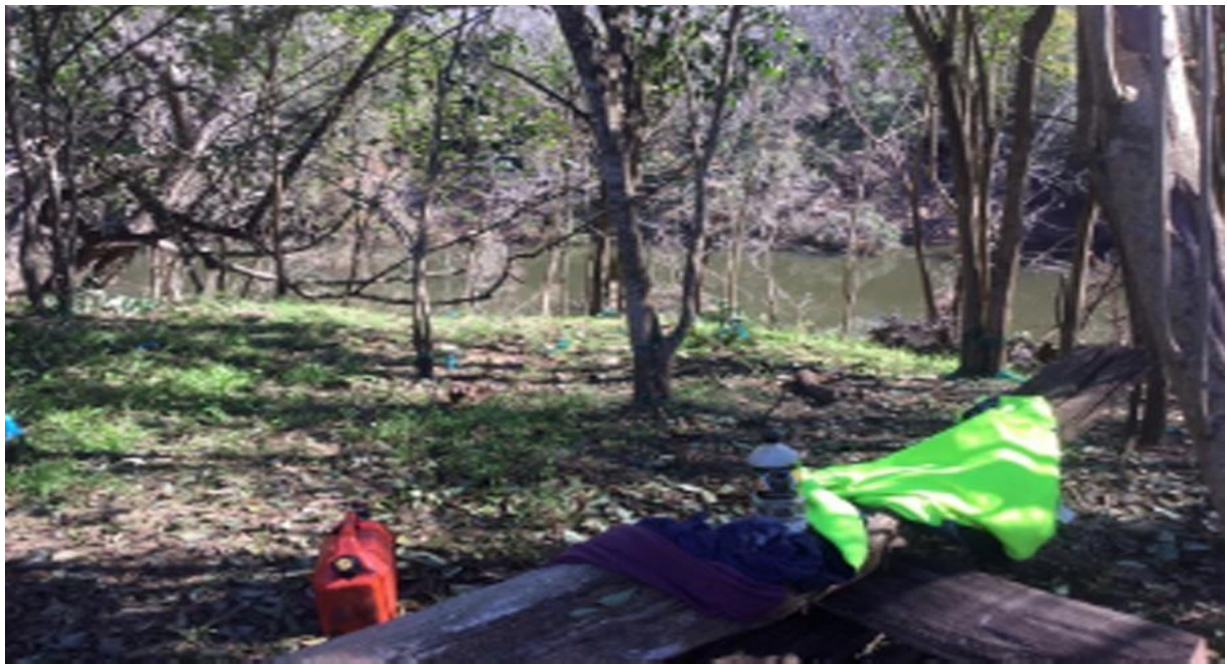
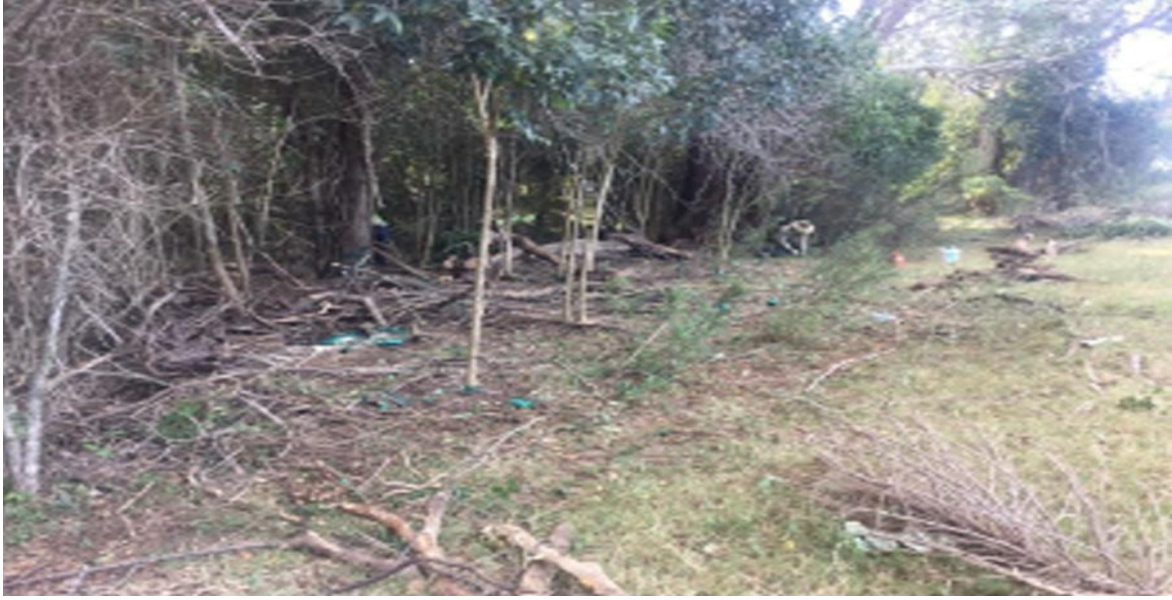
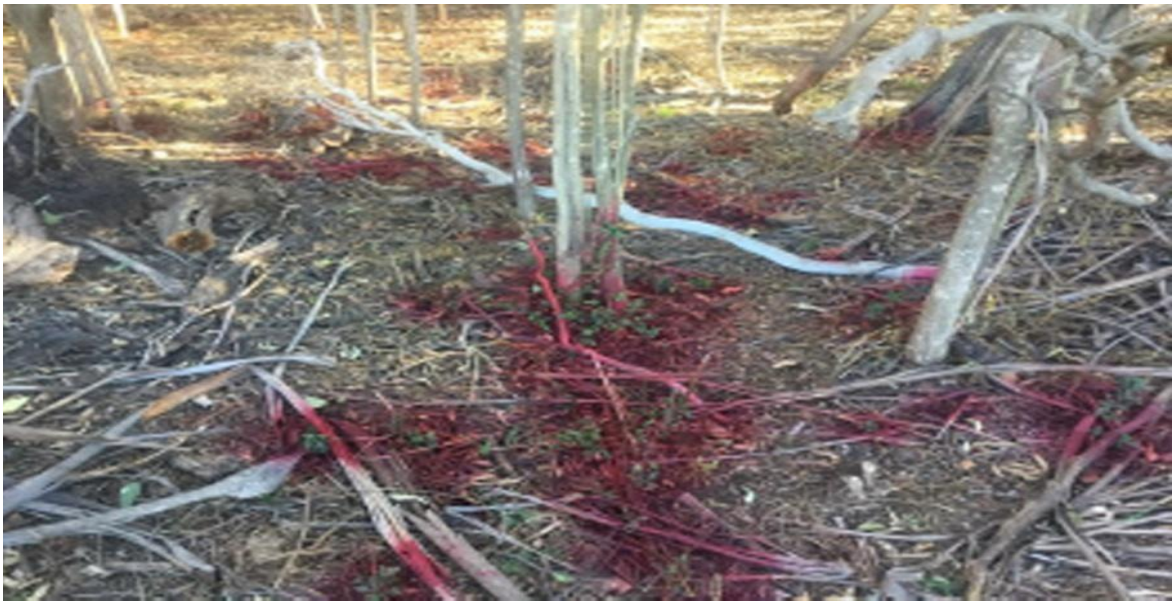
Throughout the last twelve months a concentrated effort has been made within the riparian areas adjoining the Nepean river to remove weeds and non-native vegetation from this landscape unit, This has involved cutting and poisoning non-native weeds ,grasses and shrubs and clearing away the vegetative waste . There are before and after photographs of the works that have been undertaken within this area of the site

This work has been carried out within an area of one hectare of riverside land that was extremely degraded vegetation however the native trees and grasses that are present in the area now provide a structured layer that can be complemented by planting native species that over time will be able to dominate this landscape feature adjacent to the river.

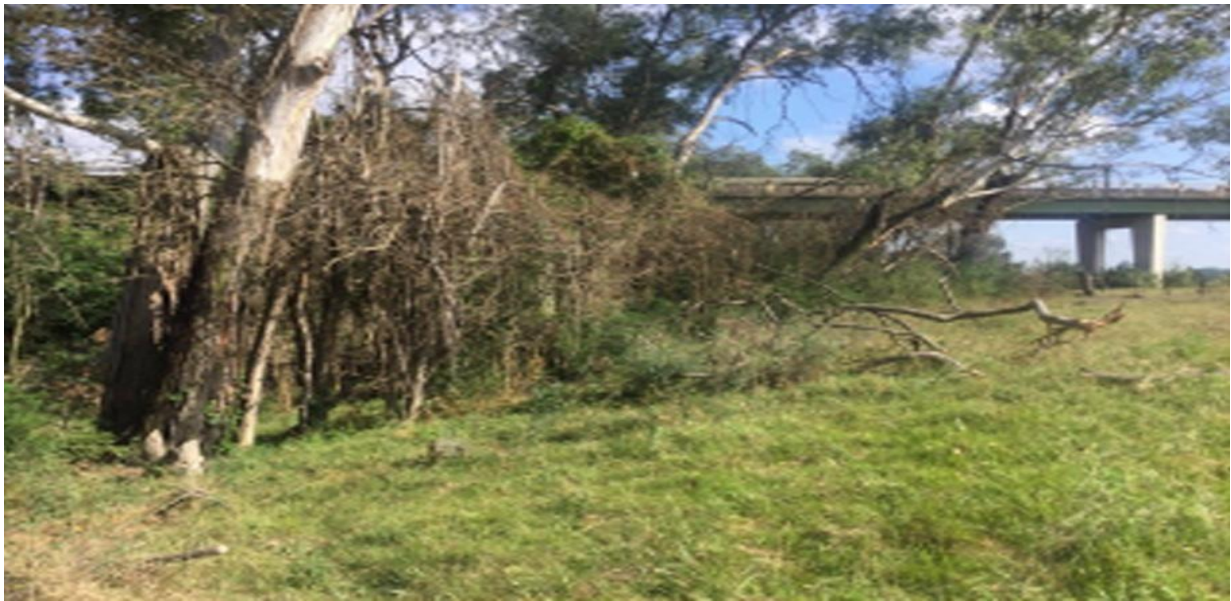
The flat grassy areas parallel to the river outside the existing vegetation area on the river bank (non-batter) are being subjected to weed management to eradicate undesirable weeds and shrubs prior to planting directly into the natural topsoil horizon.

The battered areas within Zone 1 adjacent to the Nepean River have been deep ripped and retopped with topsoil from the soil being extracted within the extraction area. The topsoil depth is a minimum of 500mm

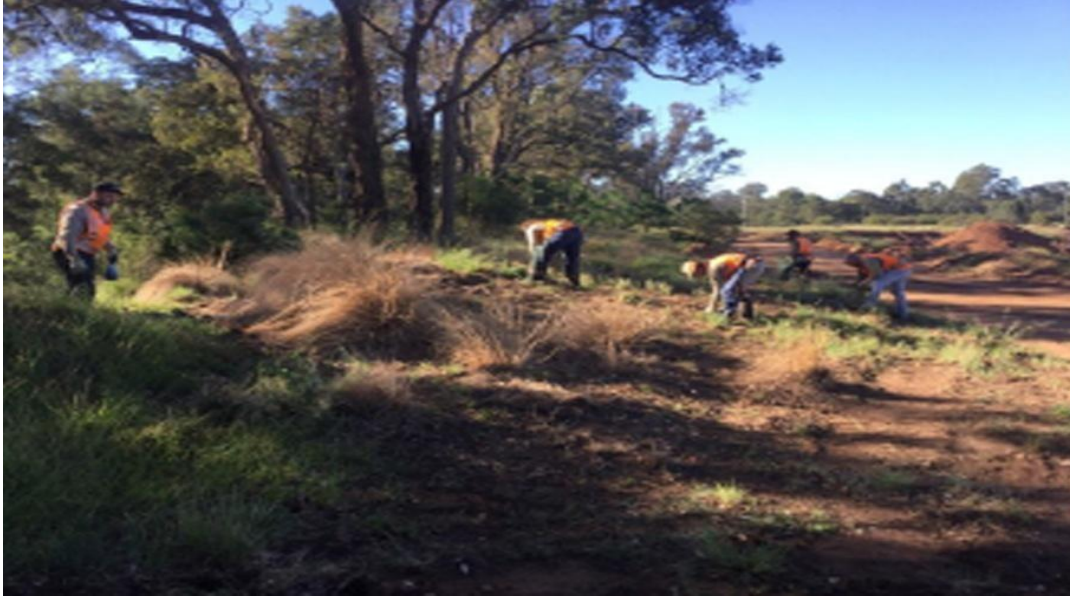
Throughout 2017 there has been a comprehensive bush regeneration work undertaken following the weeding that had been carried out in the two previous years when large woody weeds and a variety of other environmental and noxious weeds were removed along the eastern and western sides of the dry anabranh

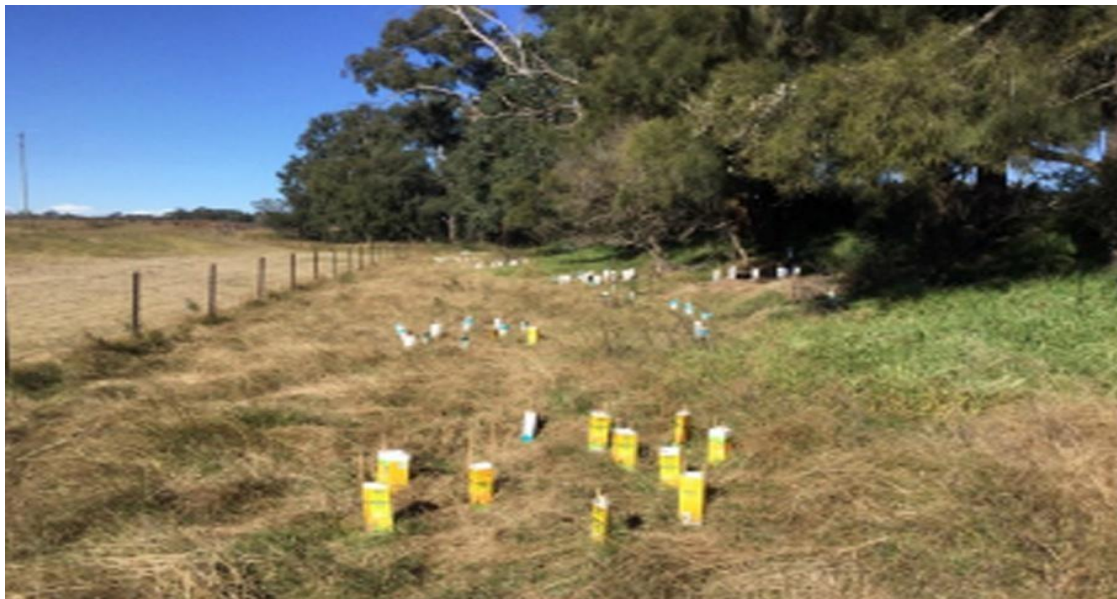
Following the completion of the weeding additional native plant stock has been planted along the dry anabranch to strengthen the diversity of species present in this important ecological zone,

The establishment of plantings has necessitated watering being carried out due to the exceptionally dry season and below average rainfall in 2017. This task has necessitated an on site water tank to ensure adequate water is on hand as required

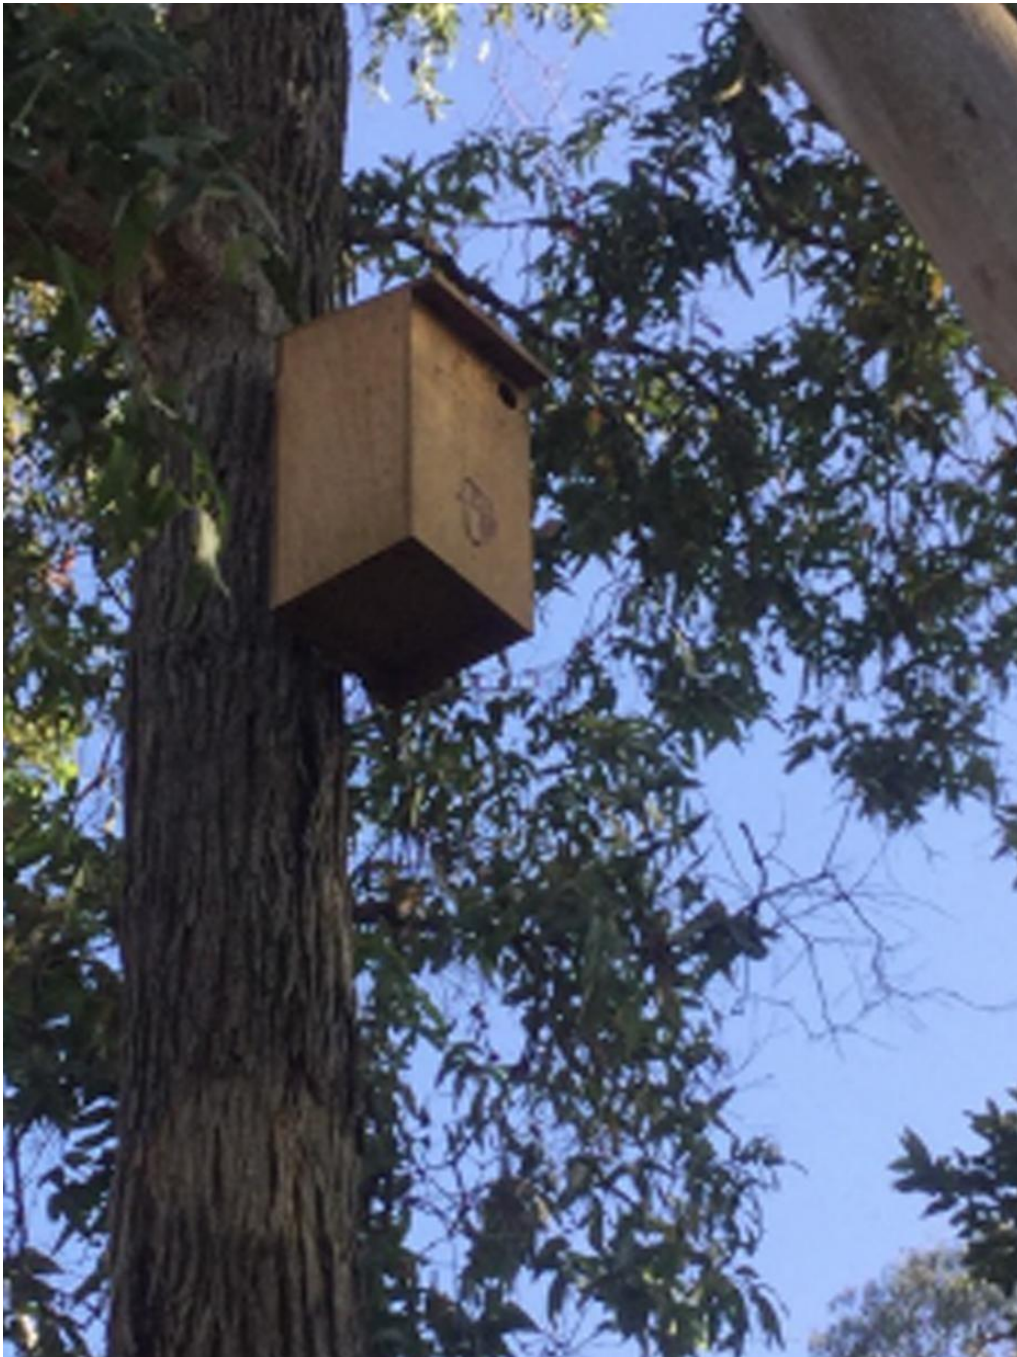
The installation of nesting boxes for fauna habitat is one method being utilised on site as compensation for lack of habitat that is available within the revegetation areas. The intention is that the boxes will artificially increase the amount of locally available hollows for arboreal marsupials thereby increasing the value of the revegetation as a habitat as a resource

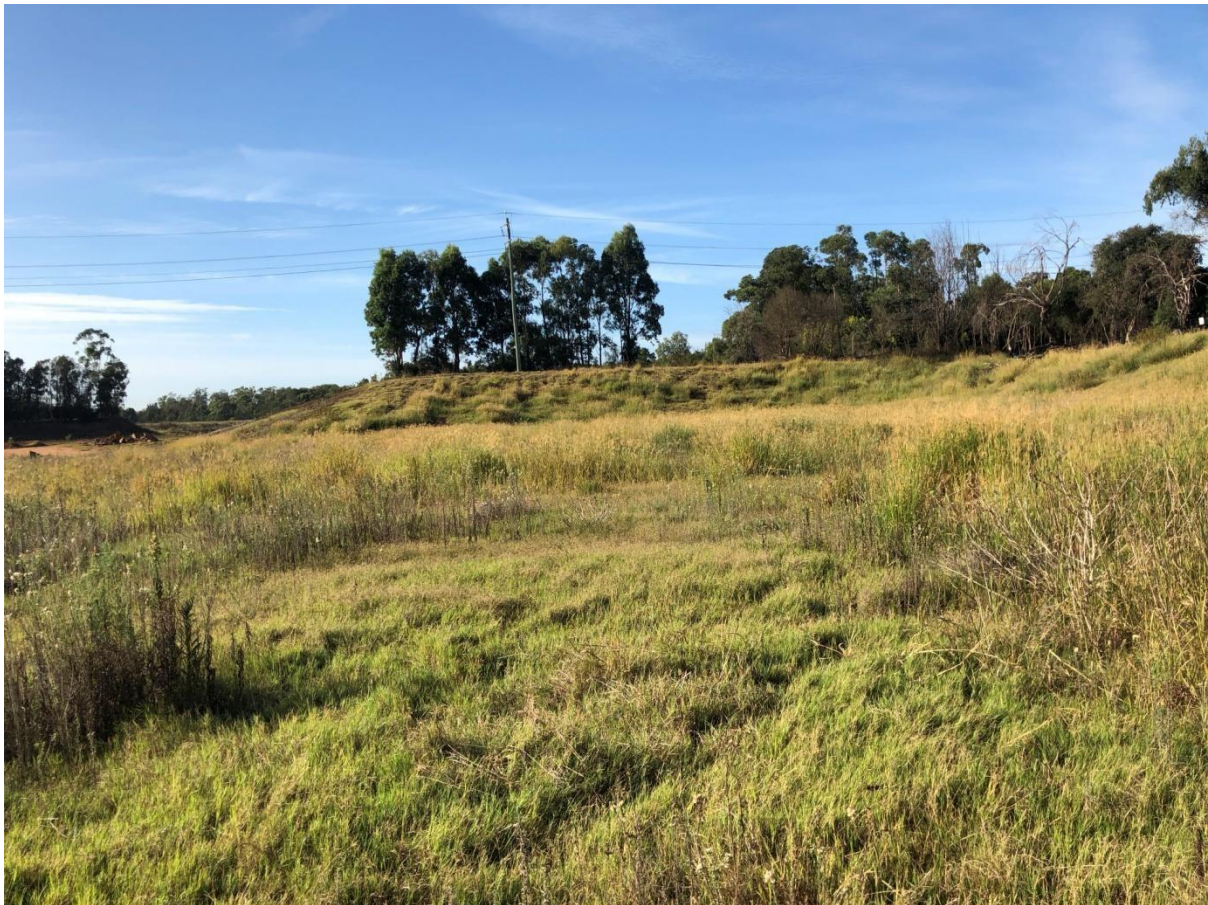
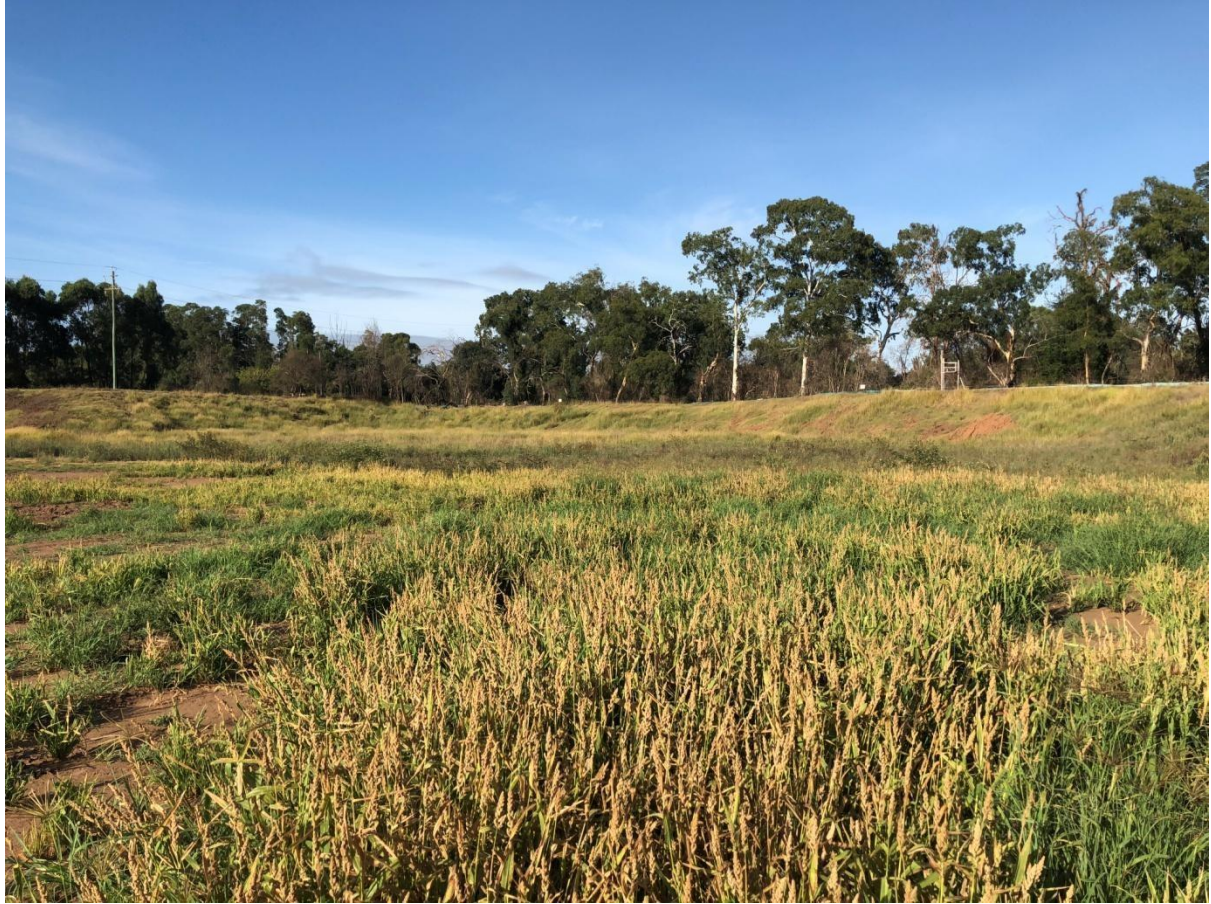
This zone is located in the open paddock area surrounded on three sides by the battersfacing Camden By-Pass bridge and adjoining the Nepean River on the west and the dry anabranch on the eastern side. The entire ground surface is ripped along the contours to fracture the soil and then cross rip to help retain moisture in the subsoil.

The entire surface is then backfilled with a minimum of 500mm stockpiled topsoil . Once the surface preparation is completed grass has been planted and additional pasture has been sown into the topsoil,
