**Haskoning Australia PTY Ltd.  
Maritime & Aviation**

To: Julian Burgess (RMS)  
From: Matthew Potter (RHDHV)  
Date: 04 October 2018  
Copy: Dave Doyle (RMS) and Greg Britton (RHDHV)  
Our reference: M&ANT181004\_Heritage Seawall  
Classification: Project related

**Subject: Stockton Boat Harbour Upgrading - Structural Adequacy of Heritage Seawall in North-Eastern Corner**

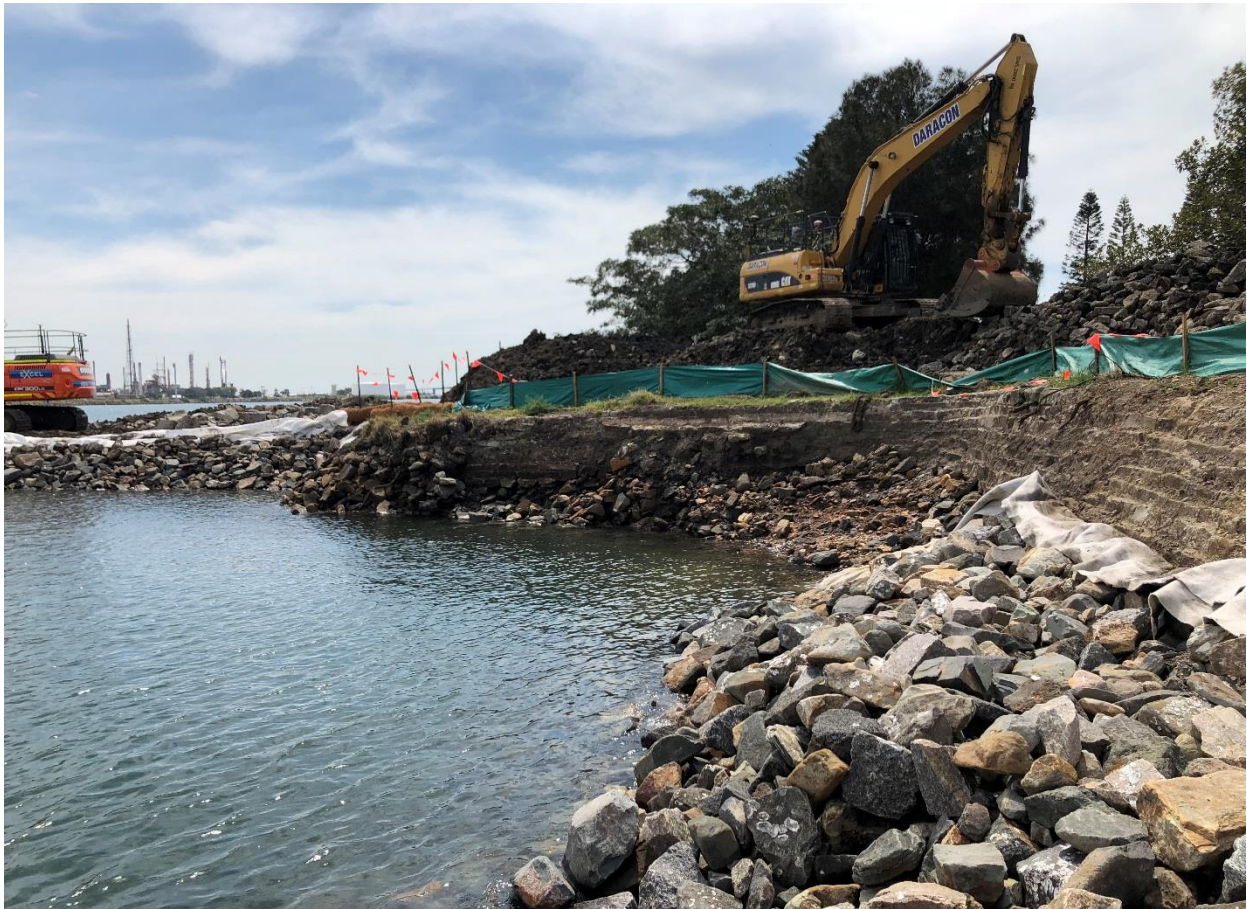
At the NE corner of the Boat Harbour the heritage seawall alignment changes from running along the eastern foreshore to extending westward alongside the existing Northern Groyne rock structure (refer **Figure 1**). It is proposed that the rock revetment would continue around the NE corner and would interface with the westward aligned section of the heritage seawall, approaching from both its southern and northern side.

Figure 1: View looking towards NE corner showing partially built rock revetment and face of heritage seawall

The remaining 4.4m of the westward length of the seawall from the NE corner (from CH1.2 to CH5.6) would be retained and a seawall face height of 0.5-0.6m would still be visible above the proposed rock revetment (approximately 3-4 block courses). The visibility of the seawall corner is considered to be beneficial as the historical perimeter of the old Boat Harbour is able to be determined from the remnant structure and potentially supplemented with interpretive signage on the foreshore.

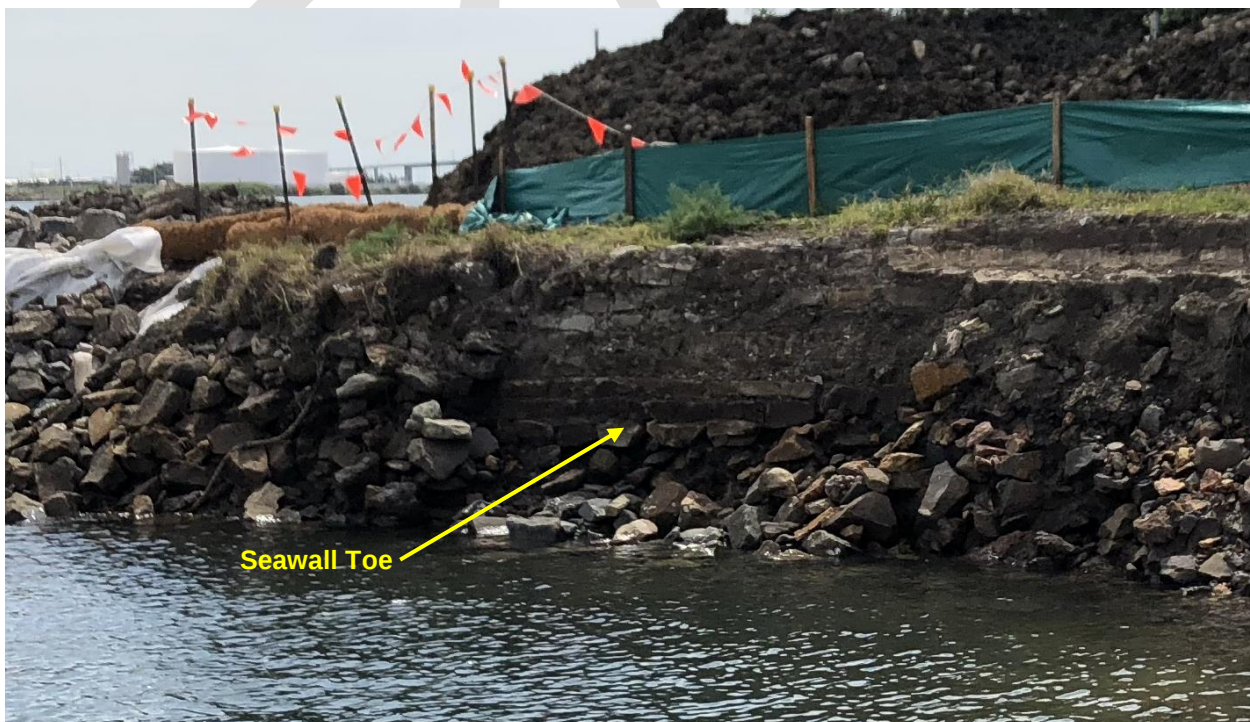
Using the recent detailed survey of the heritage seawall and partial uncovering of the seawall toe as part of site excavation activities (refer **Figure 2**), we have determined the extent of the seawall that is able to be retained as part of the upgrade works. The seawall crest varies from a level of 1.9m AHD at its change in alignment from the eastern shoreline (CH1.2) to 1.5m AHD at its seaward end (CH10.9). The uncovered section of the seawall toe indicates that the toe is approximately 8 block courses below the crest, which corresponds to a height of around 1.2m based on a block height of approximately 150mm.

Figure 2: View of uncovered toe of heritage seawall in NE corner of Boat Harbour

A plan and long section along the seaward face of the heritage seawall has been prepared (refer **Attachment A**) to show the elevations of the seawall crest and toe in comparison to the proposed rock revetment structure (armour and underlayer). The toe of the seawall would need to be protected by an armour and underlayer at least 2 rocks thick to prevent undermining of the material beneath the seawall toe by waves and currents within the Boat Harbour. The position at which this is achieved corresponds to CH5.6 on the long section. This requires a seawall length of approximately 5.3m to be demolished from CH5.6 to CH10.9. This section of the seawall is unable to be supported or protected by the adjacent proposed rock revetment and is unable to be underpinned with a foundation as the revetment profile extends several metres below the toe of the seawall.

It is noted that a section of retained seawall between CH3.6 and CH5.6 could potentially be undermined by the proposed temporary excavation profile, which is nominally shown at a 1V:2H slope. This could be mitigated by local excavation of a steeper temporary batter slope of 1V:1.5H and/or with temporary shoring of the seawall prior to rock placement.

It is recommended that deteriorated sections of the retained seawall are remediated with appropriate grout and/or mortar repairs, particularly in sections that are proposed to be exposed above the revetment surface.
