Kambala School  
c/- Carmichael Tompkins Property Group  
Detailed Site Investigation

Kambala School Sports Precinct  
794 New South Head Road  
Rose Bay, NSW

25 June 2020

58081/129431 (Rev A)

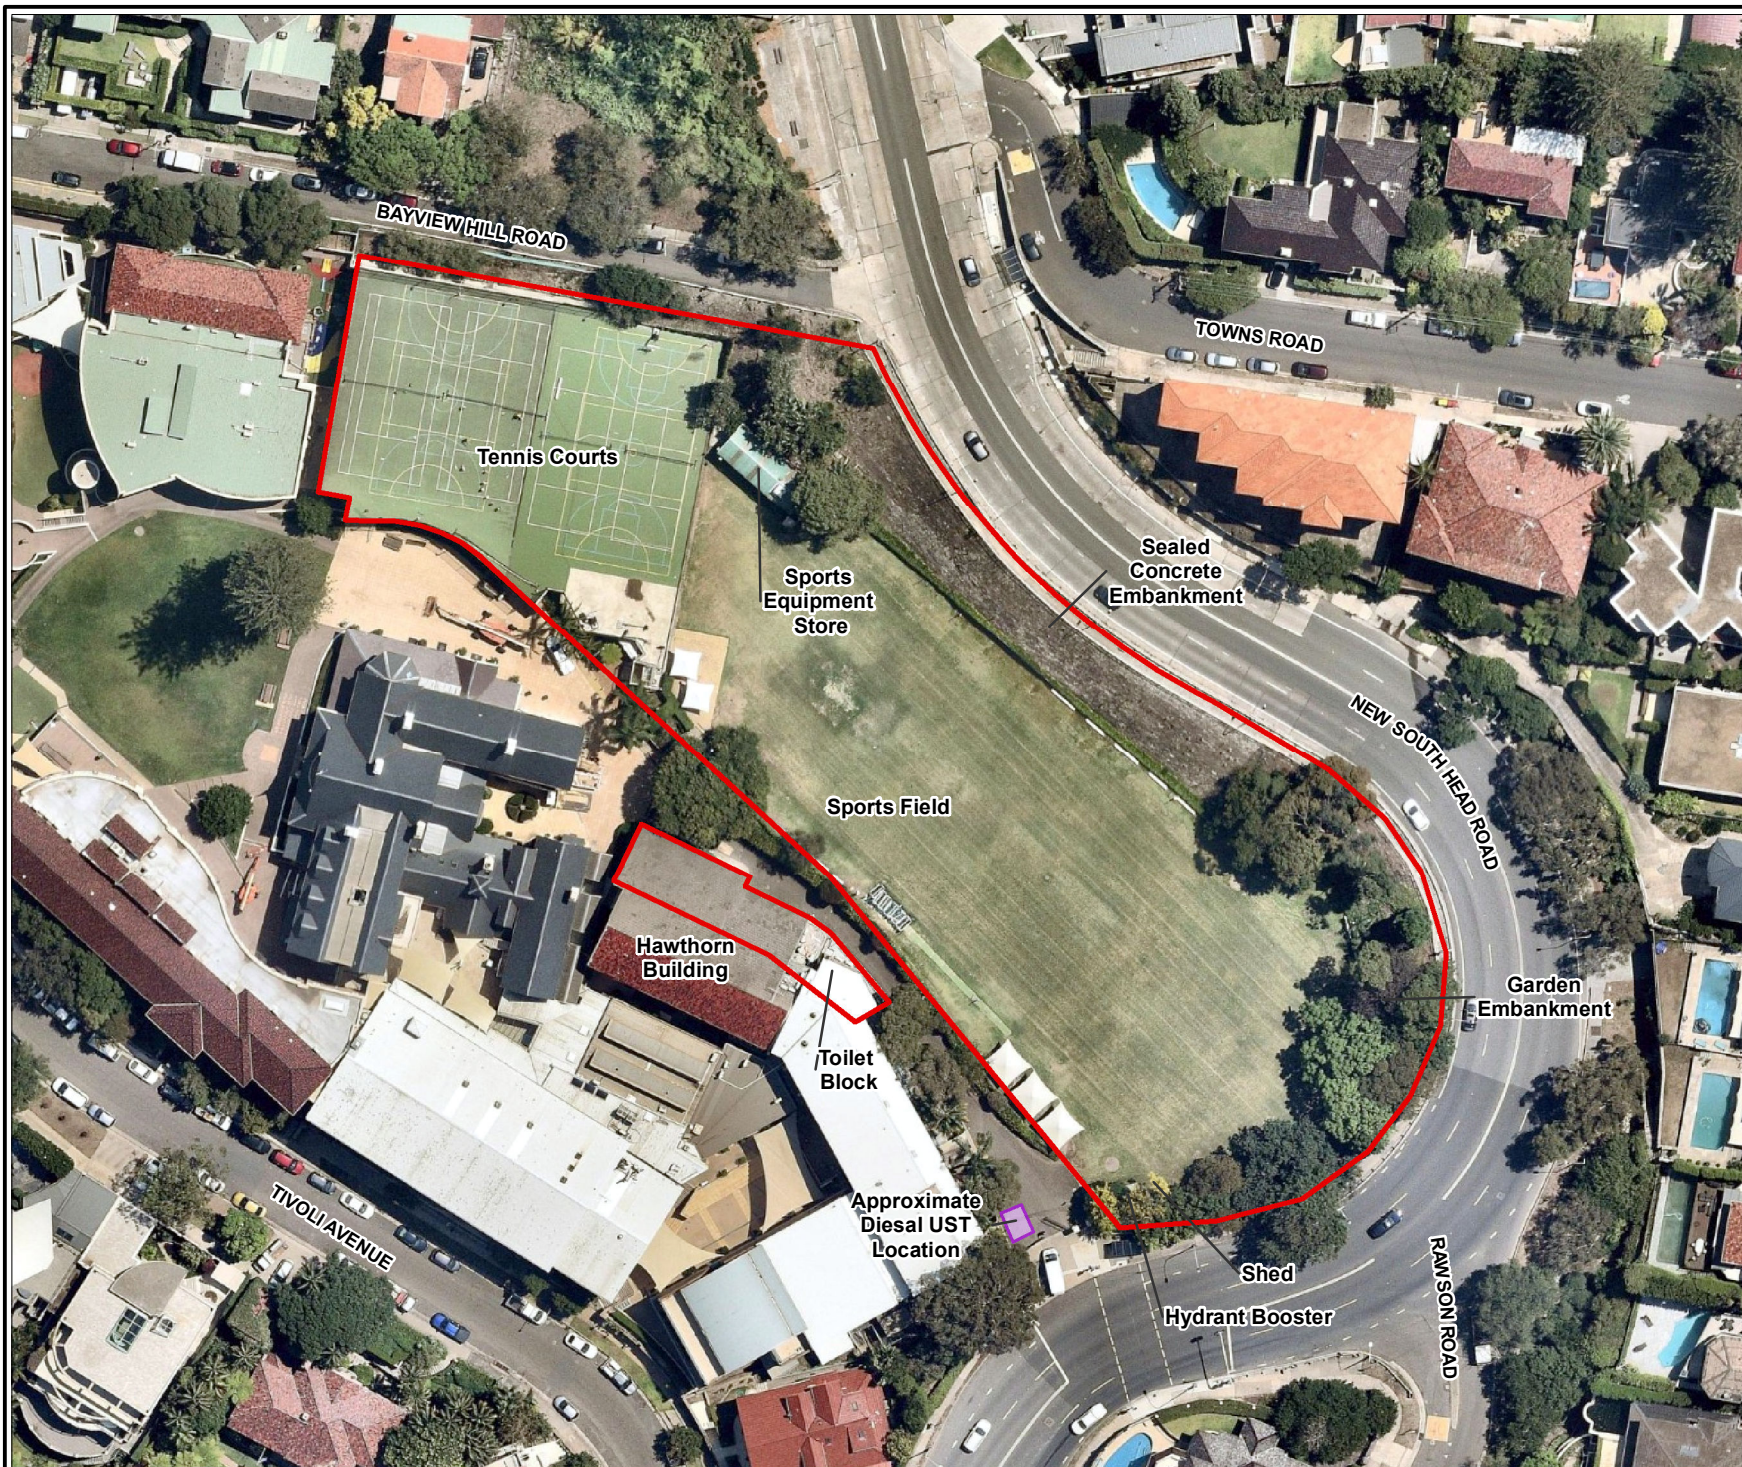
**FIGURE 2**

A detailed site inspection was undertaken on 7<sup>th</sup>, 20<sup>th</sup> and 21<sup>st</sup> April 2020 by an experienced JBS&G environmental. The layout of the site was observed to be consistent with that described in the PSI (JBS&G 2020a). Site features observed during site inspections are shown on **Figure 2**.

**SITE LAYOUT**

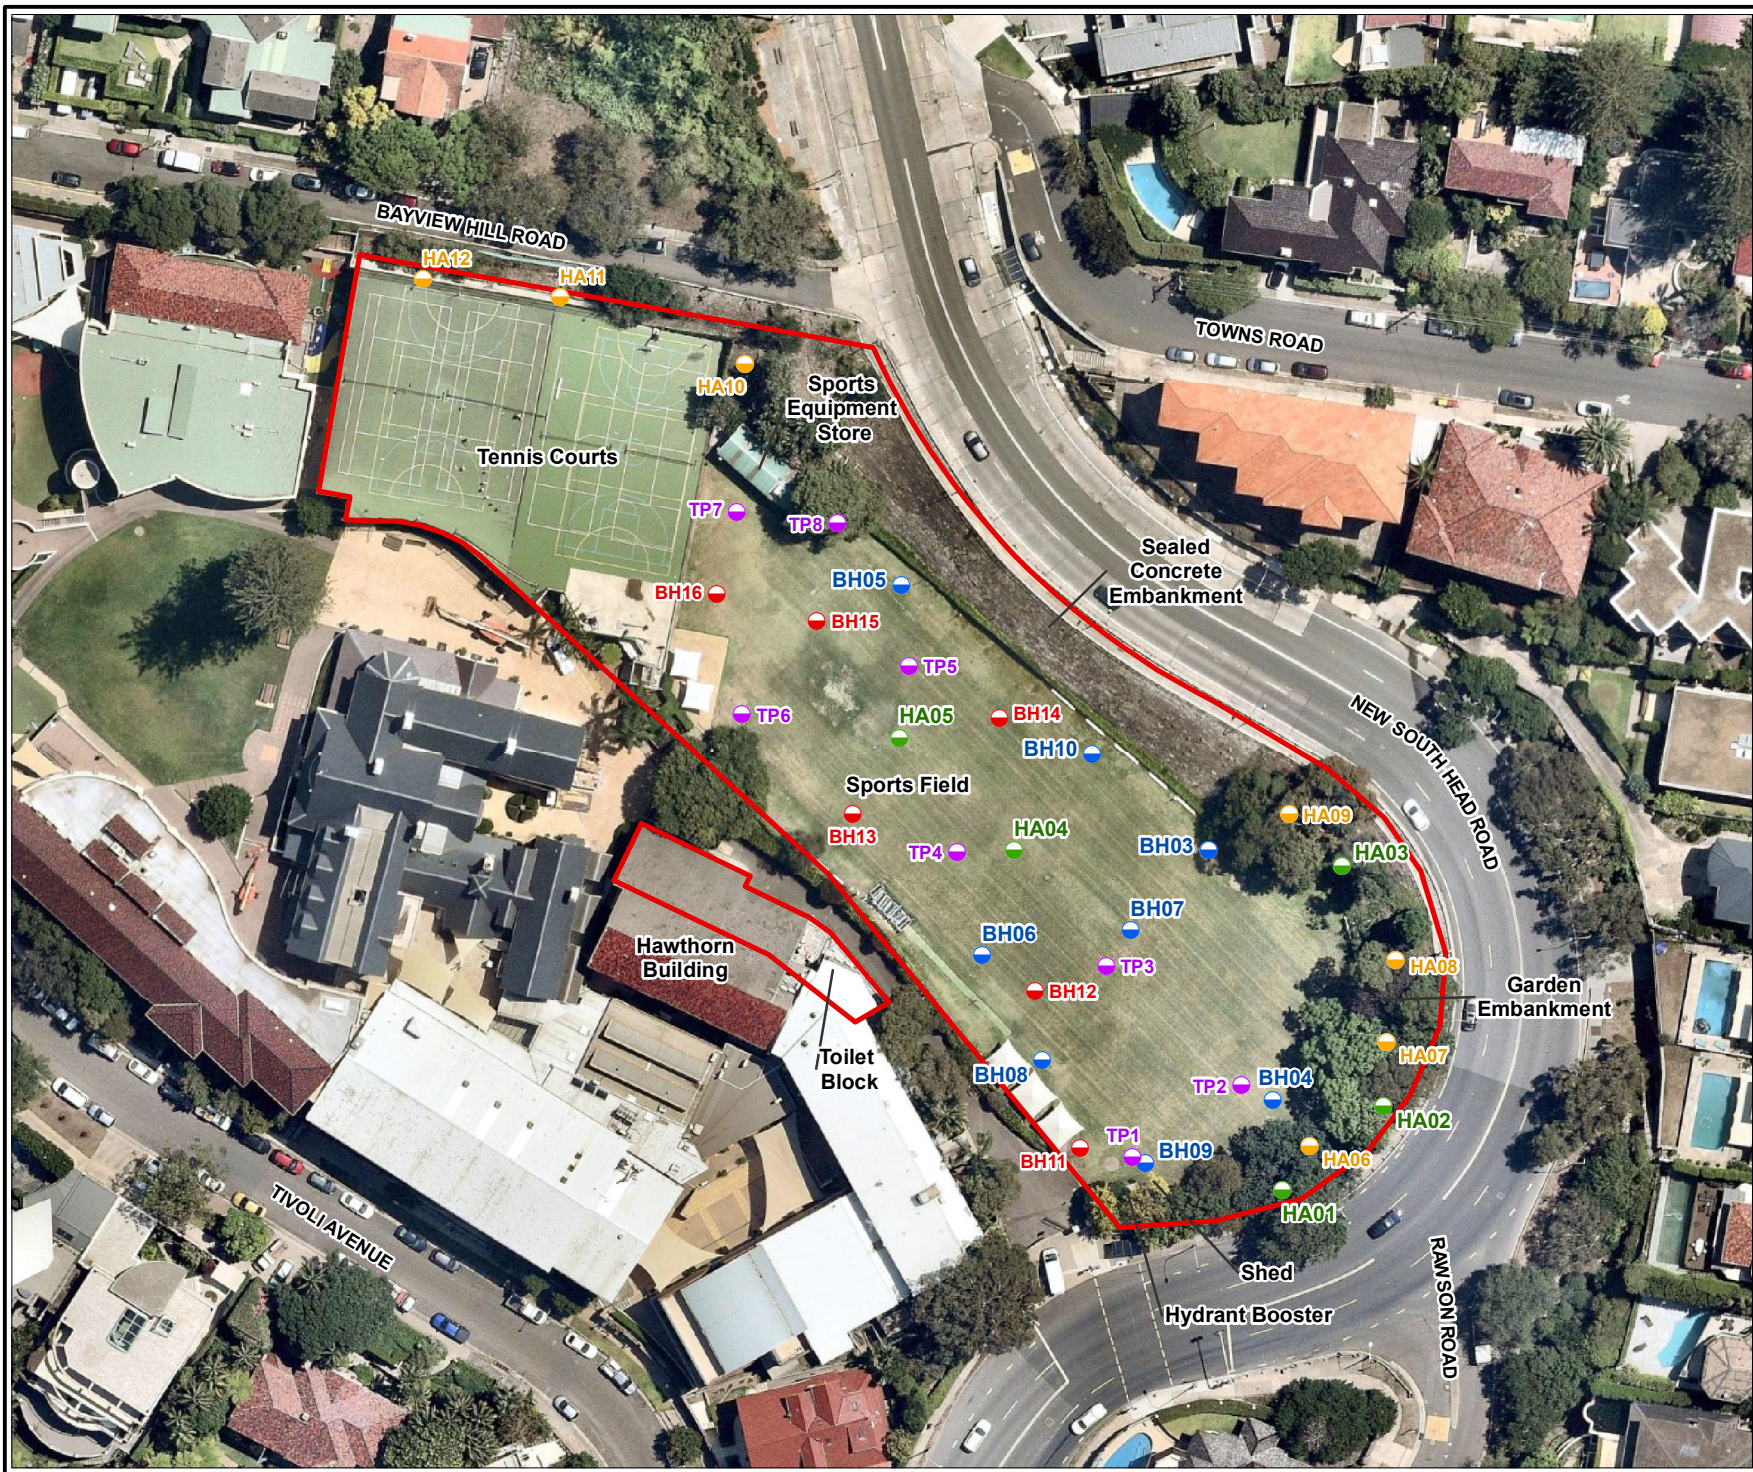
| <b>FIGURE 3</b> | |

| <b>SAMPLE LOCATIONS</b> | |

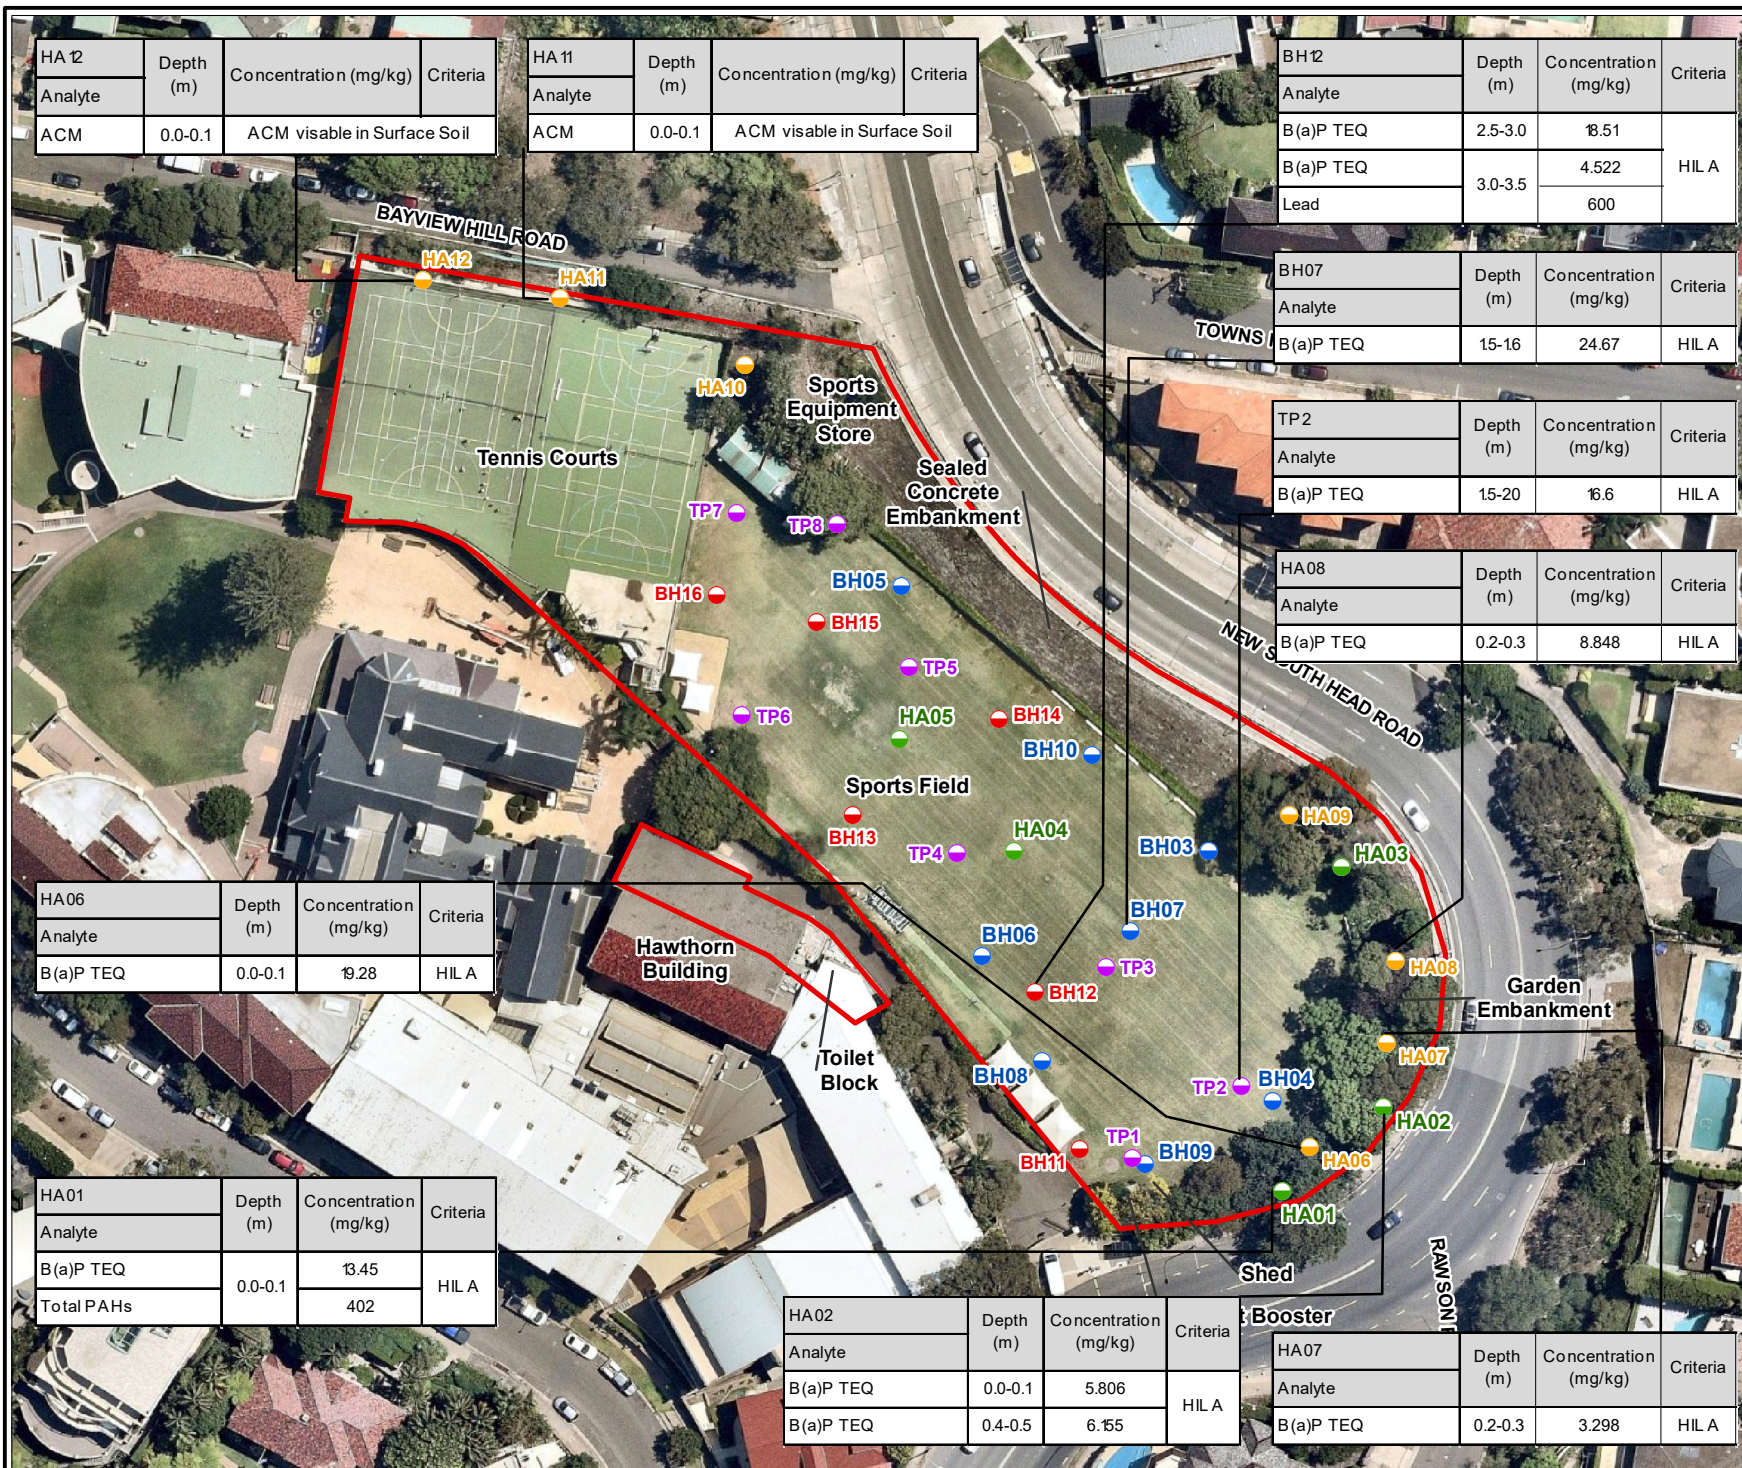
- The eastern garden embankment adjacent with the sites eastern boundary adjacent to the bend on New South Head Road; and
- The south-eastern portion of the sports field within locations BH07, BH12 and TP2 as shown on **Figure 4**. It is further noted that impact within the sports field was identified at a depth of 1.5 m or more from the surface.

Two isolated fragments of ACM were identified at locations HA11 and HA12 within a narrow garden strip north of the tennis courts and on the north-western boundary of the site as shown on **Figure 4**. The fragments potentially were discarded into the garden over the site fence, the fragments were collected and submitted for laboratory confirmation analysis. No further fragments including no ACM observed in fill material was identified at the site.

- The eastern garden embankment adjacent with the site's eastern boundary adjacent to the bend on New South Head Road; and
- The south-eastern portion of the sports field within locations BH07, BH12 and TP2 as shown on **Figure 4**. It is further noted that impact within the sports field has been identified at a depth of 1.5 m or more from the surface.
