Heritage Interpretation

Courtyard Paving

Reinstating the Carriageways

Heritage Interpretation
Courtyard Gantries

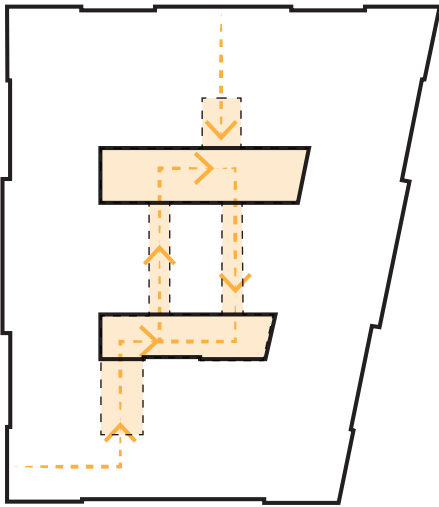
Existing Courtyard condition showing amenity blocks and lift cores in courtyards

The existing courtyards at the Lands Buildings are currently filled with ad-hoc additions to the existing building throughout the years of occupation. This includes the amenity blocks, lift core and plant spaces that have cluttered the original Carriageway for the Lands Building.

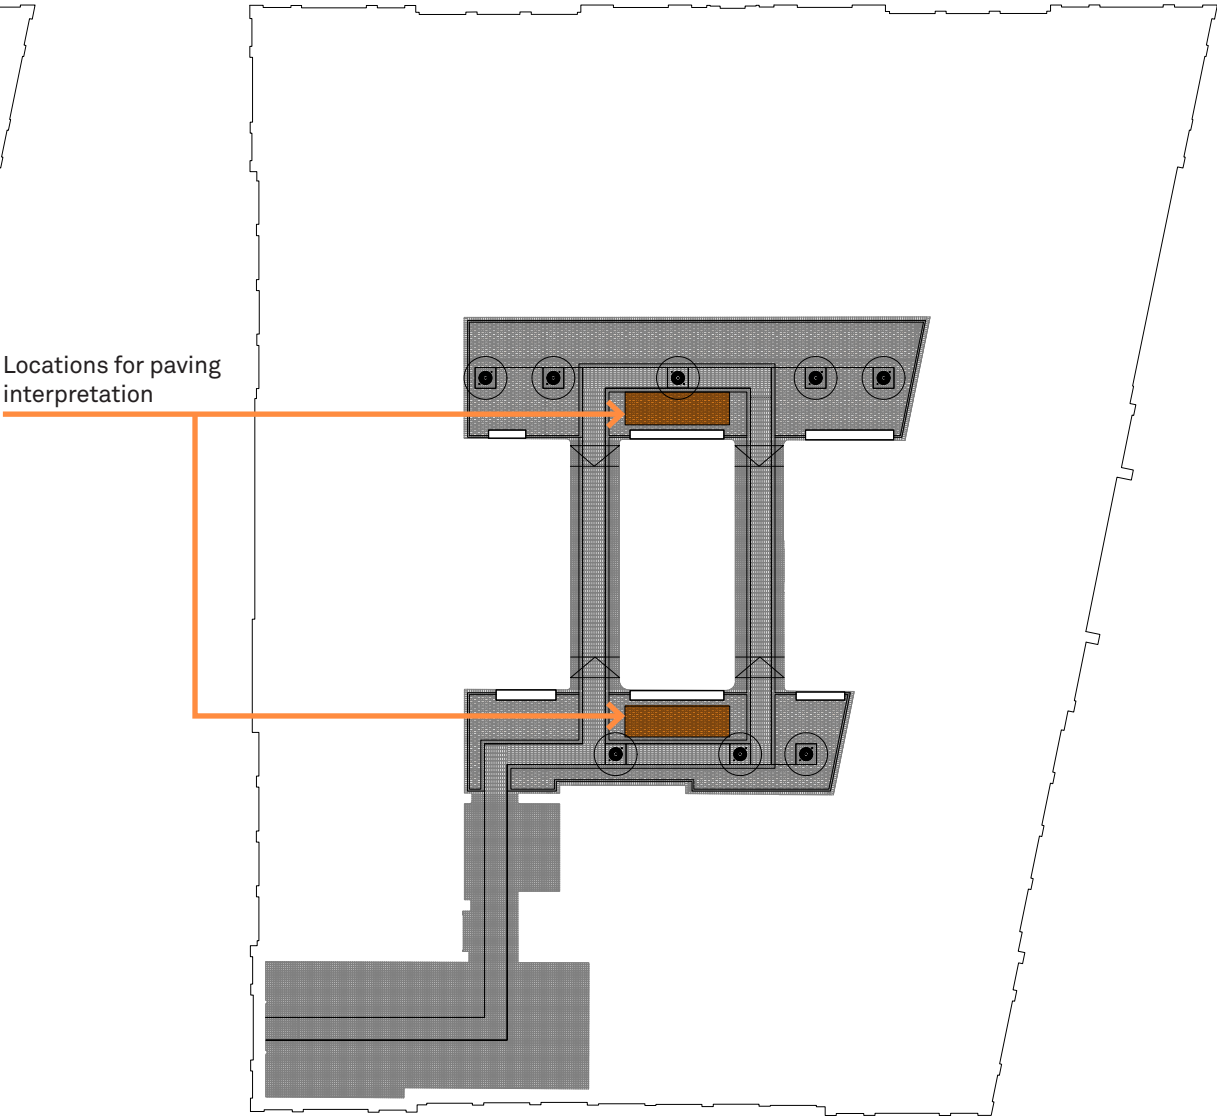
Proposed interpretation strategy with amenity block interpreted in new paving

The original amenity blocks will be reinterpreted within the new paving pattern of the proposed courtyards, referencing their historic configuration alongside the carriageway.

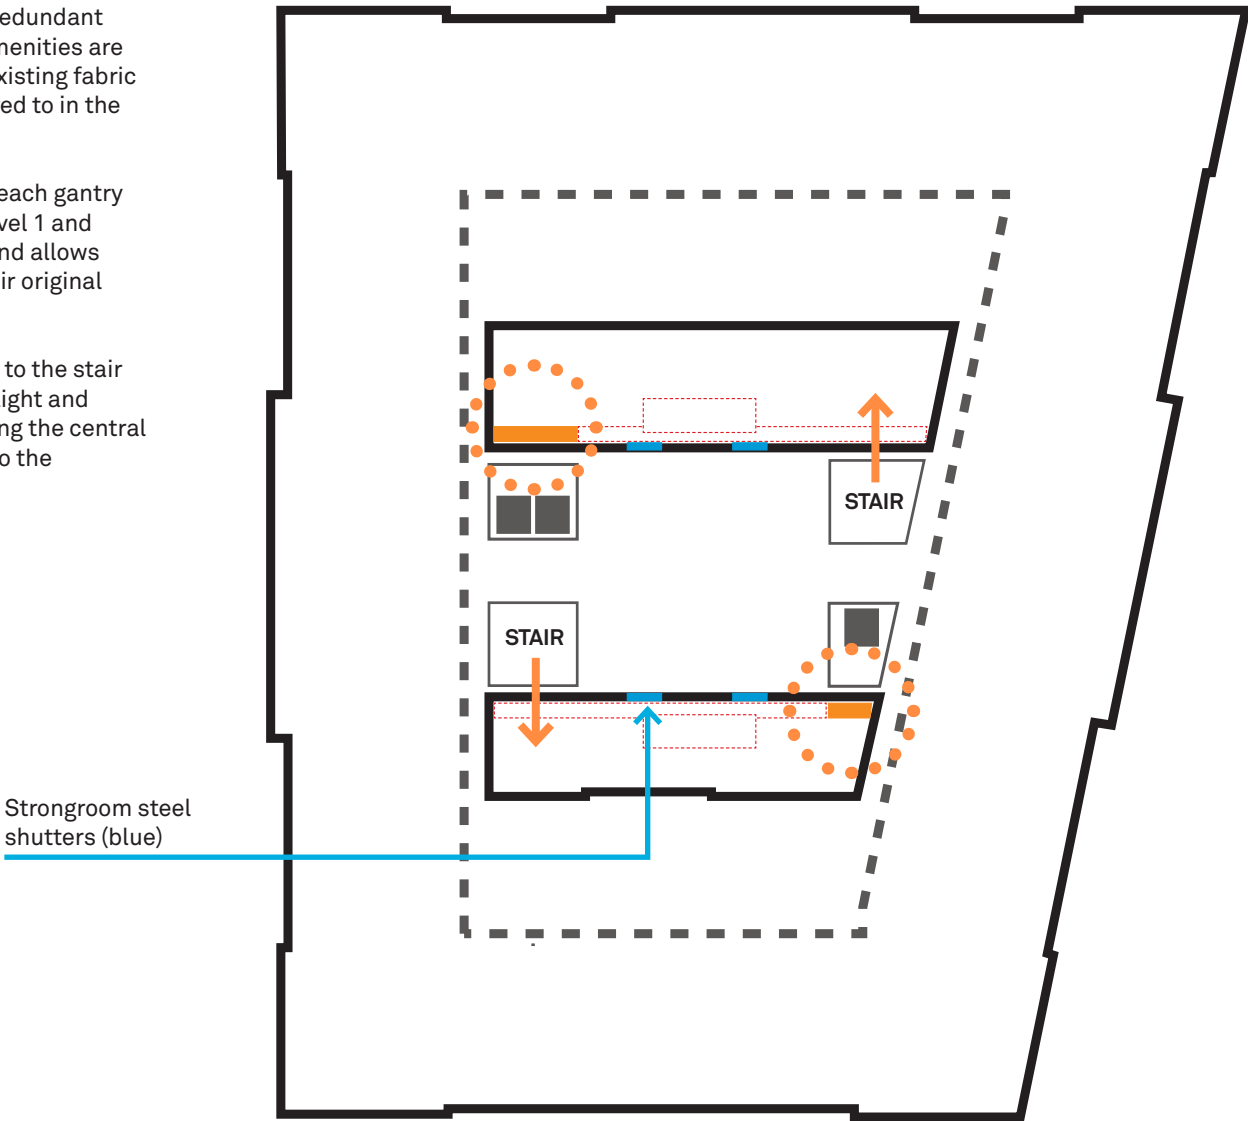
Partial Gantries to be retained for both North and South Courtyards adjacent to lift cores on GF, 1F and 2F (shown in orange).

With the removal of the amenity blocks in the North and South Courtyards, portions of the redundant gantries used to access the external amenities are proposed to be retained. Some of the existing fabric is in poor structural condition, as referred to in the GAO CMP.

The revised design retains a portion of each gantry adjacent to the lift cores on Ground, Level 1 and Level 2, using the best original fabric, and allows these elements to be interpreted in their original positions.

Existing gantries crossing the windows to the stair cores are removed to optimise natural light and views into stair wells, as well as exposing the central Strong Room elaborate steel shutters to the courtyard below.

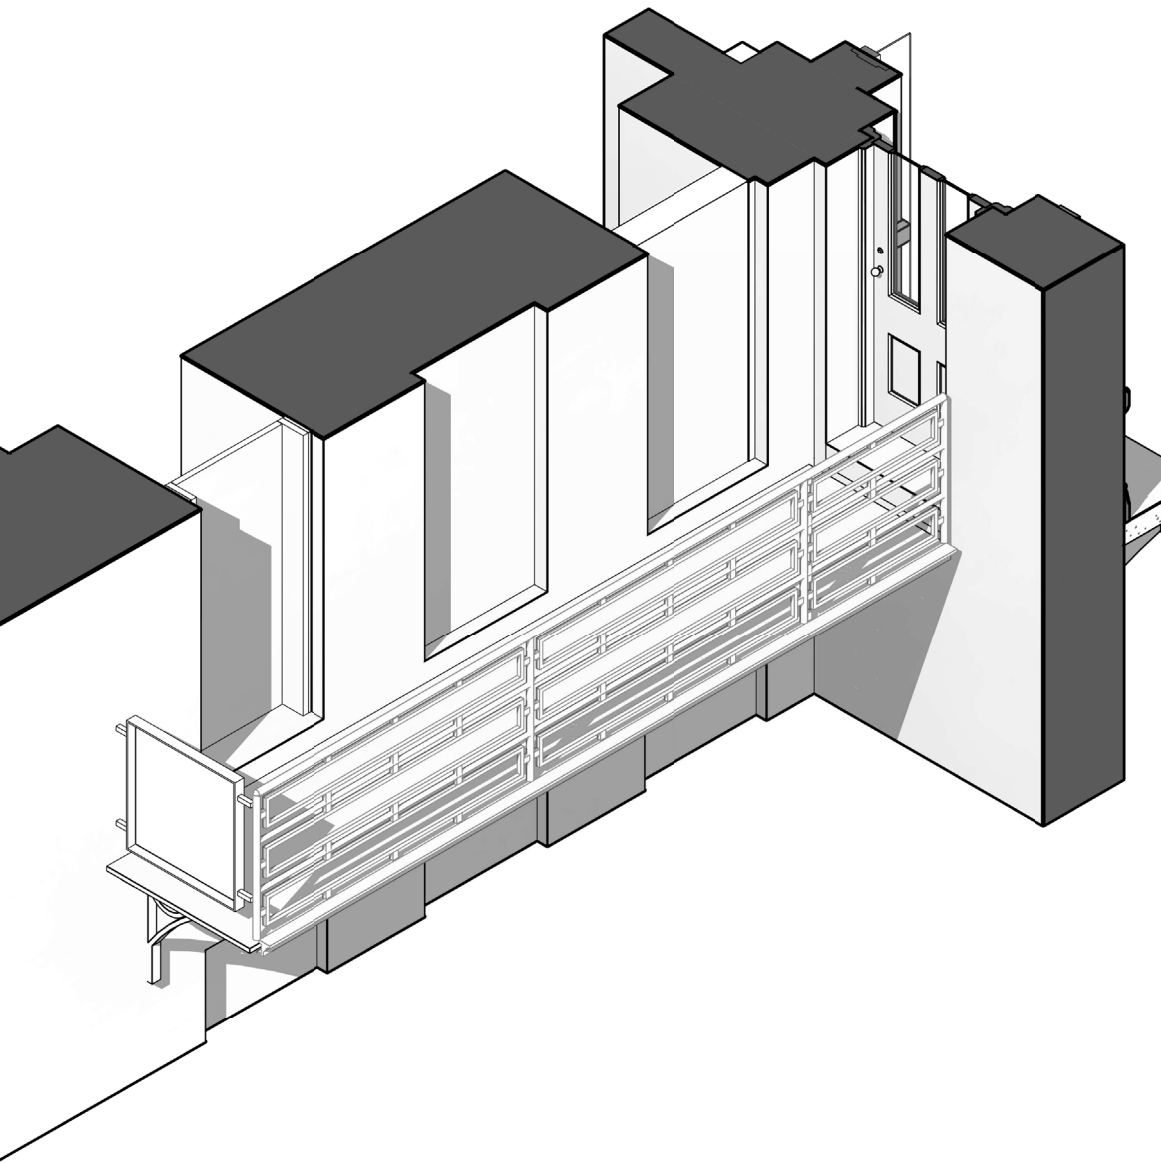
Retained gantries axonometric

Showing retained gantry balustrades, brackets and floor grates. Further Structural assessment to be undertaken in subsequent phases.
