| <b>Plan of:</b> | Metford Rehabilitation Domain Areas | <b>Location:</b> | Metford Clay Mine<br>Metford Rd, Metford NSW 2320 | <b>Source:</b> | Contours updated by GPS 22/5/07<br>Boundaries Monteath & Powys | <b>Our Ref:</b> | V:\Jobs\_MT\2013\ClosurePlan\Figs\<br>CPMOPMT.cdr |
| <b>Figure:</b> | Nine (MT13A) | <b>Council:</b> | Maitland City Council | <b>Survey:</b> | AAM Hatch 27/2/06 | <b>Plan By:</b> | LGT |

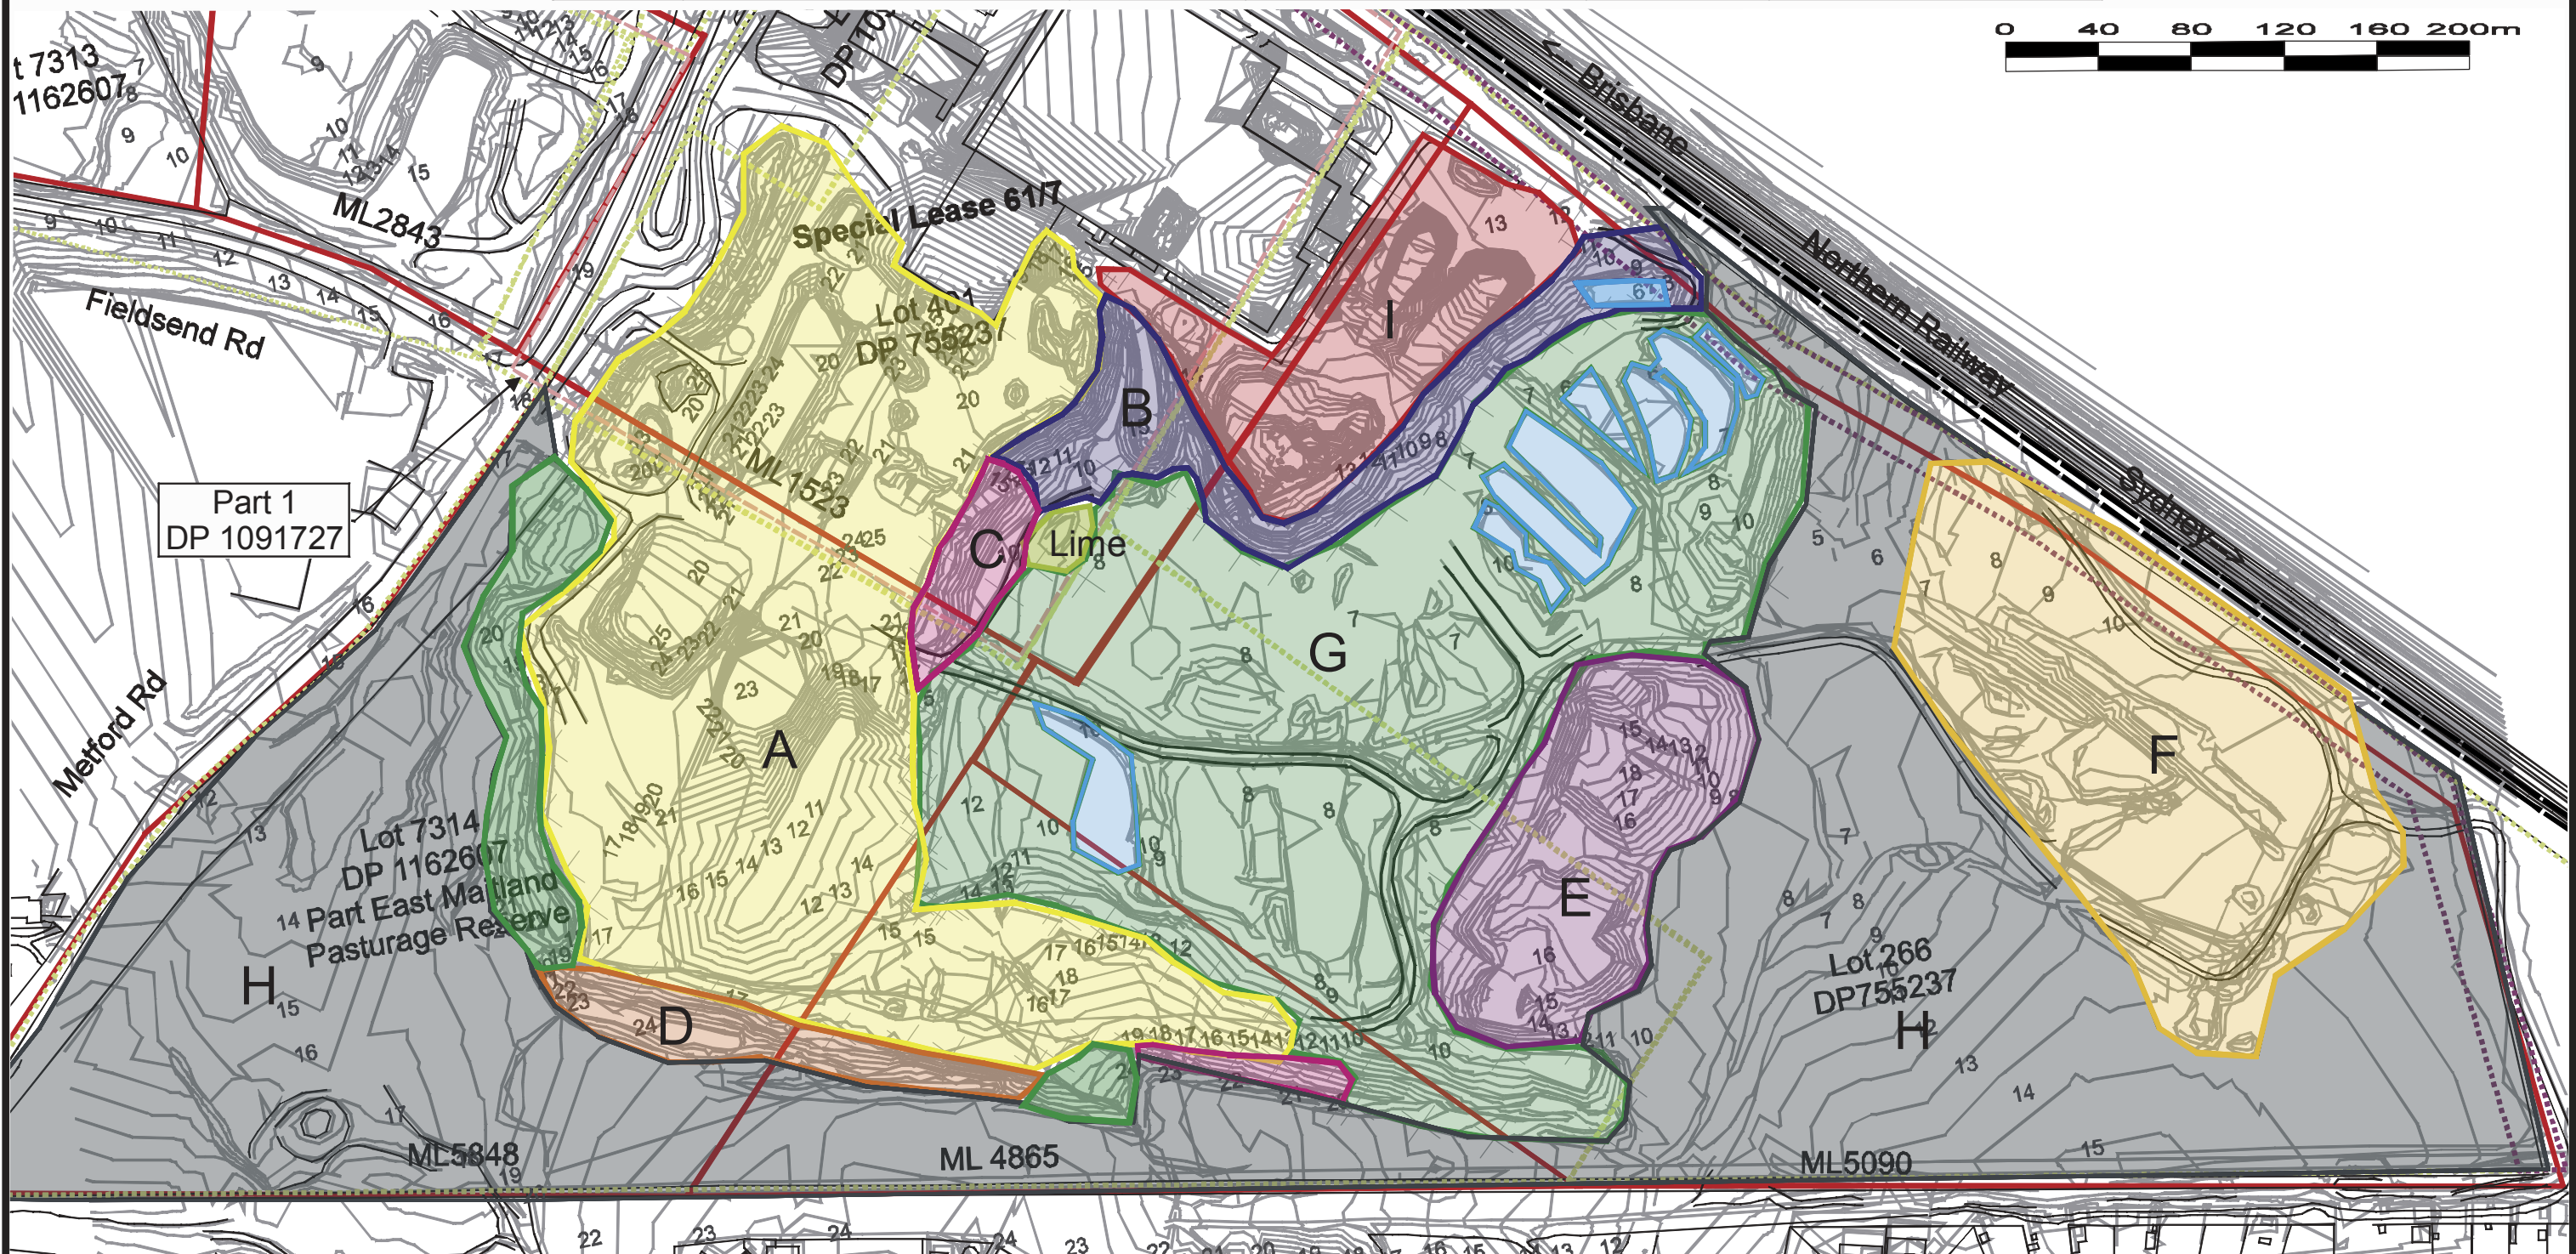
| Legend | | | | | | | |
|---|---|---|---|---|---|---|---|
| <b>Domain A</b><br> | Disturbed floor and stockpiles.<br><u>Action:</u> Fill in low lying areas with stockpile materials, shape to self-drain and apply grasses. | <b>Domain C</b><br> | Natural steep face with good vegetation.<br><u>Action:</u> Risk assess to potentially leave | <b>Domain E</b><br> | The Hill- mix of natural and carbonaceous shale stockpiles, vegetated.<br><u>Action:</u> None | <b>Domain G</b><br> | Mixed revegetated land and shallow water bodies.<br><u>Action:</u> Build access tracks for potential pedestrian use. |
| <b>Domain B</b><br> | Construction & Demolition batter with some vegetation and some steep slopes.<br><u>Action:</u> Survey, batter back slopes to 3:1 with available material, apply grasses to disturbed faces. | <b>Domain D</b><br> | Vegetated bund wall atop steep natural slope.<br><u>Action:</u> Use existing stockpiles, batter face to 3:1, apply grasses. | <b>Domain F</b><br> | Mostly revegetated with some aggregate stockpiles.<br><u>Action:</u> Pick out aggregates and apply grasses to disturbed areas | <b>Domain H</b><br> | Natural<br><u>Action:</u> None |
| | | | | | | <b>Lime</b><br> | Lime stockpile<br><u>Action:</u> Lime will be mixed with soil to assist with revegetation. |
