REMEDIATION ACTION PLAN
PROPOSED LIGHTHORSE
INTERCHANGE BUSINESS HUB
[SSD 9667]
WESTERN SYDNEY PARKLANDS TRUST

10 DECEMBER 2019
119104
VERSION 2

Remediation Action Plan, Light Horse Interchange Business Hub, Eastern Creek NSW

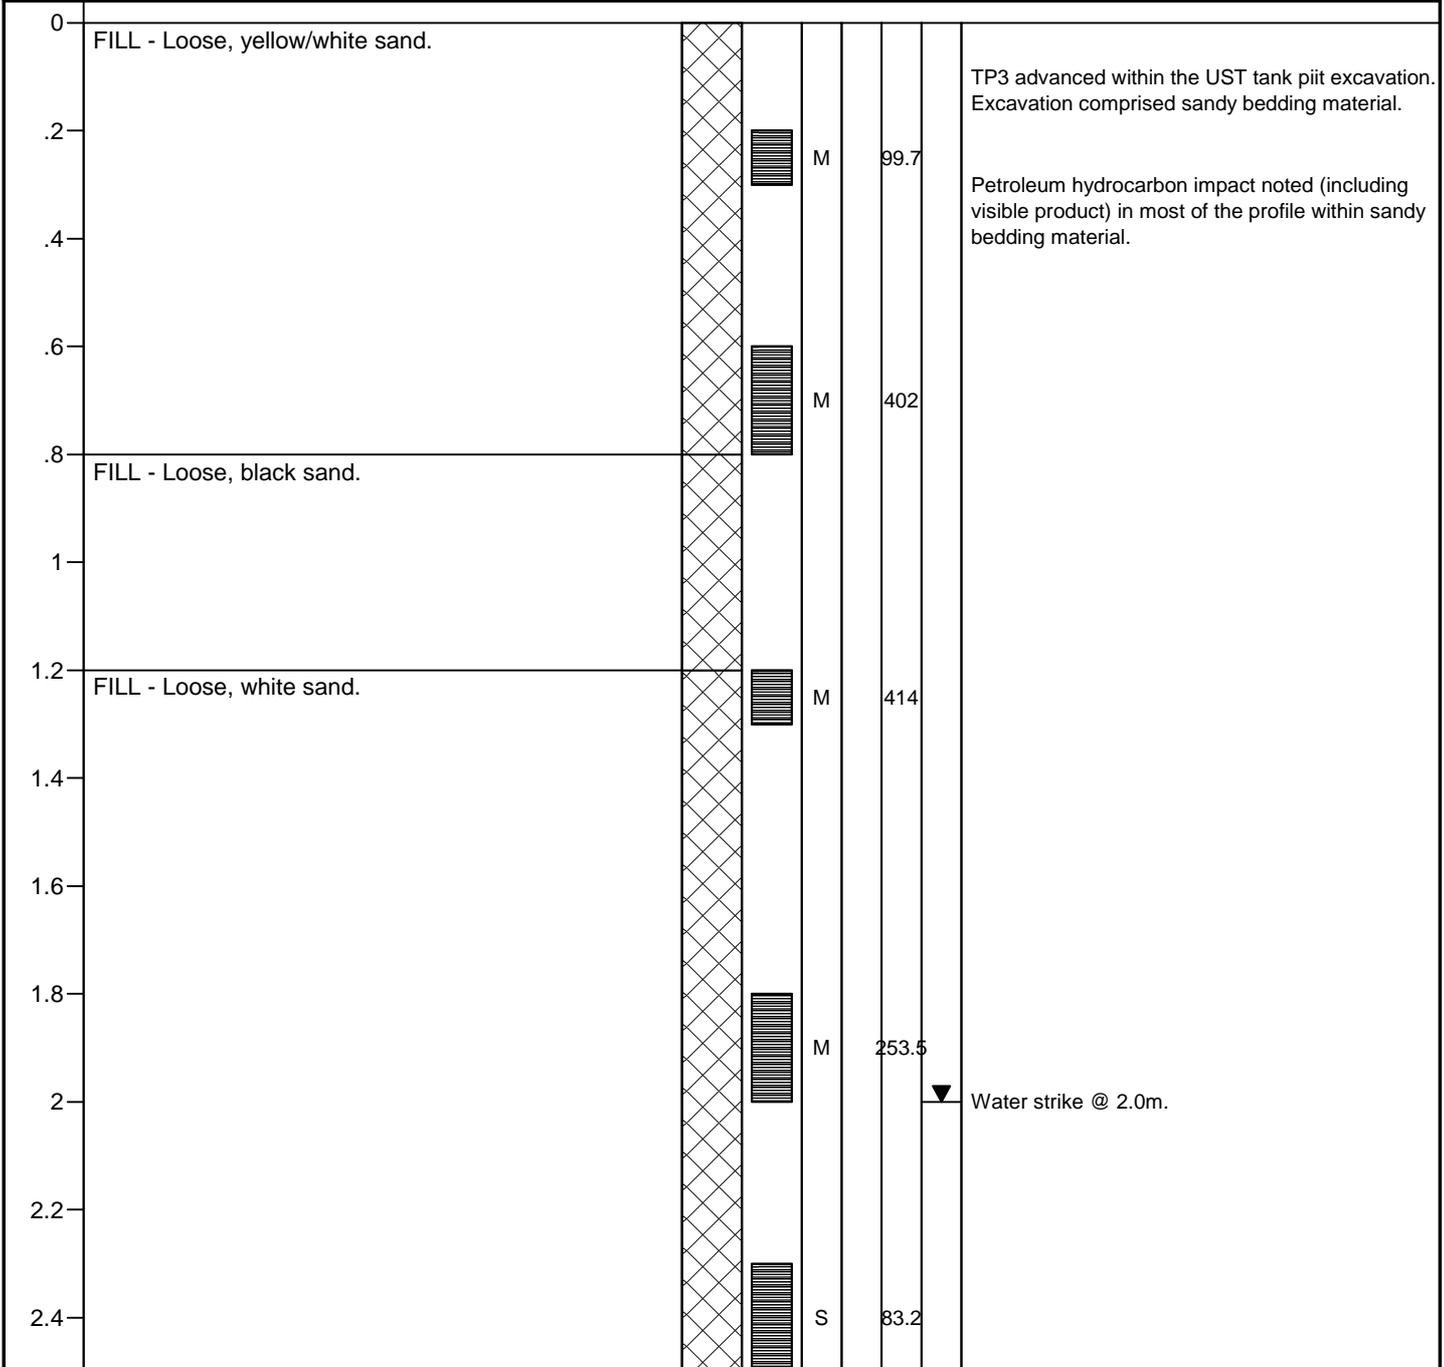
TP3 advanced within the UST tank pit excavation. Excavation comprised sandy bedding material.

Petroleum hydrocarbon impact noted (including visible product) in most of the profile within sandy bedding material.

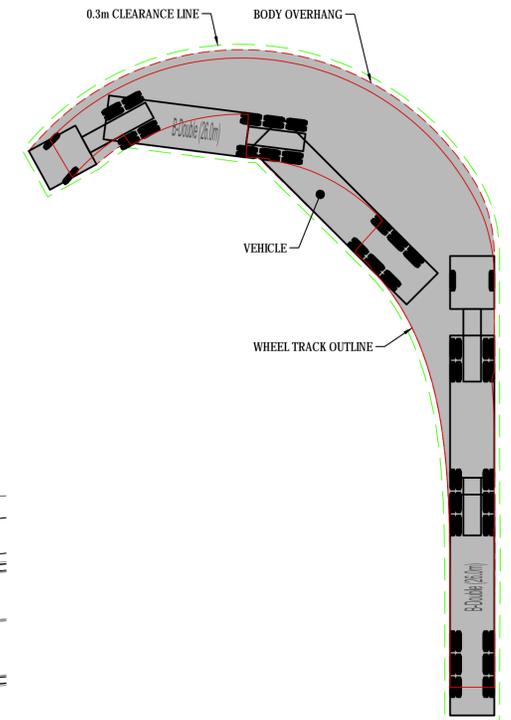
B-DOUBLE VEHICLE PROFILE
SCALE: 1:500

B-Double (26.0m)	26.000m
Overall Length	2.500m
Overall Width	4.300m
Overall Body Height	0.540m
Min Body Ground Clearance	2.500m
Track Width	6.90s
Lock-to-lock time	15.000m
Curb to Curb Turning Radius

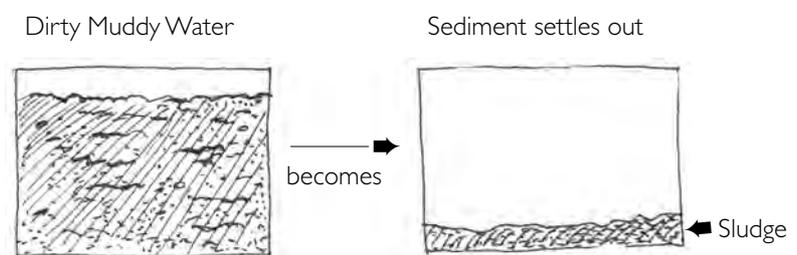
Sediment settles over time but can be sped up with flocculant.

Reuse sediment or place in bin

Pump clear water to "soak in" site or to stormwater system

If the water contains only sediment it can be pumped to the stormwater system after filtering. It must have less than 50 mg/L Total Suspended Solids. This is water with no visible cloudiness. If you do not have time or room on-site to let the sediment settle naturally, flocculants such as gypsum can be used. Flocculants speed up the settling process. Unfortunately they raise the pH of the water and pH correction is needed prior to pumping to the stormwater system. Some flocculating agents can be toxic to fish above certain critical concentrations. Council advice should be sought prior to their use. Once settled, pump the clean water from the top to an area of the site where it can soak in or to the stormwater system. The settled sediments, "the sludge", can be reused on site or disposed of in a bin.

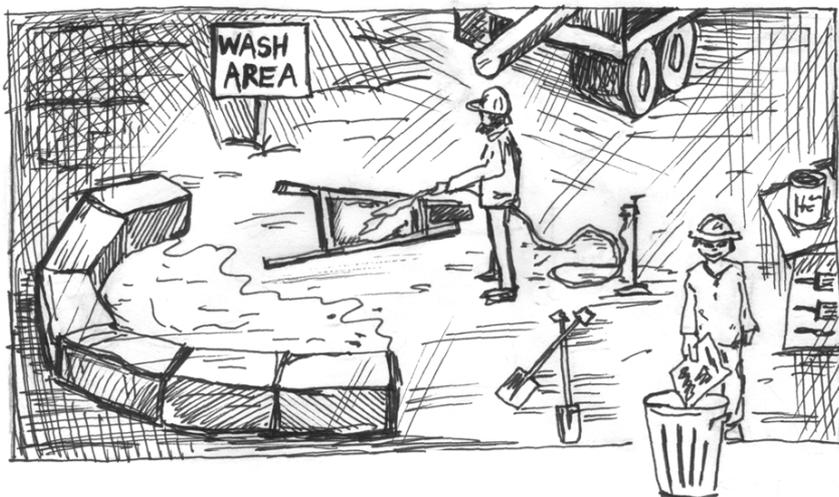
Maintenance of the controls:

The protected wash area and its sediment controls will need to be emptied of solid residues regularly in order for it to have the capacity to catch and detain waste waters. The larger the area the less often this will need to be done. Solids from this process should be disposed of in a bin or taken to a licensed waste depot.

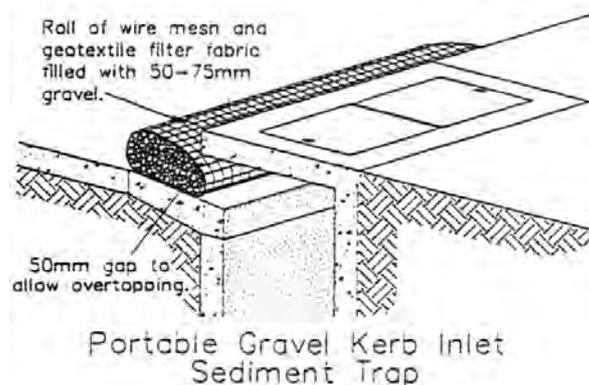
This trap involves a roll of wire mesh and geotextile filter fabric filled with gravel in front of the kerb inlet. It has the benefit of being portable and easily removed for cleaning. Ensure there is a gap at the top to allow overtopping and prevent flooding.

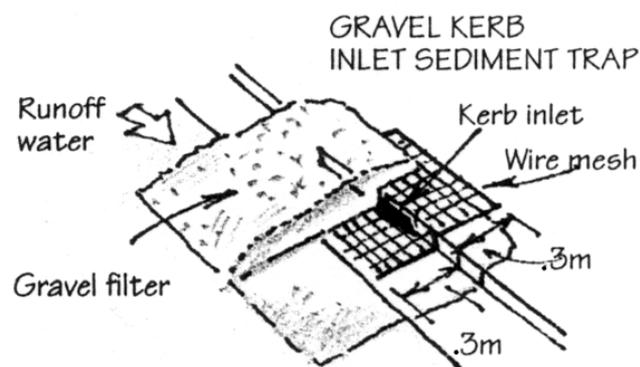
Gravel surface barrier strategy

This method involves placing wire mesh over the drain and placing large gravel upslope of it. The sediment will be filtered out into the gravel with only the clean water entering the stormwater system.

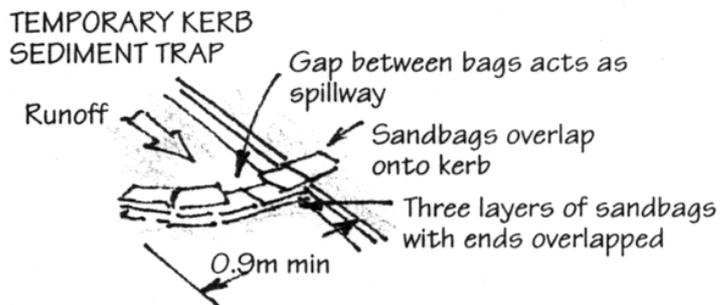
Sandbag kerb sediment trap

Place sandbags in front of flow of water. This will slow down the water enabling sediment to settle out. Two or three of these traps in a row may be required to ensure sediment settles out.

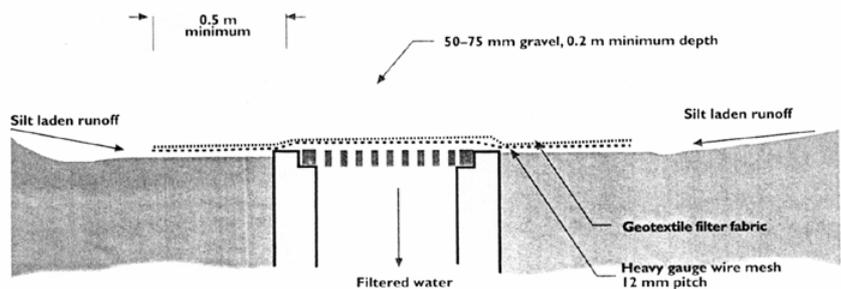
Three layers on top of the drain to trap the sediment. 1) heavy gauge wire netting or mesh 2) geotextile filter fabric with 3) a layer of prewashed 50-75mm gravel on top.

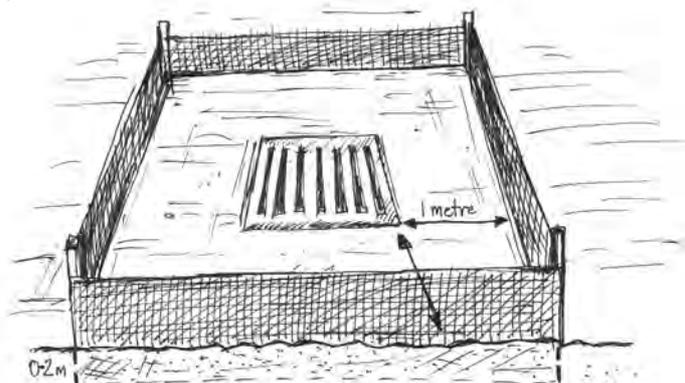
Geotextile Filter Fabric Drop Inlet Sediment Trap

Sediment fence staked around the drain to trap sediment. Note: It is important to partially bury the fabric so that water and sediment can not just flow underneath. The more space between the fence and the drain, the more chance of sediment settling and the greater the capacity of the trap.

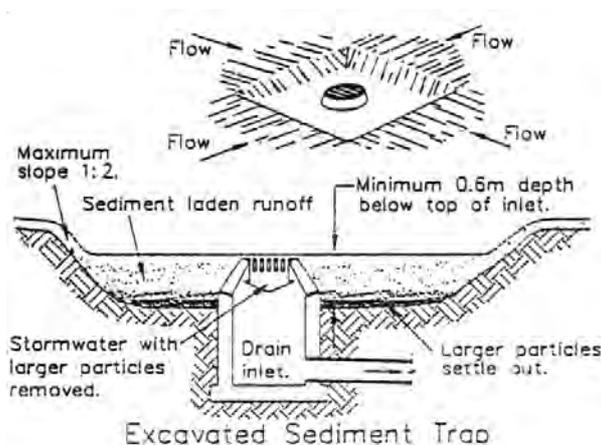
Excavated sediment trap: This is a detention basin technique for on-site drains. The basin depth needs to be at least 0.6m to ensure that water is held in place and sediment can settle out.

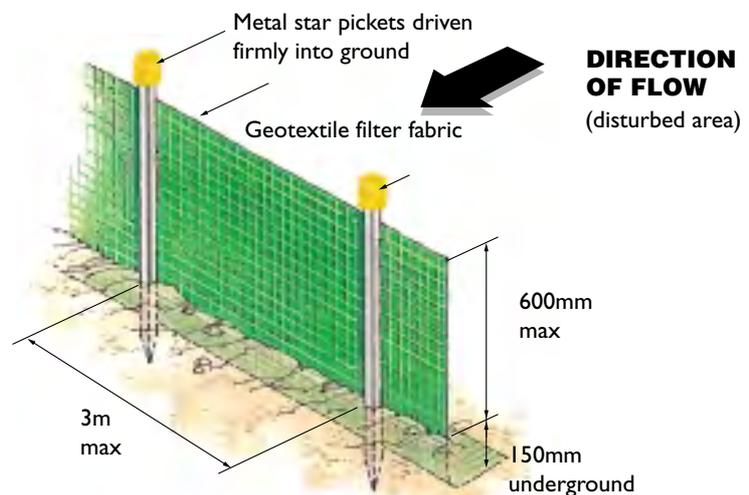
A sediment or silt fence is the most widely used strategy. It is constructed from heavy duty geofabric. Although a sediment fence looks like shade cloth it is very different and is not interchangeable. A sediment fence is specifically designed to allow the free passage of water and trap sediment
