## Eastern Creek Business Hub

### Vegetation Management Plan

Prepared for  
**Western Sydney Parklands Trust**

September 2018

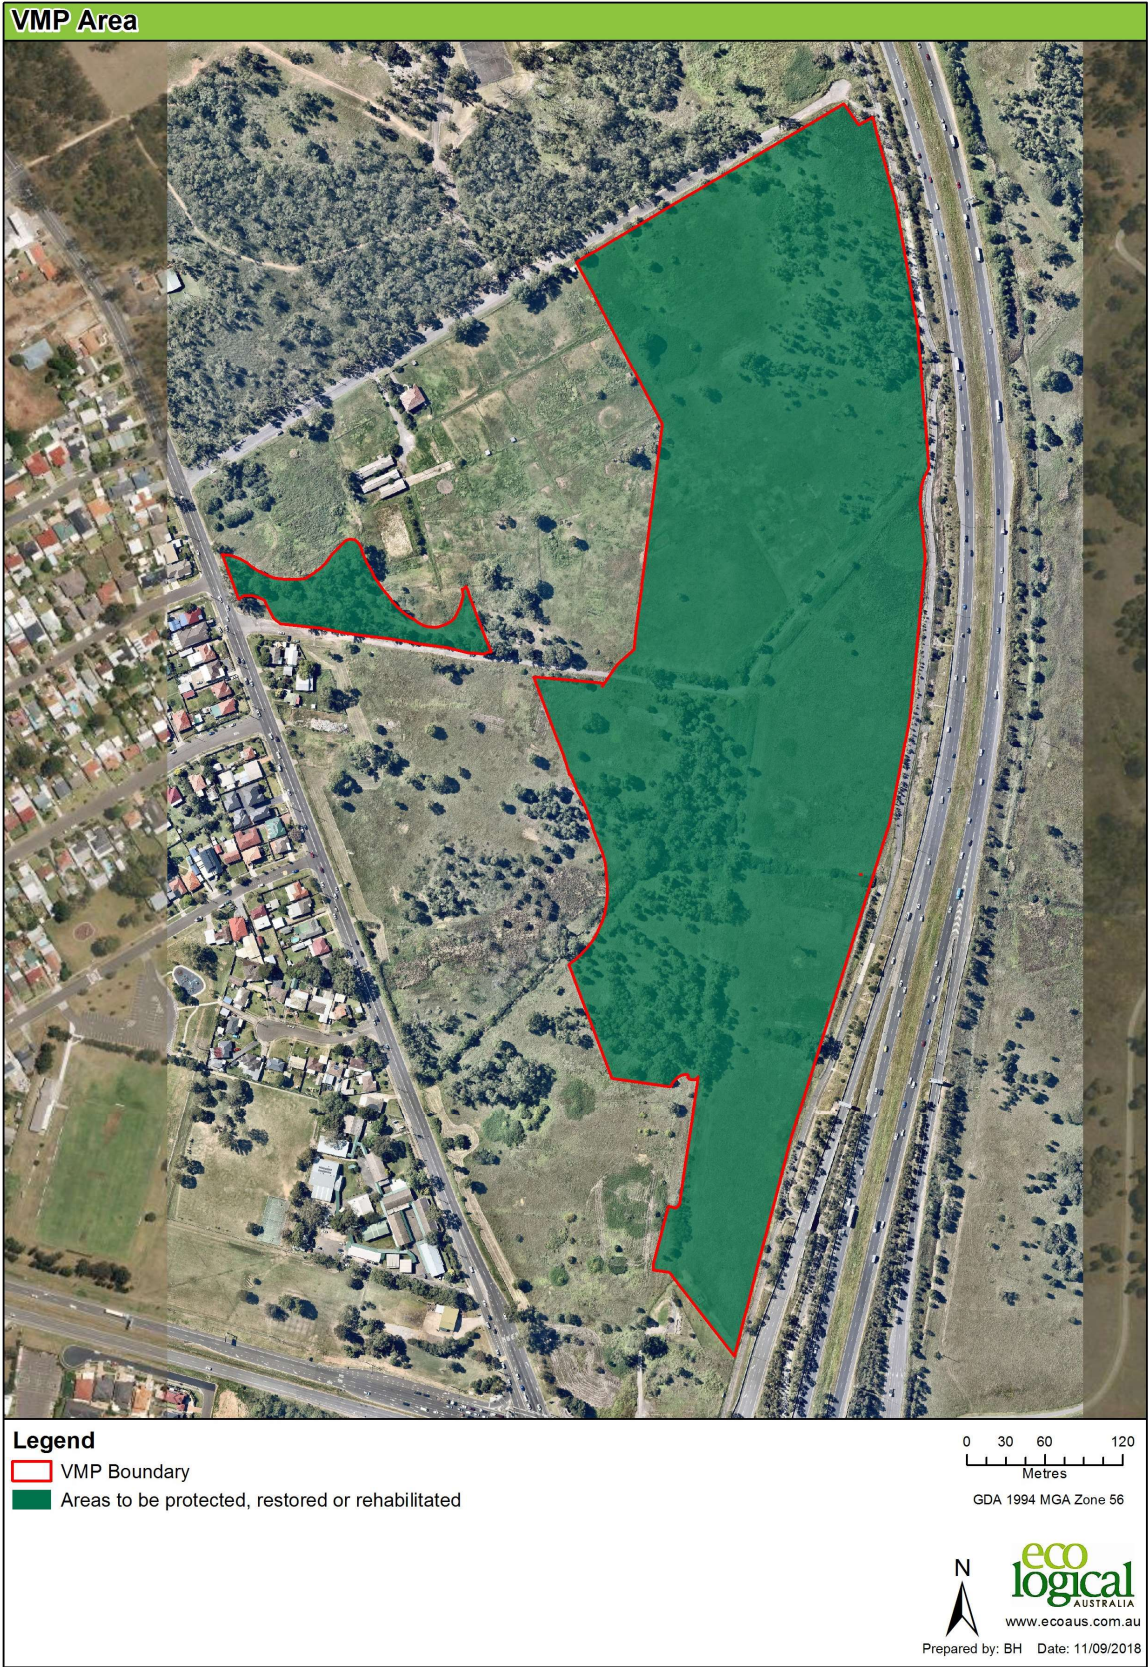
Figure 1 - VMP Area

The VMP area includes all vegetated areas to be managed under this VMP (Error! Reference source not found.).

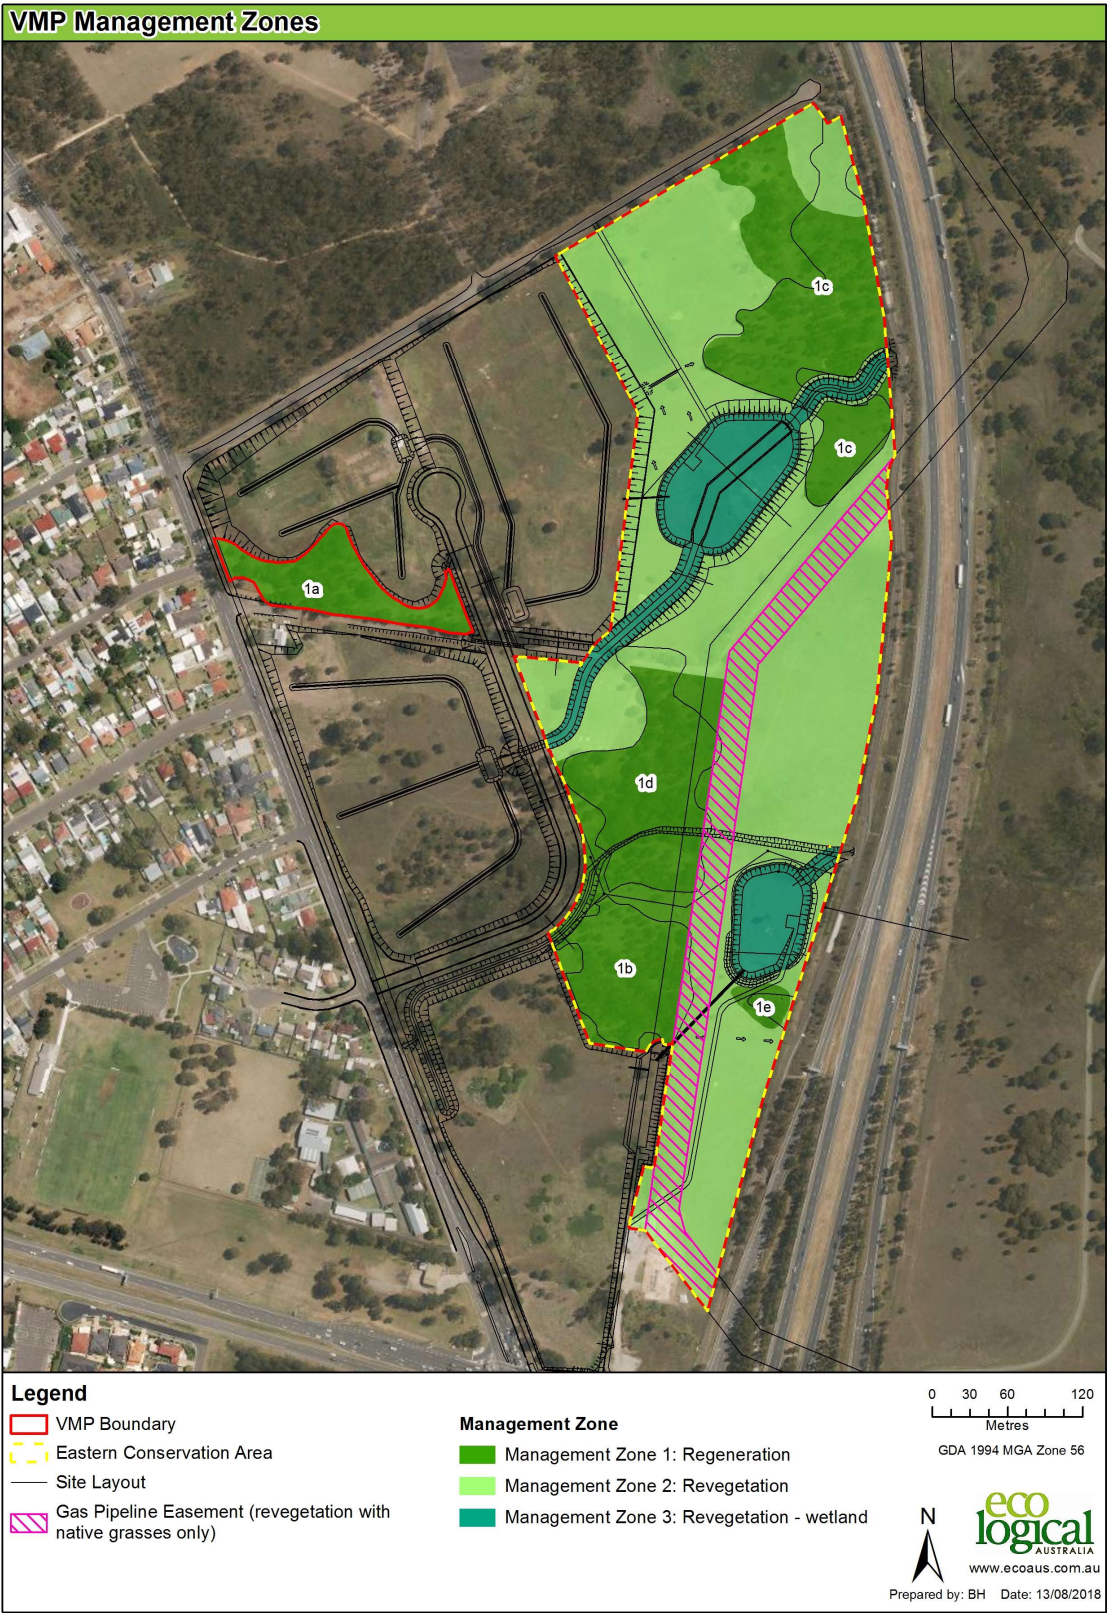
Figure 3: Vegetation management zones

Behind Beggs Rd verge, Zone 1a comprises a 0.7 ha of CPW remnant in poor to moderate condition. Zone 1a lies outside of the eastern conservation area. Native canopy is present, with limited amounts of native species in the shrub and groundcover layers.

Zone 1b comprises a 1.46 ha remnant patch of CPW in poor to moderate condition. Native canopy trees are present, native mid-storey species and native groundcovers.

Zone 1c, comprises a 2.17 ha CPW remnant, largely in good condition. Native canopy trees are young appearing to be recovering from an unknown disturbance event, *Bursaria spinosa* is present in the mid-storey and native grasses are present, including *Brunoniella australis*, *Dichondra repens*, *Microlaena stipoides* and *Themeda australis*.

Zone 1d comprises a 1.23 ha RFEF in moderate / good condition. Native canopy trees are present including *Melaleuca* sp. and includes native mid-storey species and native groundcovers.

Zone 1e comprises a 0.12 ha 'island' remnant of RFEF, surrounded by pasture areas (Zone 2). The zone is in good condition with *Melaleuca decora*, *Eucalyptus eugenioides* in the canopy, *Bursaria spinosa* in the mid-storey and *Microlaena stipoides* as groundcover. The zone is threatened by weed invasion from pasture areas, from weeds such as Kikuyu, Paspalum and Rhodes grass.

Zone 2, an area of 10.02 ha comprises the areas of site that will require revegetation, including proposed batters, the gas line easement and areas currently dominated by pasture grass, with few native shrubs or trees present. These areas will complete BC conditions only.

Zone 3, an area of 1.92 ha comprises the areas to be constructed and revegetated to native wetland including the channel base within constructed creek swales and the base of the OSD (onsite stormwater detention) / Bioretention basins. These areas will complete BC conditions only.
