Sydney Metro West, Stage 1

Technical Paper 4: Aboriginal Cultural
Heritage Assessment Report

Report to Sydney Metro

November 2020

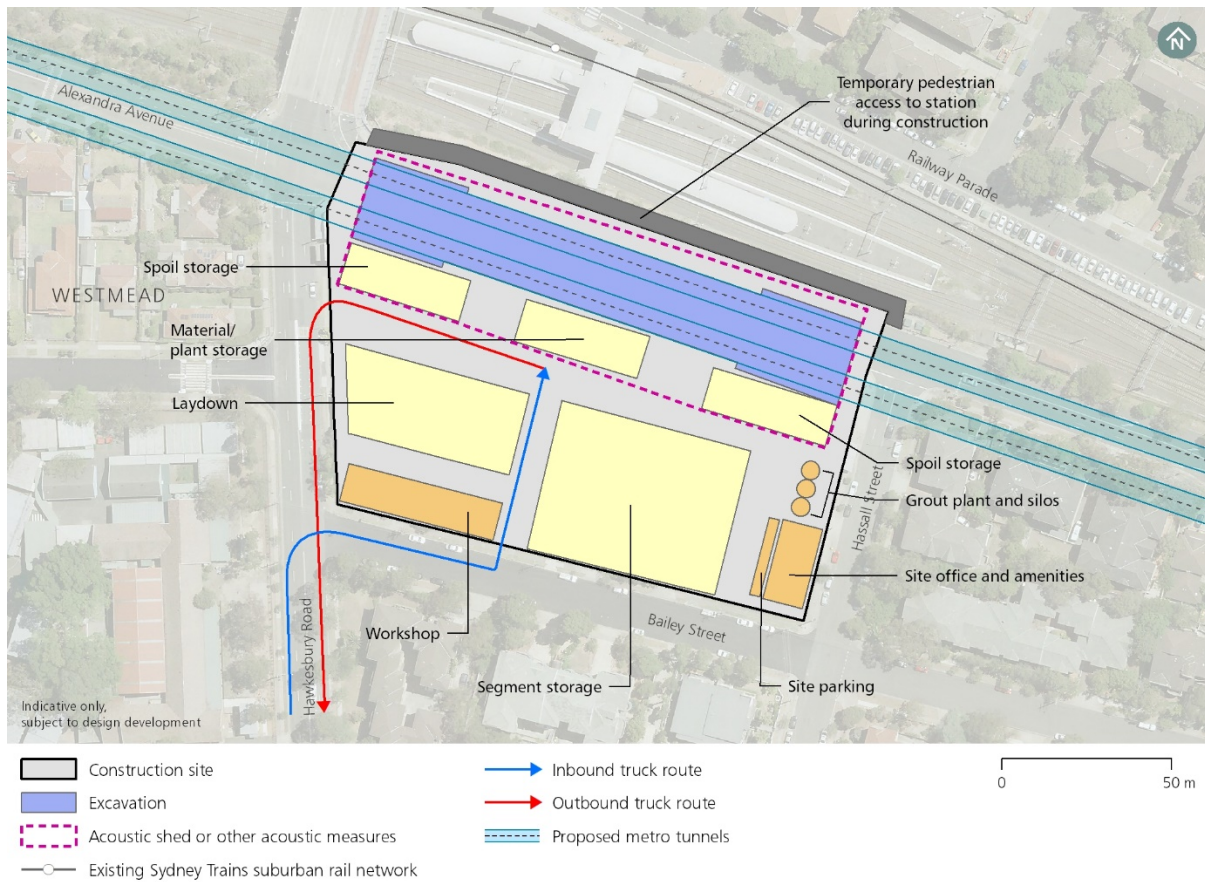
Figure 2: Westmead metro station construction site

The Westmead metro station construction site is illustrated in Figure 2. All existing structures would be removed from the site in order to clear the area for future excavation and construction. The excavation depth of the station would be around 32 metres in depth. An acoustic shed would be constructed at the construction site.

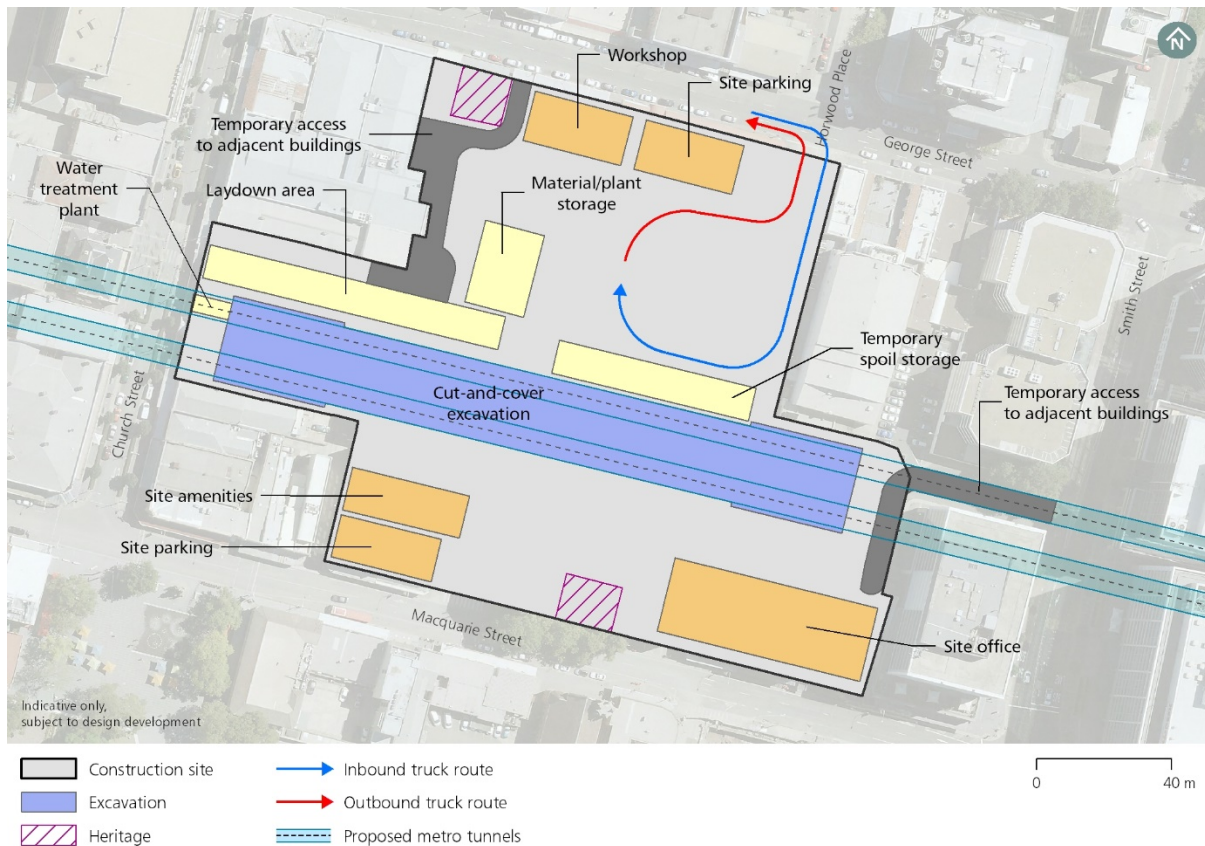
Figure 3: Parramatta metro station construction site

The final excavation depth of this station would be around 25 metres in depth.

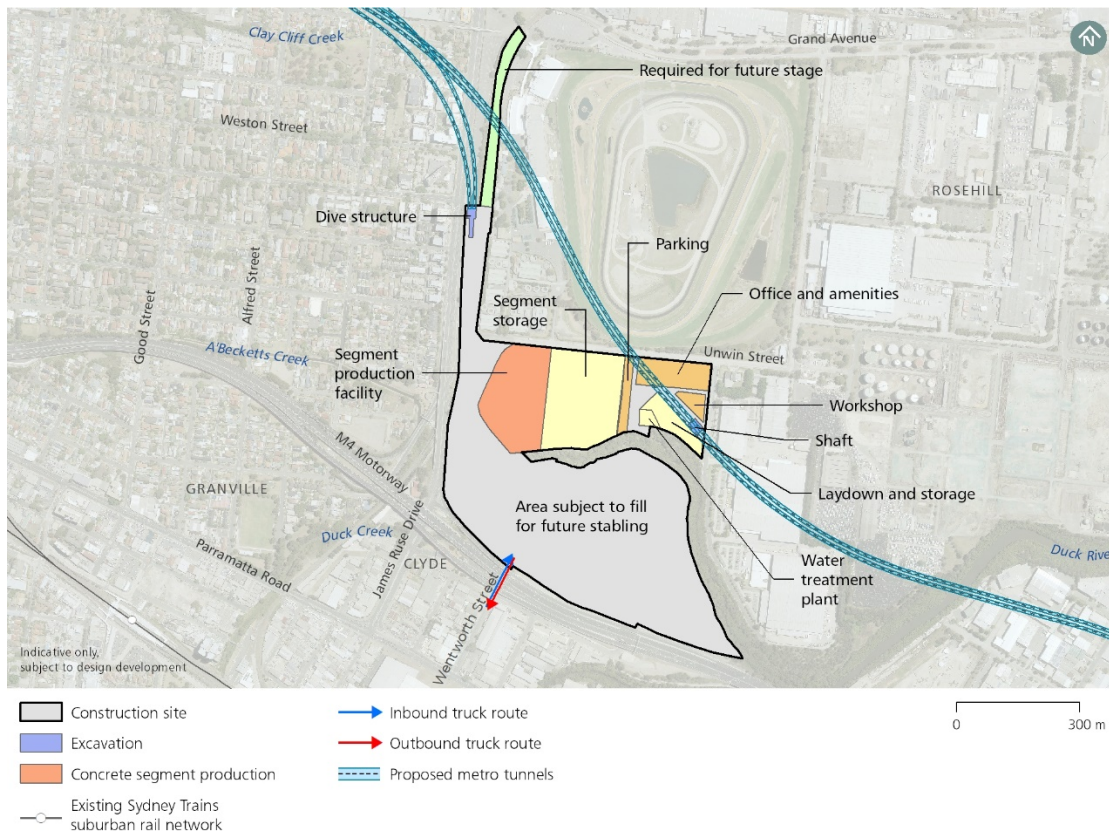
Figure 4: Clyde stabling and maintenance facility construction site

The Clyde stabling and maintenance facility would be constructed at ground level, at a site bounded by James Ruse Drive, Unwin Street, Shirley Street and the M4 Motorway in Clyde. This area is currently occupied by a variety of industrial facilities and the Sydney Speedway on NSW Government owned land. Works would involve the removal of all structures across the site to allow the construction of the proposed stabling and maintenance facility, with the exception of the façade of the RTA Depot 1B and 5 Unwin Street, Rosehill. The construction site would also include the excavation and construction of the dive structure and tunnel portal and a ventilation shaft at Rosehill and an underpass to support the realignment of Kay Street and Unwin Street. The construction site and areas of excavation are illustrated in Figure 4. The location of the Kay Street and Unwin Street route is illustrated in Figure 5.

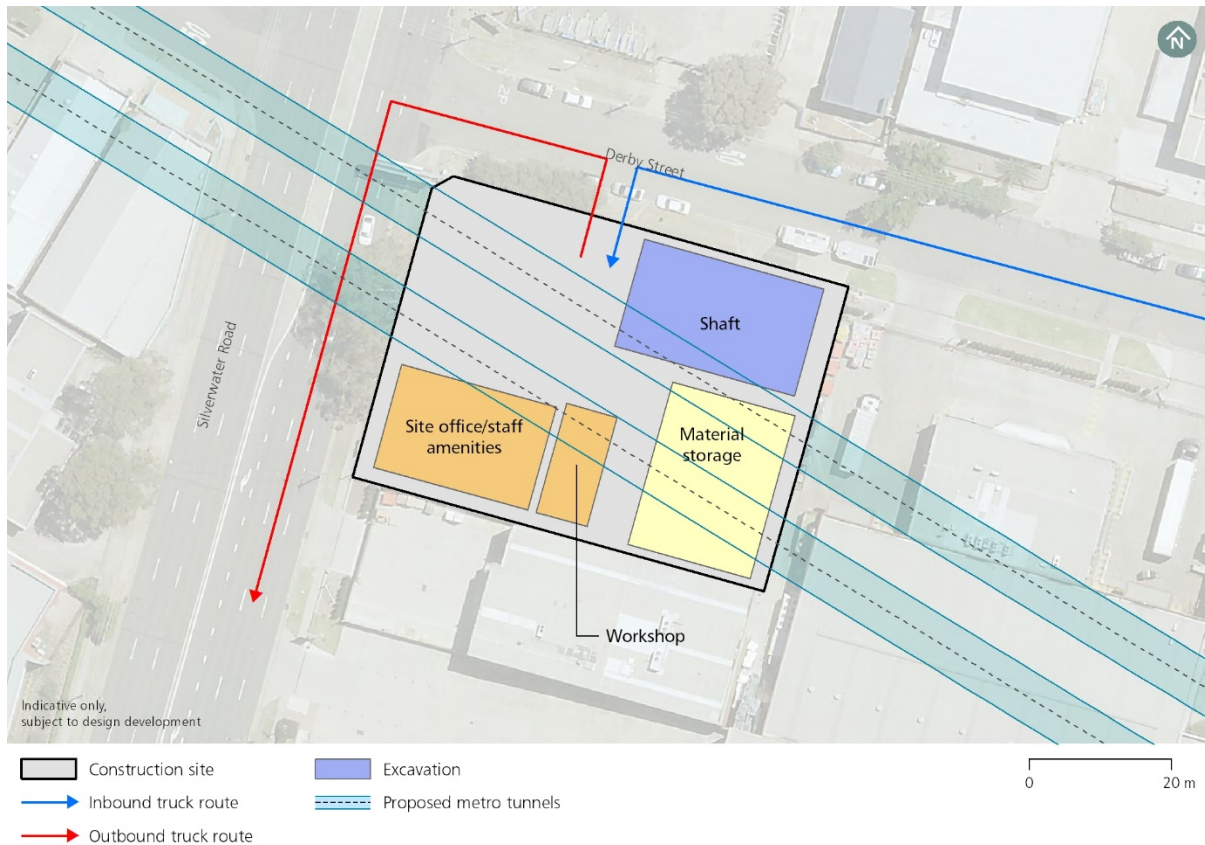
Figure 6: Silverwater services facility construction site

The Silverwater services facility would be constructed as a vertical shaft excavation, located on the corner of Silverwater Road and Derby Street in Silverwater. The site is currently a vacant lot. The construction site would include the excavation of and construction of a ventilation shaft to a depth of 46 metres. Construction offices and amenities for use during construction would also be constructed at the Silverwater services facility construction site. The construction site and area of excavation is illustrated in Figure 6.

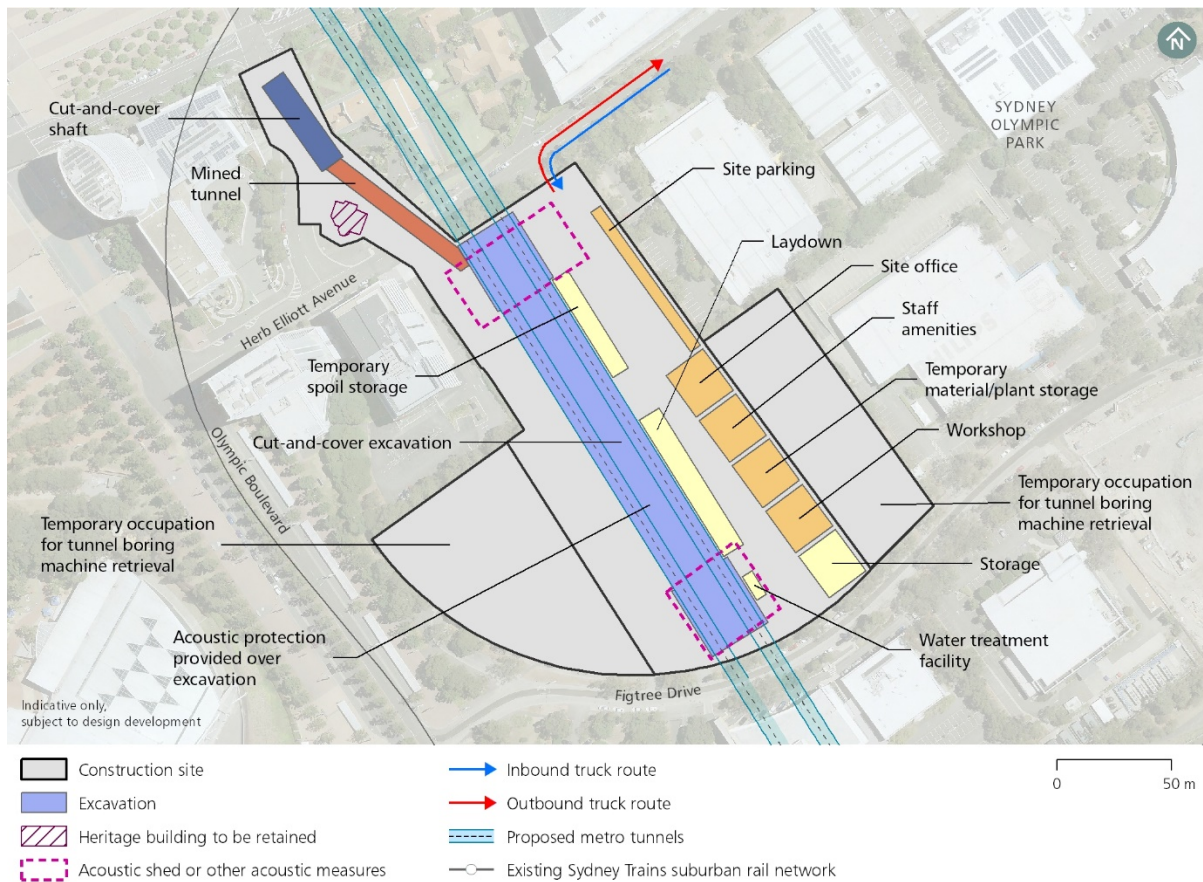
Figure 7: Sydney Olympic Park Station construction site

The Sydney Olympic Park metro station construction site is illustrated in Figure 7. All existing structures, except for the heritage-listed gatehouse in the northern portion of the construction site, would be removed from the site in order to clear the area for future excavation work and construction. The final excavation depth of this station would be around 25 metres. Acoustic sheds would be constructed at the Sydney Olympic Park metro station construction site.

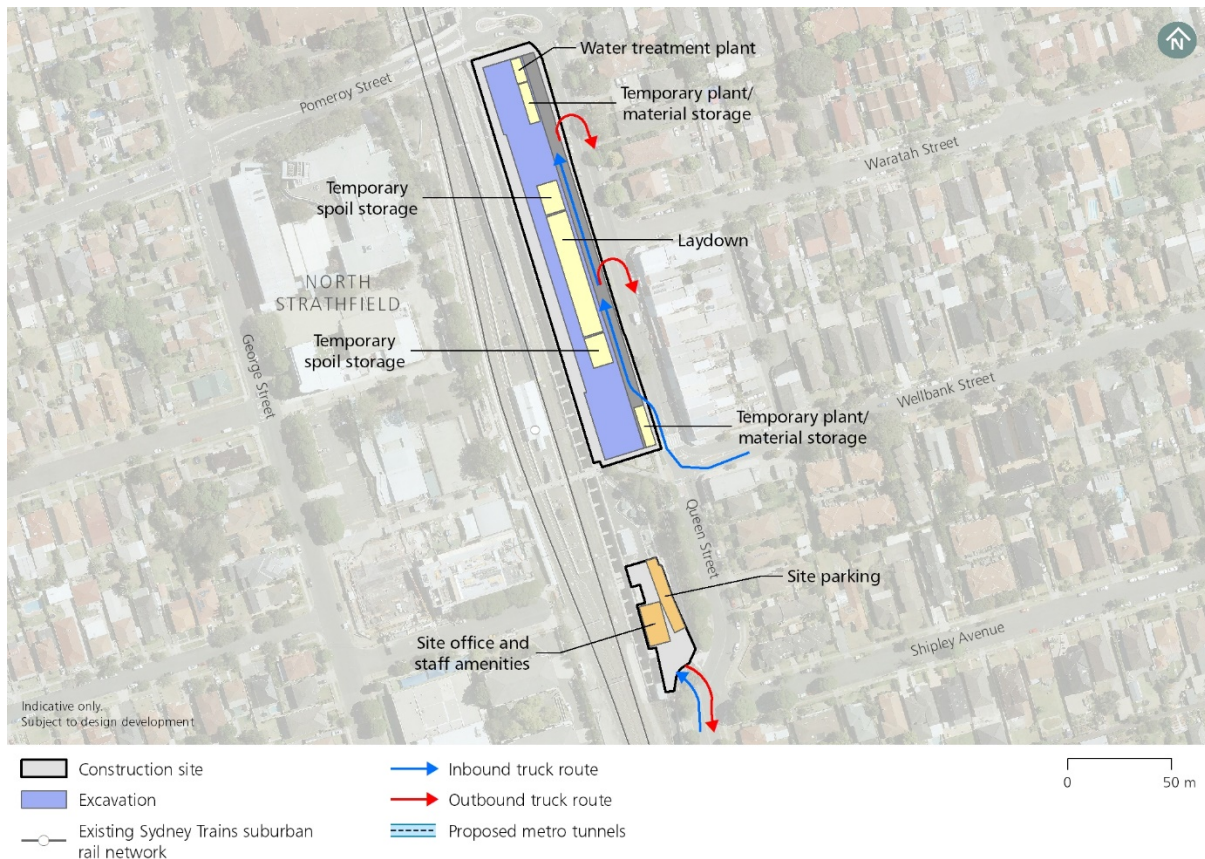
Figure 8: North Strathfield metro station construction site

The North Strathfield metro station construction site is illustrated in Figure 8. The final excavation depth of this station would be around 18 metres in depth.

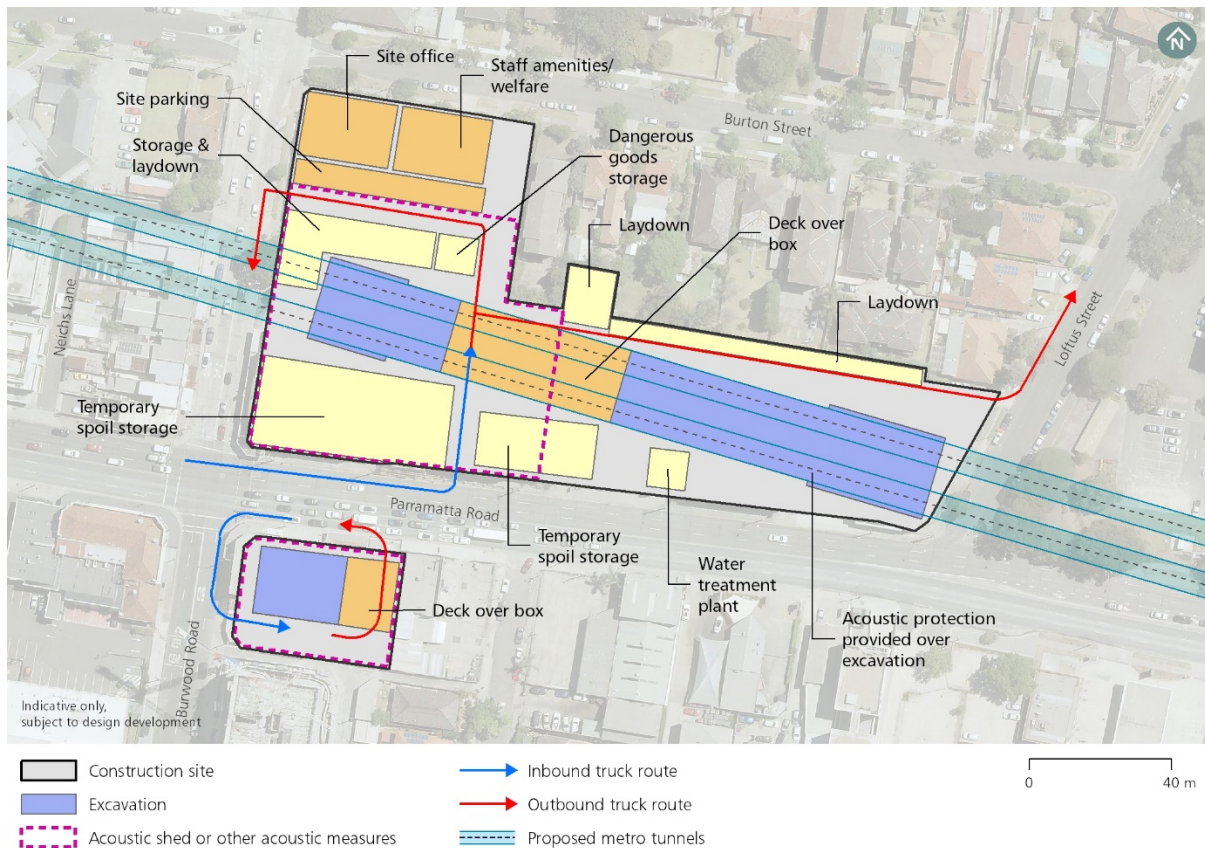
Figure 9: Burwood North Station construction site

The Burwood North Station construction site is illustrated in Figure 9. All existing structures would be removed from the site in order to clear the area for future excavation work and construction. The final excavation depth of this station would be around 32 metres in depth. Acoustic sheds would be constructed at the Burwood North Station construction sites.

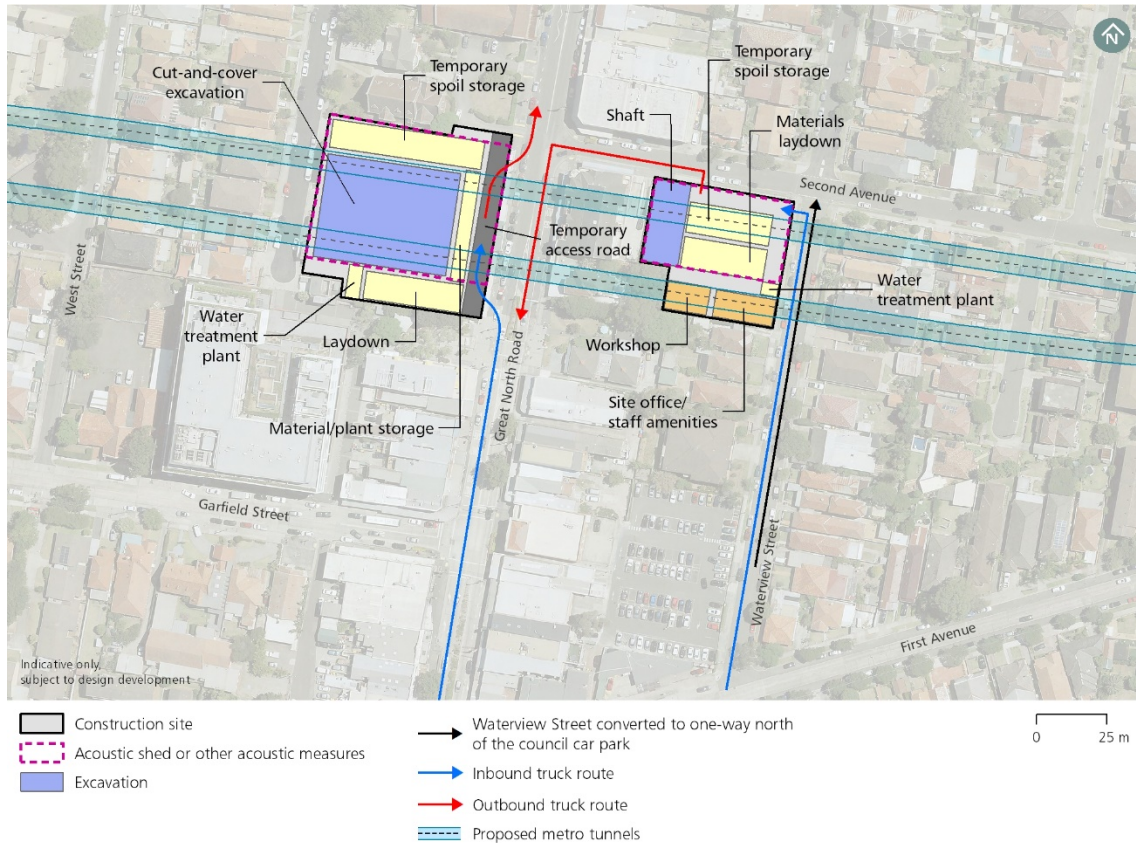
Figure 10: Five Dock Station construction site

The Five Dock Station construction site is illustrated in Figure 10. All existing structures would be removed from the site in order to clear the area for future excavation work and construction. The final excavation depth of this station would be around 30 metres in depth. Acoustic sheds would be constructed at each construction site.

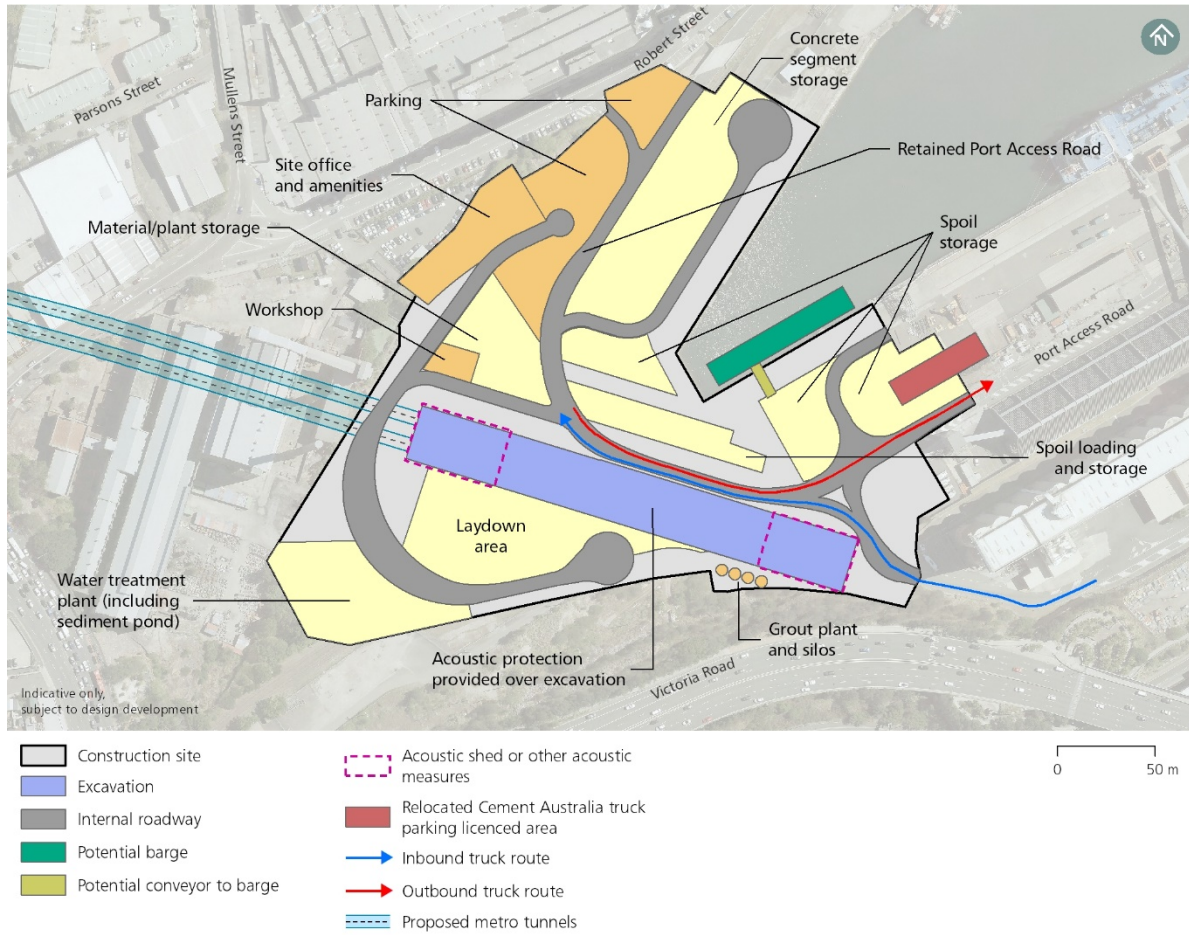
Figure 11: The Bays Station construction site

The Bays Station construction site is illustrated in Figure 11. All existing structures would be removed from the site in order to clear the area for future excavation work and construction. The final excavation depth of this station would be around 32 metres in depth.

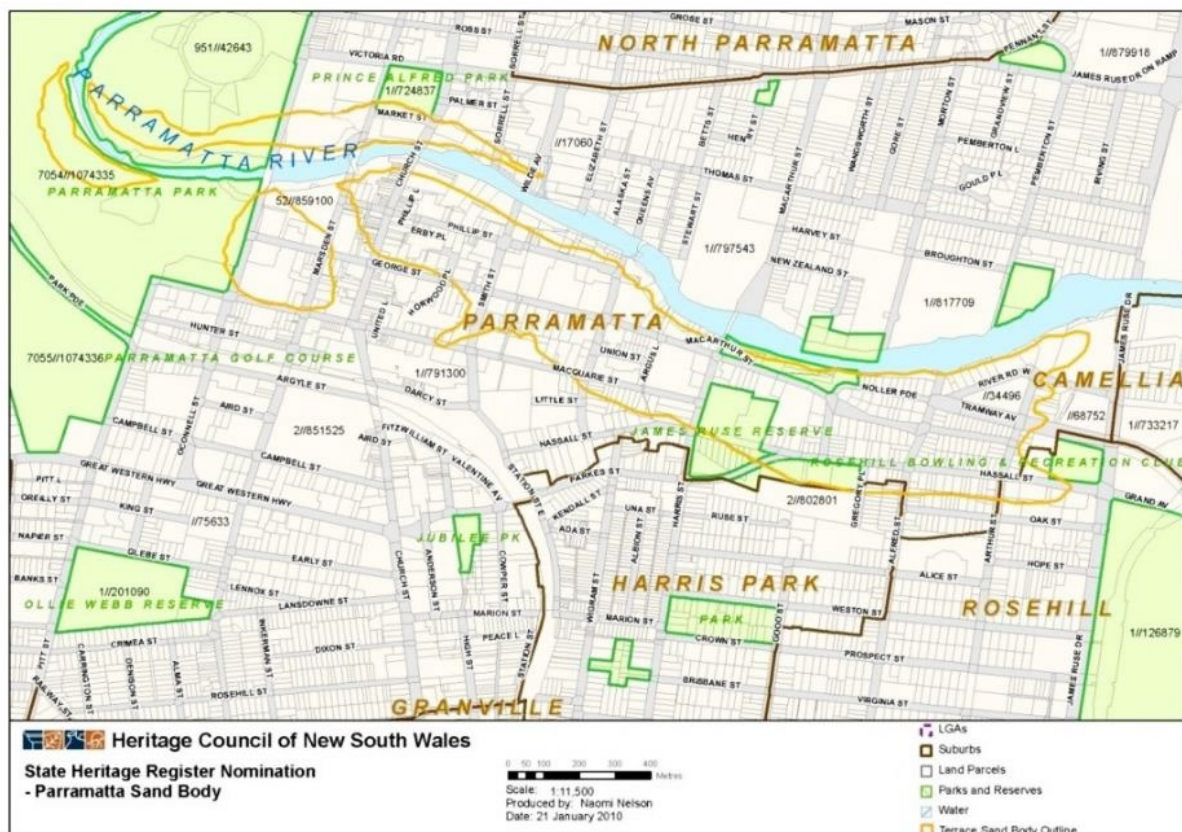
The Parramatta Sand Body is a significant archaeological resource with evidence of Aboriginal activities dating from the Holocene and Pleistocene epochs.¹⁴ The sand body is also relatively deep, increasing the possibility of portions of the sand body surviving beneath phases of historical development. Portions of the Parramatta metro station may contain the Parramatta Sand Body.

Figure 12: Mapped location of Parramatta Sand Body

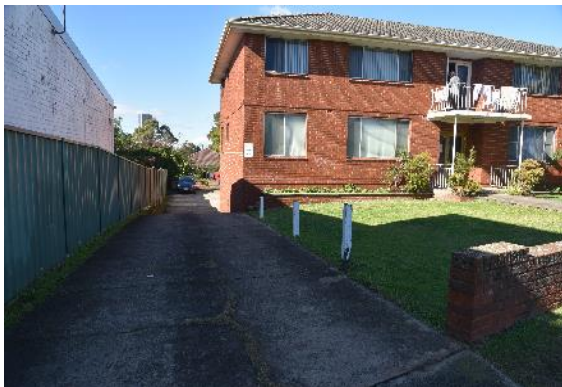
Figure 19: Observed landform modification associated with residential construction within Westmead metro station construction site

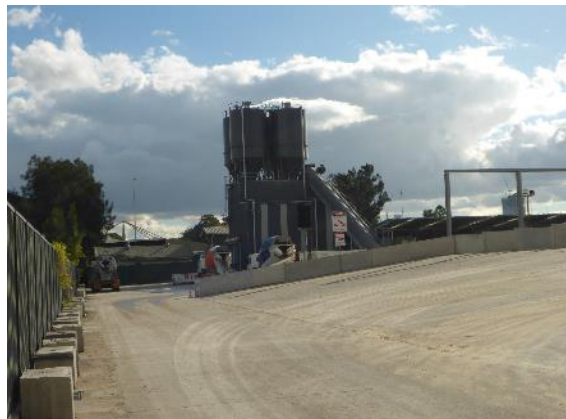
Figure 30: View west from Shirley Street showing existing landform modification associated with heavy industry

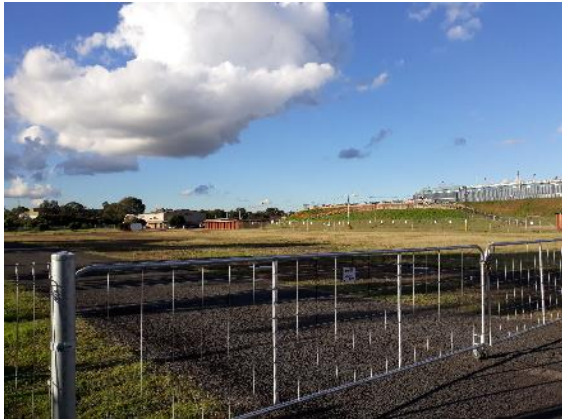
Figure 31: View east towards Sydney Speedway showing landform modification related to the speedway track

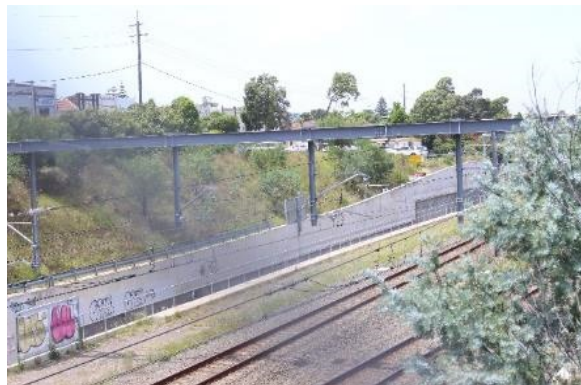
Figure 48: View across the rail corridor, showing modified landform context

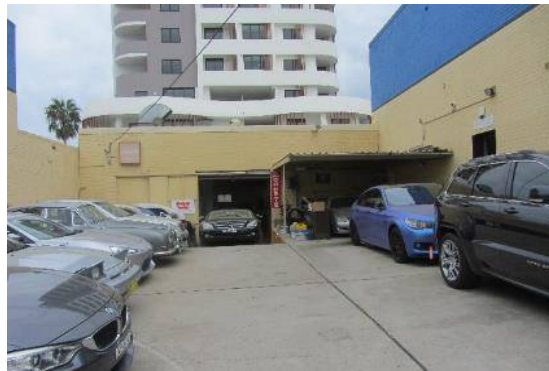
Figure 53: View south of southern construction site showing modified landform and existing disturbance

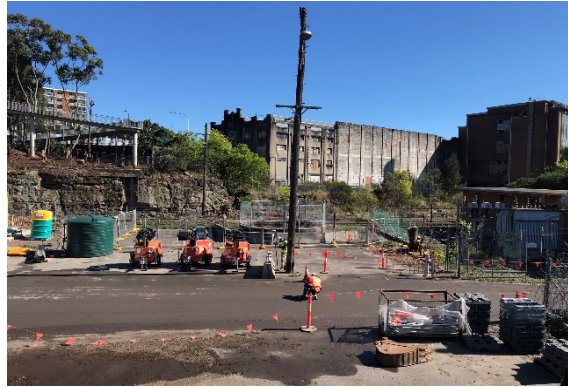
Figure 66: View of existing sandstone cuttings adjacent to the former White Bay Power Station to the west of The Bays Station construction site

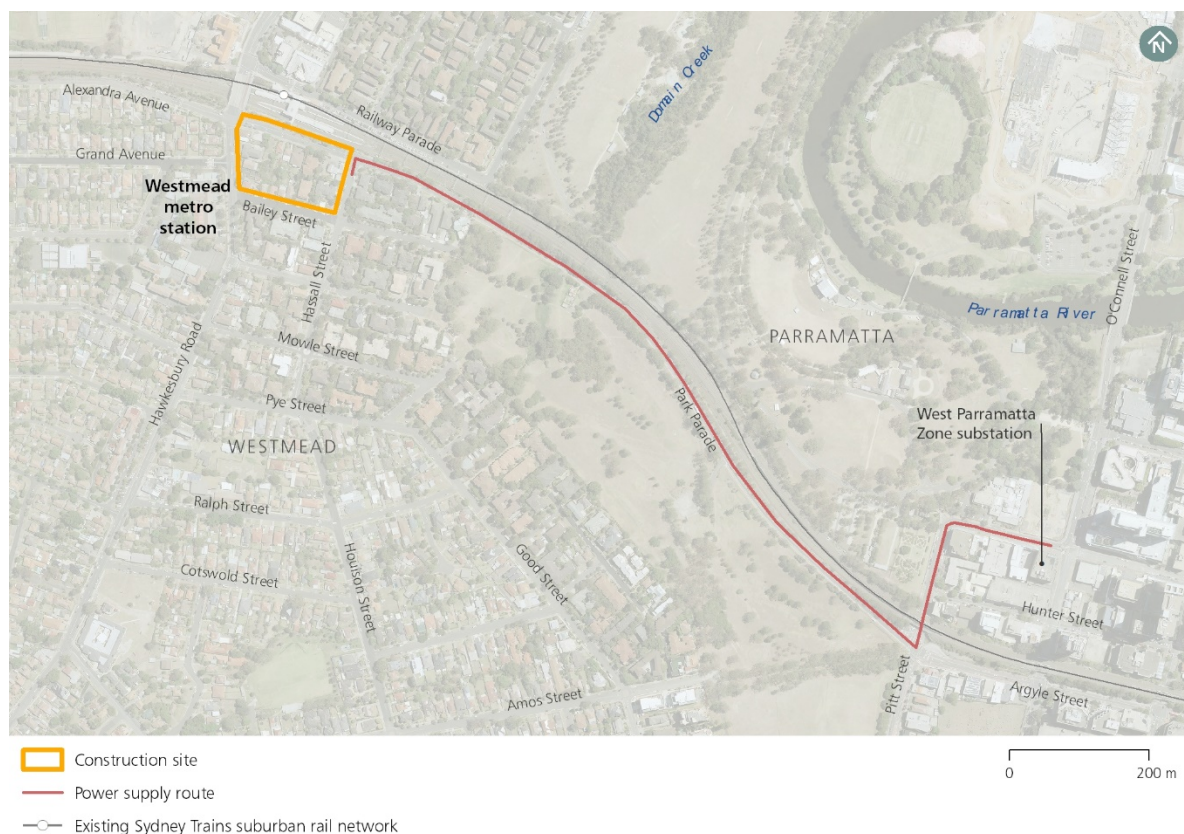
Figure 69: Proposed location of Westmead power supply route

Westmead power supply route	
Construction site:	Westmead metro station
Location:	Hawkesbury Road, Great Western Highway
Environmental factors	<ul style="list-style-type: none"> Power supply route is located across a sloped landform within the shallow residual Blacktown soil landscape. Soils within the power supply route are underlain by shale. The route crosses Domain Creek (which passes under Park Parade). Northern portion of the power supply route is located within 300 metres of Parramatta River
Known disturbances	<ul style="list-style-type: none"> Major disturbances include road construction and existing services. Disturbances considered likely to have removed intact natural soil deposits.
AHIMS sites	Several AHIMS sites are located within 100 metres of the power supply route including AHIMS ID 45-5-4942, AHIMS ID 45-5-4530 and AHIMS ID 45-5-4536
Archaeological potential	Low

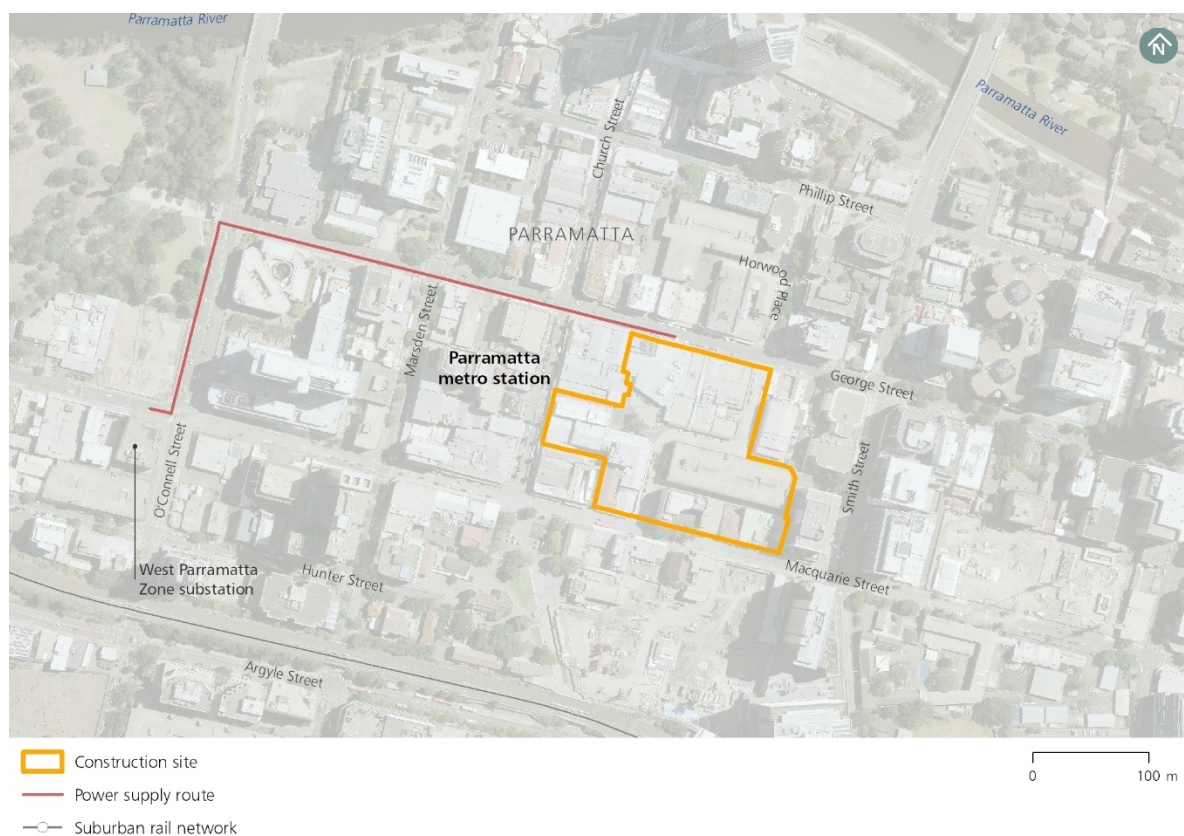
Figure 70: Proposed location of Parramatta power supply route

Parramatta power supply route	
Construction site:	Parramatta metro station
Location:	George Street, O'Connell Street, Macquarie Street
Environmental factors	<ul style="list-style-type: none"> Power supply route crosses a flat landform. Portions of the power supply route located within the mapped extent of the Parramatta Sand Body Western portion of power supply route located within 150m of the Parramatta River
Known disturbances	<ul style="list-style-type: none"> Major disturbances include road construction and existing services.
AHIMS sites	An area of PAD (AHIMS ID 45-5-4097) is located within power supply route corridor along O'Connell Street and the western portion of George Street
Archaeological potential	Moderate
