HERITAGE IMPACT STATEMENT

TRINITY GRAMMAR SCHOOL

PREPARED FOR TRINITY GRAMMAR SCHOOL

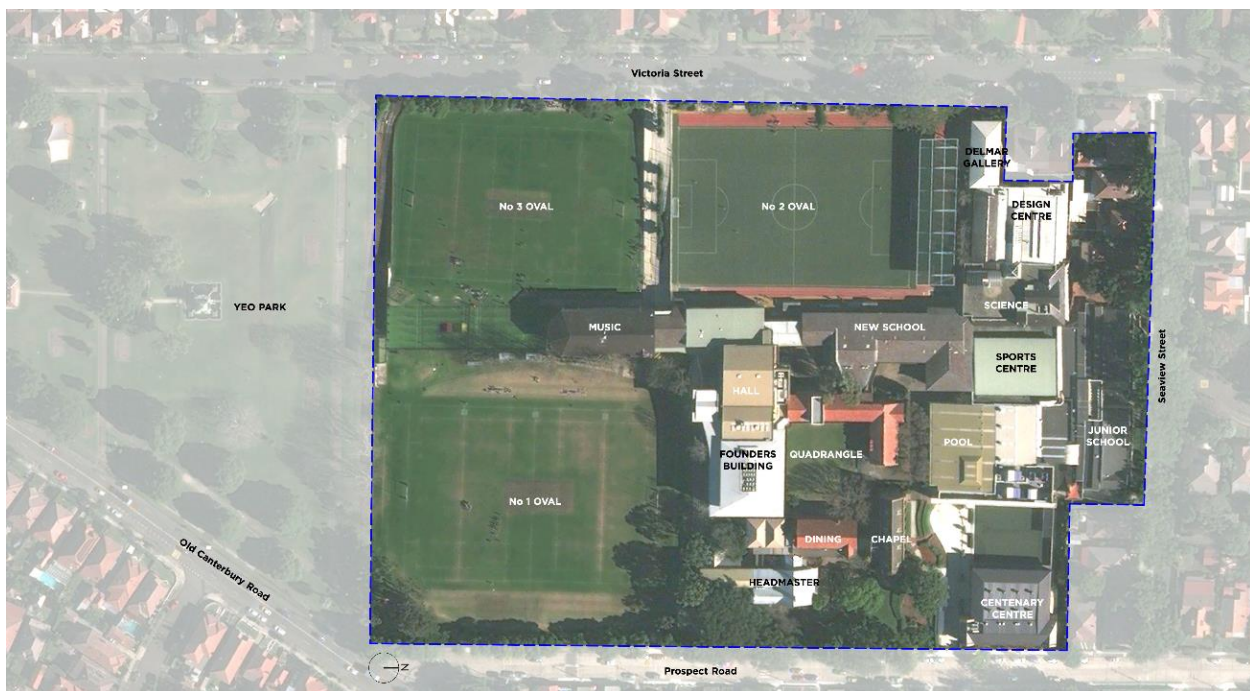
Figure 3 – Site aerial identifying building on the site.

The nomenclature has been established by Trinity Grammar School. In some instances, however, it has been necessary to develop a naming structure as to define specific built elements. Figure 3 overleaf, is the publicly available plan of the site; this plan is presented alongside Figure 4, an aerial image of the site.

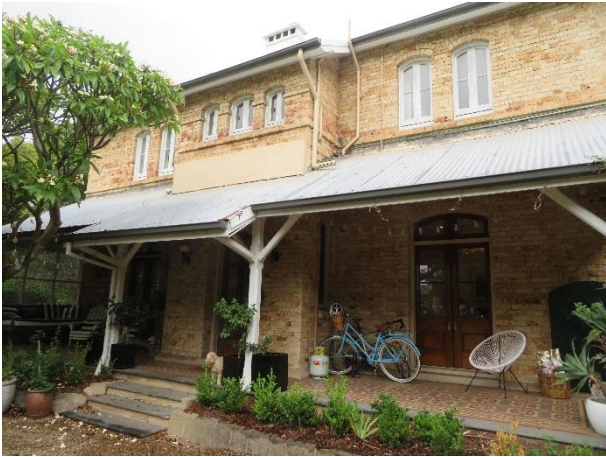
Figure 4 – Primary façade (north) and entrance, Headmaster's residence.

The primary façade of the dwelling fronts north onto formal landscaped gardens belonging to the residence. Mature hedging shields the property from Prospect Road, Summer Hill.

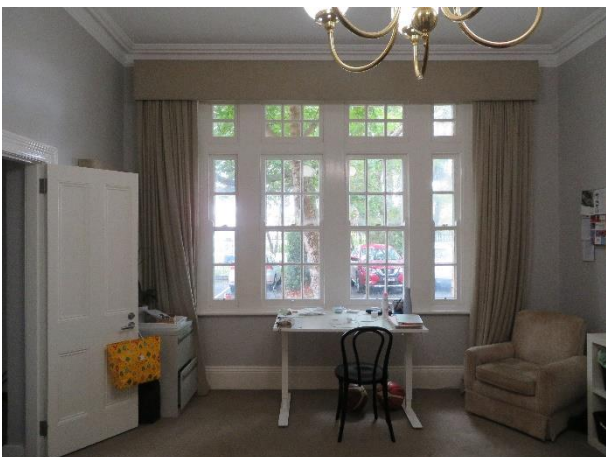
Figure 8 – Window settings, headmaster's residence.

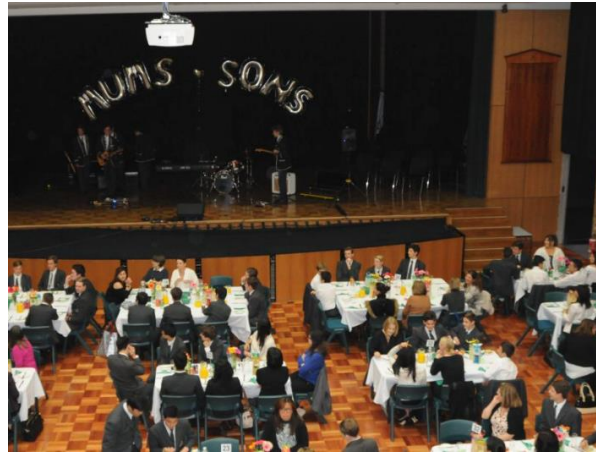
Figure 15 – Internal view of James Wilson Hogg Assembly Hall.

The James Wilson Hogg Assembly Hall is located in proximity to the Quadrangle, adjacent to the New Founder's Building. The entrance references that of the New Founder's Building, featuring a red brick construction and arched colonnade. An internal inspection of the building was not undertaken during the site inspection however, consultation of available internal images indicates that the hall is a brick construction with parquetry floor and tiered seating.

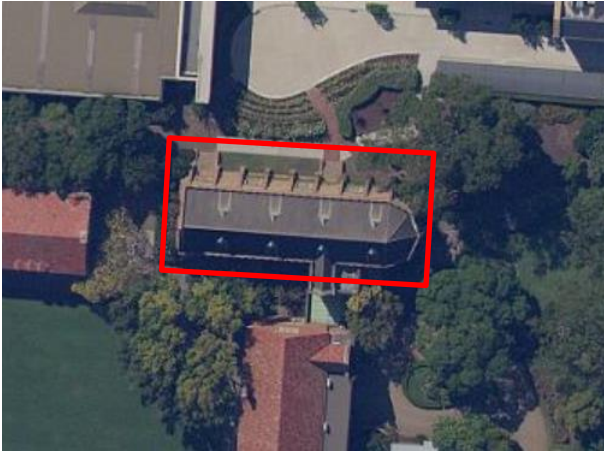
Figure 16 – Aerial image of War Memorial Chapel indicated in red.

Externally, the chapel is a rectangular building eight bays long with a polygonal east end. The chapel features a parapeted west gable with crenelated side parapets. Four centred arch windows with perpendicular tracery is positioned in alternate bays. Internally the building features curved principal rafters on timber brackets with exposed purlins and rafters top lined with tongue and groove boarding. Internal brick piers with staff beads and a highly decorated stained-glass east window contribute to the character of the chapel.

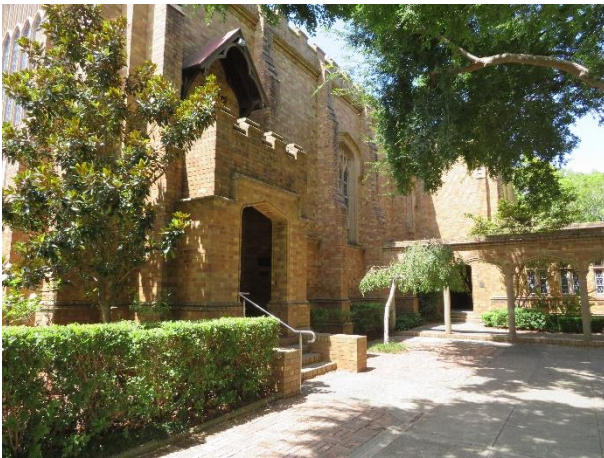
Figure 18 – Entrance to the Chapel from the west elevation.

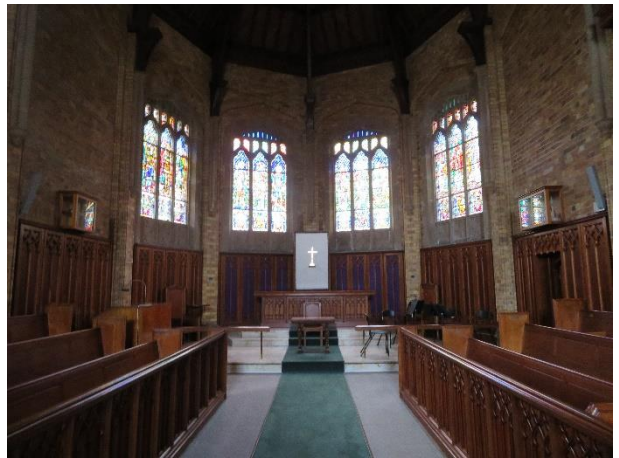
Figure 19 – Internal view of Chapel and stained-glass windows.

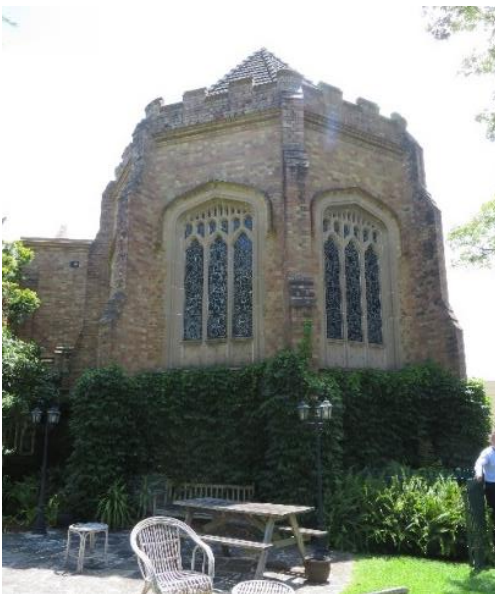
Figure 20 – Exterior detail of the War Memorial Chapel.

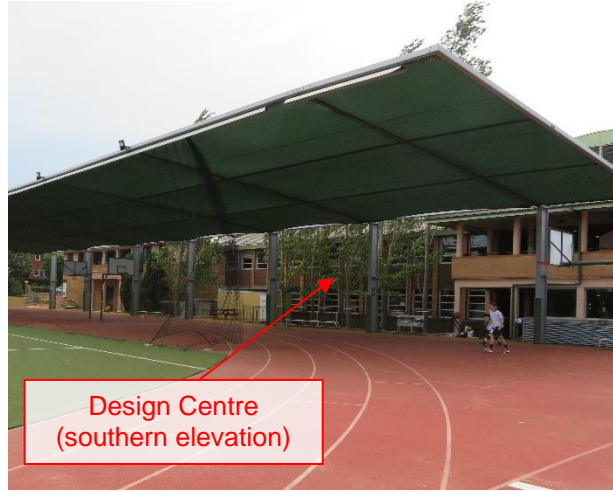
Figure 26 – South elevation of the Design Centre (indicated), located between the Delmar Gallery and the School of Science. This section of the building is the original Arts and Crafts portion of the building.

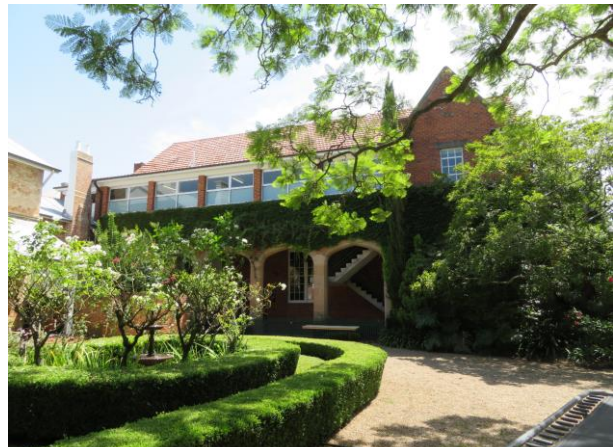
Figure 28 – East elevation of the Dining Hall.

The building that houses the Dining Hall is located on the eastern side of the campus, adjacent to the Headmasters Residence and Office and south of the Chapel. The building forms the eastern side of the quadrangle. The building is a two-storey rectangular, brick building, with a hipped roof form. The east elevation has a colonnade with sandstone arches (in a Tudor style) and is covered in ivy. The west elevation, which faces inward to the quadrangle, has minimal detailing, though features distinct twelve-pane windows. All doorways leading into the Hall are Tudor style, reflecting the interior. The ceiling detail and fireplace are Tudor in style and the timber panelling, installed in 1951, by the Old Trinitarian' Union as a memorial to those Trinitarians who served in World War II.

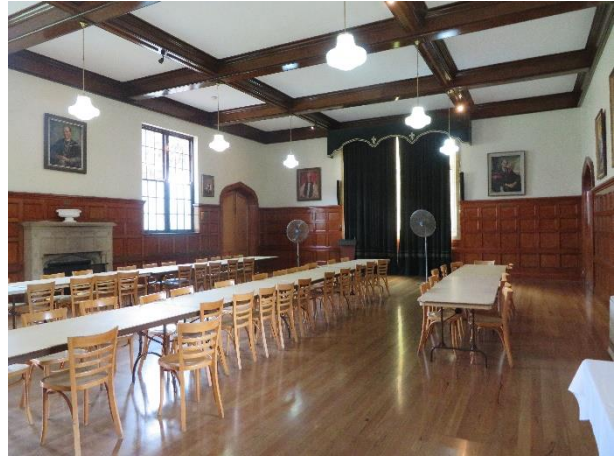
Figure 30 – Interior of the Dining Hall, showing ceiling battens, timber panelling and fireplace.

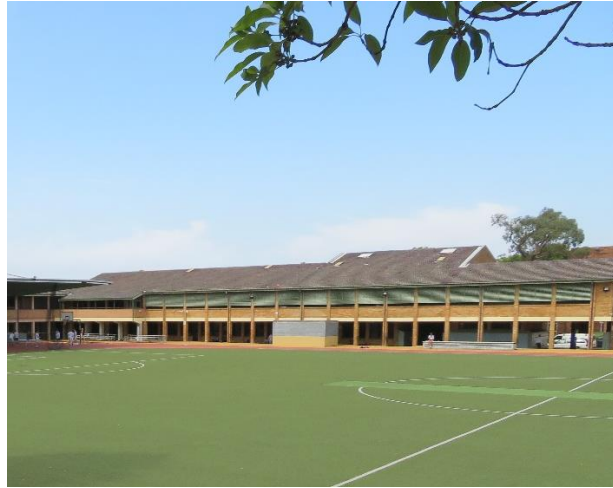
Figure 36 – West elevation of the New School Building.

The New School was constructed in 1982 along with the Latham Theatre which is connect to the east.⁵ The New School Building is located between the School of Science and the Health Centre building. The building is a two-storey structure constructed in the late-twentieth century, featuring face exposed brick and a modular form. A colonnade that extends the length of the west elevation creates a covered walkway that extends to the School of Science. The building was constructed on the site of the Hurlstone Agricultural College Buildings, which were demolished c. 1961.

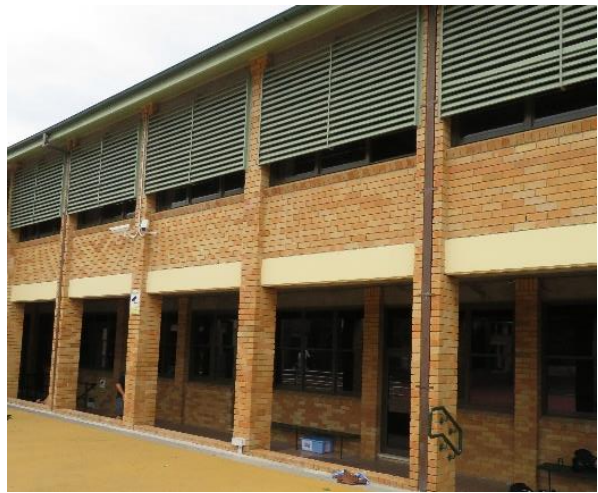
Figure 38 – Colonnade of the New School Building.

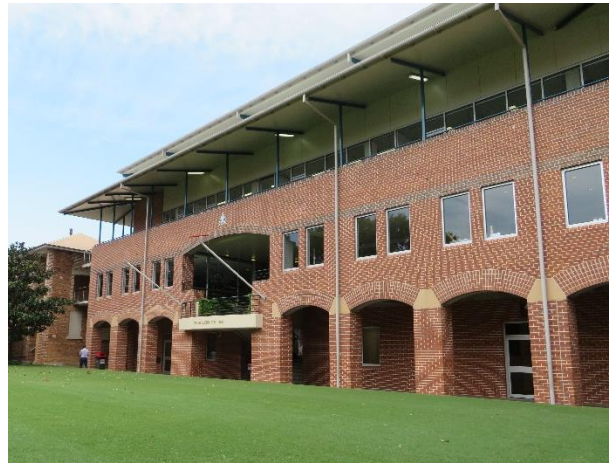
Figure 45 – View of the New Founder's Building from the Quadrangle.

The New Founder's Building has been designed to reference the Old Founder's Building, including the colonnade and face brick. The Old Founder's Building was located in the same location and had been built in 1937.

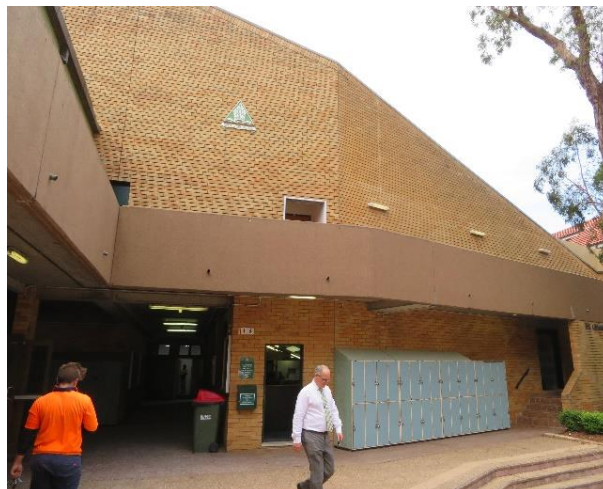
Figure 48 – Northern entrance to the Latham Building.

The Latham Theatre was constructed in 1982, along with the New School adjacent to the west. Additionally, the theatre connects to the North Quad Building, located to the east.⁶ The structure is an irregular shape and has a pale-yellow face brick finish. Two courtyards are positioned adjacent to the building, known as Compass Court and the Greek Theatre. There are two entrances to the theatre, from the north and south respectively. Latham Theatre is named in honour of Mr Latham's Geology Laboratory that was historically located in this position.⁷

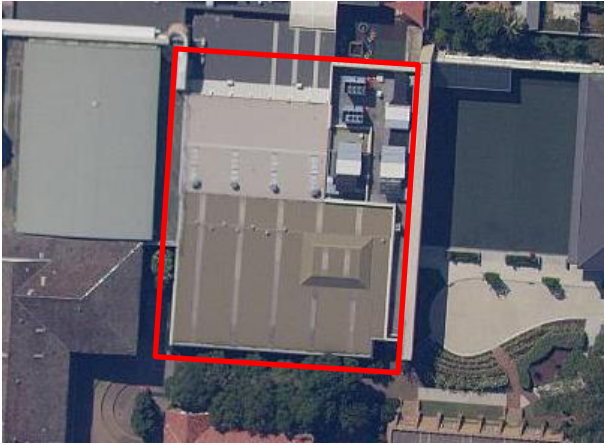
The school historically had an outdoor pool sited in proximity to the chapel, this pool was demolished following the construction of the indoor Swimming Centre in 1985. The Swimming Centre is rectangular in form and has a flat roof. Two sides of the building (the western and southern) feature glazed walls. Later modifications were undertaken to the Swimming Centre, including the addition of the western wall which identifies the indoor pool as part of the Centenary Centre.

Figure 54 – Aerial image of the Swimming Centre, indicated in red.

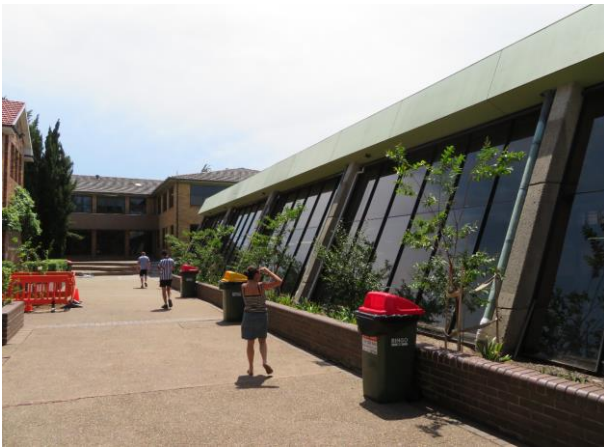
Figure 56 – South elevation of the Swimming Centre.

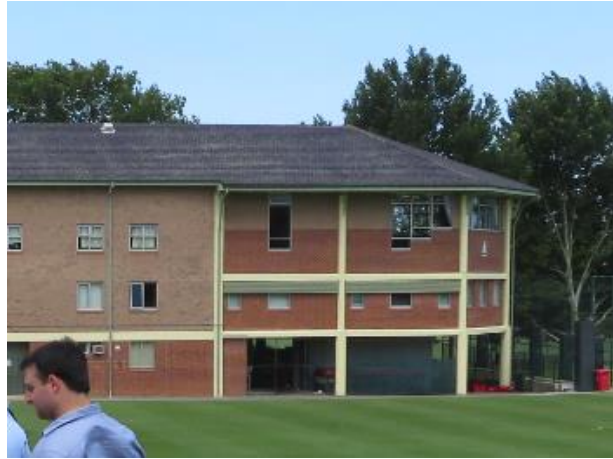
The Roderick West School of Music is located to the south of the site and is positioned between No. 1 and No. 3 Ovals. The building is named after Roderick Ian West, Headmaster between 1975-1996. The building was constructed in 1996. It is understood that the building contains a choir room, orchestra room, band room, music-composing computer labs, a recording studio and 30 music studios. The building is a three-storey structure with a pitched roof. It is constructed out of brick and reinforced concrete.

Figure 59 – West elevation of the Roderick West School of Music.

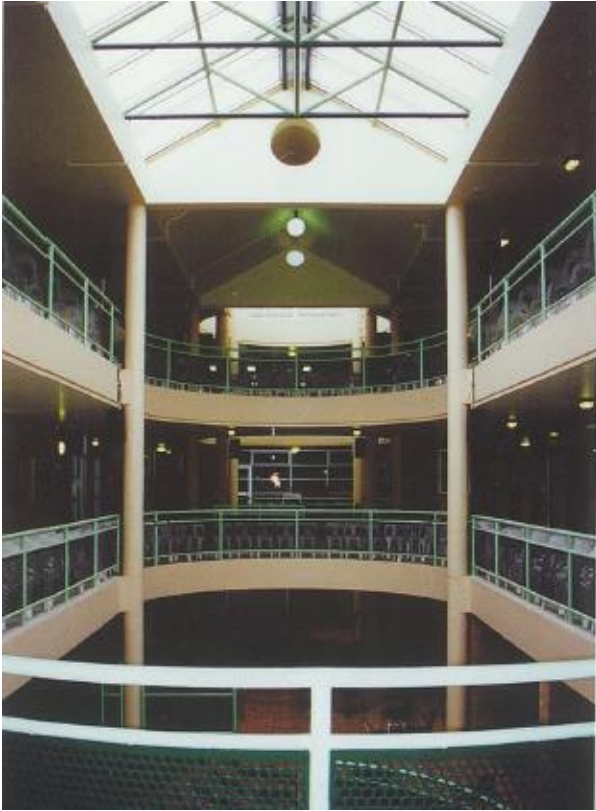
The School of Science is located to the north of the No. 2 Oval and is located between the Design Centre to the west and the Sports Centre to the east. The School of Science building includes an atrium in the centre of the building that connects it to the Design Centre. The New School Building is located to the south of the School of Science. The primary entrance to the building is to the north, accessible from Seaview Street.

Figure 62 – Internal atrium of the School of Science and Design Centre.

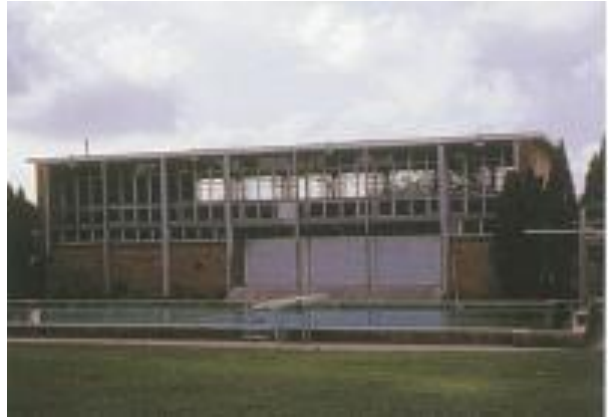
The Sports Centre was constructed in 1989, the same year as the Design Centre. It is understood that the Sports Centre replaced an earlier gymnasium (constructed 1962) that was located alongside the outdoor pool (both now demolished).⁸

Figure 65 – Former Gymnasium, previously located in proximity to former outdoor swimming pool.

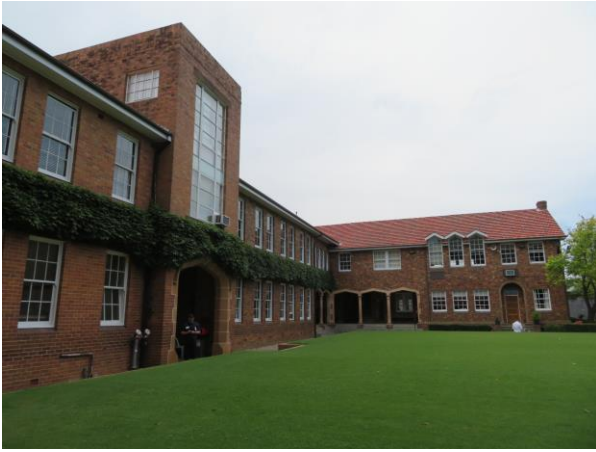
Figure 68 – View of northern and western portions of the North Quad Building from within the Quadrangle, showing the upper, central functionalist element.

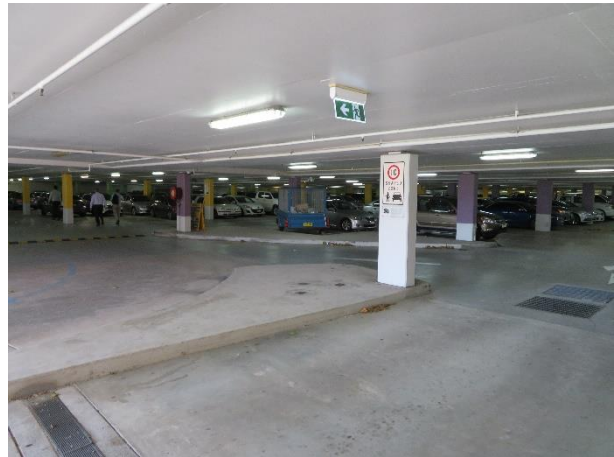
Contemporary alterations to the No. 2 Oval have allowed for the oval to be retained and serve as the roof of an underground parking for the site (accessible from Victoria Road). The No. 2 Oval is not grassed, rather it has a running track around the outside and features artificial grass within.

Figure 86 – Underground parking facilities below No.2 Oval.

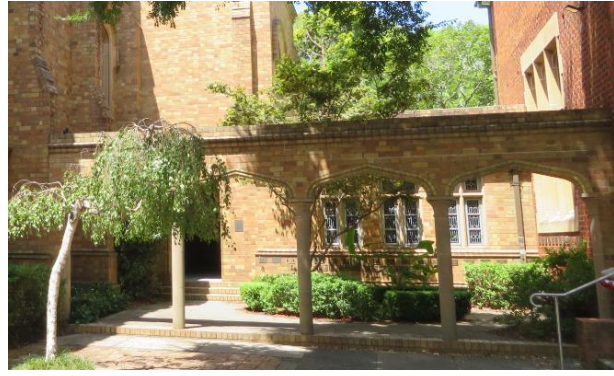
The War Memorial Chapel Court is located southeast of the chapel, and to the north of the Dining Hall Building. The courtyard contains commemorative plaques to former Headmasters, staff, Trinitarians, School Councillors, and supporters the courtyard is associated with the chapel though was constructed in 1962 (the War Memorial Chapel was constructed in 1957).

The War Memorial Chapel Court has been altered throughout its history, with the earlier fountain having been replaced for a central tree and hedge feature. It is understood that the commemorative plaques are still insitu and can be seen surrounding about the space.

Figure 88 – Chapel Court.

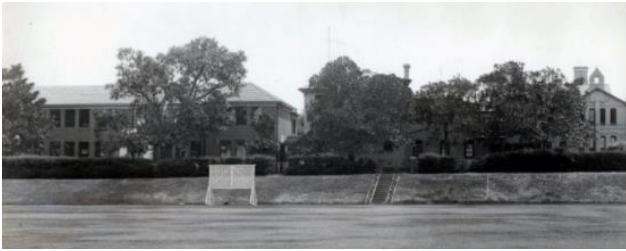
Figure 109 The first Founders Building

"the new classroom block at the Trinity Grammar School, Summer Hill, which as opened by Archbishop Mowll last week, is a step forward in the progress of that school. The building...is constructed of face bricks, with semi-glazed tile roof. It contains six classrooms, a reference library, masters' common room and offices....The rooms are lighted by southern windows overlooking the school oval. The new building will form a section of a large quadrangular layout...The classroom block just completed was erected by R. Pennington, Annandale, to plans under the supervision of F.B.B. Rice, Architect".³²

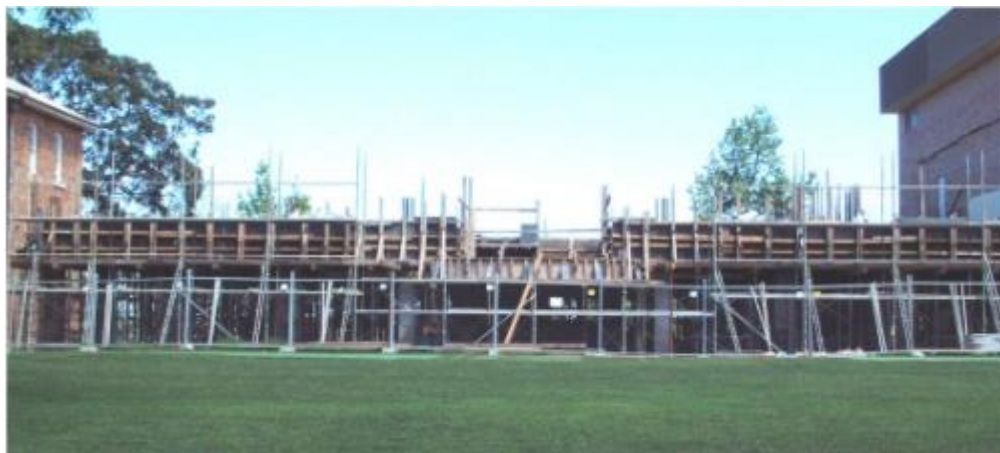
Figure 112 Construction of the second Founder's Building

In 1969, an arts and crafts block and science building were constructed. Further, Council began considering plans for the construction of a new library and Assembly Hall complex between the Founder's Block and the science buildings³⁸. Construction began in the early 1970s for the second Founder's Building, which would provide the school with a new library. The original Founder's block was reduced to one floor and incorporated into the second Founder's block³⁹.

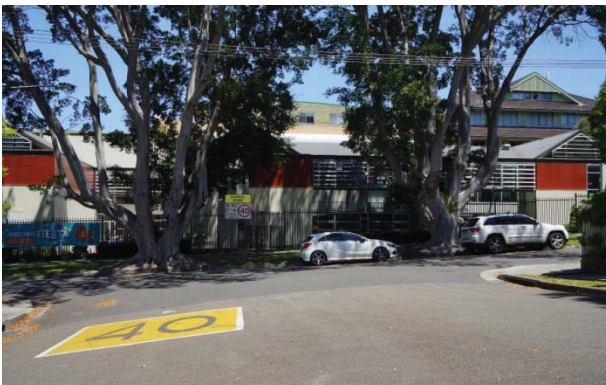
Figure 122 – View south from Victoria Square to the subject site (existing).

While there is potential for incidental views towards the proposed development it should not be considered that this necessarily equates to an adverse heritage impact. The proposed building, while of 5 storeys, would not block views to any items of importance. Rather, the result would be a minor reduction in the amount of visible sky in views south from the HCA. It is further not considered that there is risk of incremental loss to significant views as the villas within the HCA were built as suburban dwellings in close proximity to one another and there is no evidence that their significance relies on an open broad setting (as for example, a significant farmstead may). Rather the significant associated open space is the central reserve, to which no views would be obscured.

The character of the incidental views is further not assessed to have a detrimental impact. As set out in the Visual Impact Assessment the proposal would retain the existing spatial characteristic of the site and its overall visual character. This is particularly relevant to the northern boundary where the proposal would be viewed behind the highly contemporary Junior School building.

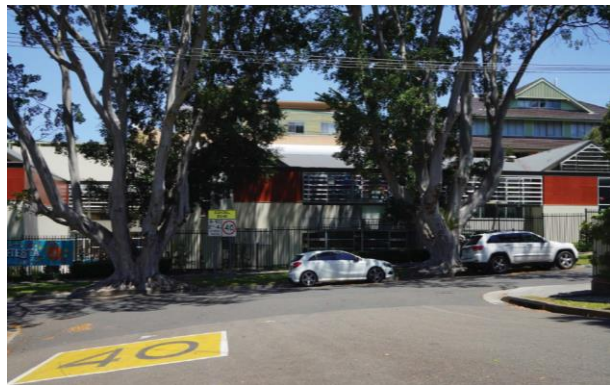
Figure 123 – View south from Victoria Square to the subject site (proposed).

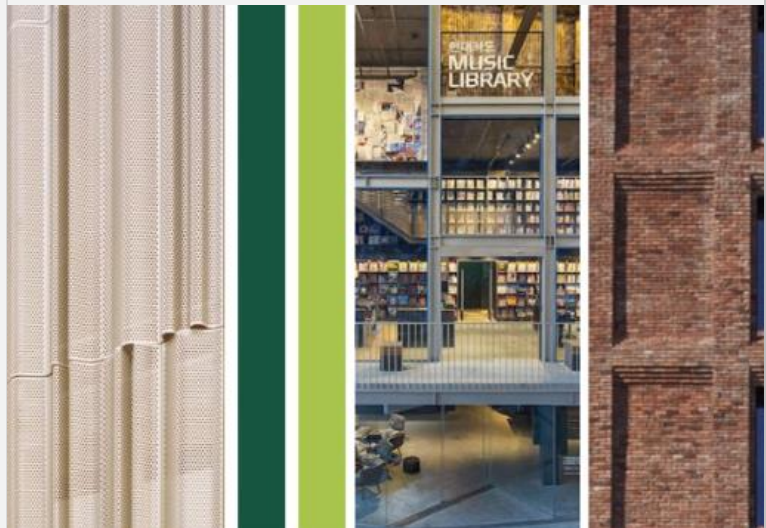
Source: PDML

- The connection between the new Teaching and Learning Building and the Quad Building will only be at ground and Level 1 such that the connections are not visible from inside the quad.
- Undulating screens in neutral tones are proposed to create a subtle backdrop to the quadrangle building and landscaping at Level 4 will ensure the building is further recessive. The use of brick will further complement the existing materiality on the site. Refer materials palette below.
