# Precinct 2A Acid Sulfate Soil Mapping

PLAN Showing Overlay of 1:25,000 Acid Sulfate Soil Mapping by Land & Water Conservation on Proposed Subdivision of Lot 7 DP 1069956 Banyula Drive OLD BAR

**McGLASHAN & CRISP Pty Ltd**

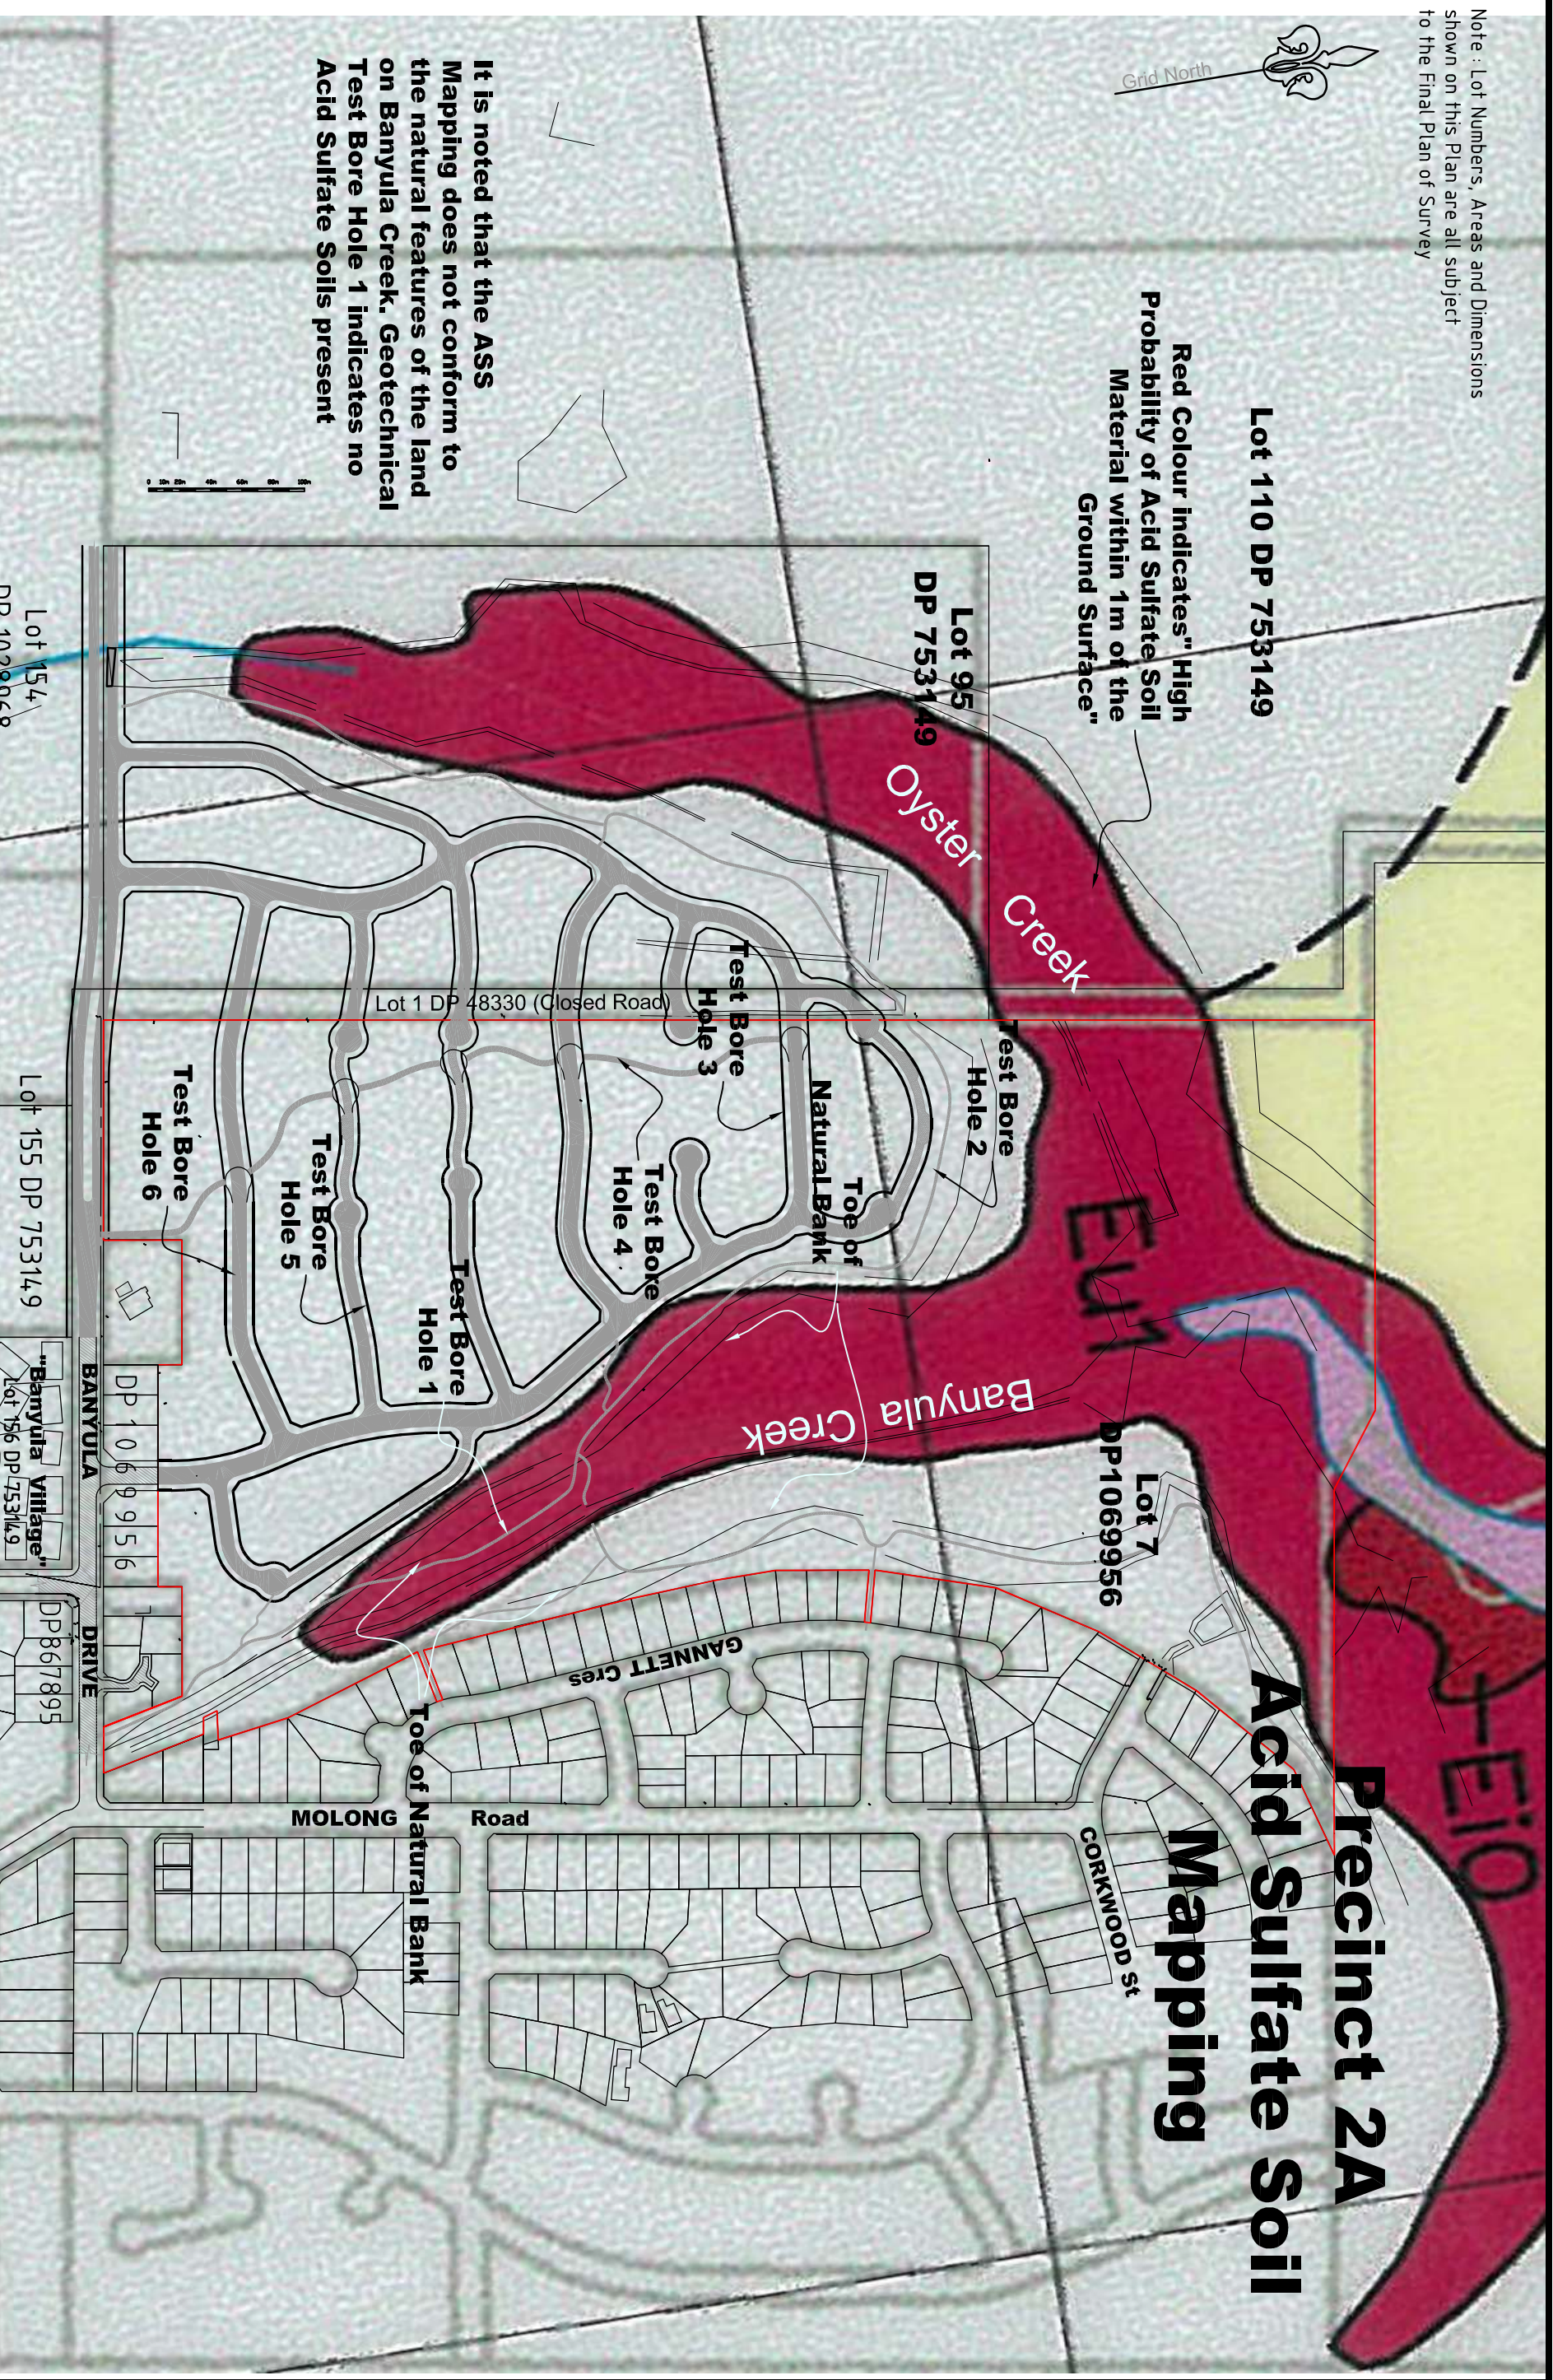
Red Colour indicates "High Probability of Acid Sulfate Soil Material within 1m of the Ground Surface"

It is noted that the ASS Mapping does not conform to the natural features of the land on Banyula Creek. Geotechnical Test Bore Hole 1 indicates no Acid Sulfate Soils present
