CENTENNIAL
ANGUS PLACE

Centennial Angus Place Pty Limited
Angus Place Colliery
Water Management Plan

June 2021

Name:	Angus Place Colliery Water Management Plan
Author:	Tess Davies
Reference:	2219614-REP-AngusPlaceCollieryWMP
Revision number	1
Document status:	Final

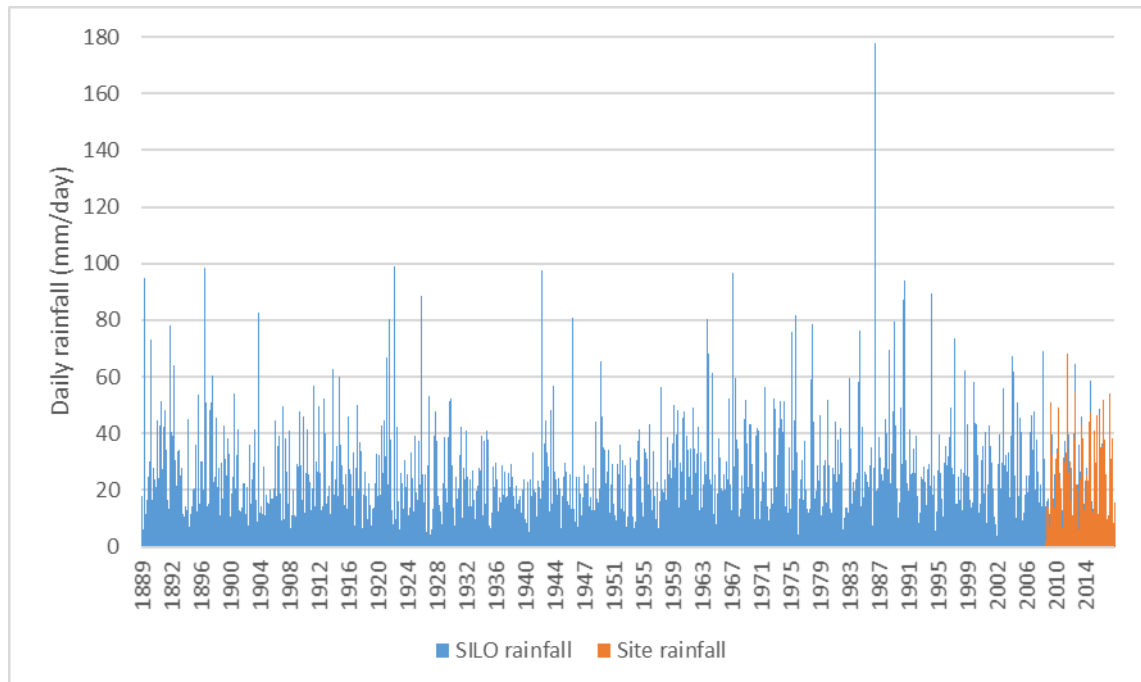
Figure 2-1 Historical daily rainfall at Angus Place Colliery

Figure 2-1 presents the historical SILO point daily rainfall data between January 1889 and December 2018. Rainfall recorded at the Angus Place Colliery pit top between April 2009 and December 2018 is also presented in Figure 2-1.

The annual statistics associated with the SILO point daily rainfall data for Angus Place Colliery presented in Figure 2-1 are:

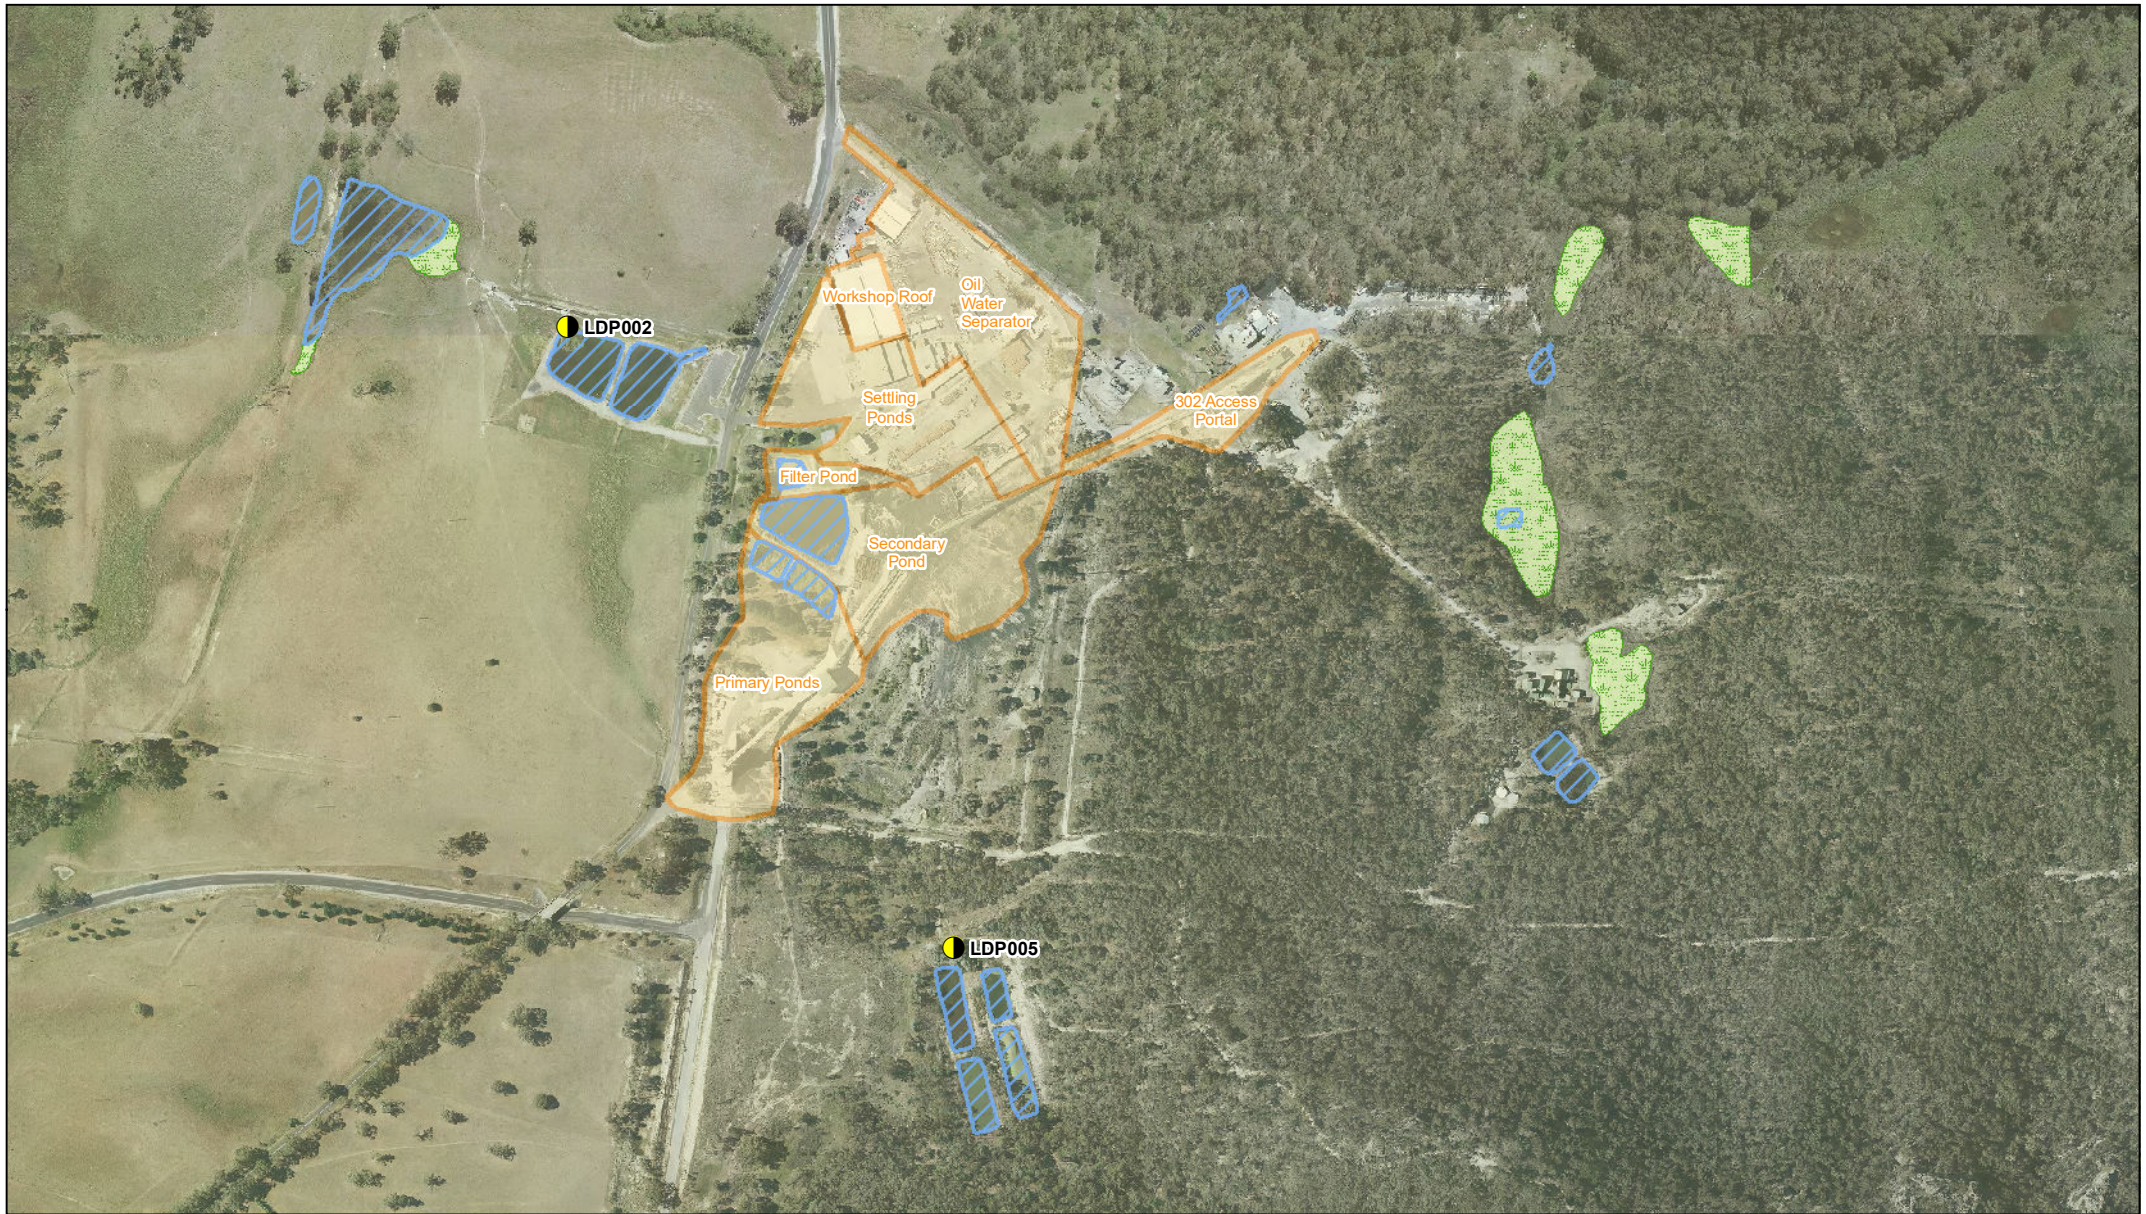
Figure 3-3 Pit top clean water management system

The clean water management system at the Angus Place Colliery pit top consists of a series of diversion bunds and drains that intercept clean runoff prior to it entering disturbed areas. This water is directed off-site into Kangaroo Creek. The clean water system is presented in Figure 3-3.

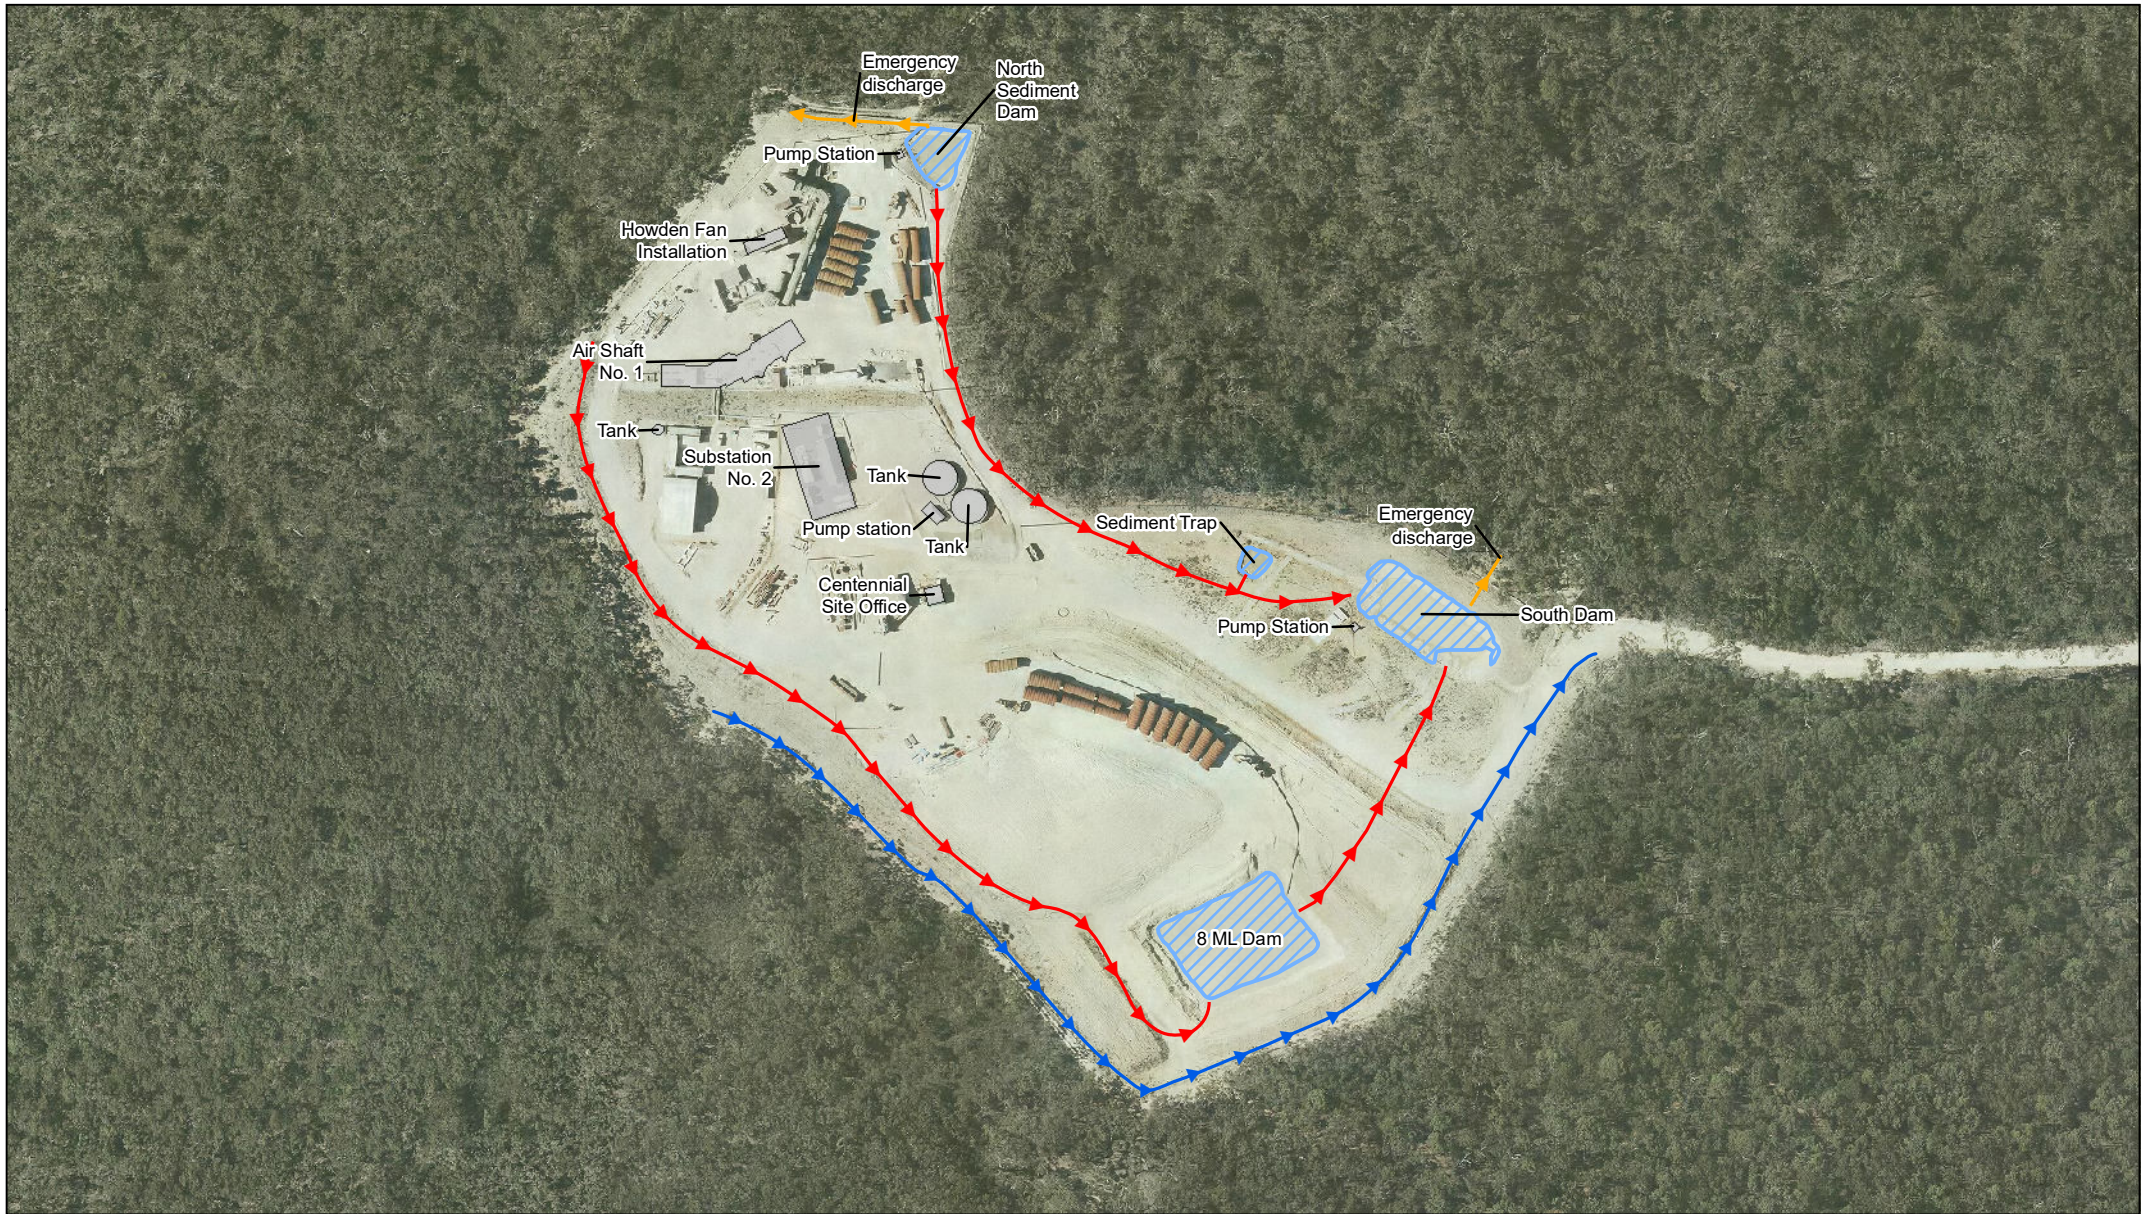
Figure 3-5 Ventilation Facility water management system

The management of captured water within the storages at the Ventilation Facility include treatment and discharge or pump out to an injection point at Springvale Mine, referred to as Bore 5. Following a rainfall event, the volume of disposal will be as high as 10.2 ML over 5 days.

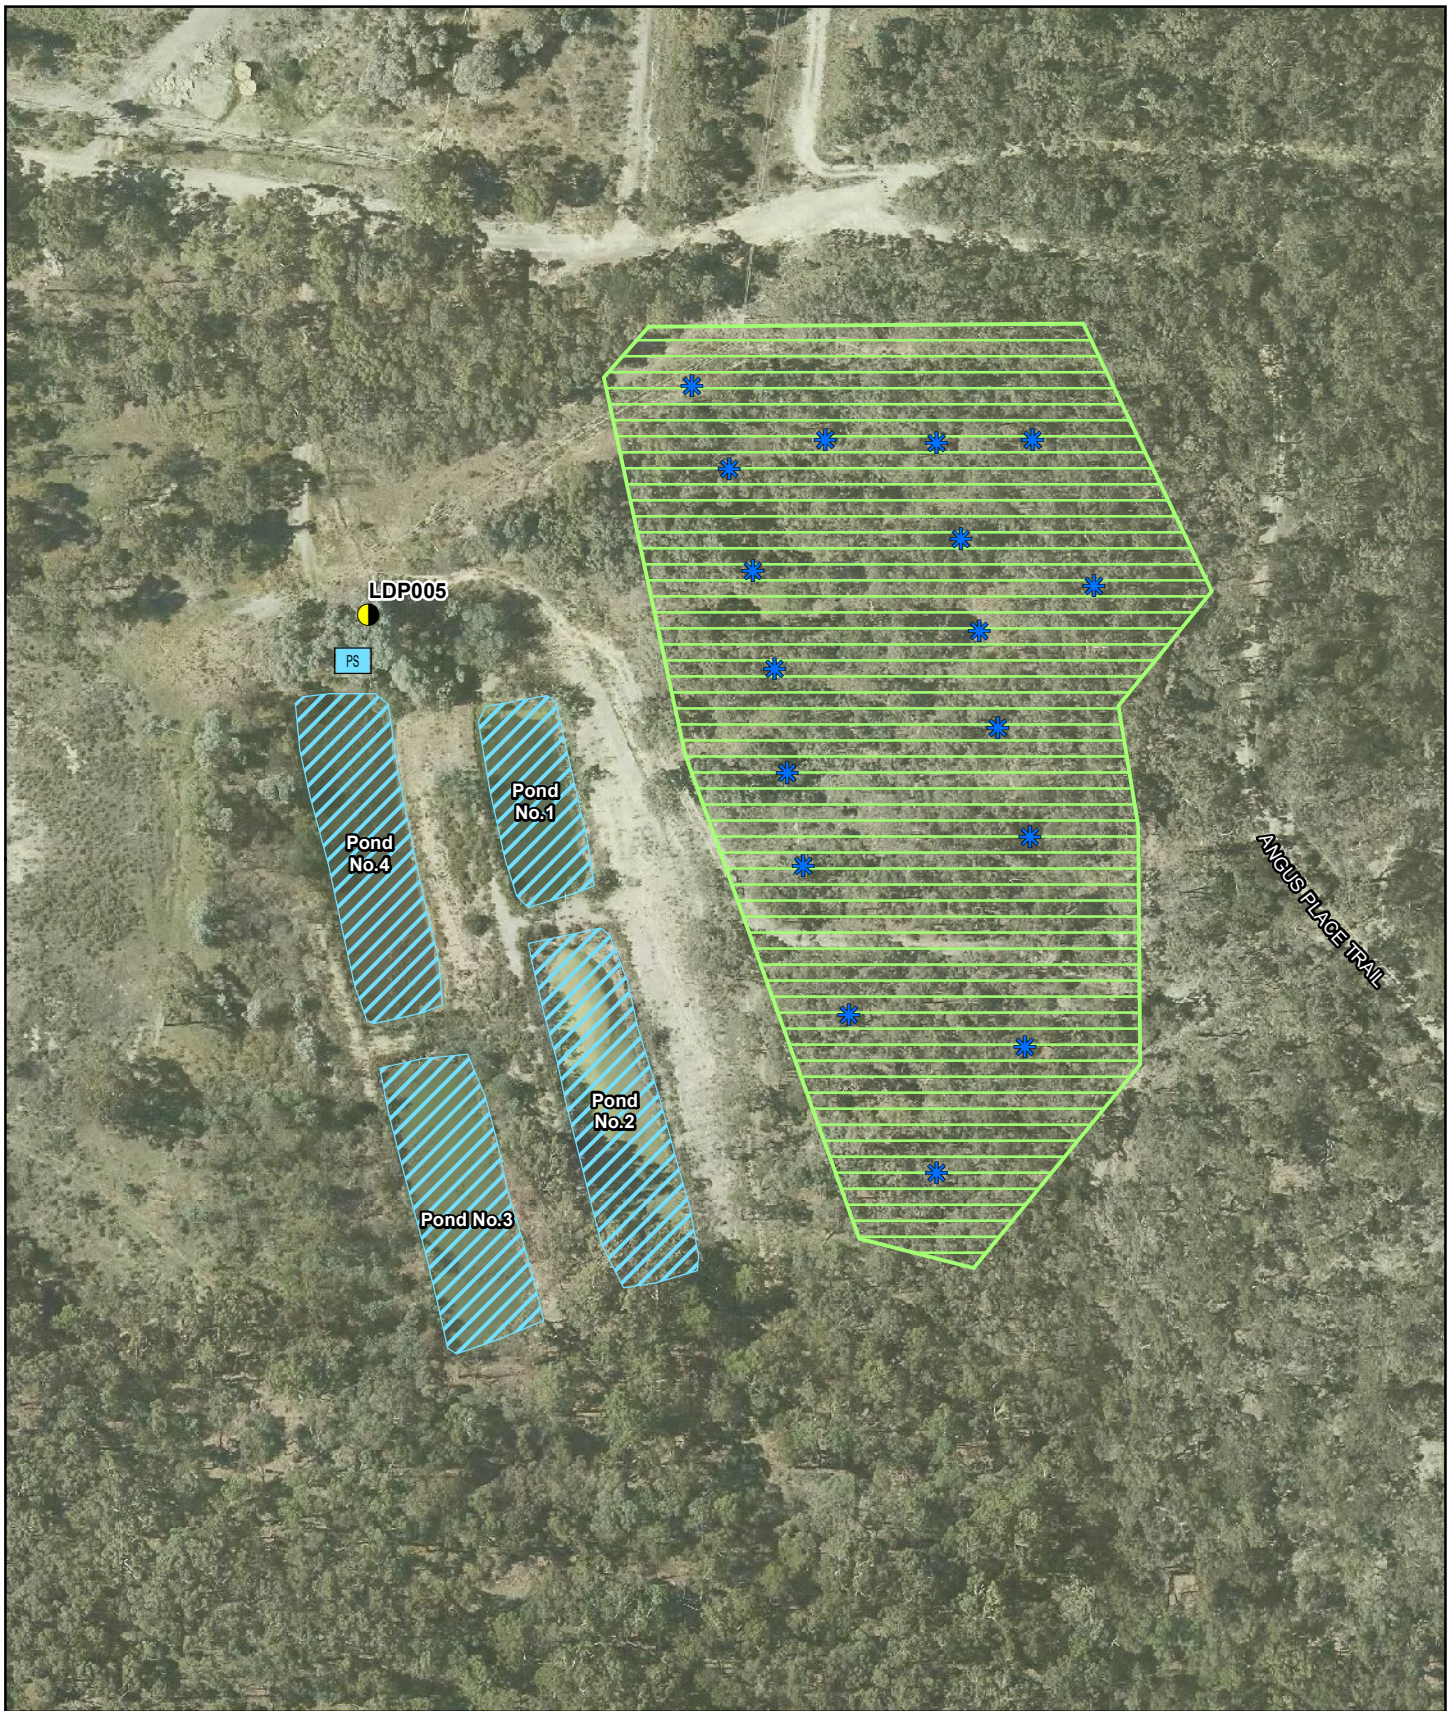
Figure 3-9 Sewage treatment system layout

Grey water and sewage is collected in a tank before being directed to a series of ponds connected by spillways and disposed via spray irrigation at the utilisation area via LDP005, as shown in Figure 3-9.

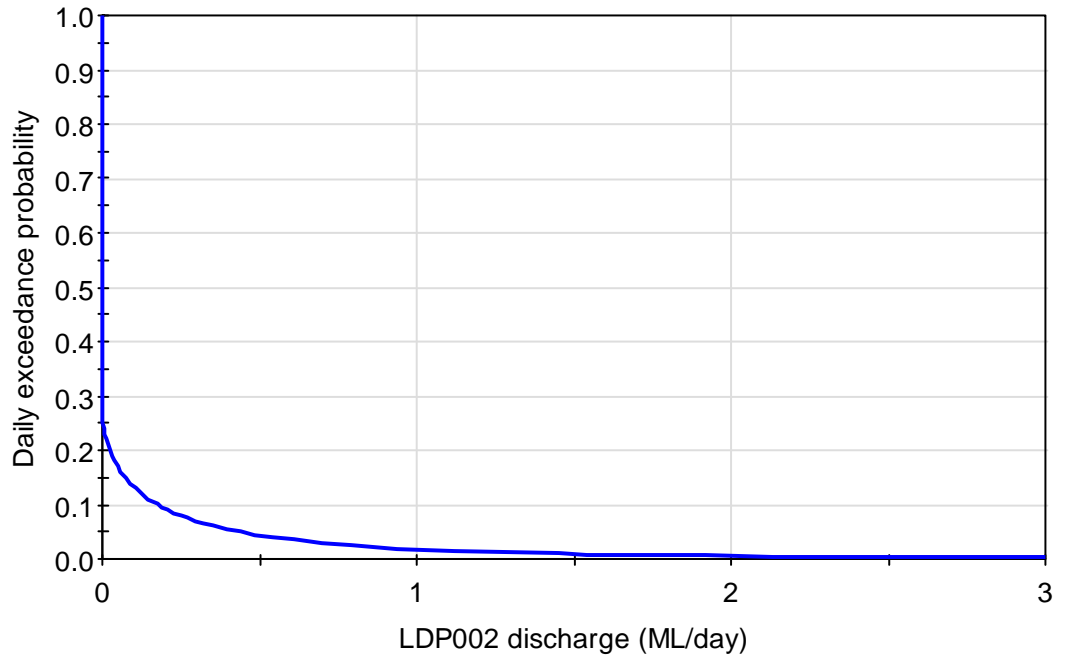
Figure 3-11 Daily exceedance probability of LDP002 discharge

The modelled daily distribution of discharges from LDP002 is summarised as a cumulative frequency plot in Figure 3-11. The water balance modelling indicates that discharges through LDP002 will vary with rainfall, up to approximately 3 ML/day due to frequent rainfall events.

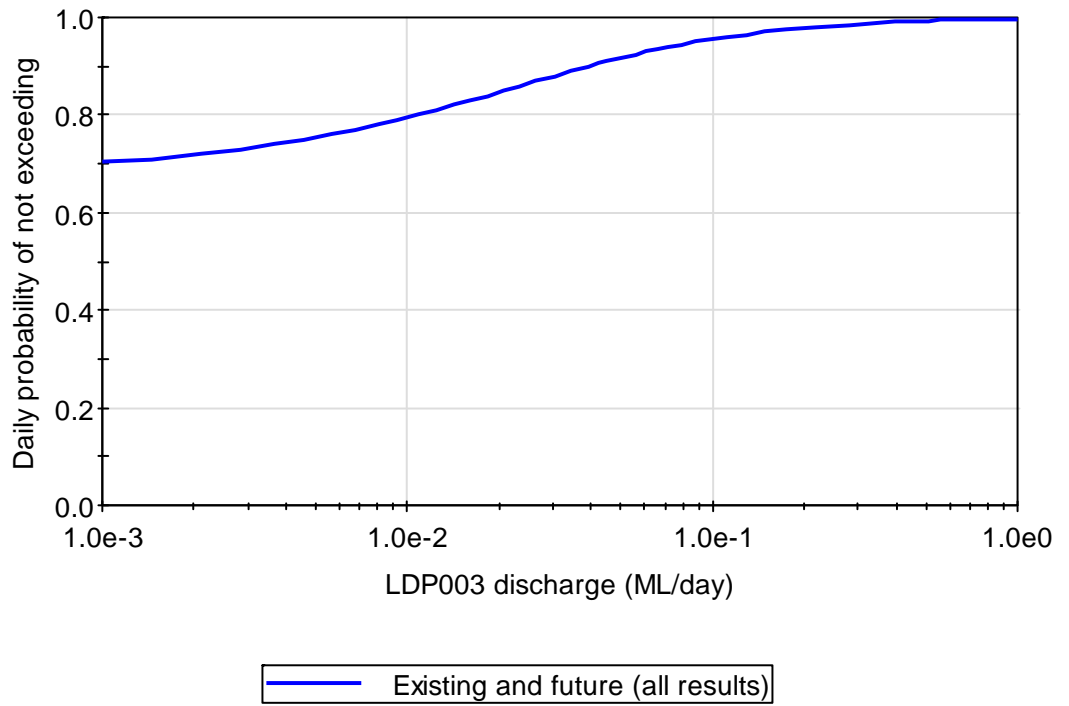
Figure 3-12 Predicted daily discharges from LDP003

Discharges through LDP003 occur from controlled discharges and overflows from the sediment basin located downstream of the KVSA. A cumulative frequency distribution of LDP003 discharges is shown in Figure 3-12. Discharges exceeding 1 kL/day from LDP003 are predicted to occur on approximately 30% of days and unlikely to exceed 1 ML/day.

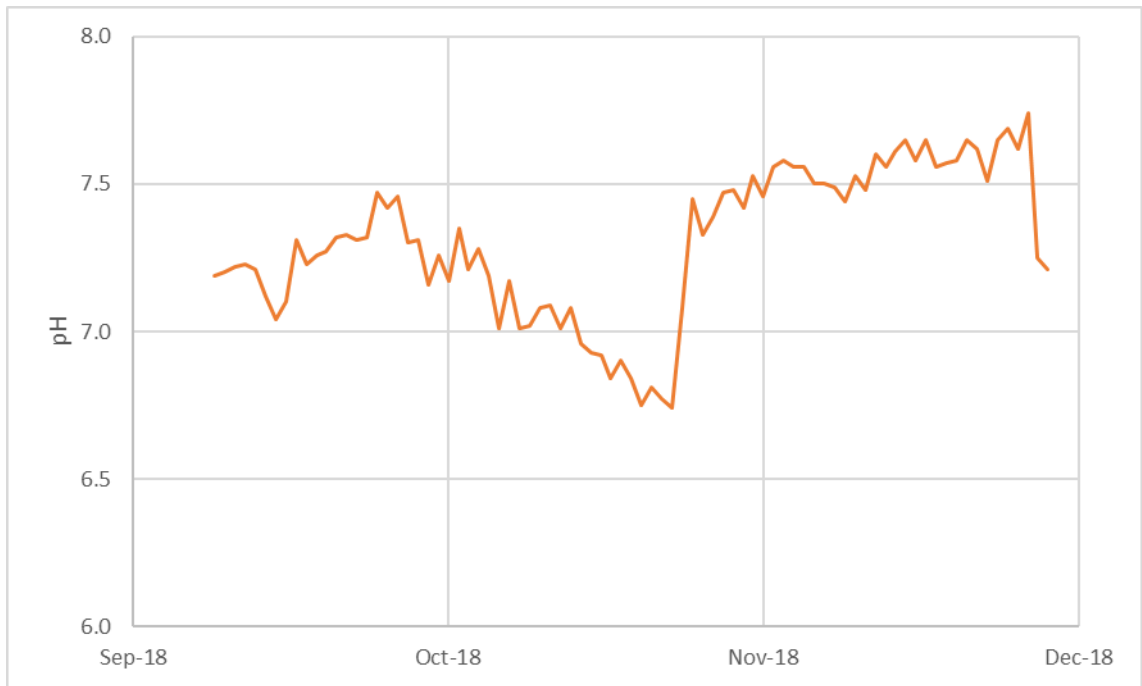
Historical daily EC and pH monitored at LDP003 from September 2018 to December 2018 are presented in Figure 5-7, Figure 5-8 respectively. Turbidity monitored at LDP003 from July 2010 to December 2018 is presented in Figure 5-9. Note that the EC, pH and turbidity are monitored by an online meter within a concrete pit and are recorded regardless of whether water is discharging through the LDP.

Figure 5-7 Recorded LDP003 discharge electrical conductivity

Figure 5-8 Recorded LDP003 discharge pH

Figure 5-9 Recorded LDP003 discharge turbidity
