**Figure 8**  
**Conceptual Internal Haulage Route and Access**  
**Orica Australia Pty Ltd**

Remediation of Car Park Waste Encapsulation  
Botany Industrial Park  
Environmental Assessment

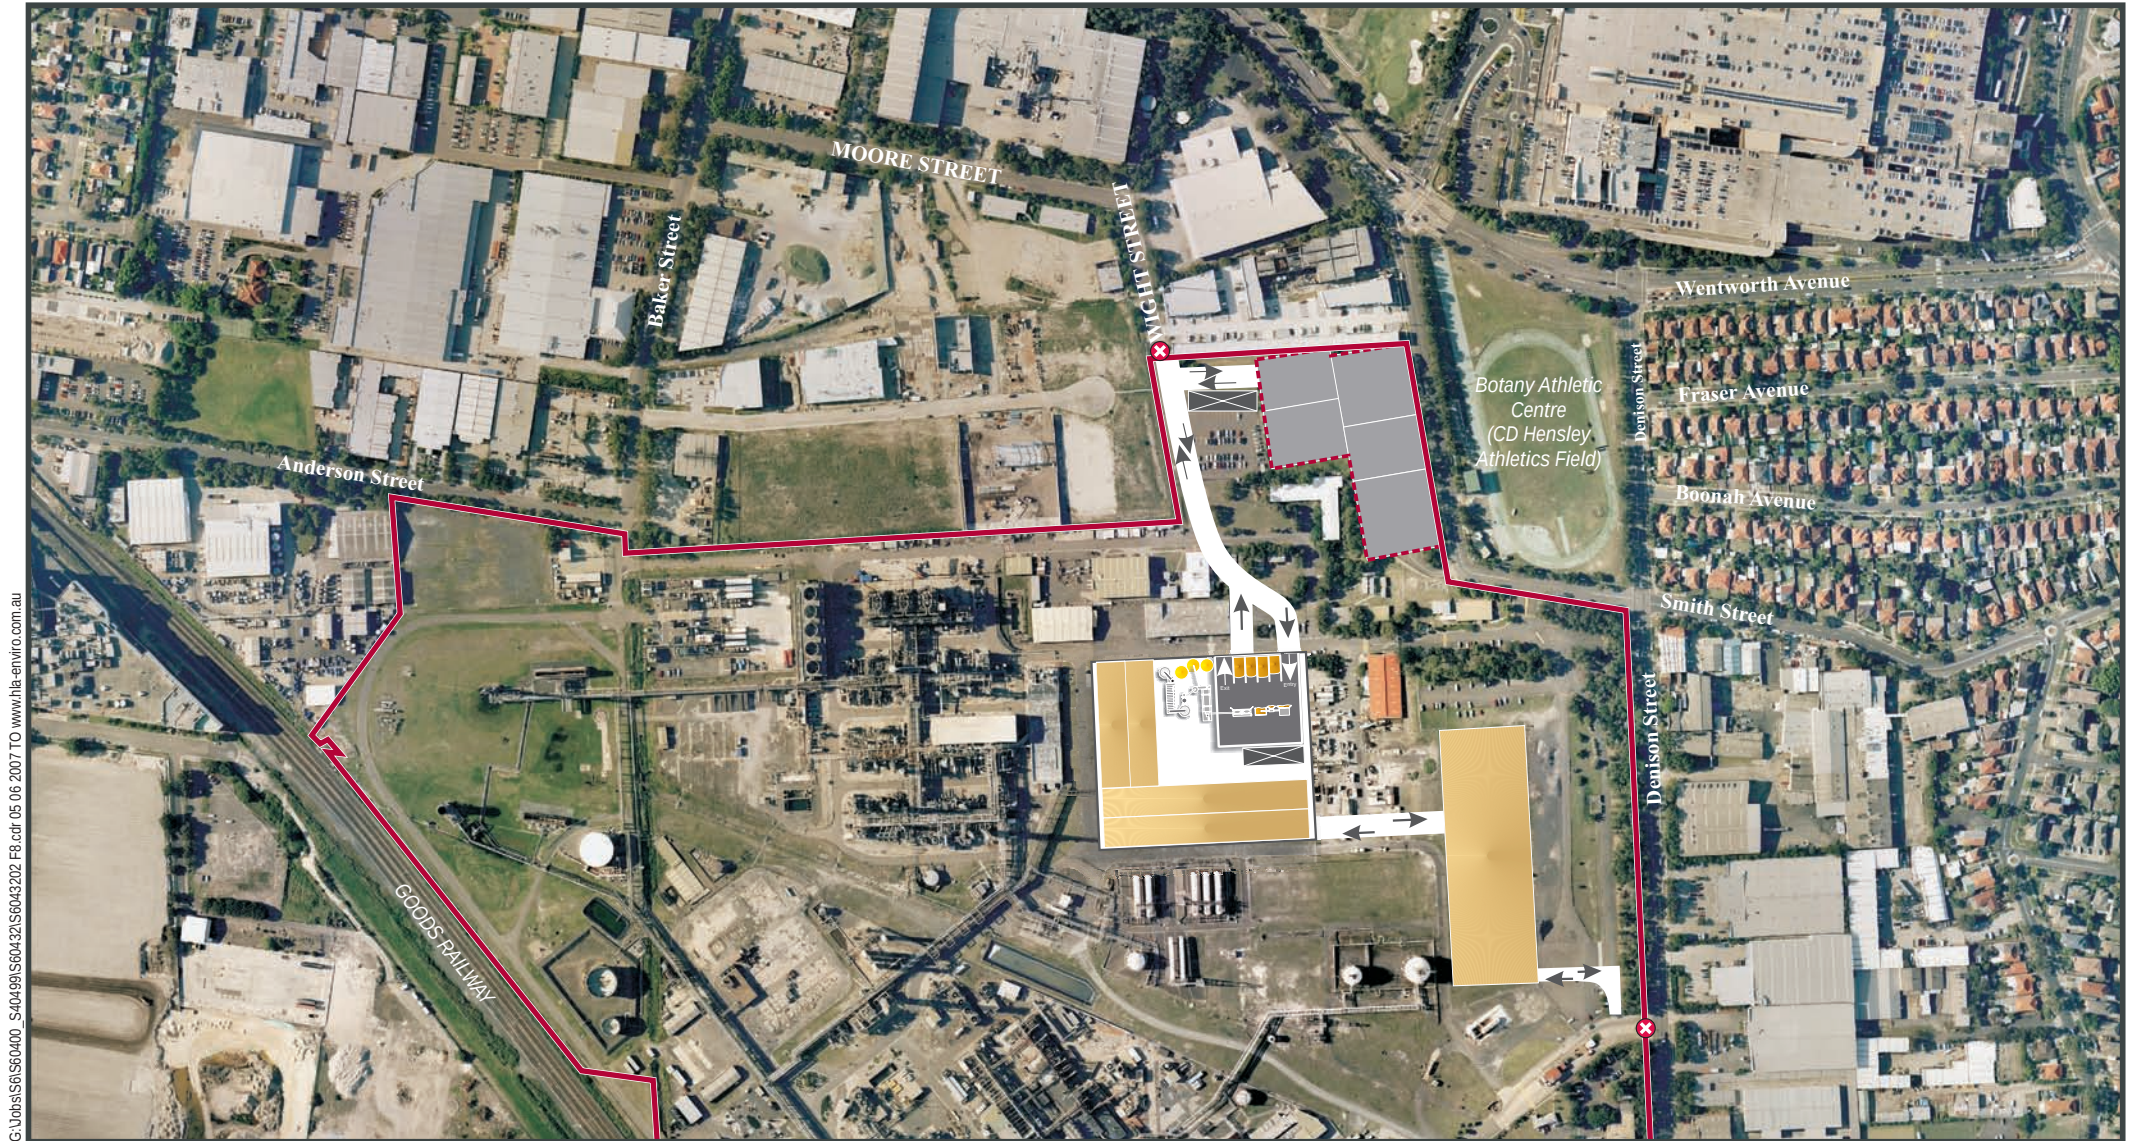
- Botany industrial park site boundary
- - - CPWE site boundary
- X Site access point

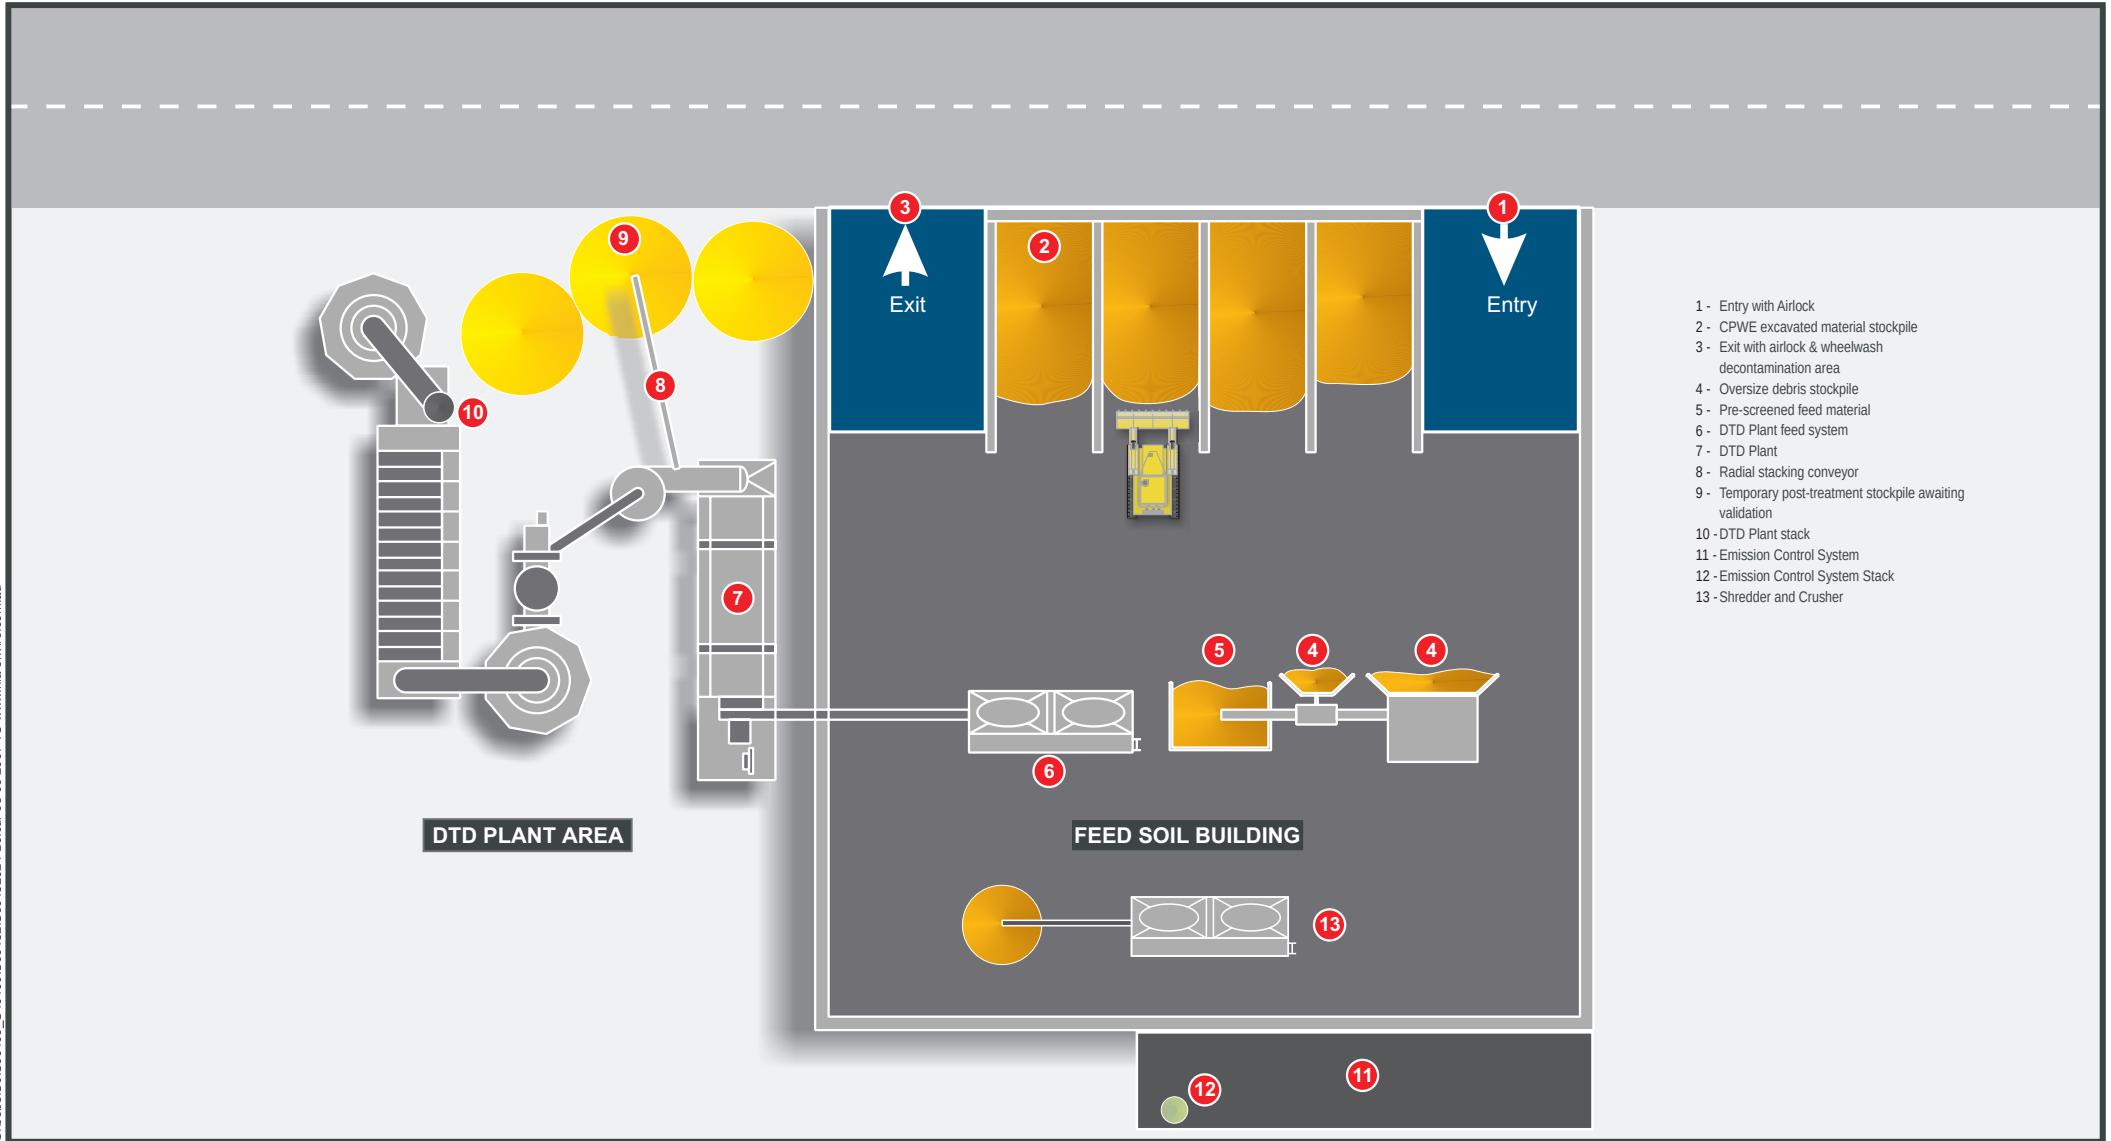
**Figure 10**  
**Conceptual Feed Soil Building Layout**  
**Orica Australia Pty Ltd**  
 Remediation of Car Park Waste Encapsulation  
 Botany Industrial Park  
 Environmental Assessment

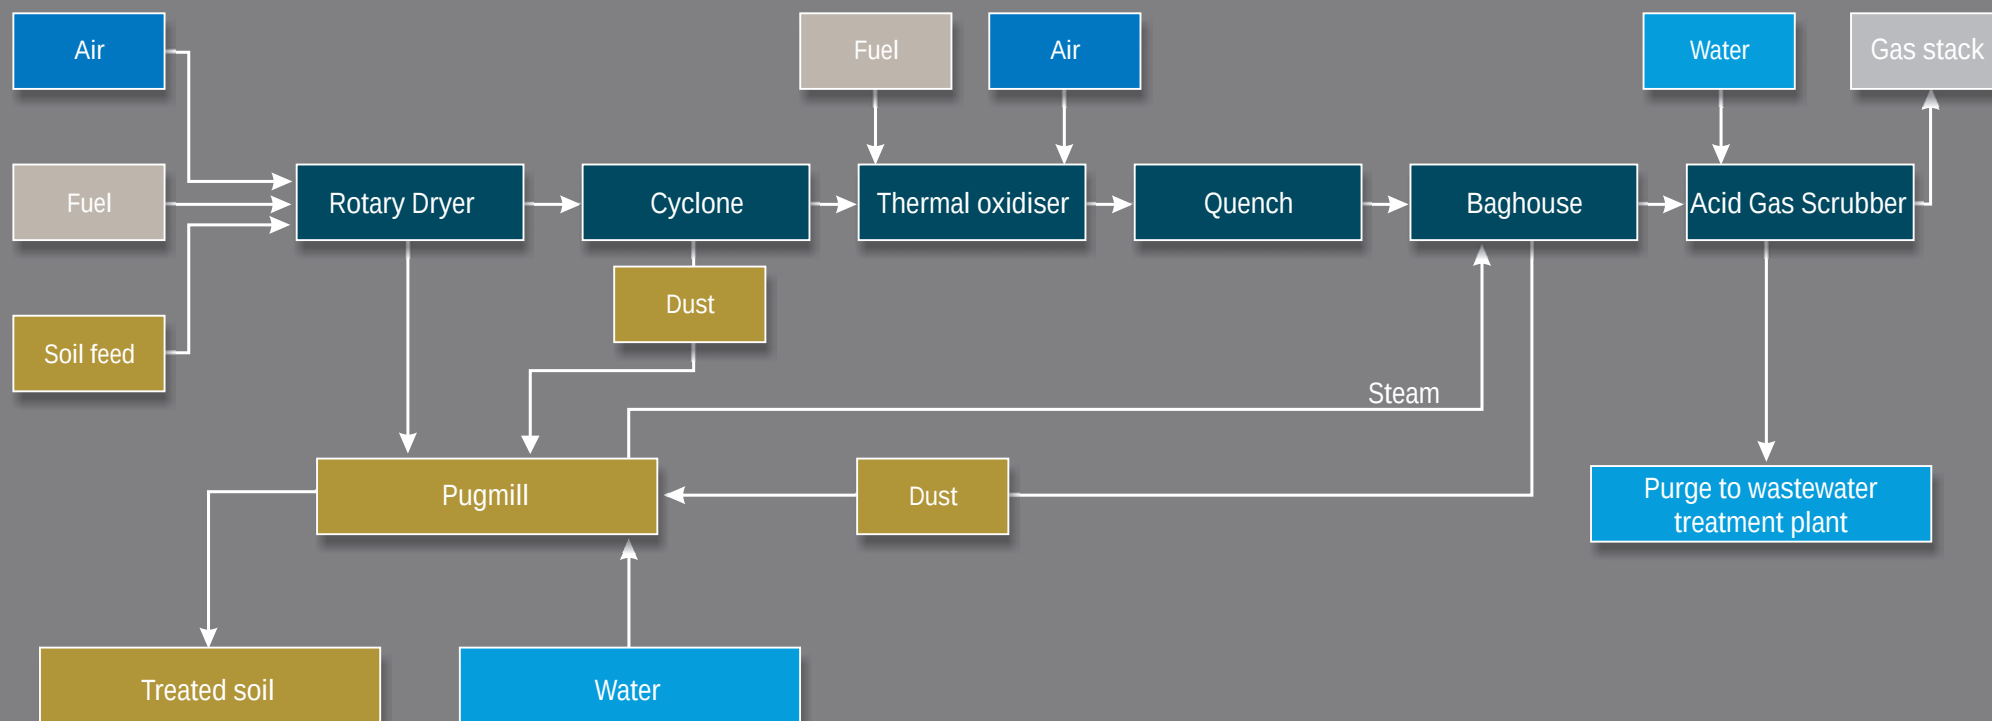
Final configuration may vary slightly depending on the thermal treatment plant selected

**Figure 11**  
**DTD Treatment Process**  
**Orica Australia Pty Ltd**  
Remediation of Car Park Waste Encapsulation  
Botany Industrial Park  
Environmental Assessment

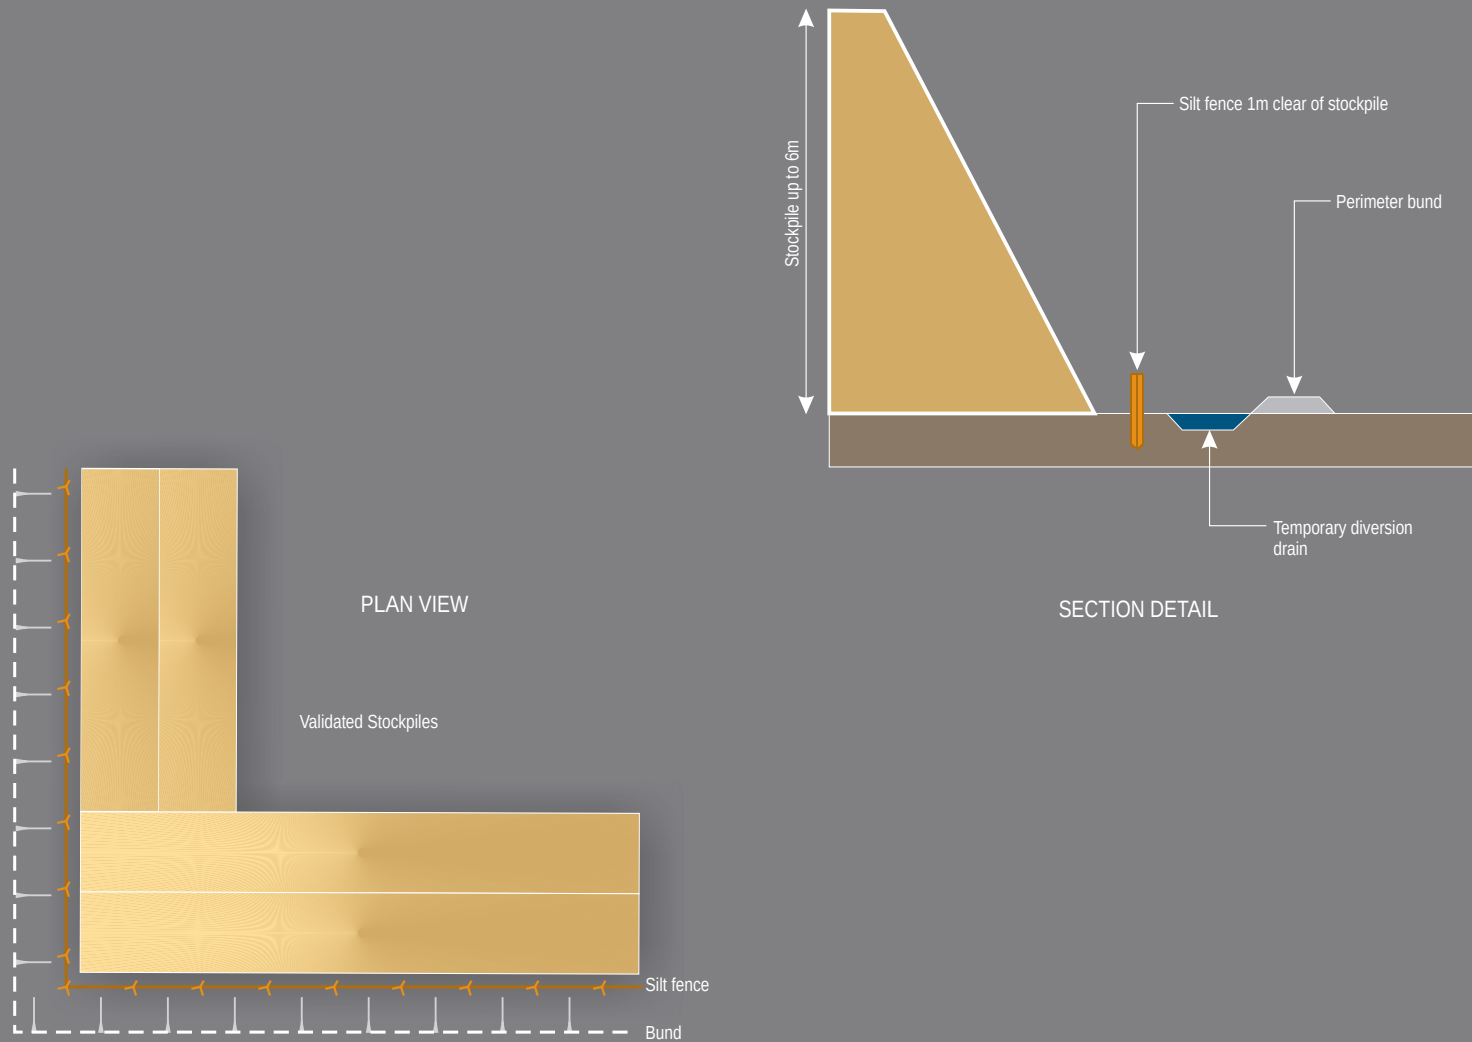
**Figure 12**  
**Conceptual Stockpile Management**  
**Orica Australia Pty Ltd**  
Remediation of Car Park Waste Encapsulation  
Botany Industrial Park  
Environmental Assessment
