Tallawarra Stage B Gas Turbine Power Station

Soil and Water Management
Sub-Plan

**EnergyAustralia Tallawarra
Pty Ltd**

Reference: MP07_0124

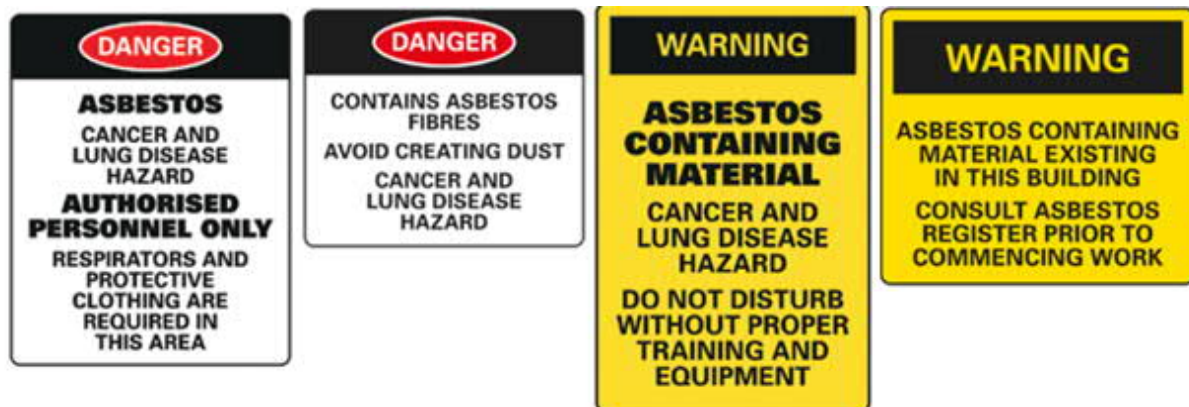
Figure 1 Examples of Warning Signs and Labels

Where direct marking of asbestos is not possible, a permit-to-work system may be implemented to ensure that all workers are aware of the presence of ACM or assumed ACM prior to commencing work so it is not knowingly disturbed without correct precautions being taken. Examples of typical warning signs are presented **Figure 1**.
