METROPOLITAN COAL GROUNDWATER MONITORING REPORT

1 July - 31 December 2020

Metropolitan Collieries Pty Ltd
A Peabody Energy Subsidiary

SLR Ref: 665.10000-R05
Version No: -v2.0
March 2021

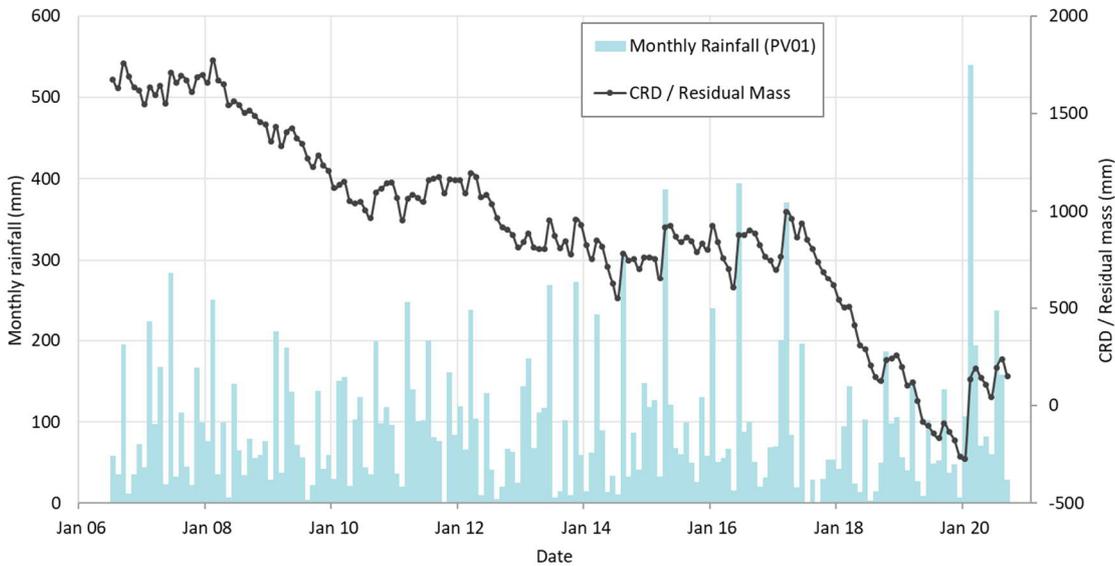
Figure 3 Monthly rainfall and cumulative rainfall departure

During the reporting timeframe (2006-2020), the rainfall condition on site can be classified as drier than average (2008-2014, and more pronounced 2017-2019) with some periods of average conditions (2006-2008 and 2014-2017). A large rain event in February 2020 broke the dry conditions, as indicated by a sudden increase in the CRD. The CRD decreased slightly in the three months after the event and had since been relatively stable which indicates average conditions.

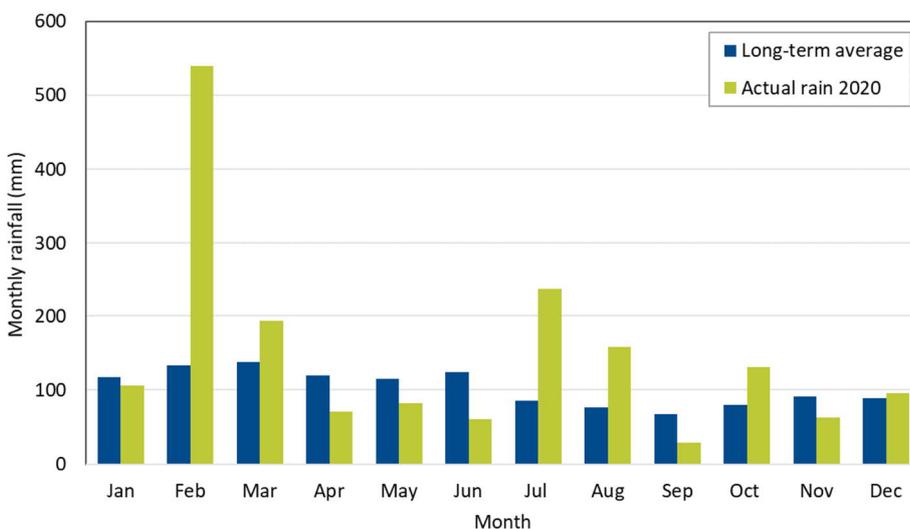
Figure 4 Comparison of average monthly rainfall with observations for 2020

Figure 4 shows the monthly rainfall observations for the calendar year 2020 in comparison with the long-term average monthly rainfall. The January 2020 rainfall was approximately at the average. February 2020 was very wet with the observed rainfall four times greater than the average. March 2020 was slightly above average and the second quarter (April, May and June) saw the monthly rainfall return to below average. July, August and October recorded above average monthly rainfall.

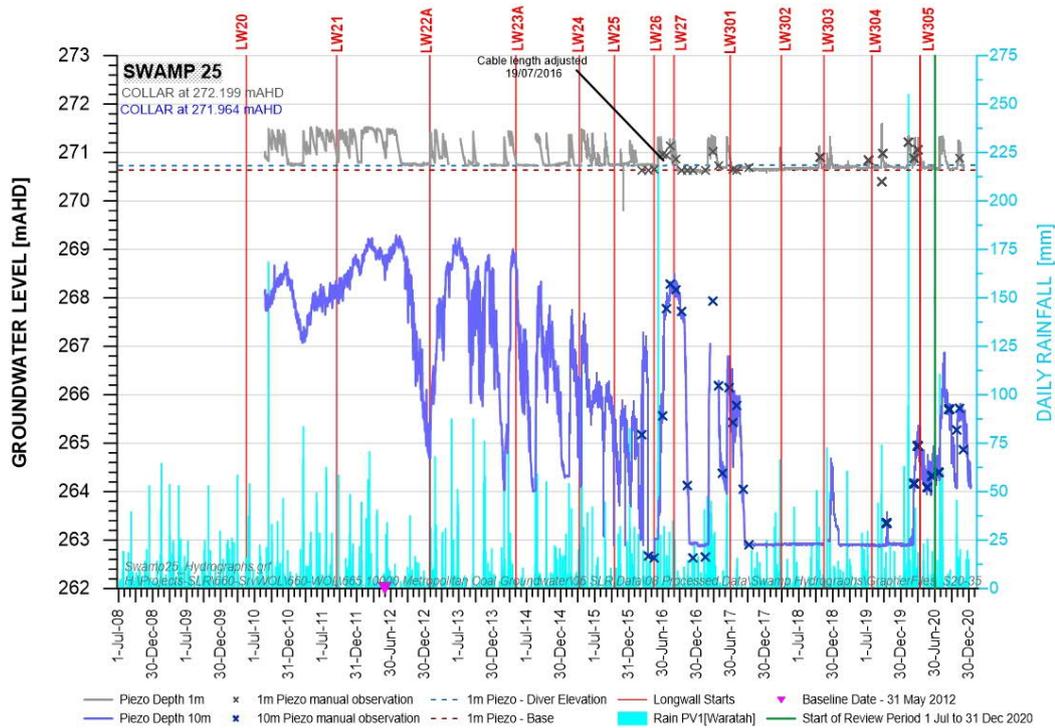
Figure 9 Groundwater Hydrographs at Swamp 25

Hydrographic responses for Swamp 25 overlying Longwalls 20-22 are shown in Figure 9 and discussed below. Swamp 25 has always maintained a separation between swamp water levels and the water table level in sandstone at 10 m depth. Accordingly, water is likely to be infiltrating downwards from the swamp. The deeper sandstone hydrograph correlates fairly well with the rainfall trend but the swamp substrate hydrograph fluctuates within the historical bandwidth with no obvious mining effect. At the time Longwall 21 passed beneath the monitoring site (August 2012), there was a decline of about 4 m in the deeper water level and the water level in the swamp dropped to sensor level. Coincidentally, the longwall crossing occurred during a particularly dry period. In 2015 the peak groundwater level in the sandstone declined by 2-3 m despite strong rainfall events but the high rainfall in June 2016 restored the peak level to 1 m below baseline peaks. Since then, low levels suggest an ongoing mining effect to the sandstone water levels. Both the substrate and sandstone piezometers in Swamp 25 remained dry (groundwater level was below the sensor level) from September 2017 to September 2018. The substrate piezometer (1 m) was intermittently saturated from October to December 2018. The sandstone piezometer recorded a rise in levels around November to December 2018, however, the data logger was not recording during November 2018. The piezometers returned to dry conditions (water level below sensor level) over 2019. An exception to this was a short-duration saturation response in the substrate piezometer in September 2019, in response to an above average rainfall event. A delay in recharge response was observed for the 10 m piezometer, which recorded a saturation response in October 2019. Both piezometers showed some recovery after the large rain events in February and July 2020. The 10 m piezometer recorded a sustained increase in groundwater levels following these rainfall events; however, the groundwater level is lower than that recorded during the baseline period.

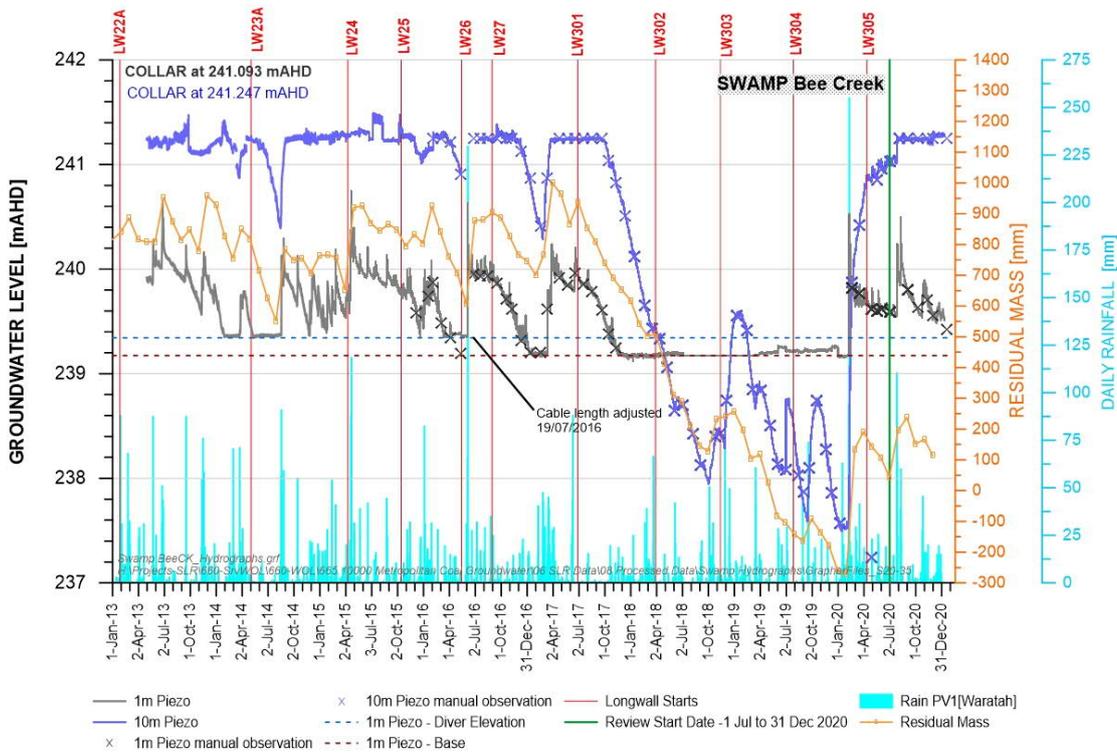
Figure 12 Groundwater Hydrographs at Bee Creek Control Swamp

At the Bee Creek Swamp (Figure 12), the swamp generally has perched water conditions. The 10 m sandstone piezometer shows groundwater levels that are typically 1.5 m higher than the swamp substrate, implying an upward gradient and upward seepage of groundwater to the swamp from the sandstone. Groundwater conditions in the sandstone were artesian during 2013-2017, varying over a narrow range (241.1 – 241.5 mAHD), with the collar reference at 241.247 mAHD, showing significant recessions only during prolonged dry periods. This is especially evident in the water levels recorded at the swamp since October 2017, with sharp decline apparent consistent with the low rainfall conditions. The direction of flow between the sandstone and the swamp substrate was reversed during most of the 2018-2019 period. The 10 m piezometer recorded a rise in levels in December 2018 and in March, July and September 2019, correlating with rainfall events. The substrate (1 m) piezometer remained dry (water level below sensor) until June 2019 while from June 2019 until December 2019 there were very minor fluctuations in groundwater level in response to rainfall. Full saturation occurred in February 2020 following a substantial rainfall event and was maintained for the rest of the 2020 monitoring period. As a result, the sandstone is again recharging the swamp substrate.

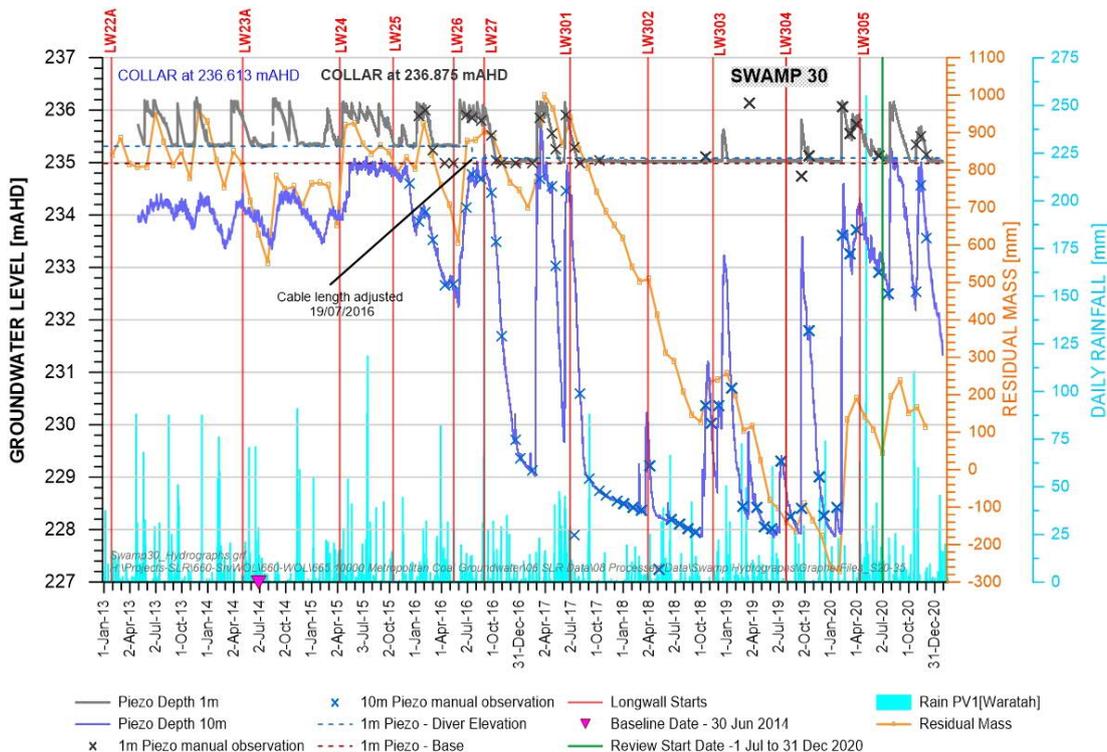
Figure 14 Groundwater Hydrographs at Swamp 30

Hydrographic responses for Swamp 30 are shown on Figure 14. The groundwater level in the 10 m sandstone piezometer at Swamp 30 displays a probable mining effect attributable to the passage of Longwall 25. A significant magnification of amplitude in water level response with rainfall, and rapid rate of decline relative to earlier in the monitoring record is displayed and corresponds with the start of mining of Longwall 27. The water level in the substrate piezometer remained below the sensor level producing a flat line (dry conditions) response in January and February 2017. From January 2017 to June 2018, the 10 m sandstone piezometer showed rainfall response, including in March 2018, but no recovery trend and continued declining water levels with low rainfall. The 10 m sandstone piezometer recorded a rise in groundwater levels in December 2018 and September 2019, with more subdued responses in March and July 2019, that appear to coincide with rainfall events. With the large rain event in February 2020, both the substrate and the shallow piezometer water levels recovered significantly. Recovery was observed again following rainfall events in July and October 2020. However, following these rainfall events the groundwater levels did not remain saturated and declined sharply, with the substrate piezometer returning to dry conditions by December 2020.

An assessment of Swamp 30 groundwater levels during the reporting period, including a comparison with the relevant control swamps, is provided in Section 5.1.1, Figure 58.

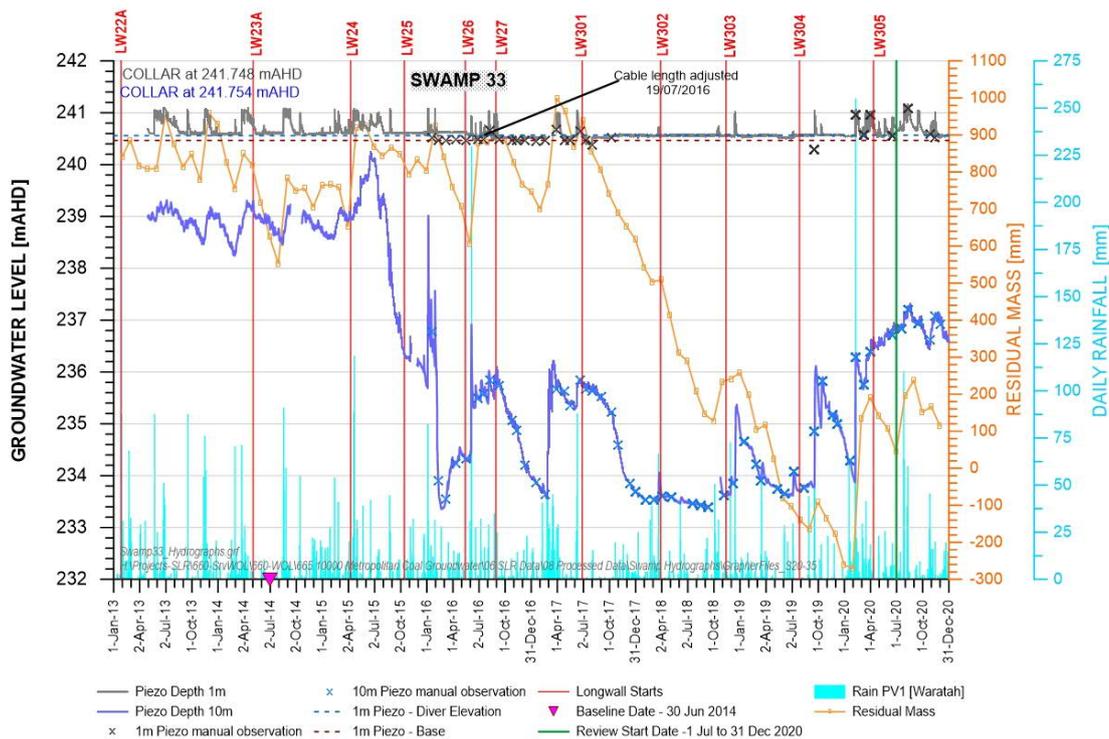
Figure 15 Groundwater Hydrographs at Swamp 33

The groundwater level in the swamp substrate (1 m) piezometer at Swamp 33 has generally been reported below the sensor elevation since 2017. Exceptions to this include short periods of saturation coinciding with rainfall events. Recent events include following rain in March, October and December 2018, as well as September and October 2019. The large rain event in February 2020 resulted in a more sustained recovery in the shallow 1 m piezometer for most of the 2020 reporting period; however, this sensor has recorded dry conditions again in December 2020.

An assessment of Swamp 33 groundwater levels during the reporting period is provided in Section 5.1.1, Figure 60.

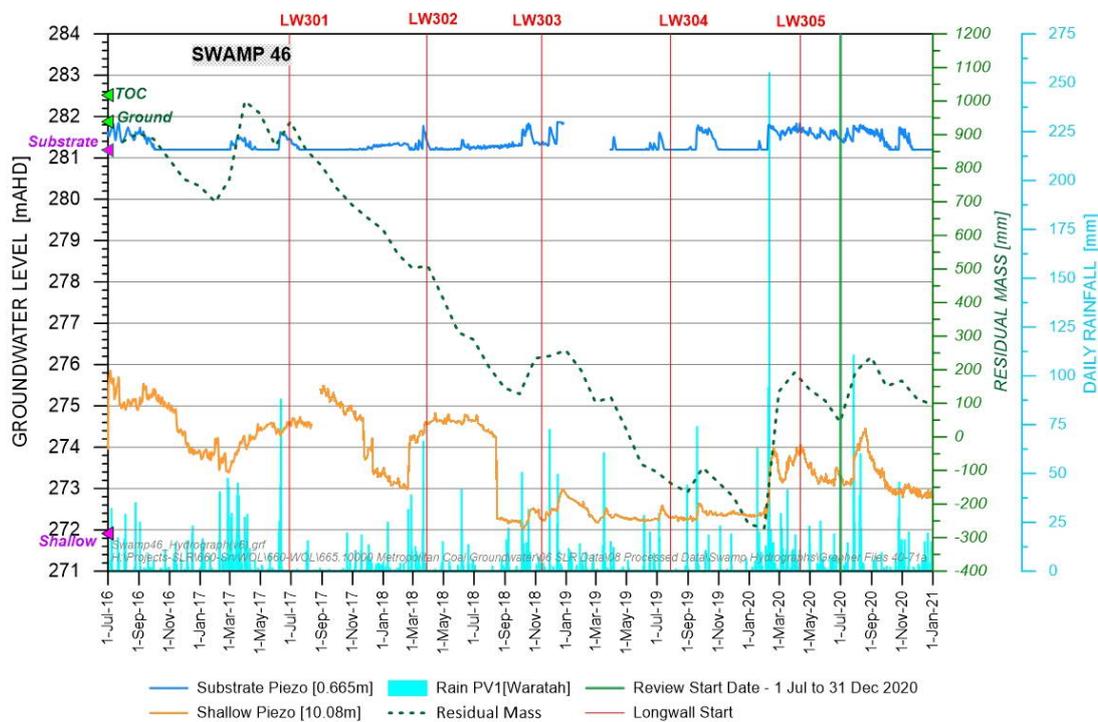
Figure 19 Groundwater Hydrographs at Swamp 46

Figure 19 shows the groundwater levels in the substrate and shallow piezometers for Swamp 46, together with the daily rainfall and CRD. The shallow piezometer generally shows a range of about 3 m in water level, whereas the substrate piezometer shows less variation over time (~ 1m) and has seen some responses to rain events that broke longer periods of groundwater levels below logger levels. Since the rain event in February and July 2020, both the shallow and the substrate water levels increased and remained saturated for the majority of the reporting period. Dry conditions were reinstated at the substrate piezometer from December 2020 in response to reduced rainfall. The substrate piezometer water level is always above the shallow water level, which indicates downward movement of water.

A comparison of the substrate hydrograph with the control swamps is presented in Section 5.1.2, Figure 68.

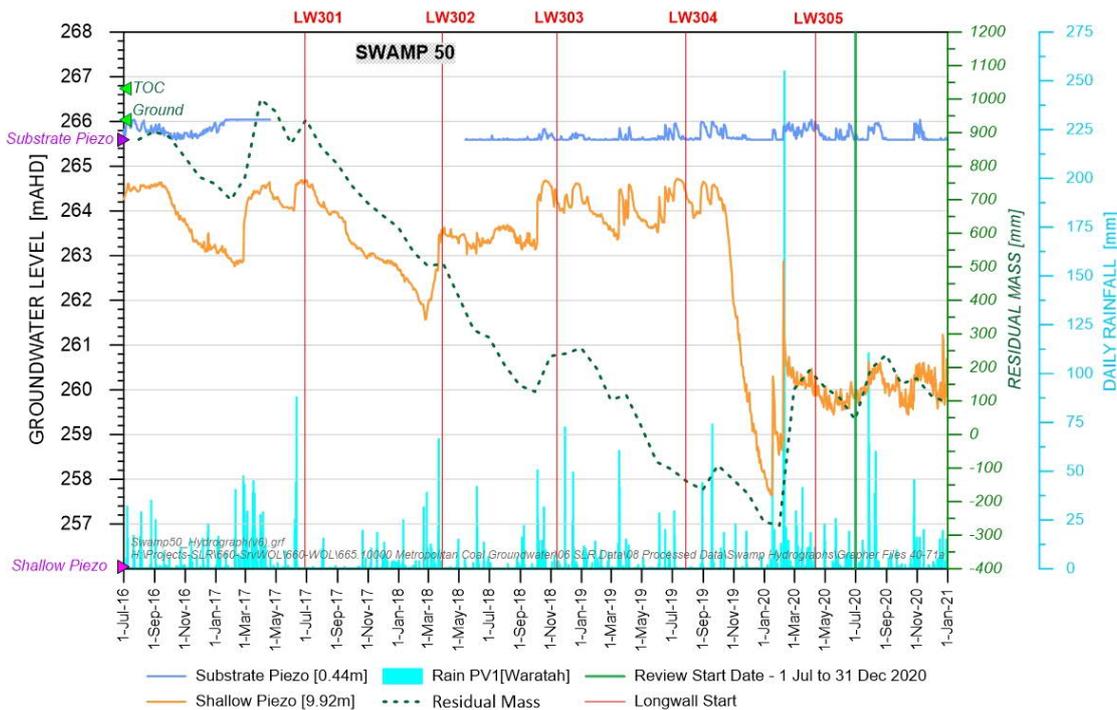
Figure 23 Groundwater Hydrographs at Swamp 50

There is a large data gap for the substrate piezometer between February 2016 and May 2018; the substrate piezometer was replaced in May 2018. The substrate piezometer did not show any evidence of decline when Longwall 304 passed beneath the swamp. The occasional flatlined water level in the plot is attributed to dry conditions. Since February 2020, the piezometer showed water levels above the minimum.

A comparison of the substrate piezometer with the control swamps is presented in Section 5.1.2, Figure 70.

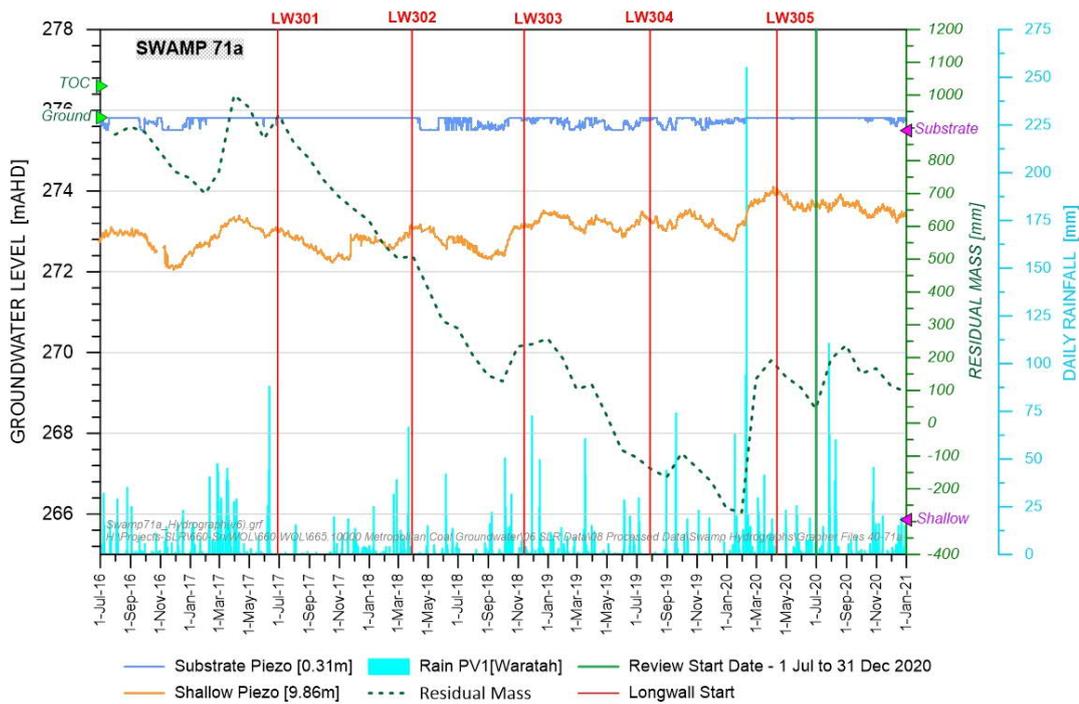
Figure 24 Groundwater Hydrographs at Swamp 71a

Downward flow from the swamp to the underlying sandstone is expected, given typically ~2 m head difference. As no longwall is to pass beneath this swamp, no mining effect is anticipated or observed.

A comparison between Swamp 71a and the control swamps 101, 137a and 137b is presented in Section 5.1.3, Figure 78.

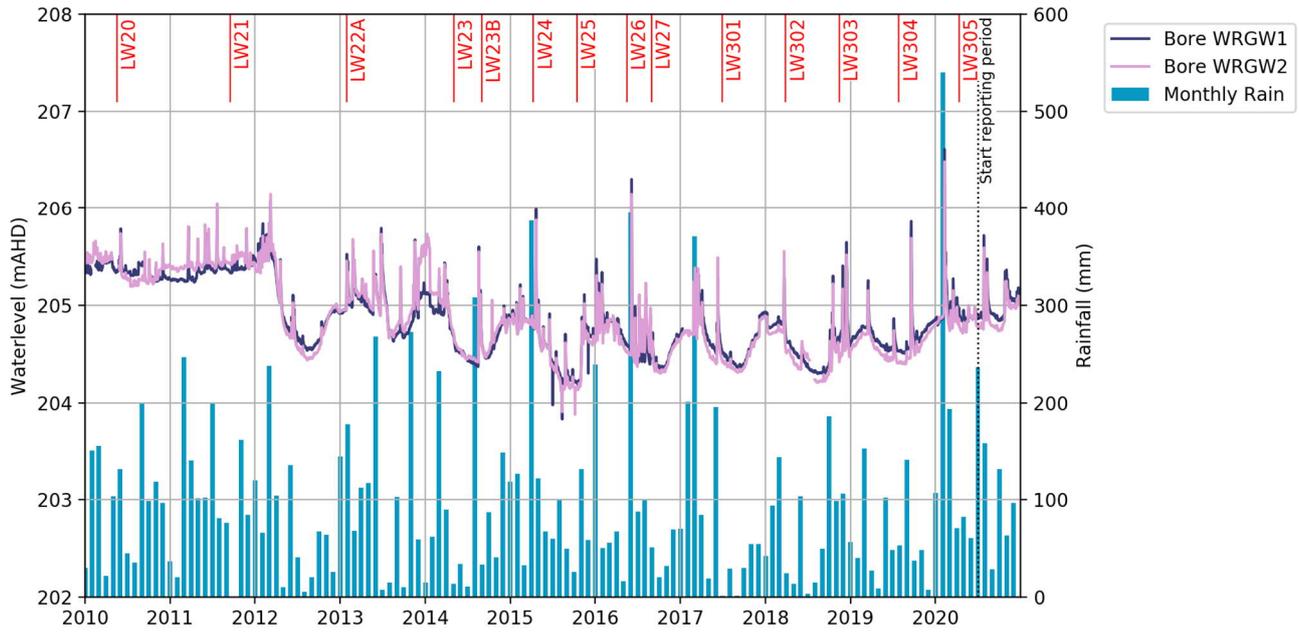
Figure 26 Shallow Groundwater Hydrographs on Waratah Rivulet at WRGW1 and WRGW2

Throughout 2017, the water levels at sites WRGW1 and WRGW2 correlated closely with rainfall trends. During October-December 2017 both piezometers followed an increasing trend as the rainfall residual mass was declining (see residual mass curve on Figure 26); this can be explained as the monthly total rainfalls were less than average, meaning the residual trend remained in decline, though monthly rainfalls and individual daily rainfalls were greater than the July-September 2017 period causing some recovery. This trend was reversed from January 2018 to September 2018 with groundwater levels following the declining rainfall residual mass; apart from a spike in water level following rainfall in March 2018, greater response was recorded in WRGW2 than WRGW1. From October 2018 to December 2018, the rainfall residual mass and water levels followed an increasing trend. During January to June 2019, the water level correlated with the daily rainfall including a large spike following the March rainfall event, and generally correlated with the residual mass curve except for January and February, when following rainfall in December 2018 the water level increased while the monthly rainfall was below average. The water levels have not returned to pre-March 2012 levels. The water levels at both WRGW1 and WRGW2 sites during 2019 displayed the usual correlation with the monthly rainfall with a large spike at a September 2019 rainfall event. The large rain event in February 2020 resulted in a spike in the groundwater level at both monitoring sites.

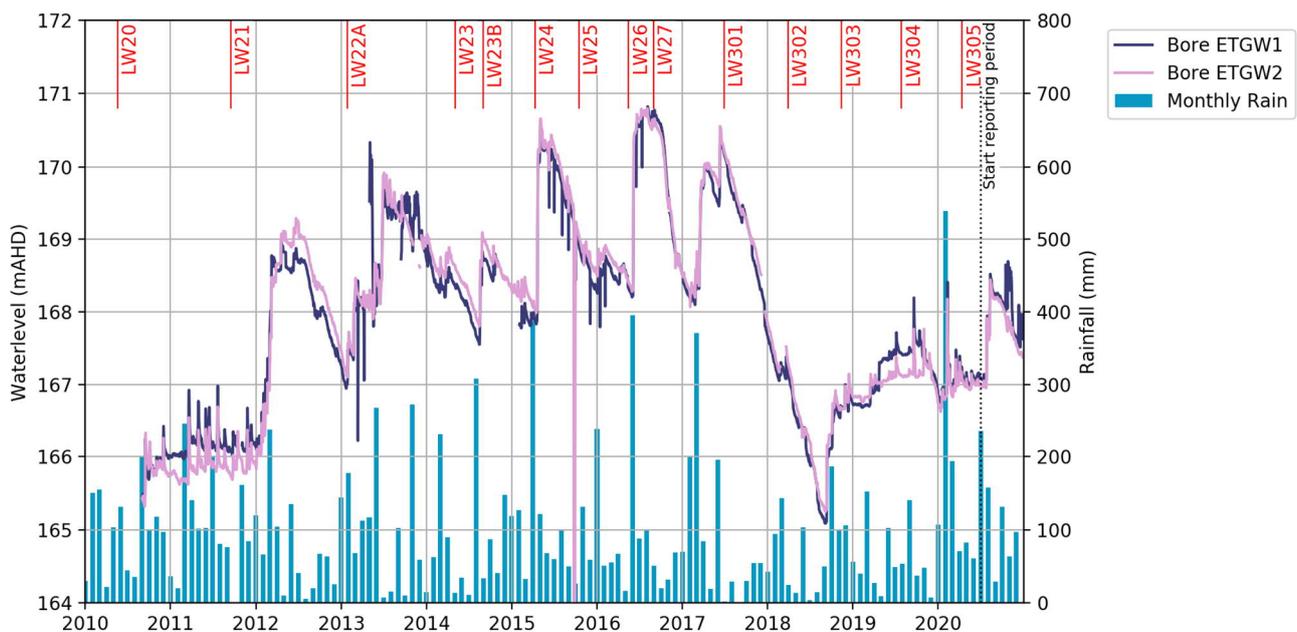
Figure 28 Shallow Groundwater Hydrographs on Eastern Tributary at ETGW1 and ETGW2

At the Eastern Tributary sites ETGW1 and ETGW2, which are located downstream of Longwall 27, shallow groundwater levels have previously followed the rainfall trends closely (Figure 28) and continued to show a close correlation during the reporting period. The variations at these sites are unrelated to mining. Reservoir water levels also respond to rainfall with a similar pattern. A groundwater hydraulic gradient was maintained towards the reservoir because the groundwater levels were 3-8 m higher than the reservoir levels, which were observed to be 160-165 mAHD during the reporting period (refer to Figure 29).

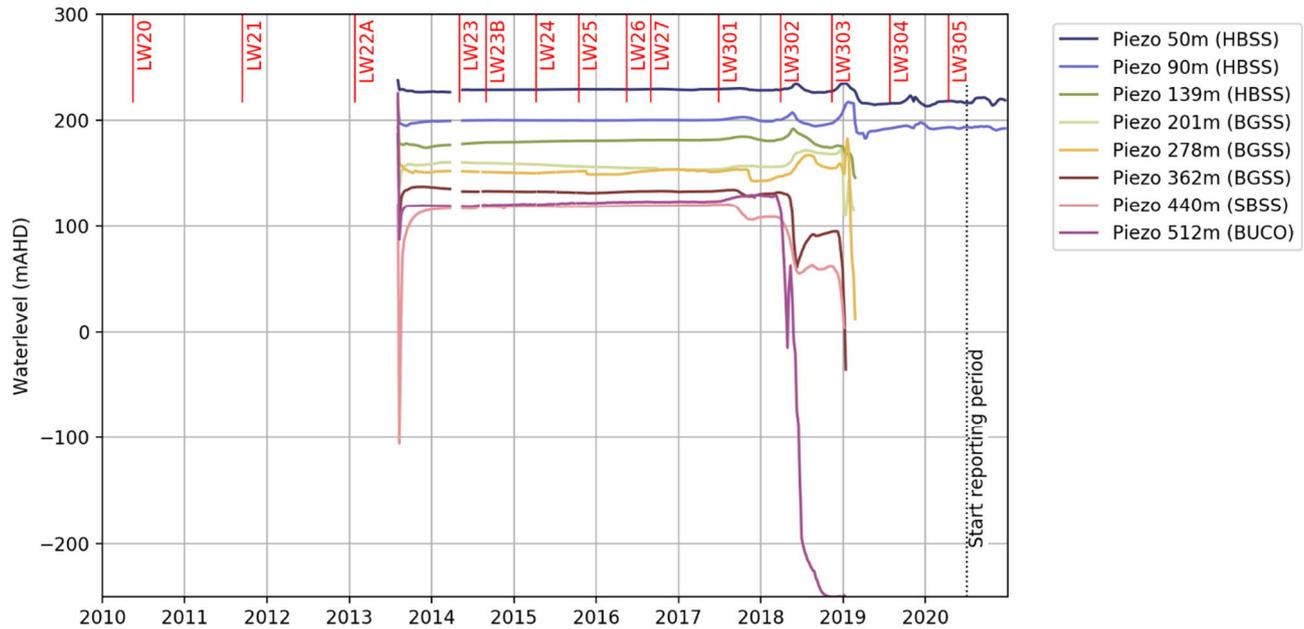
Figure 30 Time Variations in Potentiometric Heads at F6GW4A

Bore F6GW4A overlies the chain pillars between Longwalls 303 and 304; the time-series record for bore F6GW4A is shown in Figure 30. This bore is two panel widths from Longwall 301 and one panel width from Longwall 302. The respective mining faces came closest to the bore in late-September 2017 and late-May 2018, at which times distinct features are evident on all hydrographs. The passage of Longwall 301 caused mild responses, generally short-term increases in head, while the passage of Longwall 302 caused sharp cusp-like features on the Hawkesbury Sandstone hydrographs, sustained rises in the upper and mid Bulgo Sandstone, and strong declines in the three deepest piezometers. In January 2019, F6GW4A was undermined by Longwall 303 causing the depressurisation and disabling of the six lower sensors (139 m bgl, 201 m bgl, 278 m bgl, 362 m bgl, 440 m bgl and 512 m bgl).

The upper and mid Hawkesbury Sandstone piezometers (50 m bgl and 90 m bgl) also displayed a lowering of groundwater head following the passage of Longwall 303; however they showed no significant decline after the passage of Longwall 304 and 305, and none during this reporting period.

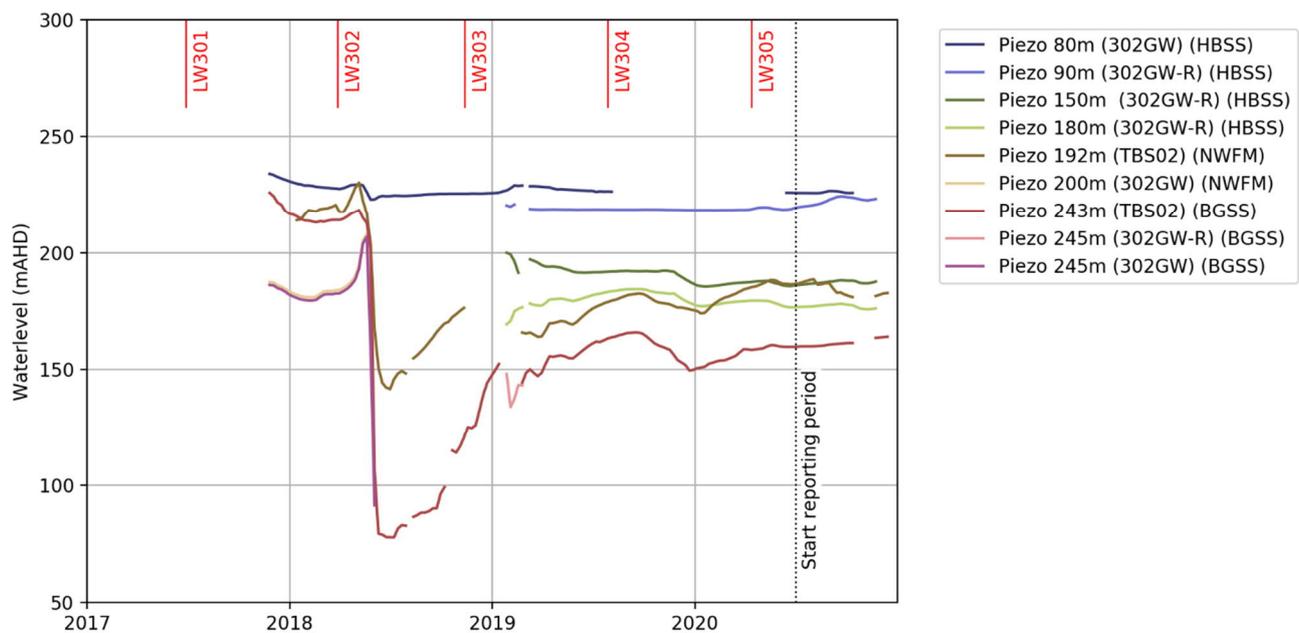
Figure 31 Time Variations in Potentiometric Heads at 302GW01 and TBS02

The TBS02 piezometer at 192 m failed in November 2018 (following passing of Longwall 302) and the piezometer at 243 m bgl failed in January 2019 (following passing of Longwall 303). The TBS02 Replacement Bore (piezometers at 90 m bgl, 150 m bgl, 180 m bgl and 245 m bgl) was installed and commenced monitoring on 24 January 2019; three of the four piezometers are recording data. The VWP piezometer at 245 m bgl failed in February 2019. In June 2020, the original TBS02 bore was found to have resumed reporting measurements from the two sensors downhole.

The water levels of the remaining active sensors showed slightly increasing trends, except for Piezo 192 (Newport Formation), which showed a small decrease.

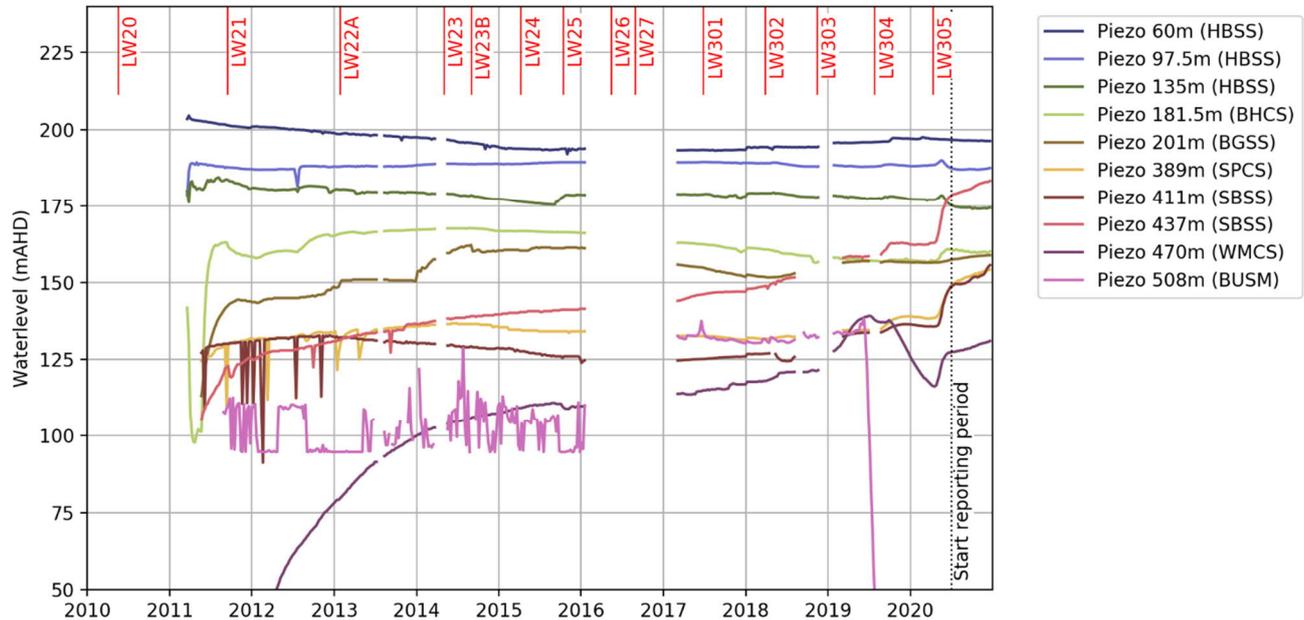
Figure 32 Time Variations in Potentiometric Heads at PHGW2A

Figure 32 shows the groundwater levels at site PHGW2A. A connection failure prevented upload of data for sensors in PHGW2A in 2016. Sensors have now been reinstated.

At the start of the reporting period, all of the deeper piezometers had come out of a period of an increase. With the start of Longwall 305, all piezometers showed a sudden increase, more pronounced with depth. This is likely a compression effect from mining Longwall 305, similar to the effects observed at bore T5 about 400 m to the south-east. The increasing water levels continued on from the last reporting period; however, the rate of increase was smaller during this reporting period. Piezo 97.5 and 135 (both Hawkesbury Sandstone) showed a small increase after the start of LW305 and have since decreased.

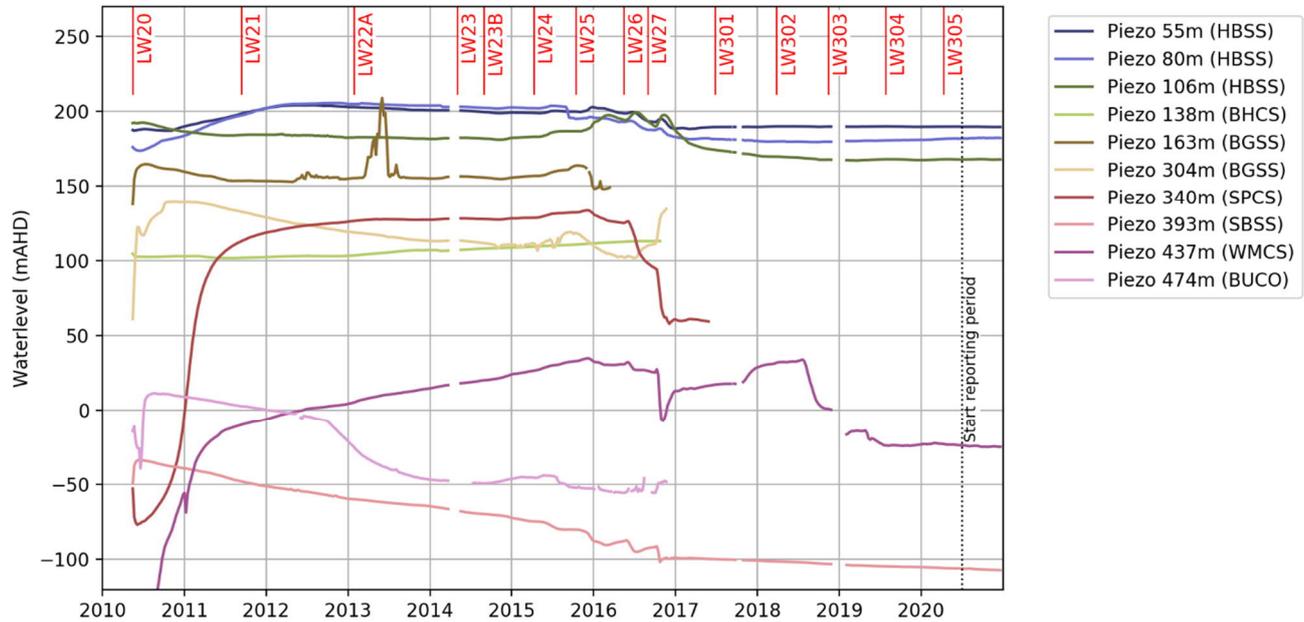
Figure 33 Time Variations in Potentiometric Heads at 9EGW2B

The time-series record for bore 9GGW2B is shown on Figure 33. As the hydrographs show inconsistent head variations with depth, some of the piezometers are unreliable. During the passage of Longwall 24 (>600 m away), minor drawdowns were observed in the Bulli Coal Seam and the Scarborough Sandstone, but other sensors exhibited no effect or a rise in head. The passage of Longwall 25 (>400 m away) caused distinct drawdowns in the Scarborough Sandstone, Wombarra Claystone, Stanwell Park Claystone and upper Bulgo Sandstone. Characteristic arcuate segments between cusps associated with subsequent longwall crossings are evident in the Scarborough Sandstone, Wombarra Claystone and Stanwell Park Claystone, but not in the Bulli Coal Seam. The lower Bulgo Sandstone shows rising head arcuate segments for Longwall 26 and Longwall 27 crossings, due to compression at that level. Sympathetic drawdowns are also exhibited in the three Hawkesbury Sandstone piezometers at the times of the Longwall 26 and Longwall 27 crossings. The 138 m bgl, 163 m bgl, 304 m bgl and 474 m bgl deep vibrating wire piezometers have not recorded data since the end of 2016. The 340 m bgl deep vibrating wire piezometer has not recorded data since June 2017. The upper, mid and lower Hawkesbury Sandstone piezometers (55 m bgl, 80 m bgl and 106 m bgl) remained stable during the reporting period. The same is true for the two deep piezometers 393 and 437.

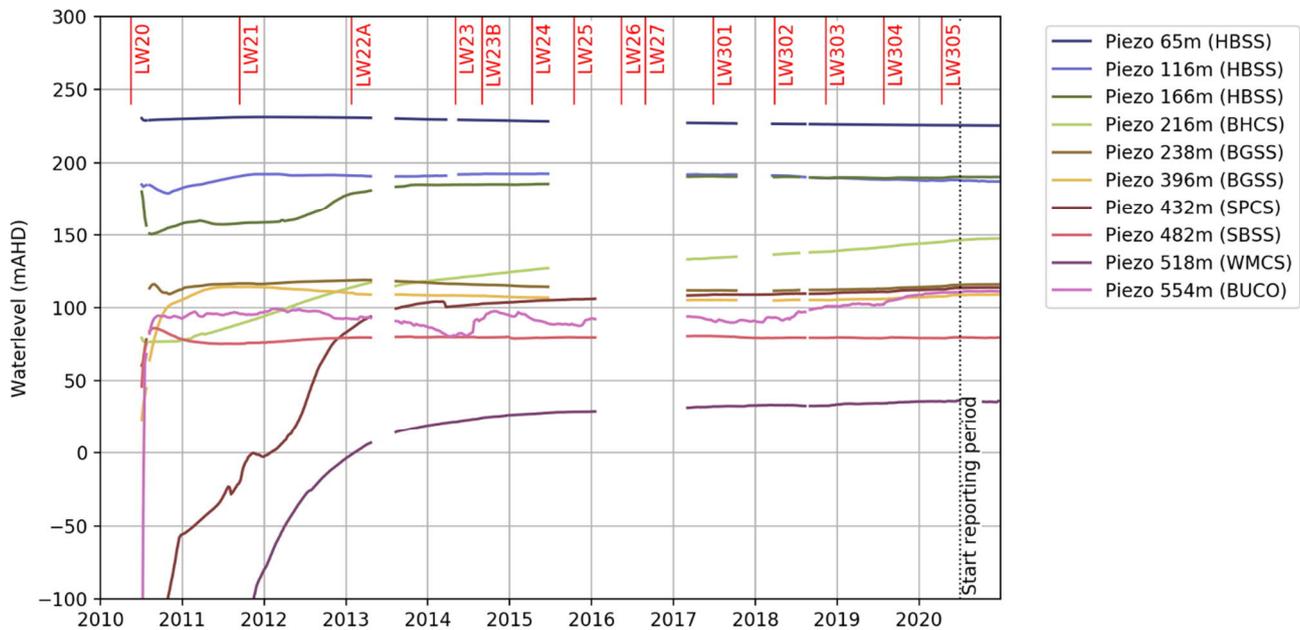
Figure 35 Time Variations in Potentiometric Heads at PHGW1B

Figure 35 shows the water levels at VWP PHGW1B. The piezometers are located approximately 750 m north of LW305. The piezometers at 216 and 554 m bgl showed a slight increase in water pressures since 2018. During the reporting period, all piezometers showed steady water pressures and no impact from mining at LW305. A connection failure prevented upload of data for sensors in PHGW1B in 2016. Sensors have now been reinstated.

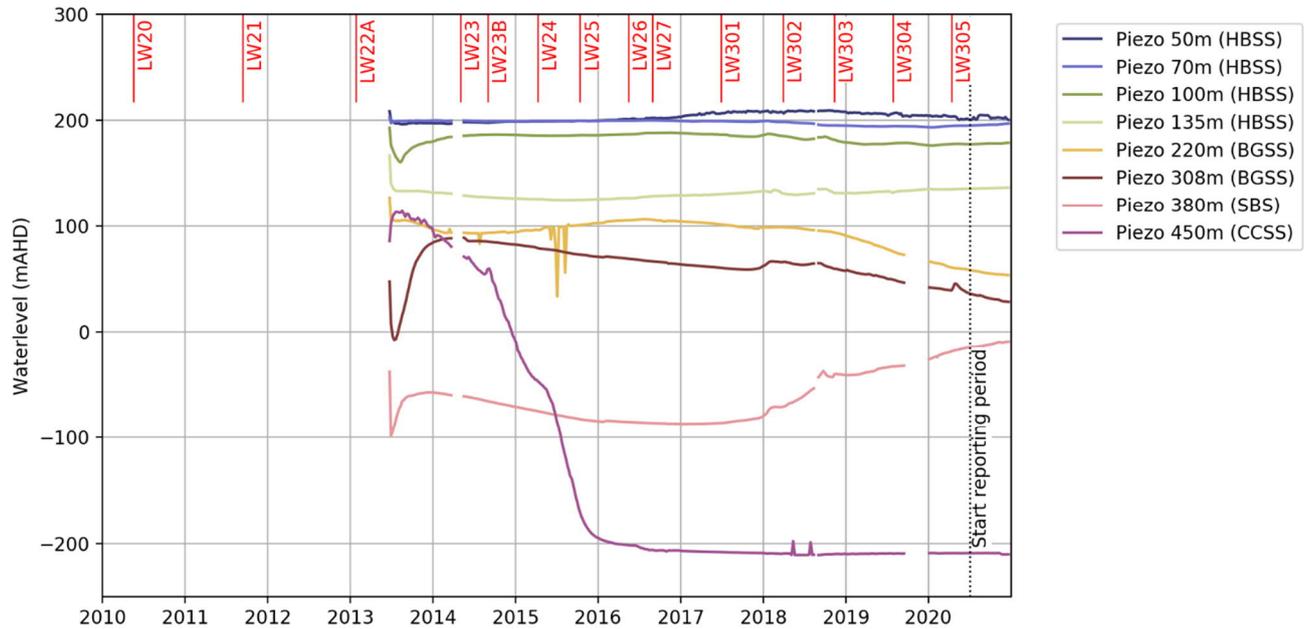
Figure 36 Time Variations in Potentiometric Heads at F6GW3A

Bore F6GW3A (Figure 36) is located adjacent to Longwall 301 about 150 m beyond its southern end, and at about 800 m from Longwall 27. Significant depressurisation has occurred from historical workings to the east at about 500 m distance. The 450 m bgl deep piezometer at the base of the Coal Cliff Sandstone displays significant depressurisation continuing from the mining of the first heading in the 300 mains in November 2013. The rise in pressure in the 380 m bgl piezometer, noted in the previous reporting periods as potentially related to compression from the adjacent LW302 beginning in March 2018, continued at a slight rate during the current reporting period. However, communications were lost due to the vandalised aerial cable for four VVPs at 220 m bgl, 308 m bgl, 380 m bgl and 450 m bgl on 22 September 2019. The cables have since been re-instated. In this reporting period, five piezometers (50 mbgl, 70 mbgl, 100 mbgl, 135 mbgl and 450 mbgl) showed stable water levels during this reporting period. The Piezos 220 and 308 showed a continuous decrease, with Piezo 308 showing an impulse increase in pressure when Longwall 305 started. Piezo 380 continued to increase in water levels.

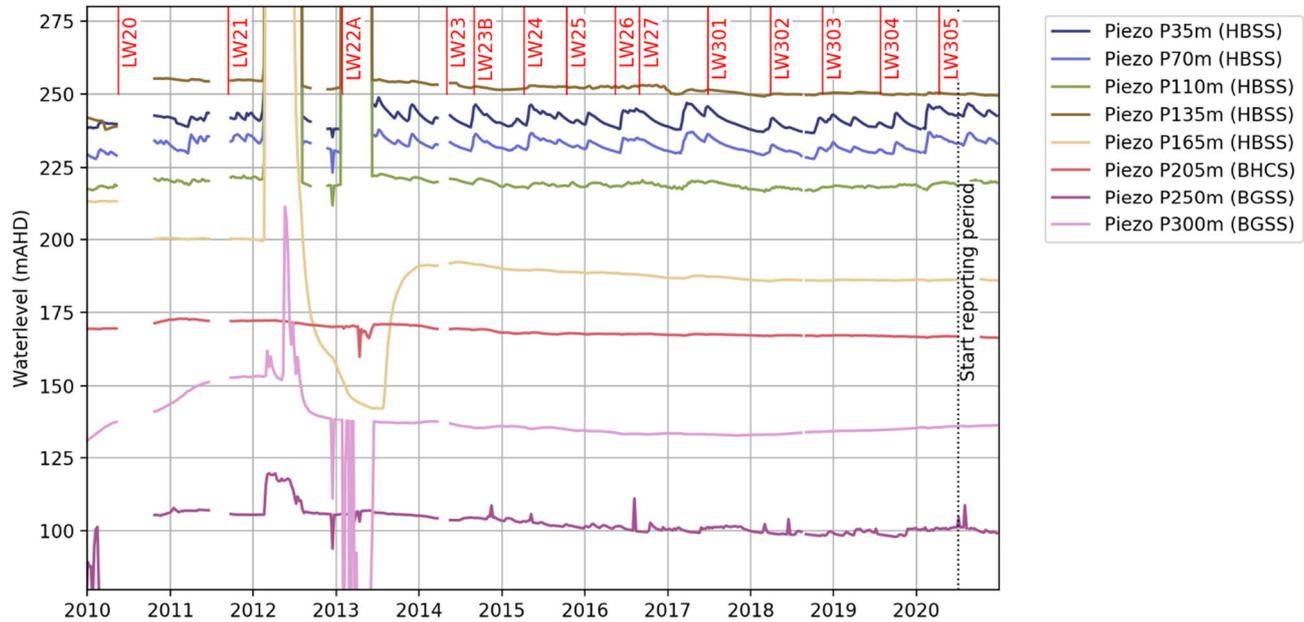
Figure 37 Time Variations in Potentiometric Heads at 9HGWO

The original goaf hole 9HGW0 (Figure 37) showed no changes to previous reporting and continued to report steady conditions for the piezometers 110 and below. The shallowest two piezometers (35 and 70) in the Hawkesbury Sandstone continued to show some variability to climatic conditions.

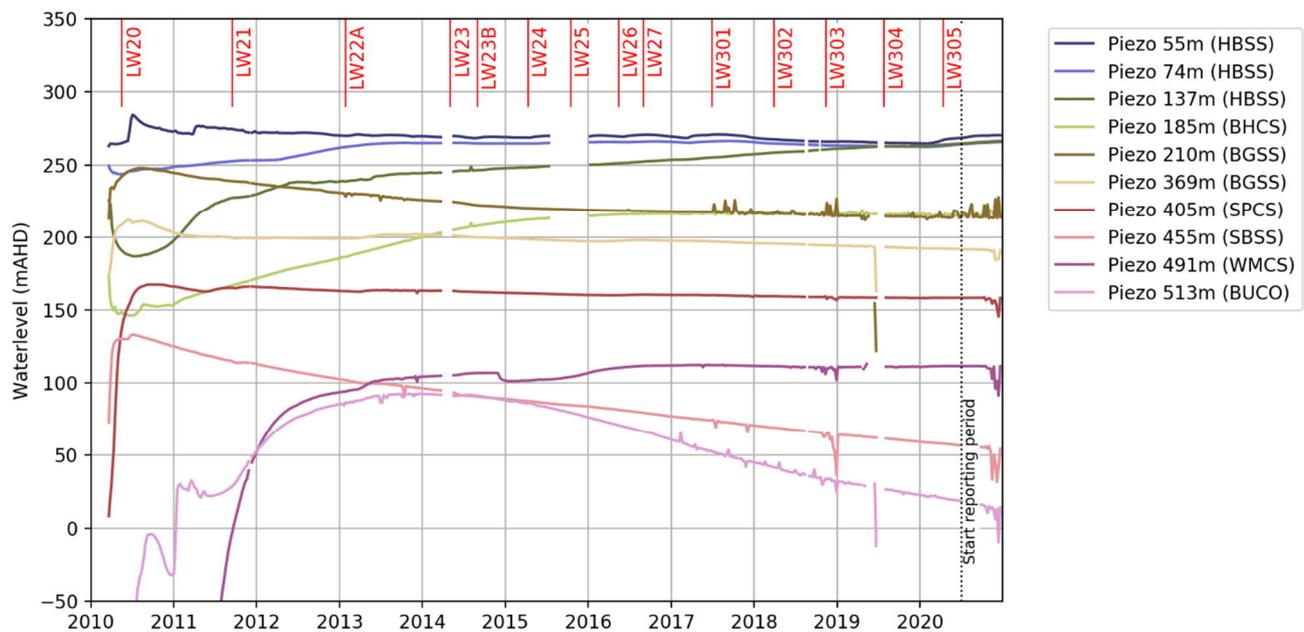
Figure 39 Time Variations in Potentiometric Heads at 9FGW1A

Figure 39 shows the groundwater levels for site 9FGW1A. All sensors showed a continuing water level record, either stable or continuing a previous declining trend. The sensor at 210 m (BGSS) showed some increasing spikes on an otherwise stable water level, which it historically has at times.

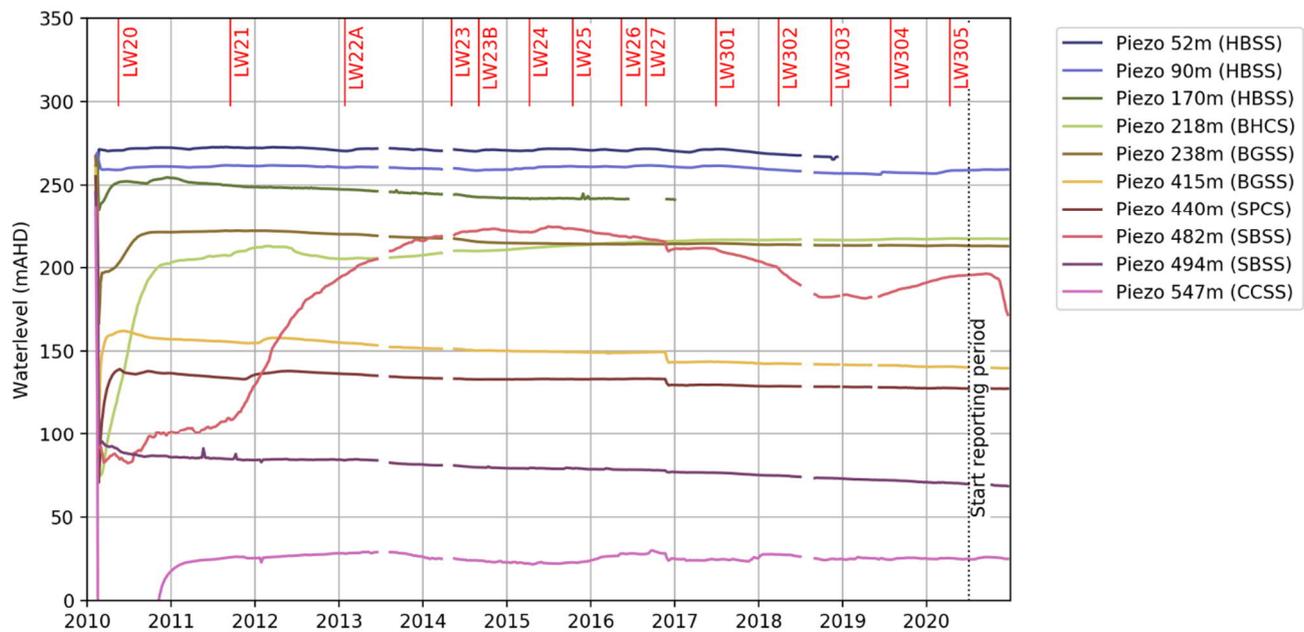
Figure 42 Time Variations in Potentiometric Heads at PM01R

Figure 42 shows the potentiometric heads at PM01R. The heads were generally stable during the reporting period, with the exception of Piezometer 482 (Scarborough Sandstone), which showed a sudden decline in early November 2020. The reason for this decrease is unknown, however it is unlikely that it is mining related due to the distance of the bore the LW305, which was mined between 12 April and 12 November 2020.

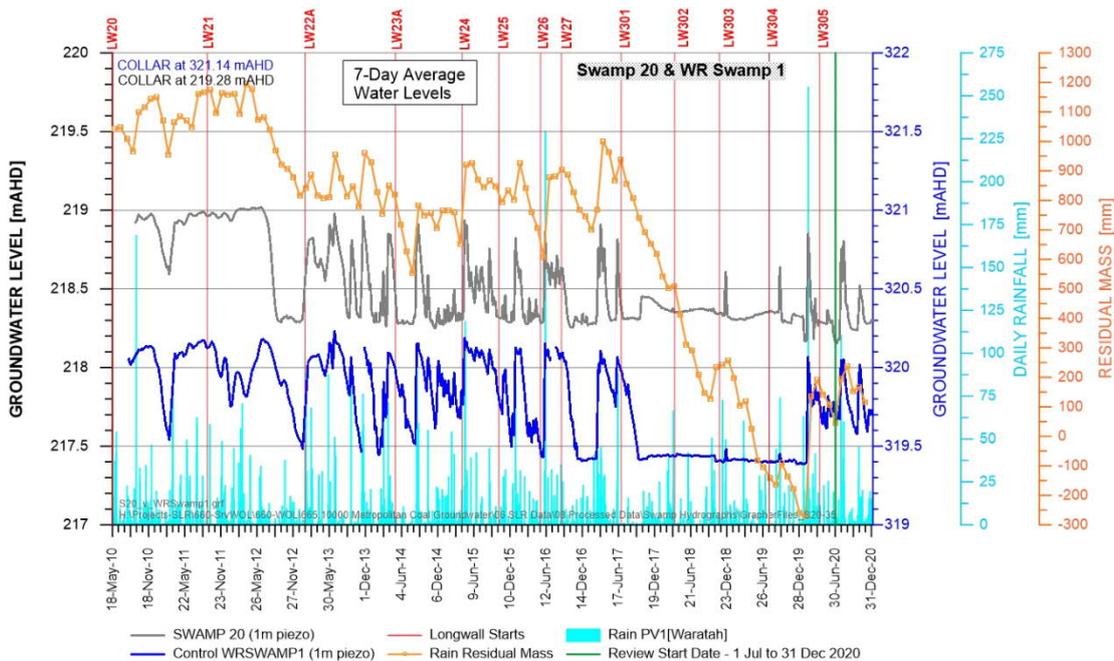
Figure 52 Comparison of Piezometer Responses at Swamp 20 and Woronora River 1 Control Swamp

Comparison is made on Figure 52 between the 1 m piezometers at Swamp 20 and the control swamp WRSWAMP1, and with rainfall residual mass. There is a very strong correlation with rainfall trend at both sites. As the rate of decline in the two piezometers is similar between 2013 and 2016, but different in 2012, it is likely that Longwall 21 caused a mining effect at Swamp 20, but Longwalls 22-27 and Longwalls 301-305 have not exacerbated the effect. In 2018 and 2019, both swamps reported water levels at the base of the substrate datalogger for the full period apart from the short period of saturation recorded in Swamp 20 in September 2019. Both swamps increased in water levels after the large rain event in February 2020. However, following rainfall events throughout 2020 Swamp 20 exhibited a decrease in groundwater levels whereas the WRSWAMP1 water levels remained at near-saturated levels for the remainder of 2020.
