METROPOLITAN COAL GROUNDWATER MONITORING REPORT

1 July - 31 December 2020

Metropolitan Collieries Pty Ltd
A Peabody Energy Subsidiary

SLR Ref: 665.10000-R05
Version No: -v2.0
March 2021

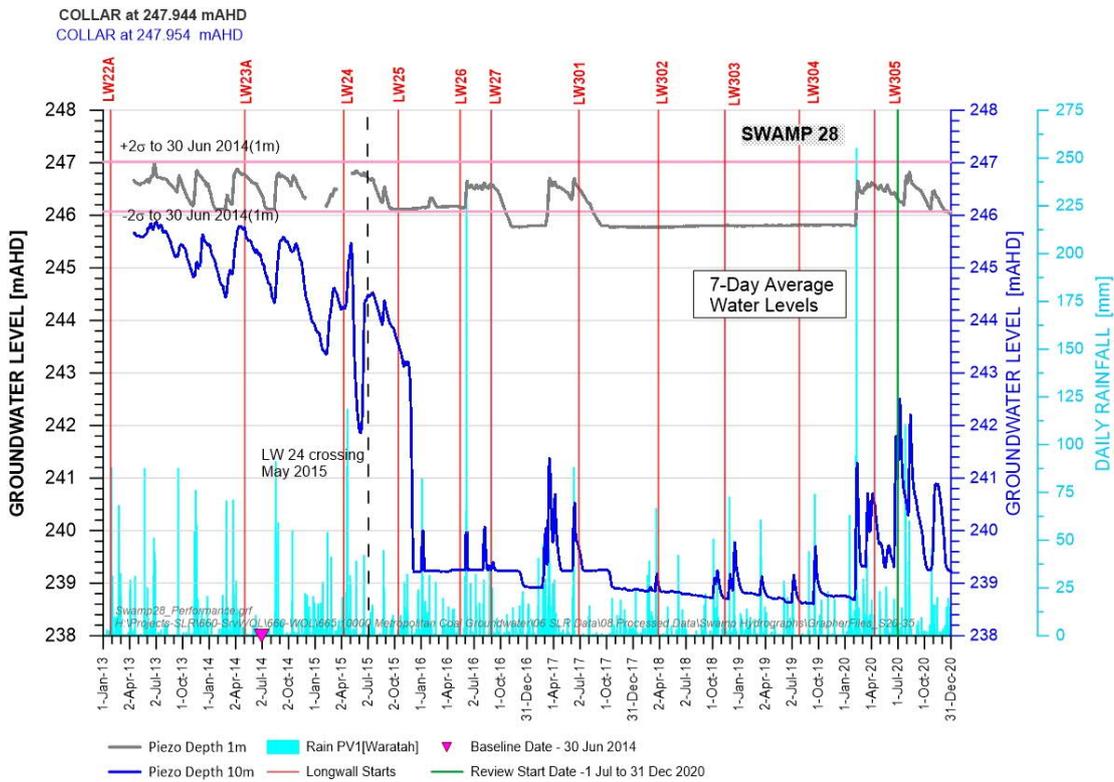
Figure 53 Seven Day Average Water Levels at Swamp 28

The face of Longwall 24 passed Swamp 28 during April/May 2015, and the swamp was passed by Longwall 25 in November 2015. The performance assessment for Swamp 28 is illustrated on Figure 53. The 2σ bandwidth for the Swamp 28 swamp substrate piezometer is about 0.9 m which is restrained by the recurrent dry episodes in 2013 and the first half of 2014, and the sensor setting at that time. The water table in the substrate piezometer during 2016 and 2017 correlates well with the rainfall trends (Figure 13 in Section 3.2.2), despite the sharp declines in groundwater level observed in the sandstone (10 m) piezometer following the passage of Longwalls 24 and 25. During the second half of 2016, water levels in the swamp substrate exceeded the -2σ limit but only in response to adjustment of the diver cable length on 19 July 2016. This should not be construed as a mining effect. However, compared to the water levels prior to 2016, the amplitude of the substrate water level response was incomplete in the January-June 2016 reporting period (best seen on Figure 54, compared with the control swamps) and this continued to be observed during the second half of 2016, with only partial recovery of swamp substrate groundwater levels. Accordingly, it was determined that a mining effect had occurred in early 2016, but not at the time when mining passed directly beneath the swamp. For the first two months of 2017, readings in the swamp substrate piezometer continued to be dry, below sensor level since November 2016. Between March and June 2017, the substrate piezometer displayed a response to increased rainfall residual similar to that of the control swamps, and the upper height of saturation had almost returned to baseline conditions. The substrate piezometer at Swamp 28 returned to dry conditions from September 2017, remaining so until the end of December 2019, as did the two control swamp piezometers. With the large rain in February 2020, the water level in both the substrate and the shallow piezometer recovered. The substrate piezometer indicated saturated conditions until the end of the reporting period in December 2020. This recovery has placed substrate groundwater levels at Swamp 28 above the base of the 2σ bandwidth for the first time since July 2017. Both piezometers appear responsive to rainfall and fluctuate accordingly. Although recovery has also been observed at the 10 m piezometer, groundwater levels remain lower than those recorded prior to the crossing of Longwall 24.

This has not changed the previous interpretation that Swamp 28 is considered to have had an impact from mining of Longwall 25, although no effect occurred on the substrate when Longwall 24 passed directly underneath the monitoring site.
