Aboriginal and Historical Heritage Impact Assessment (NSW Archaeology)

**Flyer Creek Wind Farm
Modification 4**
Aboriginal and Historical Heritage Assessment

Date: 20 July 2018
Author: Dr Julie Dibden
Proponent: Flyers Creek Wind Farm Pty Ltd

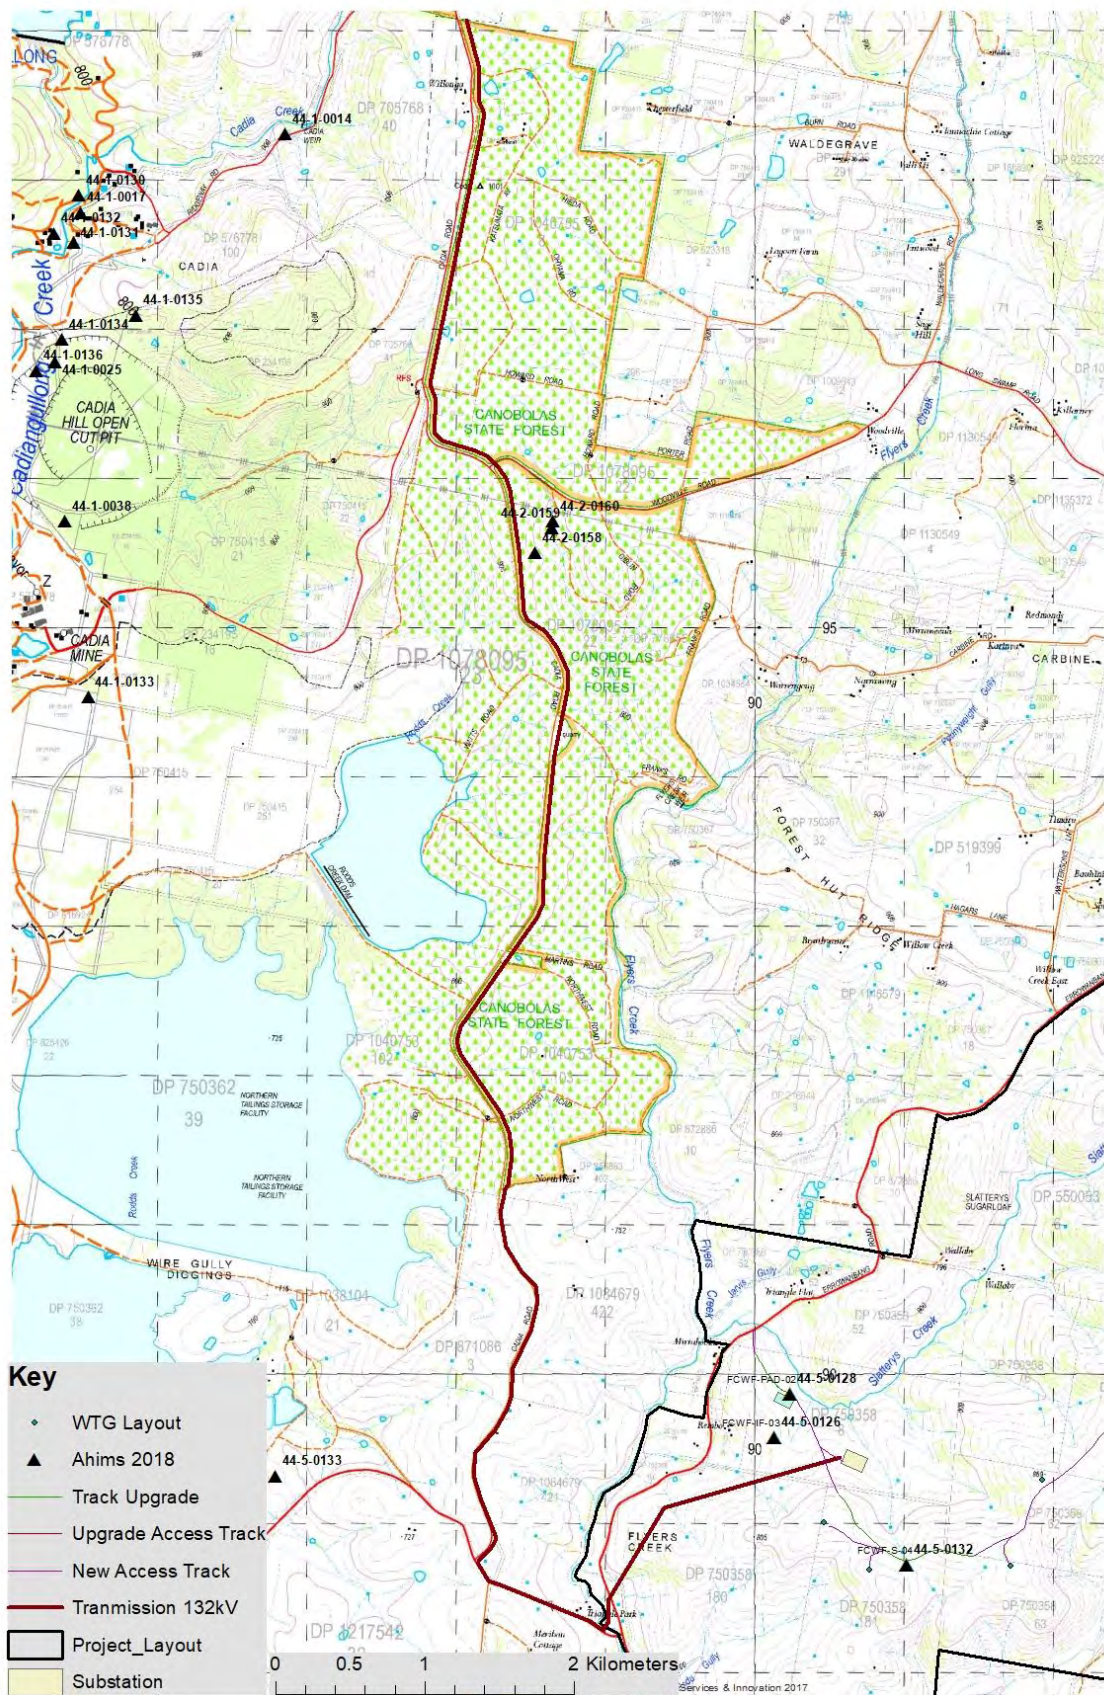
Figure 1 Location of Aboriginal object sites as per AHIMS site search.

1. increase the wind turbine envelope so as to accommodate the newer, more efficient turbine models now available; and
2. reinstatement of the 132 kilovolt (kV) transmission line from the on-site substation to connection point on the Essential Energy (EE) transmission line to the north of the site (Figure 1).

A total of 18 Aboriginal object sites are listed on AHIMS for the search area (Figure 1).

The route of the 132kV is shown in Figure 1. The transmission route corridor is 100 m wide. The 132kv line will:

- be approximately 14.5 km in length;
- travel across open farmland from the substation westwards, cross Errowanbang Rd (public road) and then travel along Panuara Rd reserve before heading north on Cadia Rd reserve before travelling alongside the road/in NSW Forestry Corporation state forest.
- The power poles will likely be approximately 24 m high and the easement corridor will be 45 m wide within a 100 m wide route corridor.
