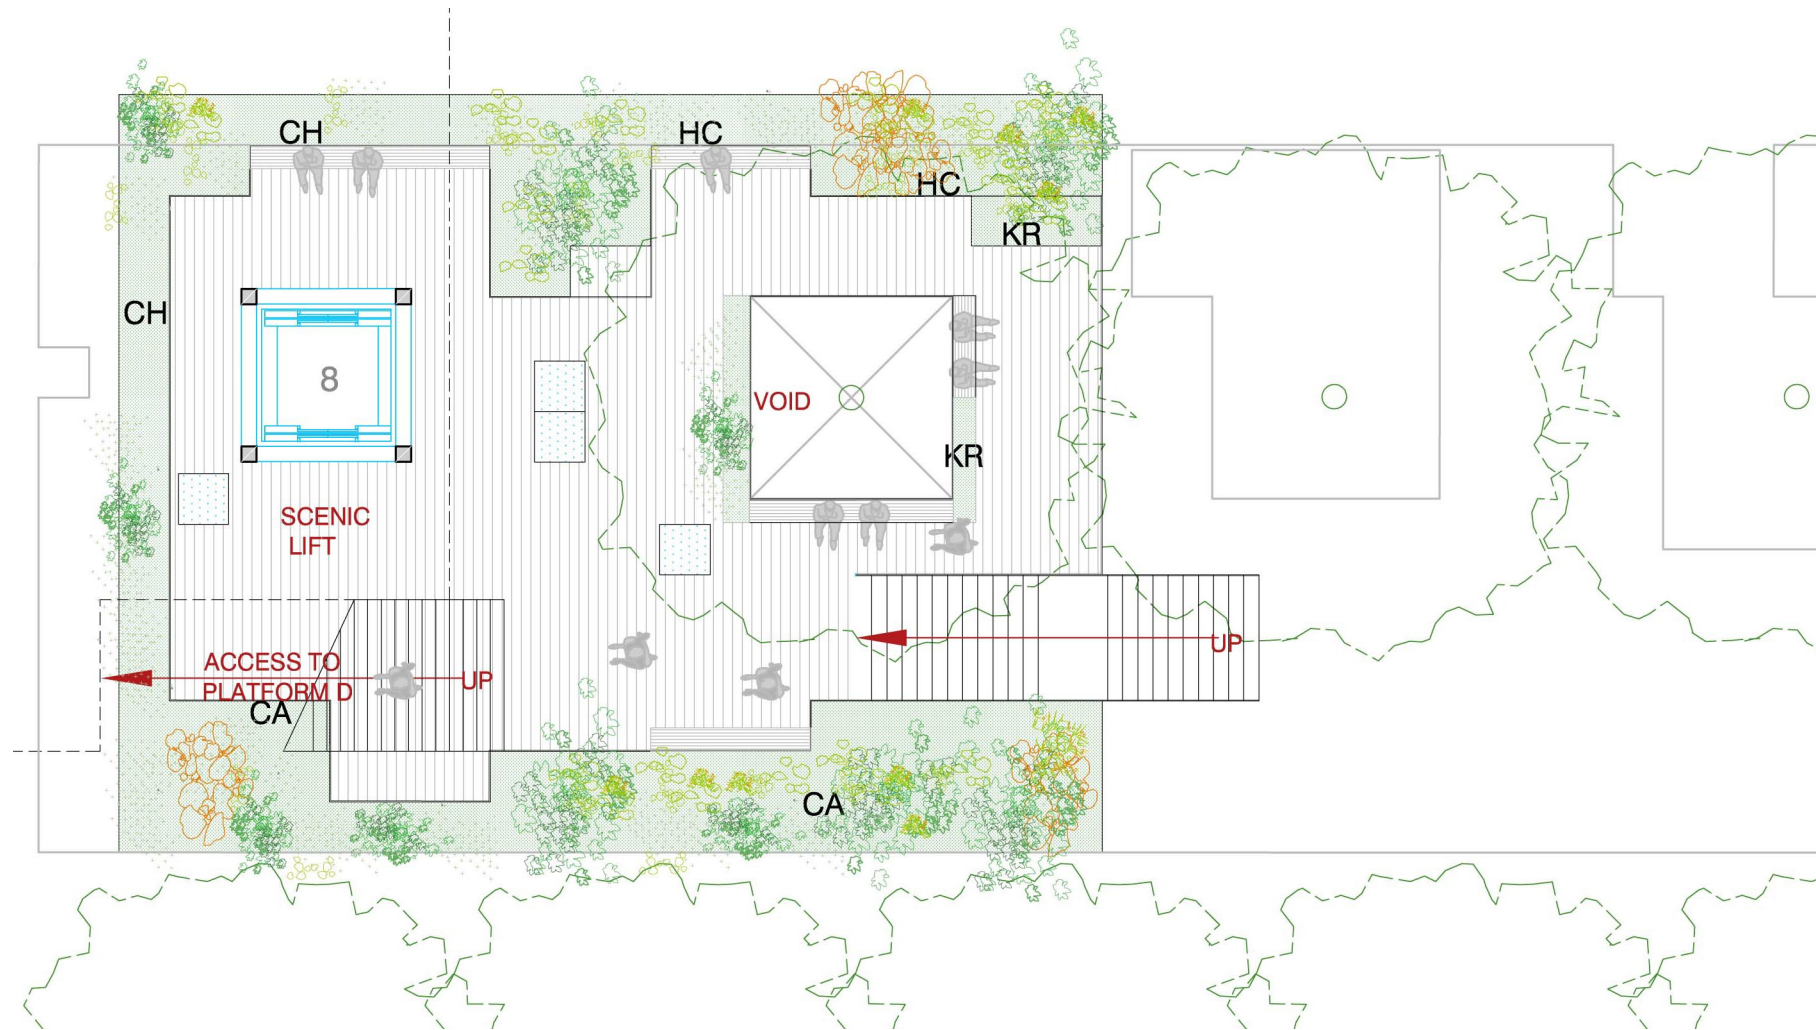
CH - Cissus hypoglauca

CA - Clematis aristata

HC - Hardenbergia  
comptoniana

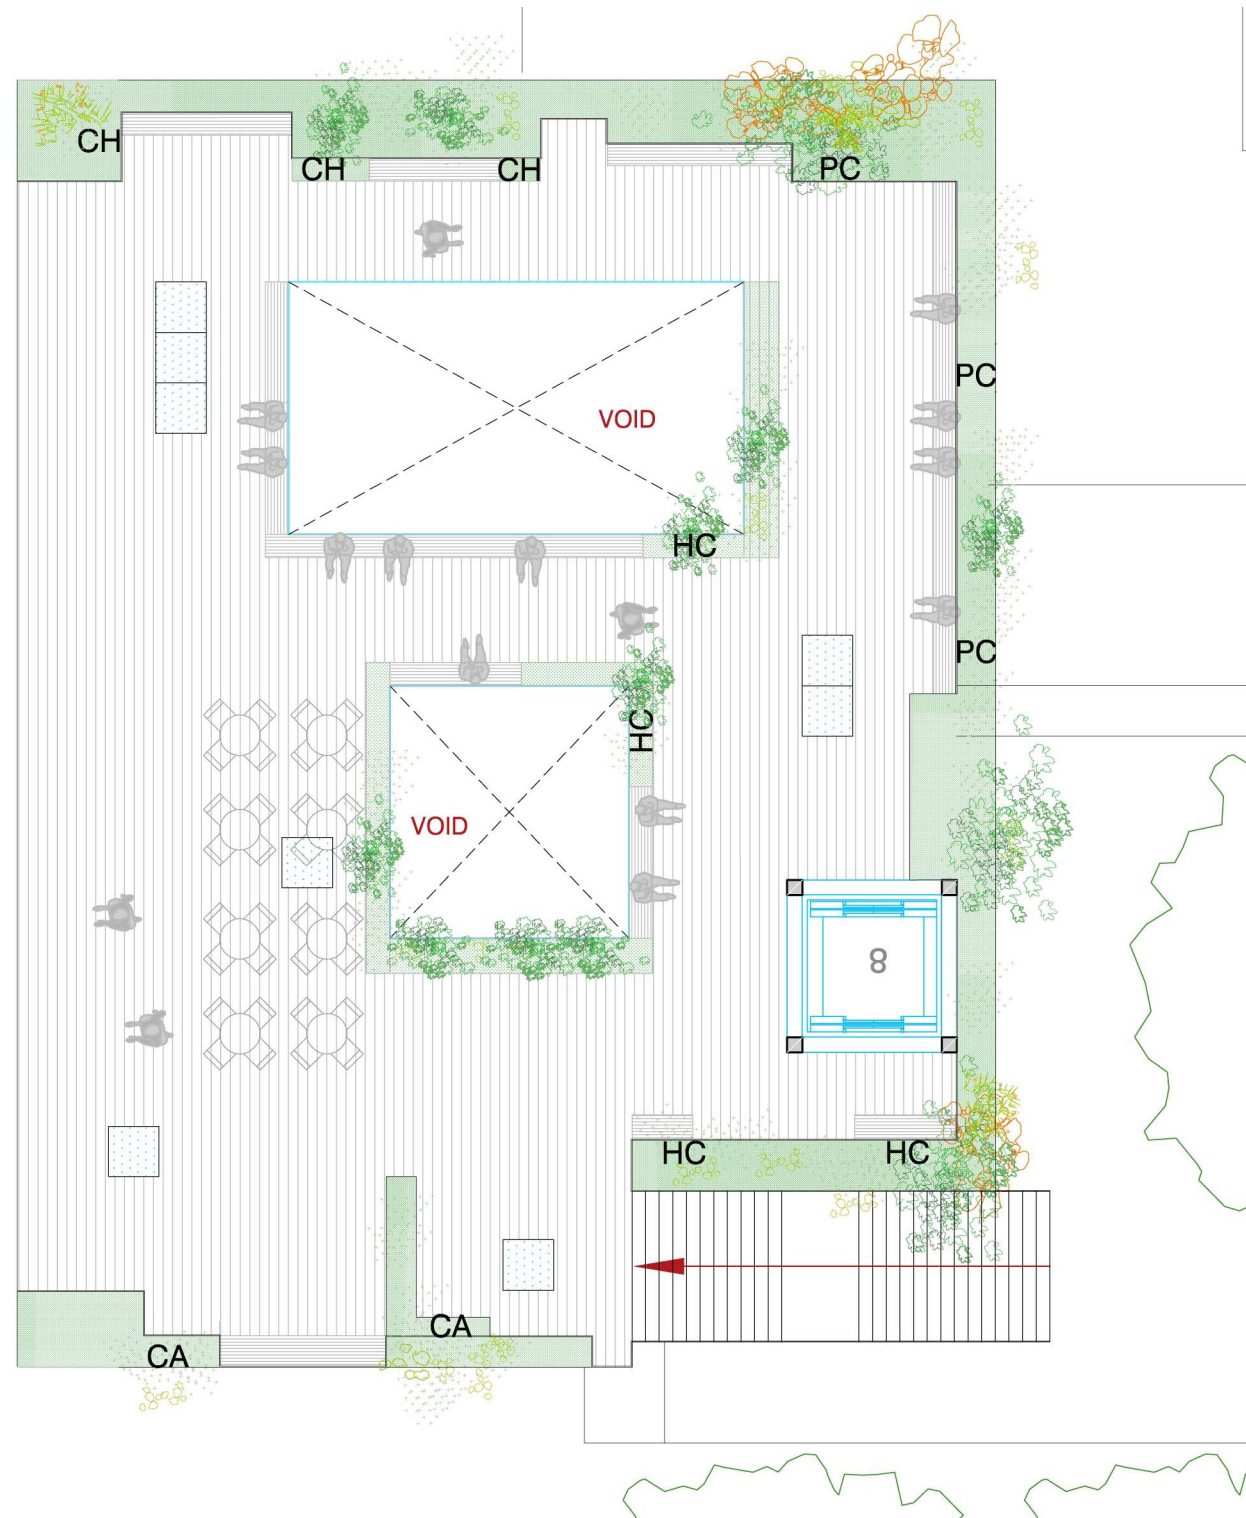
CH - Cissus hypoglauca

CA - Clematis aristata

HC - Hardenbergia  
comptoniana

PC - Passiflora cinnabarina

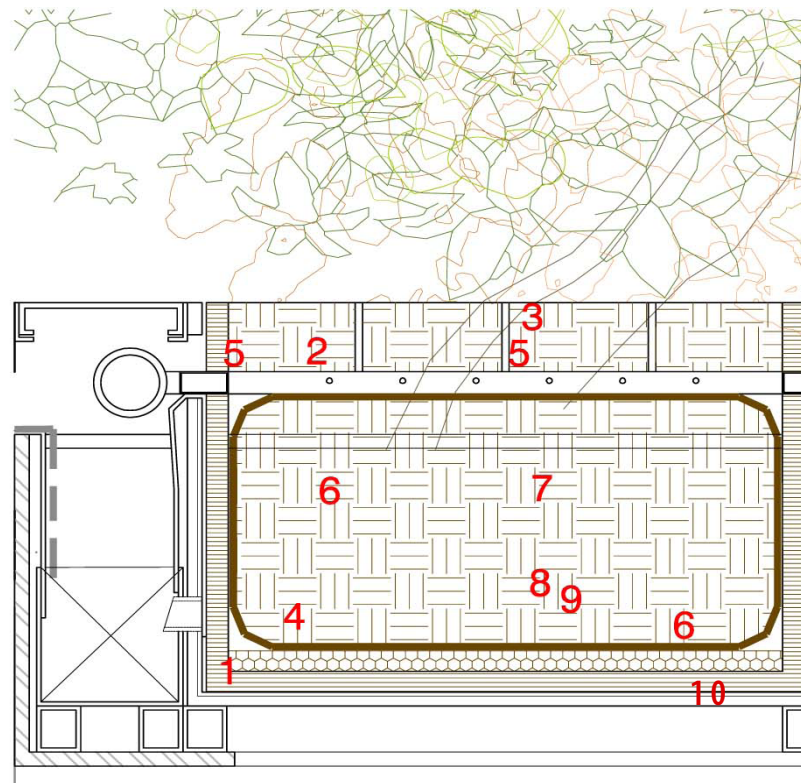
- 1 GALVANIZED STEEL GUTTER
- 2 OUTFLOW
- 3 STEEL GRATING
- 4 OUTLET
- 5 DRIP IRRIGATION PIPE
- 6 PERFORATED PLASTIC TRAY
- 7 SUBSTRATE
- 8 GEOTEXTILE MEMBRANE
- 9 DRAINAGE LAYER
- 10 POLISHED SCHELL

- 1 METAL MESH BALUSTRADE
- 2 STAINLESS STEEL PROFILE
- 3 TIMBER DECK
- 4 POLISHED CONCRETE CEILING
- 5 POLISHED CONCRETE COLUMN

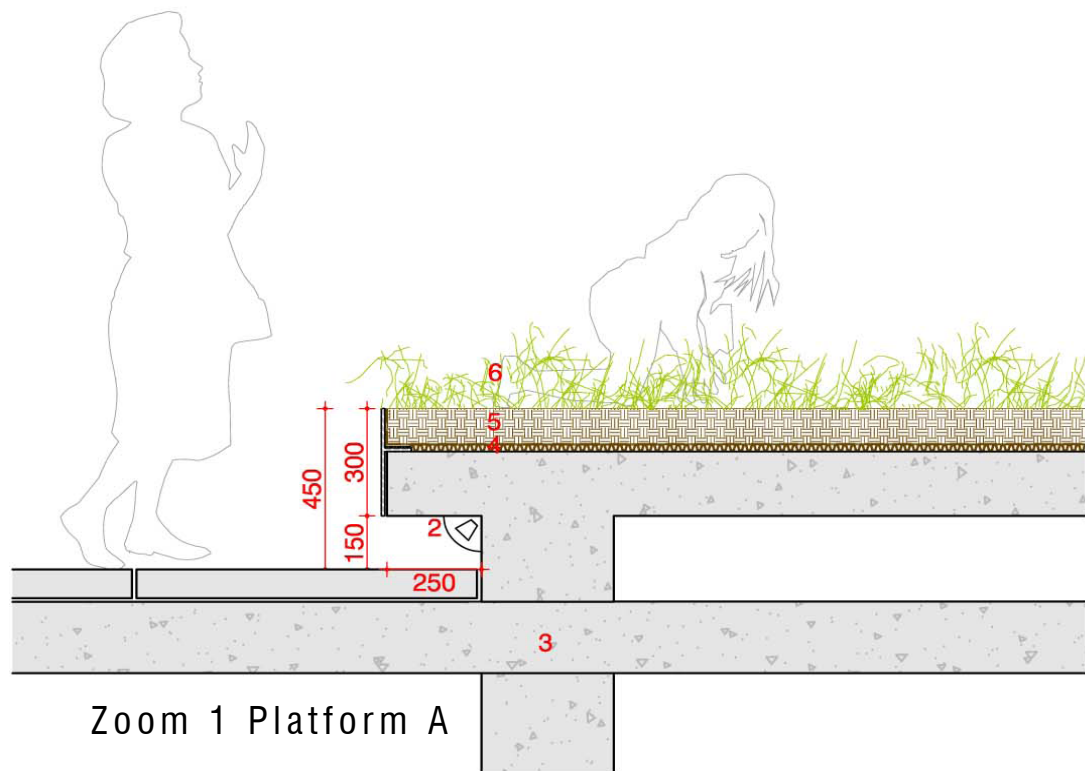
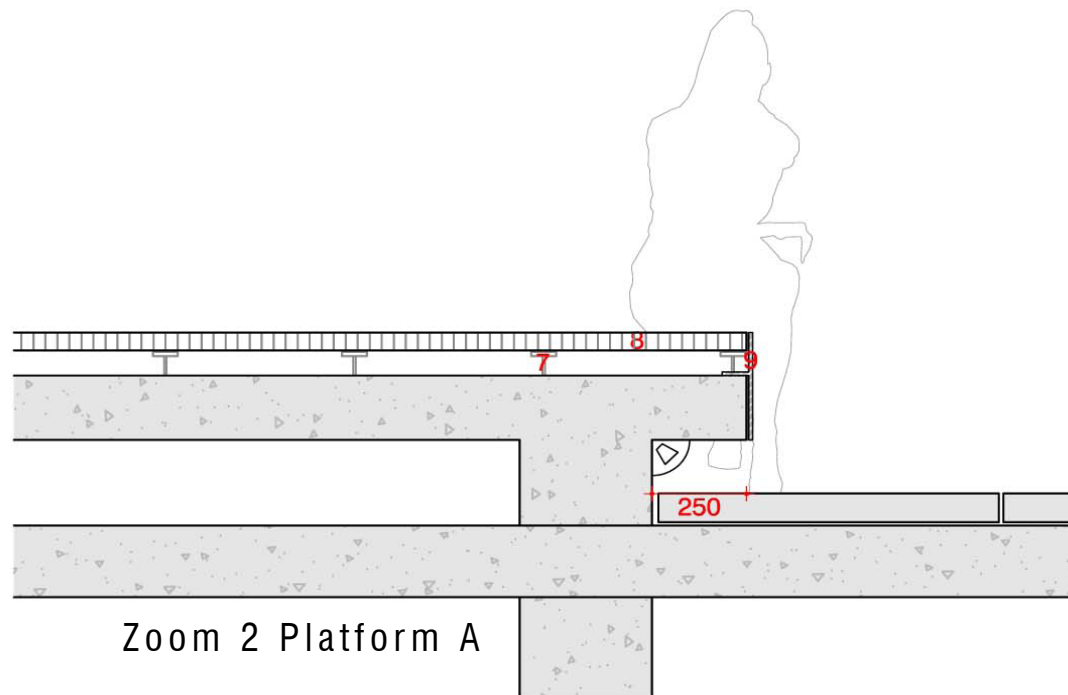
- 1 GRANITE PAVING STONE
- 2 LIGHTING FEATURE
- 3 CONCRETE SLAB
- 4 WATERPROOF AND DRAINAGE LAYERS
- 5 LIGHT SOIL MIXTURE
- 6 LAWN
- 7 DECK STRUCTURE
- 8 TIMBER DECK
- 9 STEEL PLATE
