**Re: Revised Preferred Project Application, Altitude Aspire, Terranora, New South Wales – Summary of soil contamination assessments**

**Soil Contamination  
Assessment for  
'Area E' Properties  
Terranora**

**Volume 1 - Report**

## SOIL CONTAMINATION ASSESSMENT

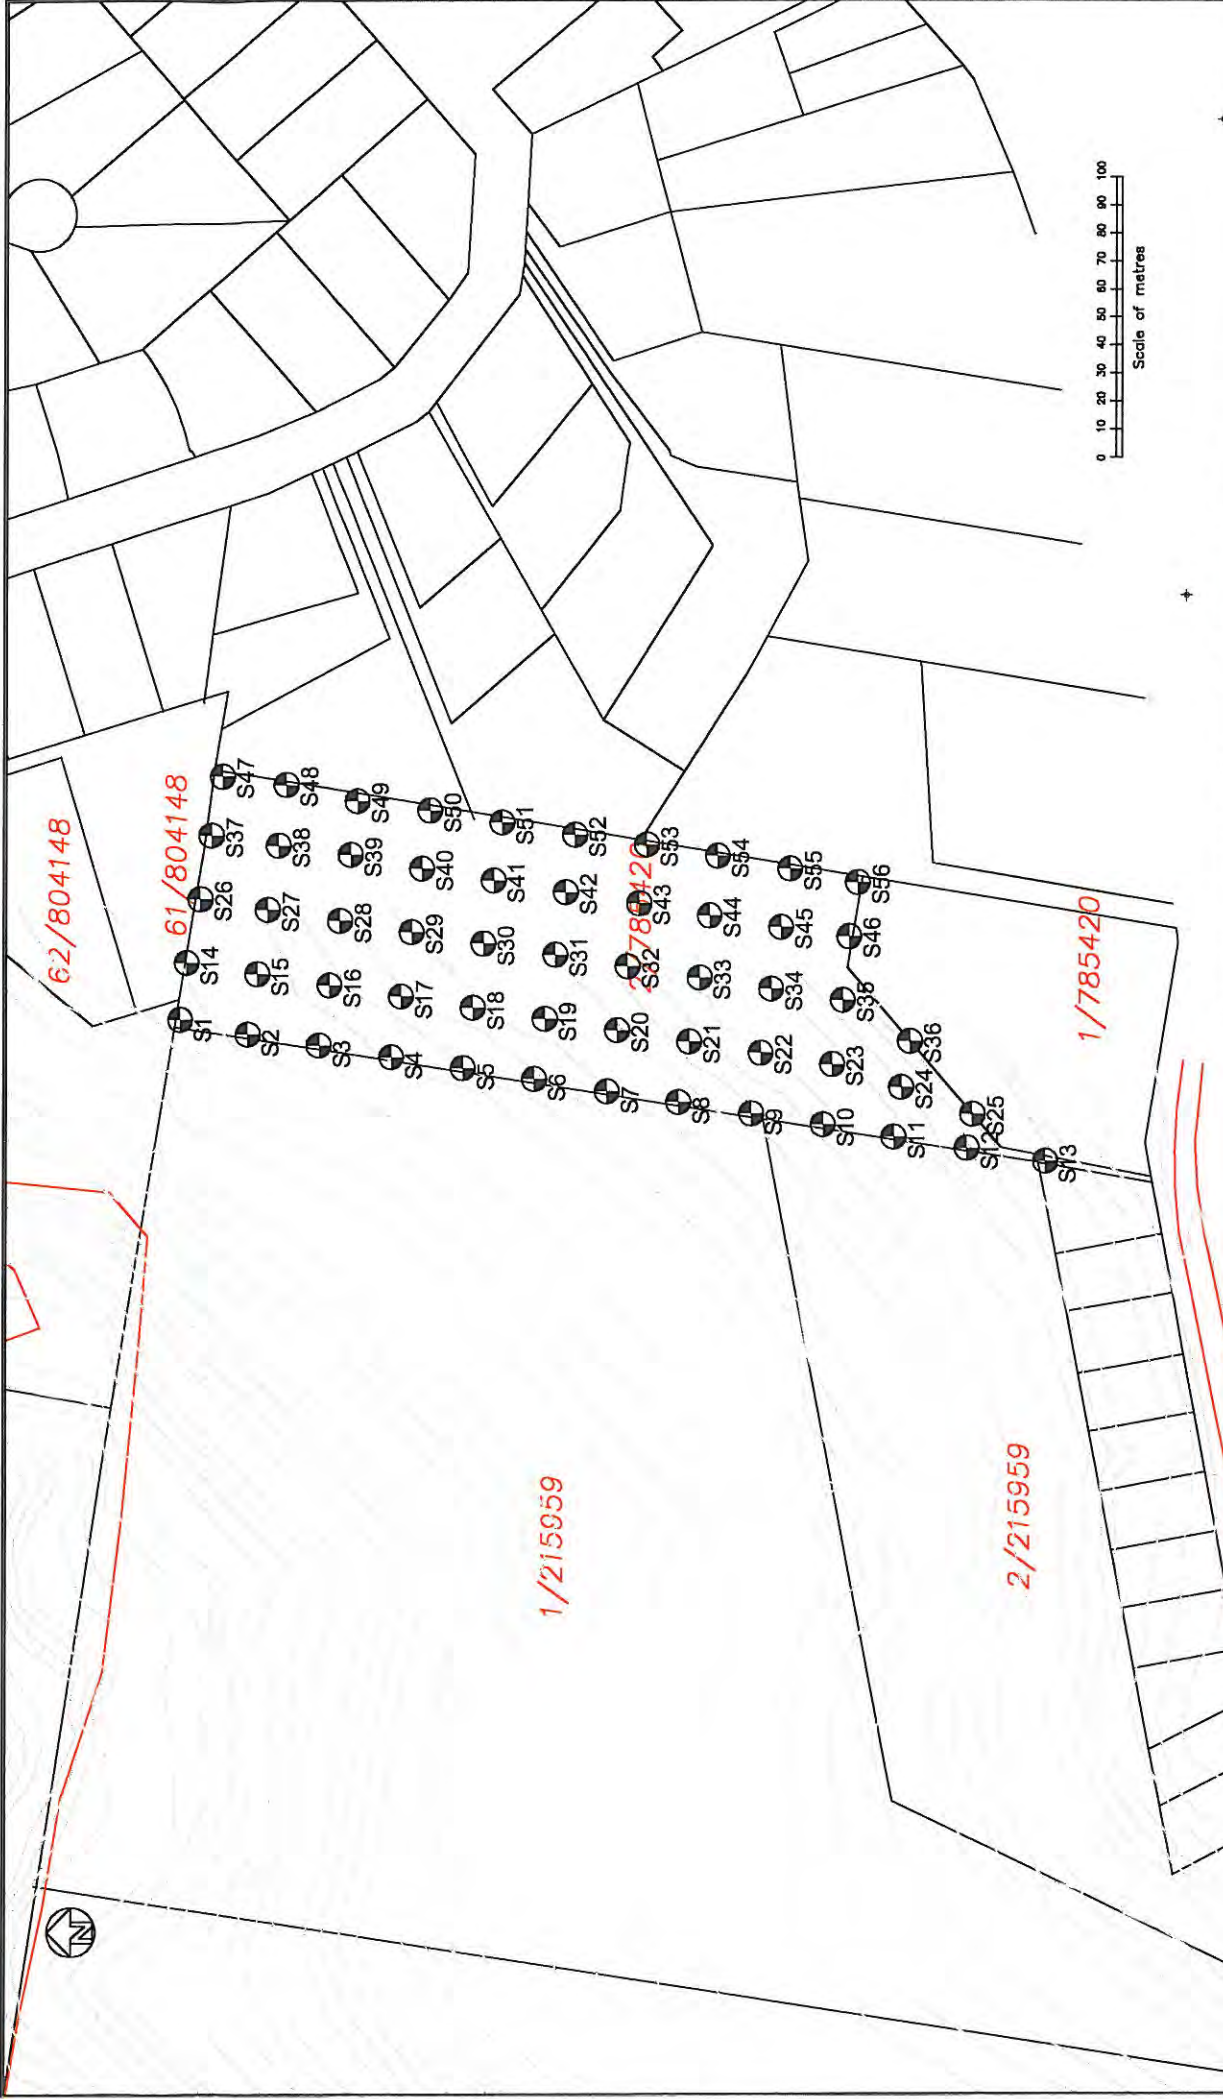
DRAWING No.  
GJ0128.1.2

A summary of the analytical results for Lot 2 DP 785420 are shown in Table 6.2.1 below. The sample locations are shown on Drawing Number GJ0128.1.2.

Five (5) of the fourteen (14) composite samples (C2, C3, C12, C13 & C14) analysed exceeded the adjusted HIL of 25mg/kg for arsenic. The arsenic concentration of these composite samples was 34, 32, 28, 40 & 27 mg/kg respectively. The concentrations of lead, cadmium, copper, zinc, mercury and organochlorine compounds were below the adjusted HIL's within all fourteen (14) of the composite samples analysed.

The twenty (20) samples used to form composite samples C2, C3, C12, C13 & C14 were analysed for arsenic concentration. The analytical results for these samples are shown in Table 6.2.2 below.

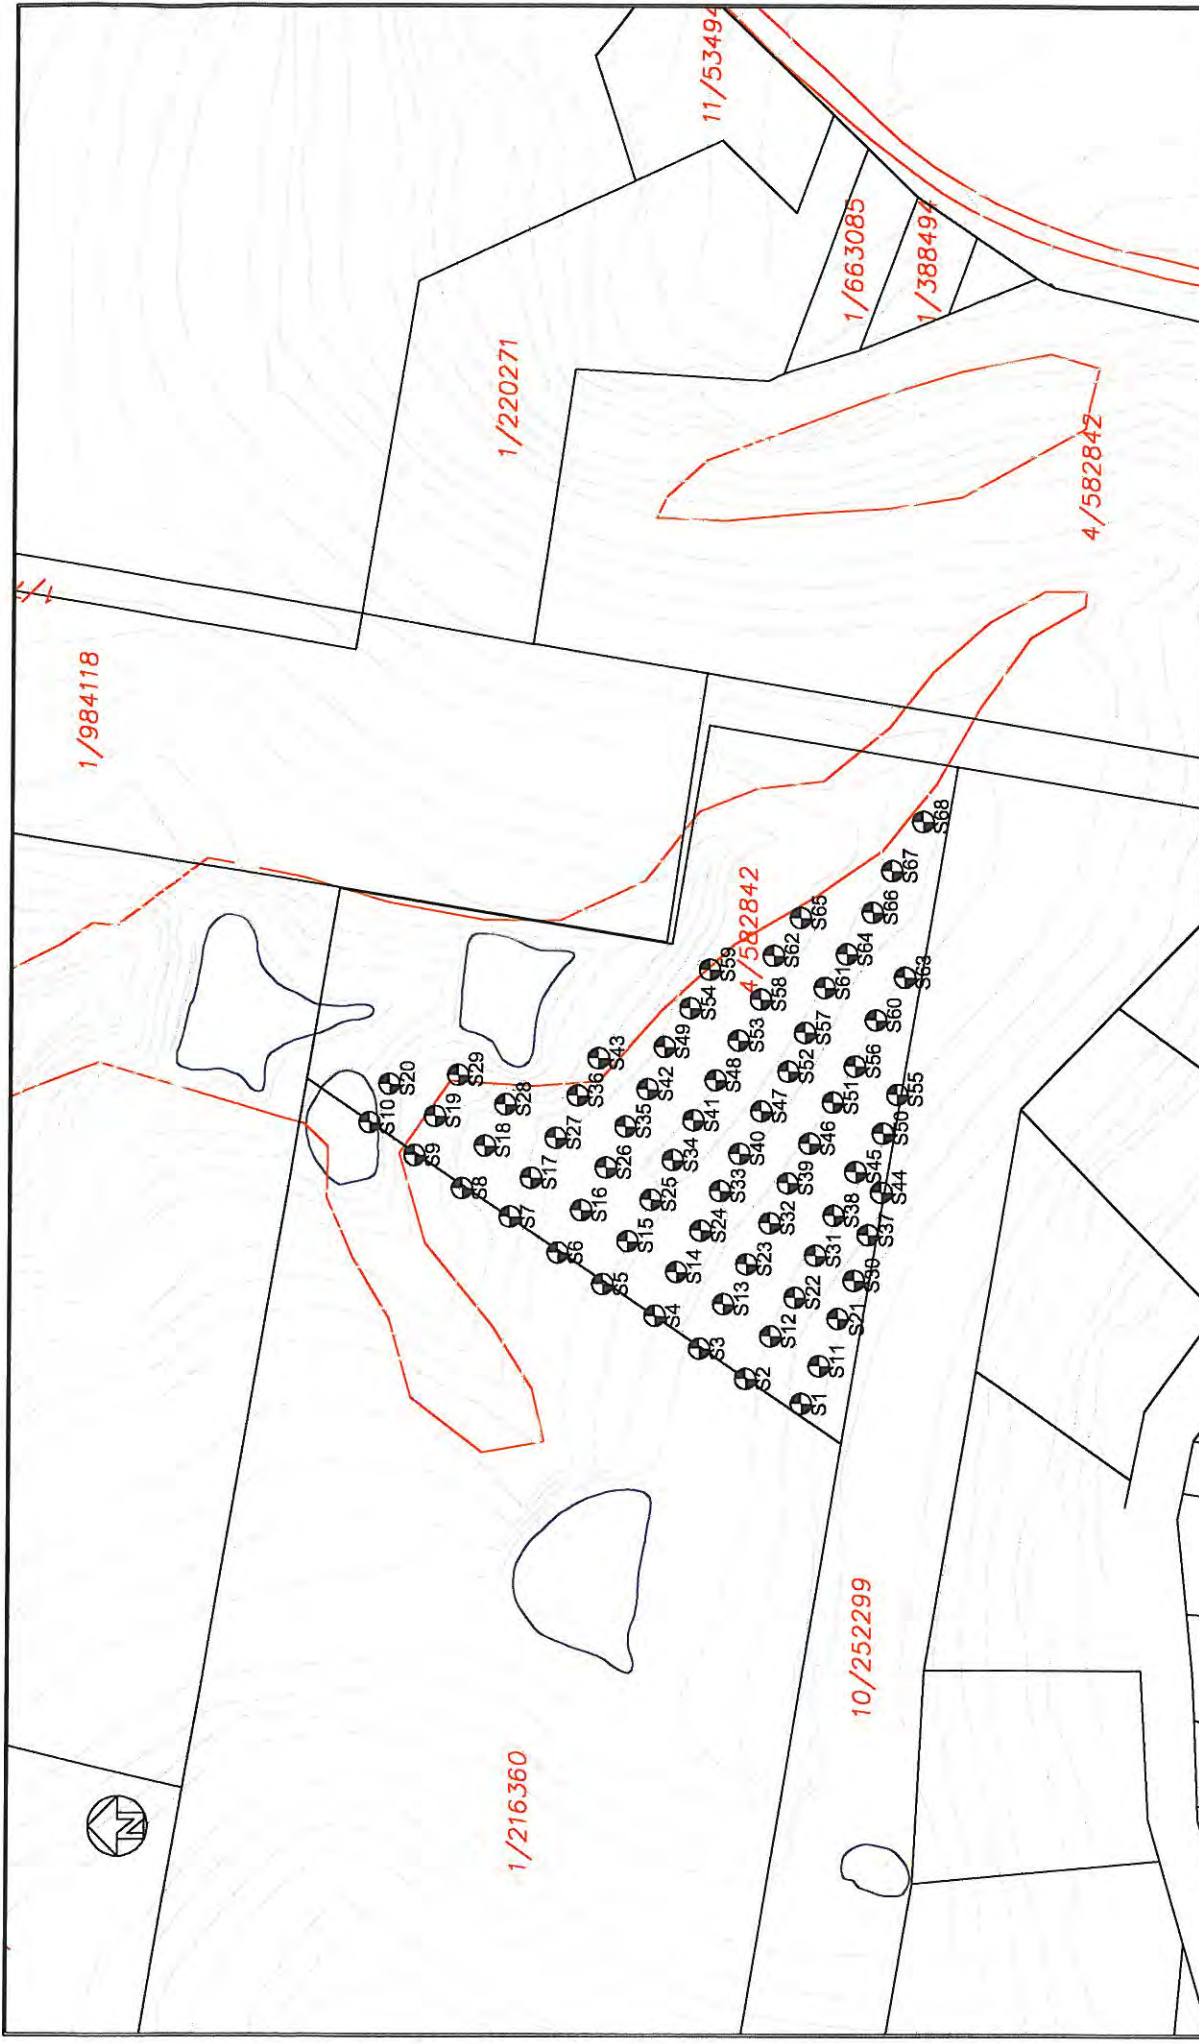
A summary of the analytical results for Lot 4 (Site A) DP 582842 are shown in Table 6.7.1 on the following page. The sample locations are shown on Drawing Number GJ0128.1.7.
