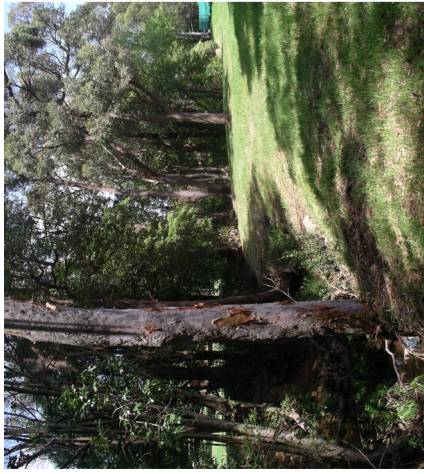
REACH A

- Deeply scoured and narrow creek line
- Various vegetation communities including remnant Sydney Turpentine Ironbark Forest
- Part of Cochlear precinct

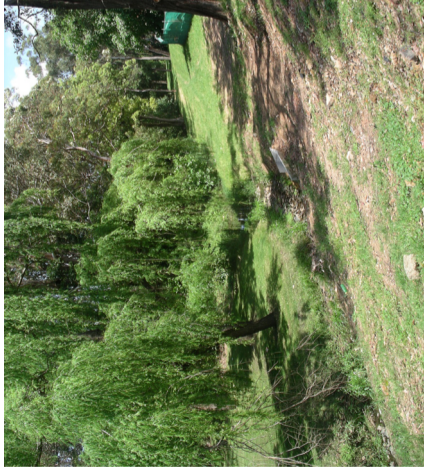
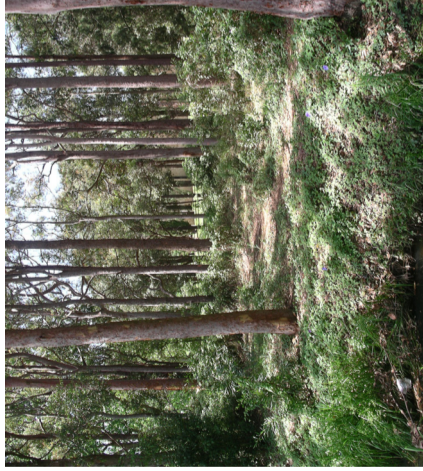
REACH B

- Narrow, eroded creekline with high banks (near vertical) and exposed tree roots
- Woodland character with remnant Sydney Turpentine Ironbark Forest, more densely grouped along the creek zone
- Some weed infestation including Willows.
- Lawn area rising gently up to the Colleges on the south side, with open stands of native Eucalypts and Cottonwoods (from the agricultural days)
- Located in Flood zone

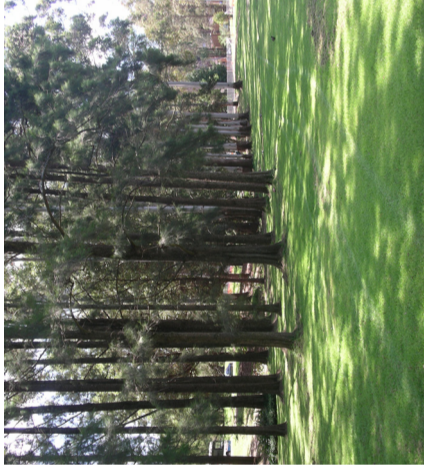
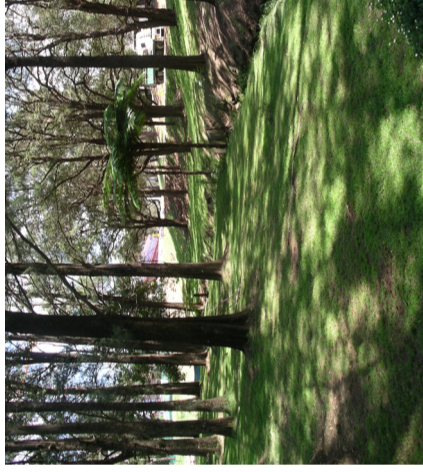
REACH C

- Narrow channel with eroded sandstone cobbles on the northern bank.
- Distinctive landscape with heavily planted line of she oaks (Casuarina cunninghamiana) and white trunked Flooded Gums (Eucalyptus grandis)
- Interspersed with dark Turpentines (Syncarpia glommuifera)
- Relatively level grass riparian zone on either side of creekline
- Pedestrian pathways and open grass area, commonly used for informal ball games on the south side
- Located in Flood zone

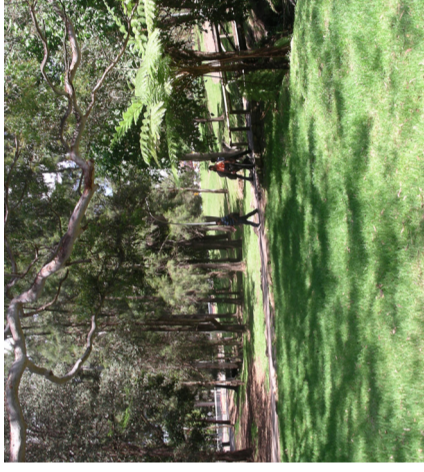
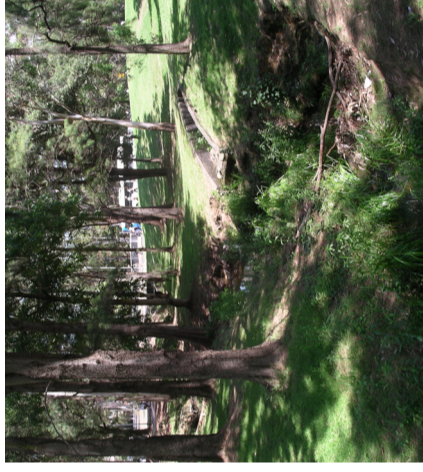
REACH D

- Prominent landscaped rise with sinuous creek line, located on the axis of Waterloo Road.
- Shaded sylvan character, created by stands of remnant Eucalypts, Turpentine and Sydney Red Gums
- Backdrop of buildings to the north.
- Erosion evident on both banks of creek
- Area of high pedestrian activity criss- crossed by pathways from the University to Herring Road bust stops and Macquarie Centre

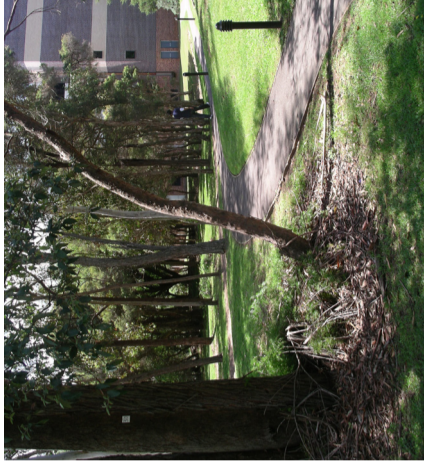
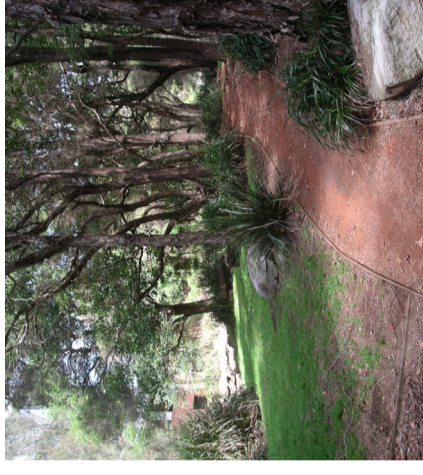
REACH E

- Precinct distinguished by the proximity of buildings and a more structured rock lined creek with rock boulders and planted embankments to the north.
- Open grass area to the south with Paperbarks Melaleuca linarifolia, Coral trees (Erythrina) and Eucalypts used for circulation and passive recreation
- Prominent drainage outlets underneath Research Drive

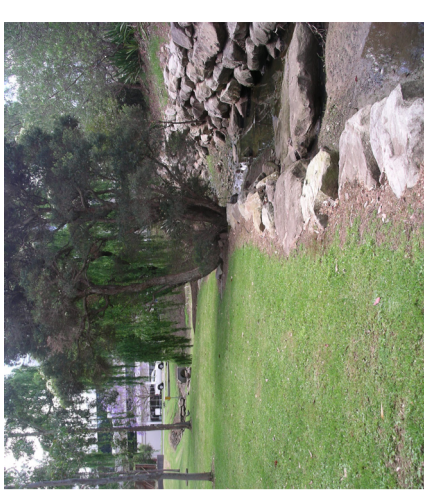
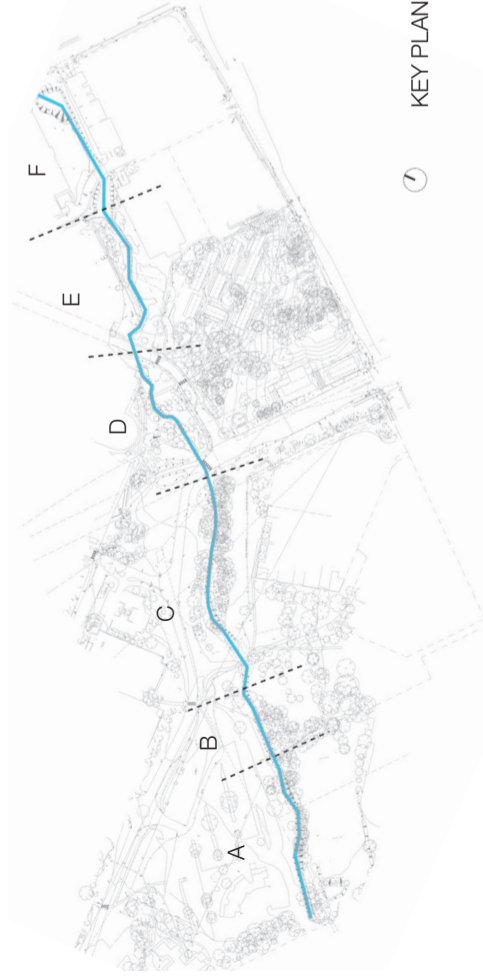
REACH F

- Constructed creek line with artificial boulder dams and more open landscape on either side.
- Landscape character is less distinguished than the other precincts.
- Sandstone bedrock and outcrops apparent on the creekline, which appears to have been re-located.
- Right bank replaced by a 2.5 m high sandstone block wall
