FIGURE 33
PEAK FLOOD LEVEL IMPACT
POST-SWRL
PMF
CROSSING 4, 5 AND 6

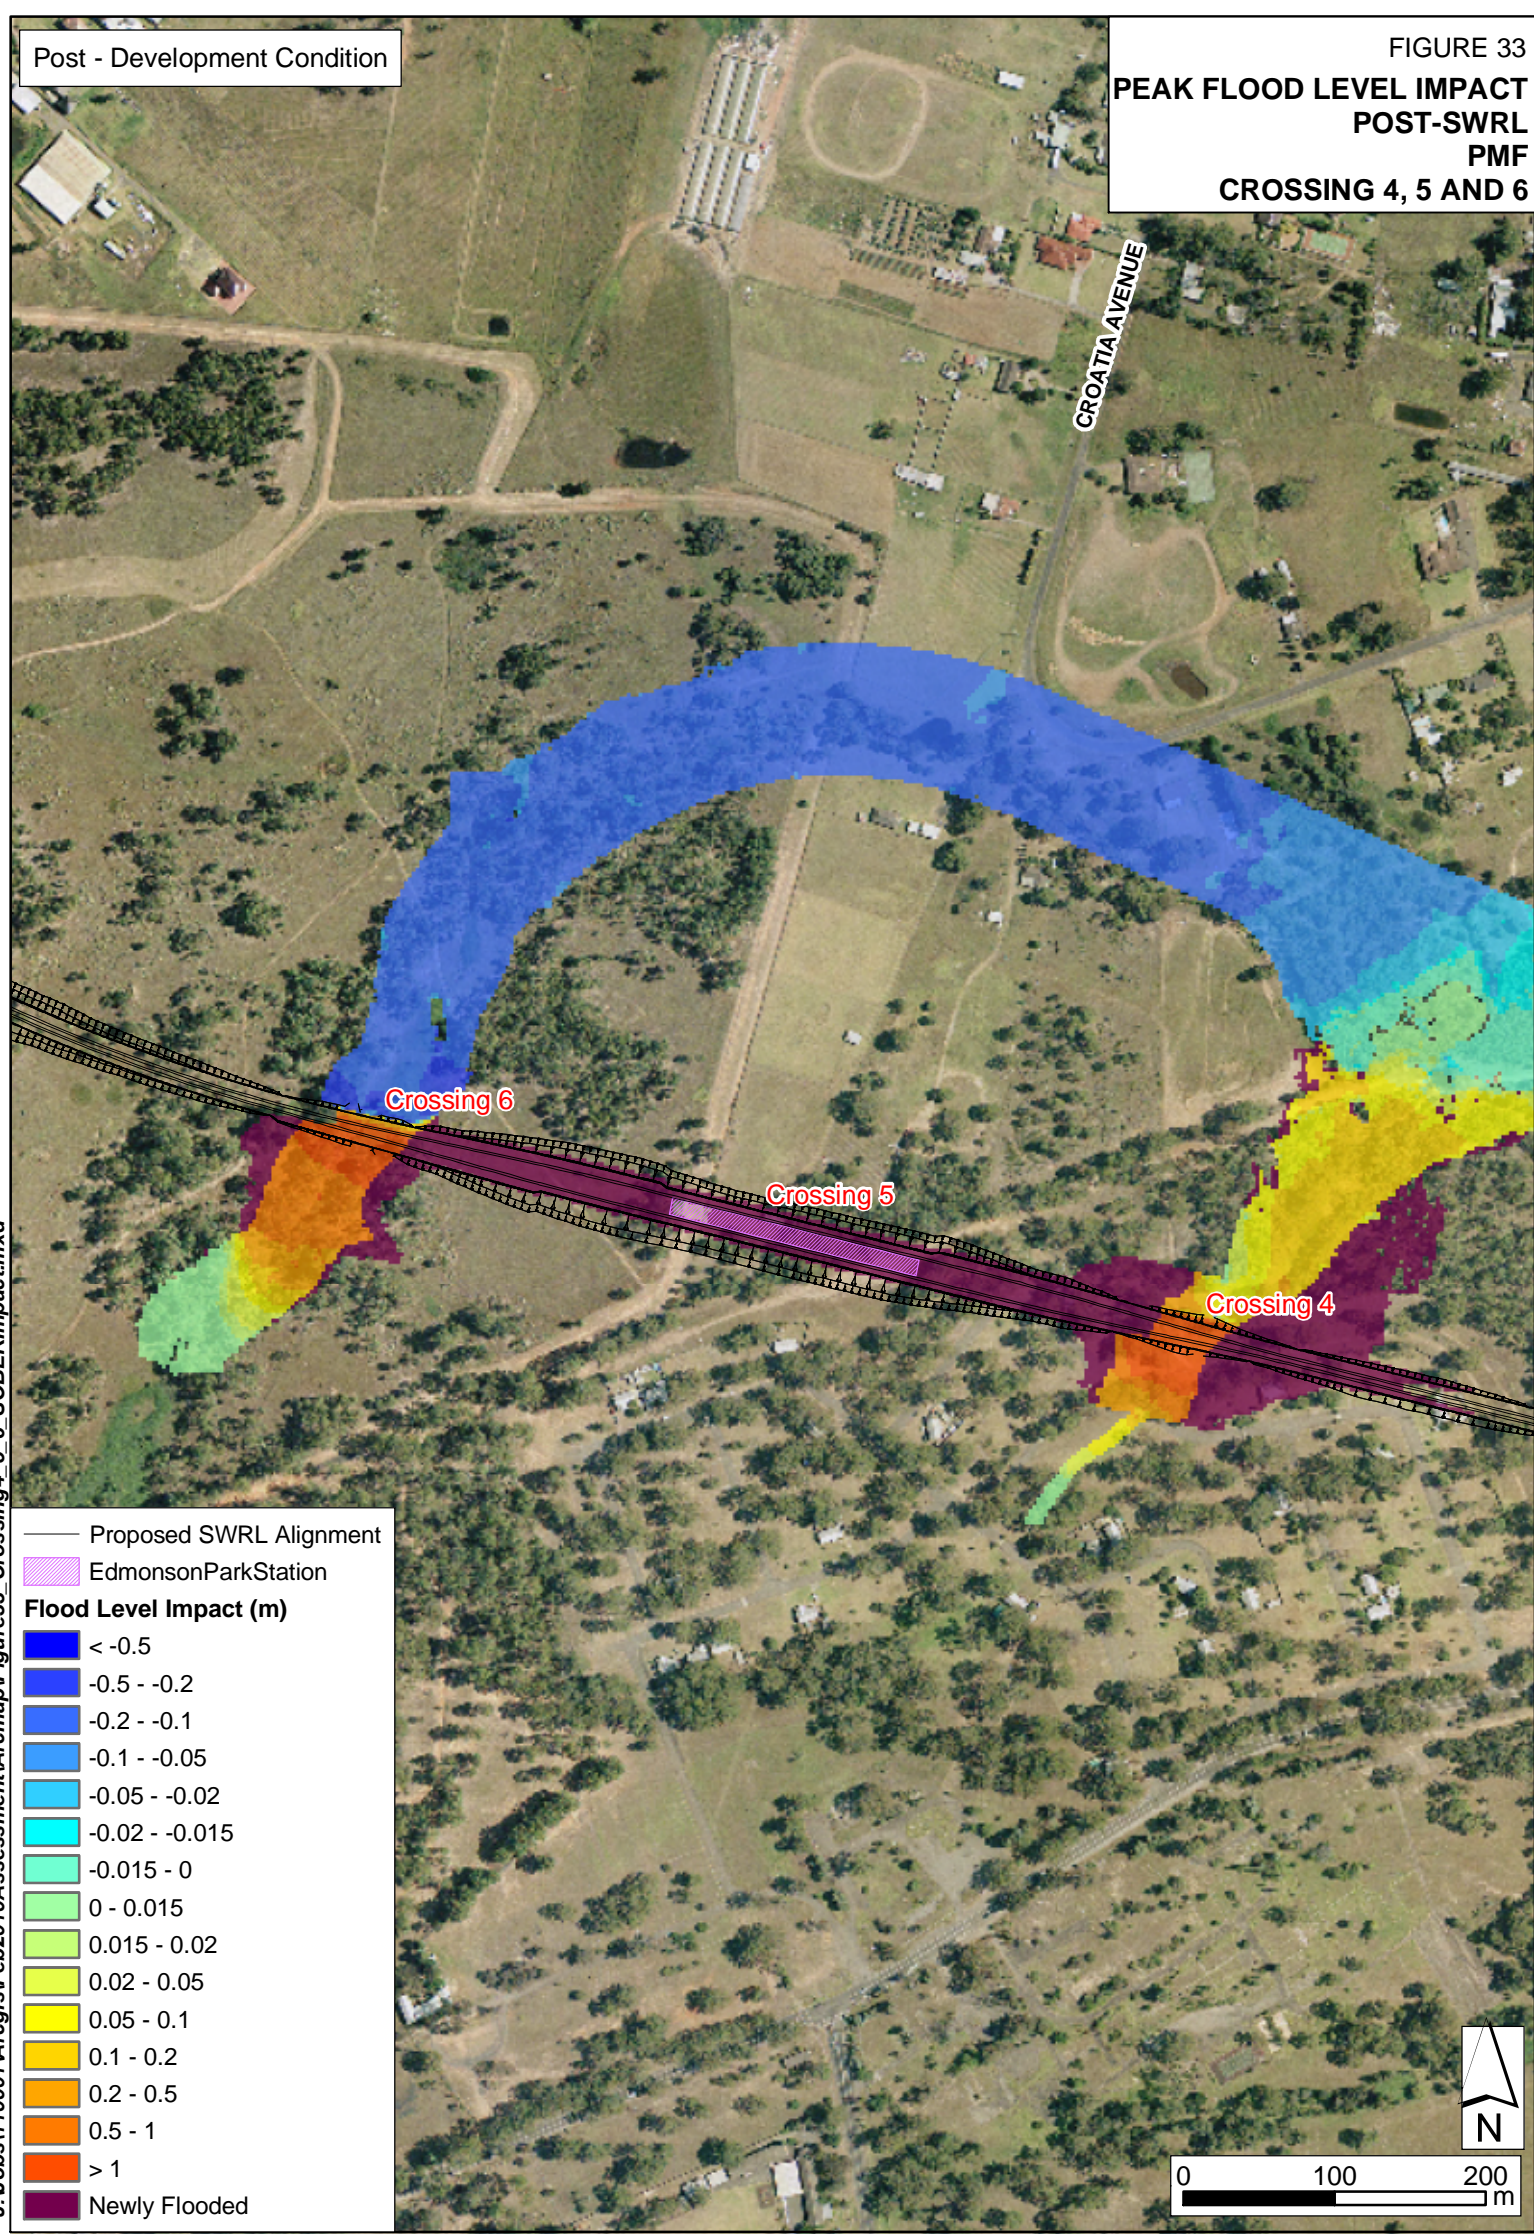
Post - Development Condition

- Proposed SWRL Alignment
- Edmonson Park Station
- Flood Level Impact (m)**
- < -0.5
- 0.5 - -0.2
- 0.2 - -0.1
- 0.1 - -0.05
- 0.05 - -0.02
- 0.02 - -0.015
- 0.015 - 0
- 0 - 0.015
- 0.015 - 0.02
- 0.02 - 0.05
- 0.05 - 0.1
- 0.1 - 0.2
- 0.2 - 0.5
- 0.5 - 1
- > 1
- Newly Flooded
