This Specific Element Conservation Management Plan for the Administration Building of the former Carlton United Brewery and the County Clare Hotel has built upon the earlier Conservation Management Plans (2005 and 1991) for the wider Brewery Site and the recommendations and policy directions established by the recent approvals for the Administration Building and the County Clare Hotel.

Annexure B
Fabric Description from the
2005 Conservation Management Plan
by Noel Bell Ridley Smith and Partners Pty Ltd

CONSERVATION MANAGEMENT PLAN

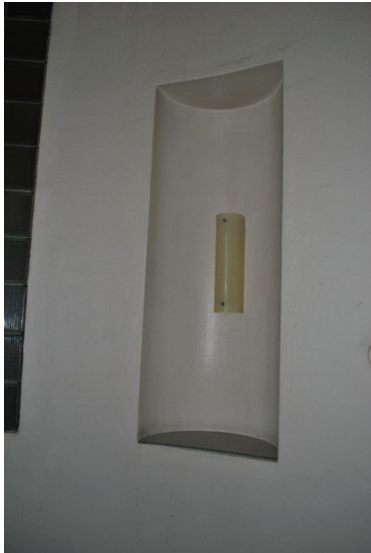
Figure 89. Decorative elements include niches placed regularly up the stair fitted with simple semi-cylindrical lights.

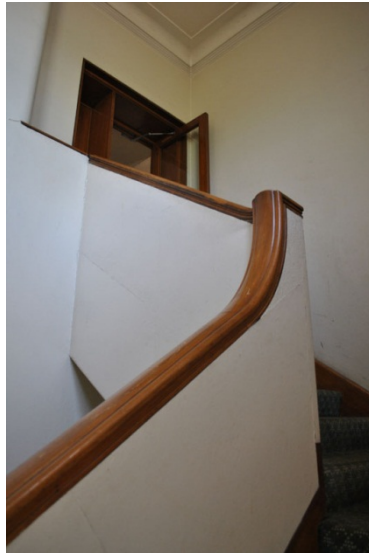
Figure 90. The detailing of the stair decreases as it rises, but it retains a simple elegance in form.

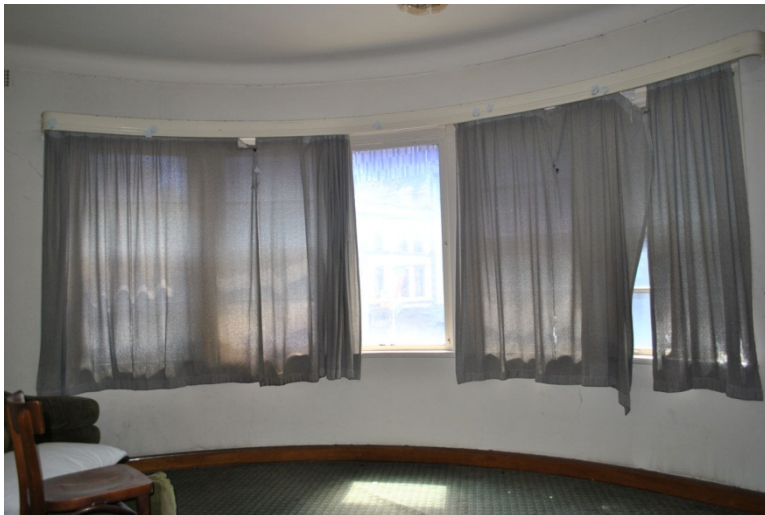
Figure 91. The two upper levels provide simple residential accommodation, with the Art Deco form and detailing evident throughout.

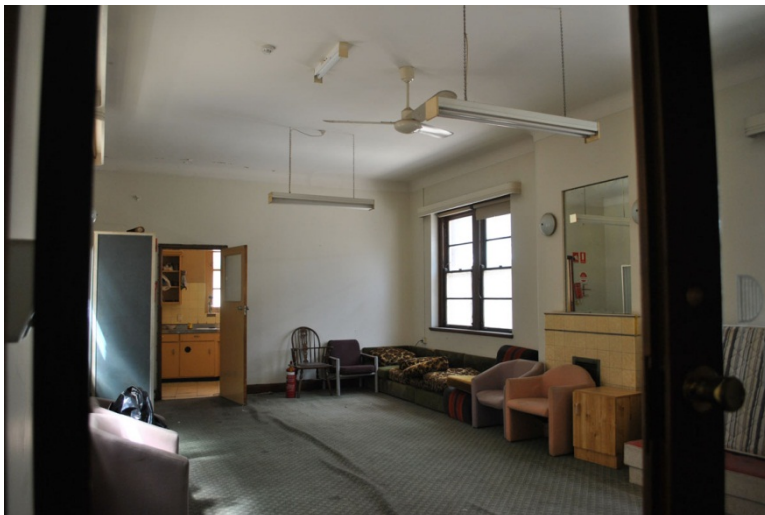
Figure 92. The dining room on level 1.

Fitout	The fitout remains from the construction period seen in the kitchen and dining areas.

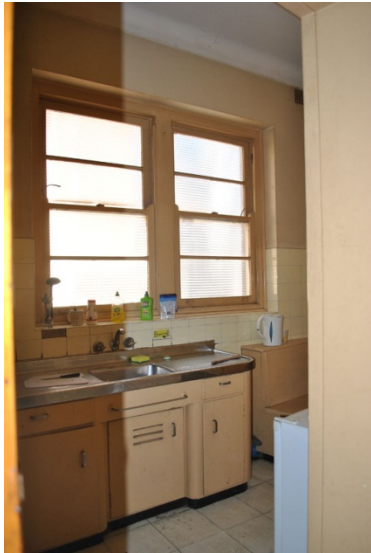
Figure 93. The kitchen fitout appears original

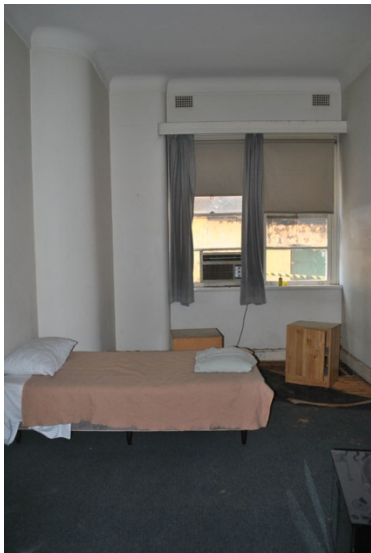
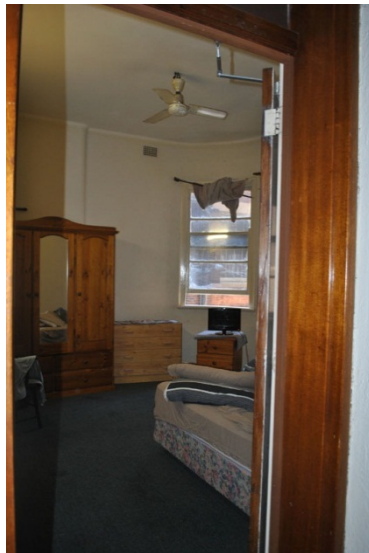
Figure 95 and 96. Typical modest bedrooms on levels 1 and 2.

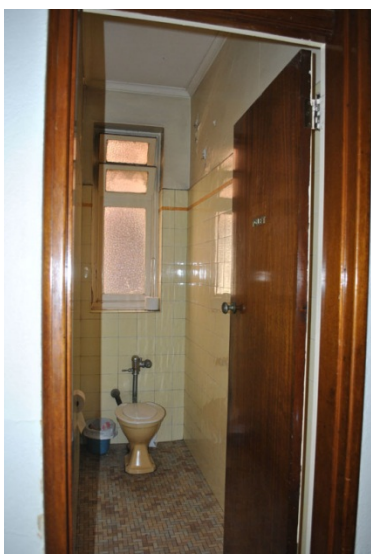
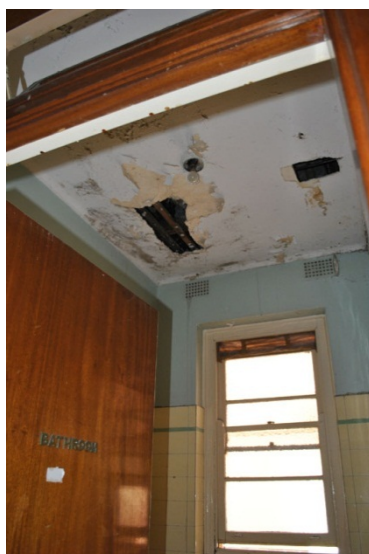
Figure 97 and 98. Bathroom areas. Evidence of water damage can be seen.

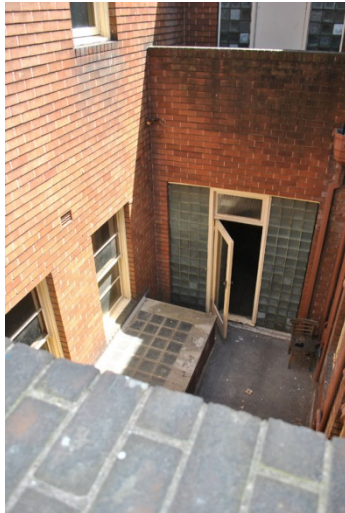
Figure 99. Looking into the lightwell from the roof terrace. Note the skylight to the saloon bar that is now blocked

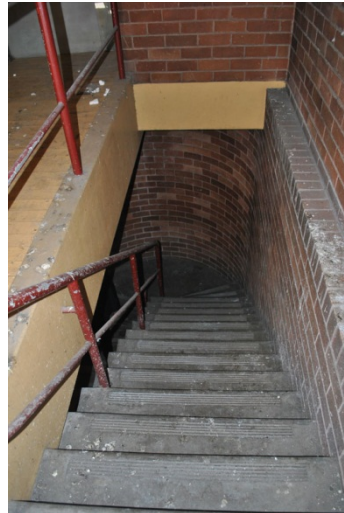
Figure 100. The exit stairs include winders and do not comply with current building codes.

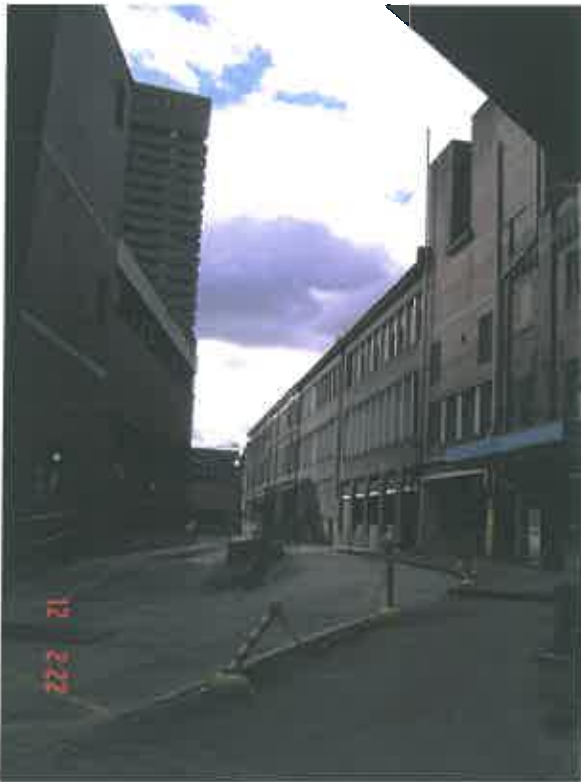
Figure 33 - Main Avenue (former Kent Road) looking north from the former Kent Brewery Yard showing the continuous run of the administration buildings on the right

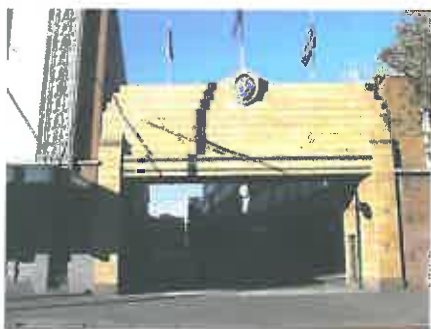
Figure 34 - Main Entrance Gateway (51)

The stepped parapet features the "Invicta" brewery shield. The original "Tooth & Co. Limited Kent Brewery" metal lettering was replaced by a detracting "Carlton" sign in 1983. Massive decorative, top hung metal gates feature two inset 'KB' logos. The gates are raised in two sections by a motor in the portal structure. Detracting traffic mirrors have been added to the structure and a steel; framed access ladder added on the southern side.

The condition of the gateway entry is fair with some tiles fallen or removed from the underside of the portal, some tiles cracked and chipped. Some original tiles have been salvaged and are stored on site for future repairs.

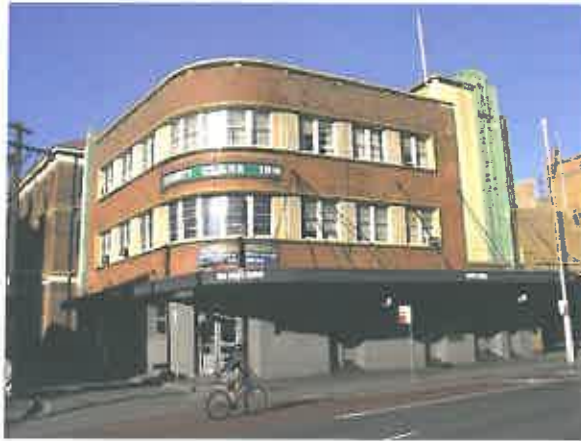
Figure 35 - The County Clare Hotel (38)

The building's condition is good, with few signs of material or structural defects. Parts have been progressively modified as noted below.

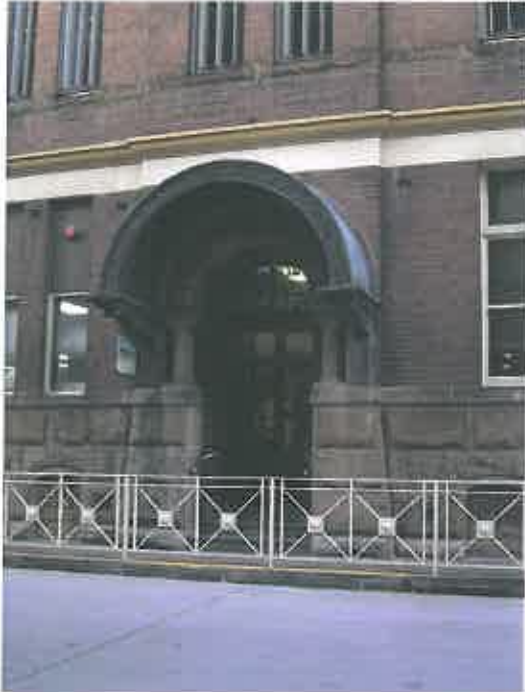
Figure 36 - Exterior view of the main entry door to the Administration building 10B showing the Romanesque entry doorway and cantilevered copper hood

Concurrent with the 1930 Second Floor addition, some modifications were made to the exterior of the original sections of the building, the most notable being the construction of the arched copper canopy over the main entrance, an inclusion that added focus to the Main Avenue administration precinct. Other alterations were mostly as a result of internal modifications, such as the removal of the private entrance to the Manager's office and the removal of the entrance directly leading to the basement. Changes are legible in the use of rendered faux rusticated sandstone at the base of the building along Main Avenue. The leadlight glazing of the first floor Show Room dates from this period.

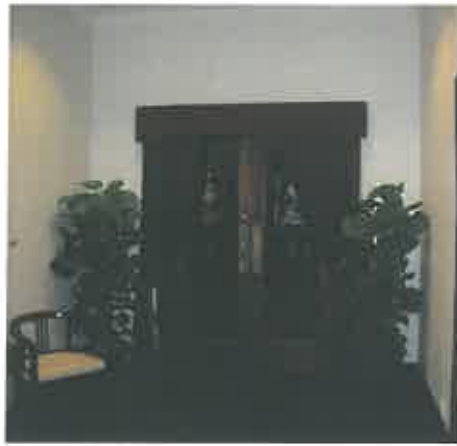
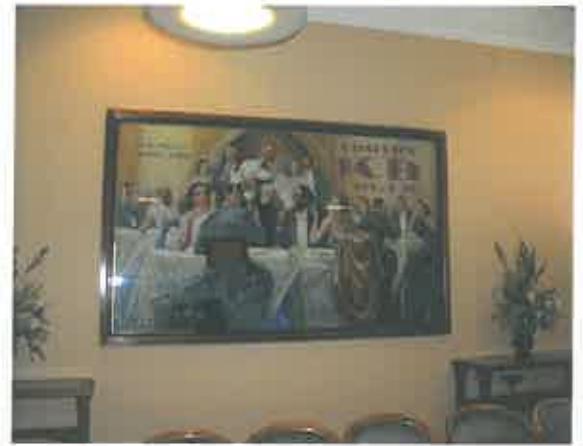
Much of the Ground floor of the original interior of the building was devoted to loading docks situated at both the northern end opening to the service lane and the southern end of both the Main Avenue and Kensington facades, whilst the first floor, intended as offices was constructed around an open well in the centre of the building. The basement was formerly open space for the aerating functions with storerooms at the southern end. Progressive alterations have modified the interior to primarily open planned space. The basement level is used primarily for building services installations and storage.

Figure 37 - Internal fabric Building 10A

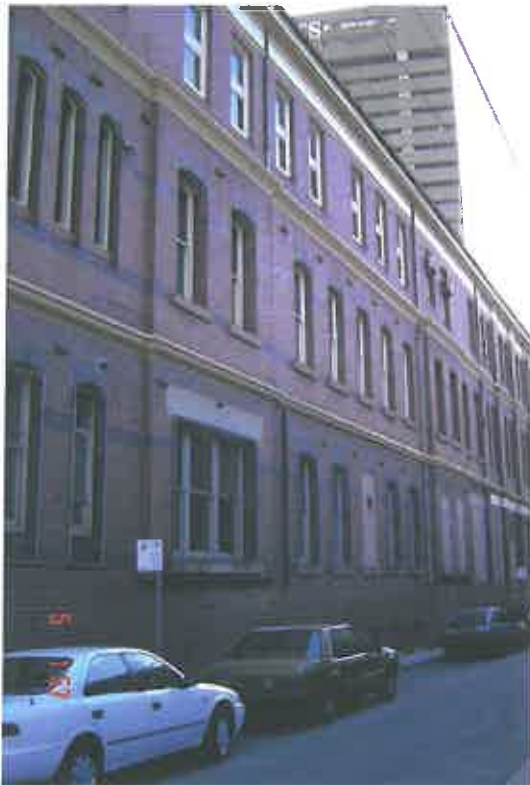
Figure 38 - External fabric Building 10B

The construction of the facades, above the ground floor sill height, in mid Chestnut brown brickwork laid in English bond and contrasting dark brick voussoirs and stringer coursing and the heavily rusticated sandstone base on the Main Avenue elevation is in contrast to the earlier buildings with their monochromatic brickwork and simple corbelled detailing. The two symmetrically opposing projecting bays established a more comprehensively symmetrical composition than the repetitive rhythm of bays of the earlier buildings, and the battered detail of their stone base provides further emphasis to this symmetry.

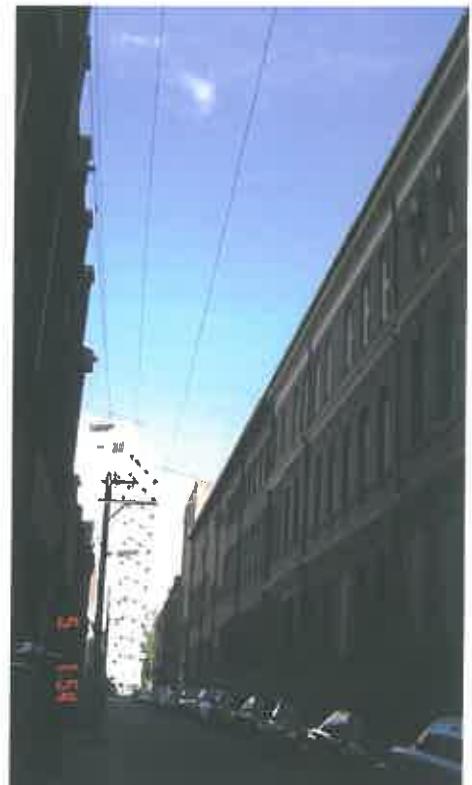
Figure 39 - External fabric of Buildings 10 A & B as seen in Kensington Street showing the unified character following the alterations made in 1930.

The treatment of the east elevation facing Kensington Street is simpler in treatment. In the absence of the stone base, the projecting bays are cantilevered in an Italianate style by corbelled and dentil courses of brickwork.

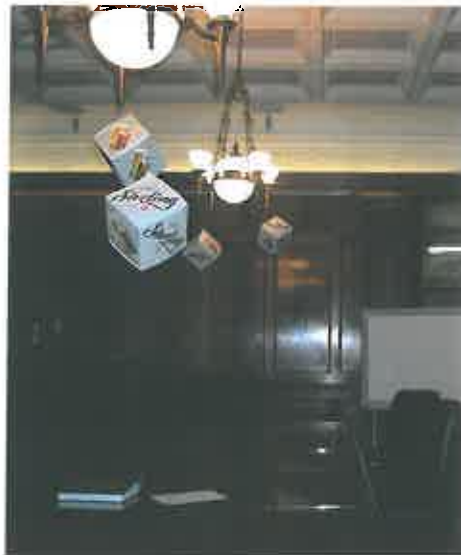
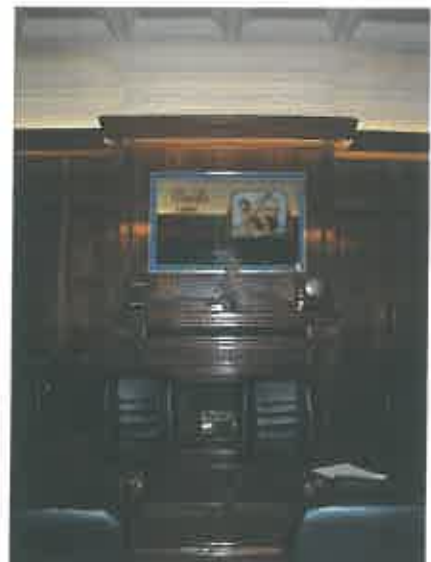
Figure 40 - Interiors of Building 10B showing the conservative Board Room fitout designed by Robertson & Marks that were carried out in 1930 and are substantially intact
