# REMEDIATION ACTION PLAN

11-13 Percy Street  
Auburn NSW 2144

Fabcot Pty Ltd – February 2021

### REMEDIATION ACTION PLAN

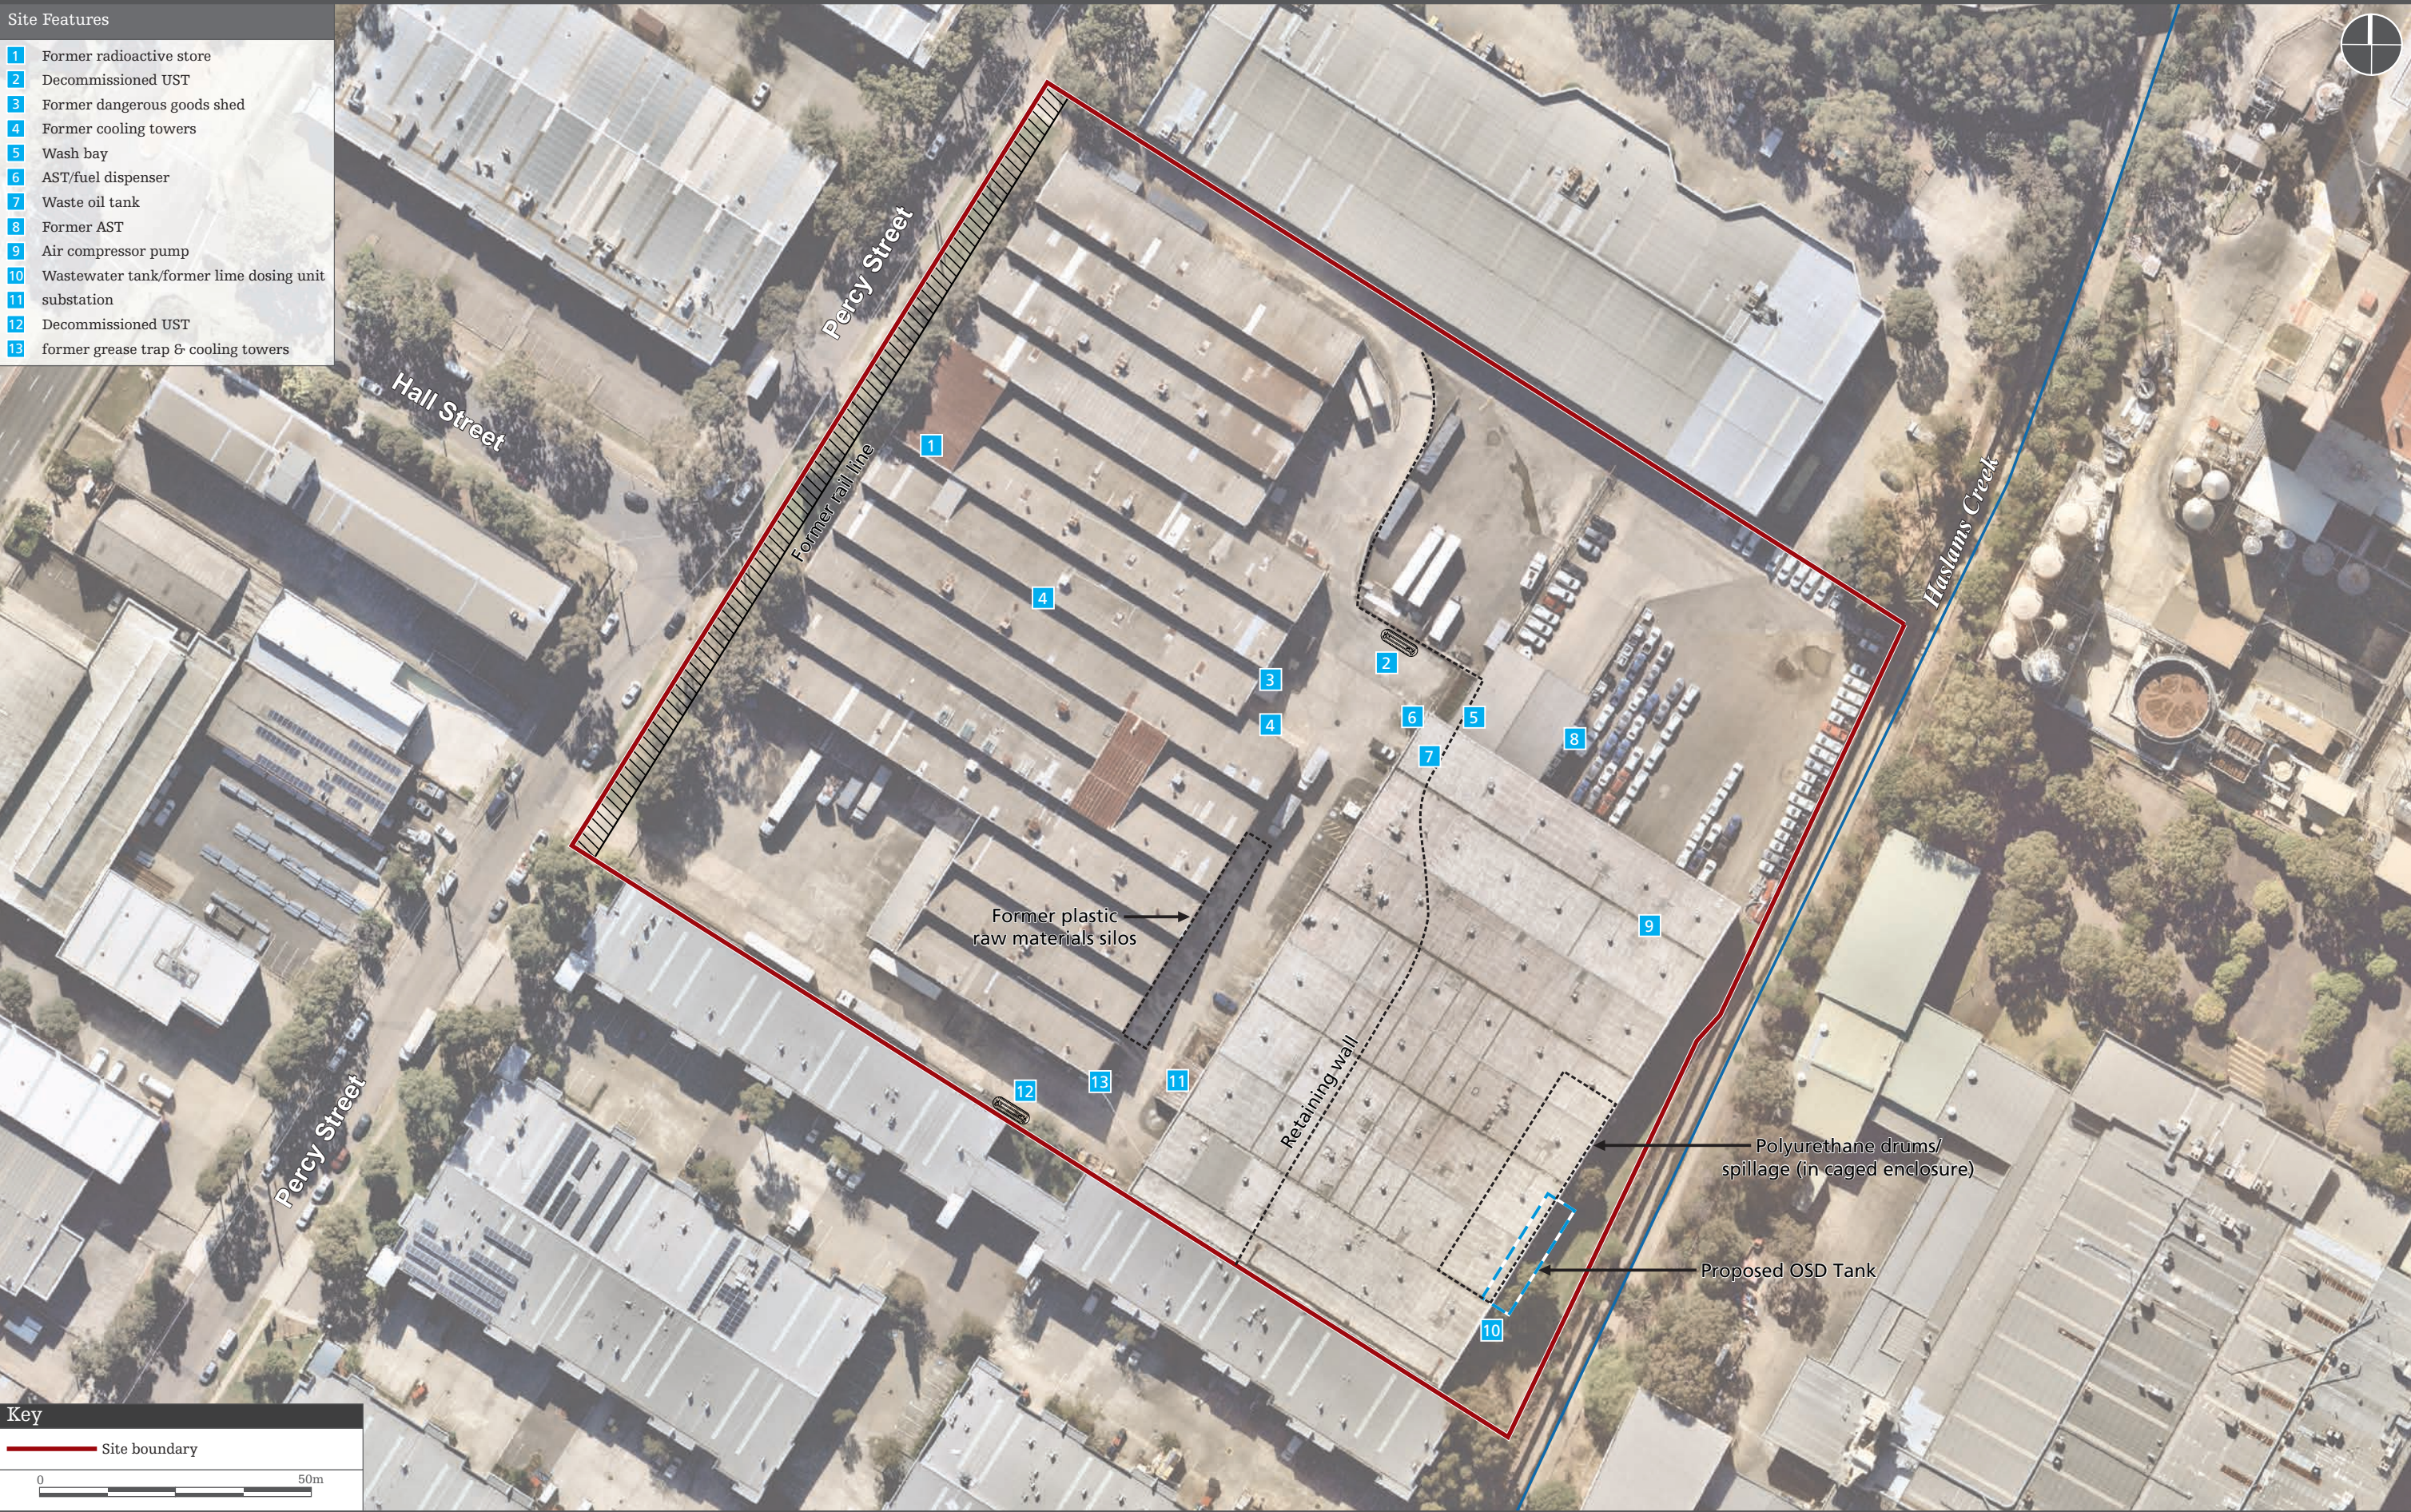
**Figure 2:** Site Map

- Site Features
- 1 Former radioactive store
  - 2 Decommissioned UST
  - 3 Former dangerous goods shed
  - 4 Former cooling towers
  - 5 Wash bay
  - 6 AST/fuel dispenser
  - 7 Waste oil tank
  - 8 Former AST
  - 9 Air compressor pump
  - 10 Wastewater tank/former lime dosing unit
  - 11 substation
  - 12 Decommissioned UST
  - 13 former grease trap & cooling towers

Site features are presented on Figure 2.

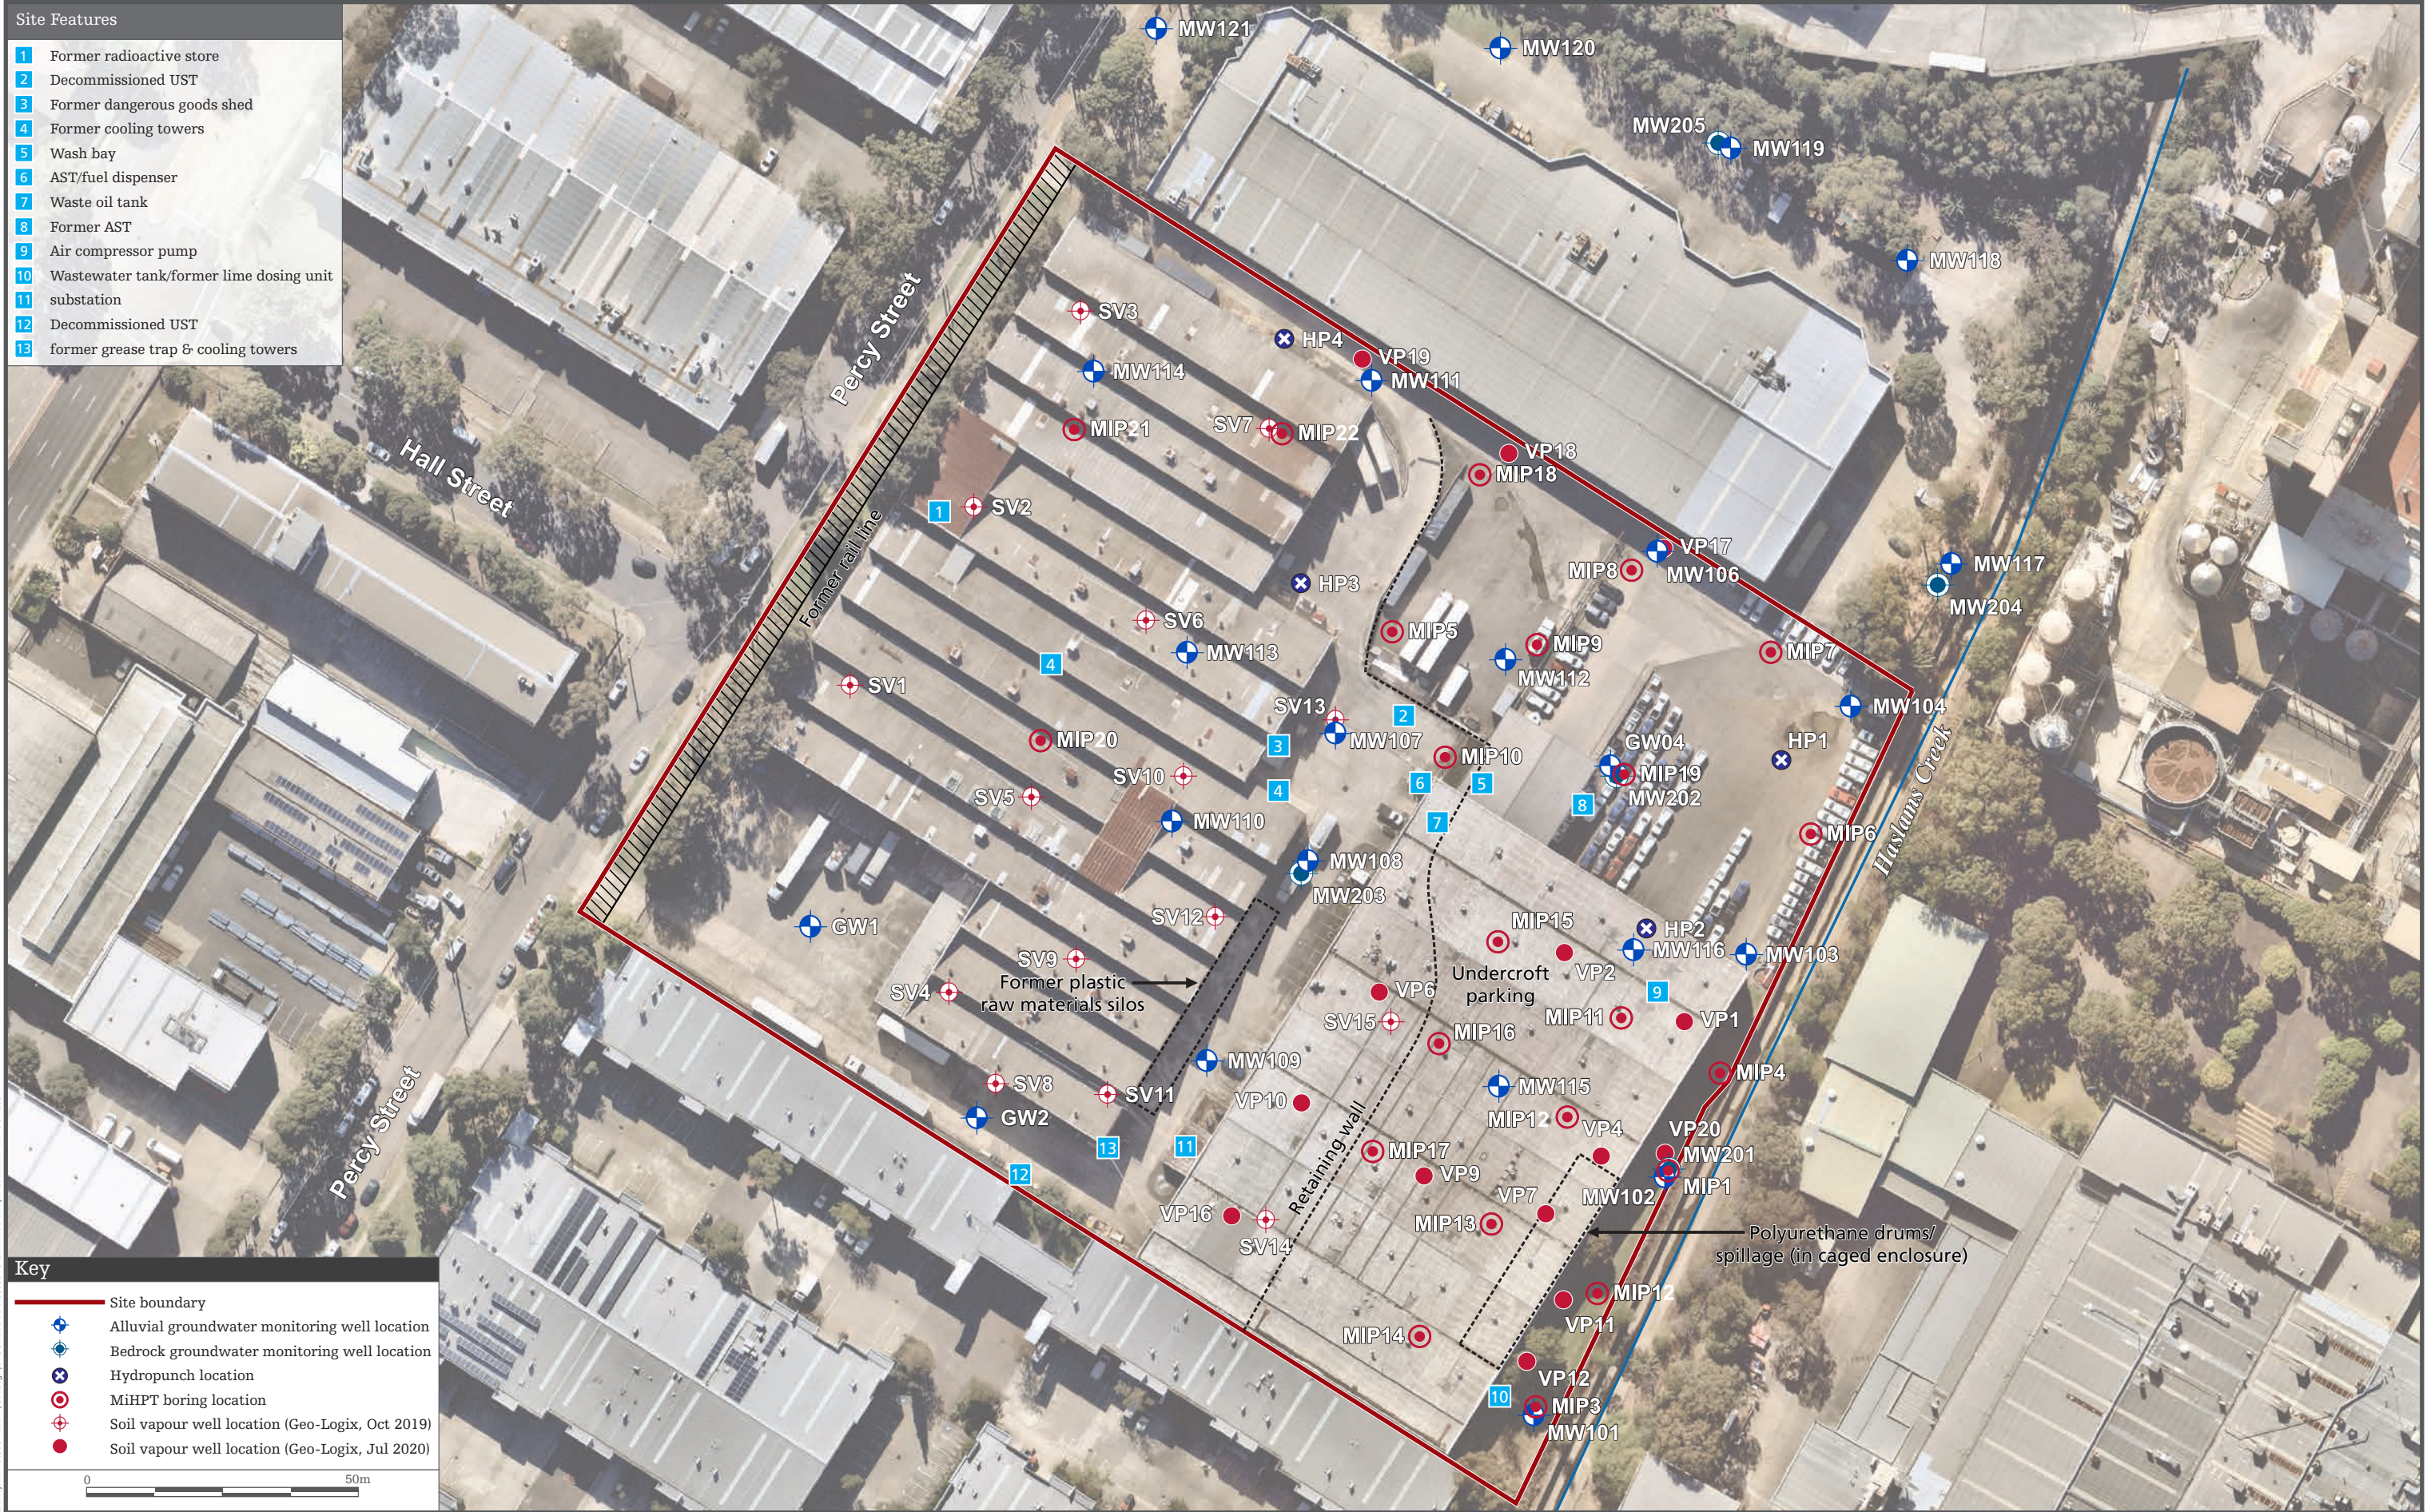
**Figure 3:** Combined Sample Location Map

El:\Projects\100385 Auburn (Geo-Logix)\FIGURES\RAP\100385\_F3\_Combined Sample Location Plan 19.01.2021

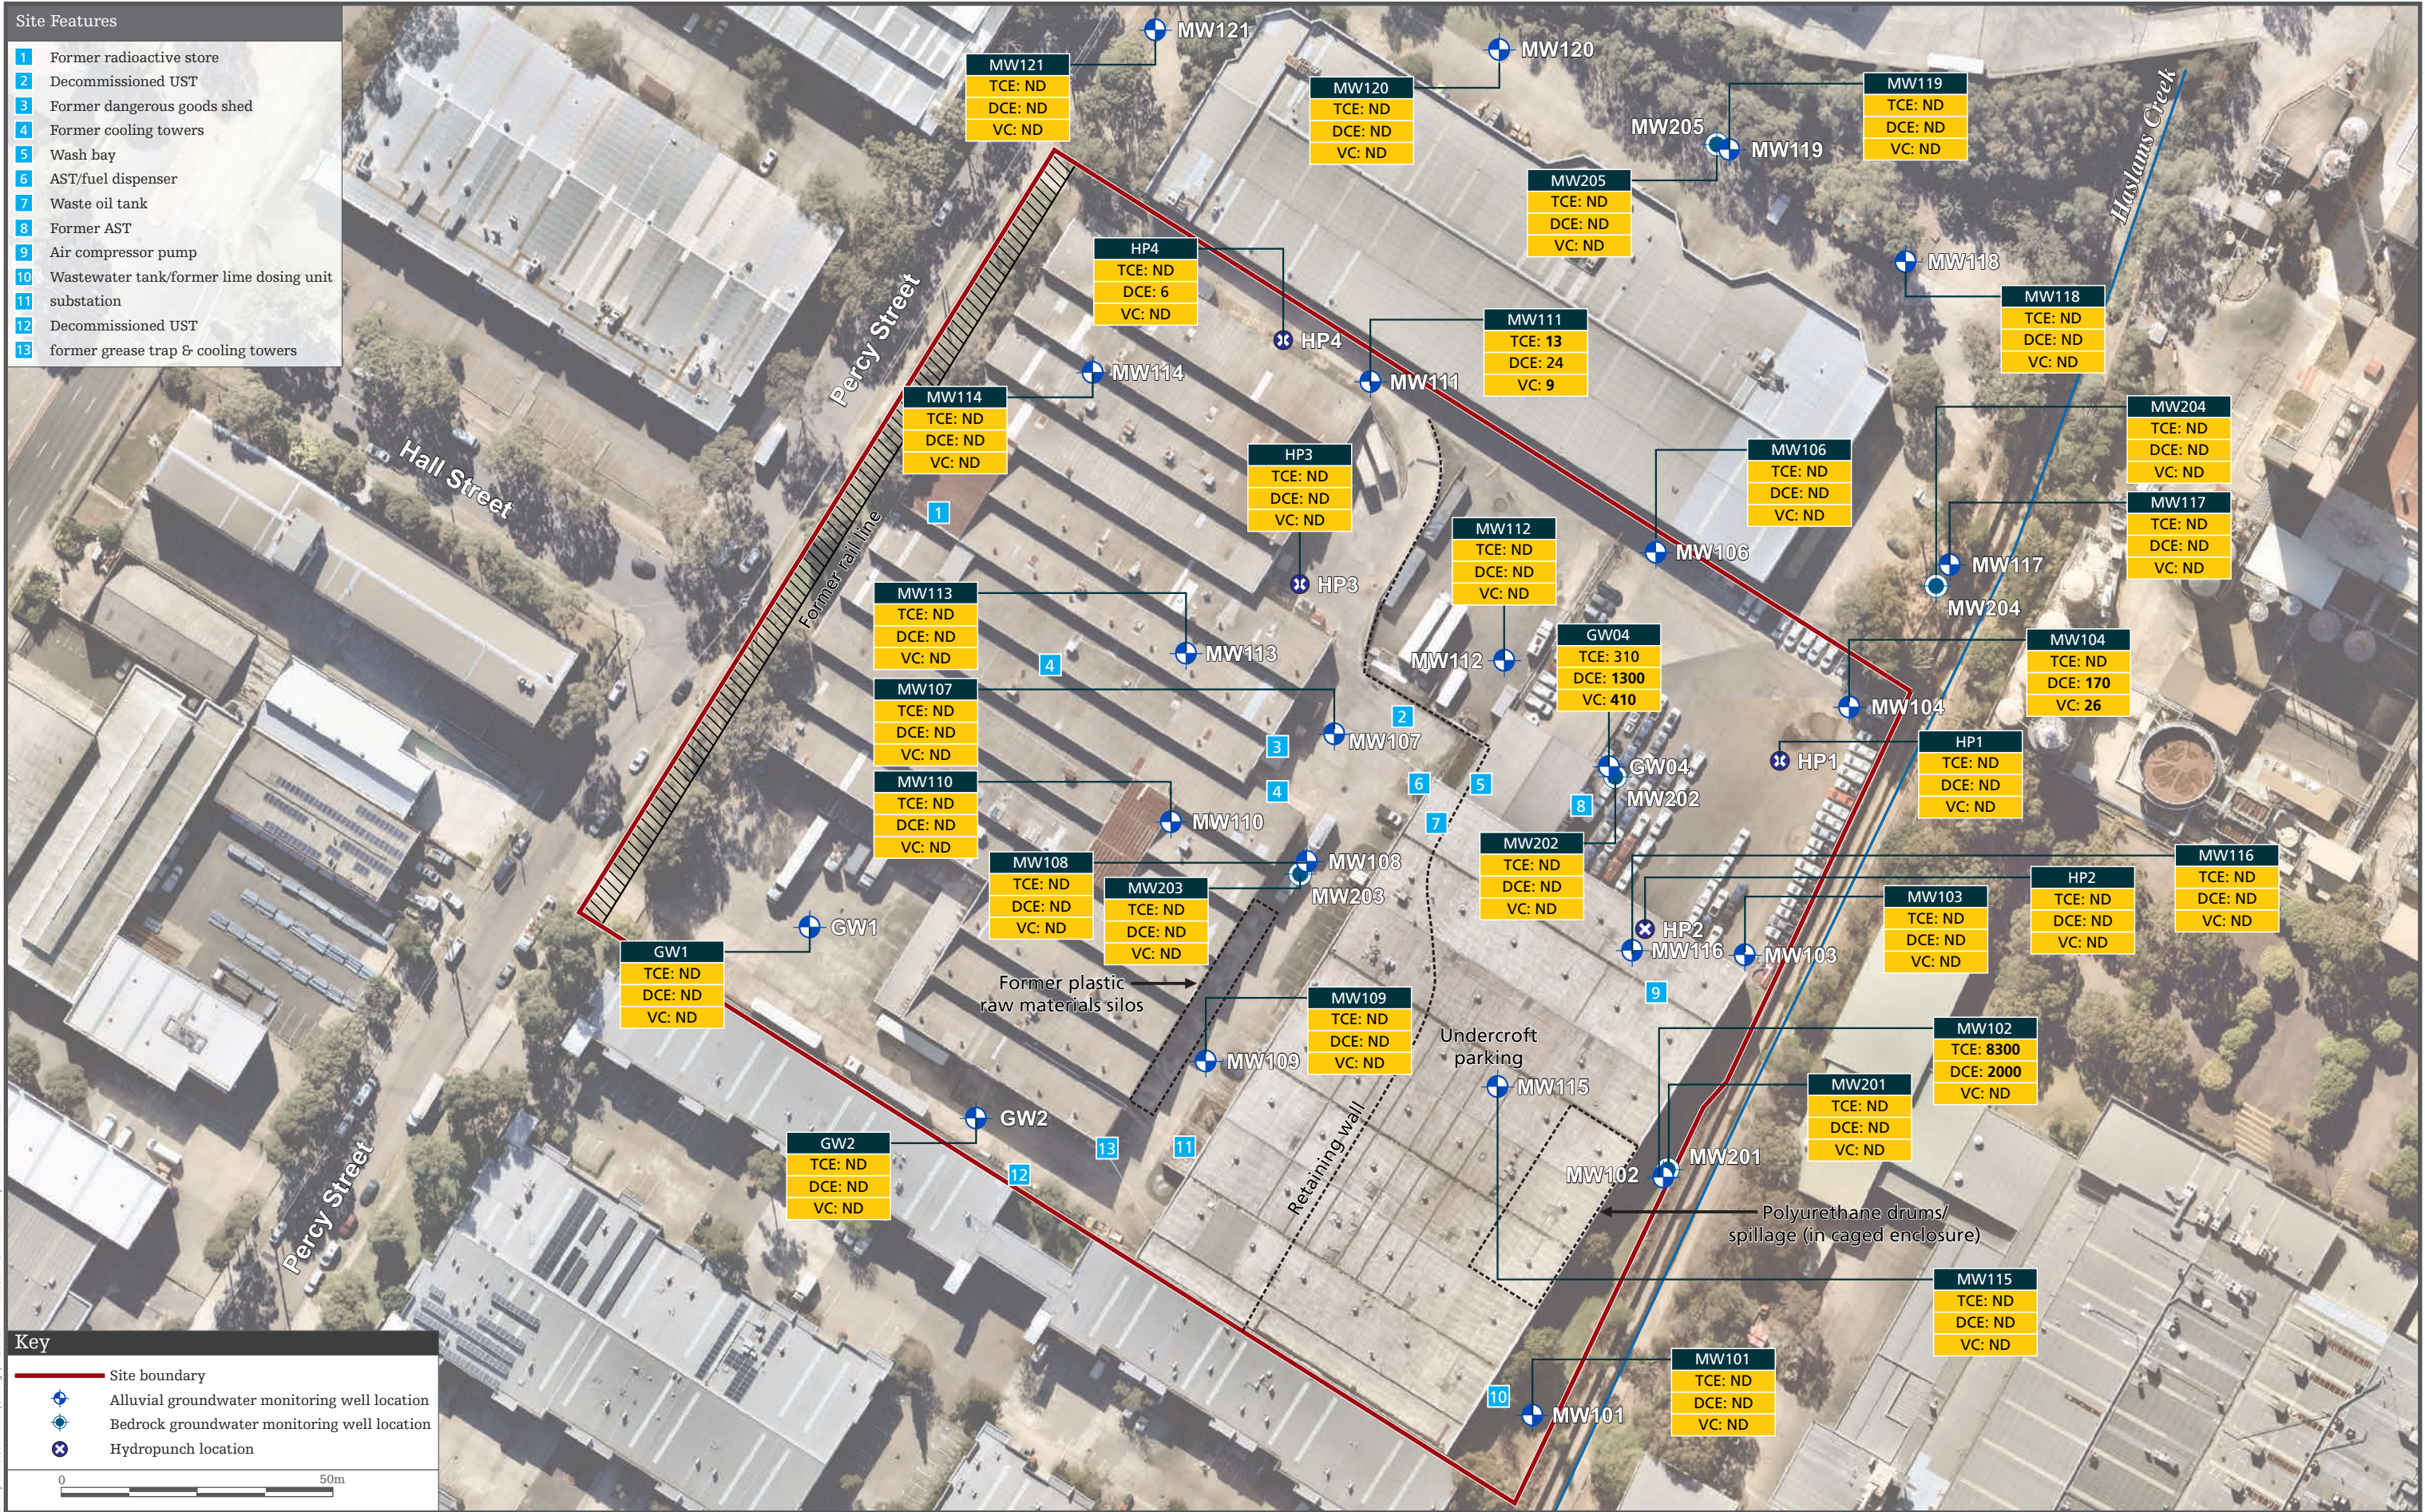
Figure 4

Note: Chlorinated hydrocarbon concentrations are displayed in  $\mu\text{g/L}$   
**Bold concentrations above human health or ecosystem protection criteria**

TCE: Trichloroethene  
DCE: cis-1,2-dichloroethene  
VC: Vinyl chloride

TCE and its degradant products DCE and VC were identified in groundwater across the eastern and northern portion of the site with potential for a minor incursion into 15 Percy Street (Figure 4). Soil vapour investigations did not identify TCE and its degradant products in soil vapour across the western portion of the site where the proposed building will be constructed as slab on grade. Soil vapour was not investigated across the lower eastern half of the site as the proposed construction method, suspended slab, negated the vapour intrusion pathway across this portion of the site.
