Boggabri Coal Operations Pty Ltd  
**Boggabri Coal Mine**  
**2020 Annual Review**  
3 August 2021

Boggabri Coal Operations Pty Ltd  
**Site Water Balance**  
April 2021

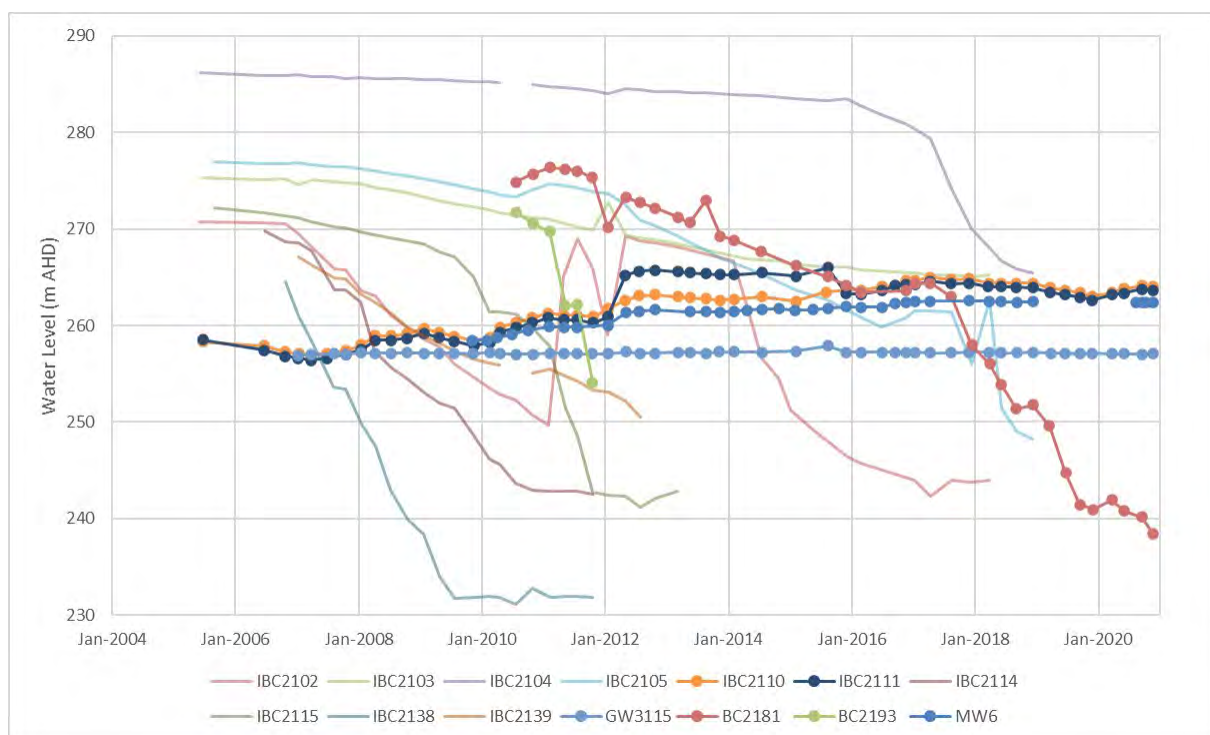
**Figure 7-2 Long Term Groundwater Levels for all Bores**

The groundwater level monitoring results obtained during the reporting period have been added to the long-term hydrographs presented annually for BCM, as shown in Figure 7-2. Figure 7-2 also includes historical monitoring data from the discontinued bores.

Figure 7-2 clearly shows that the monitoring bores within the Boggabri Volcanics (IBC2110, IBC2111 and GW3115) and alluvium (MW6) have continued to remain relatively stable. A clear downward trend continues for the monitoring bore within the Merriown Seam (BC2181), as mining progresses and depressurises the seam (as predicted to occur over time).
