# Arboricultural Development Assessment Report

**Nepean Hospital and Integrated Ambulatory  
Services Redevelopment - SSDA**

July 2018

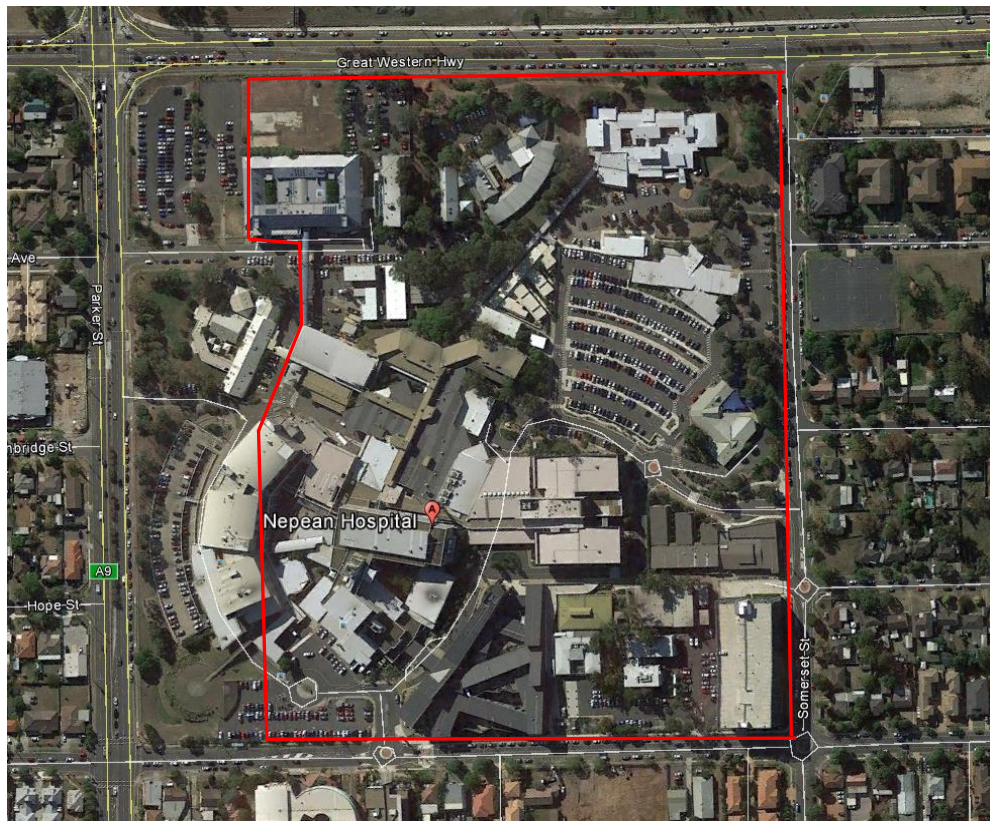
**Diagram 2:** Location of the study area (Google earth, 2017)

- 3.1** The site is located on the corner of Parker Street and Barber Avenue and is part of the Nepean Hospital complex. The study area (Diagram 2) contains multiple high-rise buildings and associated car parking areas. No formal planted plan was noted, and trees and shrubs appear to have been randomly planted throughout the area. Some of the areas are newly landscaped due to new buildings. Tree species consist of both native and exotic species. Due to some areas being densely planted these have been grouped together and not individually assessed.

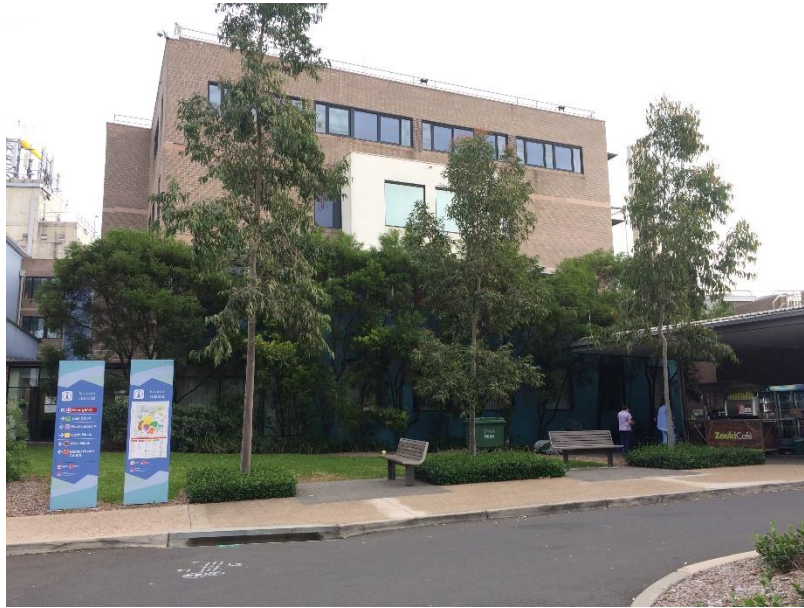
**Plate 1:** Trees 70-72. P. Vezgoff.

- 3.4** The site trees are located along path ways, between buildings, within courtyards and surrounding car park areas (Plate 1). The species present are diverse and include exotic and native specimens. All species found are listed in the Tree Schedule (Appendix 2).

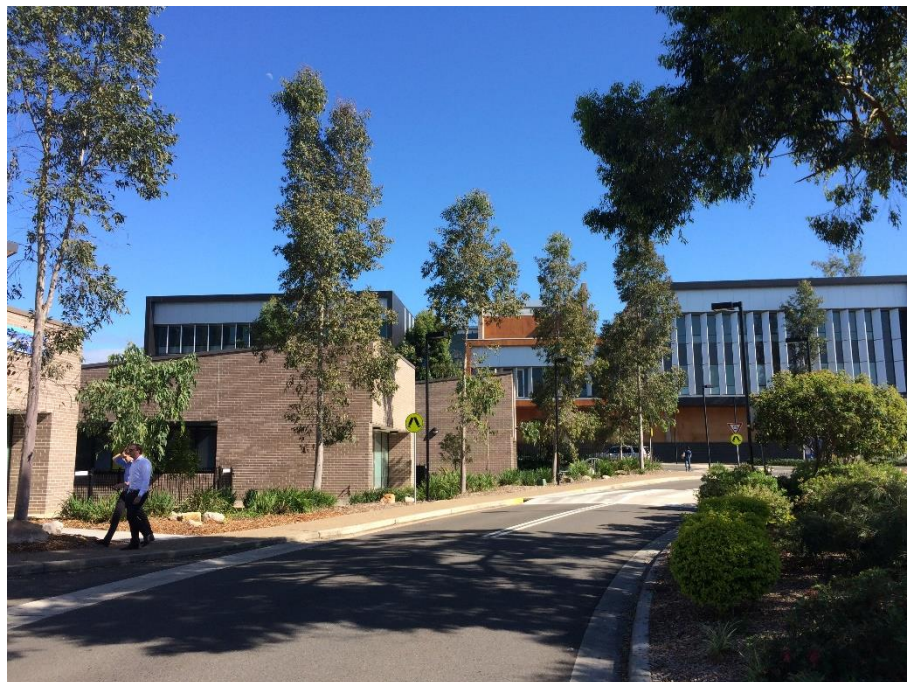
**Plate 2:** Trees 154-158 an example of high value trees. P. Vezgoff.

| High Value Trees |
|---|
| These could be young newly planted trees that are growing very well or mature trees that form good specimen trees or provide excellent visual amenity to the site. Screening a building with space to grow (Plate 2). |

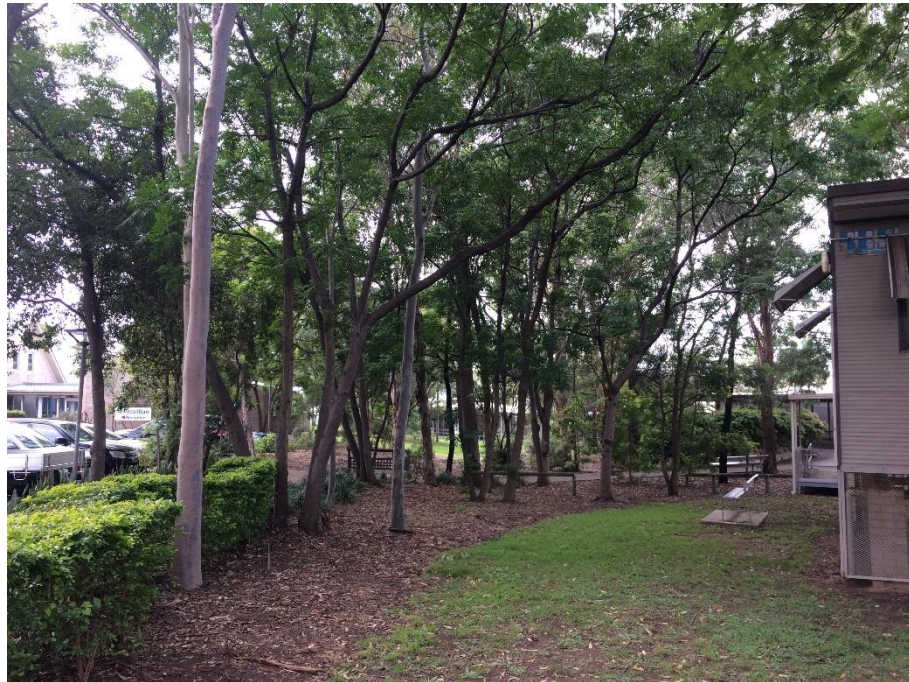
**Plate 3:** Tree group 279. P. Vezgoff.

| These could be trees growing as a group (Plate 5) that are not great individual specimens. Trees in poorer health or have a limited SULE ratings (Plate 3). |

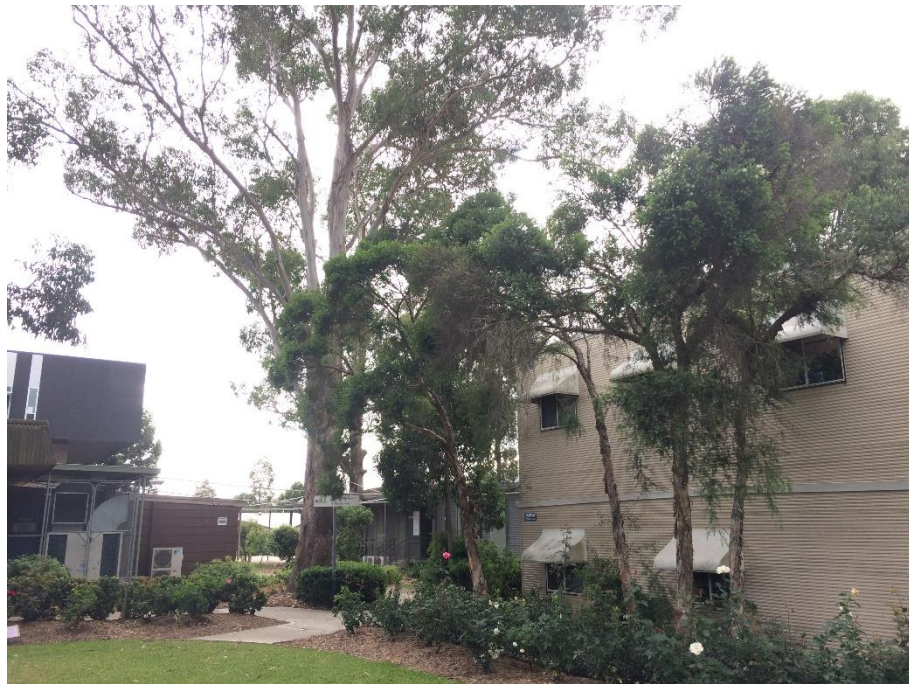
**Plate 4:** Trees 88-91 as low value trees. P. Vezgoff.

| Low Value Trees |
|---|
| Smaller underperforming trees. Trees with structural faults. Trees planted too close to buildings for future growth or trees that could be readily replaced (Plate 4). |
