# Tallawarra Stage B Gas Turbine Power Station

Flora and Fauna Management  
Sub-Plan

**EnergyAustralia Tallawarra  
Pty Ltd**

Reference: MP07\_0124

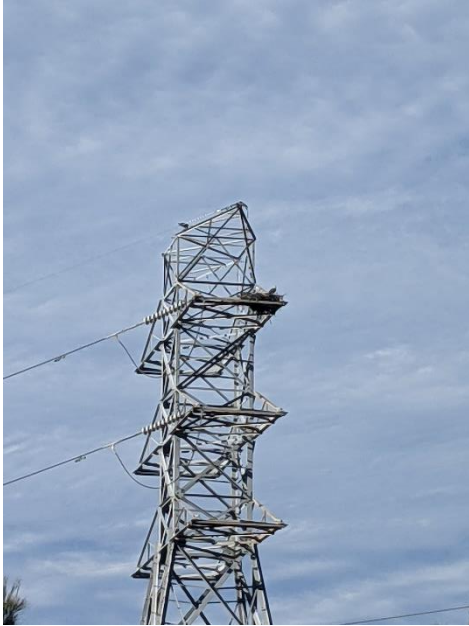
Figure 3-3 Resident Eastern Ospreys nesting atop a transmission tower at Tallawarra Power Station

To assist in identification of the species, the nesting site at Tallawarra Power Station is shown in Figure 3-3 and an example image of an Eastern Osprey is shown Figure 3-4.

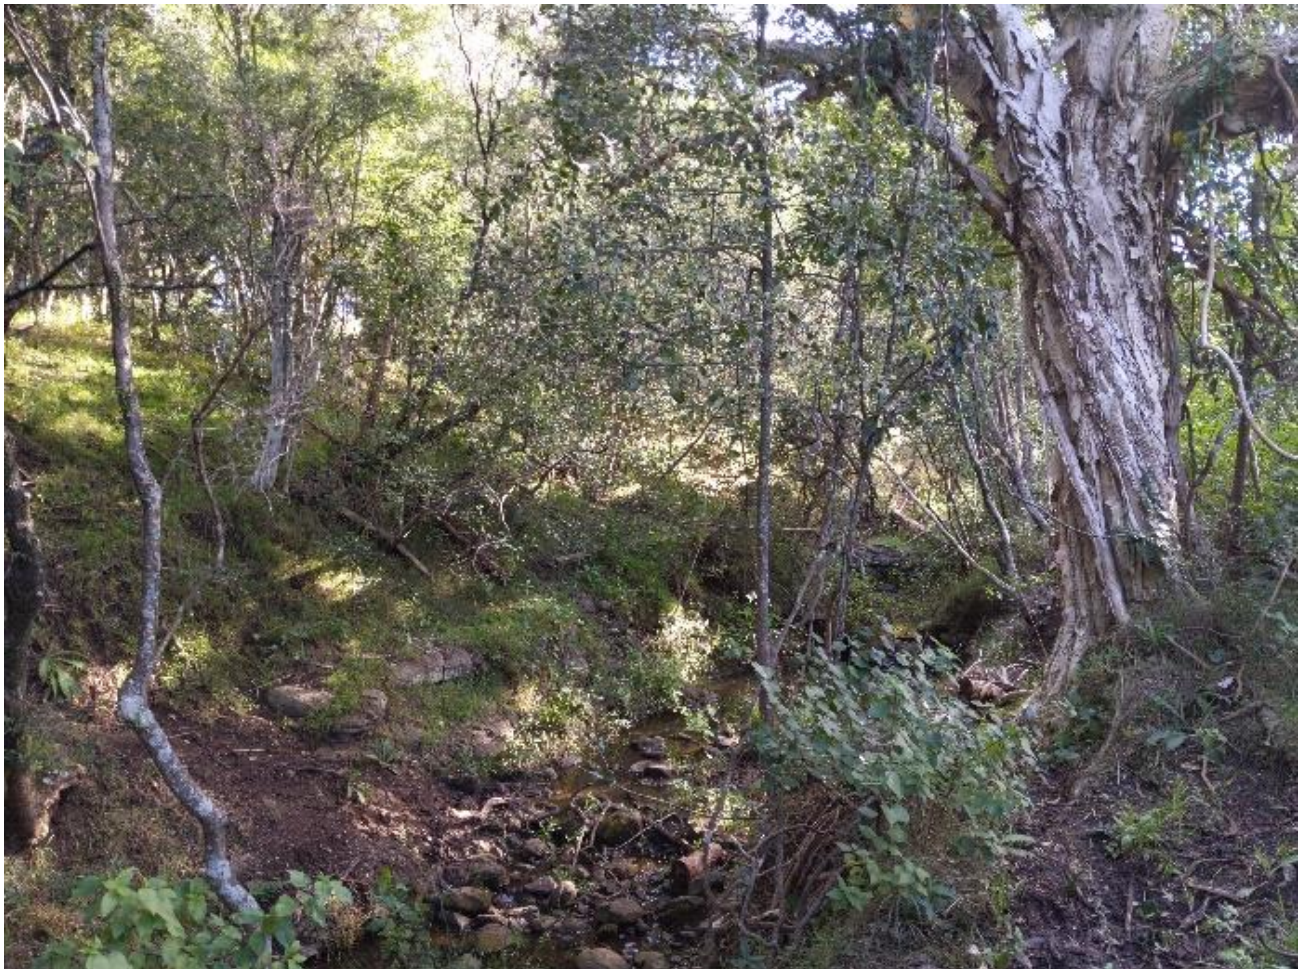
**Figure 3-9 Example of an area of Illawarra Subtropical Rainforest within Yallah Creek north of the site which is to be avoided**

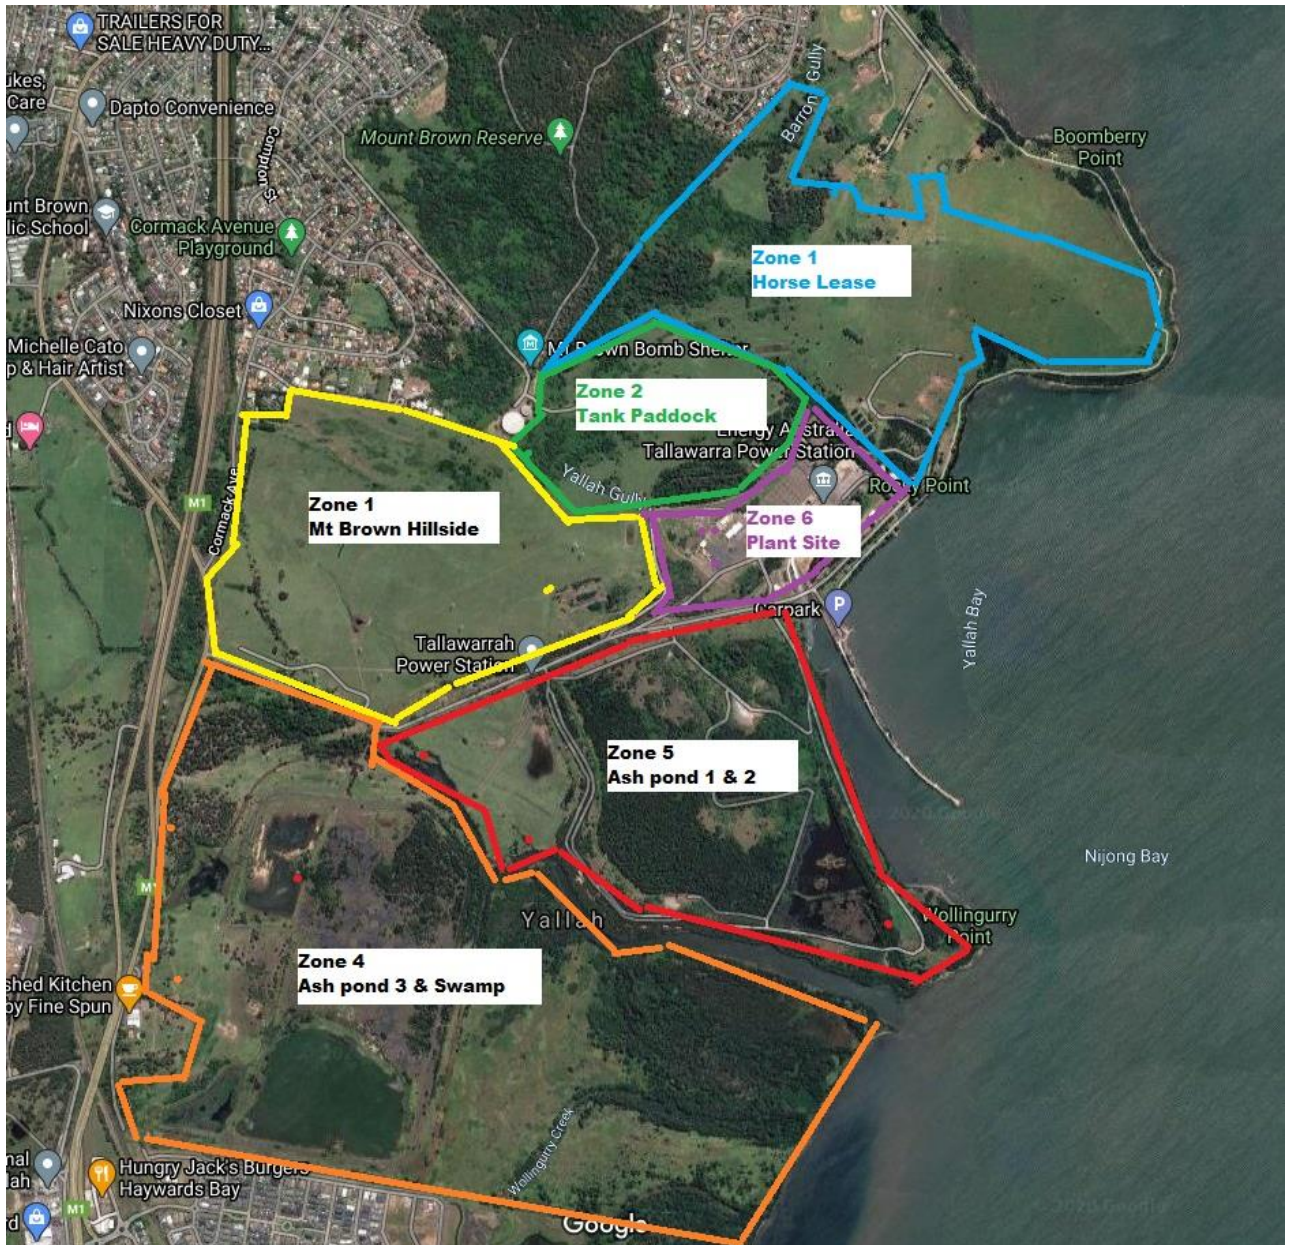
Figure 3-10 IDWA 2021 and onwards priority weed management map of Tallawarra Power Station and Tallawarra Lands

**Table 3-4 IDWA Priority weed management program for 2021 onwards**

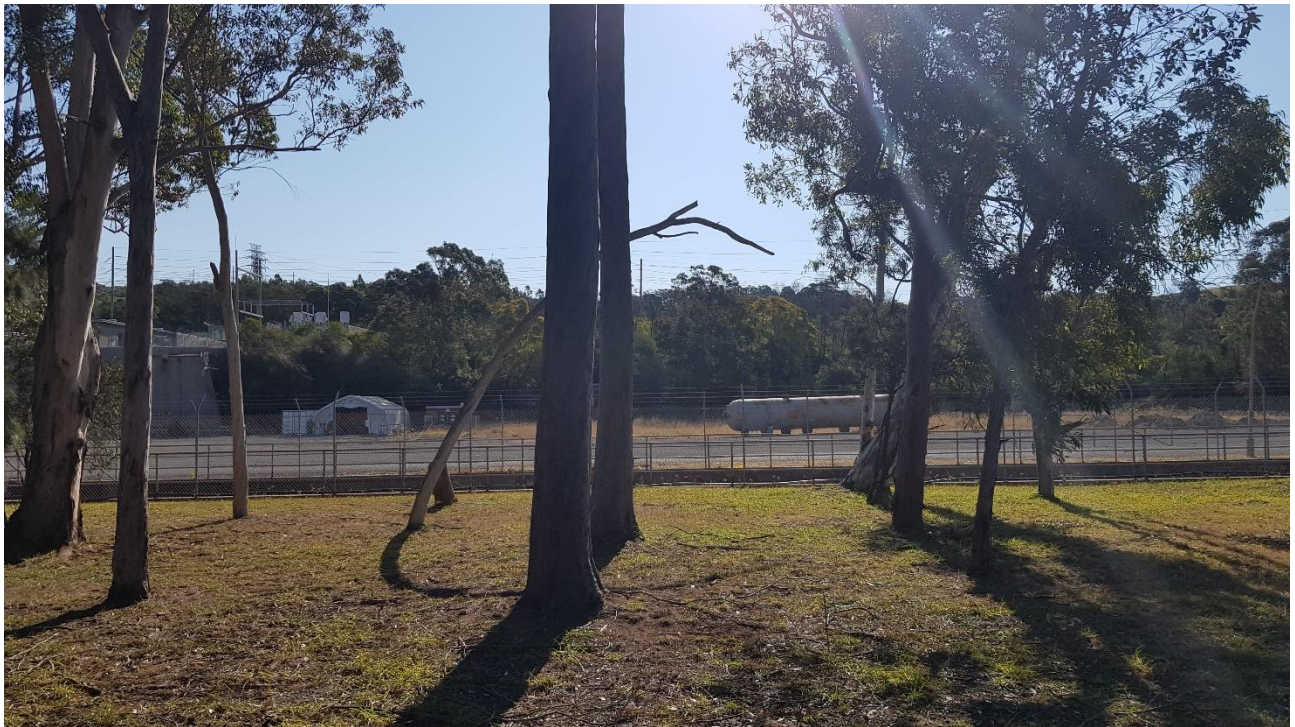
This is an open woodland community with assorted eucalypt species including brown stringybark (*Eucalyptus capitellata*), spotted gum (*Corymbia maculata*), lemon scented gum (*Corymbia citriodora*), forest red gum (*Eucalyptus teriticornis*) and coast grey box (*Eucalyptus bosistoana*). There are several additional medium to large trees including willow bottlebrush (*Callistemon salignus*) and swamp oak (*Casuarina glauca*). The ground cover is dominated by couch grass (*Cynodon dactylon*) and other ground herbs including clovers (*Trifolium spp.*), plantains (*Plantago spp.*), crabgrass (*Digitaria sanguinalis*), and flea bane (*Conyza spp.*).

This community does not fit a PCT description as it is an assortment of scattered trees of various species, the majority of which may have been planted. The condition of the vegetation is moderate.

Typical representation of the 'Eucalypt and casuarina grassy woodland'. Photo facing north west towards the Tallawarra Stage B Gas Turbine Power Station Site

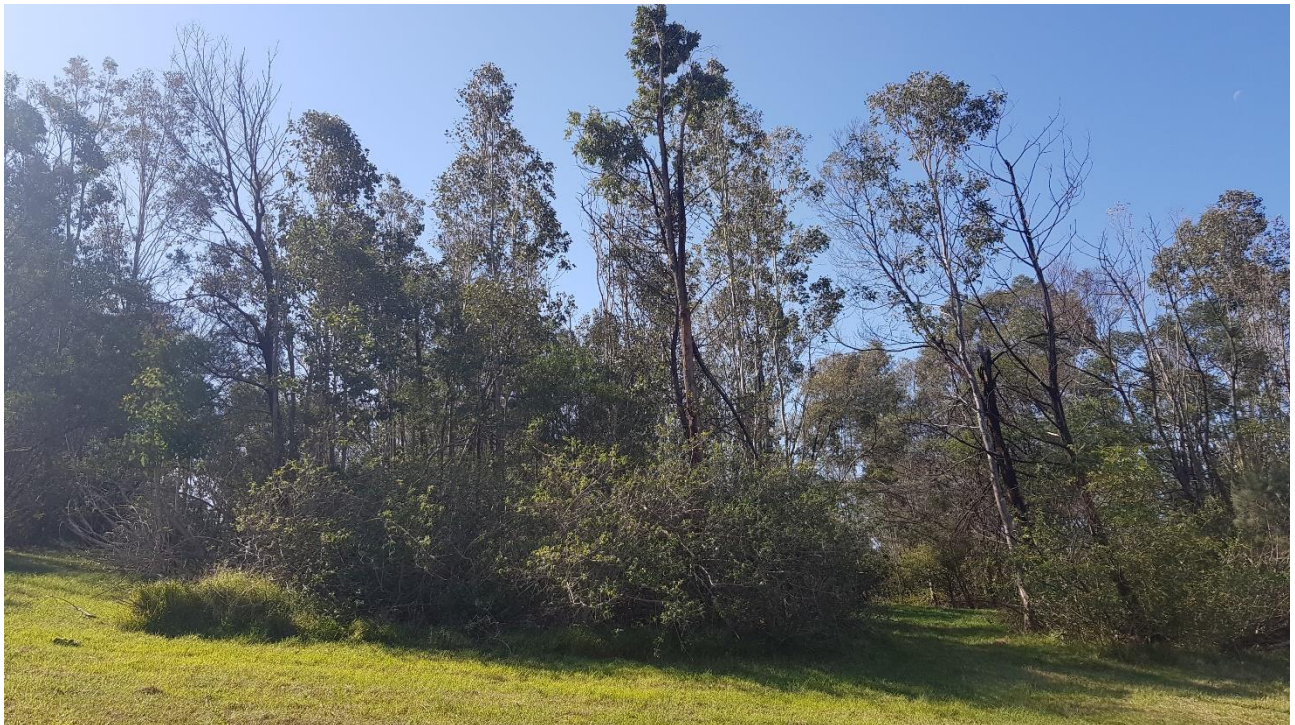
This is a closed woodland structure with a canopy of about 5 – 10 metres high. It is dominated by forest red gum (*Eucalyptus tereticornis*), grey gum (*Eucalyptus punctata*) and some thin-leaved stringy bark (*Eucalyptus eugenioides*) (Figure 6). It should be noted that very little fruiting material was available due to the young age of the trees, which makes identification difficult. It is possible there are other eucalypt species present in this community that were not identified in the field assessment. The midstorey is generally dominated by large lantana shrubs (*Lantana camara*).

**Typical representation of the 'Grey gum and forest red gum woodland'. Photo facing north east towards the woodland from the existing cleared transmission alignment**

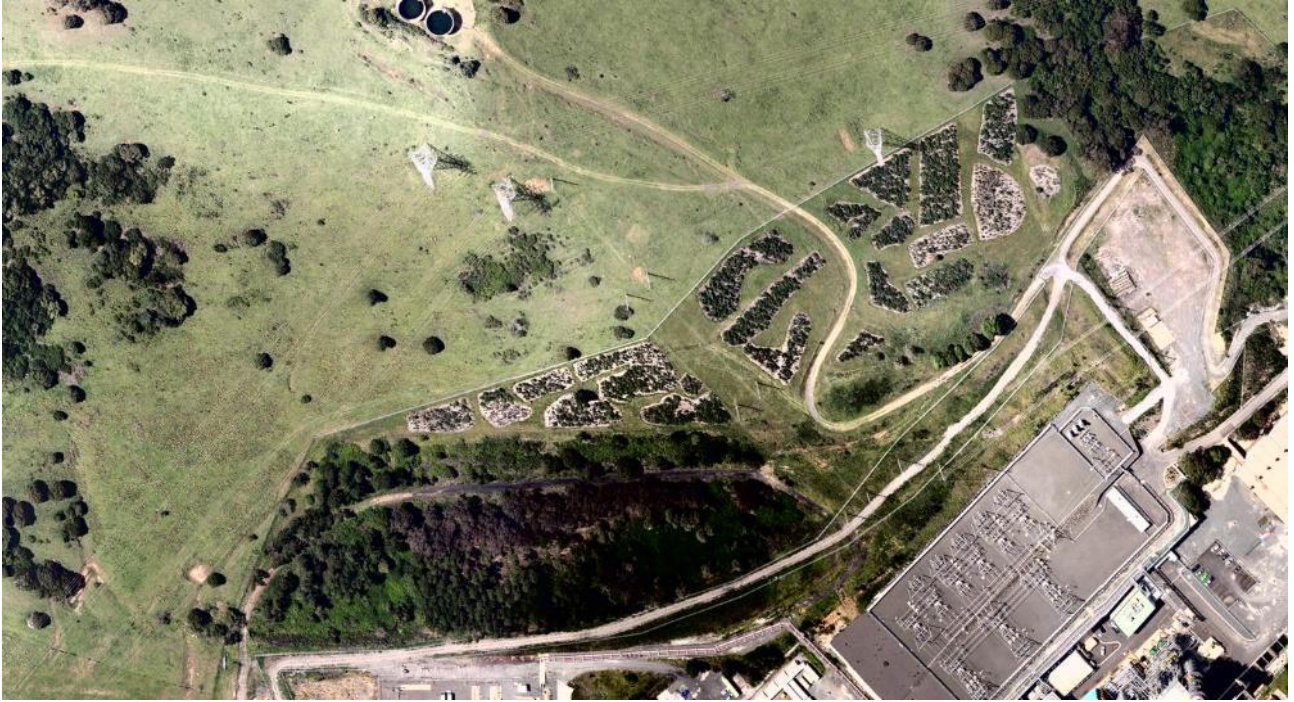
A review of historical aerial images and details provided in the Tallawarra Power Station Master Plan (URS Australia, 2006) indicates this area was planted in the late 2000's and therefore is about 10-12 years old. The relatively young age of the species present supports the observation of a minimal amount of fruiting material and a lack of hollows. Nonetheless, a higher than expected amount of fallen timber was observed for a community of this age which indicates previous clearing or wind damage. Fallen timber may provide habitat for ground dwelling fauna species.

Historical aerial image from January 2010 showing the planting of the 'Grey gum and forest red gum woodland', indicating this area was planted in the late 2000's. Source: Nearmap

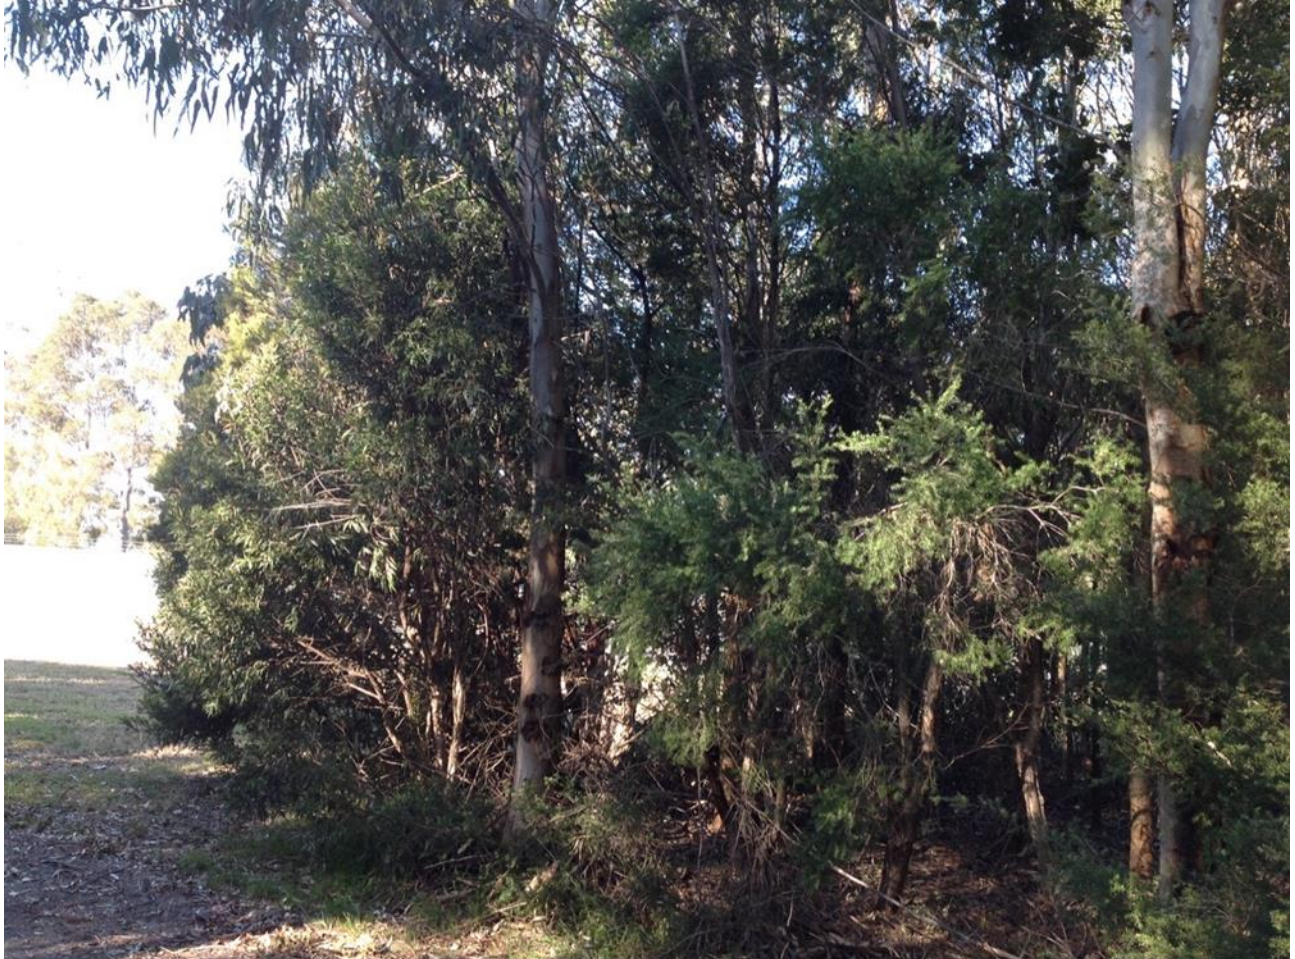
**Typical representation of the 'Forest red gum and prickly-leaved paperbark forest' south of the 'office and laydown area'. Photo facing north east along the existing access track.**

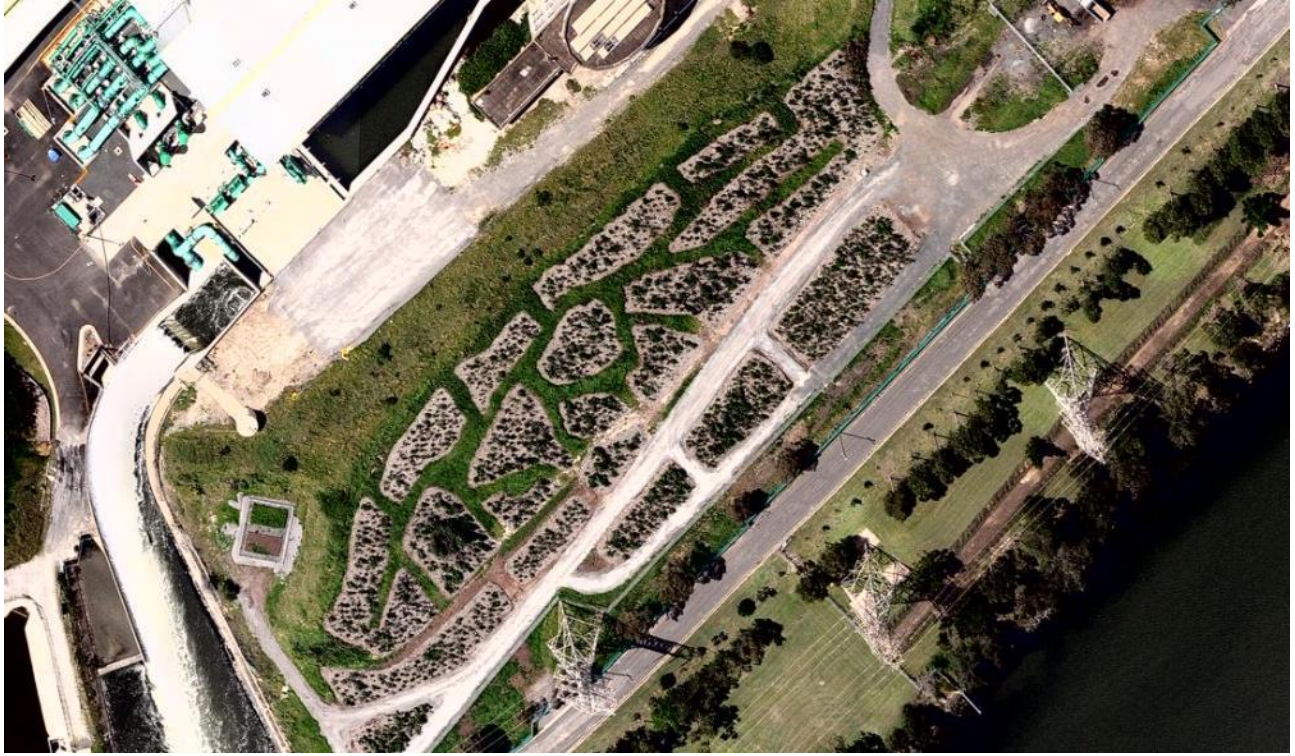
A review of historical aerial images and details provided in the Tallawarra Power Station Master Plan (URS Australia, 2006) indicates this area was planted in the late 2000's and therefore is expected to be about 10- 12 years old. This information supports the minimal amount of fruiting material found and the lack of hollows observed.

**Historical aerial image from January 2010, showing the planting of the 'Forest red gum and paperbark forest', indicating this area was planted in the late 2000's. Source: Nearmap**

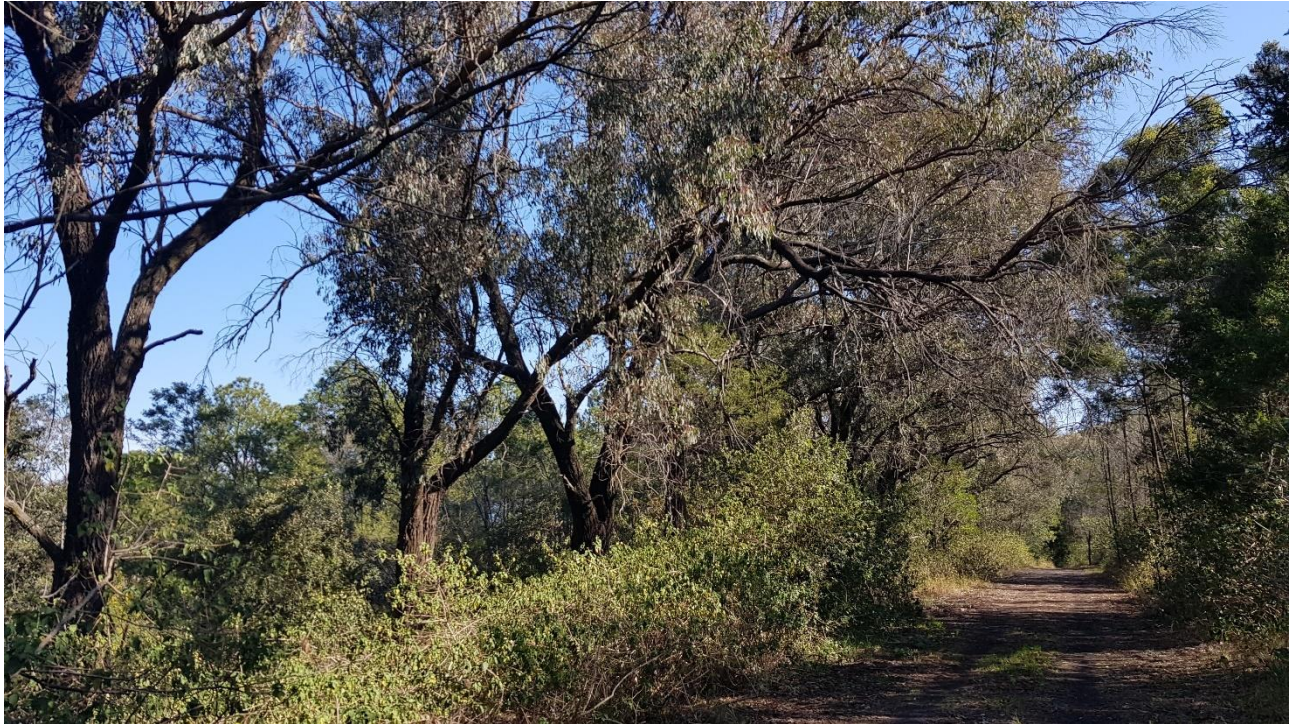
Three mature trees with small hollows were identified south of the access track. The hollows may provide habitat for birds and small mammals. It is possible that there are more hollows in this area that were not observed due to the large size of the trees and the inability to access the site due to the extensive lantana.

Typical representation of the 'Ironbark forest' along the access the existing switchyard access track route. Photo facing west along the existing access track.

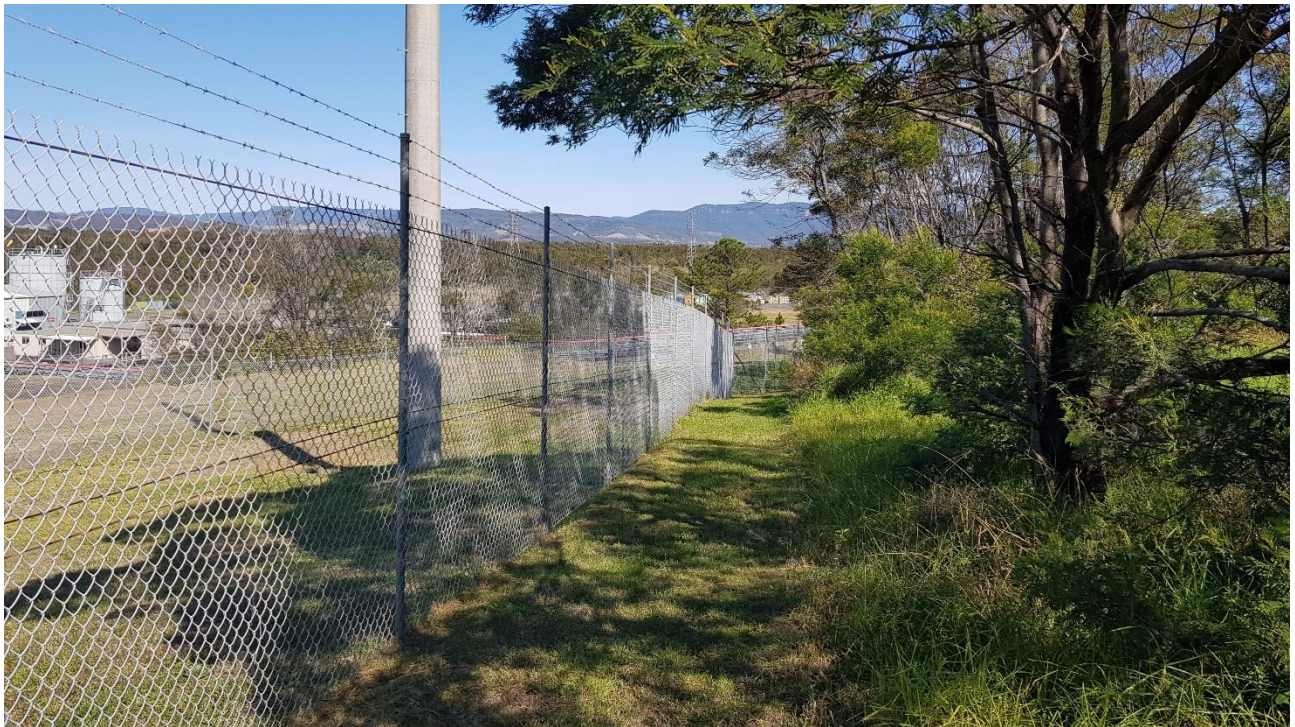
This community is a scrubland with a canopy of about 3 – 5m high. It is a derived vegetation community resulting from colonisation by acacias and other colonising species following past clearing and disturbance of the original vegetation community. Acacia species present include *Acacia mearnsii*, *Acacia maidenii*, *Acacia longifolia*, *Acacia suaveolens*. The midstorey is generally dominated by large lantana shrubs (*Lantana camara*). Other weed species identified in the understorey includes asparagus weed (*Asparagus spp.*), bitou bush (*Chrysanthemoides monilifera*), fireweed (*Senecio madagascariensis*), blackberry (*Rubus fruticosus*), balloon cotton bush (*Gomphocarpus physocarpus*), oxalis (*Oxalis spp.*), cassia (*Senna spp.*), olive (*Olea europaea*) and passion vine (*Passiflora spp.*).

Typical representation of 'Acacia scrub' along the 'approved transmission line alignment'. Photo facing south west along the northern power station site fence line.

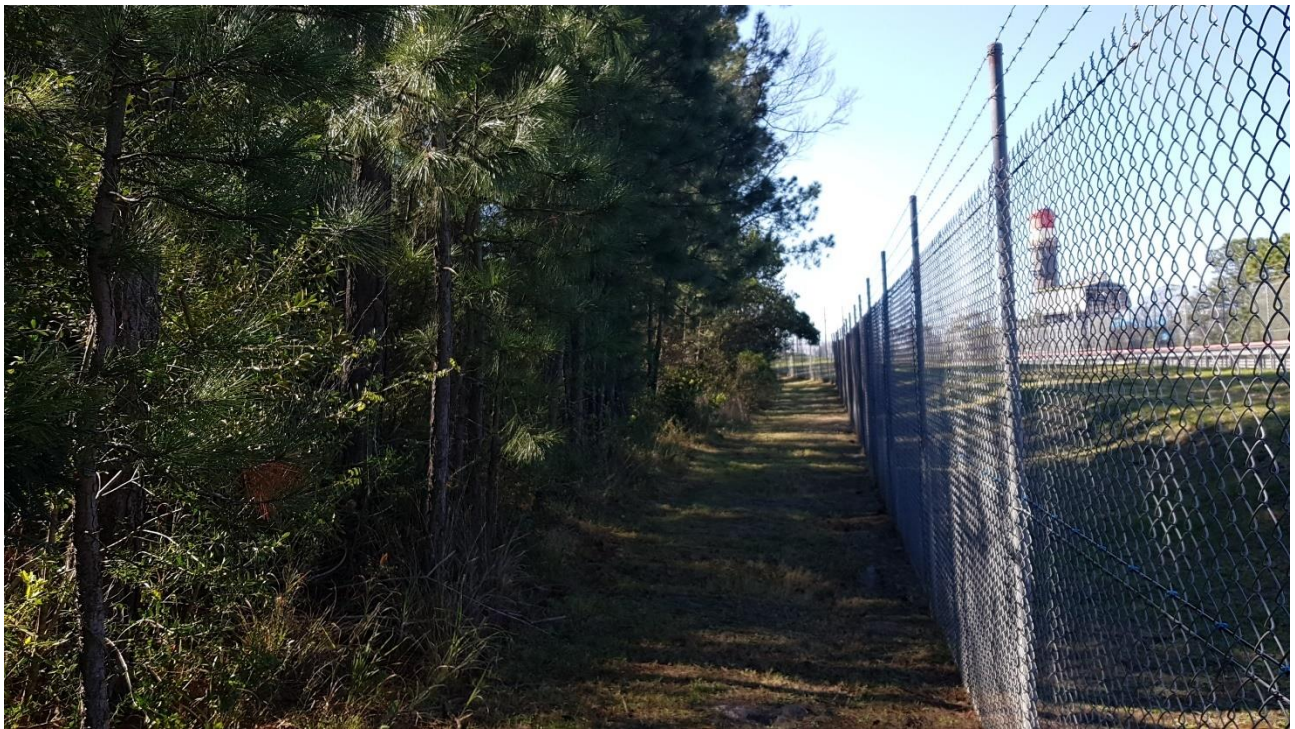
This is an open woodland community dominated by radiata pine (*Pinus radiata*) and with a canopy of about 10 – 15 metres high. The midstorey was variable depending on the density, and therefore canopy cover, of the radiata pine (*Pinus radiata*). In more open areas (less canopy cover), the midstorey is dominated by weed species including lantana (*Lantana camera*), cotoneaster (*Cotoneaster spp.*), small-leaved privet (*Ligustrum sinense*). Other weed species identified in the understory including asparagus weed (*Asparagus spp.*), bitou bush (*Chrysanthemoides monilifera*), fireweed (*Senecio madagascariensis*), blackberry (*Rubus fruticosus*), balloon cotton bush (*Gomphocarpus physocarpus*). In areas where the radiata pine (*Pinus radiata*) is in denser stands that shade or crowd out other species (more canopy cover), there is little mid or understory, with the ground covered by pine leaf litter.

Typical representation of 'Radiata pine forest' along the 'approved project transmission line alignment'. Photo facing east along the northern power station site fence line.

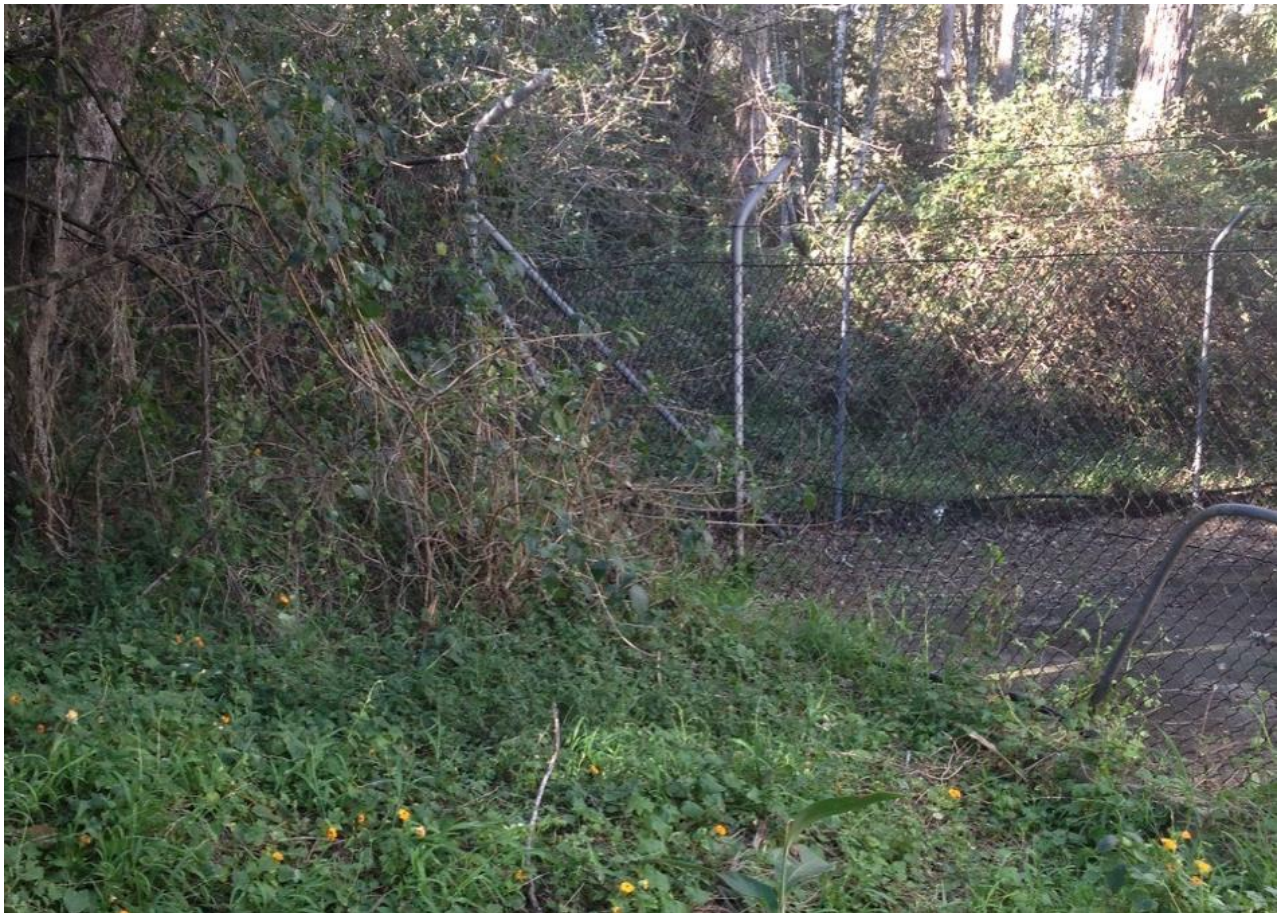
Isolated individual emergent trees were present including swamp oak (*Casuarina glauca*) which may have been indicative of the original vegetation type before clearing and the colonisation of exotic species.

Typical representation of the 'Weeds and exotics' within the 'diesel storage area'. Photo facing south.

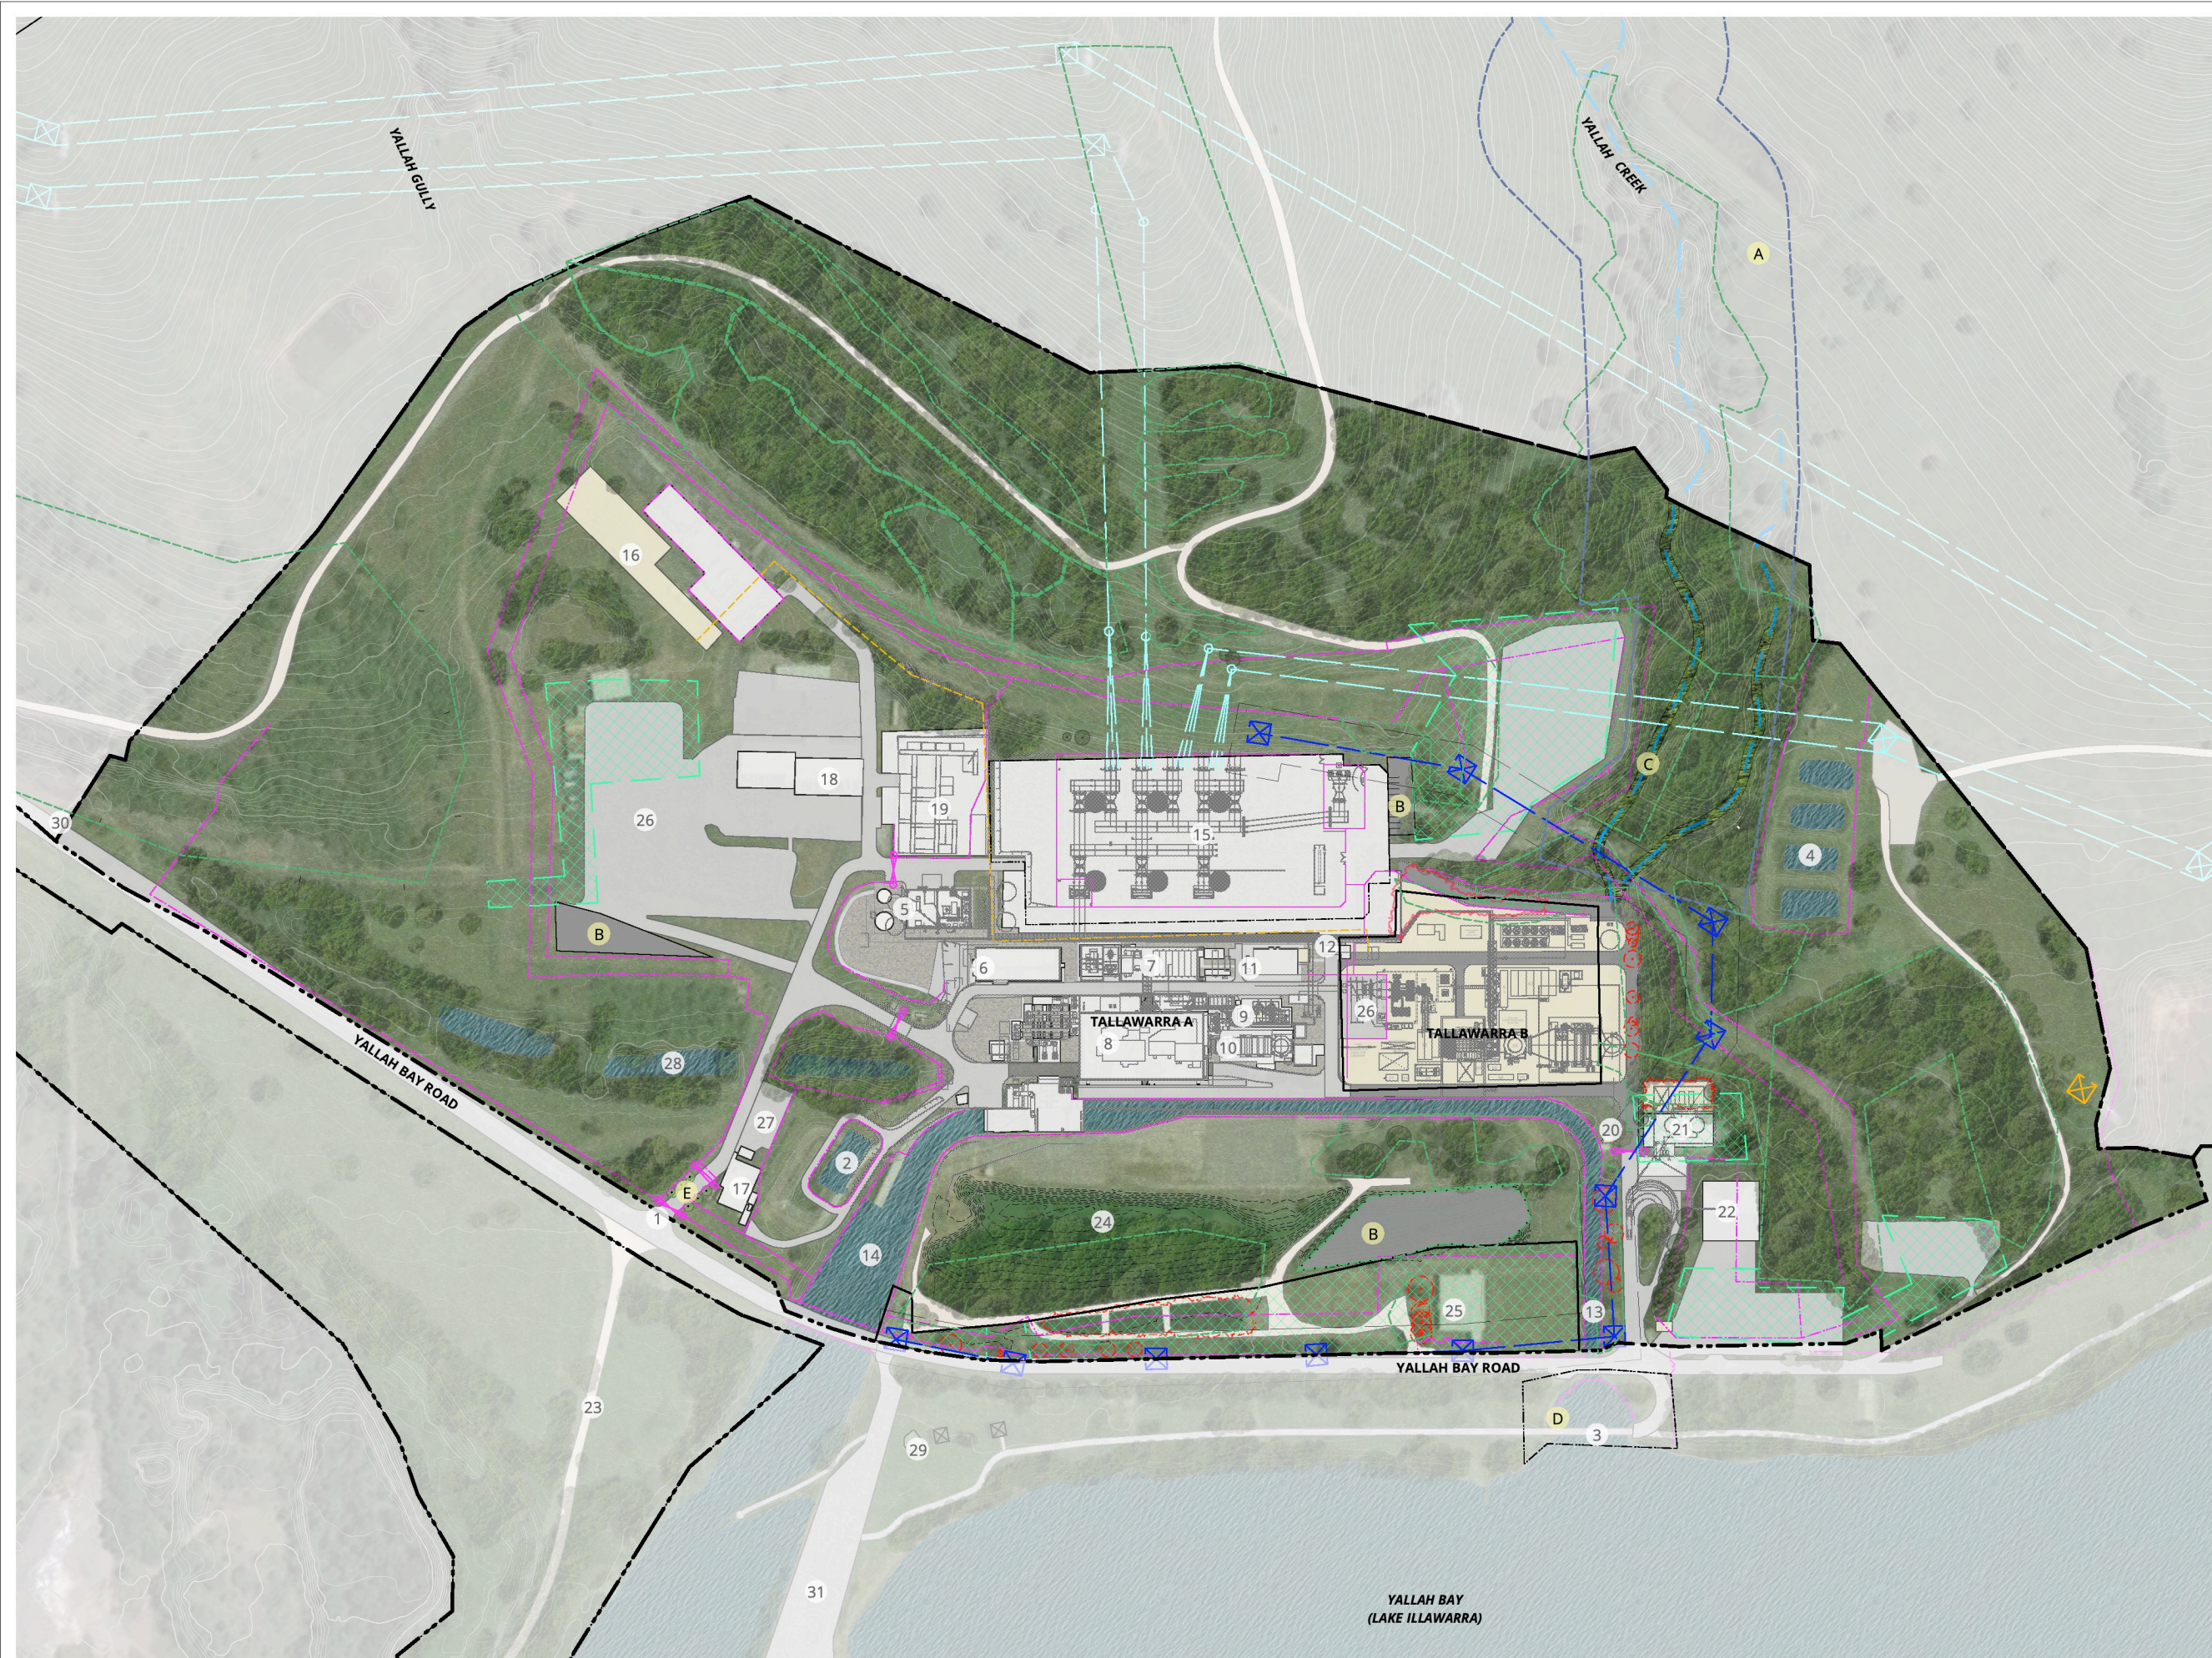
# Appendix E: Landscape plan

Legend	
<b>EXISTING PROGRAMME</b>	
1	Tallawarra A entrance
2	Stormwater retention pond
3	Pedestrian bridge (maintenance only)
4	Sewerage treatment ponds
5	Water treatment plant
6	Workshop & store building
7	Electrical module ST & GT
8	Gas turbine & steam turbine generator building
9	Feedwater structure
10	Heat recovery steam generator
11	Administration & control building
12	Storage
13	Inlet canal
14	Outlet canal
15	Switching station
16	Gas station
17	Security office
18	Project office
19	Crib hut area
20	Gate 12 security hut
21	Scaffold crib hut
22	Warehouse
23	Maintenance road (no public access) to be maintained
24	Vegetated earth mound
25	Former bowling club
26	Parking for power station
27	Visitor car park
28	Drainage / settlement ponds
29	Playground and picnic area
30	Heavy haulage entrance
31	Boat ramp car park
<b>PROPOSED / UPGRADED PROGRAMME</b>	
A	Riparian exclusion zone to be maintained
B	Potential car park
C	Riparian corridor to be rehabilitated

D	Public access diversion
E	New street planting with decorative treeguards to highlight site entry
<b>GENERAL</b>	
---	Tallawarra lands cadastral boundary
---	Tallawarra lands internal boundary
---	Staging boundary
---	Riparian buffer
---	Existing building / plant
---	Proposed building / plant
---	Laydown area to be remediated
---	Gate general - existing
---	Boom gate - existing
<b>SERVICES</b>	
---	Existing transmission lines retained
---	Existing transmission tower retained
---	Proposed transmission lines
---	Proposed 132 Kw transmission tower
---	Temporary transmission tower retained
---	Gas feeder
<b>RAILS AND FENCING</b>	
---	Fencing - general
---	Fencing - propose
<b>WATER ELEMENTS</b>	
---	Water element - natural grade
---	Yallah Creek route
<b>FURNITURE AND FITTINGS</b>	
---	Existing picnic shelter
<b>PAVEMENTS</b>	
---	Existing road / parking
---	Existing maintenance & bushfire access track
---	Existing stone chipping
