CHAIN VALLEY COLLIERY
Annual Review 2019
1 January 2019 – 31 December 2019

Chain Valley Colliery – Annual Review (AEMR) 2019

Name of operation	Chain Valley Colliery
Name of operator	Great Southern Energy Pty Ltd trading as Delta Coal Pty Ltd
Project Approval #	SSD 5465
Name of Project Approval holder	Delta Coal Pty Ltd
Titles/Mining Leases #	Consolidated Coal Lease 707, Consolidated Coal Lease 706 (part), Mining lease 1051, Mining lease 1052, Mining lease 1308, Mining Lease 1370, Mining lease 1632 (part sublease), Mining Purposes Lease 1349, Mining Purposes Lease 337, Mining Purposes Lease 1389, Mining Purposes Lease 1400, Consolidated Coal Lease 719 (part sublease), Consolidated Coal Lease 721 (part sublease), Consolidated Coal Lease 722.
Name of holder of mining leases	Great Southern Energy Pty Ltd
Water License #	WAL41508 / Work Approval 20MW065025
MOP Commencement Date	1 st October 2018
MOP Completion Date	31 st December 2020
Annual Review start date	1 January 2019
Annual Review end date	31 December 2019

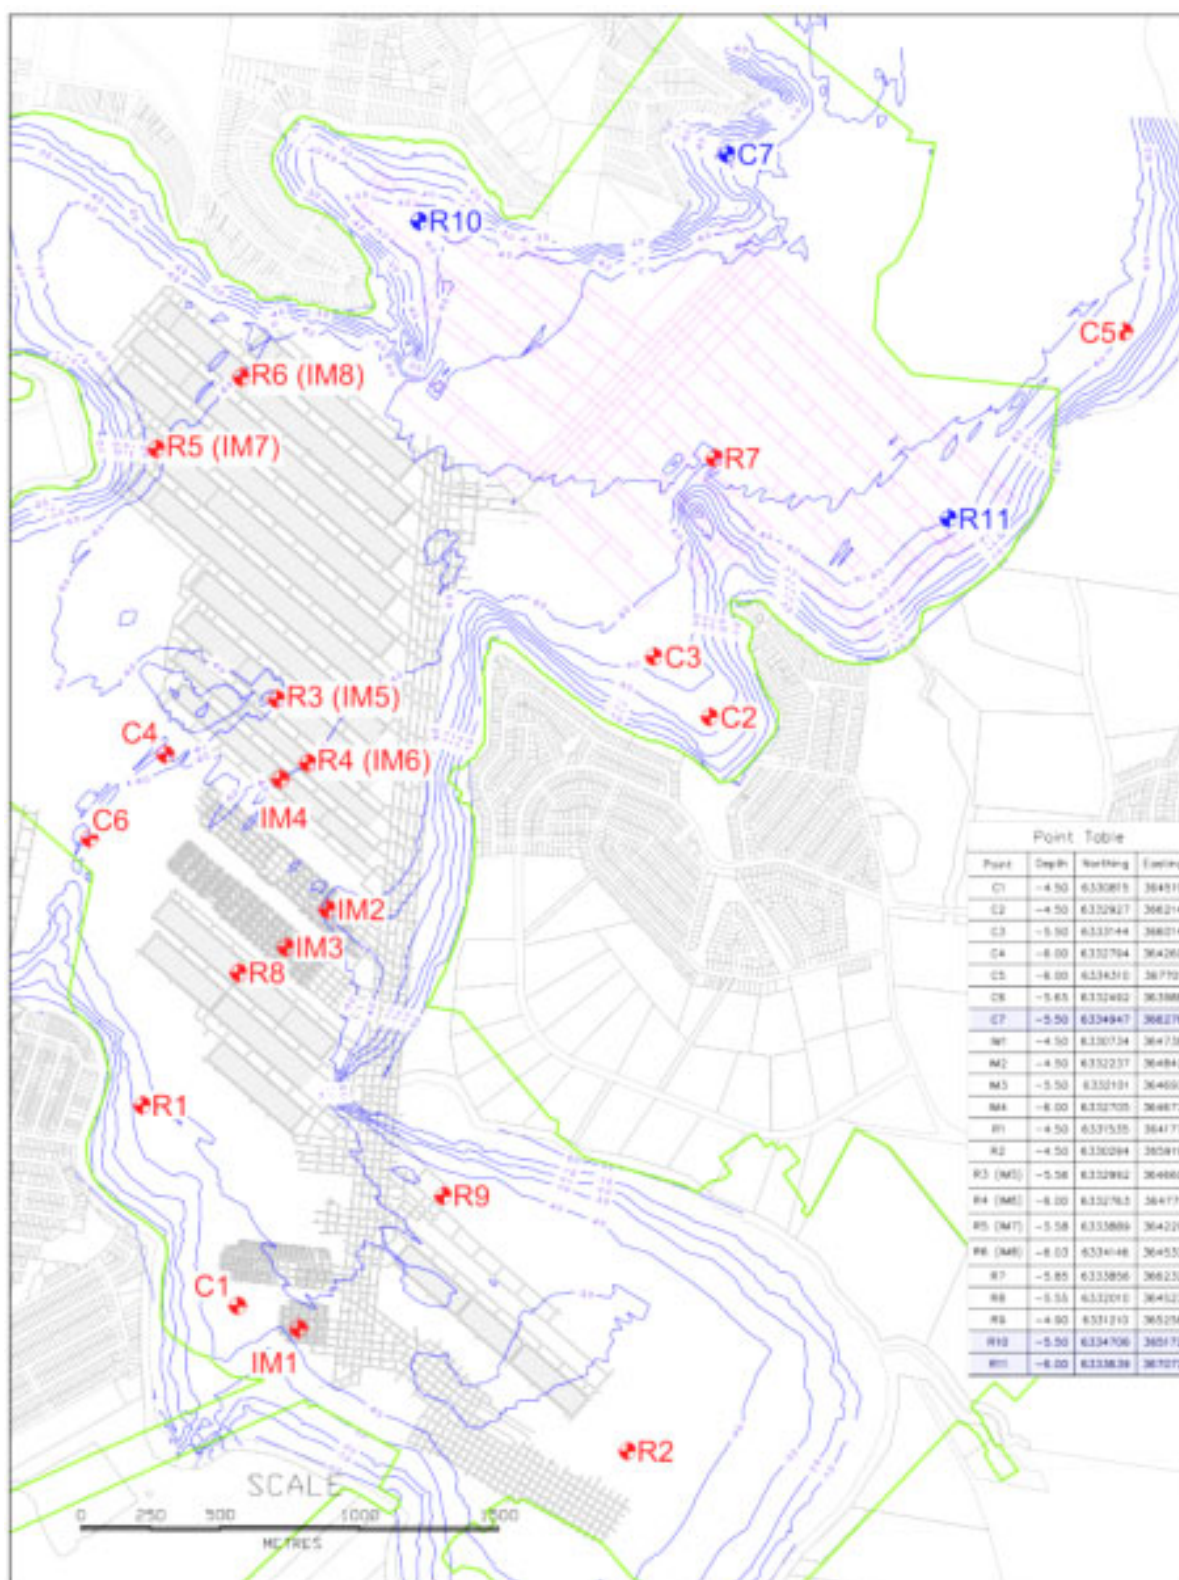
Figure 15: Benthic Sampling Locations

In summary, the mud basin off Summerland Point and in Chain Valley between February 2012 and September 2019 was found to be inhabited by 24 species of organisms greater than 1 mm in size. Polychaete worms and bivalve molluscs were the most frequently encountered animals. Benthic sampling locations are shown in **Figure 15**.

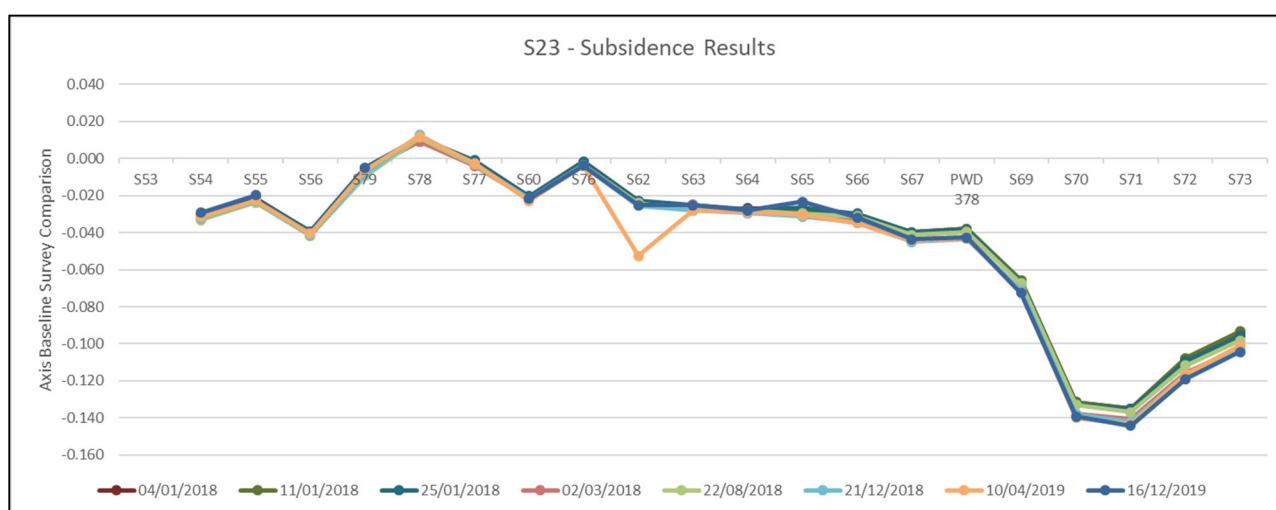
Figure 23: Line 23 Subsidence Results

It is noted this point, along with points #63-75 have all experienced more than negligible amounts of subsidence (20 mm) since June 2008. Since 2008, when Fassifern first workings were completed, subsidence movement has ranged between 20-40 mm, primarily due to the impact of multi-seam extraction in the Wallarah and Great Northern seams. Ongoing subsidence appears to have slowed in recent years, with approximately 10 mm of movement (Point S71) during the 2018 and 2019 reporting periods as detailed in **Figure 23**.

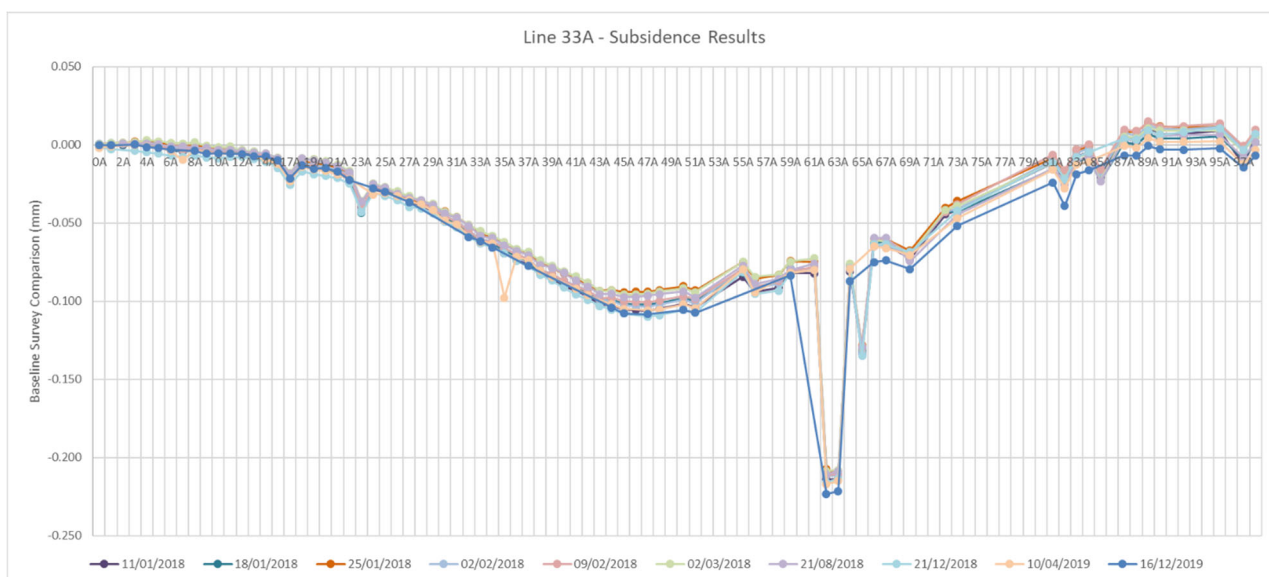
Figure 25: Line 33A Subsidence Results

As the area where Line 33A monitoring marks are located is along a public reserve where regular slashing / brush cutting activities are carried out, a number of monitoring points have been disturbed / moved over time. Where this type of movement occurs, the new RL point is adopted and monitoring continues.

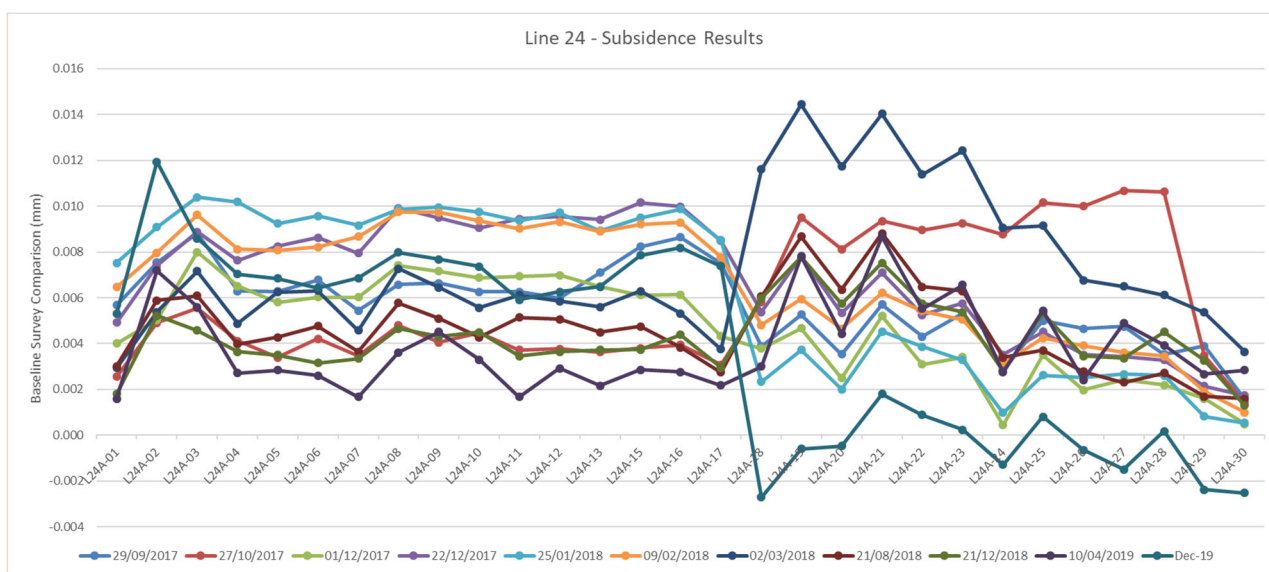
Figure 26: Line 24 Subsidence Results

The survey accuracy, combined with ground movement, is generally responsible for most movement <10 mm. Occasionally there will be disturbance or deterioration to survey marks, particularly given they are in publicly accessed areas.

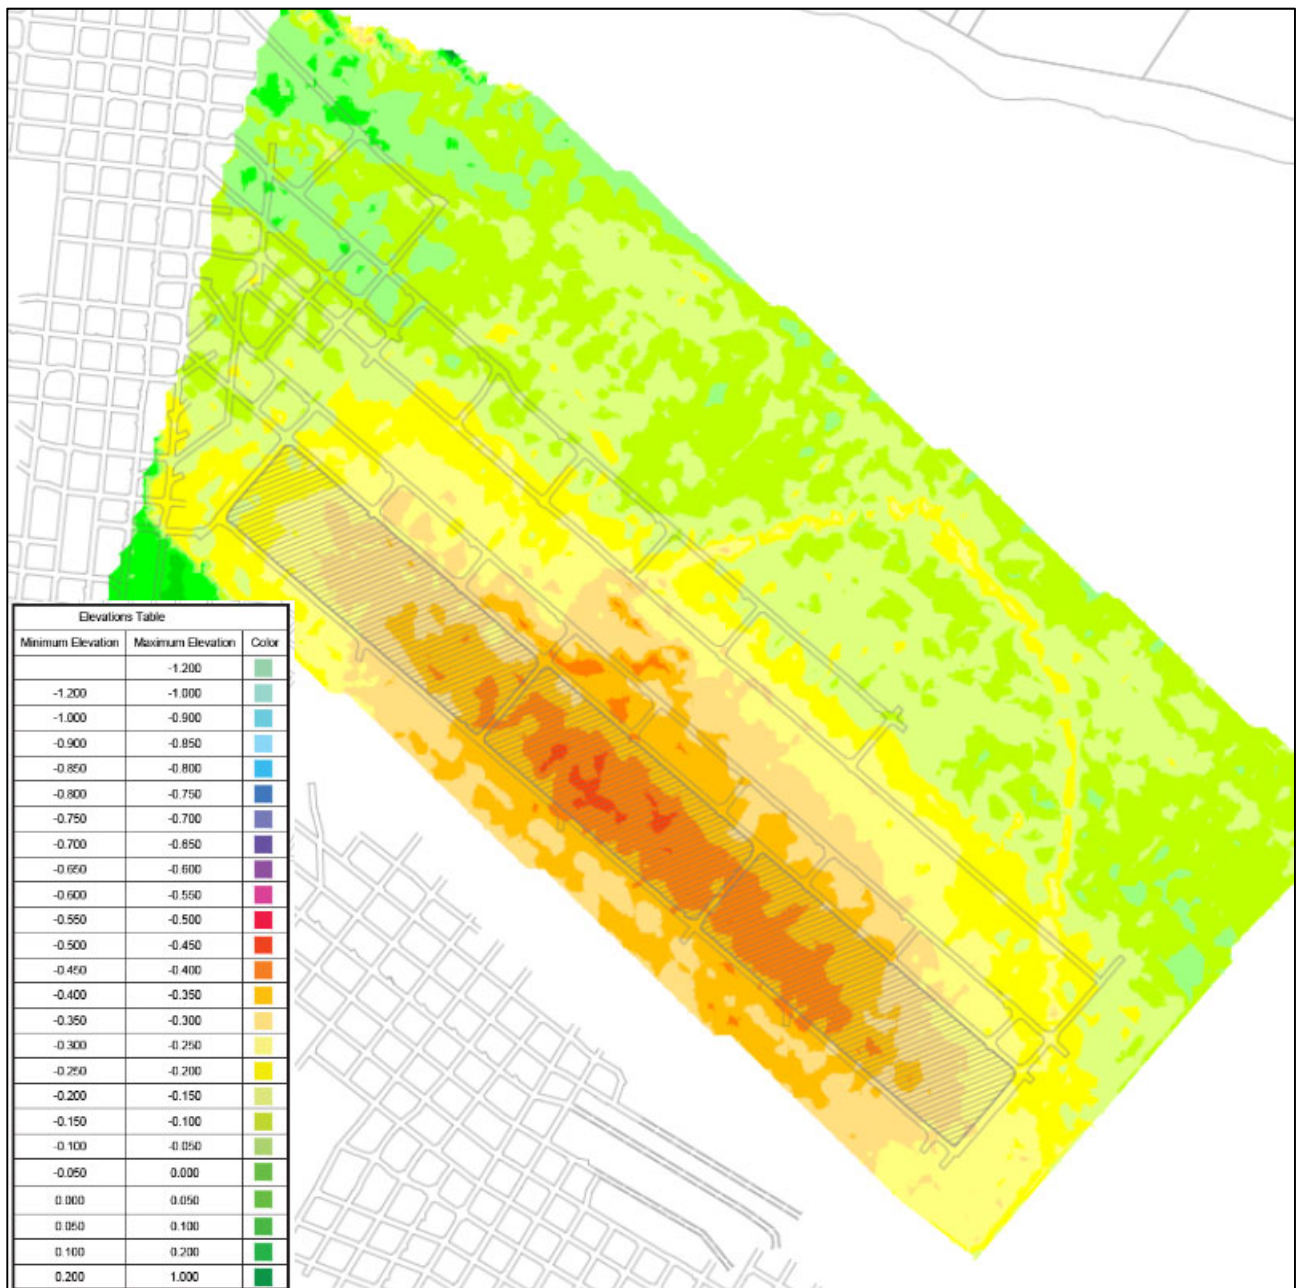
Figure 30: Lake Bed Subsidence Results, Chain Valley Bay Miniwall CVB1, July 2019

Bathymetric surveys over the Chain Valley Bay mining area (**Figure 30**) have indicated subsidence of up to 400 mm directly over the extracted area. An increased angle of draw of surface subsidence has been detected, but no impacts to the shoreline were observed. Minimal subsidence movement was detected from the previous survey in the area (January 2018).

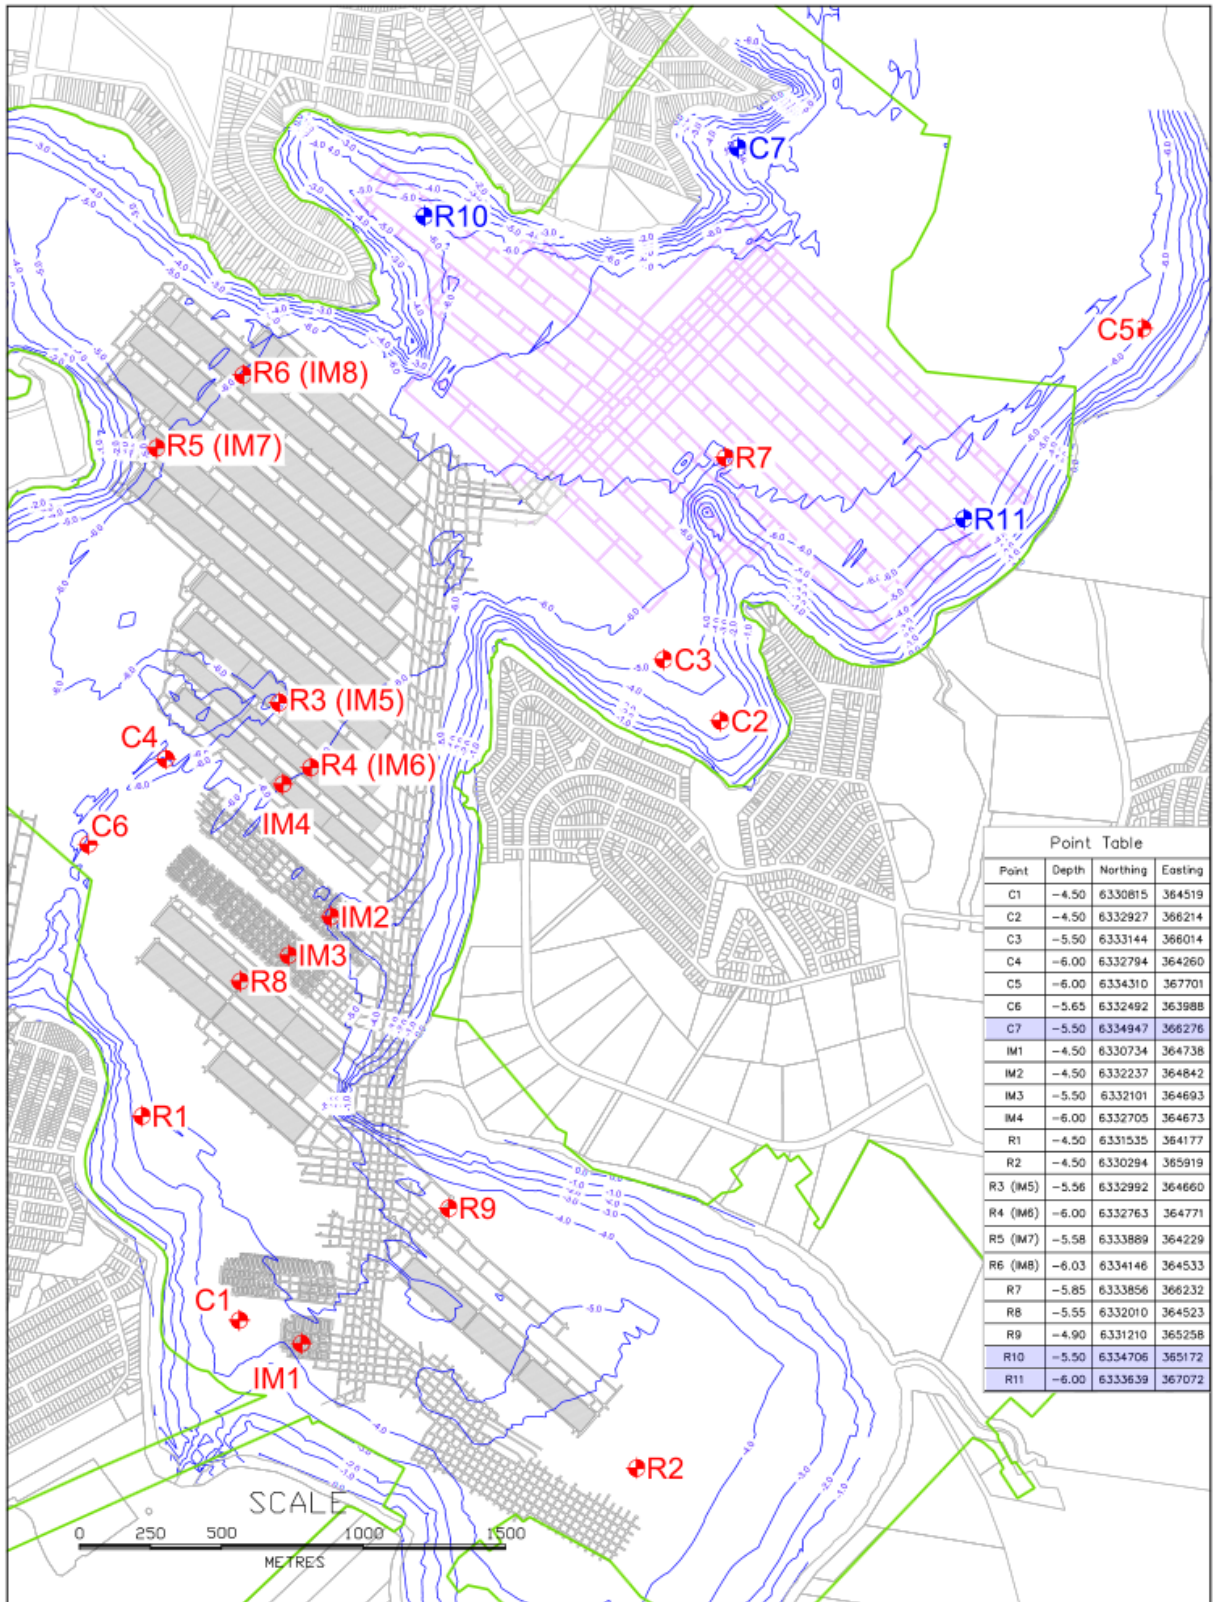
Figure 9.1. Extent of Underground Mining up to June 2019.

Figure 9.1 shows the extent of mining up to June 2019.

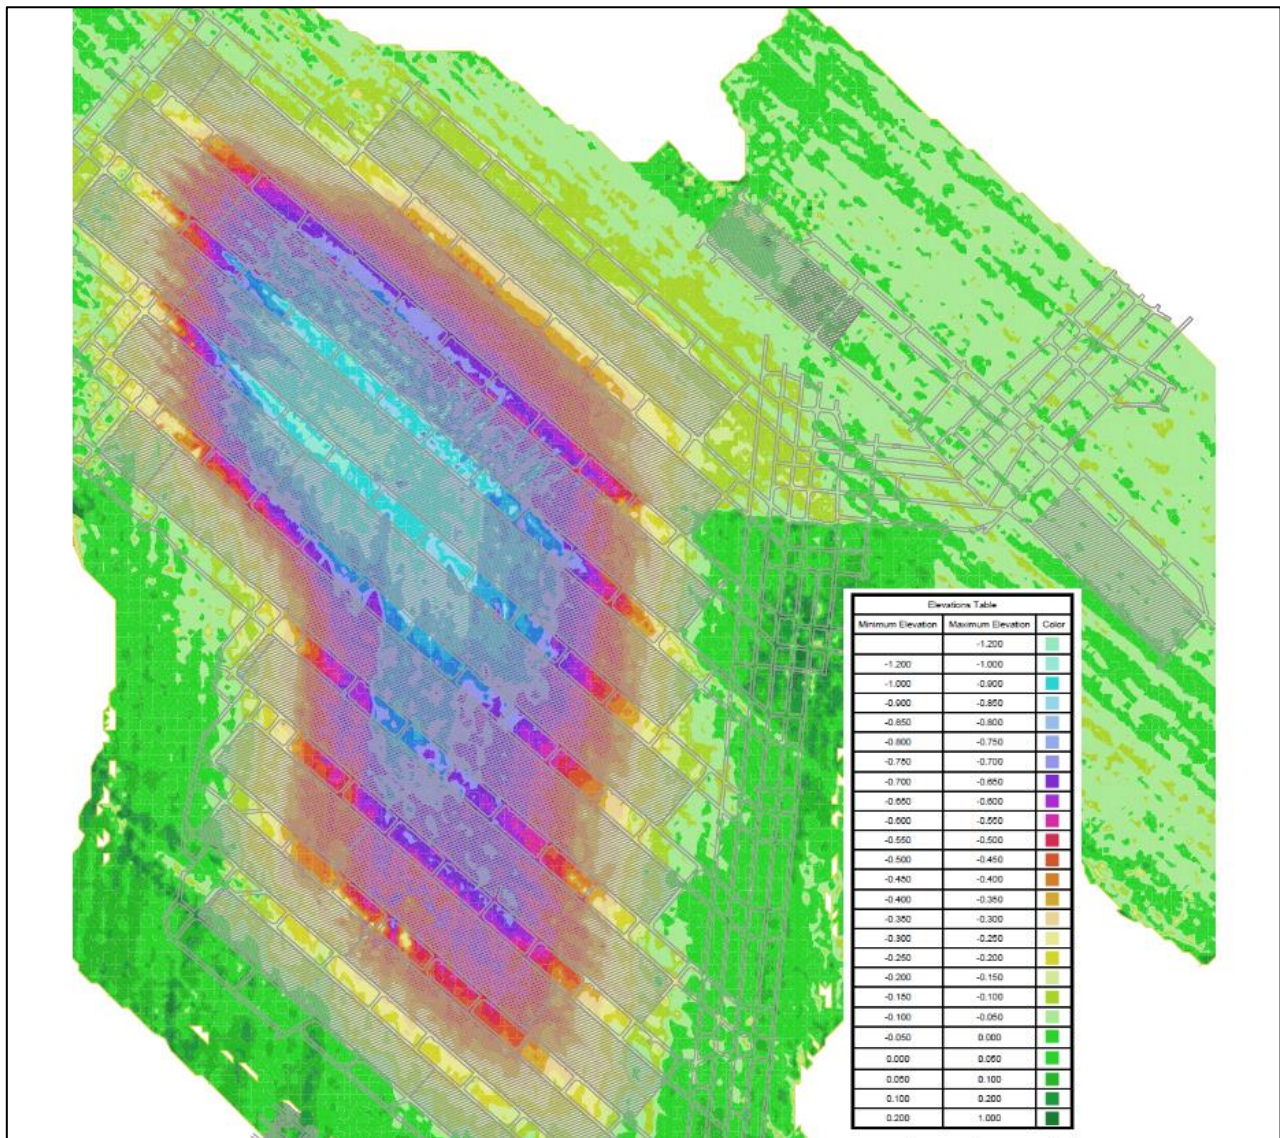
- assess the stability of remnant coal pillars within former workings in the Great Northern and Wallarah Seams;
 - give particular consideration to the risks of irregular subsidence, pillar run and long-term subsidence leading to subsidence outside of the predicted angle of draw;

Figure -Figure shows the 2019 scan results over Miniwalls 7-12 and N1, S1 comparative to the initial bathymetric surveys. Approximately 1200mm of subsidence has developed over the Miniwall 7-12 domain (above predictions of 780mm), but no further subsidence have been detected since the 2017 surveys.

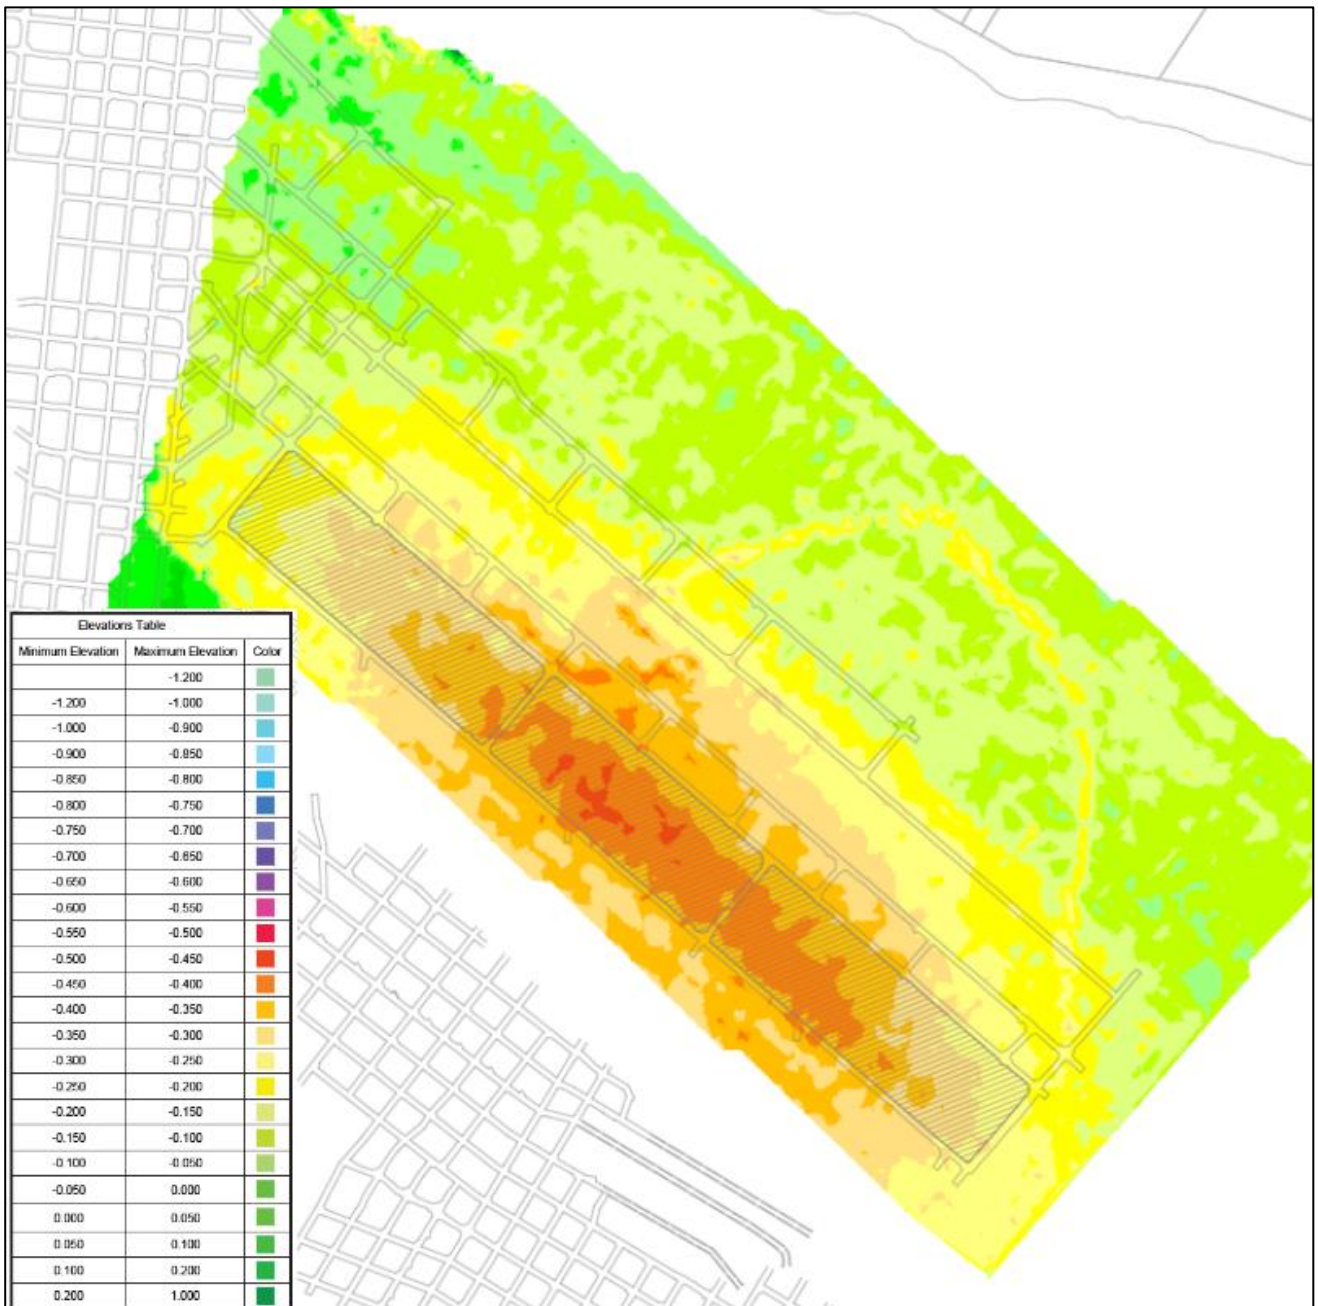
Figure 4 – Chain Valley Bay Miniwall CVB1 (July-19)

Bathymetric surveys over the Chain Valley Bay mining area (Figure) have indicated subsidence of up to 400mm directly over the extracted area. An increased angle of draw of surface subsidence has been detected, but no impacts to the shoreline were observed. Minimal subsidence movement was detected from the previous survey in the area (January 2018).

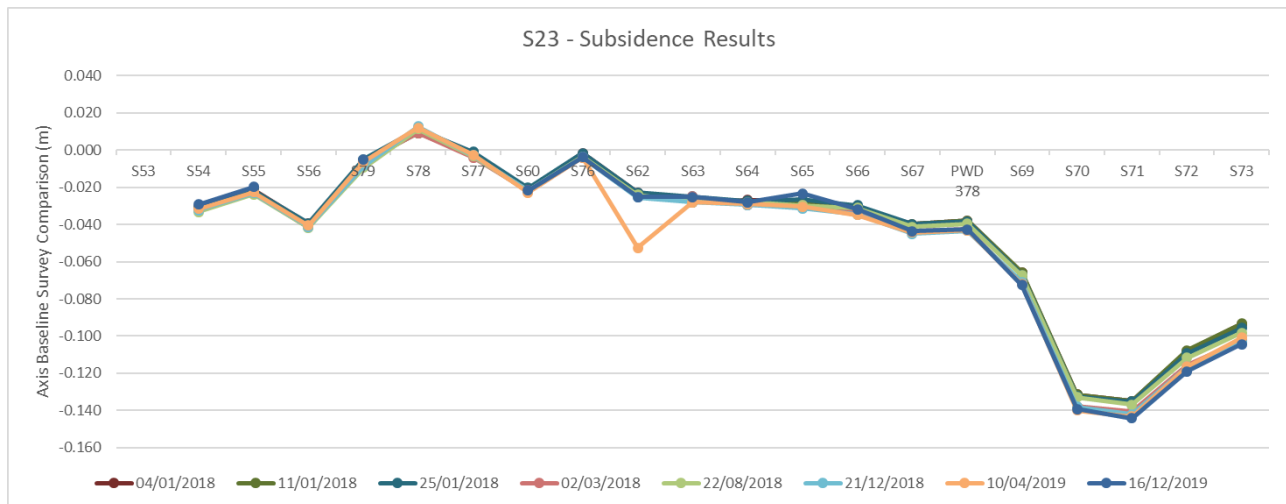
Figure 8 - Line 23 Subsidence Results

It is noted this point, along with points #63-75 have all experienced more than negligible amounts of subsidence (20mm) since June 2008. Since 2008, when Fassifern first workings were completed, subsidence has ranged between 20-40mm, primarily due to the impact of multi-seam extraction in the Wallarah and Great Northern Seams. Ongoing subsidence movement appears to have slowed in recent years, with approximately 10mm of movement (Point S71) during the 2018 and 2019 reporting periods.
