# New England Solar – Biodiversity Management Plan

Stage 1b – 400MWac – Operations  
Stage 2a – 320MWac - Construction  
Stage 3a – 200MW/2hr - Construction

21 December 2023

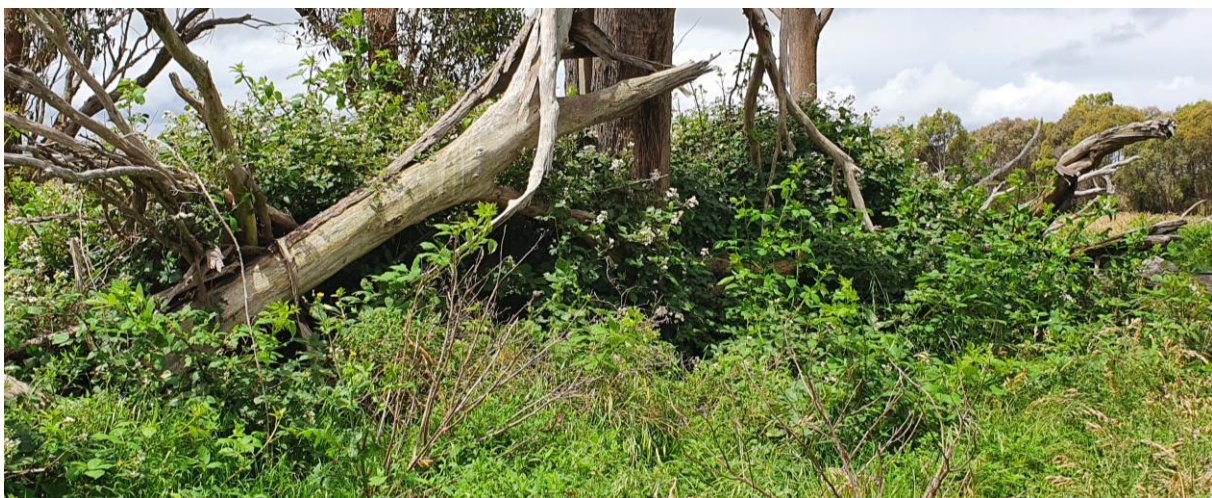
Blackberry was observed growing in zones A, B, C and D. Typically, this weed was found growing as small clumps of regenerating canes between 1-2 m<sup>2</sup> up to an area of 400 m<sup>2</sup> at more than 35 locations (Plate 1; Appendix B). It was observed in open cleared paddocks as well as growing around existing planted shelter belts and within some of the mapped plant community types.

Plate 1 – Blackberry growing around fallen tree with native plant community type in western precinct of Zone B.

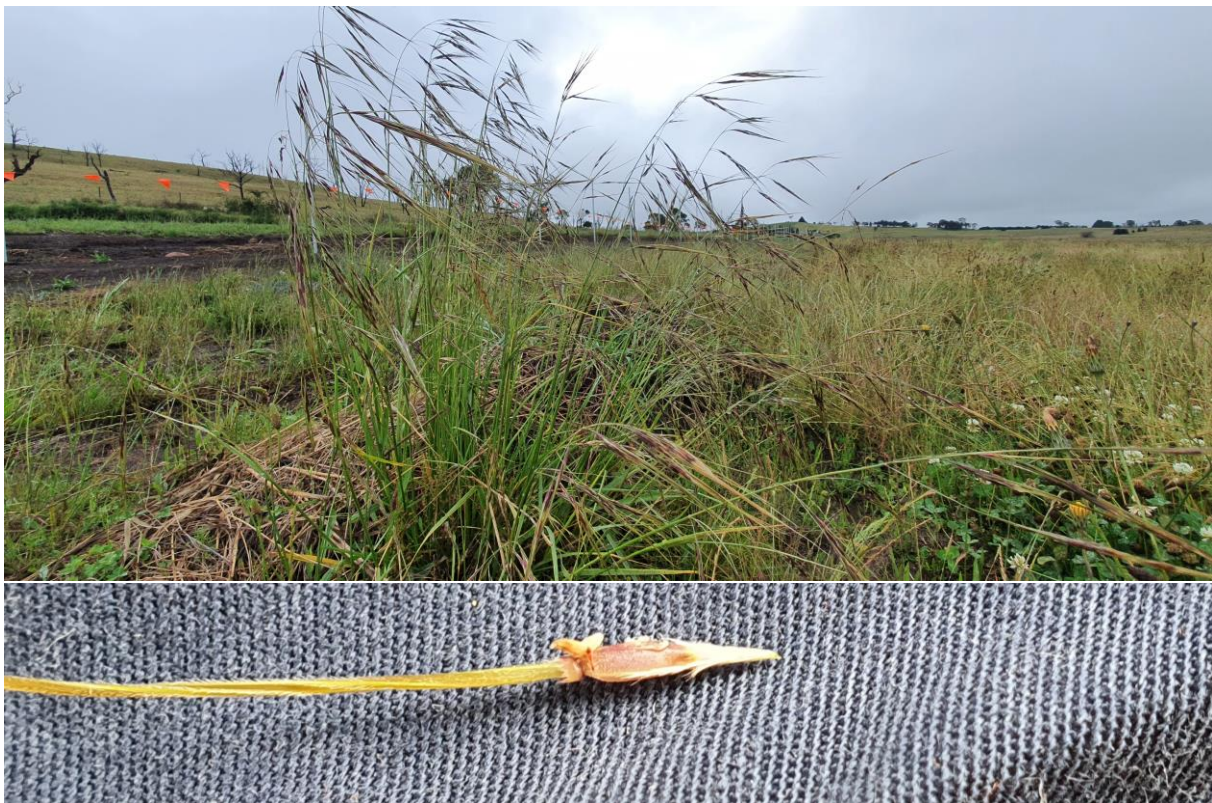
Chilean Needle Grass was recorded at five locations along the southern precinct of Zone B adjacent to Big Ridge Road (Appendix B). Plants were recorded as single and occasionally multiple tussocks in this area (Plate 2).

Plate 2 – Chilean Needle Grass from Zone B adjacent to Big Ridge Road.

To reduce the chance of Chilean needle grass establishing you can limit animal movement from infested areas into clean paddocks; quarantine animals from infested areas, although not all seed will fall from animal coats; consider shearing sheep with Chilean needle grass in their wool before release; seed bare soil areas with pasture species and clean vehicles and machinery before moving into clean areas.

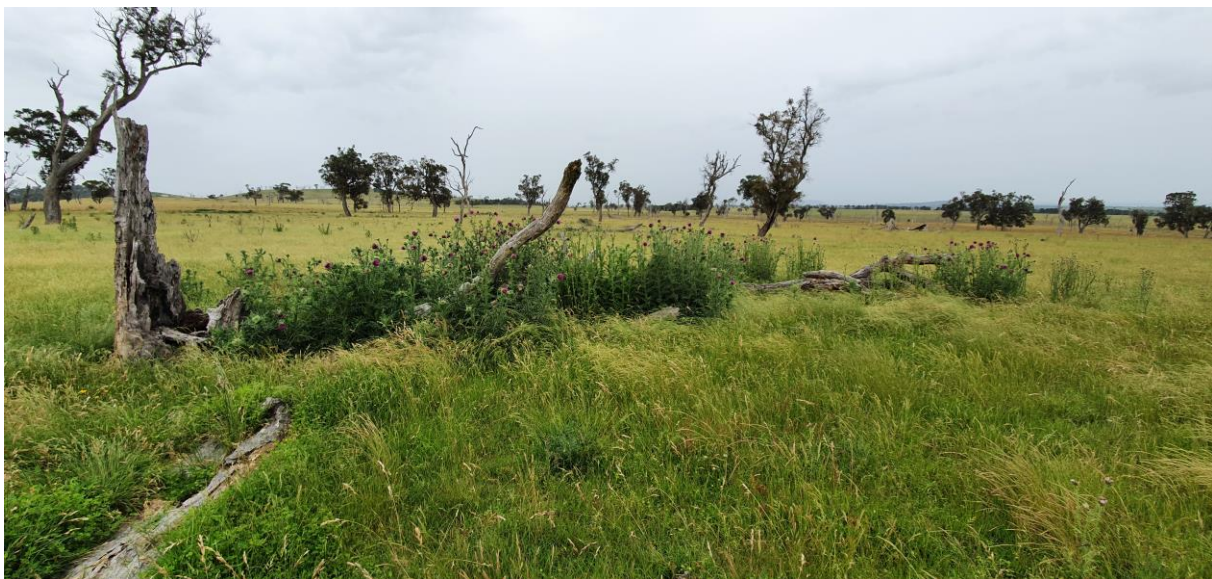
Nodding Thistle was observed growing at 35 locations distributed across each of the four zones. This weed was often found growing in small clumps from 1m<sup>2</sup> through to 400 m<sup>2</sup> (Plate 3). Details for each location is provided in Appendix B.

Plate 3 – Nodding Thistle growing around fallen tree at an undisturbed location in Zone D.

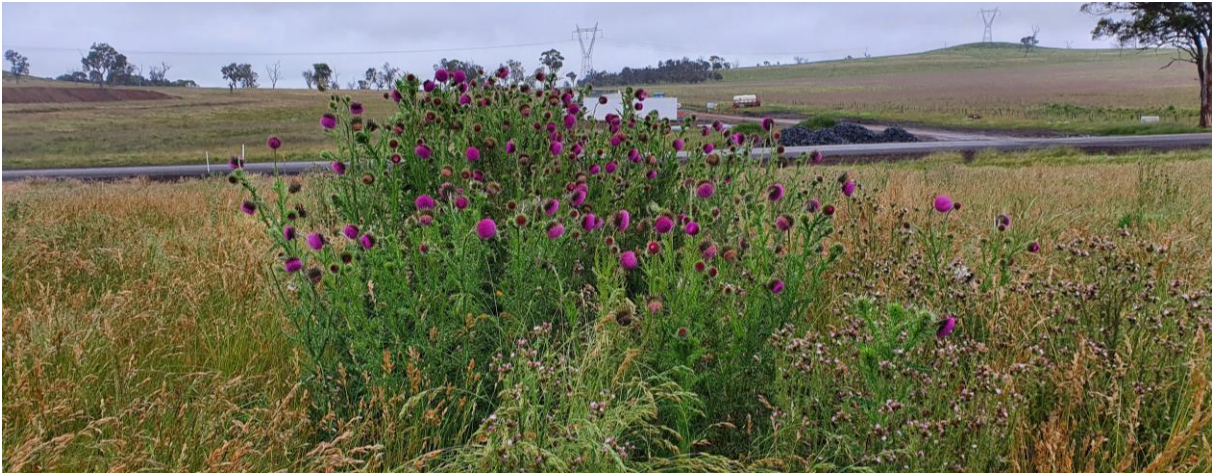
Plate 4 – Nodding Thistle growing as an isolated clump at the southern end of Zone B adjacent Big Ridge Road.

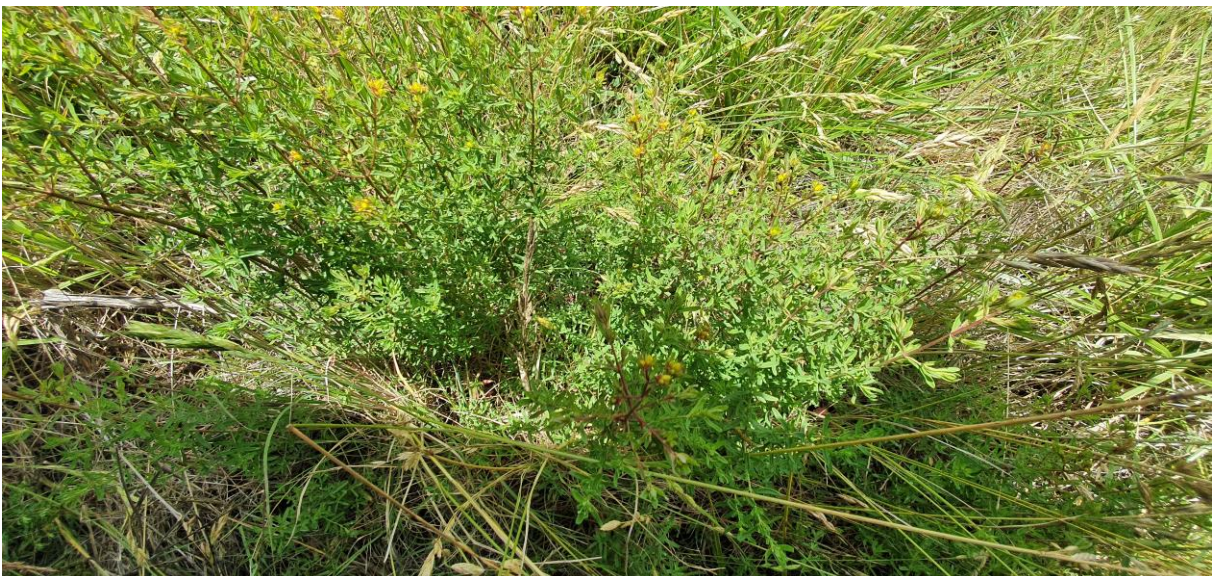
St John's Wort (narrow leaf strain) was recorded from the western precinct of Zone A where it covers an area of approximately 900 m<sup>2</sup> (Plate 5). Details for each location is provided in B. St John's Wort competes with pastures, poisons livestock, can downgrade wool with 'vegetable fault' and reduces property value.

Plate 5 – St John's Wort from the western precinct of Zone A.

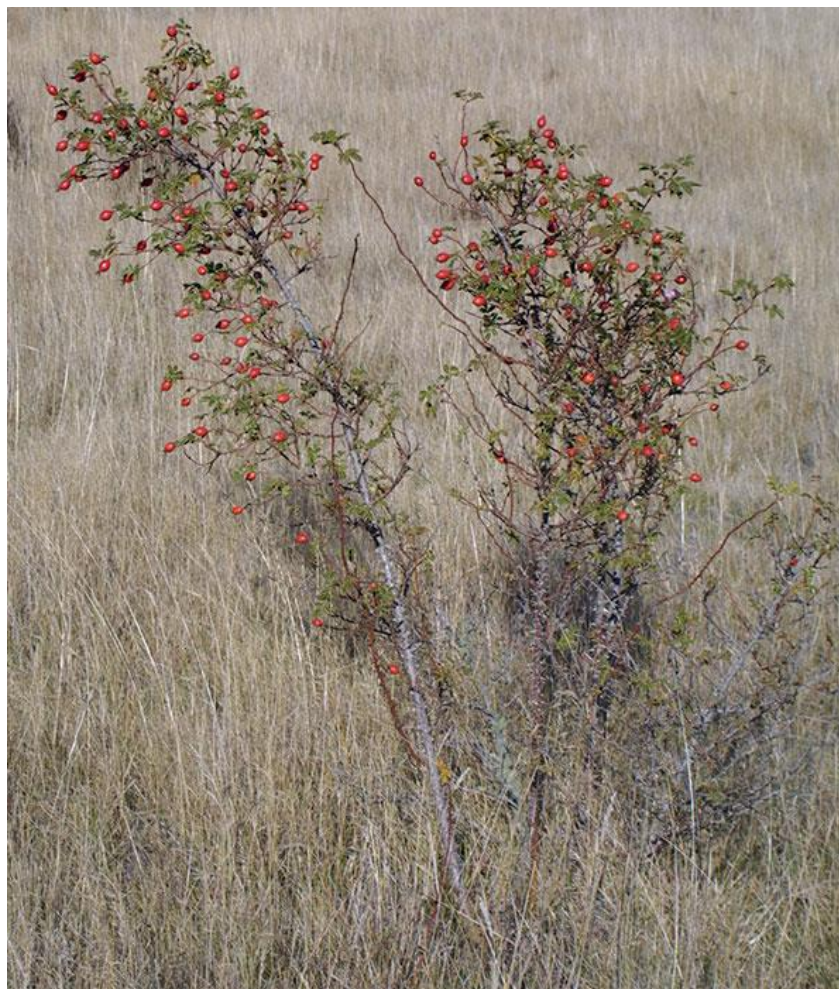
Sweet briar was observed growing at 10 locations distributed across Zone A, B and C as well as those areas near the main site compound. This weed was often the dominant shrub within planted wind breaks, however, it was also found as isolated stems in open paddocks (Plate 2).

Plate 6 – Sweet briar, a common shrub found within planted wind breaks and as isolated stems in open paddocks on the NESF.

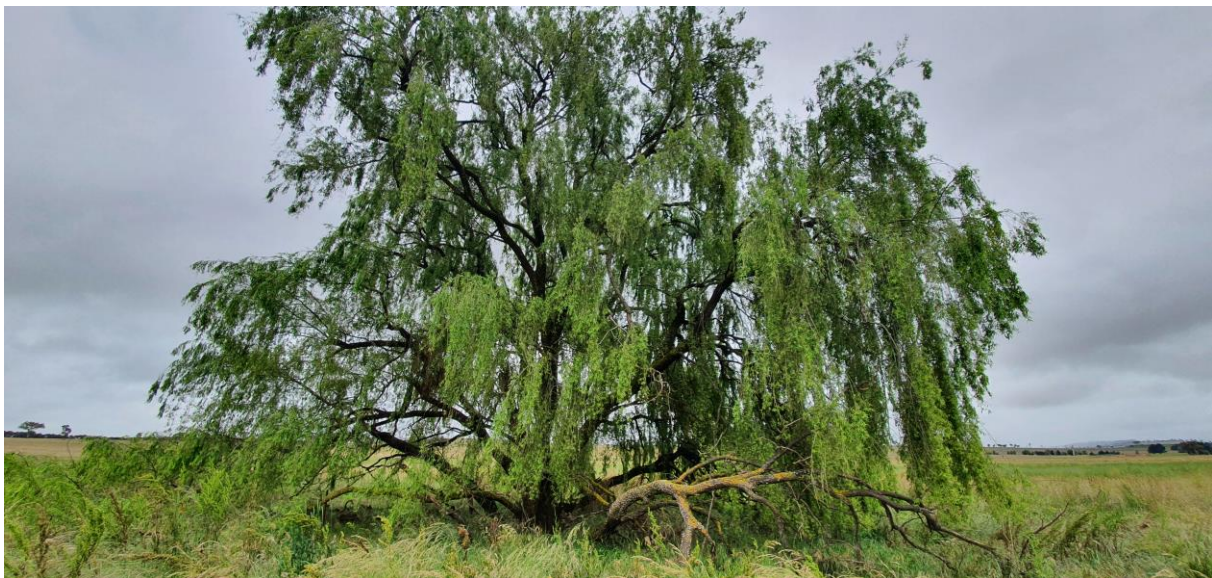
Plate 7 – White Willow growing in Zone B east of the solar array demonstration site.

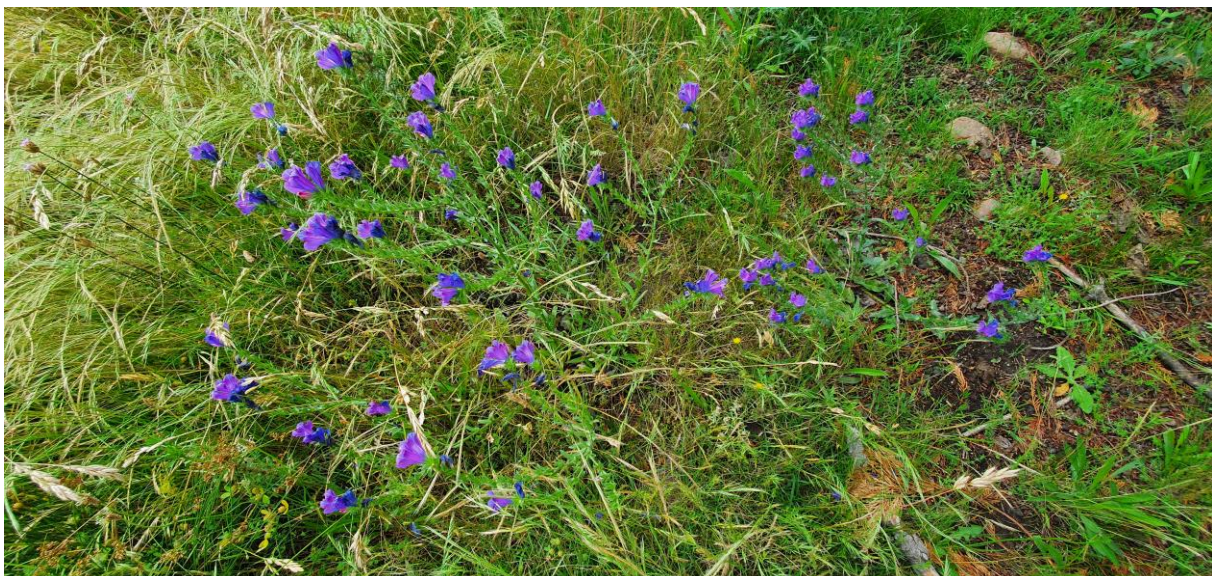
Paterson's curse was recorded at two locations in Zone C and Zone A (Plate 8). Both area contains relatively small infestation of less than 10 m<sup>2</sup>. Details for each location is provided in B.

Plate 8 – Patterson's Curse growing in Zone C.

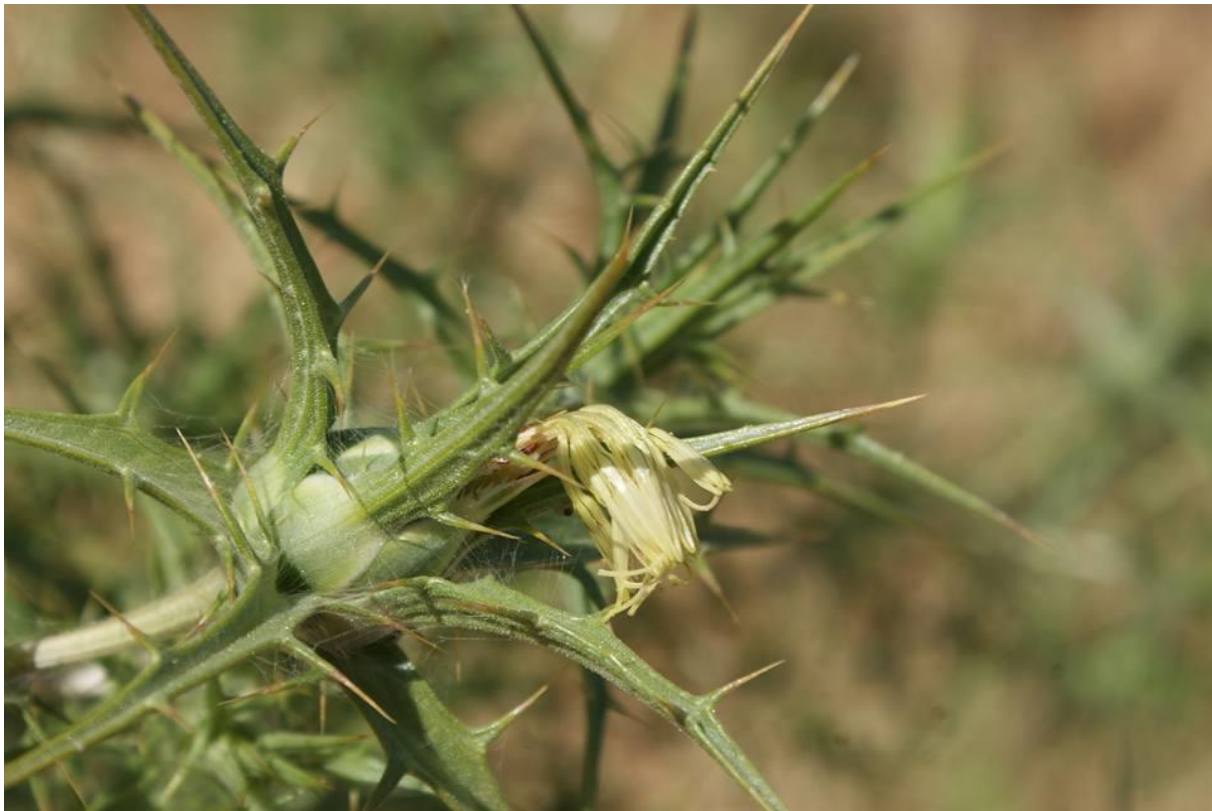
Saffron Thistle was found to occur over much of the NESF (Plate 9). It is for this reason that its distribution wasn't specifically mapped.

Plate 9 – Saffron Thistle which is widespread across the NESF.

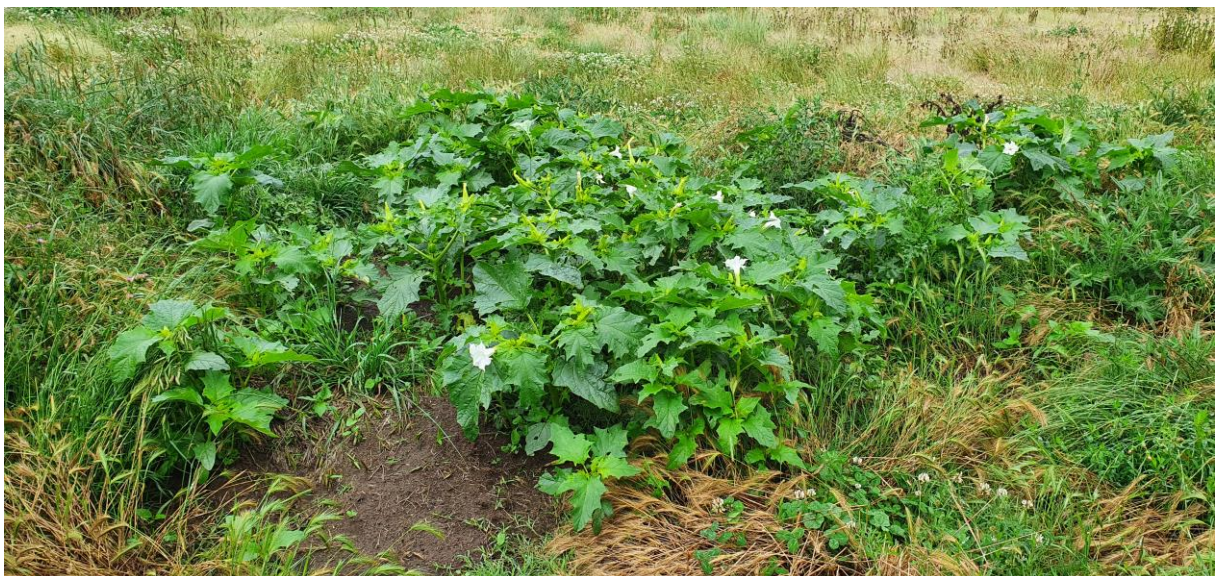
Common Thornapple was recorded at two locations in Zone B and C (Plate 10). It is an annual plant with large, trumpet-shaped flowers and spiny fruit. The whole plant is poisonous to people, pets and livestock. The toxins in common thornapple can affect horses, cattle, sheep, pigs, dogs and poultry. Livestock usually avoid eating it. Most cases of livestock poisoning are caused by the weed being present in hay, silage or contaminated grain. Symptoms in animals include:

Plate 10 – Common Thornapple growing in Zone B around 50m north of Big Ridge Road.

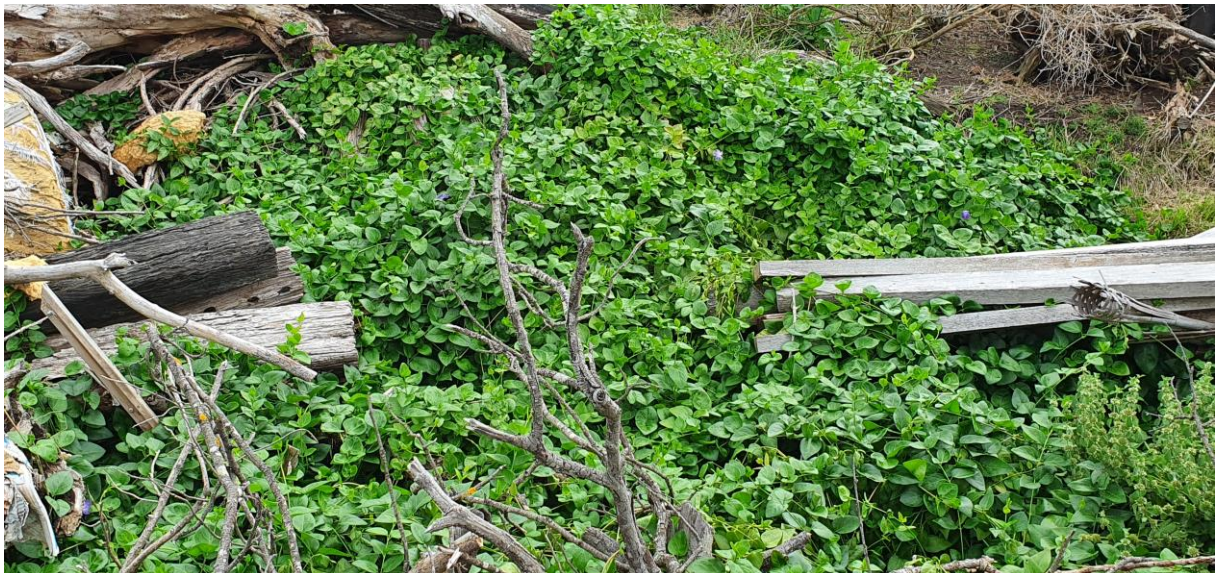
Blue Periwinkle was recorded in the western precinct of Zone B where it was among the dominant groundcover at a disused farm tip (Plate 10). At the time of the survey, it covered an area of approximately 120 m<sup>2</sup> (Appendix B).

Plate 10 – Blue Periwinkle from the western part of Zone B.

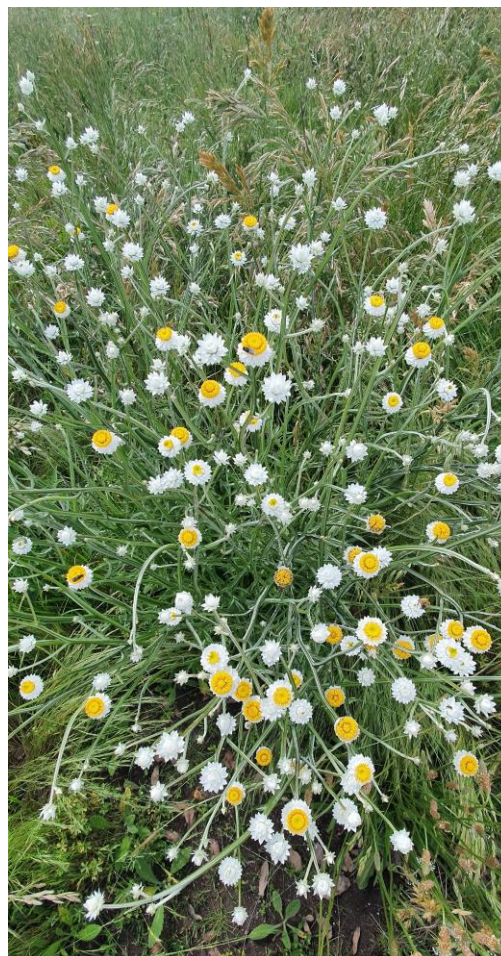
Oxeye Daisy was observed from 11 locations throughout the NESF growing in zones A, B, C and D (Plate 11). The area or extent range from a small number of plants over a 10m<sup>2</sup> area through to areas cover several hectares in size (Appendix B).

Plate 11 – Oxeye Daisy from Zone B on the NESF.

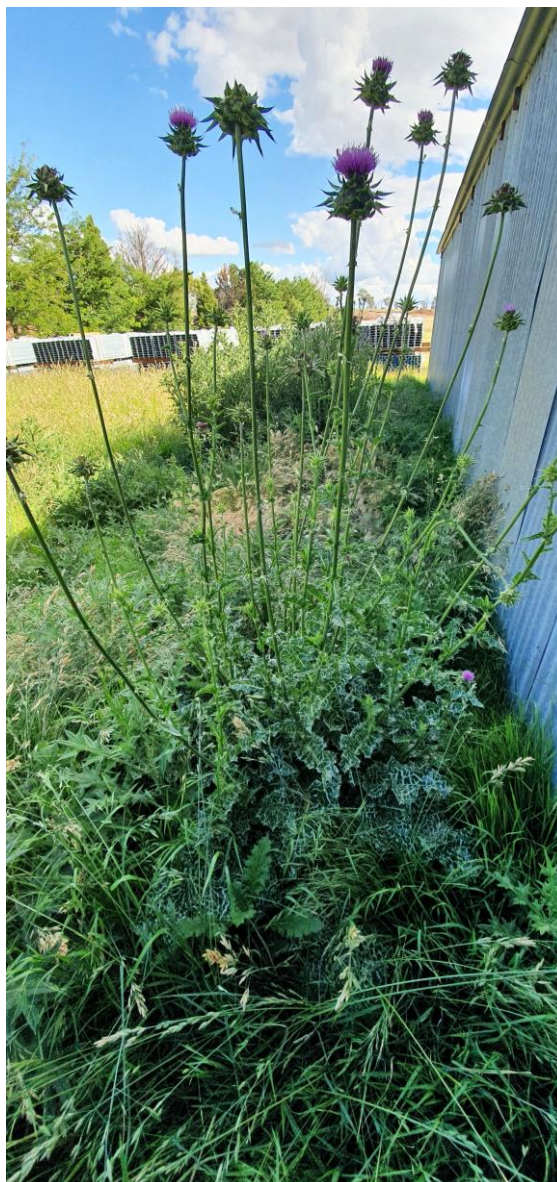
Variegated thistle was found at three locations in Zone A, B and D (Appendix B; Plate 12). It is likely to sporadically occur throughout much of the NESF.

Plate 12 – Variegated Thistle from Zone B on the NESF.

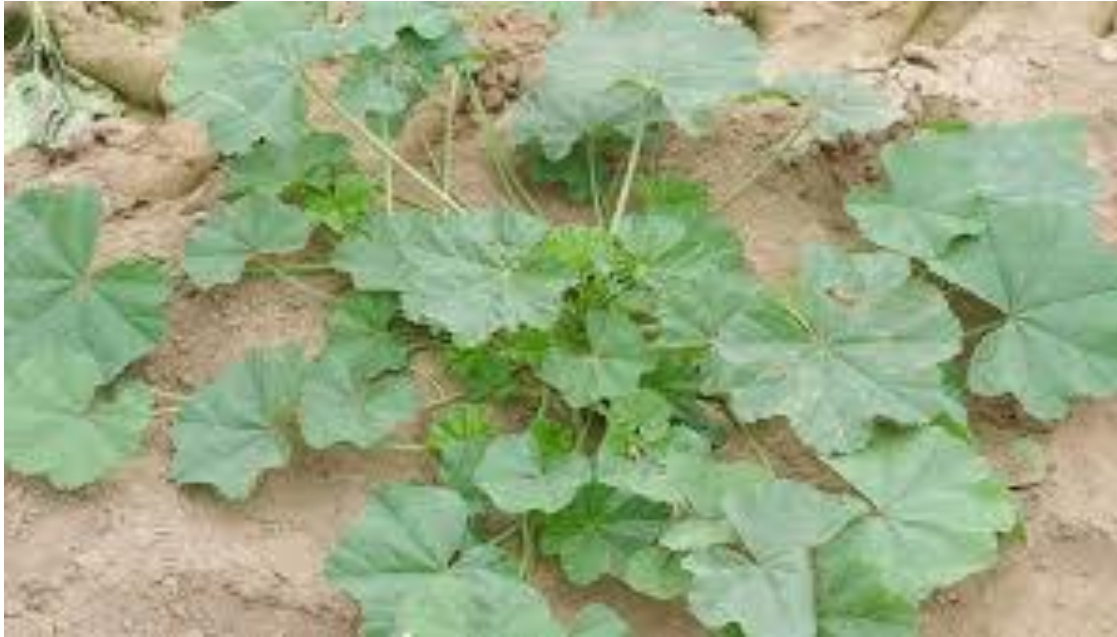
Marshmallow was recorded at one location at the southern extent of Zone B where it extended over an area of approximately 200 m<sup>2</sup>. It tends to colonise waste places, in sheep yards, around farm buildings, closed yards, watercourses and roadsides.

Plate 13 – Marshmallow from the southern extent of Zone B on the NESF.
