# HUNTER VALLEY OPERATIONS

## 2024 ANNUAL ENVIRONMENTAL REVIEW

**DOCUMENT NUMBER**  
HVOOC-748212775-6

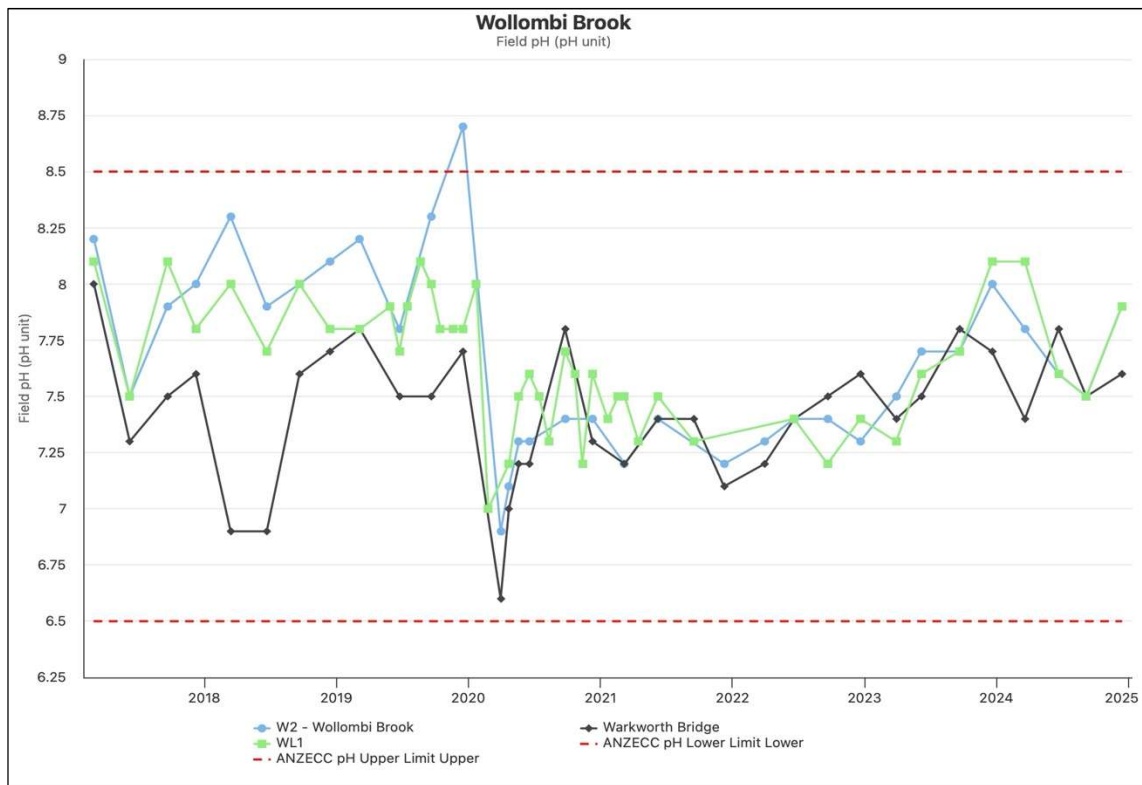
Figure 7-8: Wollombi Brook pH Trends 2017 - 2024

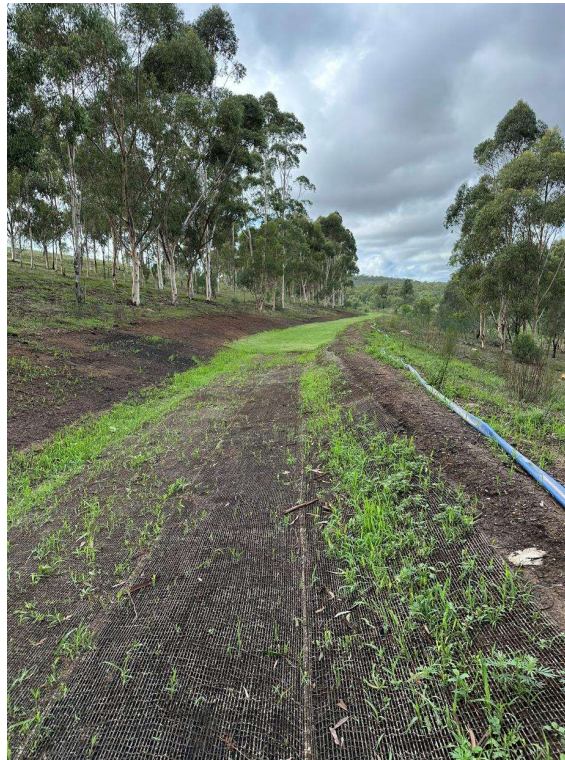
*Figure 8-4- Jute mesh and vegetation establishment at WOOP Dump*

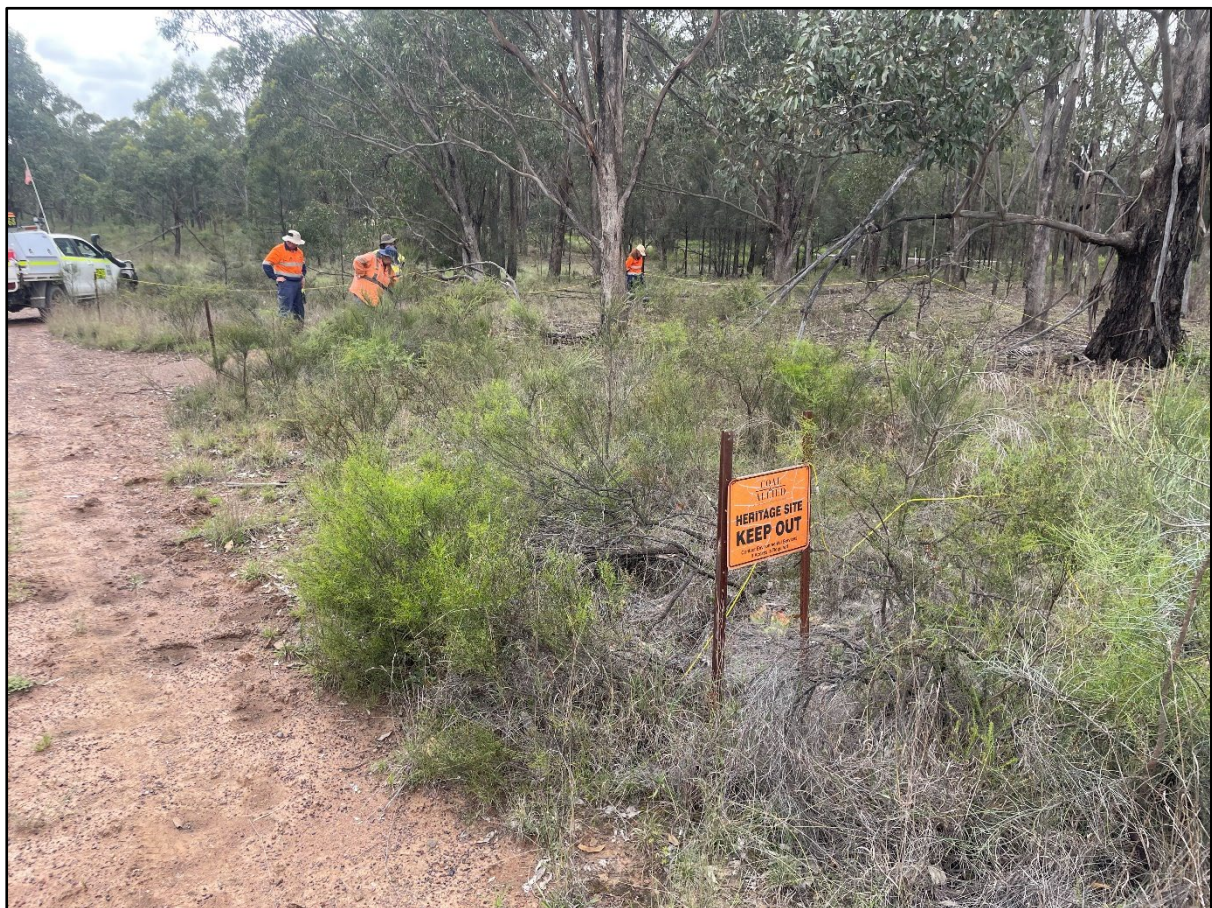
***Example of dilapidated barricading to be repaired***
