Ref: CAE1534.CC1

Client: AKA Contractors Pty Ltd

### **Re: Site Investigation Report- Clearance Certificate 810 Pacific Highway, Gordon NSW**

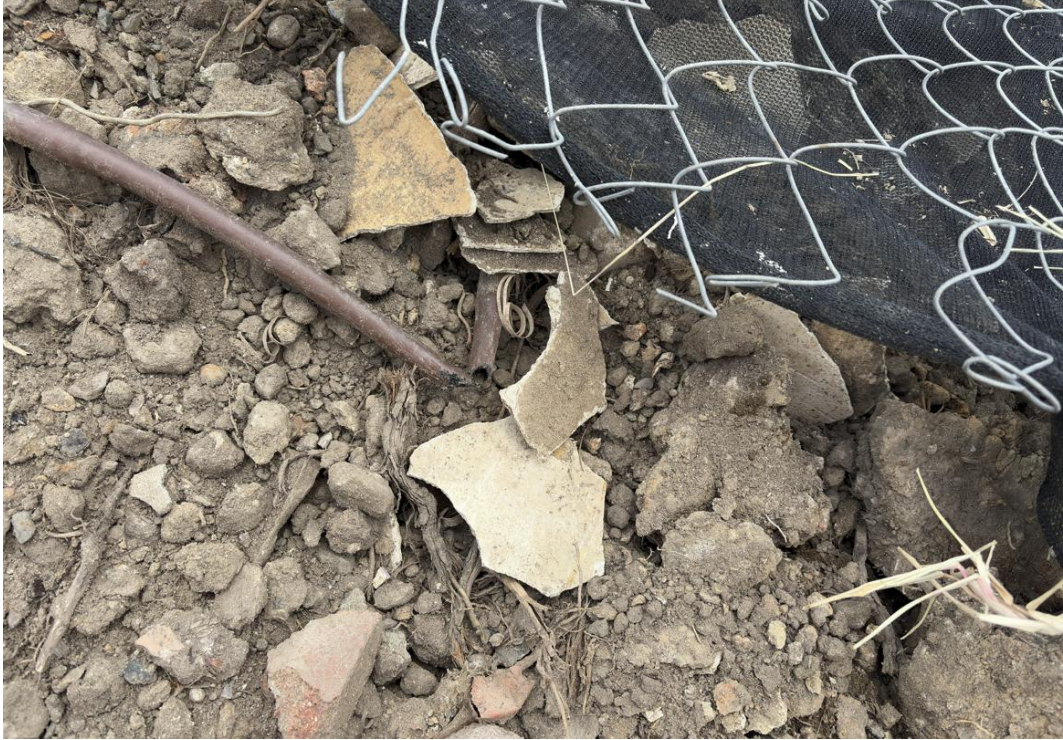
Vinyl Material- Not ACM

Samples were collected for asbestos analysis of the vinyl sheeting and were sent to a NATA accredited laboratory for assessment. No ACM were detected within representative samples collected. Sampling was not undertaken of the compressed concrete sheeting as this material was assessed by a Licenced Asbestos Assessor (LAA) and the material was no asbestos or potential asbestos sheeting.

| Client Sample ID | Eurofins Sample No. | Date Sampled | Sample Description | Result |
|---|---|---|---|---|
| 1534.5.2 | 25-No0024520 | Nov 10, 2025 | Approximate Sample 22g / 74x34x4mm<br>Sample consisted of: Off-white fibre cement material painted brown | No asbestos detected.<br>Organic fibre detected.<br>No trace asbestos detected. |

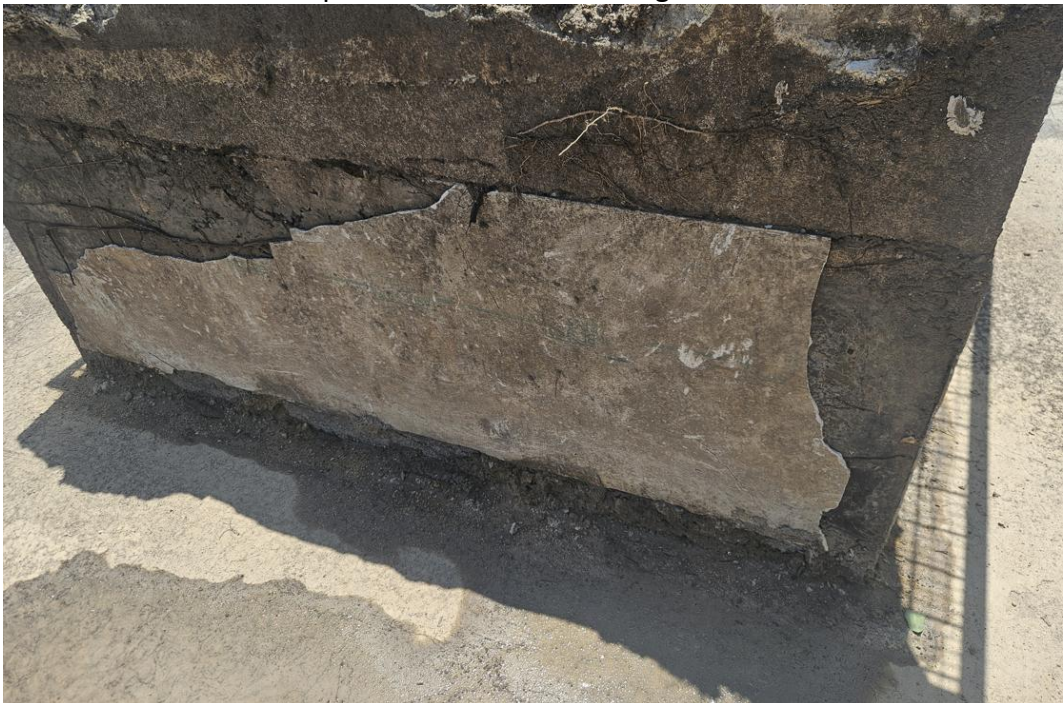
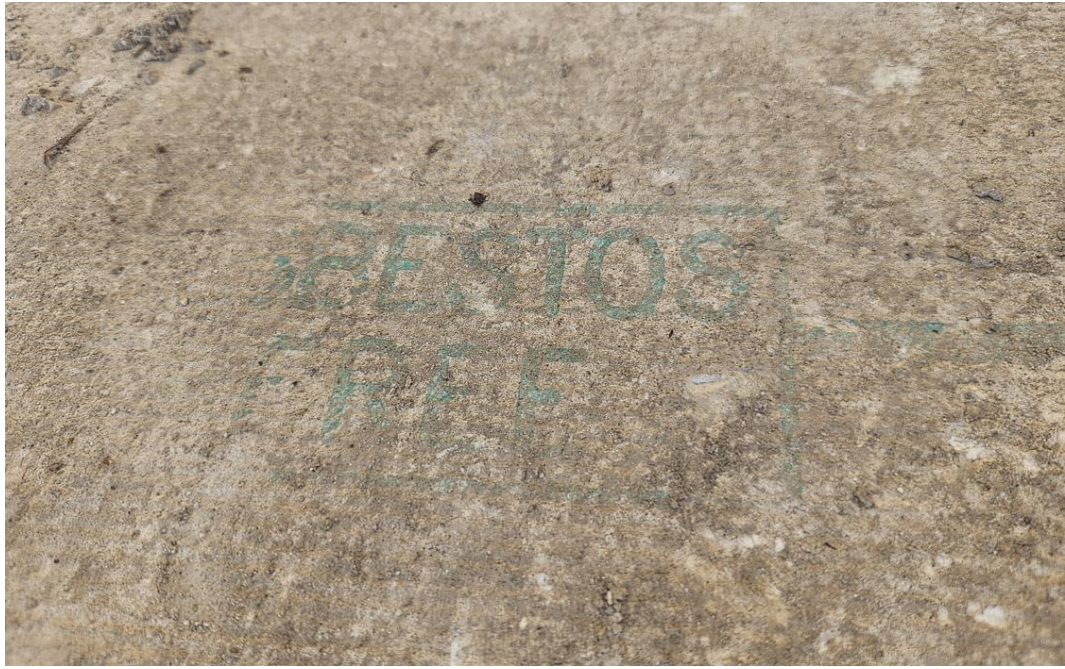
Compressed Concrete Sheeting- Not ACM
