QANTAS GROUP FLIGHT TRAINING CENTRE

# PUBLIC DOMAIN & LANDSCAPE REPORT

### **Qantas Group Flight Training Centre**

Project Number: 20180199

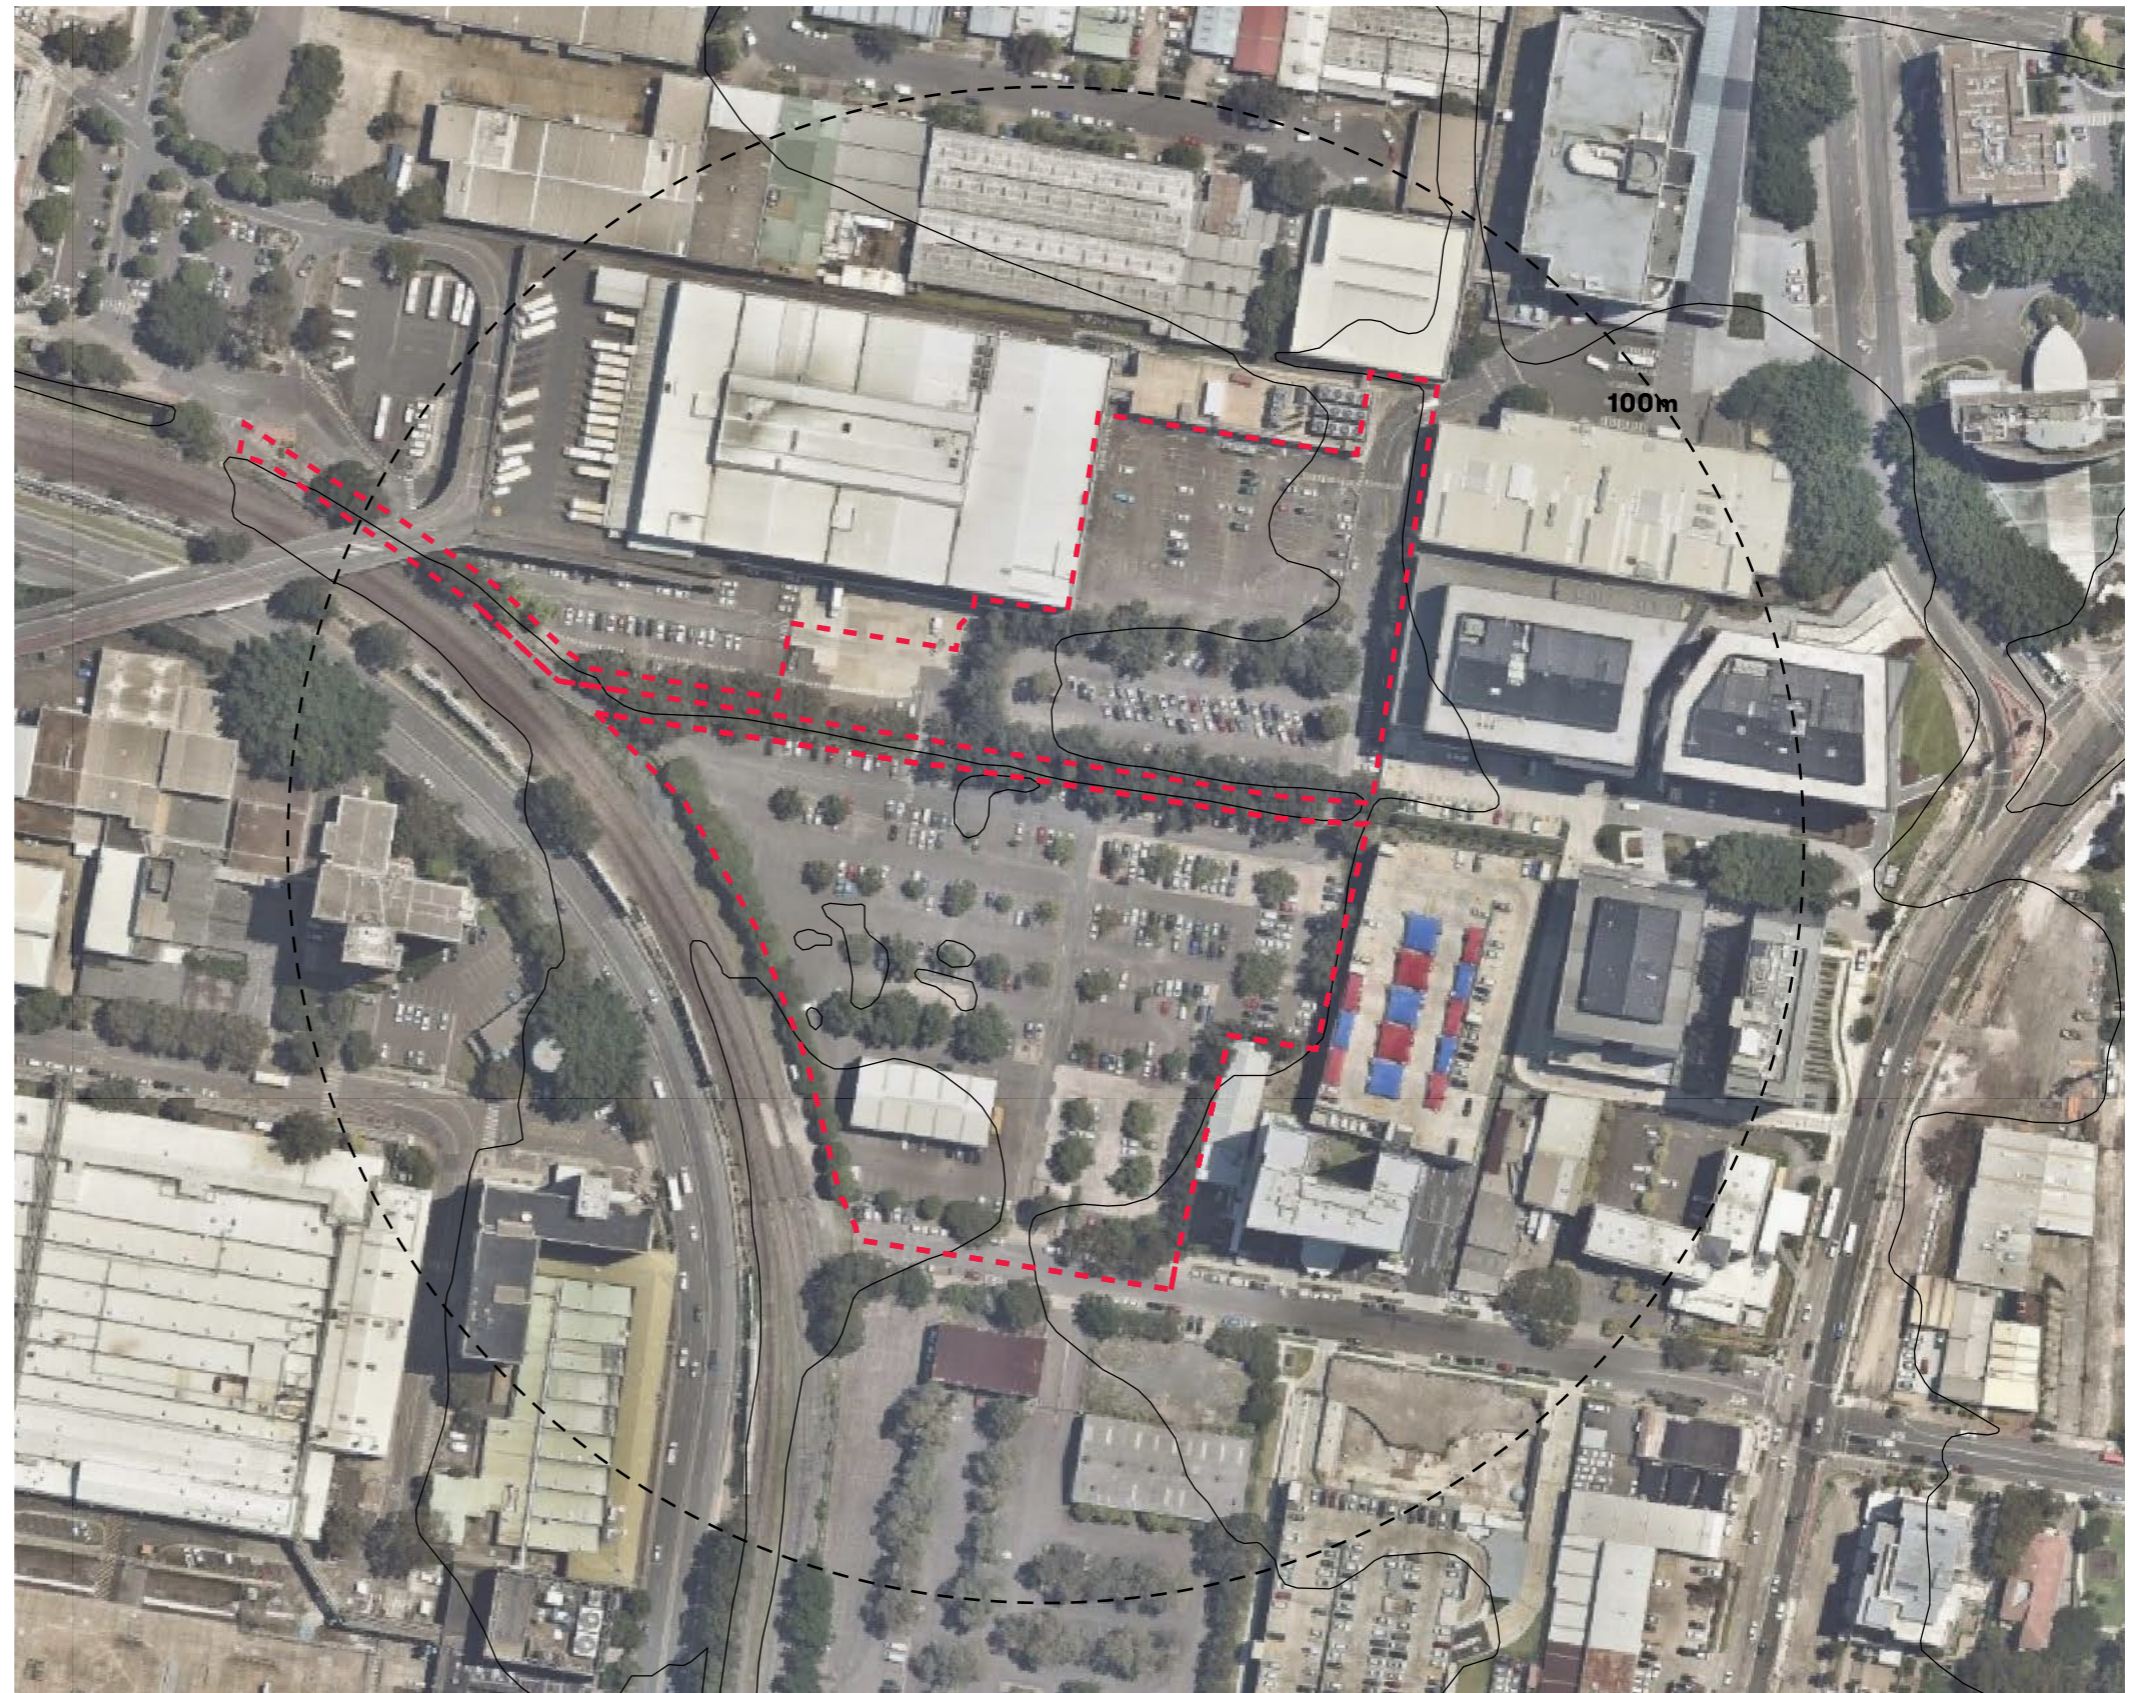
Figure 2 Existing Site Plan

- + The site is approximately 5.417ha and is an irregular shape. It is approximately 240m in length and maintains a variable width of between approximately 321m in the northern portion of the site and approximately 93m along the King Street frontage (refer to Figure 2).

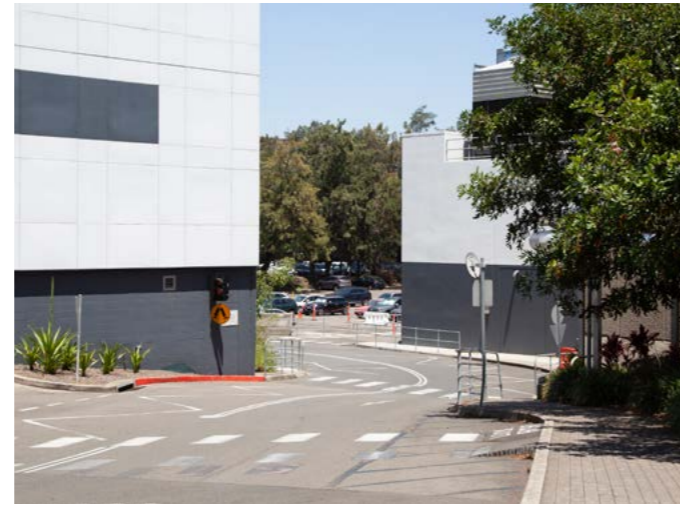
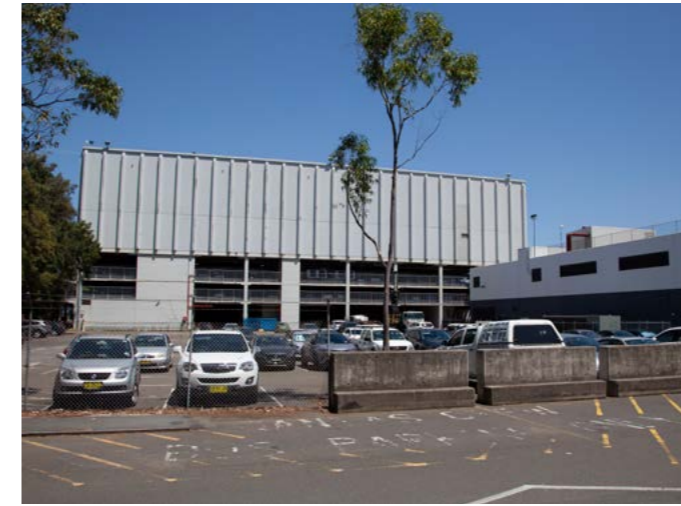
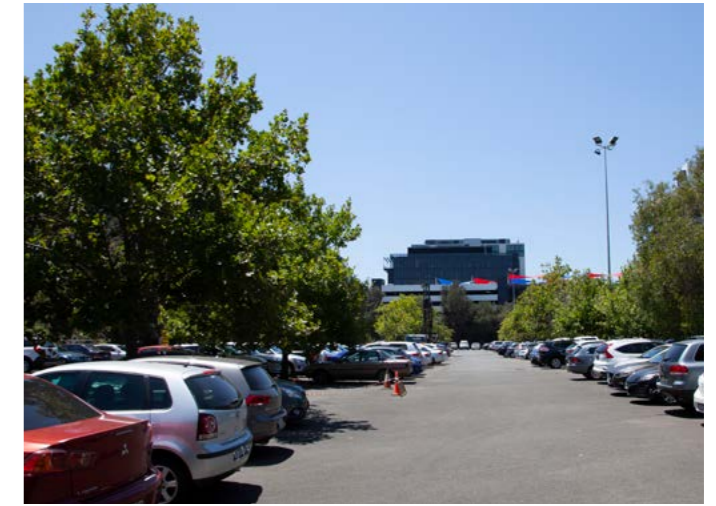
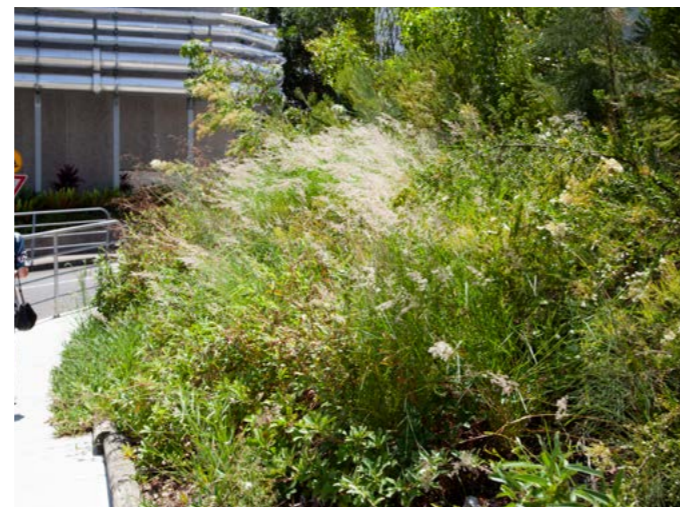
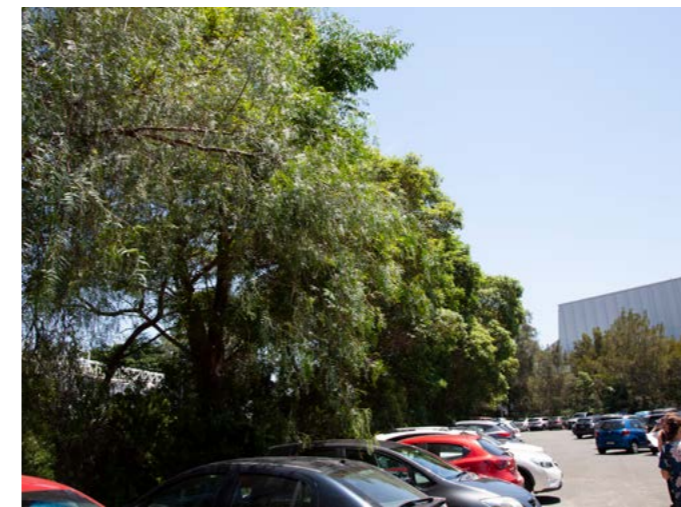
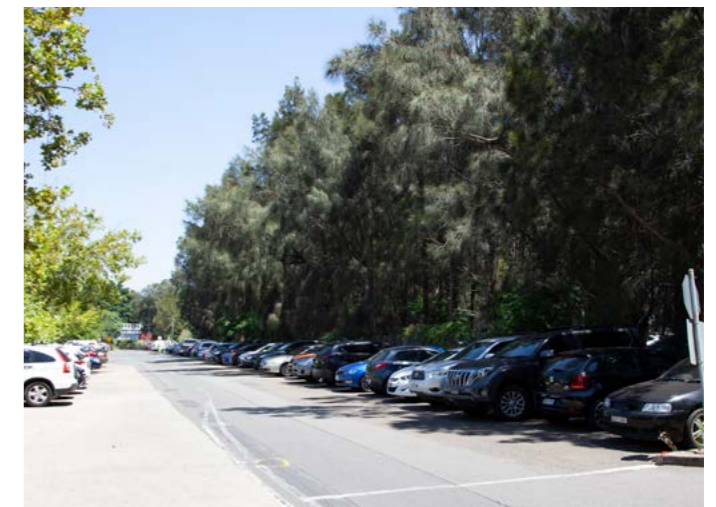
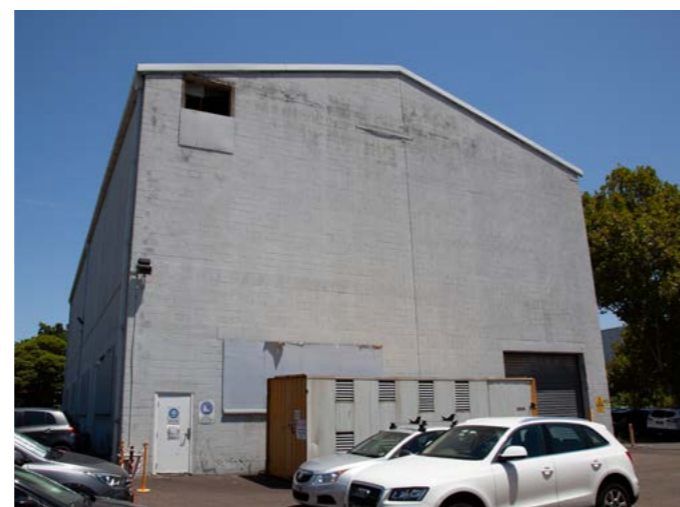
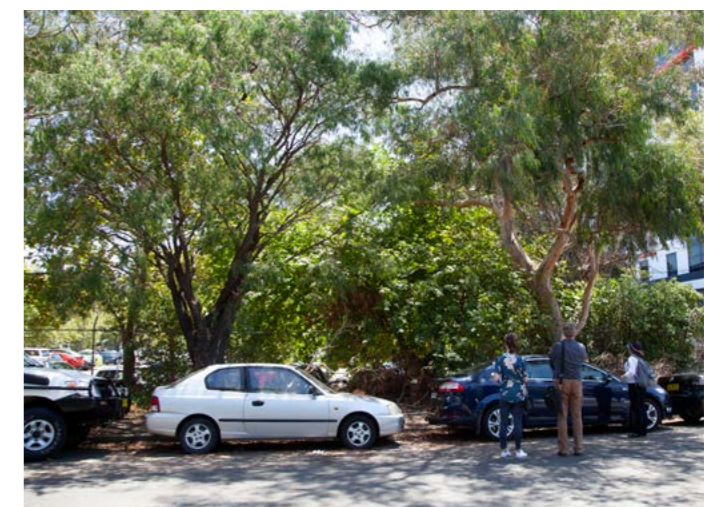
Figure 3 Site and Location Photographs

North-eastern entrance from Qantas Corporate

Northern carpark

Main carpark

Eastern Boundary

Western Boundary

Sydney Water Drainage Channel

Existing Warehouse Storage

King Street Frontage

Separated from the main carpark by the heavily vegetated Sydney Water Channel the northern carpark contains a number of large native trees between the car bays and along the channel boundary fence. The trees consist largely of *Casuarina* species. In general these trees are in good condition and are of substantial size, as such they will be retained where possible outside the proposed multi-storey carpark's footprint.

The main carpark contains a single existing building surrounded by bitumen carparking with a grid of *Platanus* species between the bays. In general these trees are in poor condition. These trees will all be removed as part of the works due to the extent of the Flight Training Centre building and surrounds.

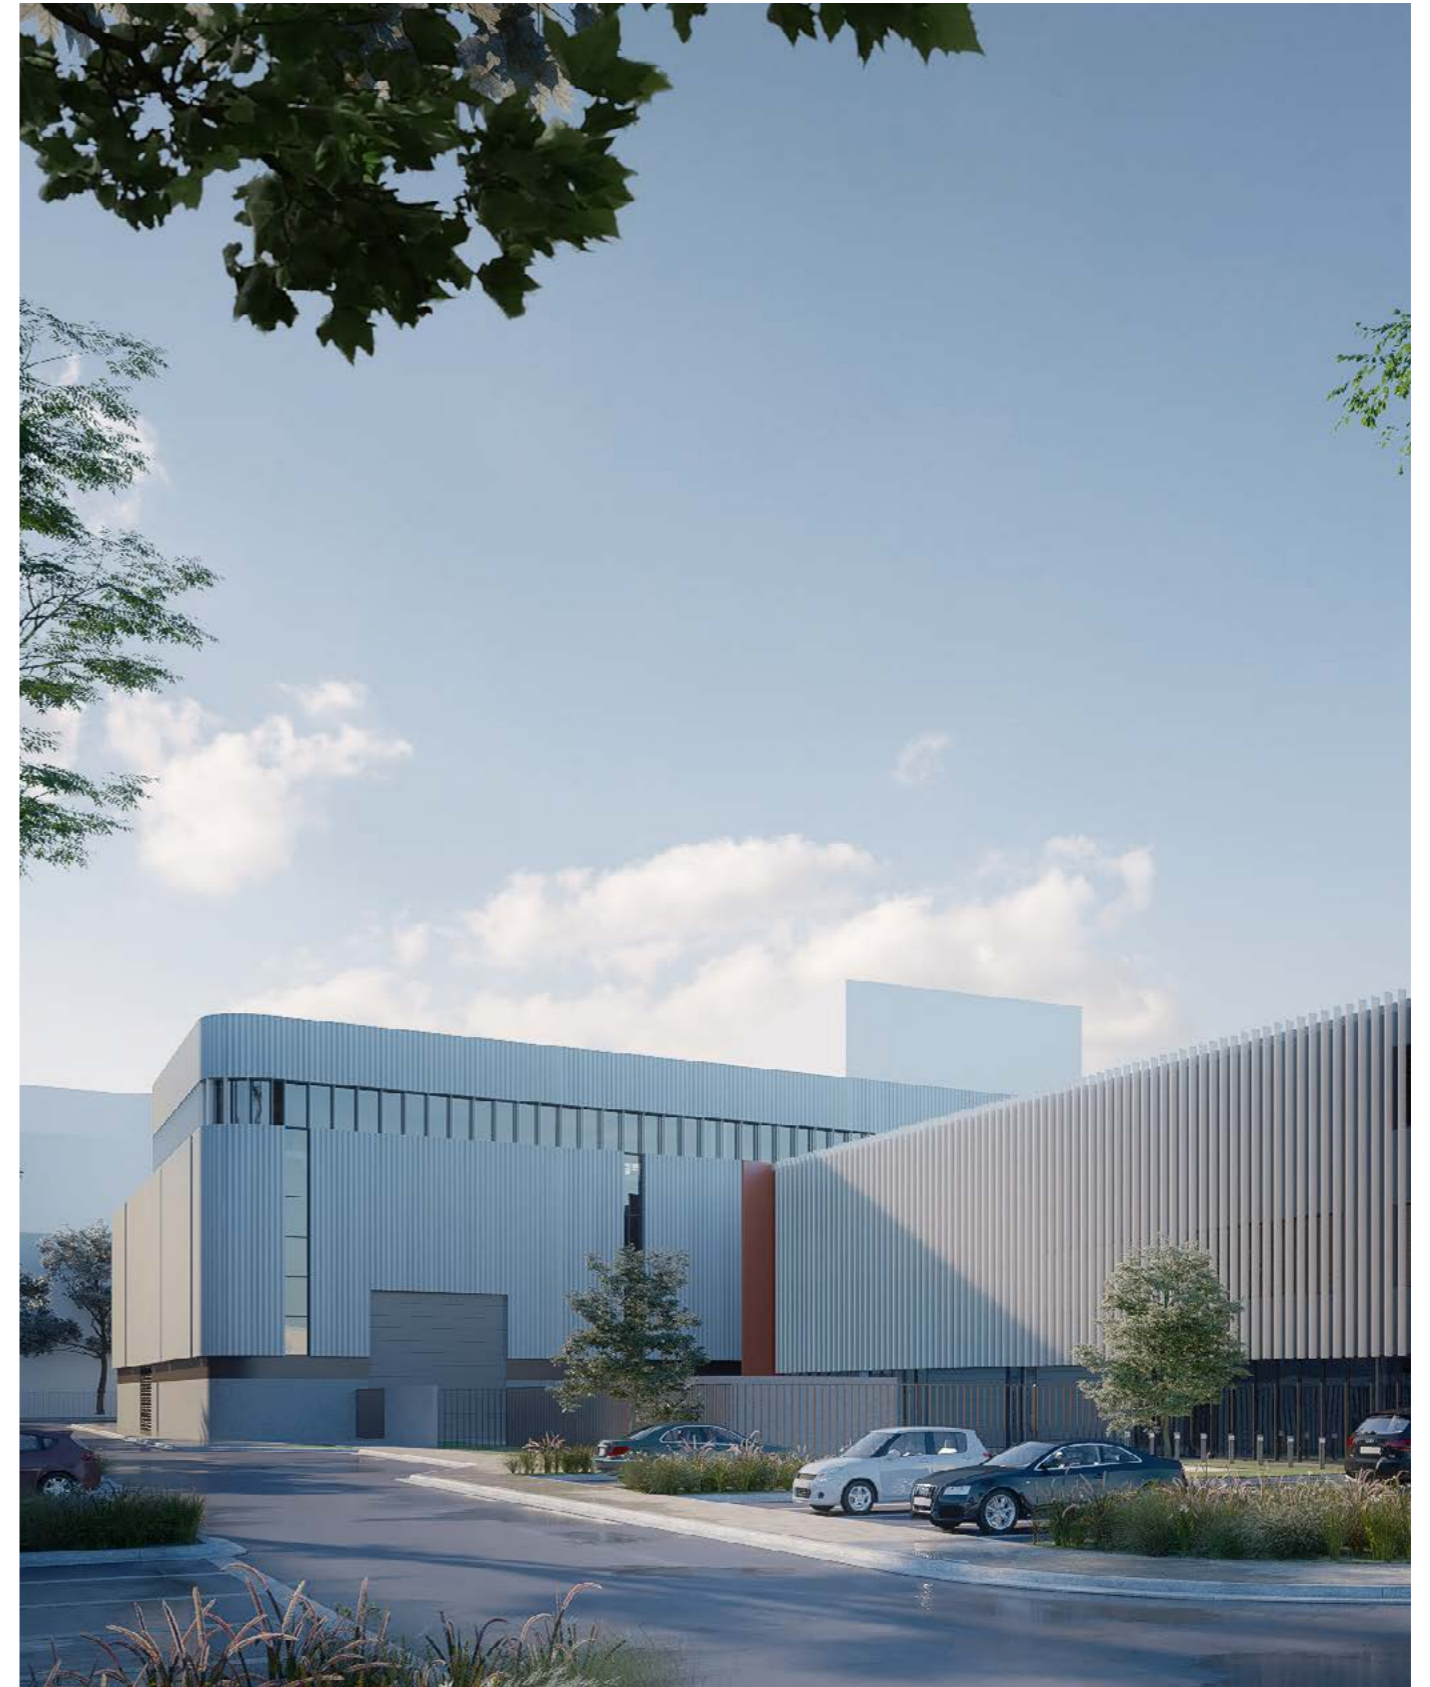
Figure 4 Artists Impression of the Proposed Development

The proposed multi-deck carpark will be located to the north-east of the flight training centre and adjacent to the existing Qantas catering facility and tri-generation plant. The carpark is 13 levels and will provide 2059 spaces for Qantas staff. Vehicle access to the carpark will be provided via King Street, Kent Road and from Qantas Drive via the existing catering bridge.

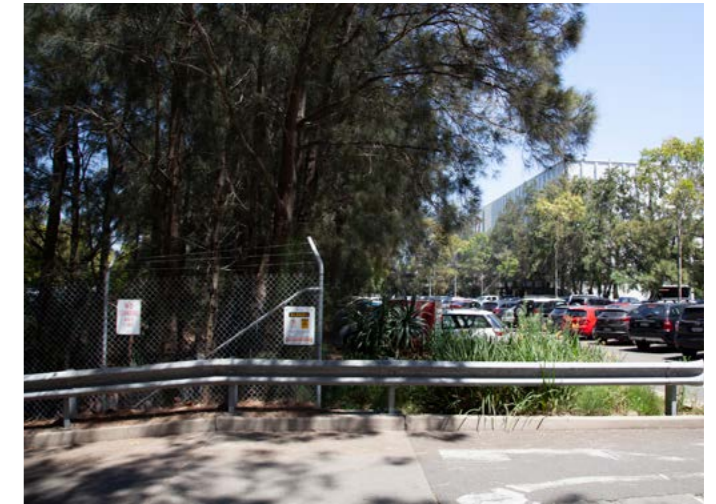
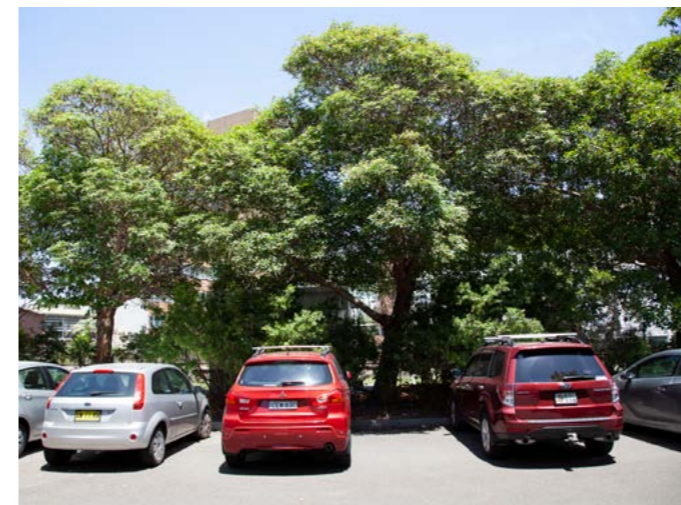
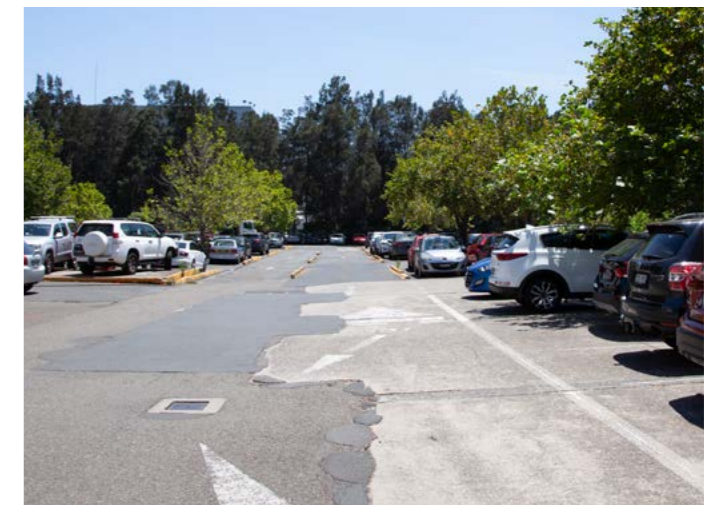
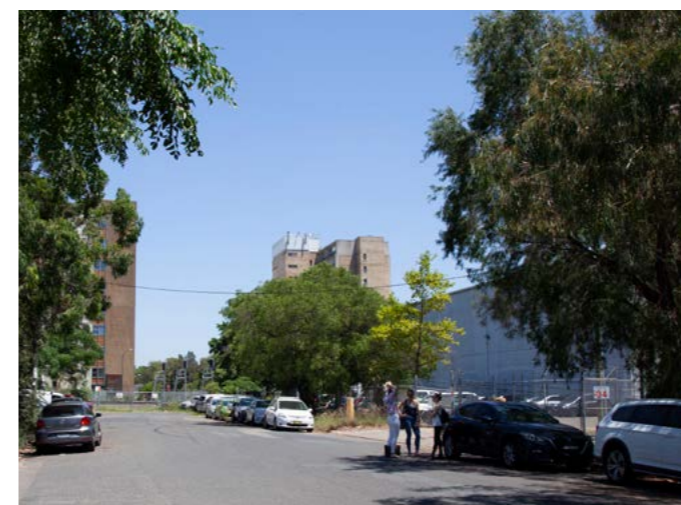
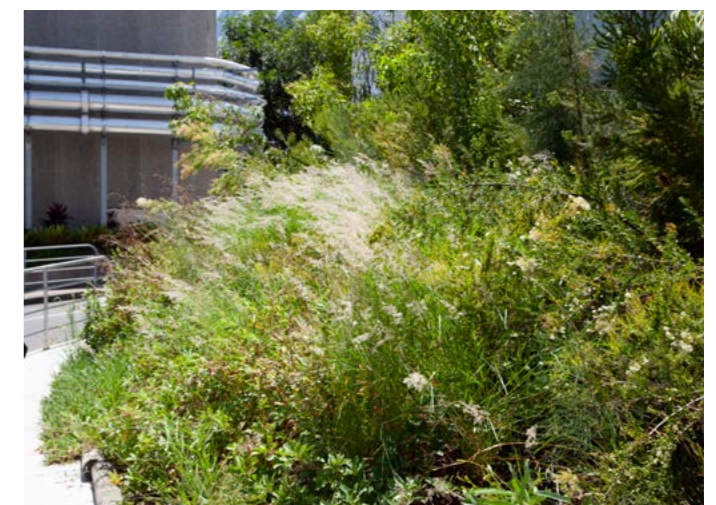
Figure 5 Existing Site Landscape Photographs

Sydney Water Drainage Channel

Boundary planting of *Lophostemon confertus*

Asphalt and concrete surfacing

King Street interface

Overgrown verges

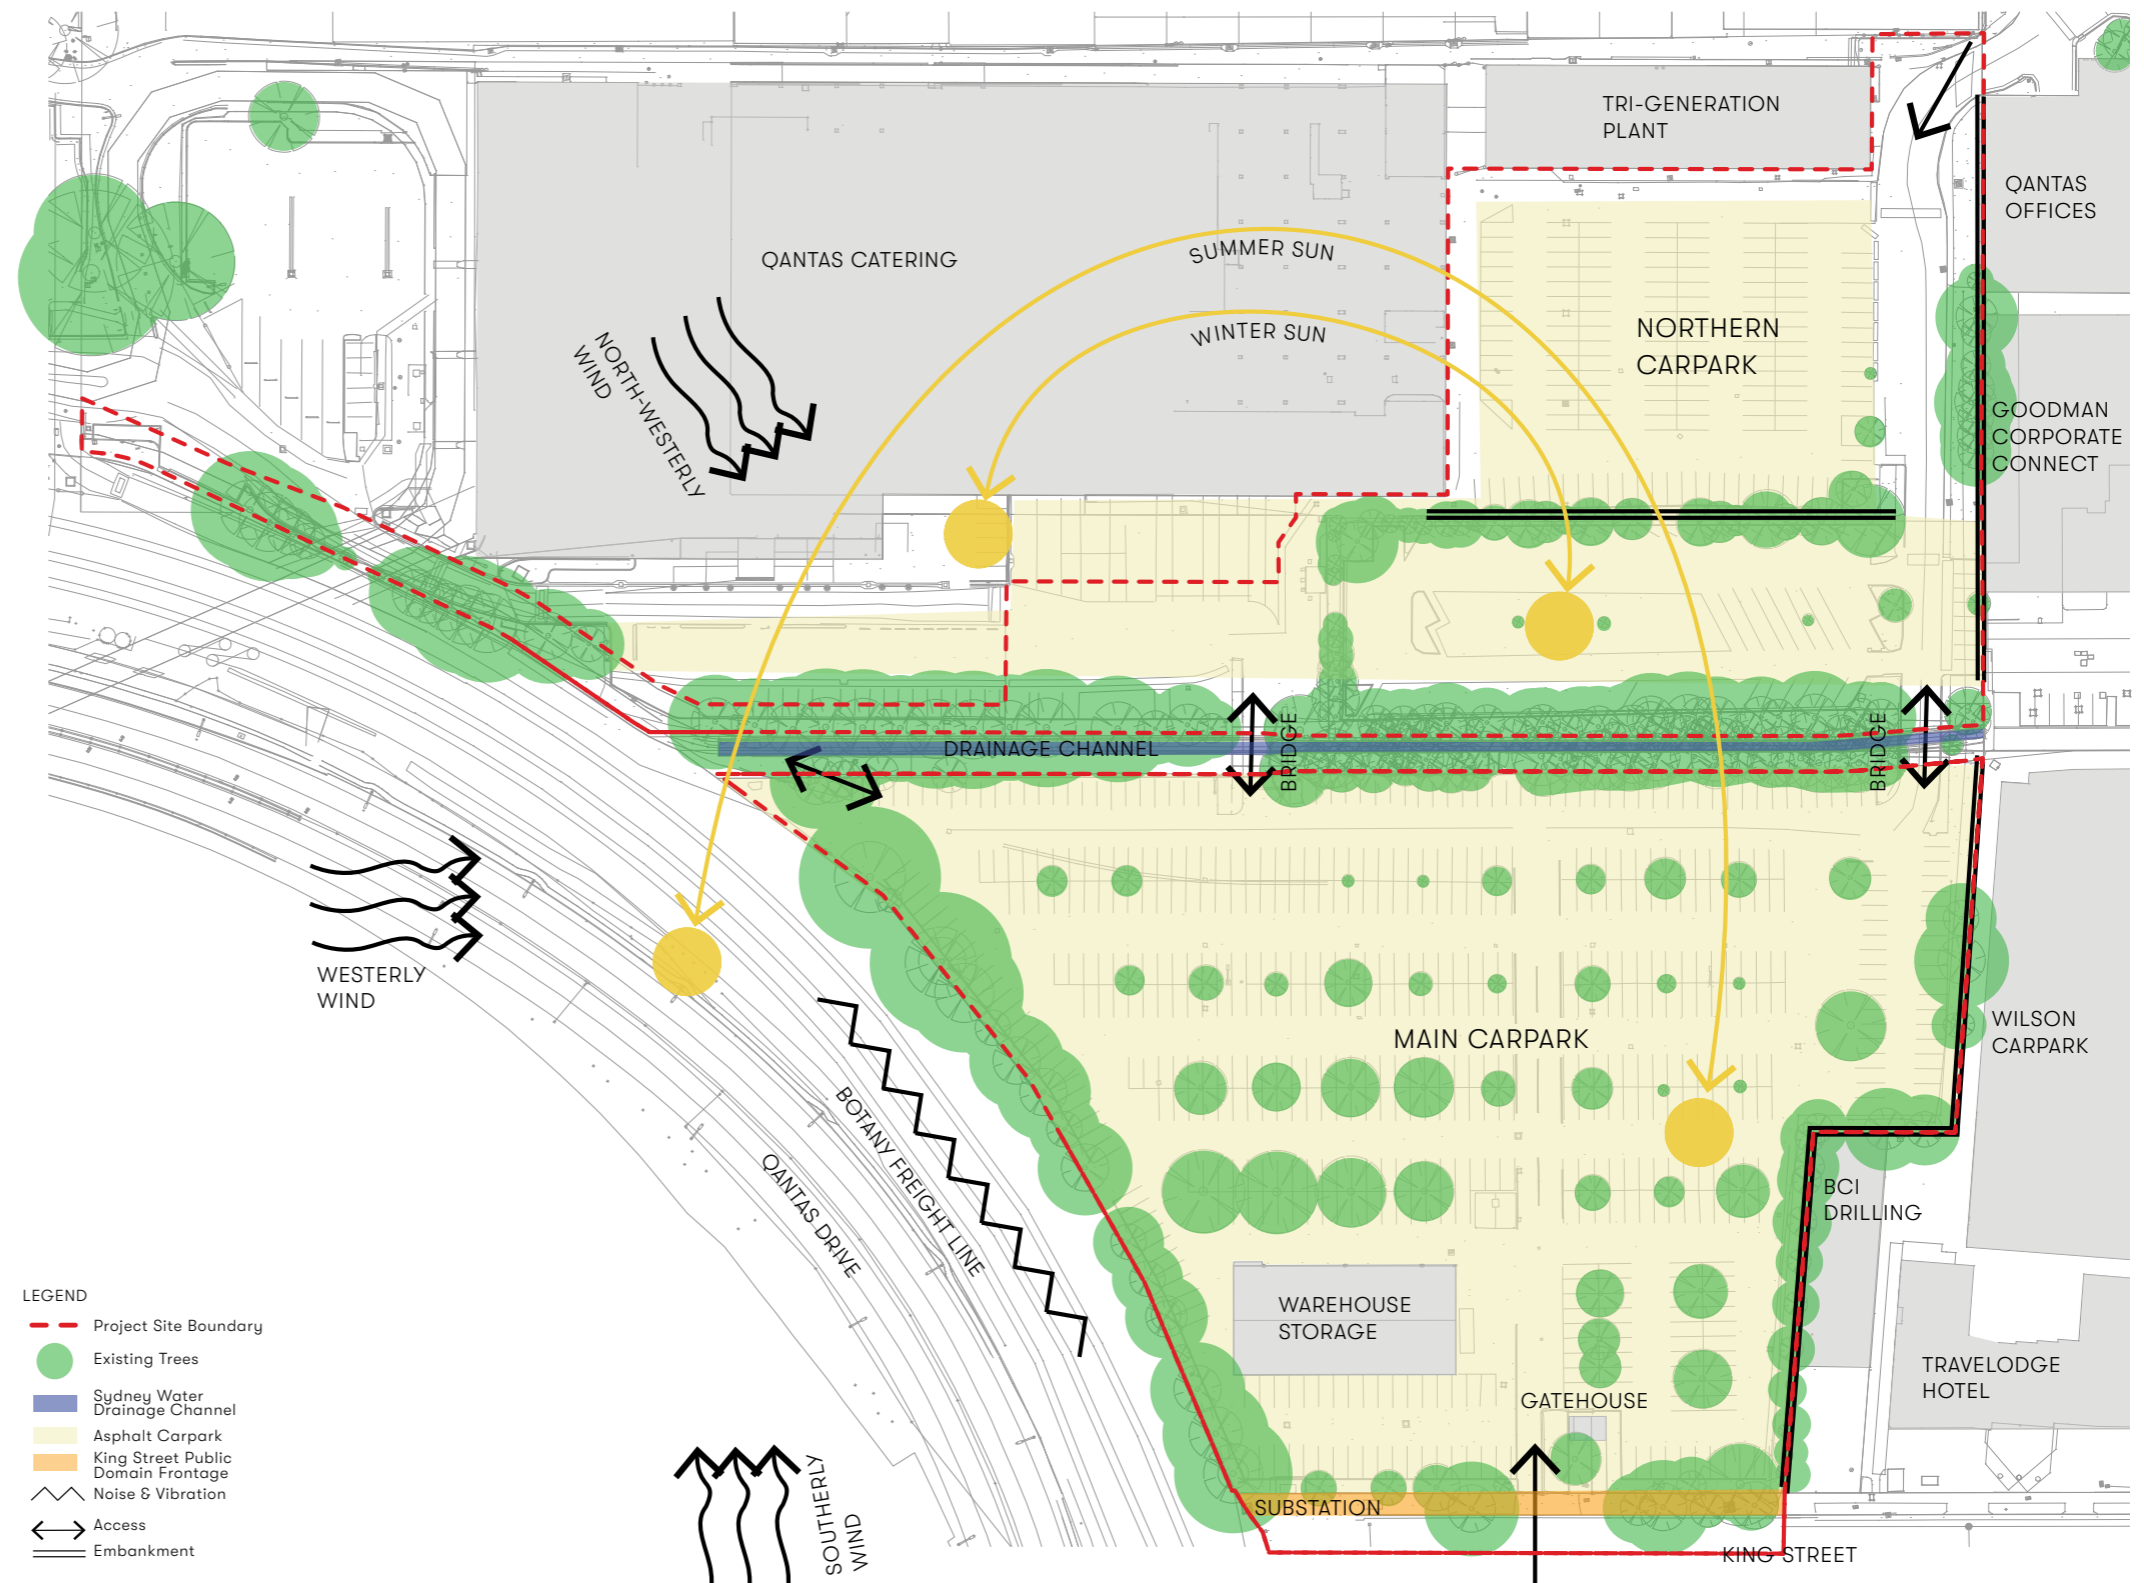
Figure 6 Landscape Site Analysis Plan

The site is quite internalised within the Qantas Campus with only glimpsed views into the area available from along O’Riordan Street, Bourke Street, Coward Street, Kent Road and Chalmers Crescent. The new Travelodge Hotel with associated Wilson Carpark and Goodman’s Corporate Connect will have the widest views of the development. The Landscape and Visual Impact Assessment (LVIA) prepared by Scott Carver as part of the application, explains the significance of the impacts and key mitigation measures in detail.

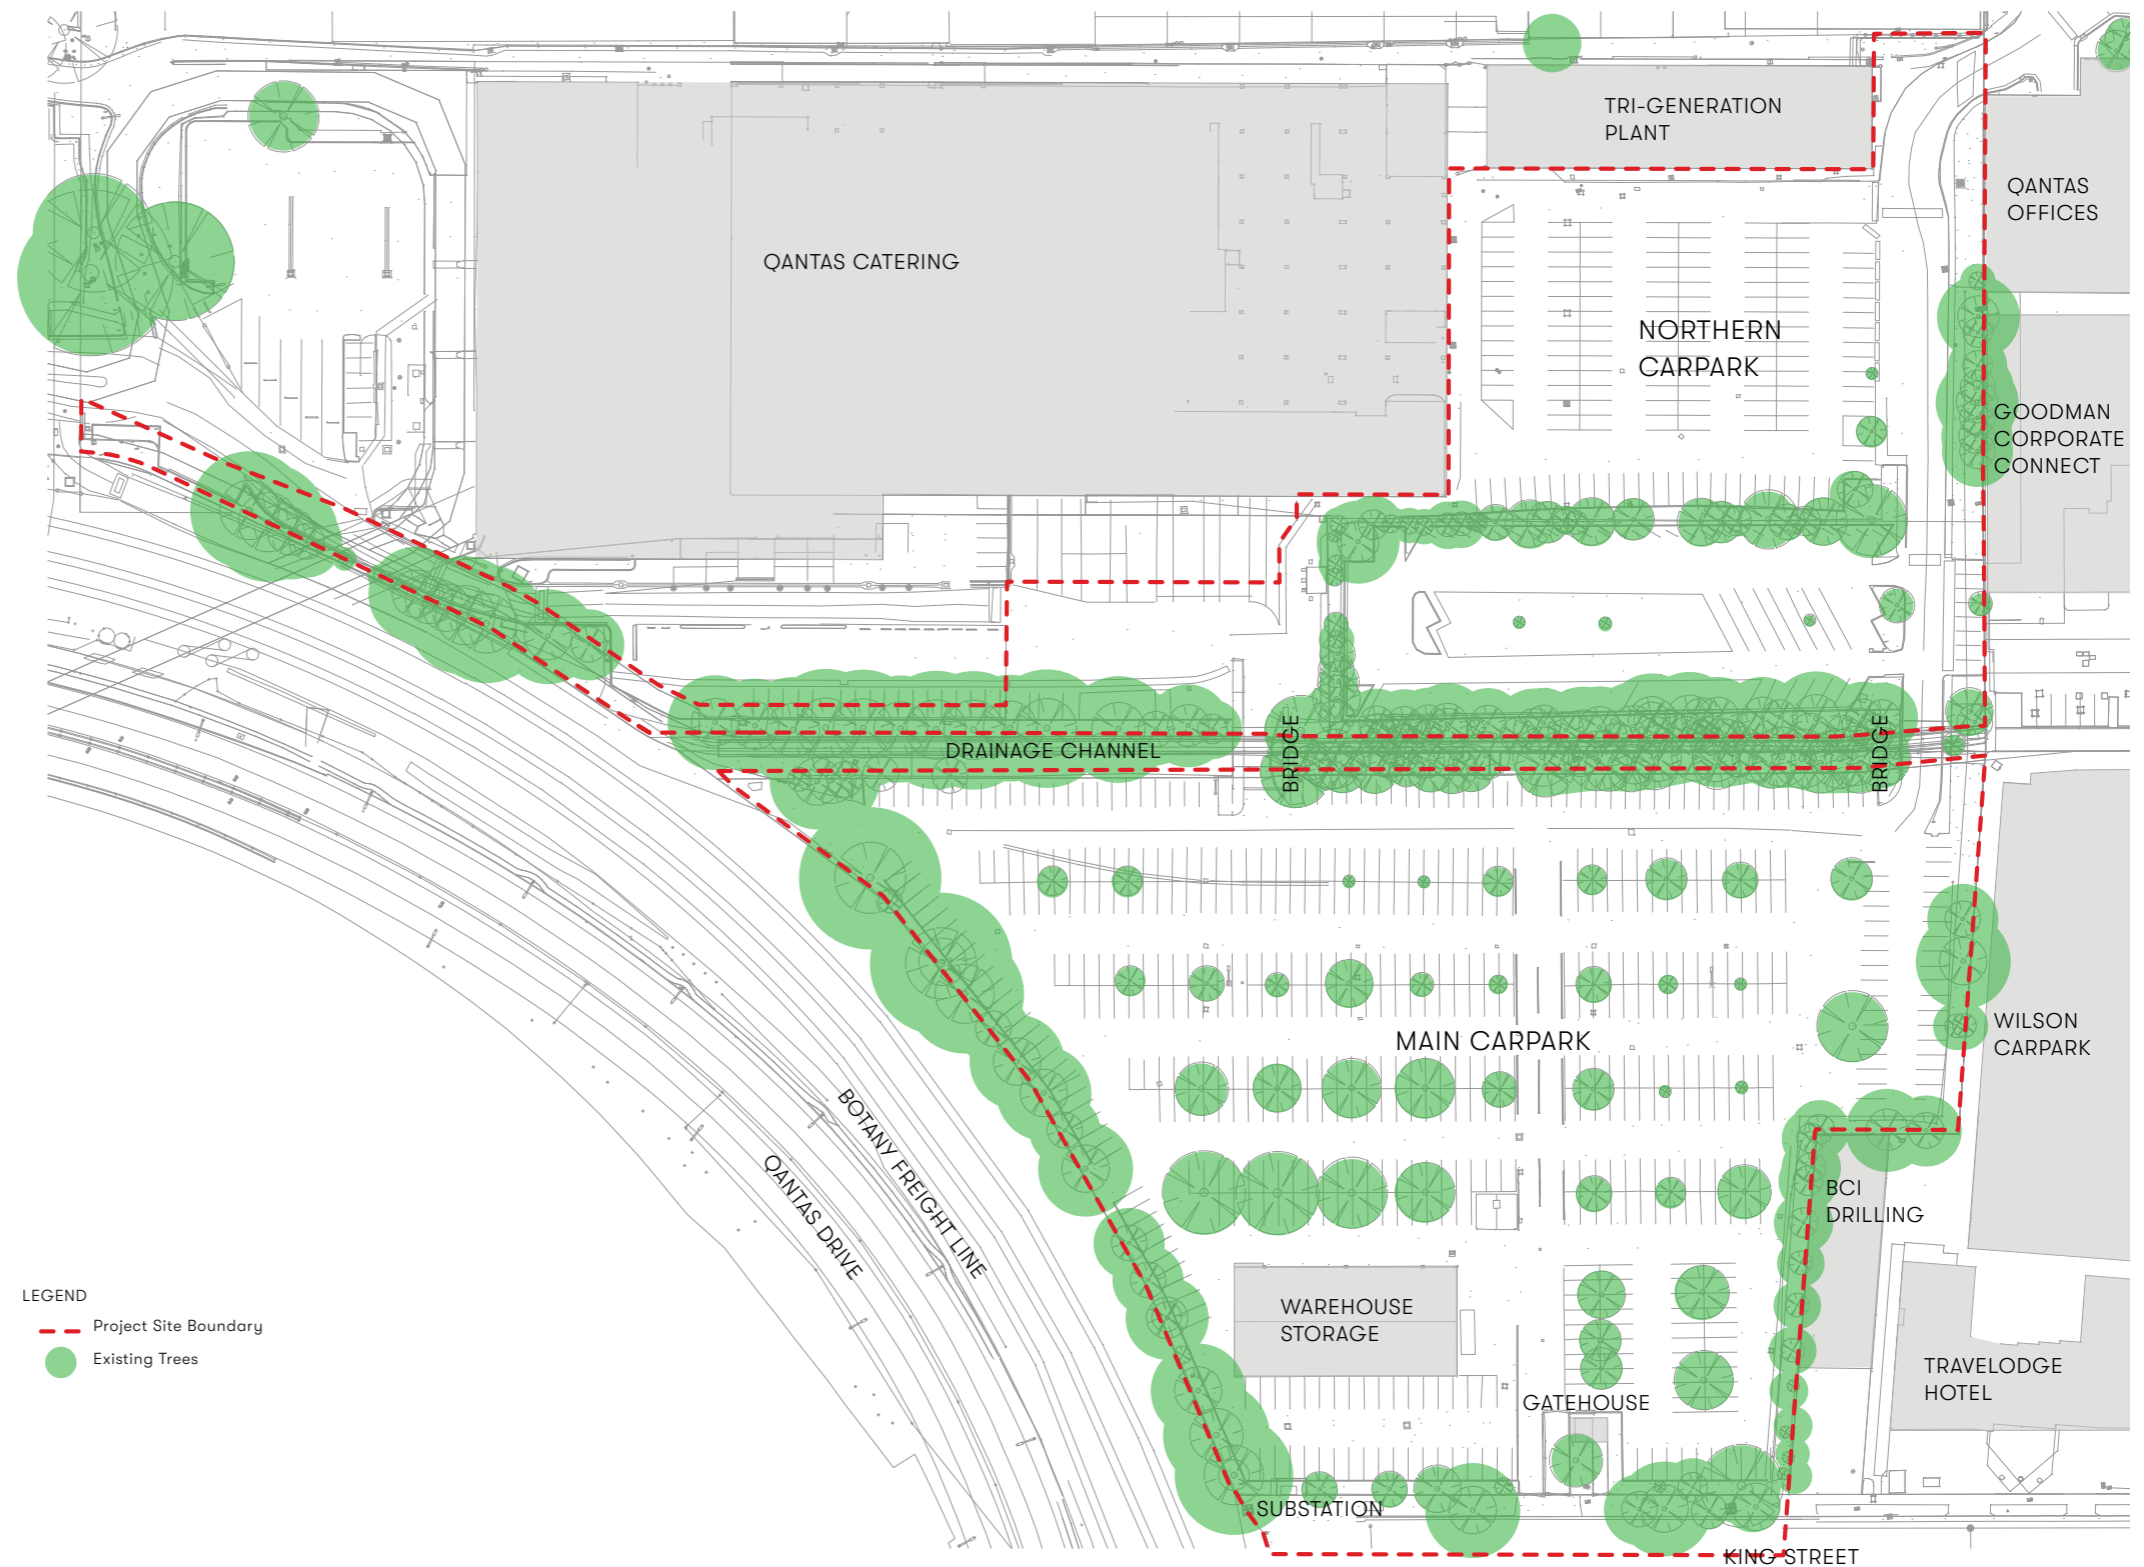
Figure 7 Existing Trees Plan

The site contains a significant number of existing trees as shown on Figure 7.

The species, size and condition of these trees are detailed in the Arborist's Report by The Ents Tree Consultancy.

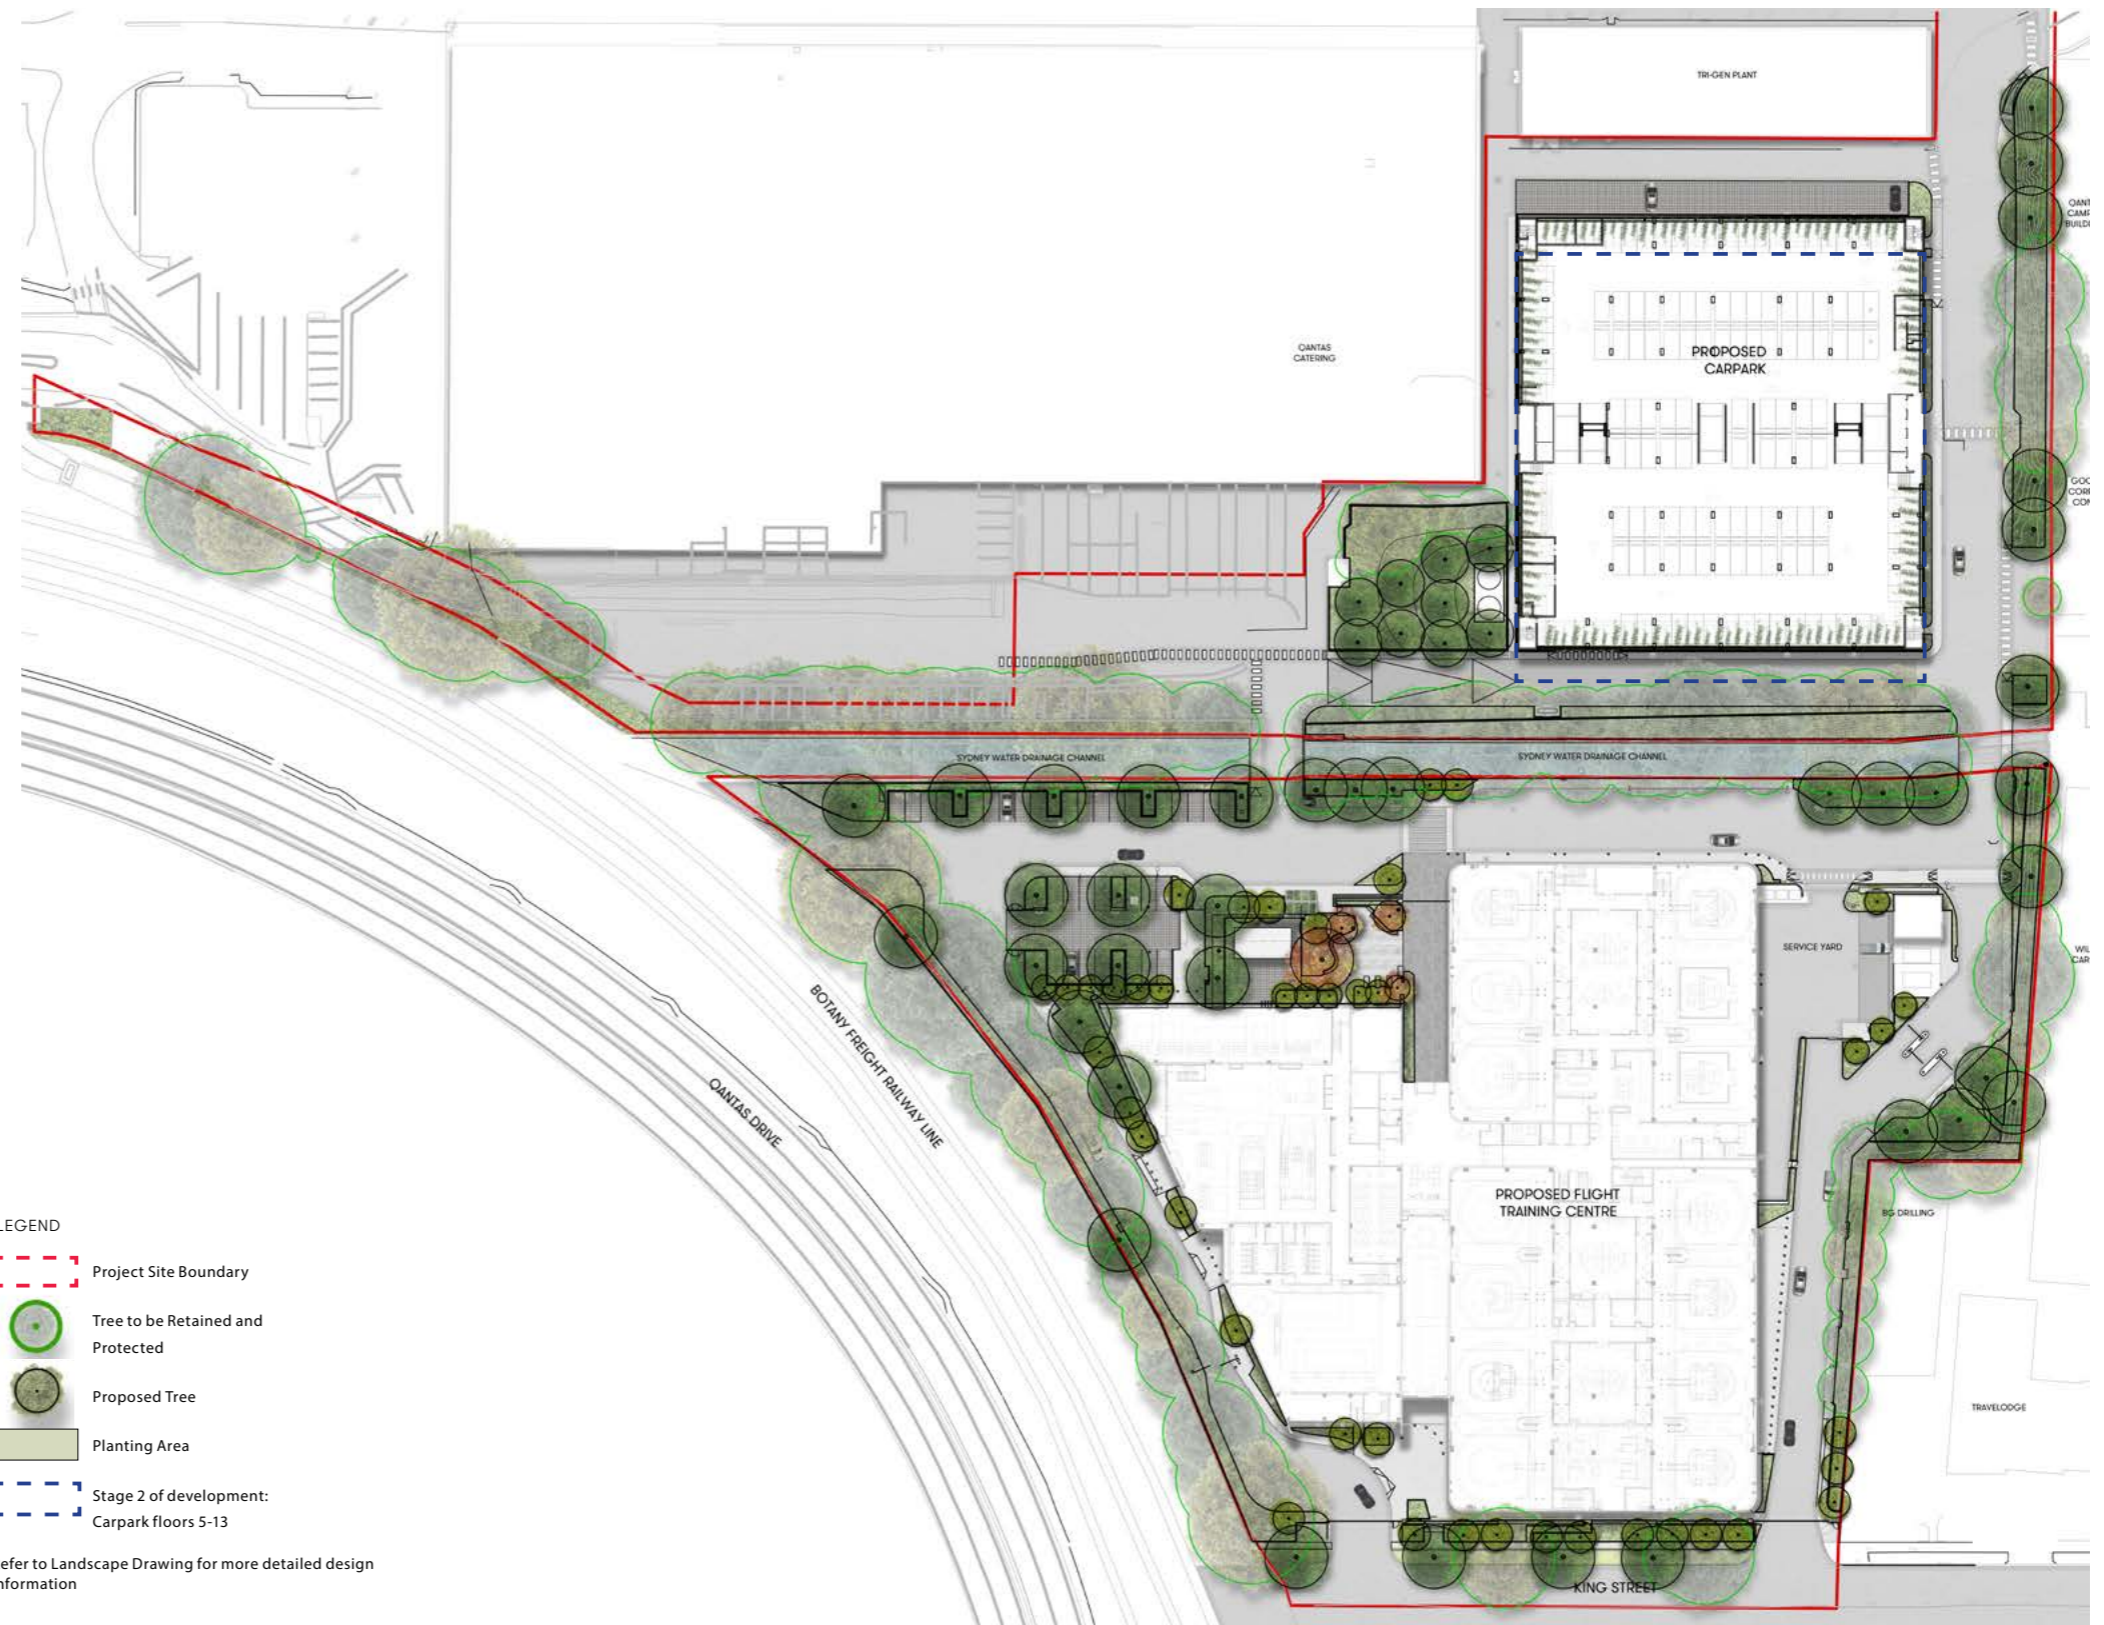
Figure 8 Landscape Site Plan

Figure 8 Illustrates the proposed Landscape Site Plan. Following is a description of each of the key landscape areas and treatments.
