QANTAS GROUP FLIGHT TRAINING CENTRE

# PUBLIC DOMAIN & LANDSCAPE REPORT

### **Qantas Group Flight Training Centre**

Project Number: 20180199

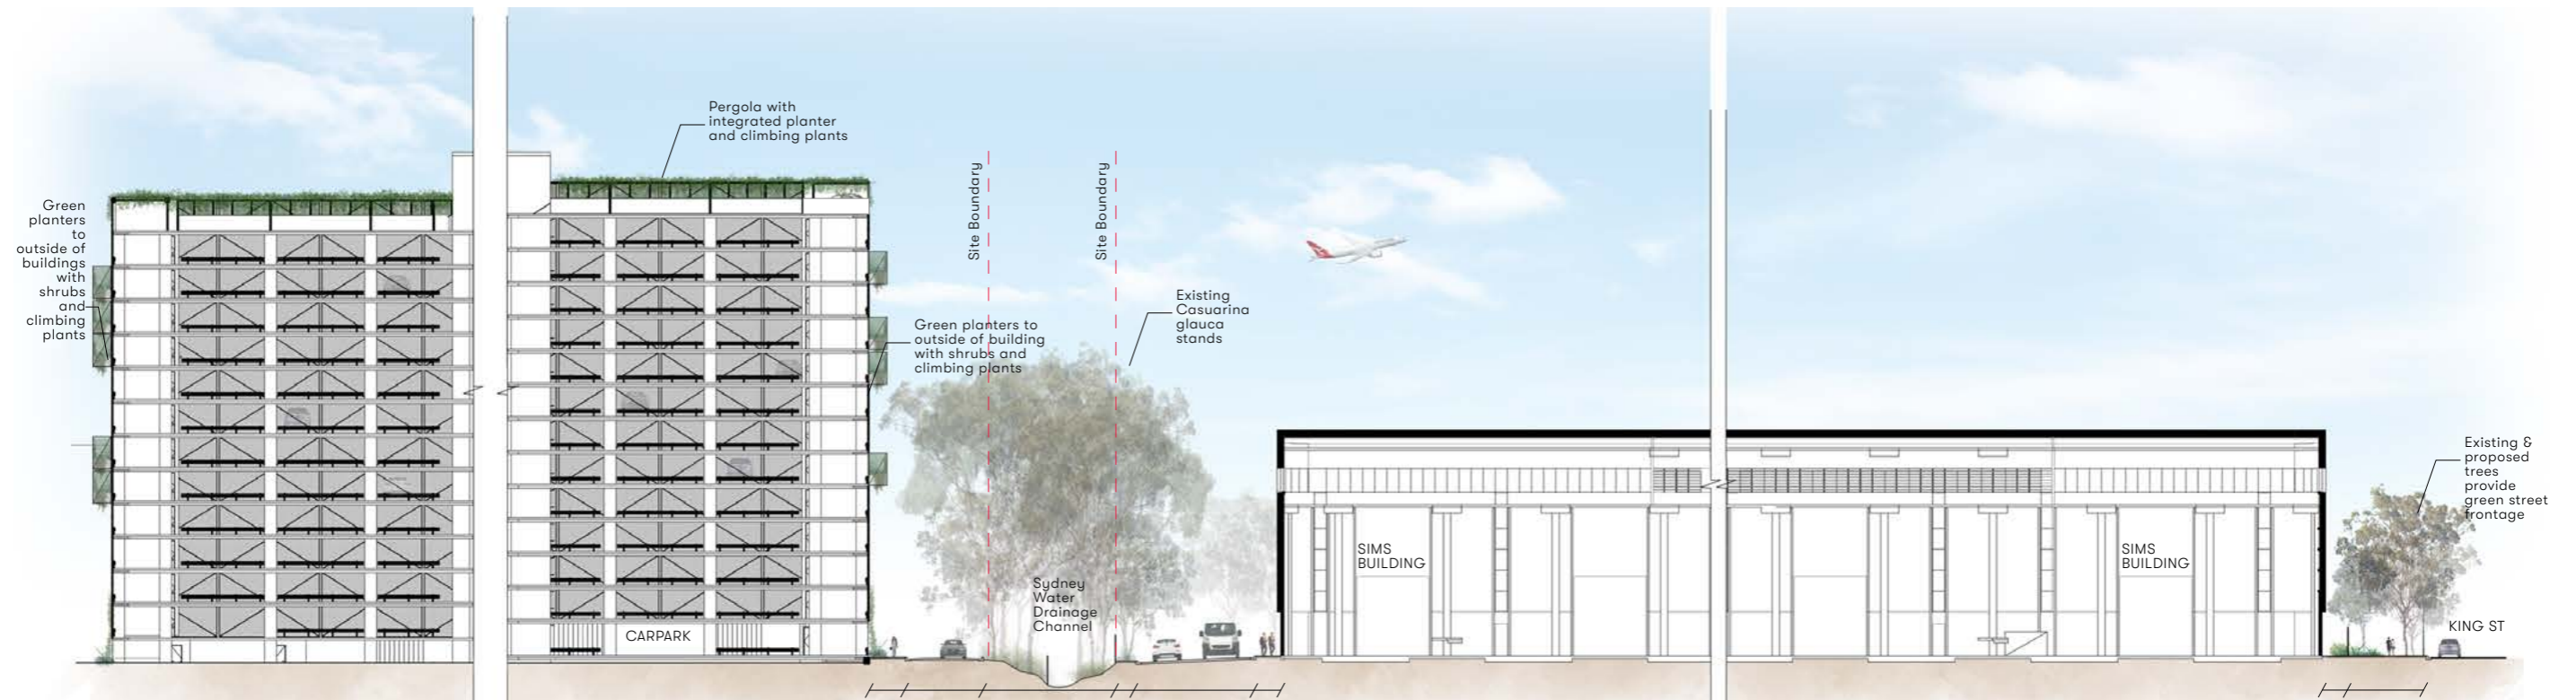
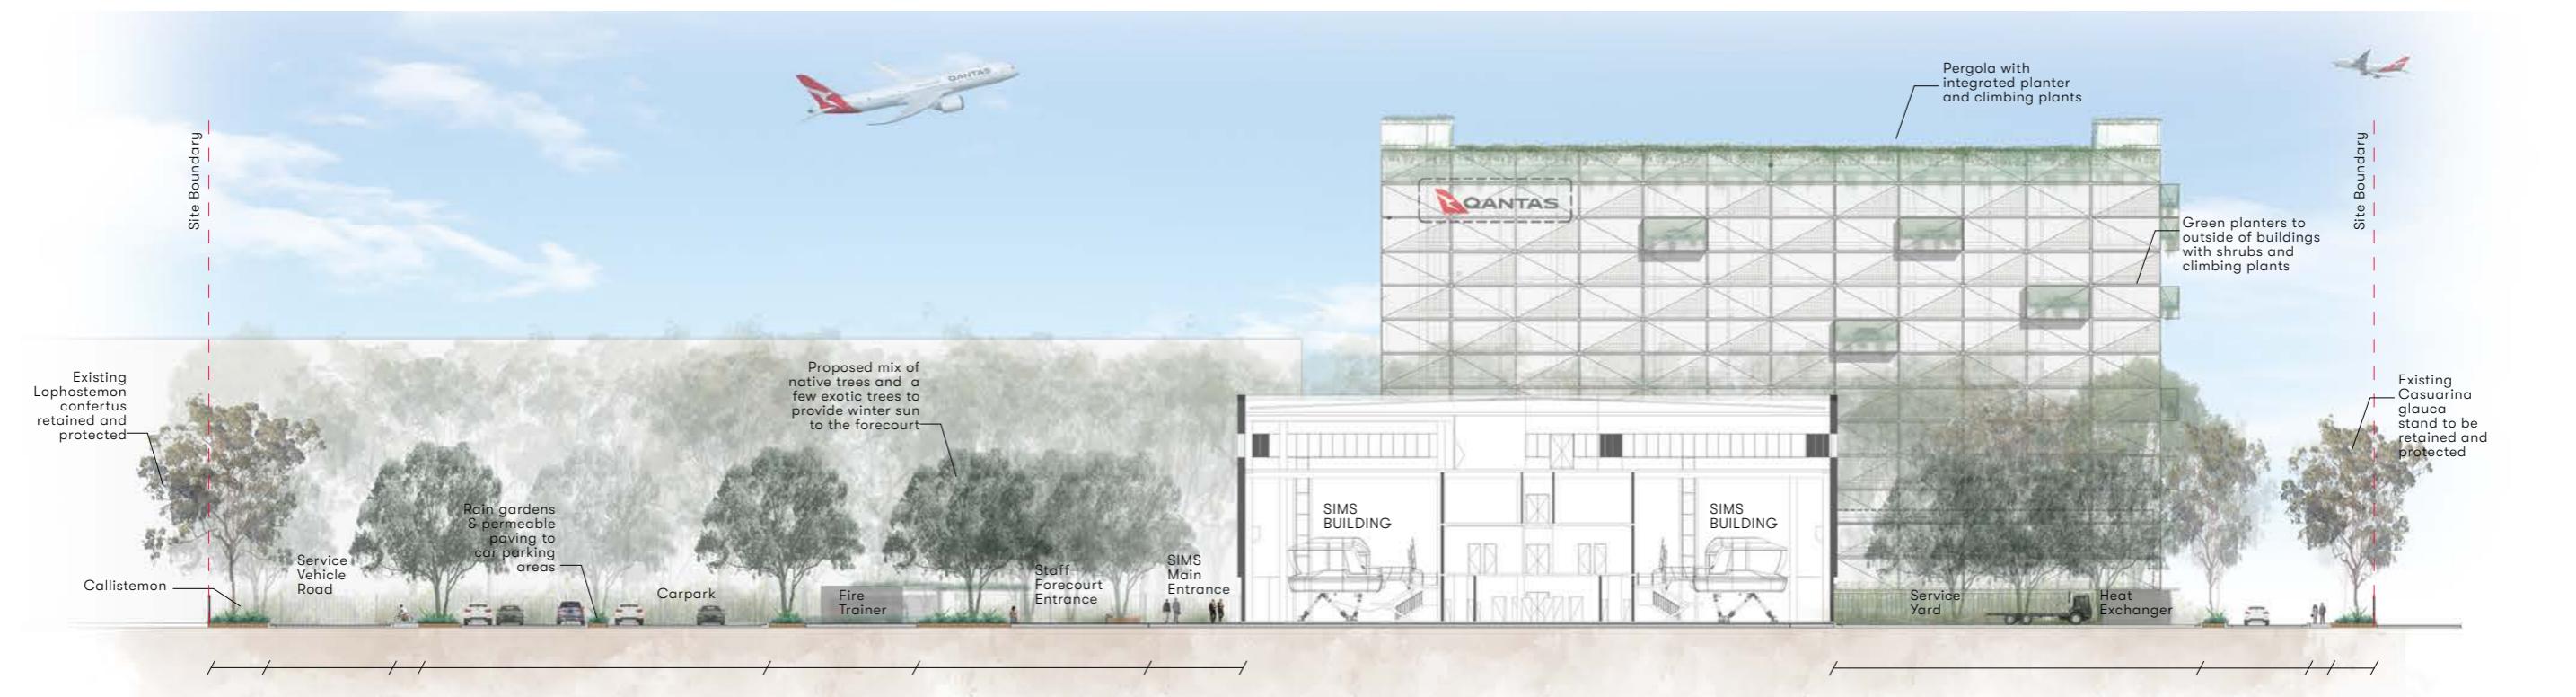
Figure 9 Landscape Site Sections

North / South Section

East / West Section

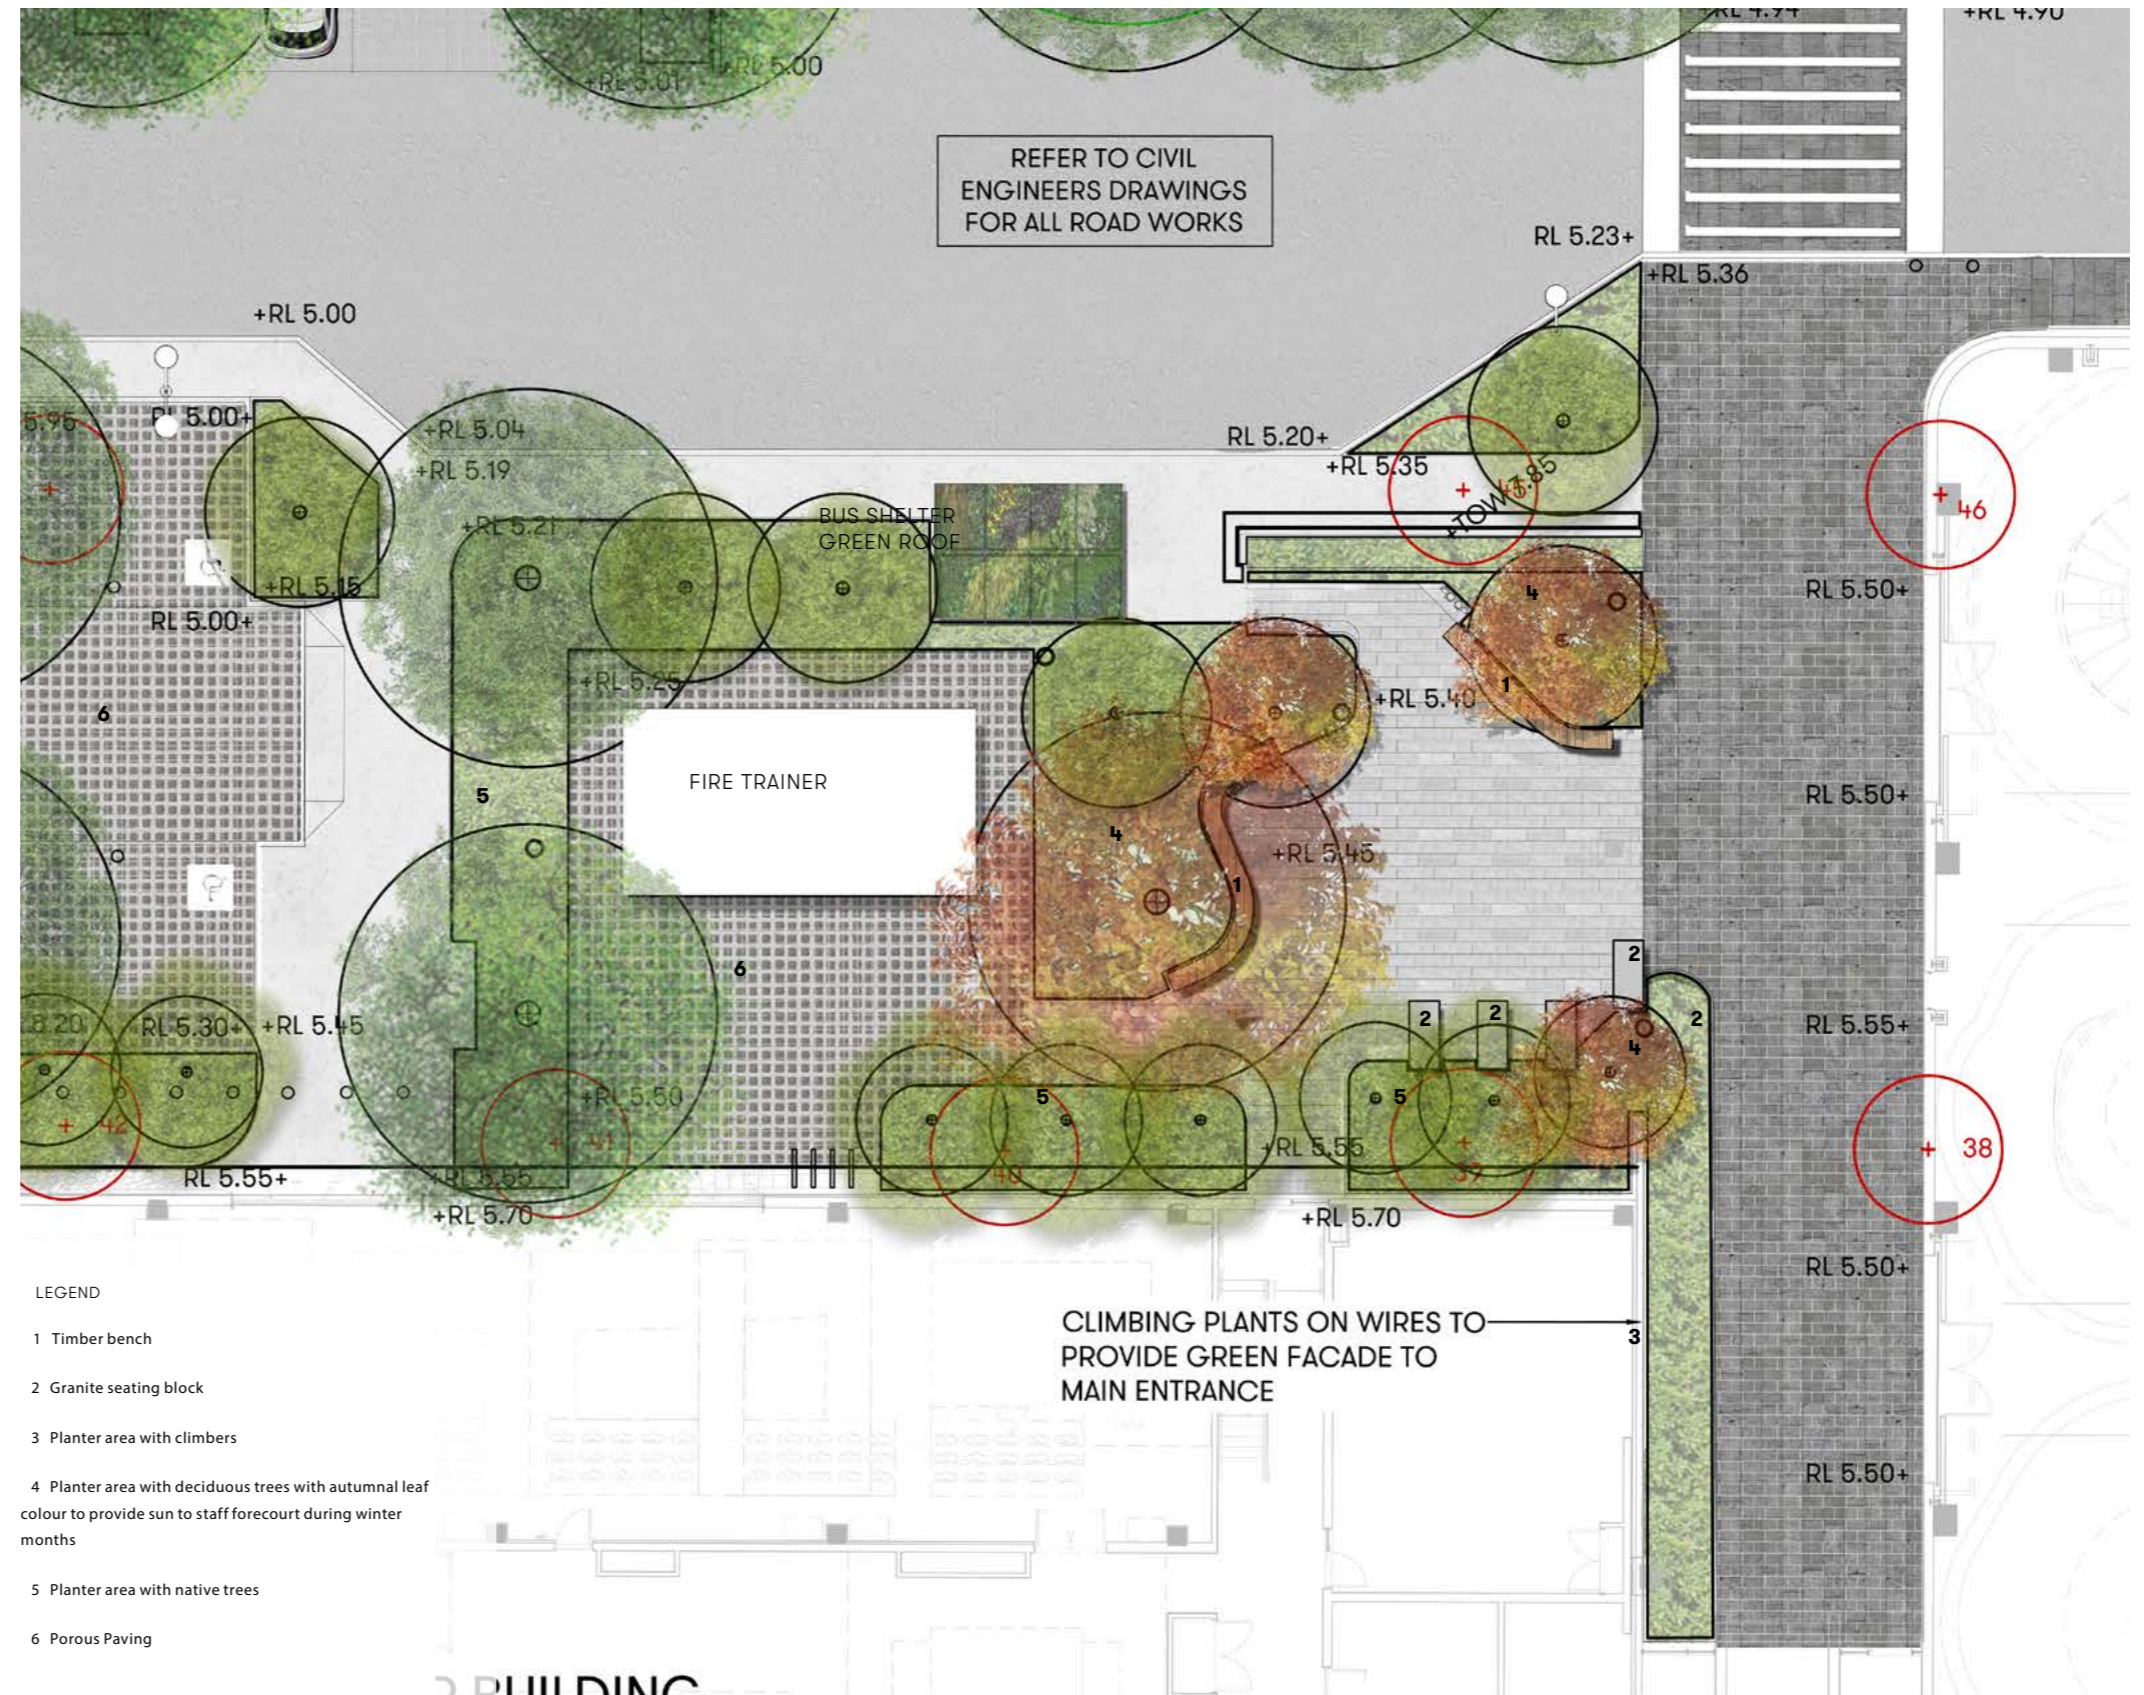
Figure 10 Flight Training Centre Entry Forecourt Plan

- + 2400m fenced forecourt to allow after hours security and the inclusion of an after hours pedestrian gate
- + Paved main entry zone with signage and main gate (to remain open during the day). A largely open area providing clear visual connection from the internal street to the entry. In keeping with the Qantas Corporate Headquarters forecourt in Bourke Road a series of stone seats will provide amenity to the entry area. This space must also accommodate access for the removal of the simulators during replacement

- + Landscape provides shade, visual amenity and soft screening from the internal street and of the fence.
- + Fire Trainer (Container)
- + Access to the cabin training facilities including for replacement of training equipment.

- + Internal bus stops (2 directions) with bus shelter structure on the southern side with a green roof
- + Car parking related directly to the Flight Training Centre.

- LEGEND
- 1 Timber bench
  - 2 Granite seating block
  - 3 Planter area with climbers
  - 4 Planter area with deciduous trees with autumnal leaf colour to provide sun to staff forecourt during winter months
  - 5 Planter area with native trees
  - 6 Porous Paving

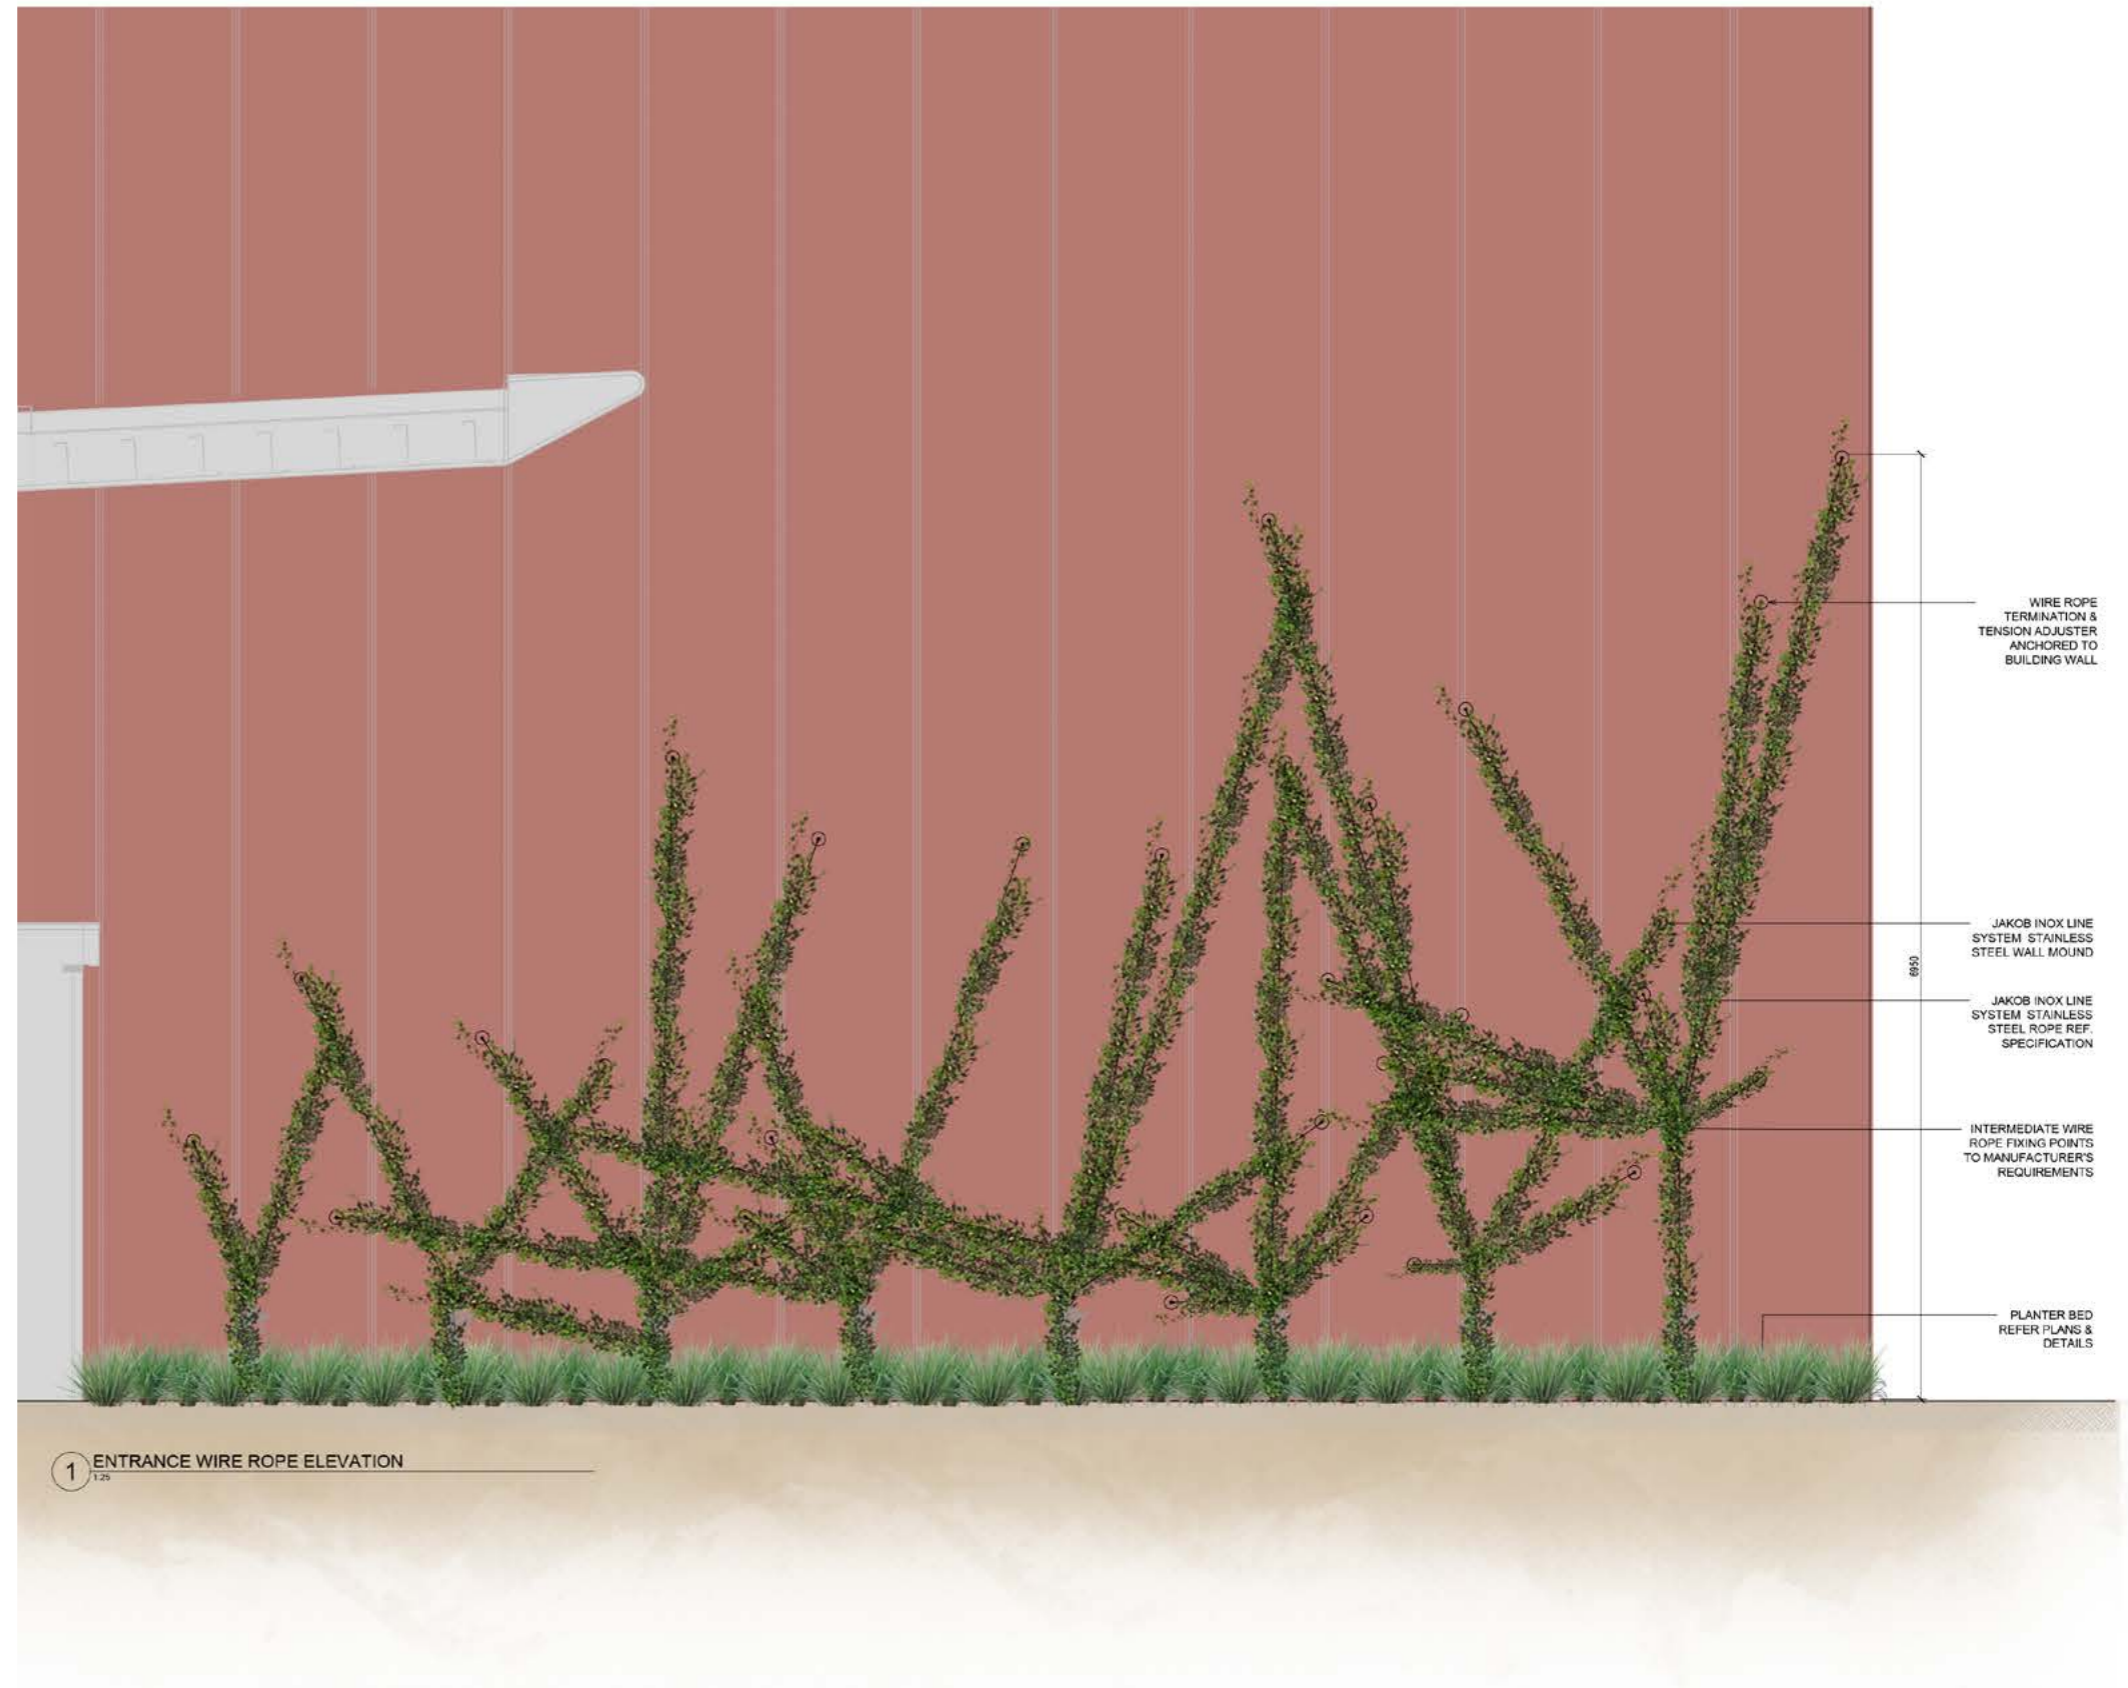
Figure 11 Green facade to Sims Main Entrance

**GREEN FACADE TO SIMS MAIN ENTRANCE**

- + Climbing plants to provide arrival green facade at the the SIMS Main Entrance.
- + Plants to grow across stainless steel wires; design inspired by Qantas flight paths from Sydney.

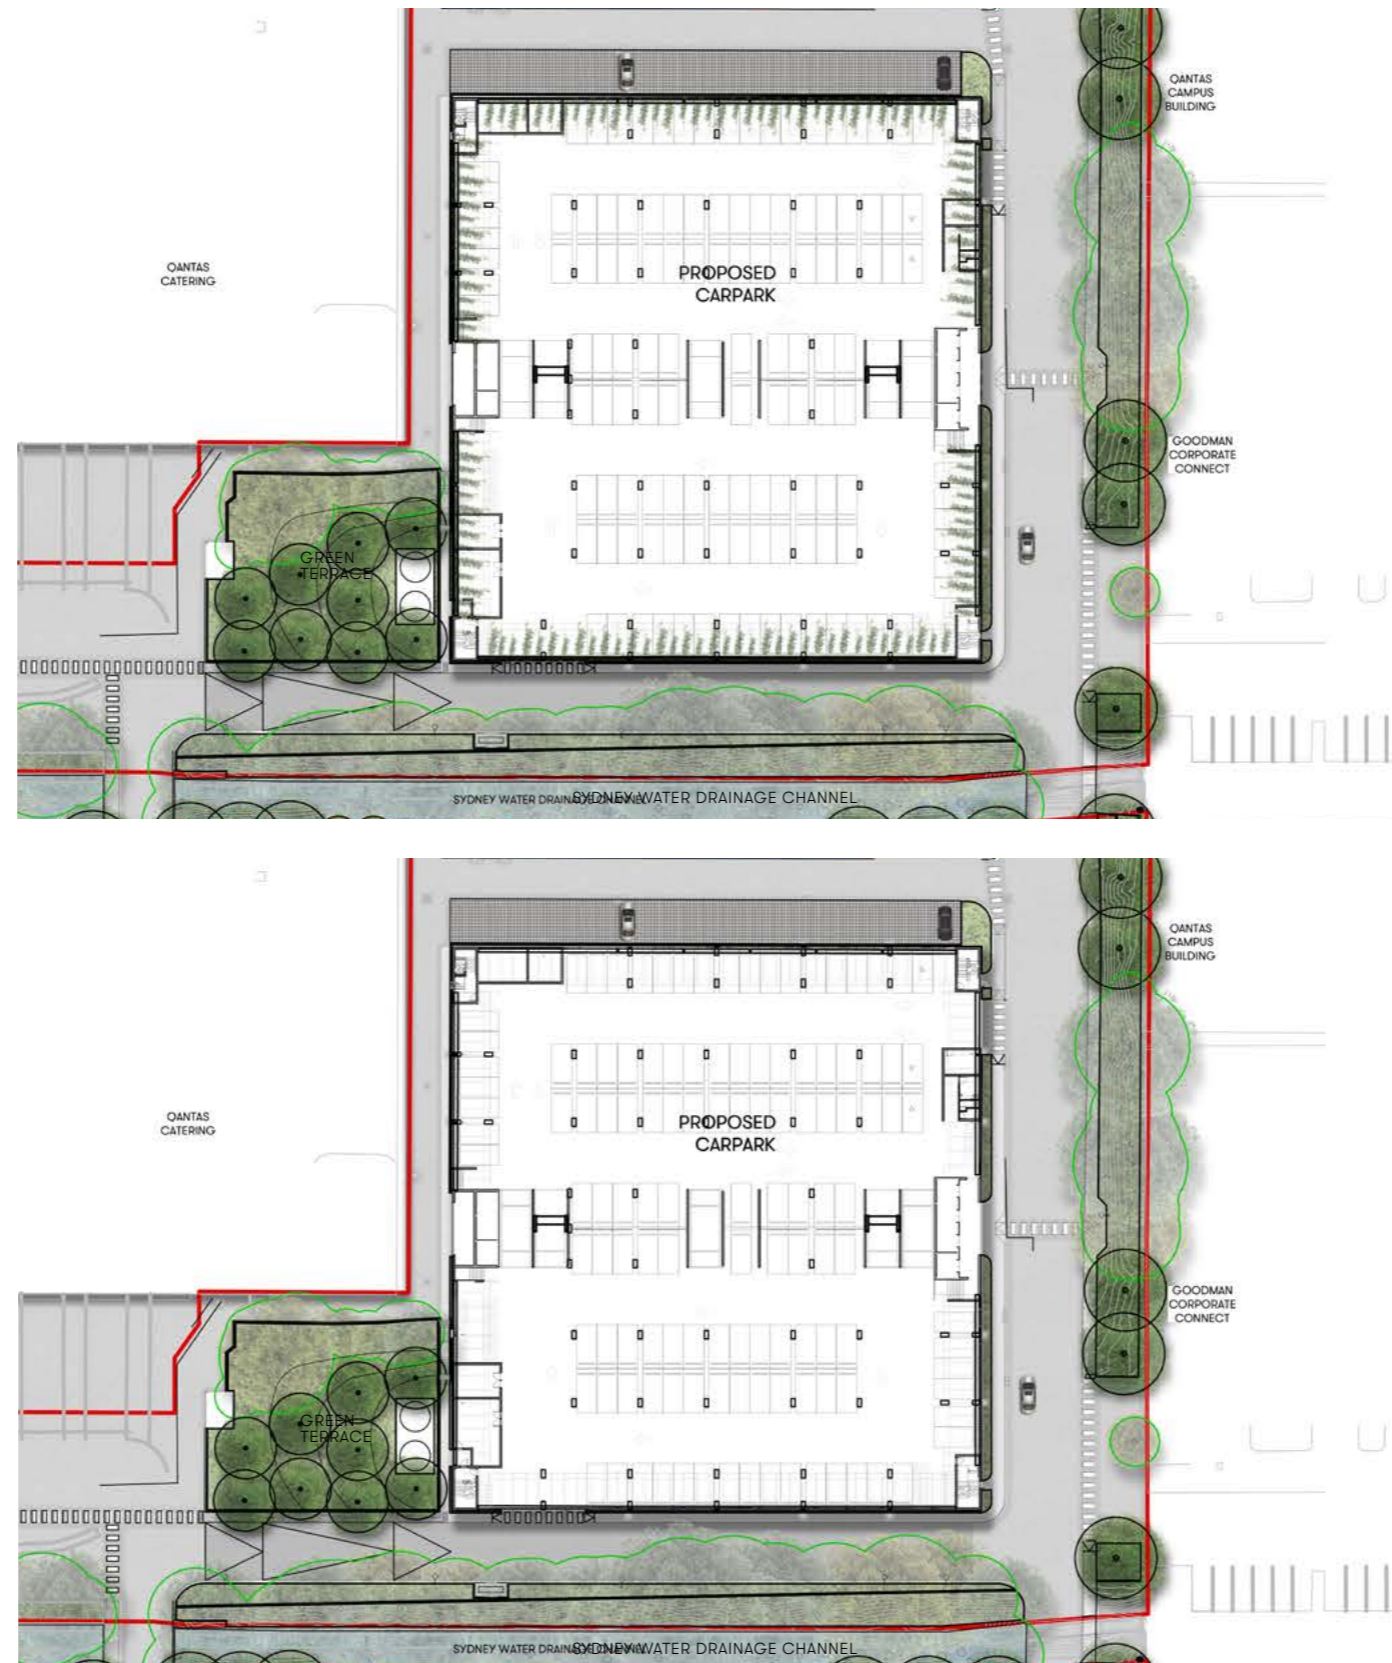
Figure 12 Proposed Multi Level Carpark Ground & Roof Plans

- + On the rooftop level of parking (level 13), a raised planter and pergola structure will accommodate both trailing and climbing plants. This landscaped treatment will perform the dual function of providing shade to the parked cars and visual mitigation for taller surrounding buildings and the public domain where the structure will be visible.

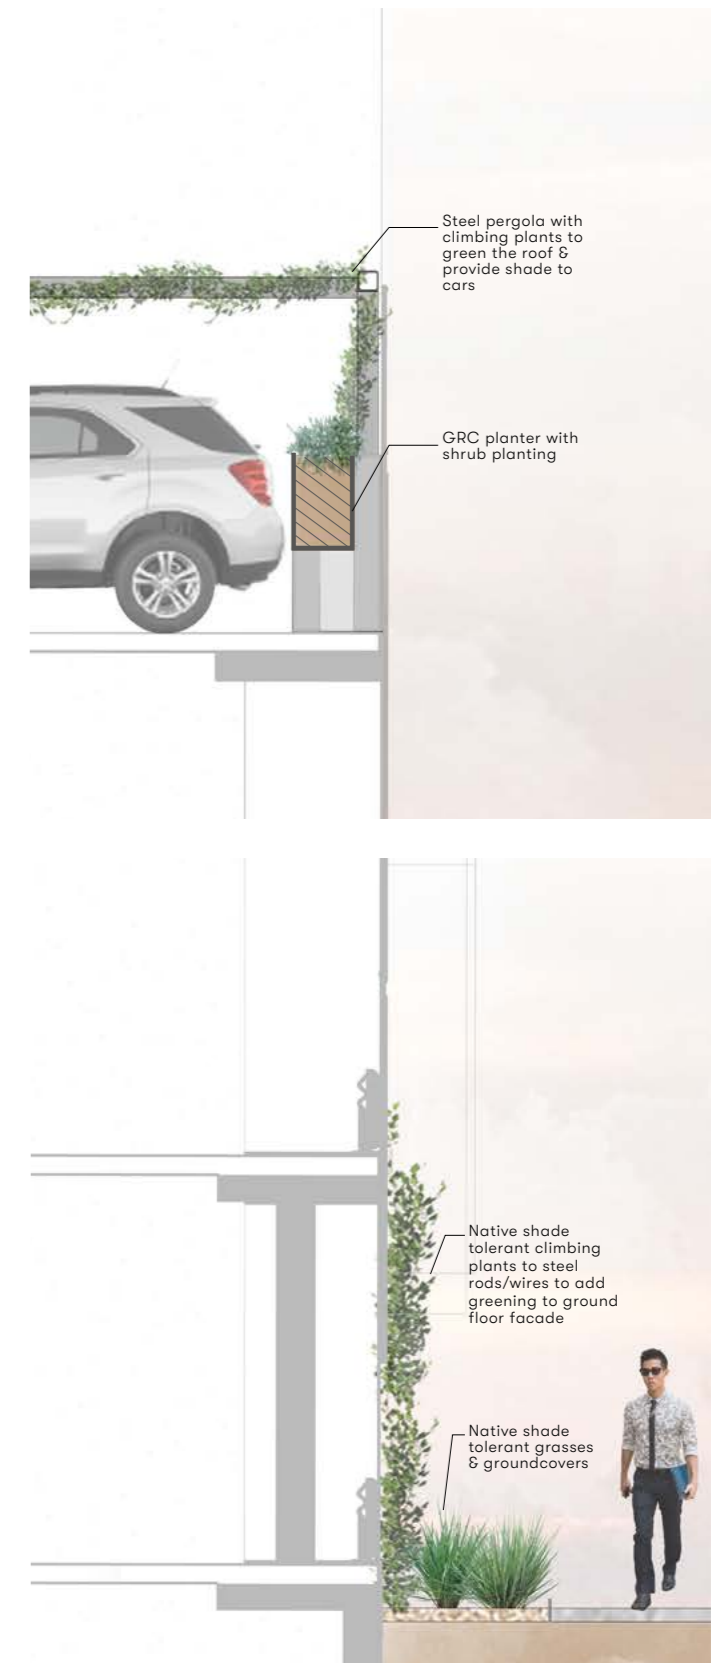
Figure 13 Ground & Rooftop Facade Section

- + Along the northern, eastern and southern facade there are 21 no. facade planters that are sized at approximately 1.5m x 4m in size cantilevered from the building. These provide pockets of green in the carpark facade feature a mix of native shrubs and climbing plants, which provide green visual amenity to the surrounding buildings where the structure will be visible. (Figure 13, 14, 15, 16)

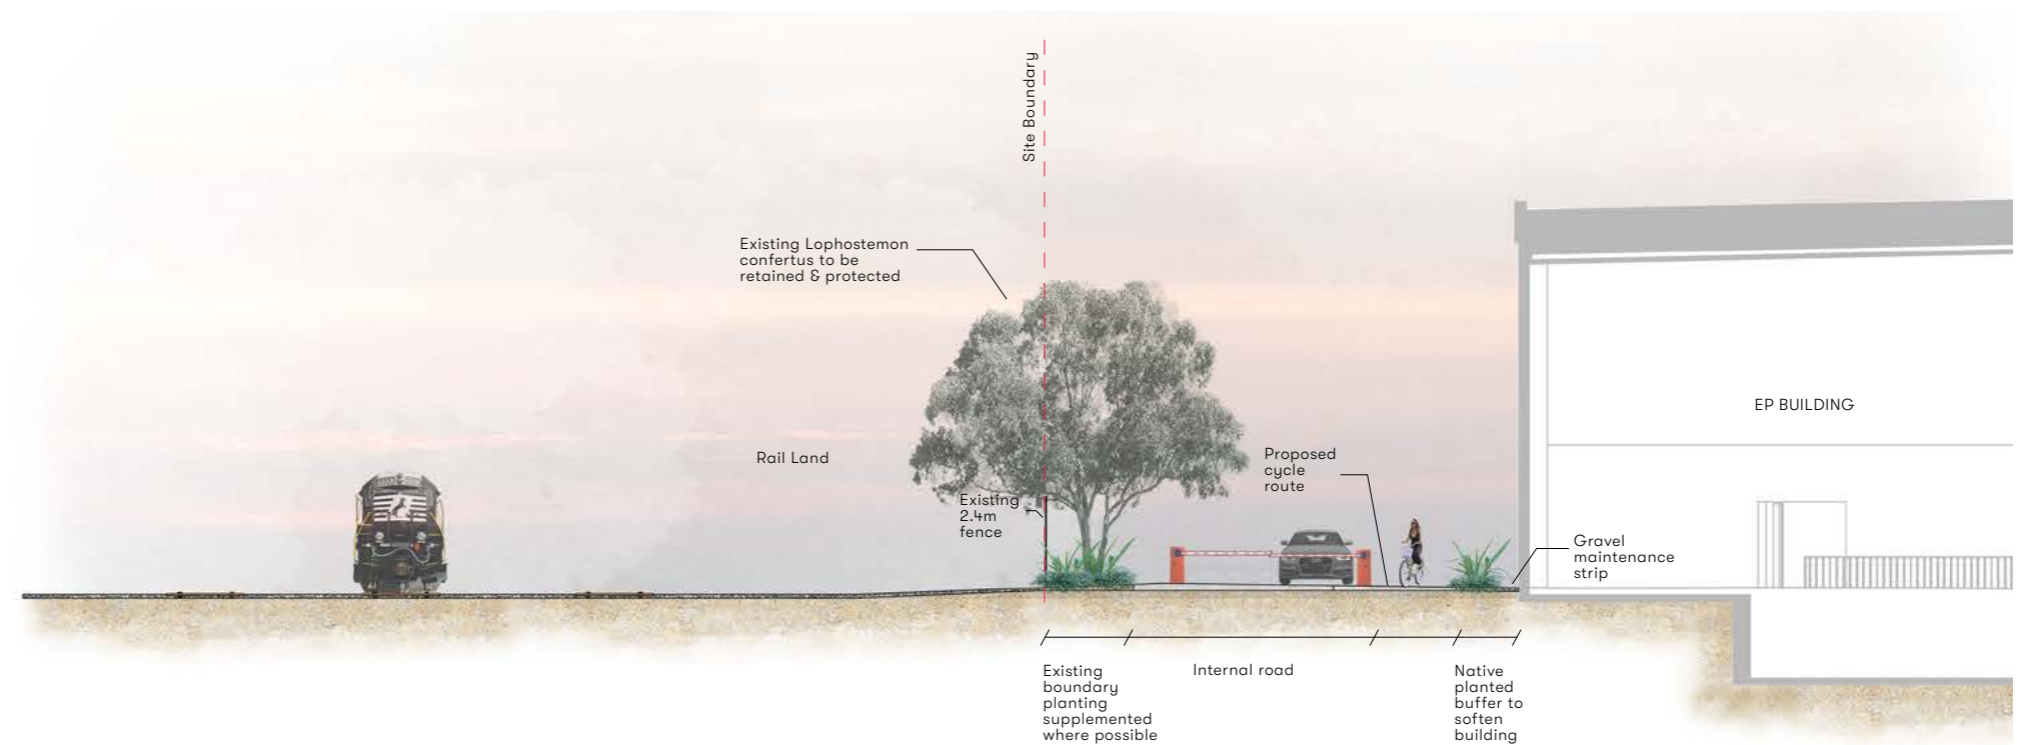
Figure 19 Western Boundary Typical Section

The trees on the western boundary will be retained and protected, along with the existing under storey planting. Augmentation of the planting will be undertaken where gaps exist.

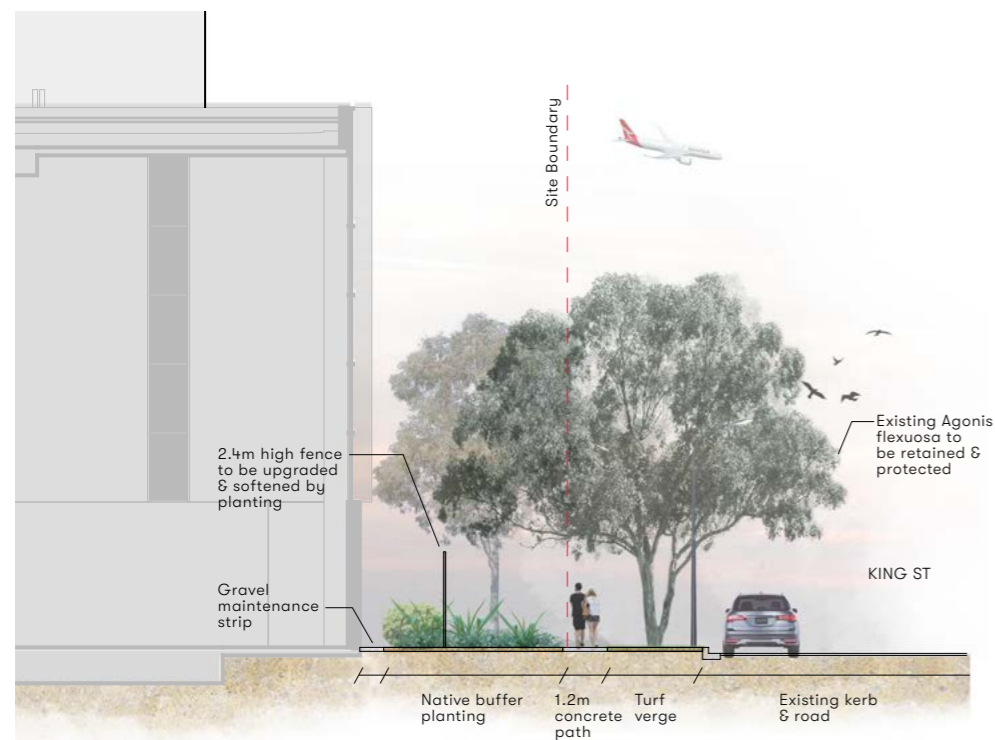
Figure 20 King Street Frontage Typical Section East

Three of the existing street trees will be removed to allow the new eastern site entry, two *Eucalyptus scoparia* and one *Agonis flexuosa*. The public verge will be reinstated including turf and 4 additional *Eucalyptus haematoma* to compliment the existing Eucalypt trees. A no fines porous concrete footpath 1.2m wide shall provide pedestrian access along King Street. The porous concrete shall have minimal disturbance to the the existing tree root zone and allow water to percolate down.

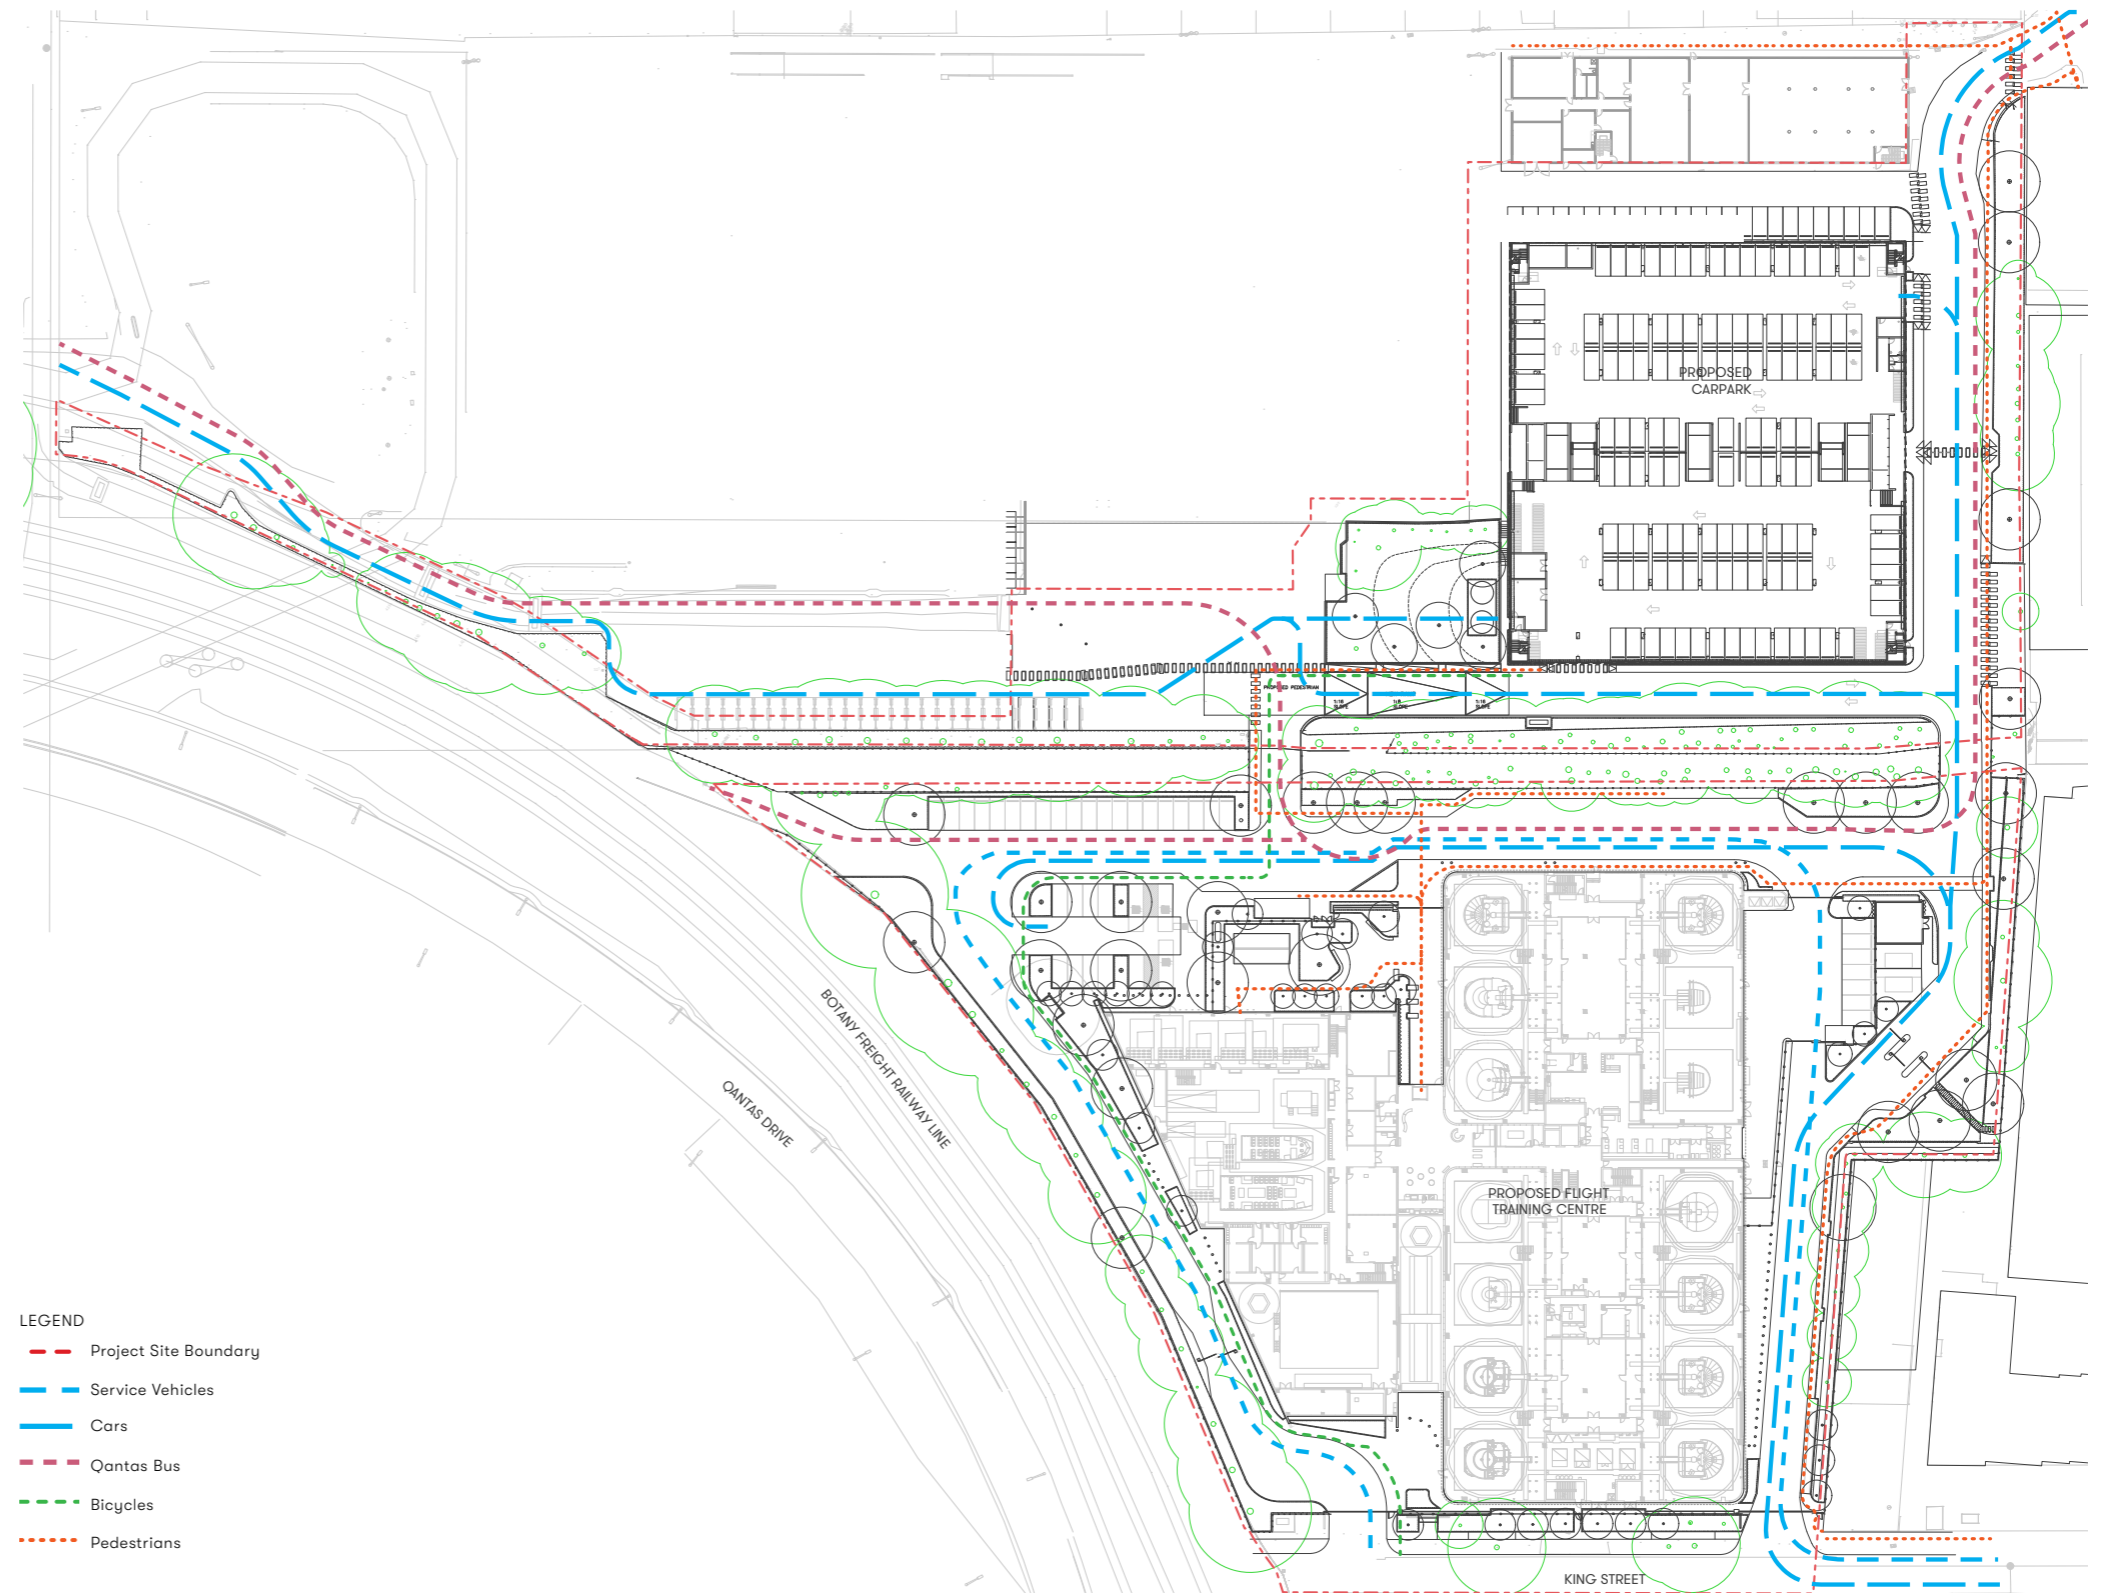
Figure 23 Access Diagram

Planting treatments will maintain clear sight lines through the use of clear trunked trees and lower level understory species where visibility for safety is required.

A safe lighting level will be incorporated to encourage surveillance and enhance safety. This will include the service areas which will also be appropriately lit for safety.
