QANTAS GROUP FLIGHT TRAINING CENTRE

# PUBLIC DOMAIN & LANDSCAPE REPORT

### **Qantas Group Flight Training Centre**

Project Number: 20180199

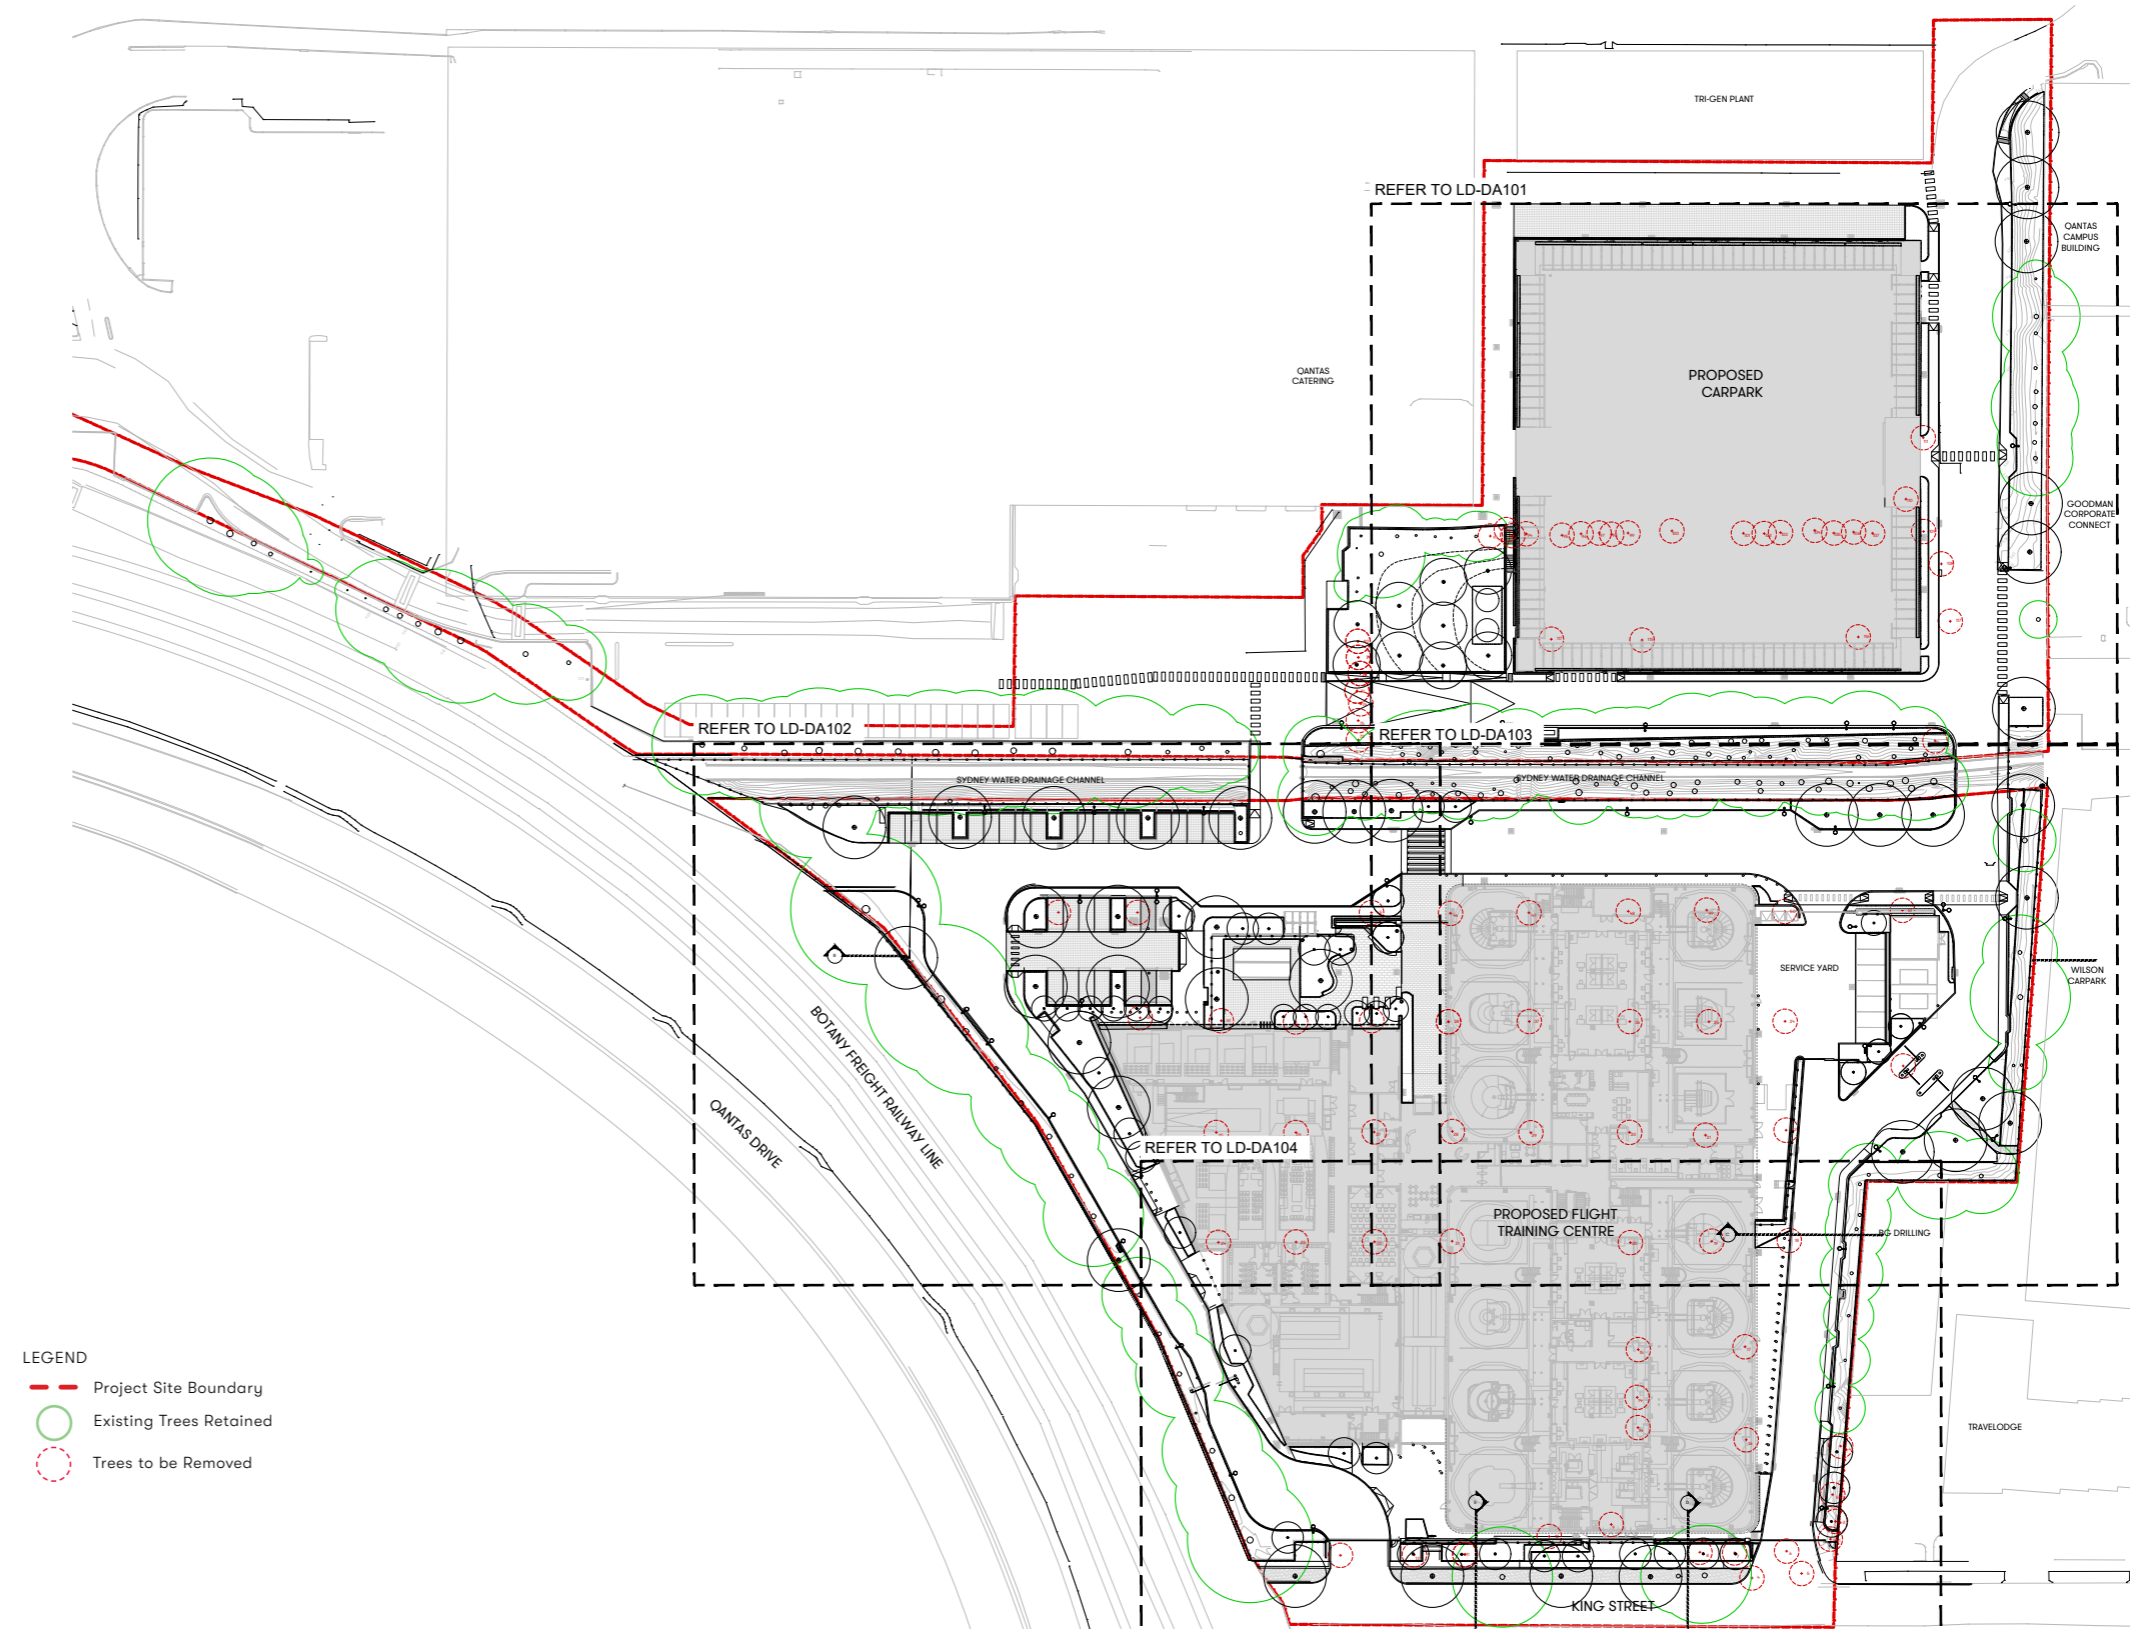
Figure 24 Tree Removal, Retention & Replacement Plan

The trees to be removed will have 1:1 ratio replacement by the proposed trees. The trees numbers are as follows:

All proposed trees shall be native and/or endemic where possible\*. All proposed trees shall also have 200L container size\*. Refer to Planting Schedule for more details on tree species.

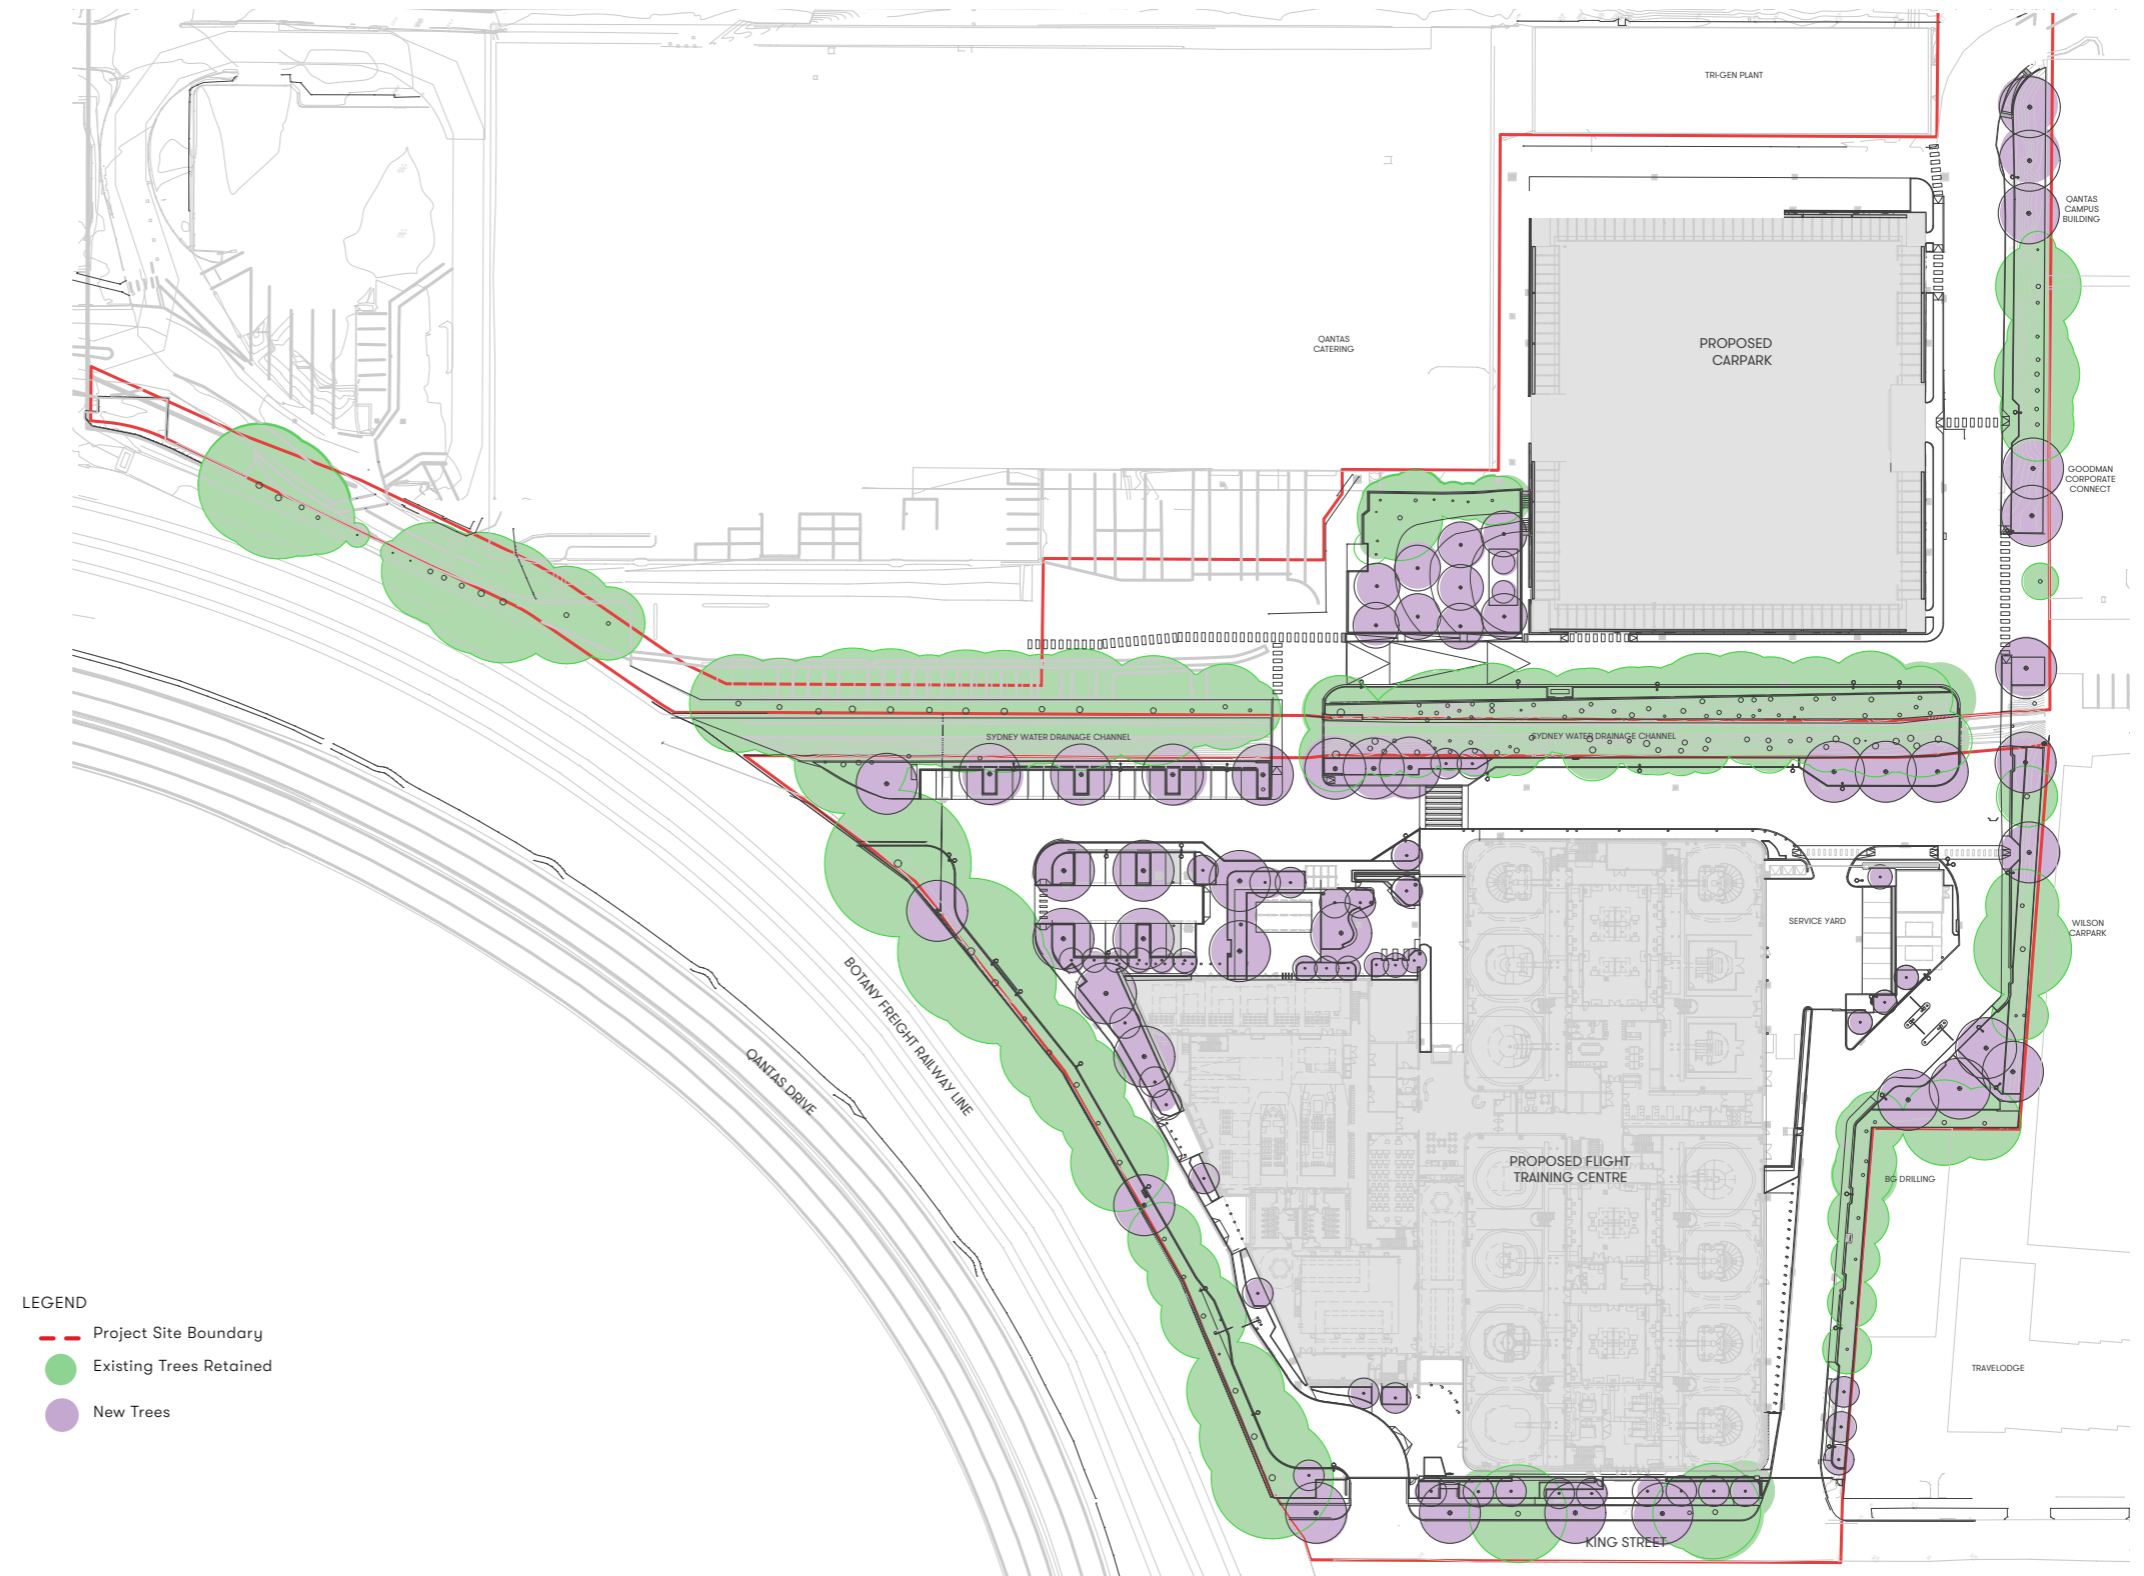
Figure 25 Canopy Cover Plan

In addition, to compliment this, it is proposed that the bus stop shelter shall have a green roof and the car park shall have a green pergola.

The existing and additional proposed canopy cover is illustrated opposite in Figure 19.

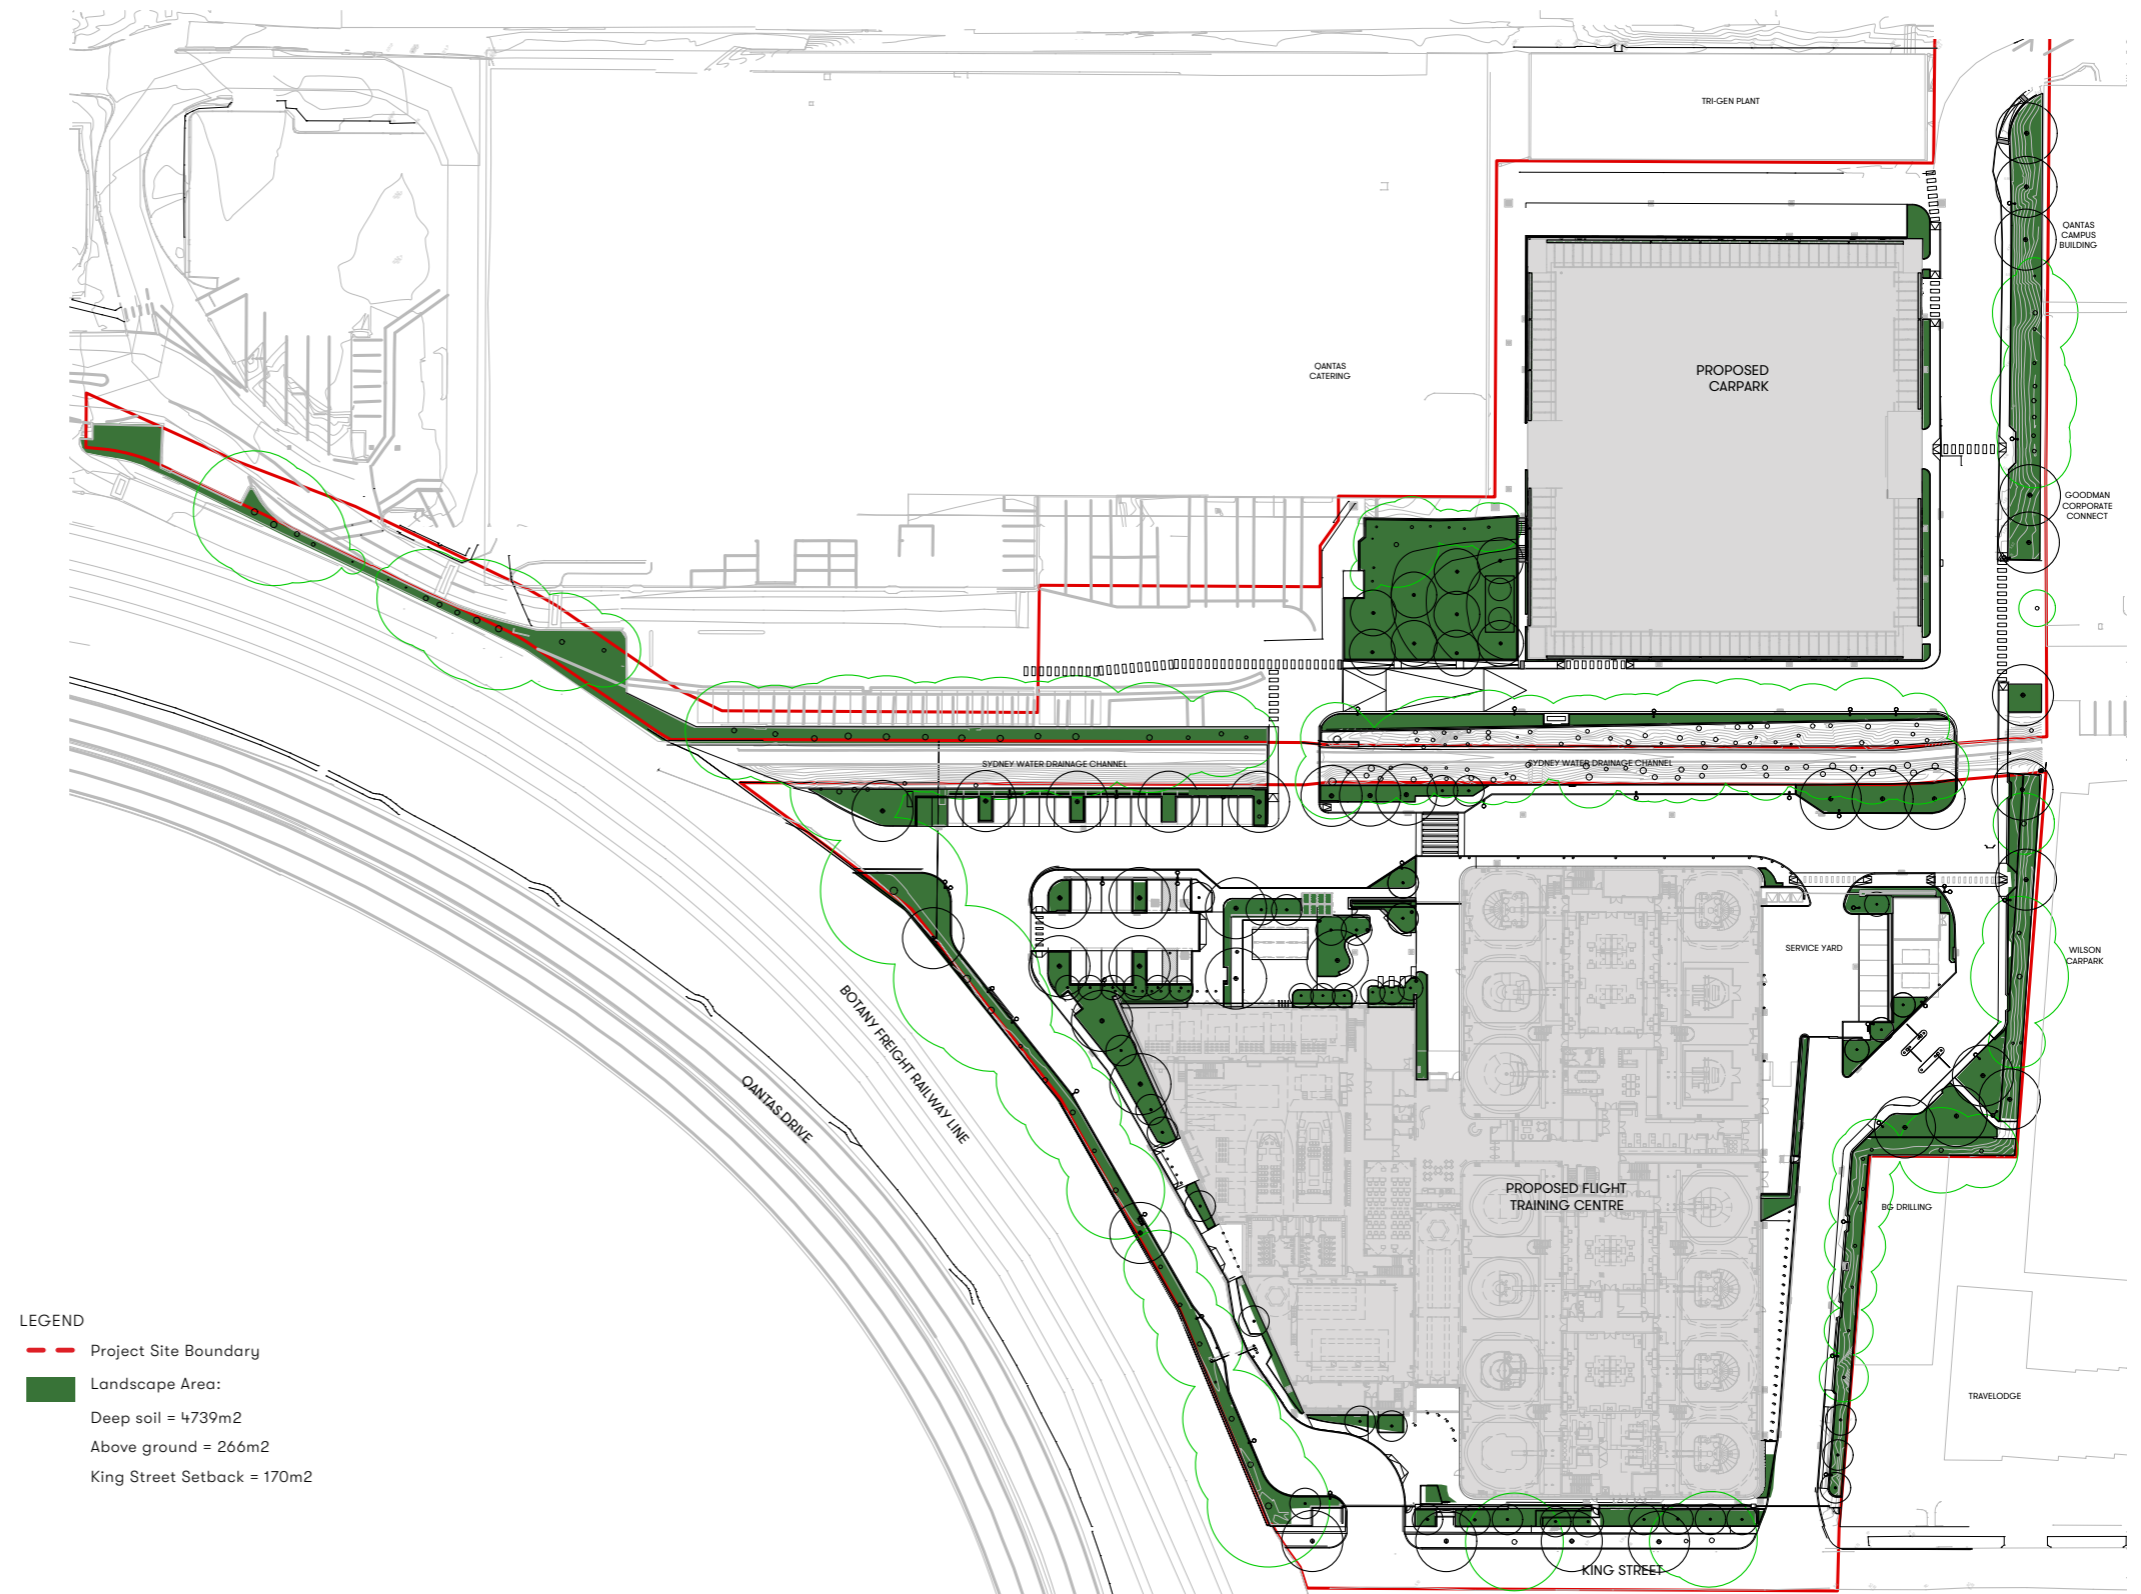
Figure 26 Landscape Provision Plan

The DCP calls for a minimum of 10% of a site to be landscaped. The front setback on King Street has to be excluded from this calculation in accordance with the DCP part 6.3.5. On the ground floor the landscape area has been maximised where possible while considering access, servicing and maintenance access. In particular the periodic replacement of the simulators requires significant hard stand access. Additional landscape area is achieved by providing planting above ground to including a green roof to the bus shelter, 21 no. facade planters to the car park and rooftop planters to the perimeter of the carpark rooftop.

There is no % requirement for deep soil in employment zone in the DCP. Along with the landscape area, deep soil zone has been maximised where possible. According to the DCP setbacks are included in the deep soil calculation.

The site which has a total area of 30,484m<sup>2</sup> achieves a deep soil area of **4739m<sup>2</sup>** or **15.35%**.

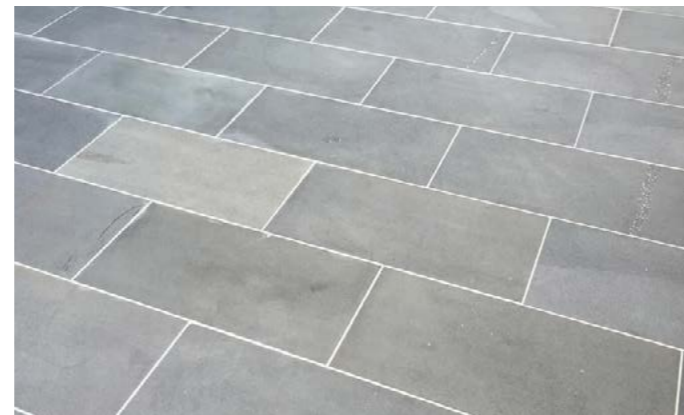
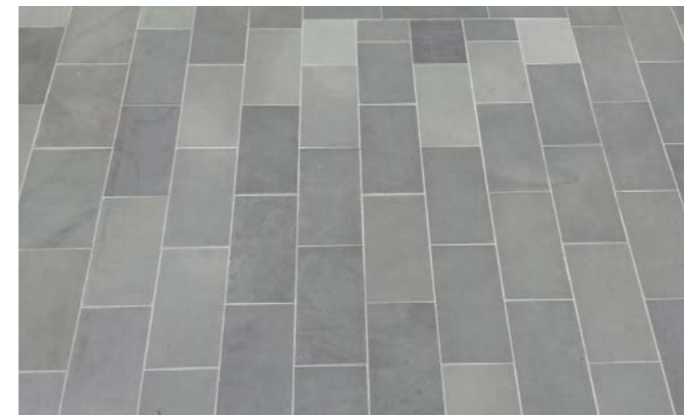
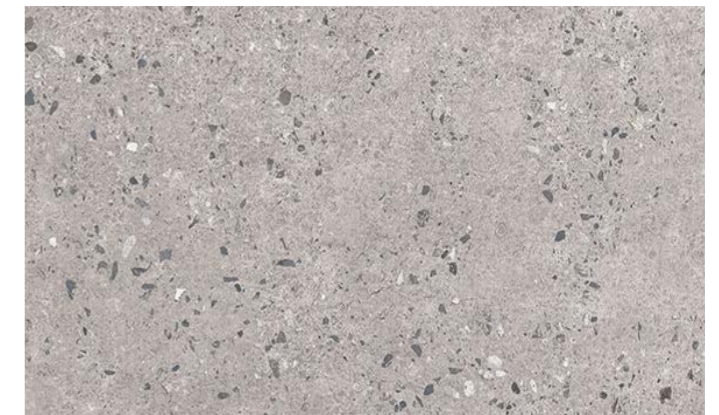
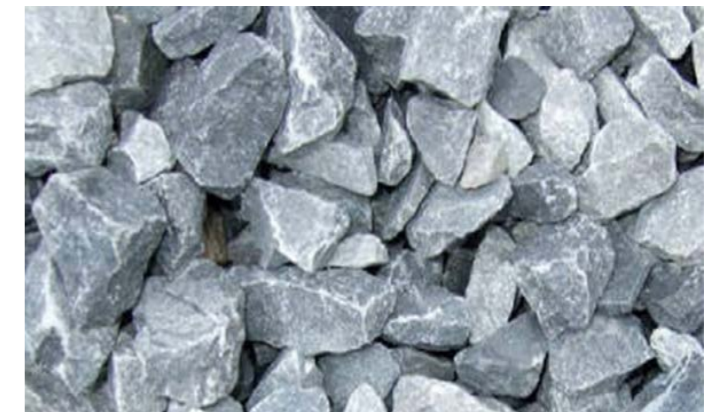
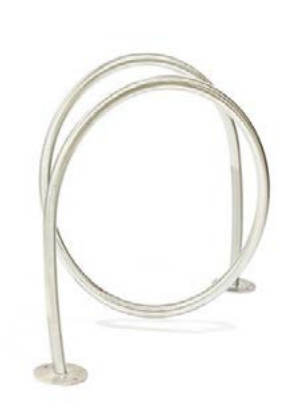
Figure 27 Landscape Materials Palette

800x400x80mm Granite Paving

400x200x80mm Granite Paving

Natural Concrete, exposed aggregate; liightly washed

Gravel

Bike Racks

Matching shelters for the bus stop and staff area are cantilevered steel structures supported off the fence line with green roofs.

Furniture proposed will be durable, easily cleaned and include anti-graffiti coatings where necessary to reduce vandalism. Tactiles and other pedestrian safety devices will be installed as required by the relevant standards.

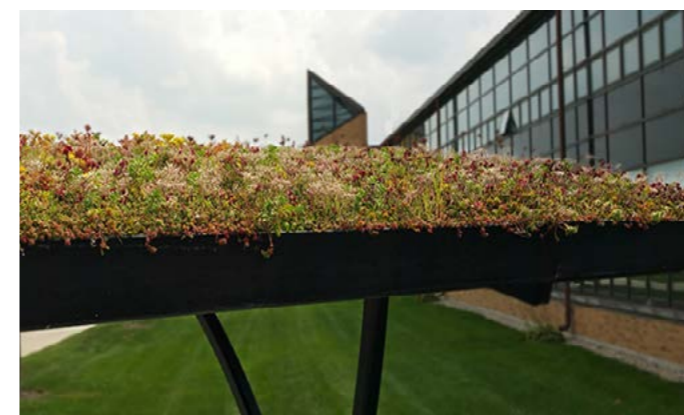
Shelters - Cantilevered steel structure with green roof

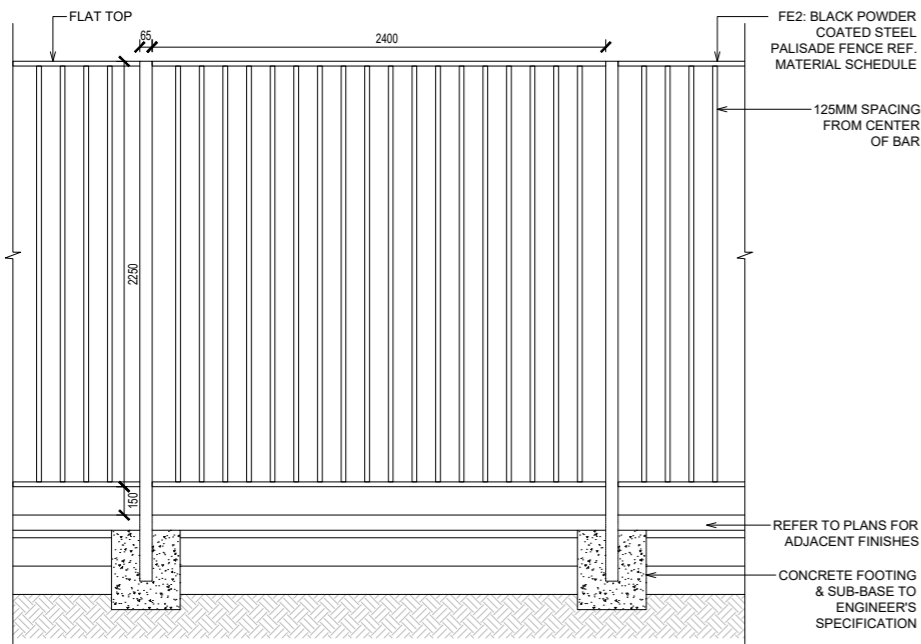
1 FE2 - TYPICAL SECURITY FENCE DETAIL  
1:20

NOTE: SHOP DRAWINGS FROM FABRICATOR TO BE PROVIDED PRIOR TO INSTALLATION FOR APPROVAL BY LANDSCAPE ARCHITECT.  
 • INCLUDE 1 REMOVABLE FENCE PANEL 2400MM FOR HPU REPLACEMENT TO SIMS BUILDING KING STREET; REFER TO LANDSCAPE PLANS
